ARCHAEOLOGICAL  
SERVICES  
DURHAM UNIVERSITY

on behalf of  
R Stevenson & Sons

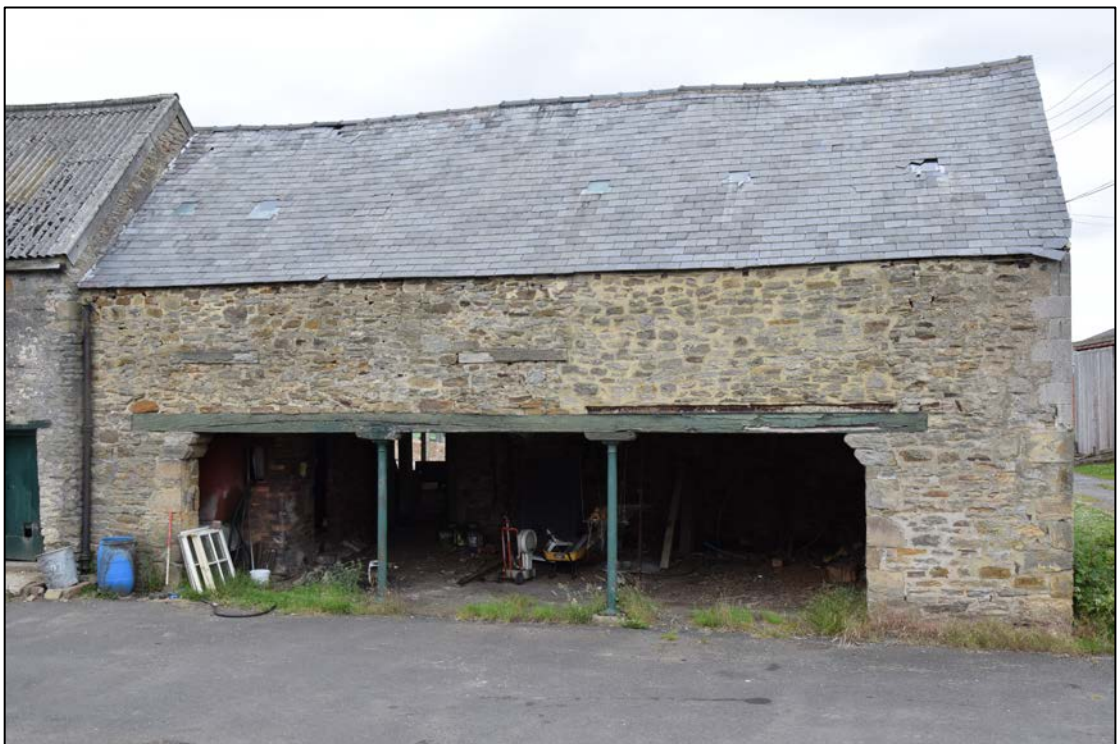
Photograph 36: The south face of the cart shed / granary, building B. Note the sills of blocked windows, left and centre, which project slightly from the wall face. A matching window at the right has been replaced by a larger blocked opening

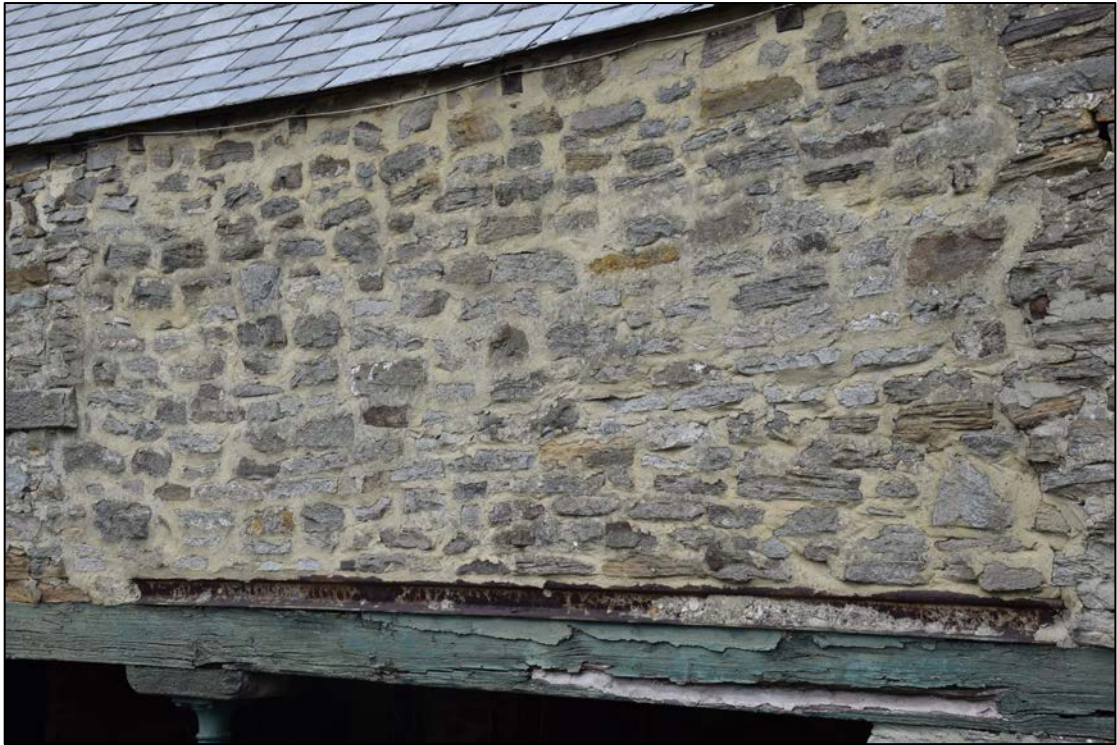
Photograph 37: Detail of the blocked opening at the east end of the granary. The masonry rests on a length of railway line
