# BREAKSPEARS

## THE EARLY HOUSE

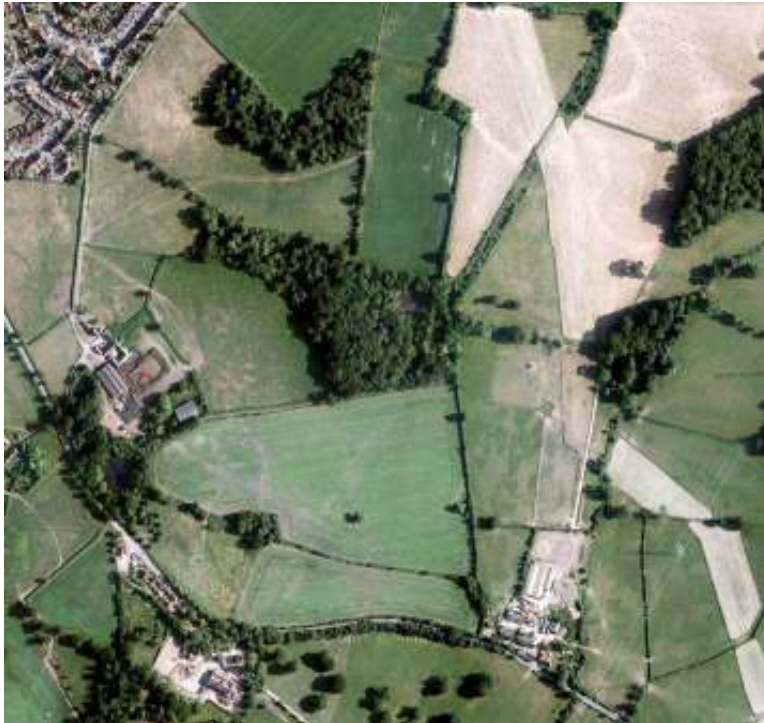
*Fig. 2: Aerial view of Breakspears today, with the avenue of oak trees stretching across the fields to the north-east of the house visible in crop-marks. (©Google Maps).*

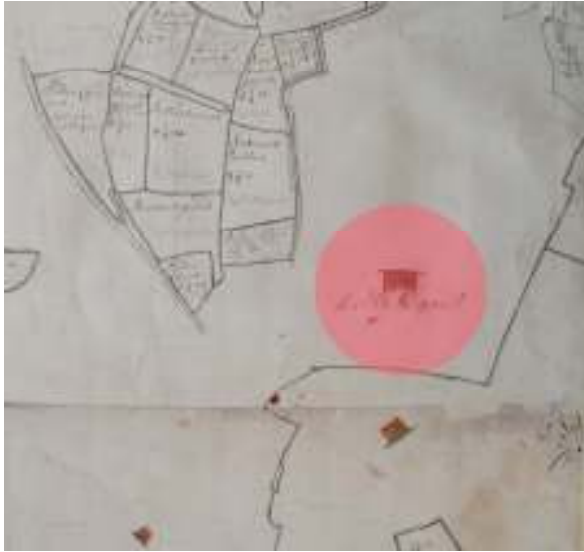
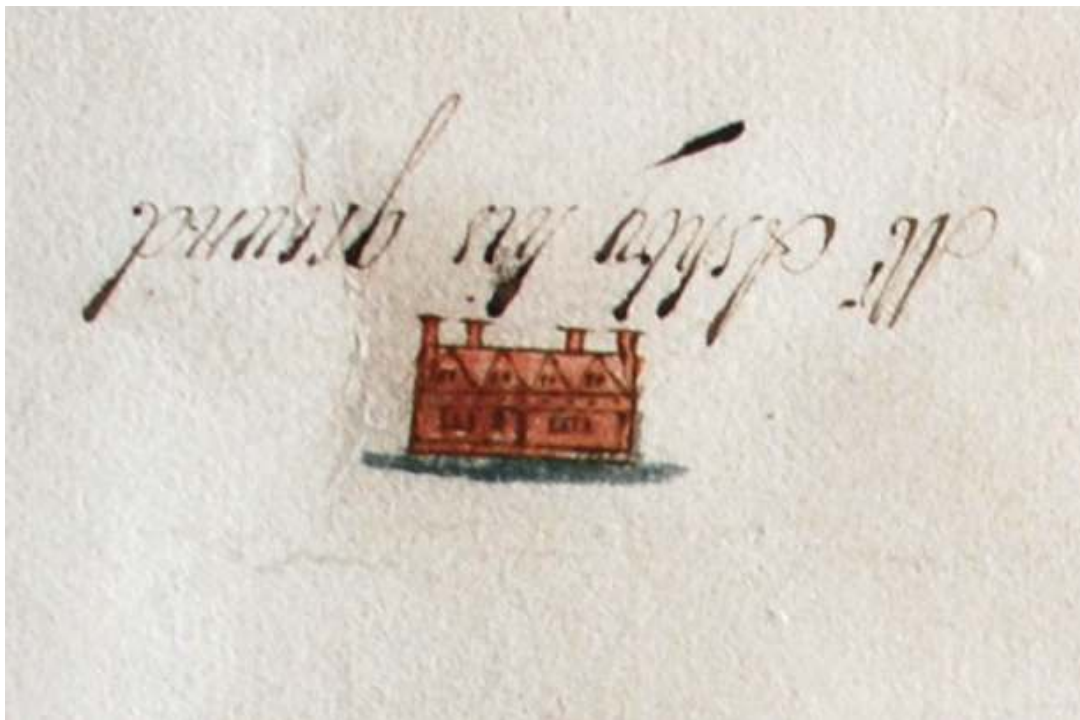
*Fig. 3: Extract from the 1681-85 Harefield Portion of the Estate Map – upper image depicts Breakspears and the surrounding countryside; lower figure is a close-up depiction of the house.*

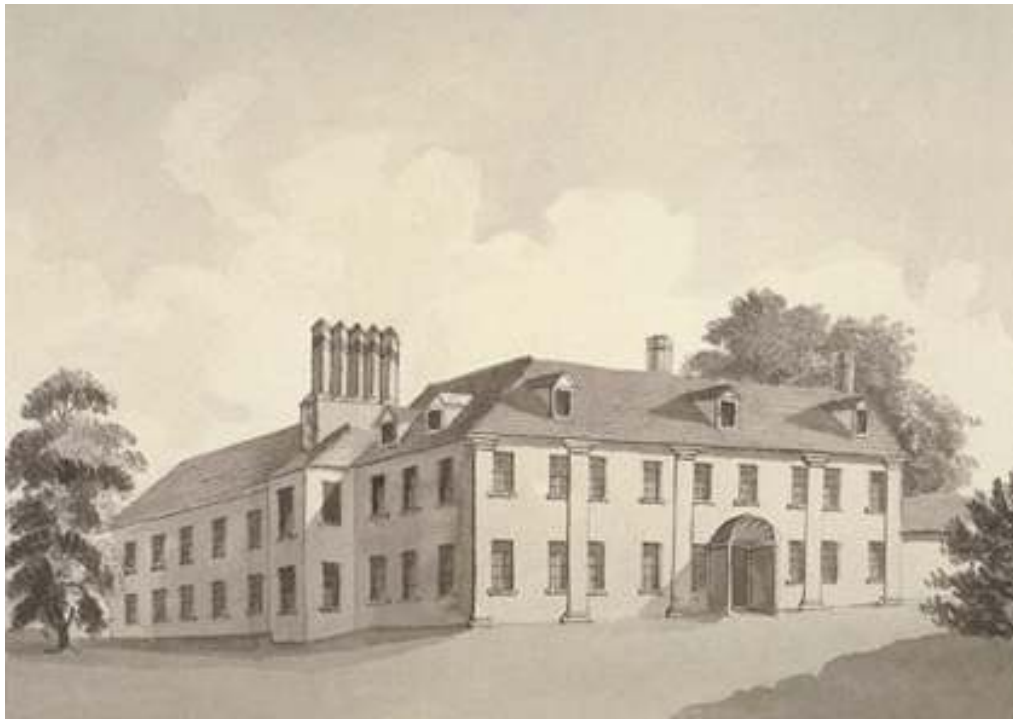
*Fig. 8: 1794 image of Breakspears.*

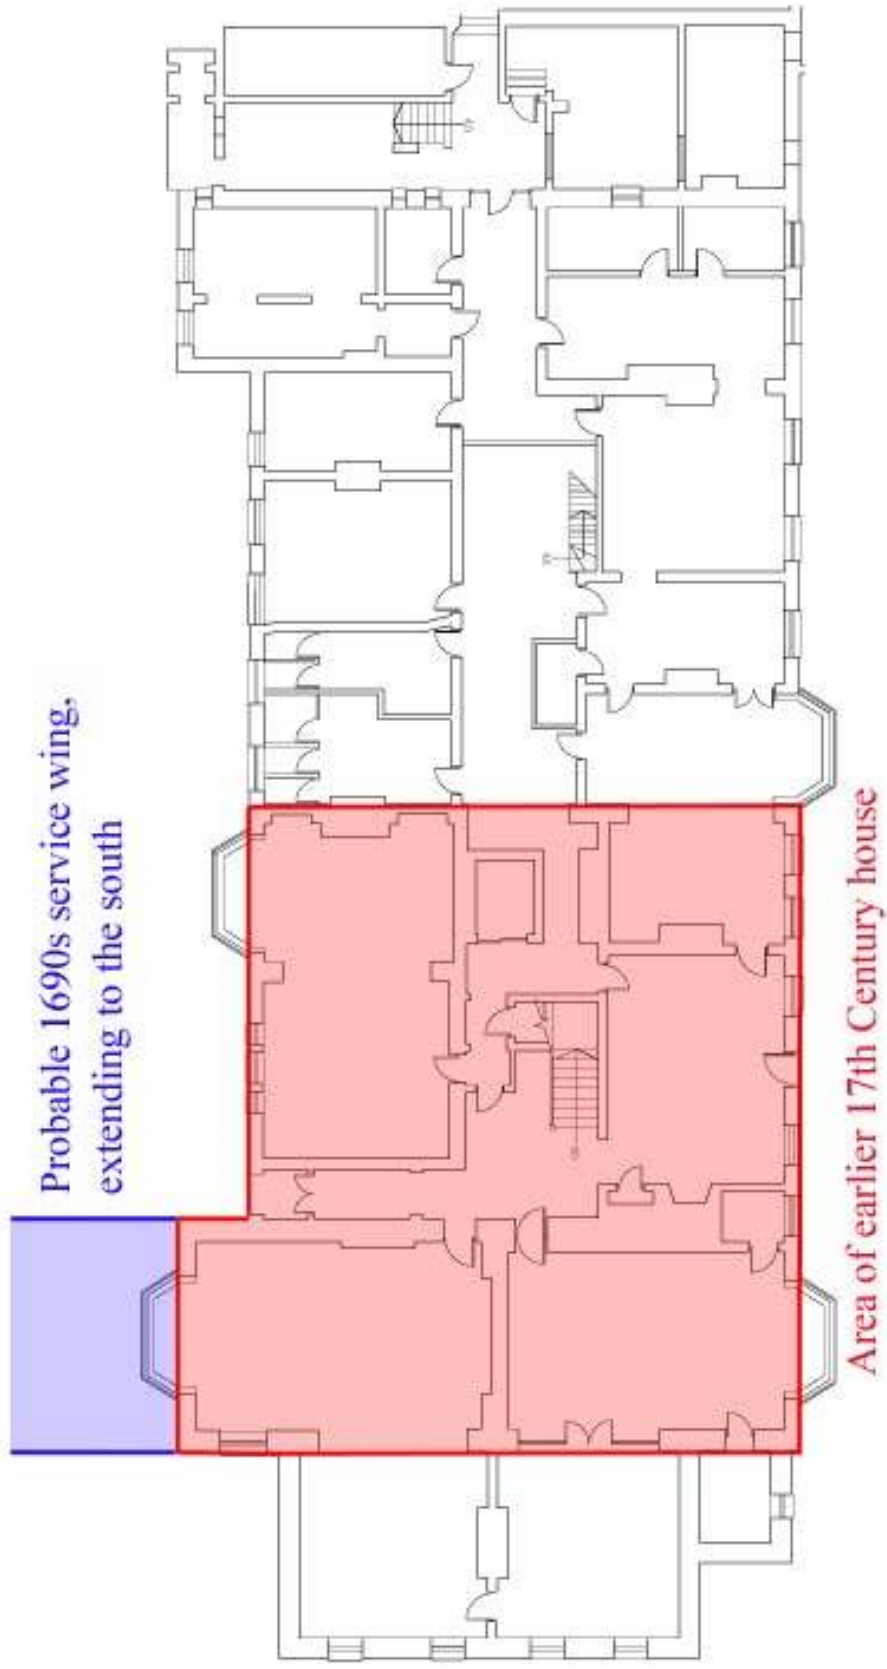
Fig. 10: Floor-plan of Breakspears, with the area of the earlier (17<sup>th</sup> Century) House highlighted.

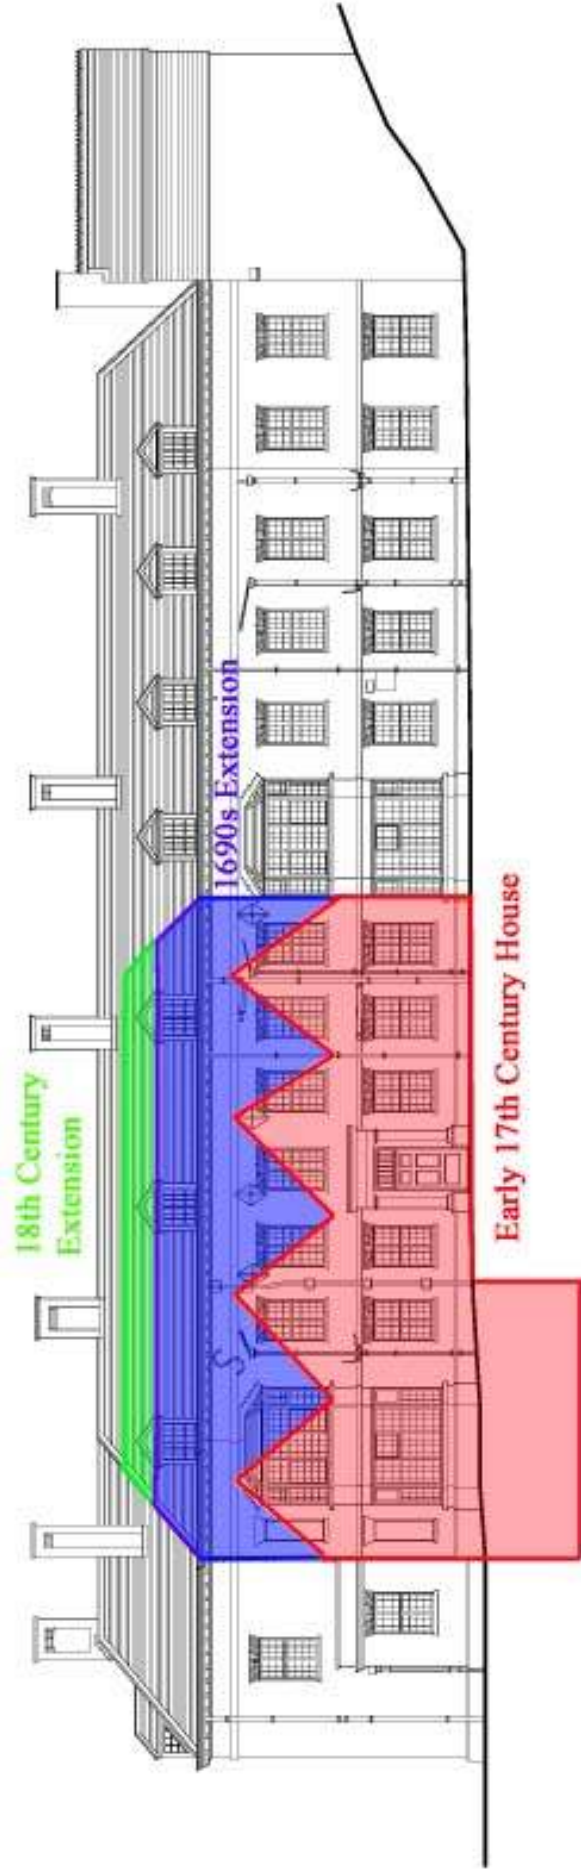
Fig. 11: Northern elevation of Breakspears, with the earlier (17<sup>th</sup> – 18<sup>th</sup> Century) House highlighted and labelled, according to developments (essentially extensions) over time. It should be noted that this is purely an indicative elevation, simply to show probable profiles at the time of constructions. Much of this has now been removed (see fig. 12).

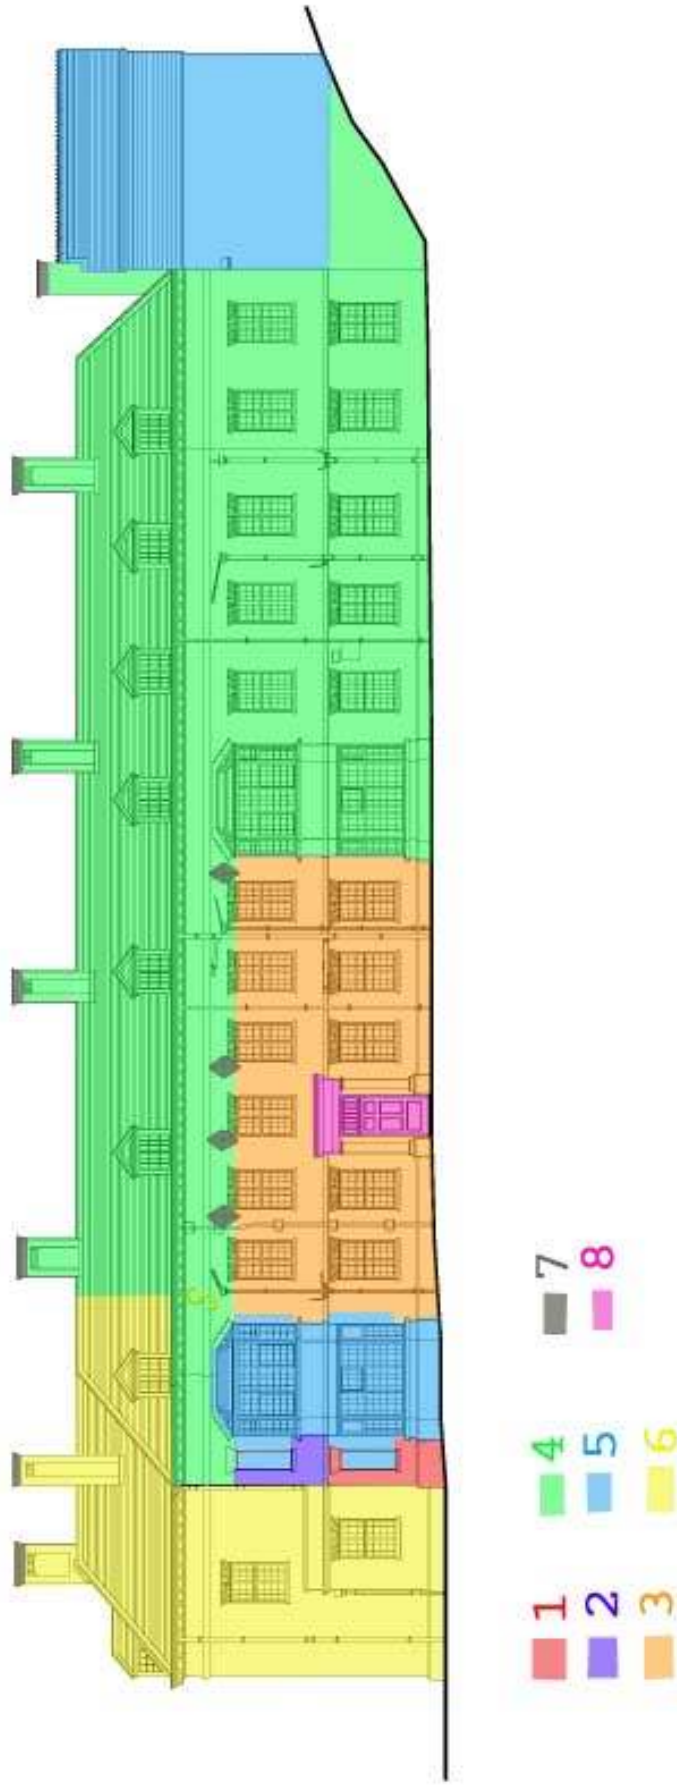
Fig. 12: Elevation showing the physical remains from the different phases of development of Breakspears, northern frontage. The different phases represented are as follows. NB only the first three phases are discussed in this report.

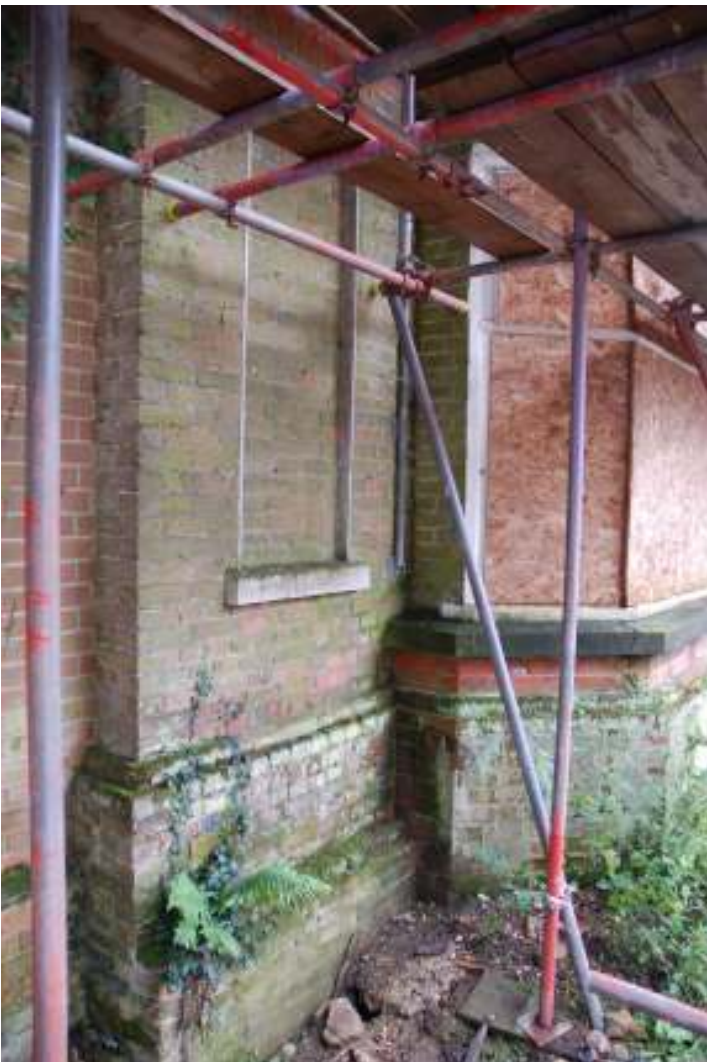
*Fig. 16: Photograph of the lower part of the eastern part of the northern wall – in English bond and part of the earlier 17<sup>th</sup> Century house.*

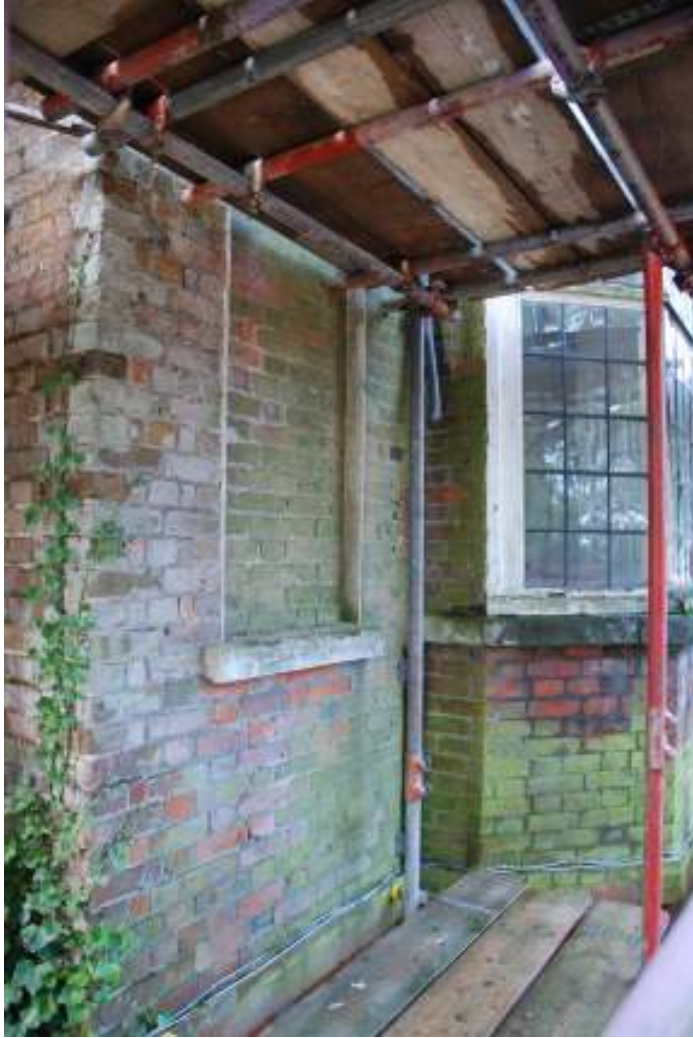
*Fig. 17: Photograph of the upper part of the eastern part of the northern wall – in Flemish bond and part of the mid-1690s extension.*

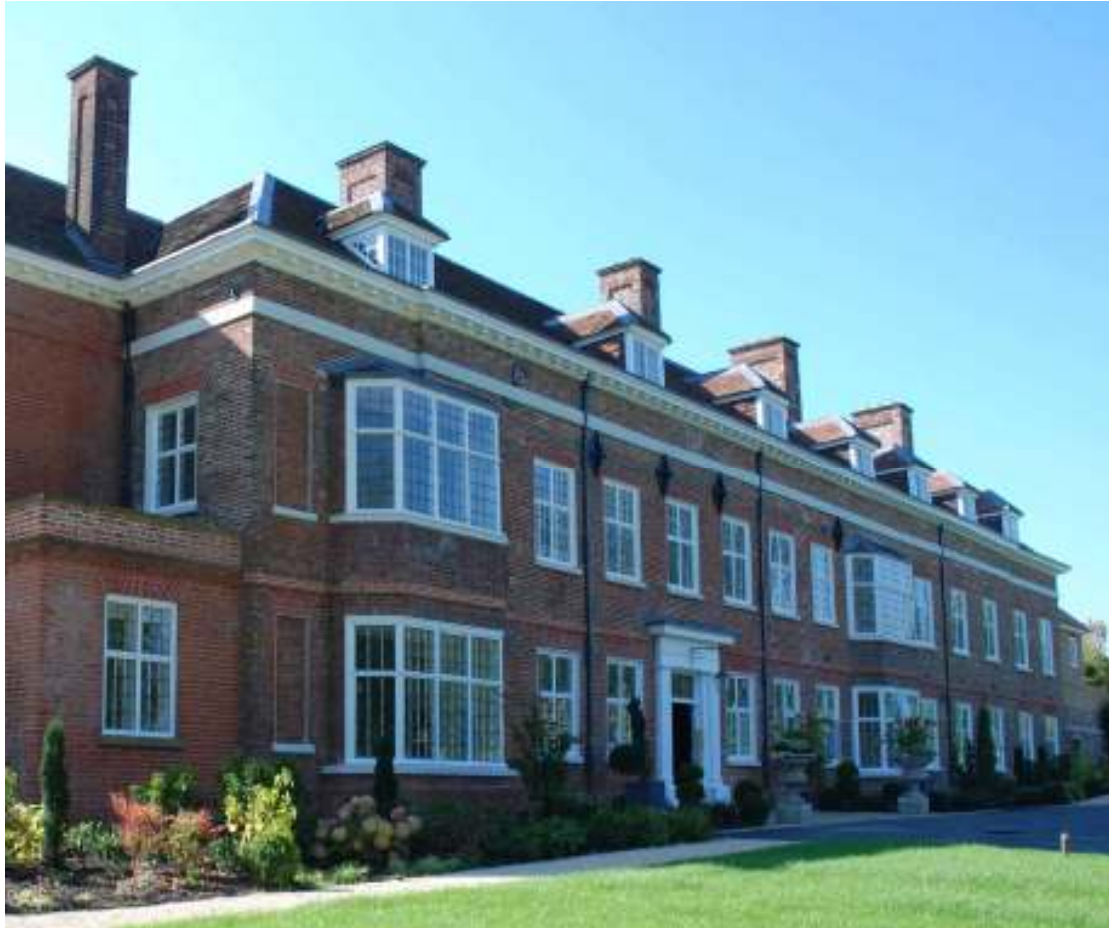
*Fig. 18: Photograph of the northern frontage of the house. The façade can be seen surrounding the front-door, with the 'step' in the brickwork visible above the upper nearest bay-window.*

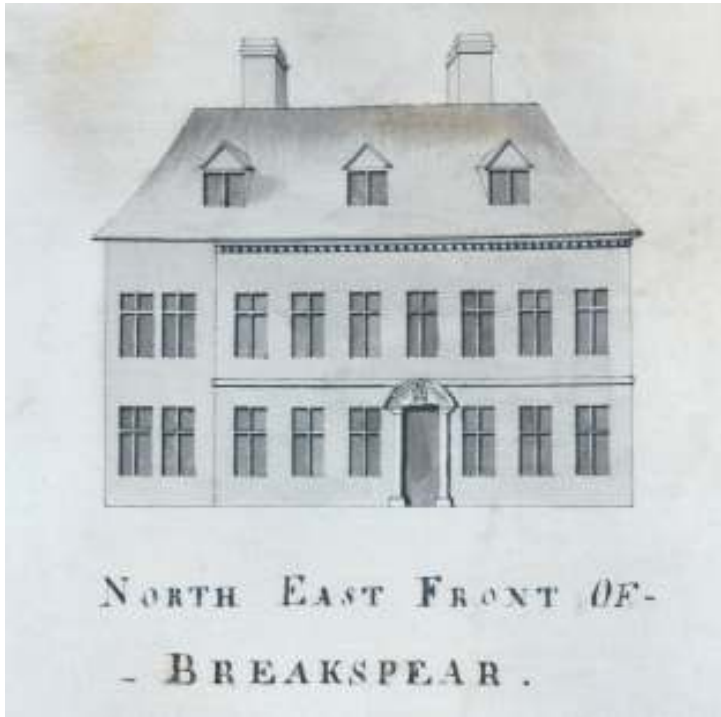
*Fig. 19: 1771 Northern Elevation – the façade can be seen surrounding the door.*

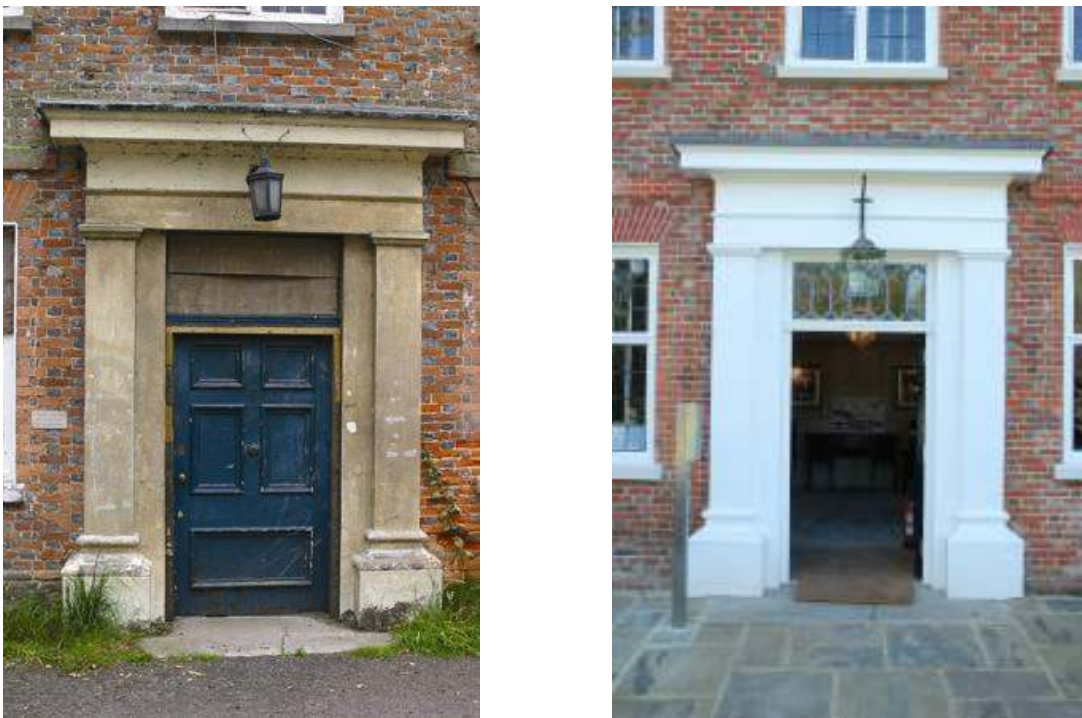
*Fig. 25: Photographs of the door today – taken before and after restoration.*

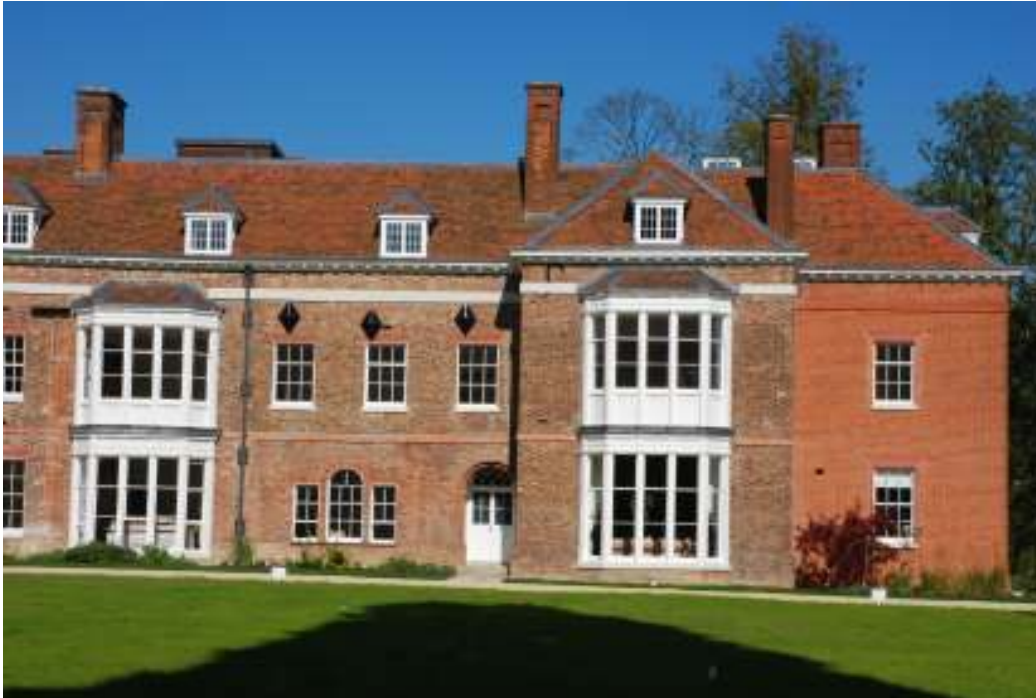
*Fig. 30: Photograph of the southern frontage today.*

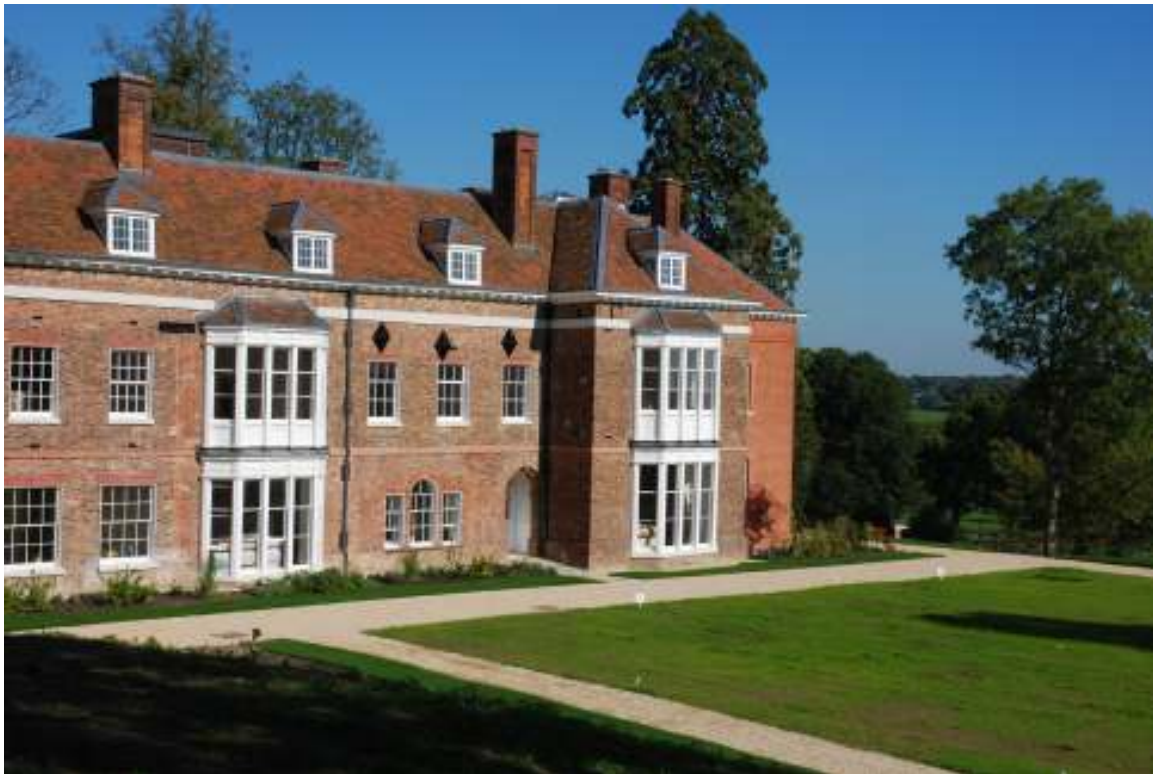
*Fig. 31: Photograph of the southern frontage today. The line of abutting brickwork, representing the original south-western corner of the earlier 17<sup>th</sup> Century house, can be seen just to the left of the nearest bay windows.*

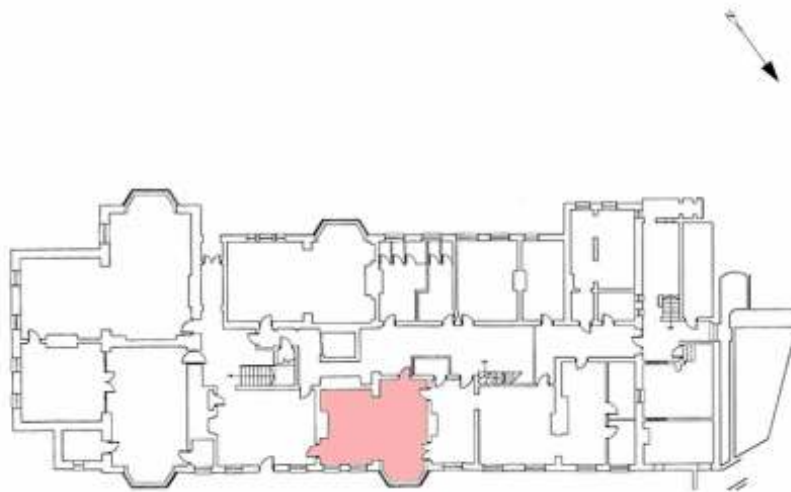
*Fig. 34: Plan of the archaeological features observed in the dining room.*

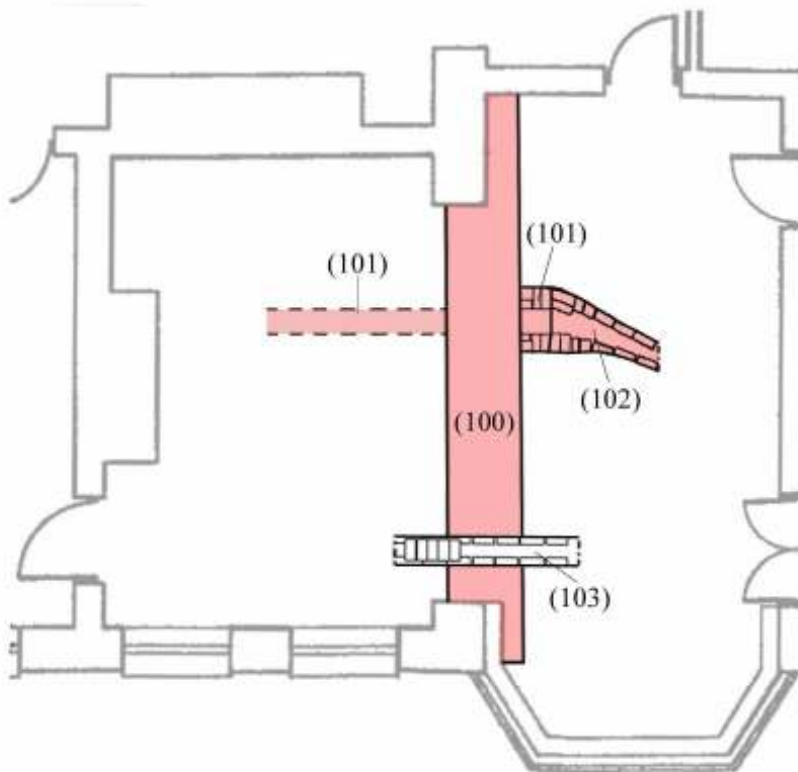
- 7.3.2** Feature (103) was the most recent feature in the sequence, and of relatively low relevance to the understanding of the development of Breakspears. It was an iron pipe, *c.*60mm in diameter, lying within a yellow-stock brick channel. It truncated the top of wall (100) at right angles. No brick samples were taken as it was clearly a relatively modern feature.

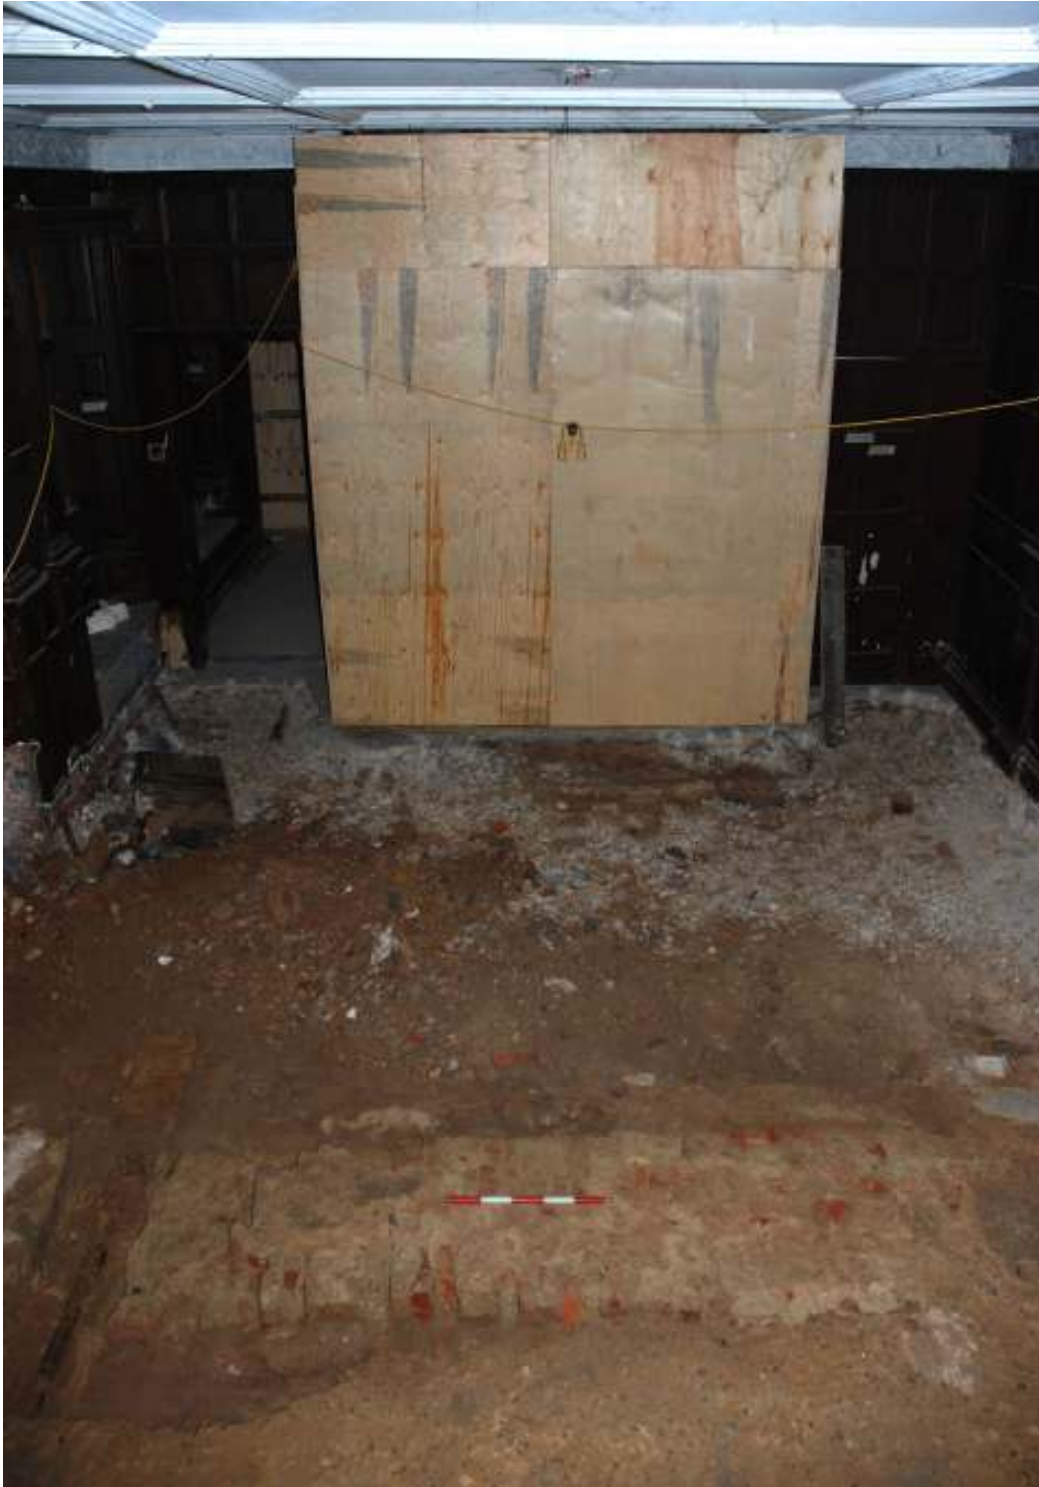
*Fig. 35: Photograph of wall (100), looking east. The boarded-up fireplace is visible in the background.*

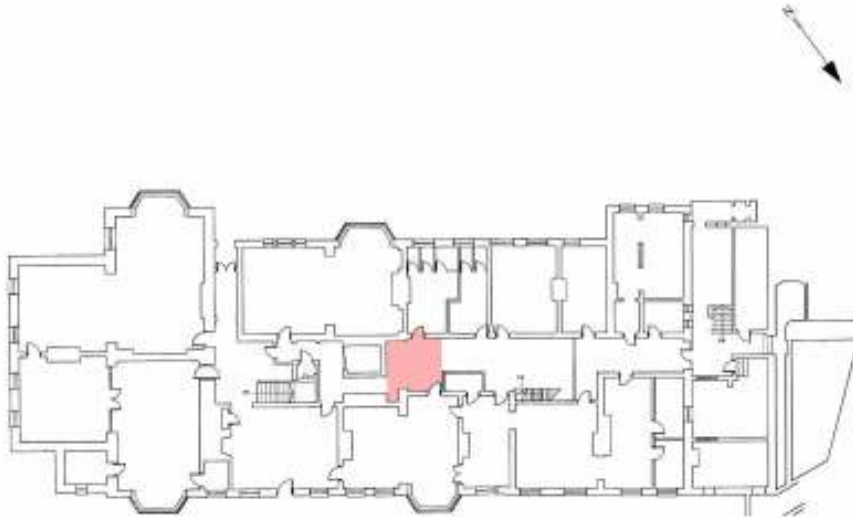
*Fig. 43: Plan of the archaeological features observed in the spine corridor.*

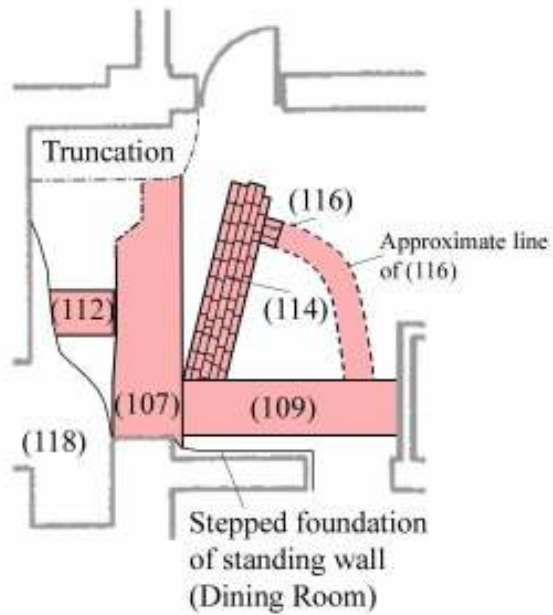
**7.4.2** As mentioned above, wall (107) is the continuation of wall (100) – interpreted as part of the western wall of the earlier 17<sup>th</sup> Century house (fig. 45). It seems to have been slightly less wide here, measuring 0.71 – 0.73m, and was truncated at its southern end.

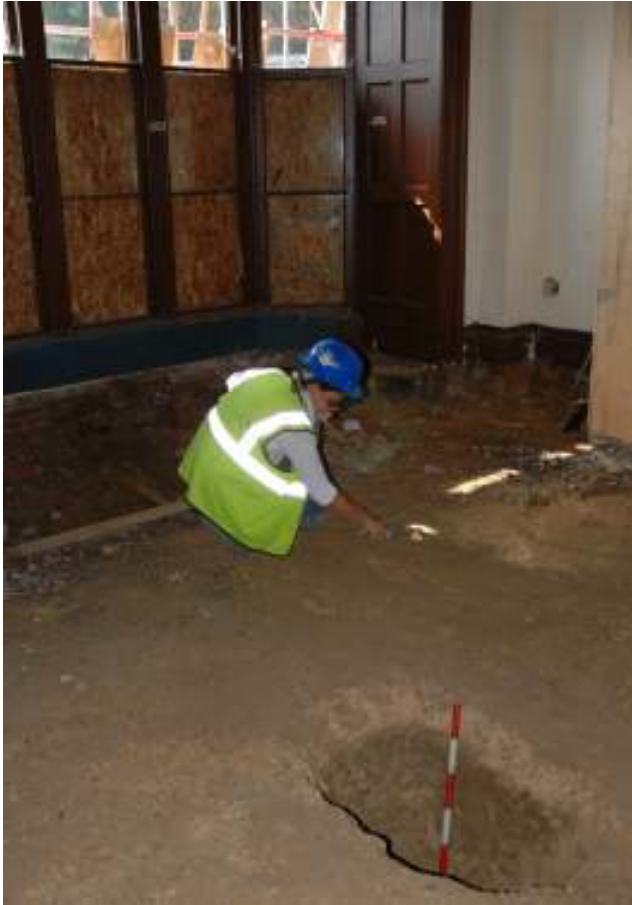
*Fig. 51: Photograph of the excavations in the library, looking south-west. One pit is visible in the foreground, which revealed concrete floor surface directly overlying natural deposits.*

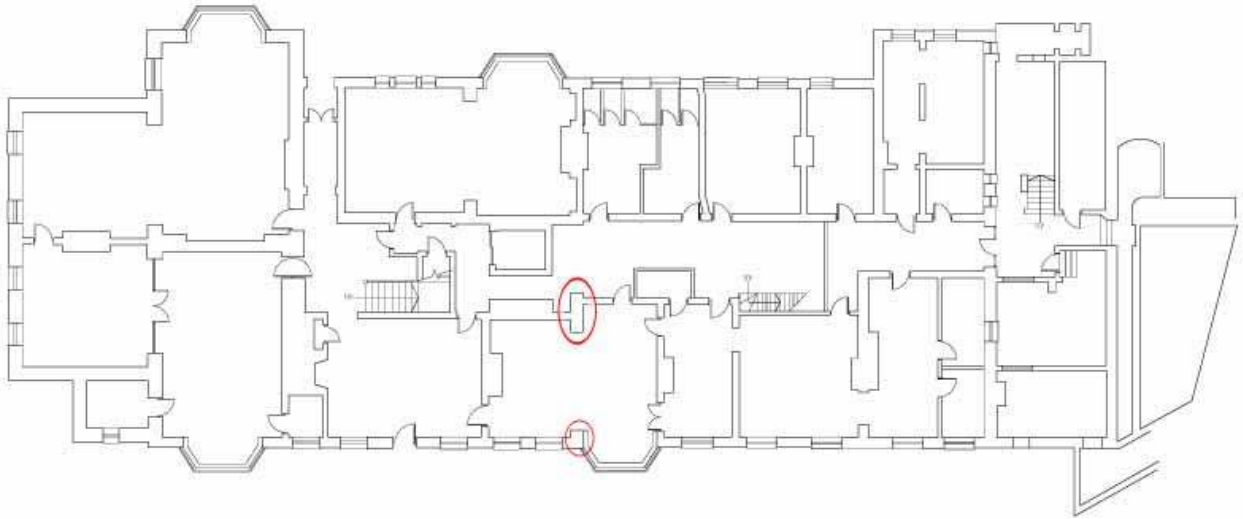
*Fig. 52: Plan of the modern house, with the existing evidence for the earlier western wall in the dining room ringed.*

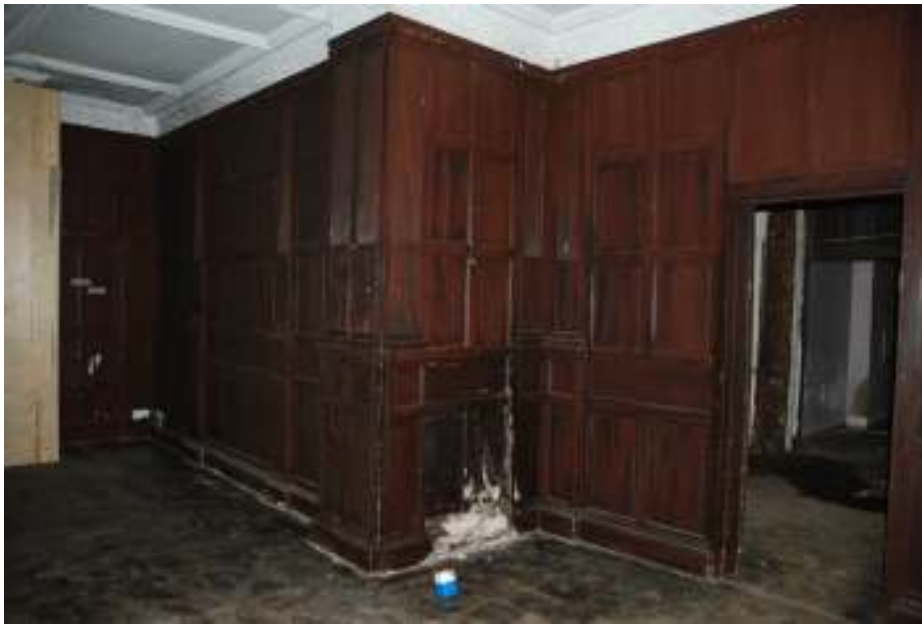
*Fig. 53:  
Photograph of the  
'stub' wall  
projecting out of  
the southern wall  
of the dining room  
(part of the earlier  
western wall of the  
house).*

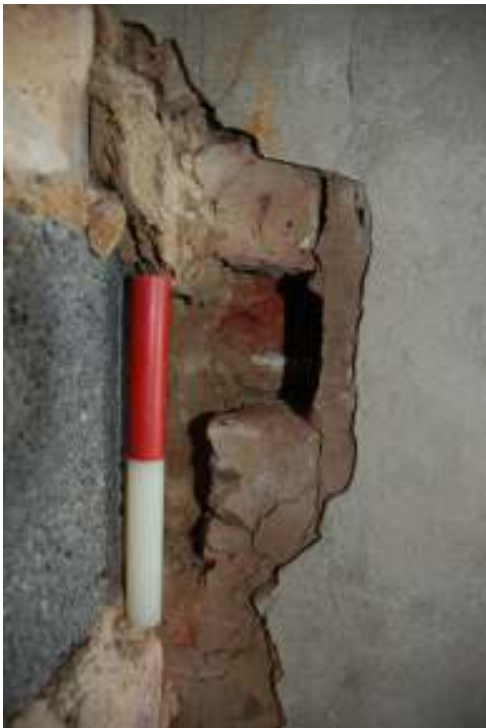
*Fig. 54: Photograph showing the internal face of the earlier western wall, exposed in the 'secret' cupboard' in the dining room.*

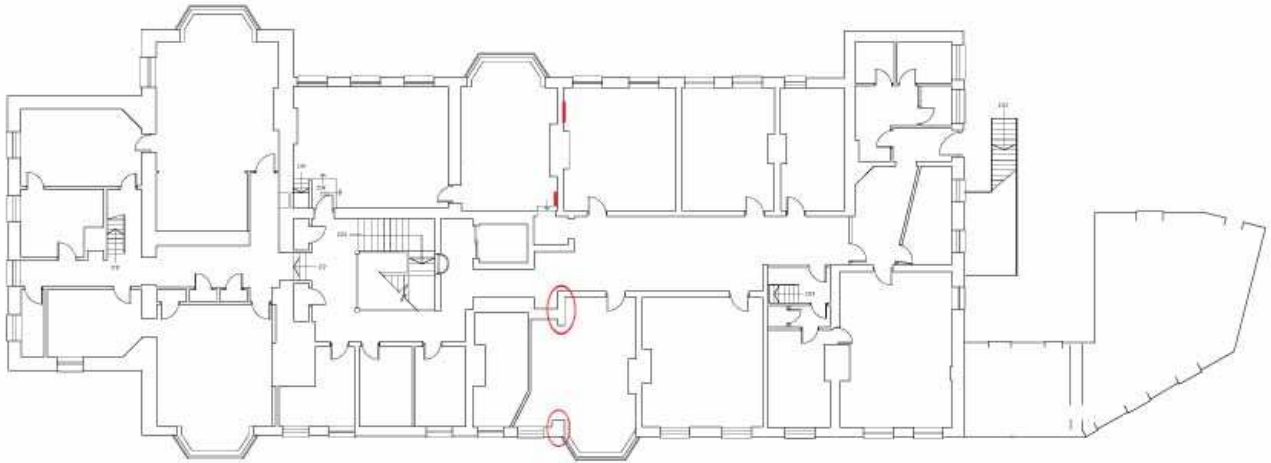
*Fig. 55: Plan of the first floor of the modern house, with the existing evidence for the earlier western wall ringed.*

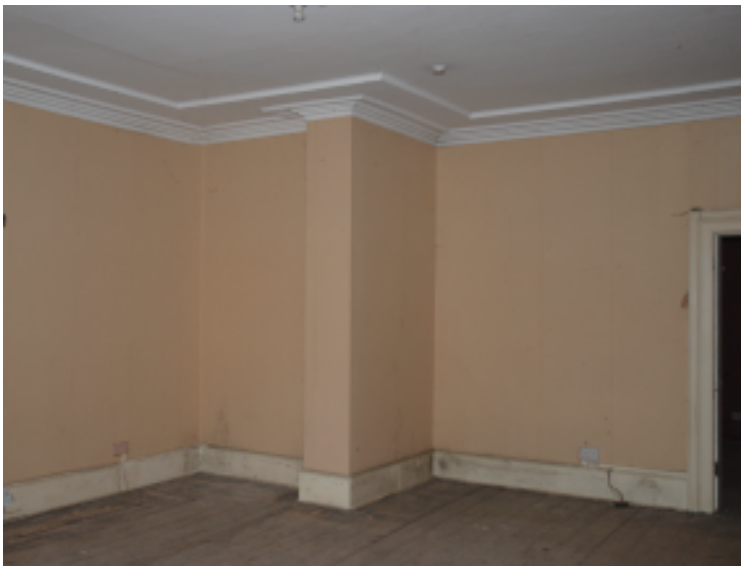
*Fig. 56: Photograph of the stub wall in room F22, projecting out of the southern wall (part of the western wall of the earlier house).*

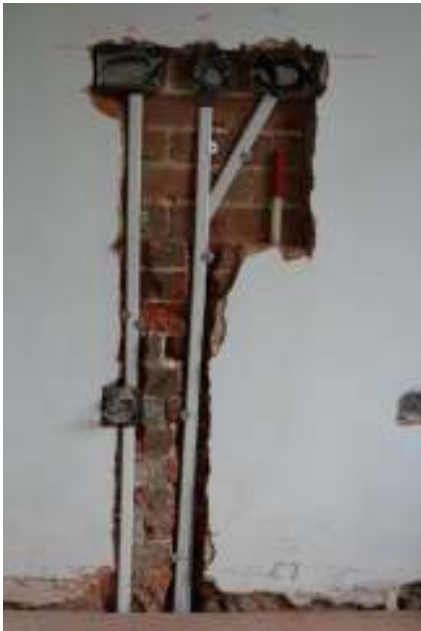
*Fig. 57: Photograph of the patch of the external earlier western wall observed in room F9 (first floor).*

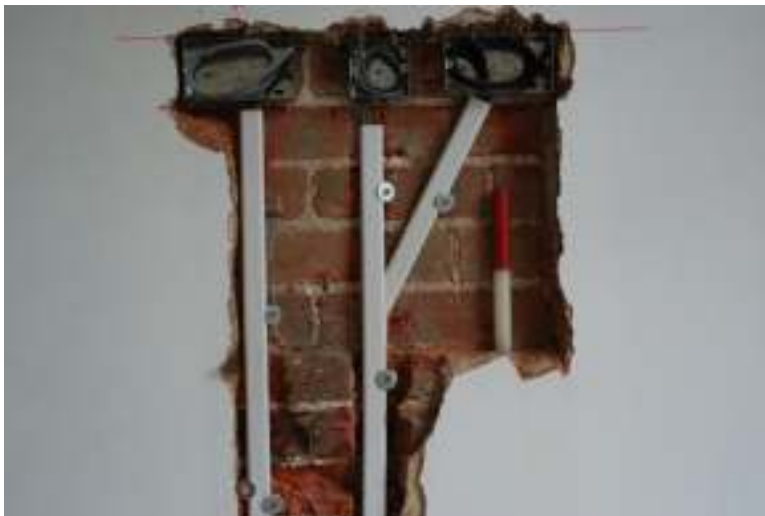
*Fig. 58: Close-up photograph of the patch of the external earlier western wall, showing the step-in in the brickwork (the scale is resting on this).*

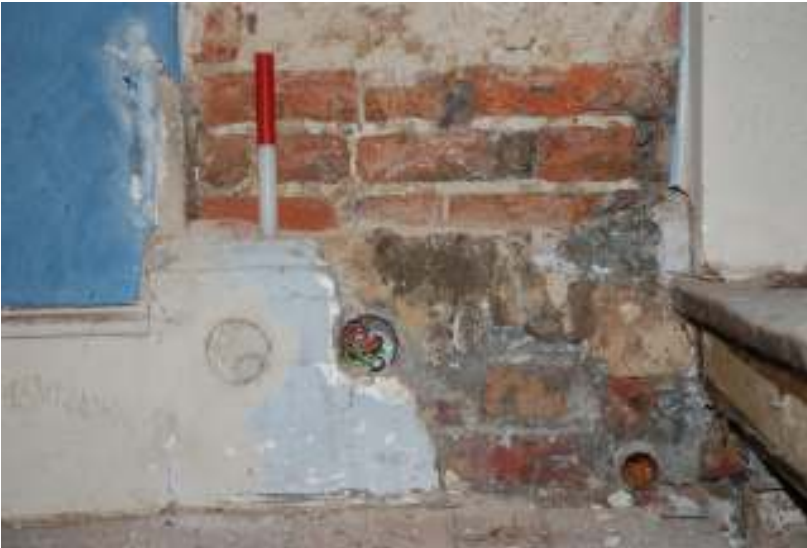
*Fig. 59: Photograph of the interior face of the earlier western wall observed in room F8.*

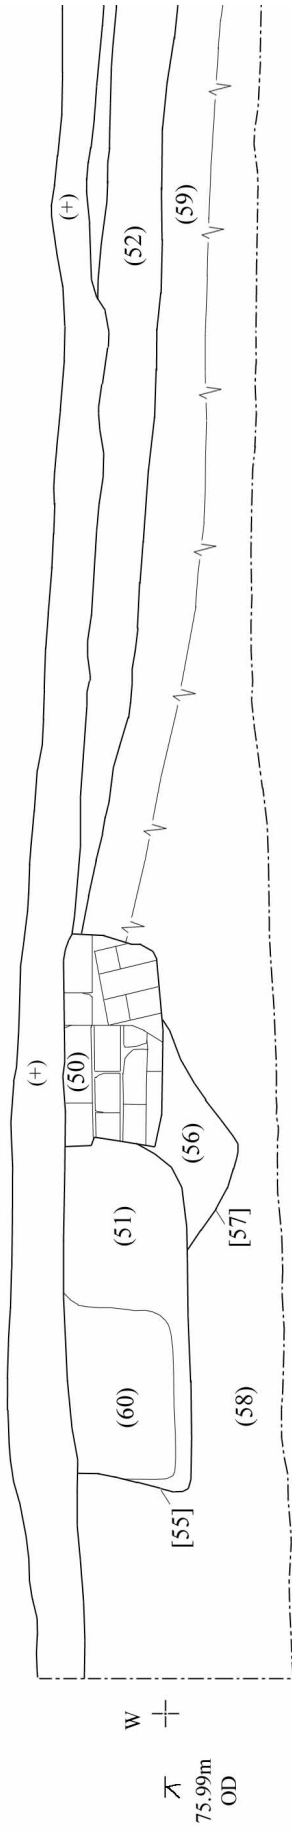
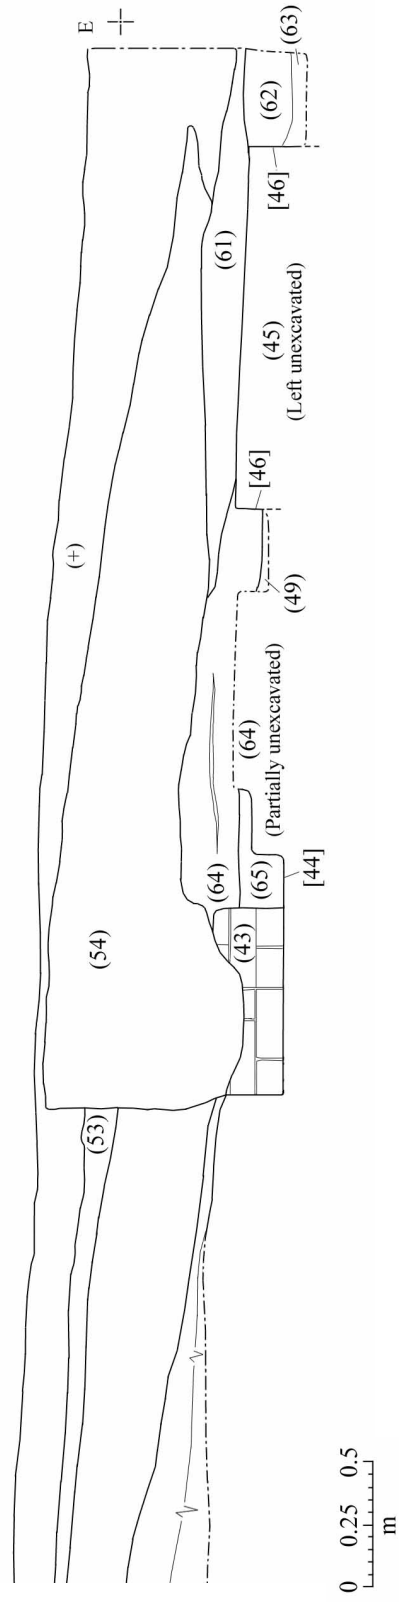
Fig. 62: South-facing section of the trench, showing the main archaeological deposits.

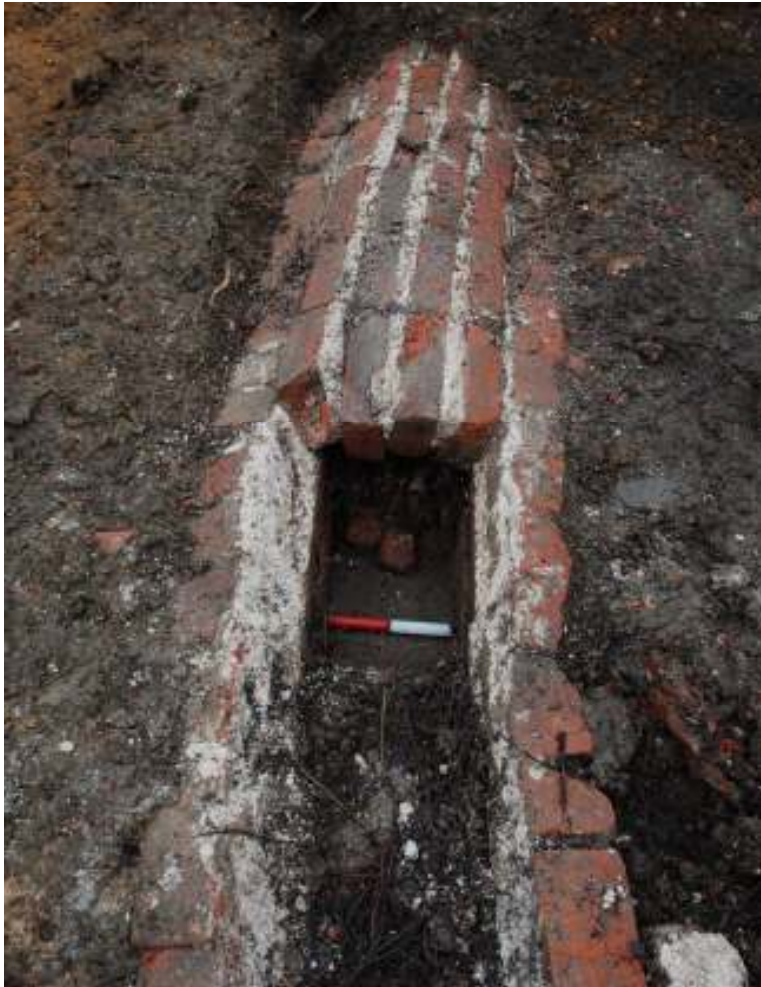
*Fig. 78: Photograph of the brick drain (41).*

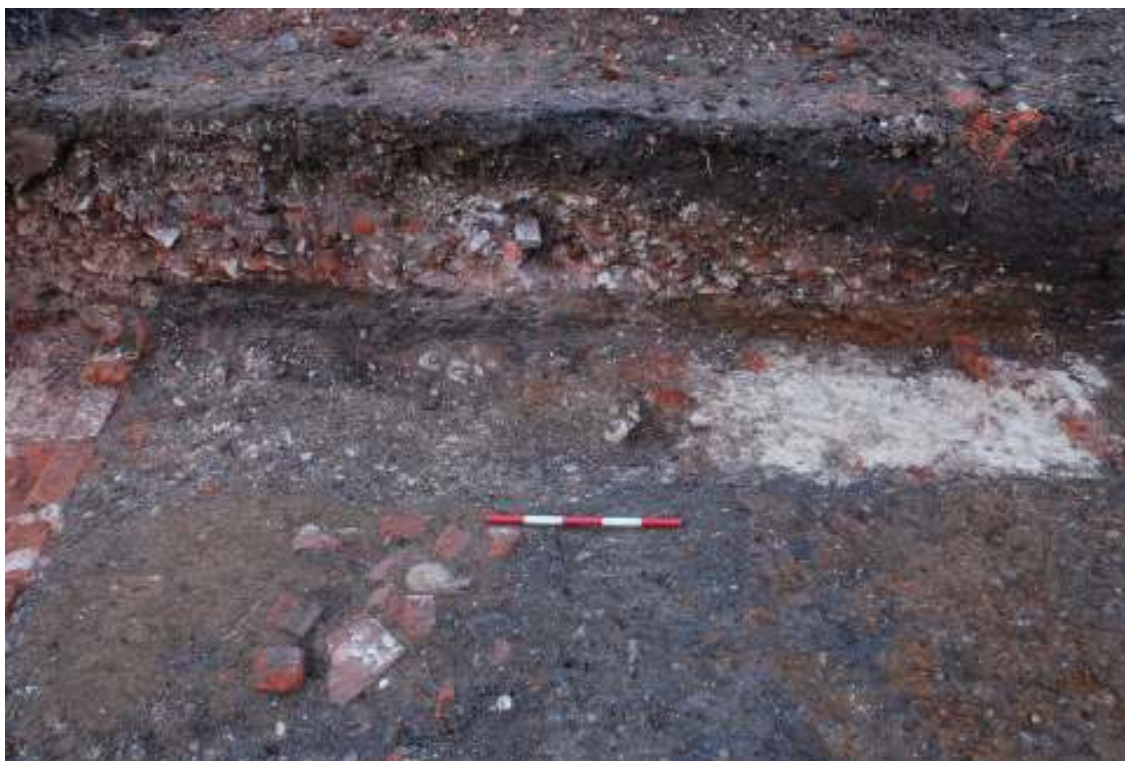
*Fig. 79: Photograph of wall base (45) (right-hand side of the image) and layer (64) left-hand side of the image). Patches of orange gravel (61), thought to have been part of the path, can also be seen in section overlying wall base (45) and in plan to the south of (45).*
