# BREAKSPEARS

## THE EARLY HOUSE

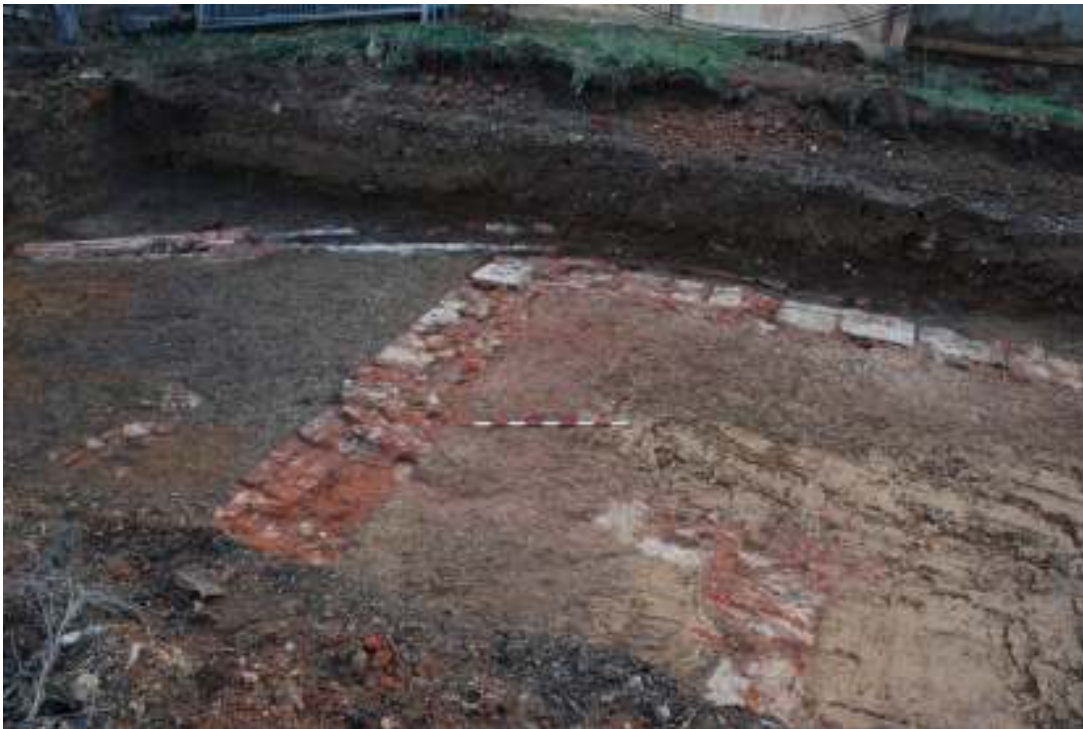
*Fig. 82: Photograph of brick and mortar deposit (47), clearly enclosed within wall (43) and therefore within the area of the 17<sup>th</sup> Century service wing.*

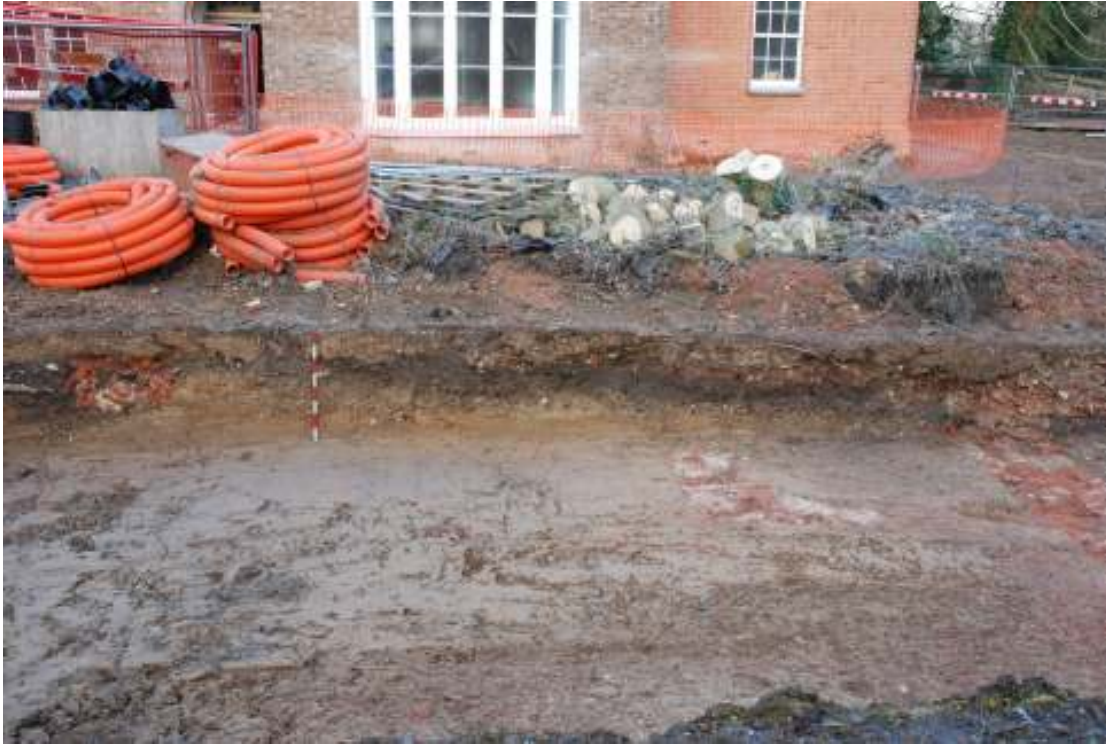
*Fig. 87: Photograph of the south-facing section, within the area of the 17<sup>th</sup> Century service wing. The natural clay deposits can be seen towards the base of the section.*

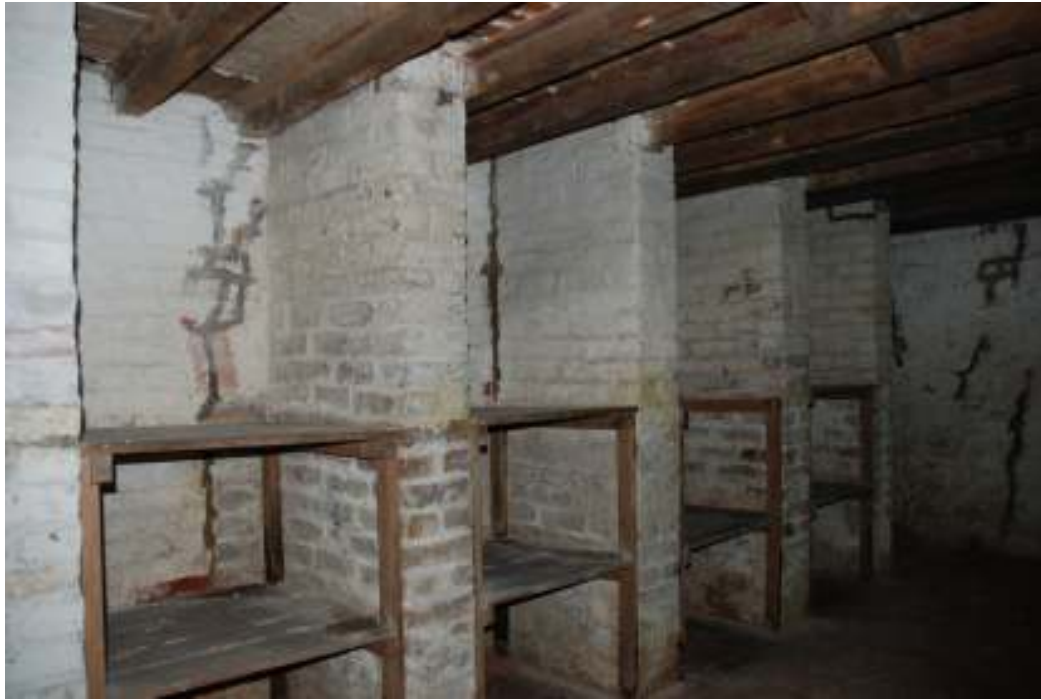
*Fig. 92: Photograph of the southern wall of the earliest southern-most room of the cellar. The remains of a blocked-up doorway are visible in the foreground, on the wall behind one of the later brick columns / partitions.*

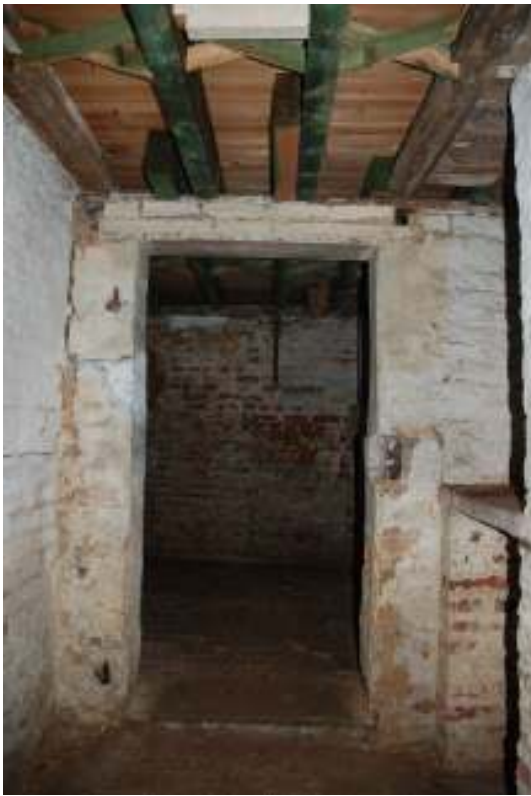
*Fig. 95: Photograph of the doorway through from the original central room into the northern-most room. The two hinge-brackets are visible on the right-hand side of the door, and the catch-rebate on the left-hand side.*

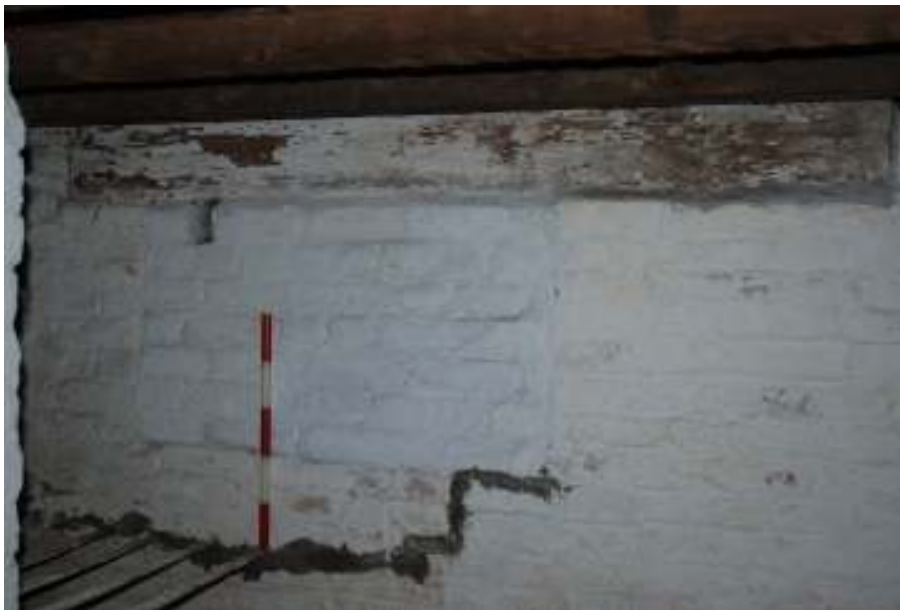
*Fig. 96: Photograph of the blocked-up high window in the eastern wall of the southern-most room, and overlying timber lintel.*

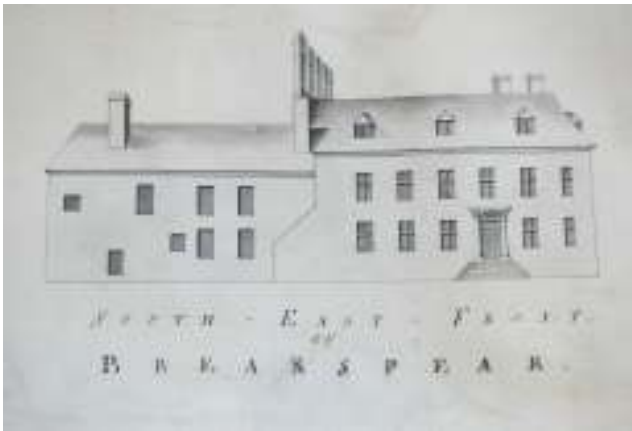
*Fig. 97: 1771 Elevation of the eastern frontage of Breakspears. The contemporary ground-surface, some five steps beneath the entranceway, is clearly visible.*

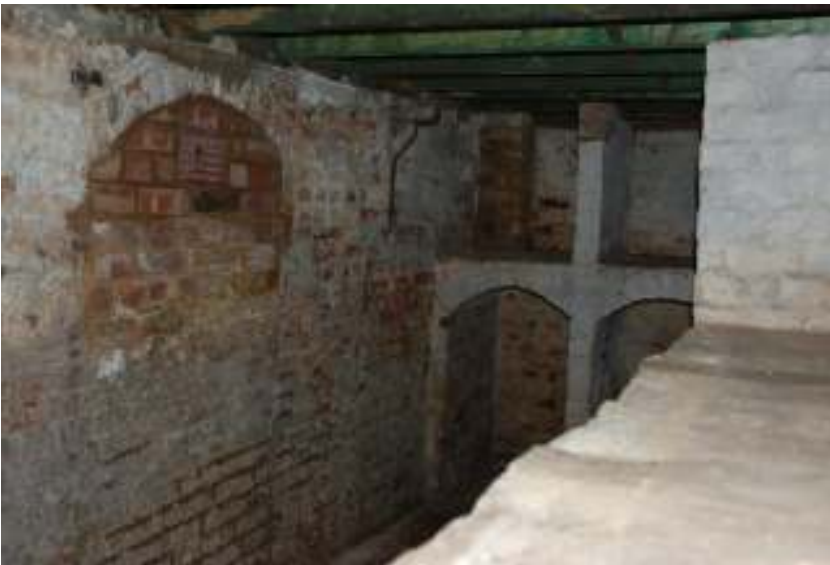
*Fig. 98: Photograph of a blocked-up lightwell (now containing a vent) in the northern wall of the northern-most room in the cellars.*

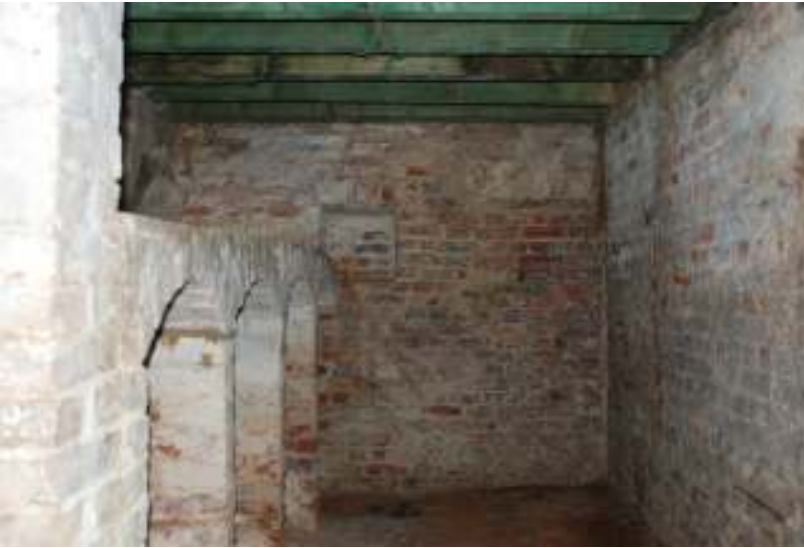
*Fig. 99: Photograph showing the 'soldier course' on the western wall of the northern room (top right of this wall). This may indicate the original entrance into the cellar.*

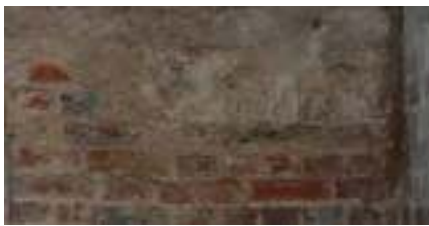
*Fig. 100: Close-up photograph showing the 'soldier course'.*

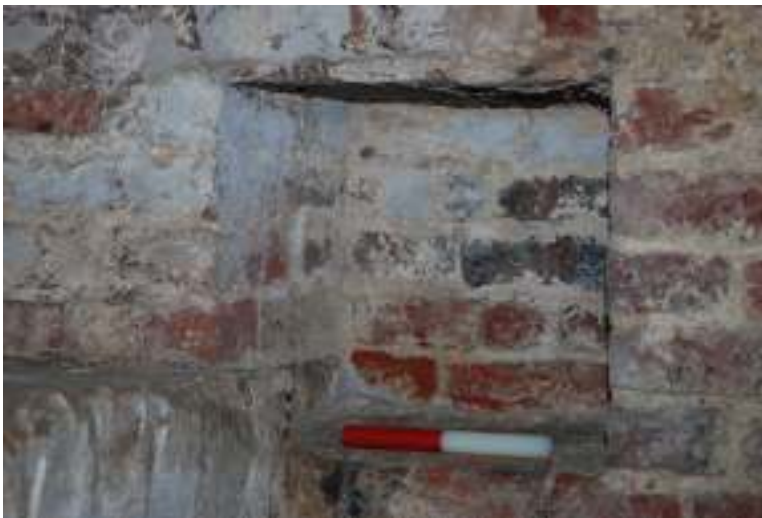
*Fig. 101: Photograph of the small square niche observed in the western wall of the northern-most room in the cellars.*

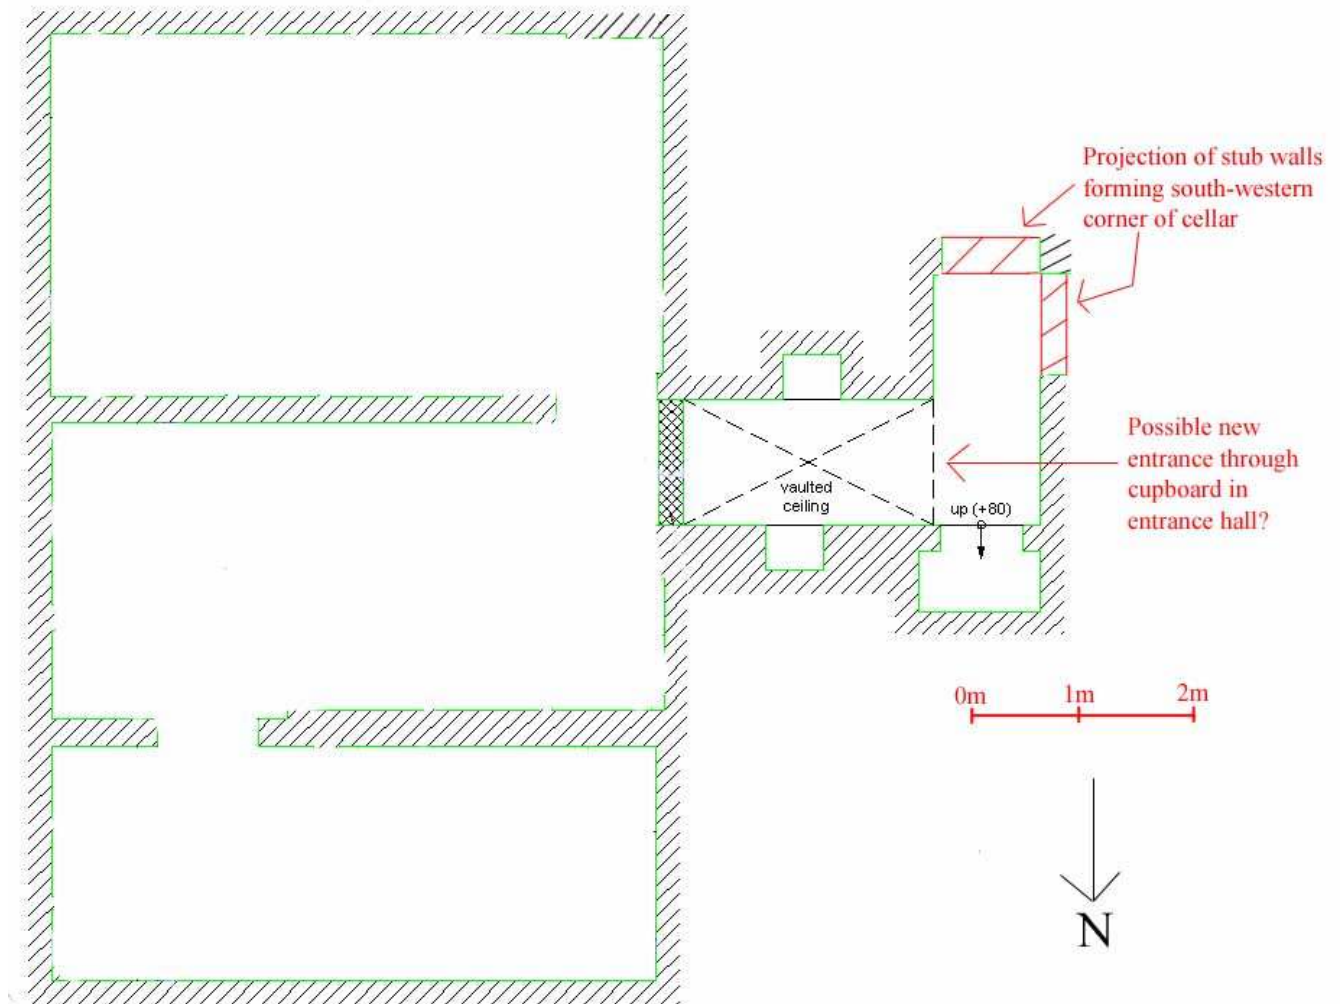
*Fig. 102: Plan showing the extension of the cellars, with a small addition to the west.*

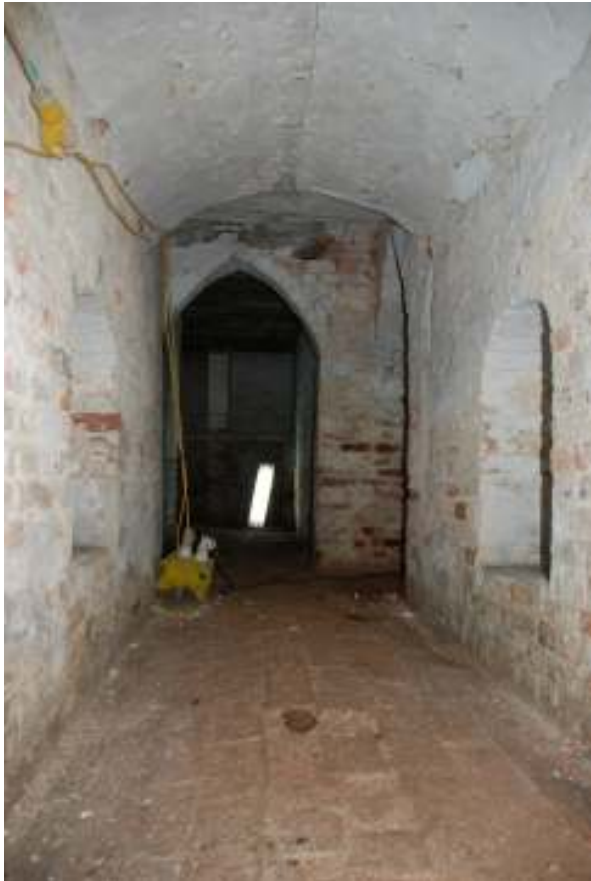
*Fig. 103: Photograph of the small passageway to the west, looking towards the earliest part of the cellars. The line in the wall-build and roof construction can be seen towards the end of this passageway, reflecting the start of the extension.*

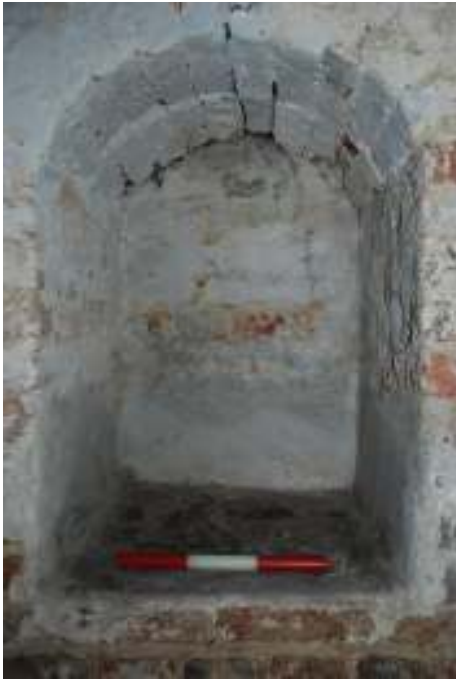
*Fig. 105: Photograph of the open niche on the southern wall of the passageway through into the main part of the cellar.*

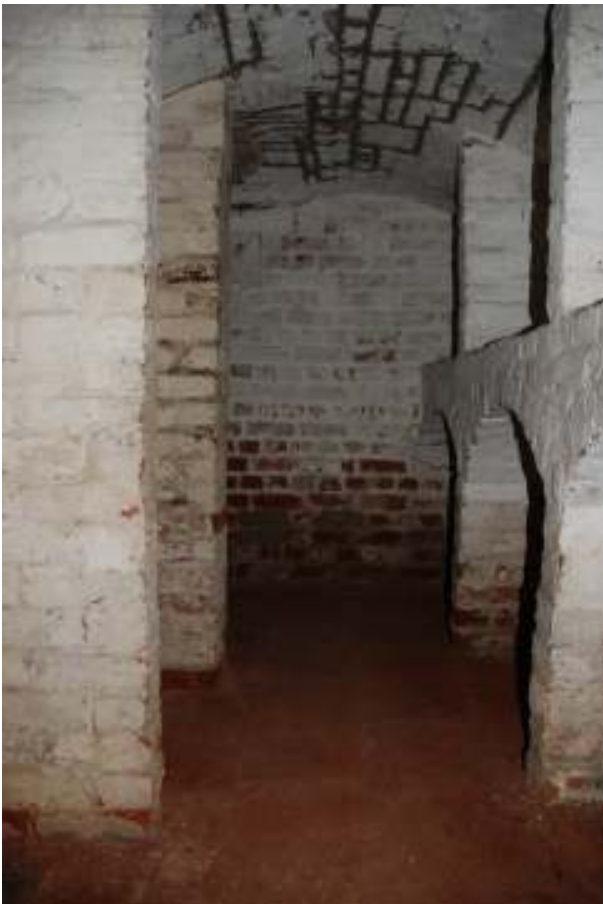
*Fig. 110: Photograph of the, later, western-most room.*

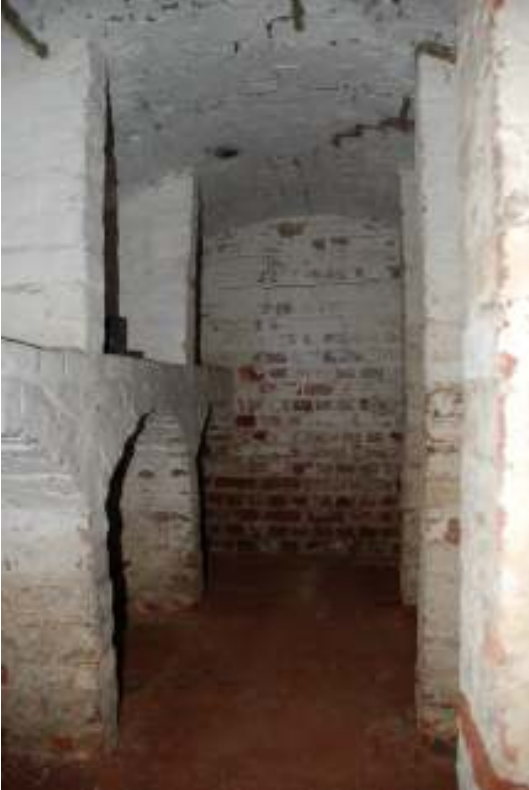
*Fig. 111: Photograph of the first room on the right (on entering the cellar), with the bays / shelving that are original to this build on the left.*

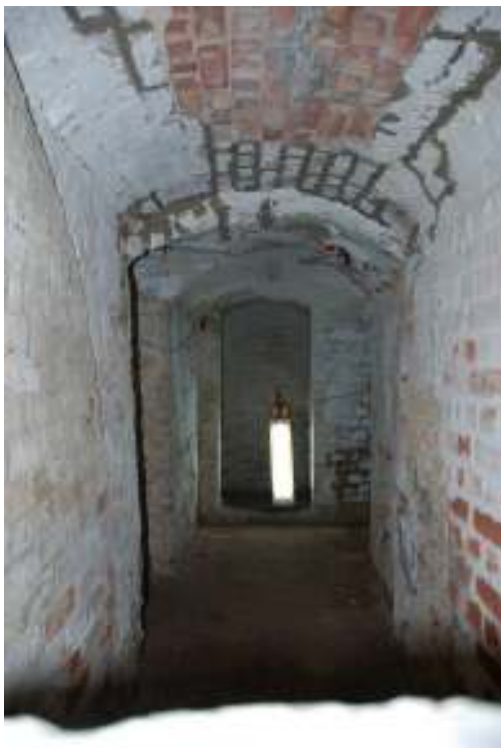
*Fig. 113: Photograph looking out of the western-most room in the cellars. The way in which the brick partitions are added on at a later date is clearly visible, in the left hand side of the image.*

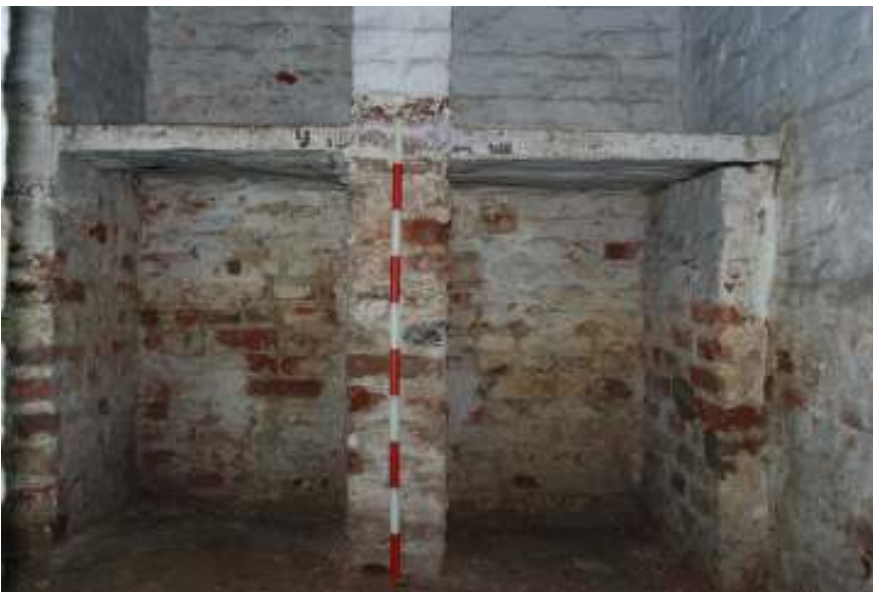
*Fig. 117: Close-up photograph of the brick bays / shelves in the central room of the cellar.*

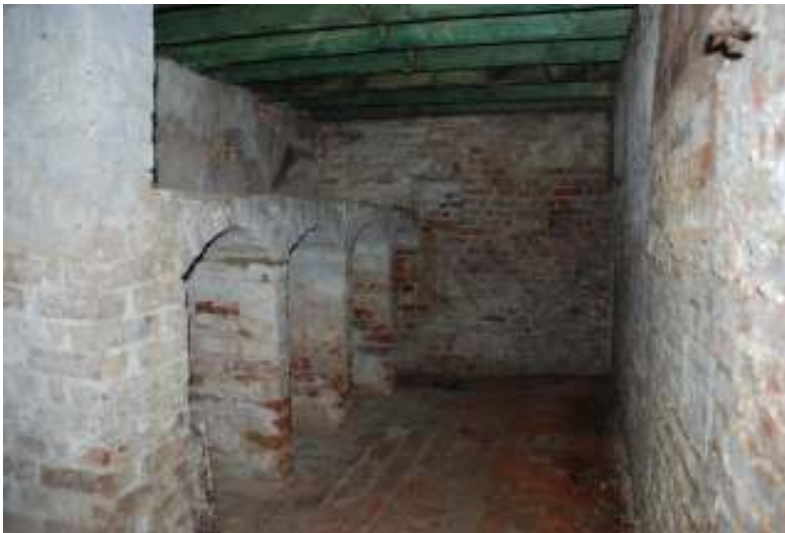
*Fig. 118: Photograph of the brick bays / shelves on the southern wall of the northern-most room in the cellar.*

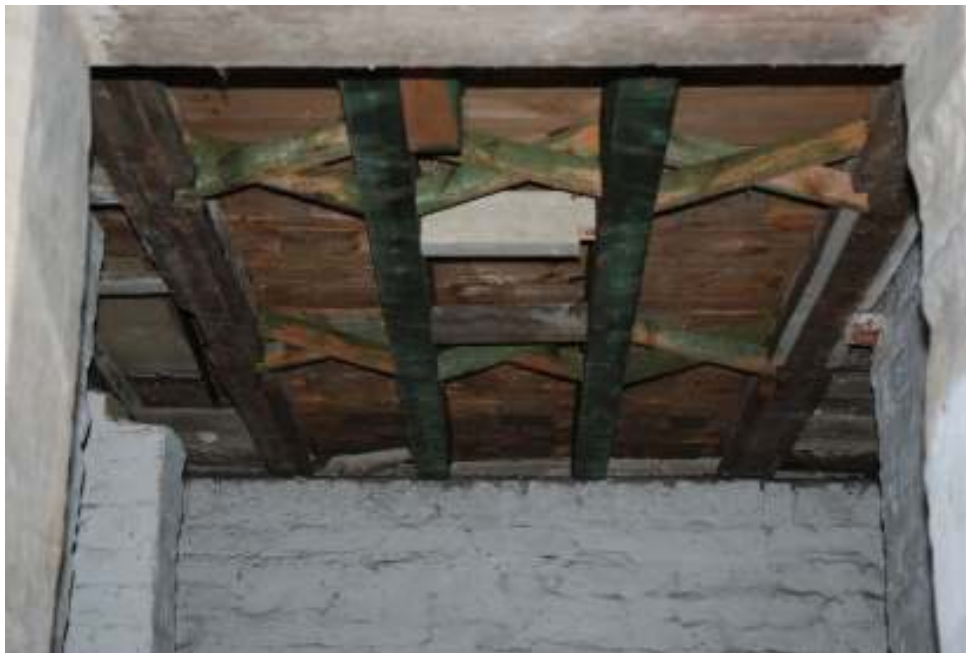
*Fig. 120: Photograph of the ceiling of the cellars.*

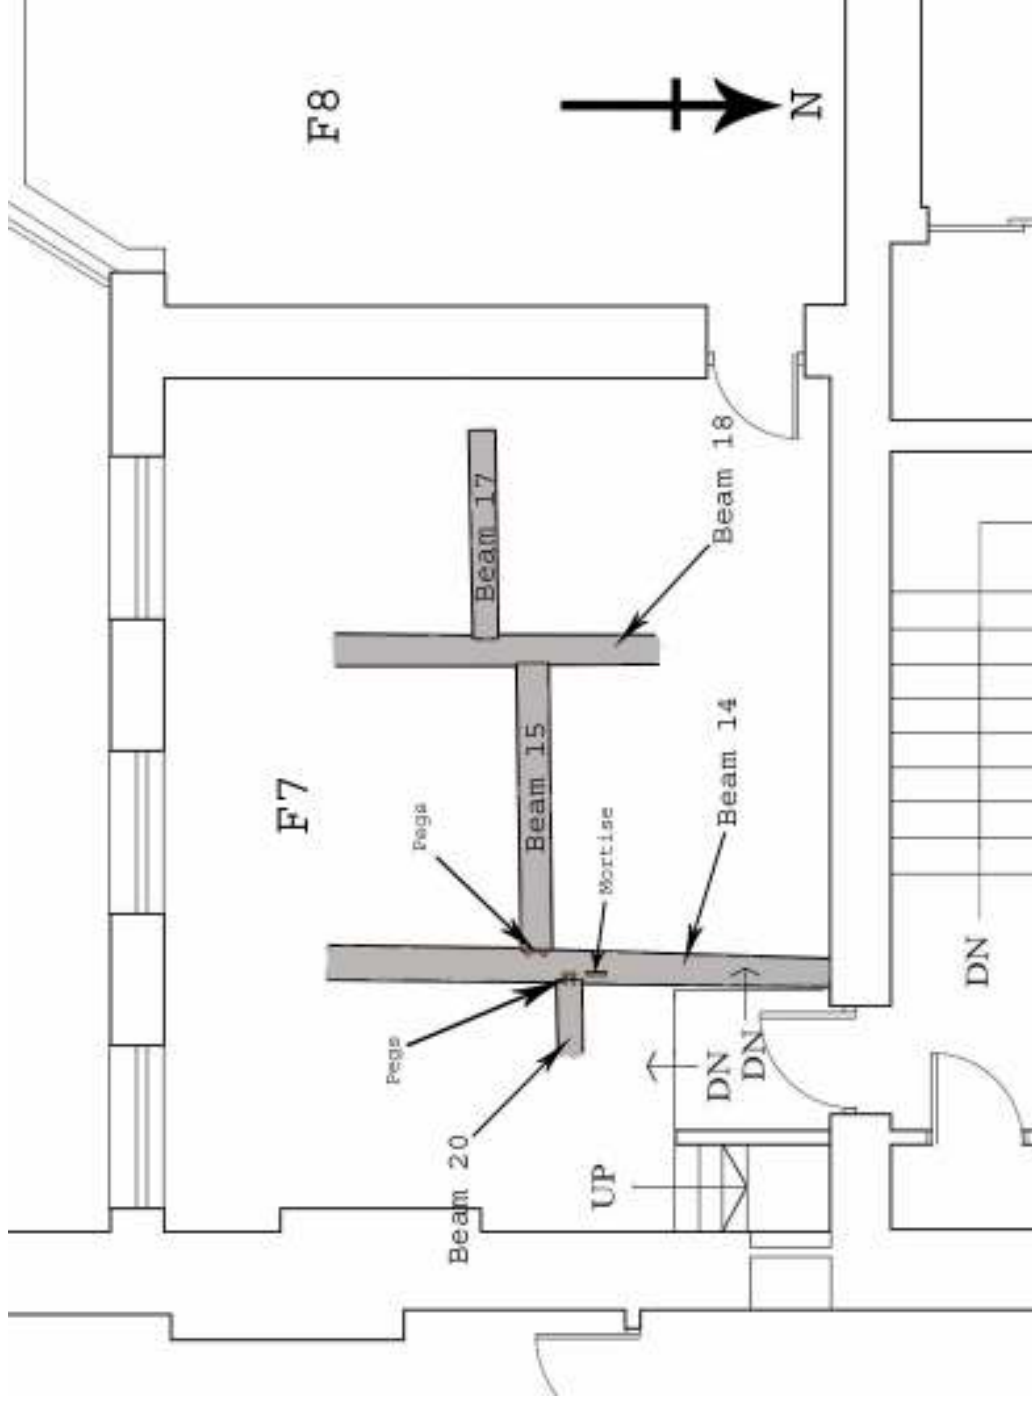
Fig. 121: Plan of timbers in room F7 (timbers 14-20).

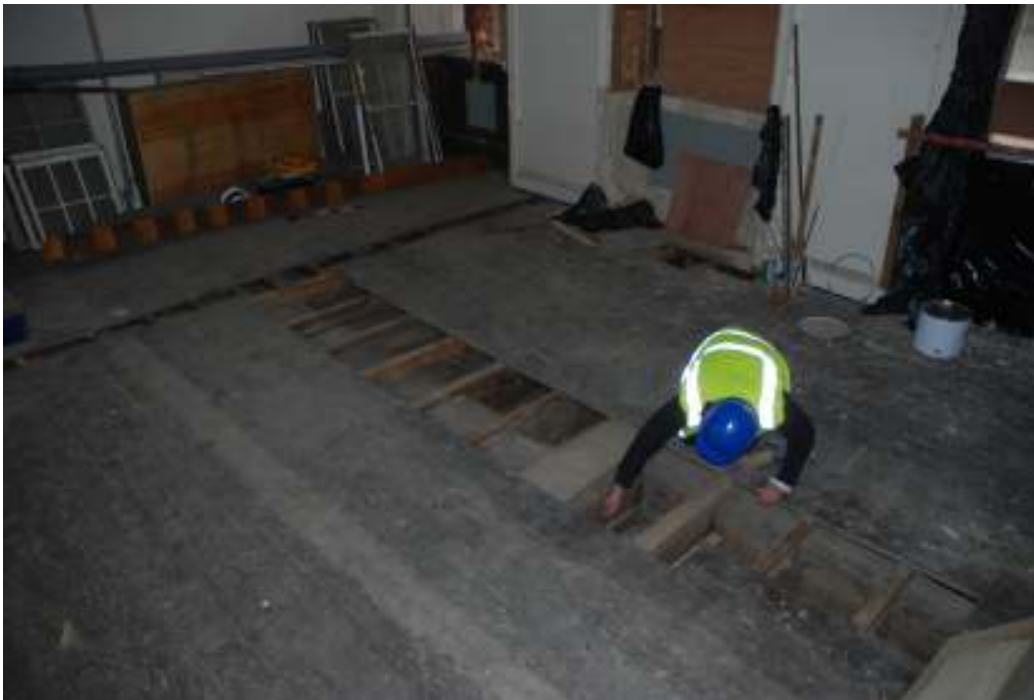
*Fig. 122: Inspecting timbers in room F7.*

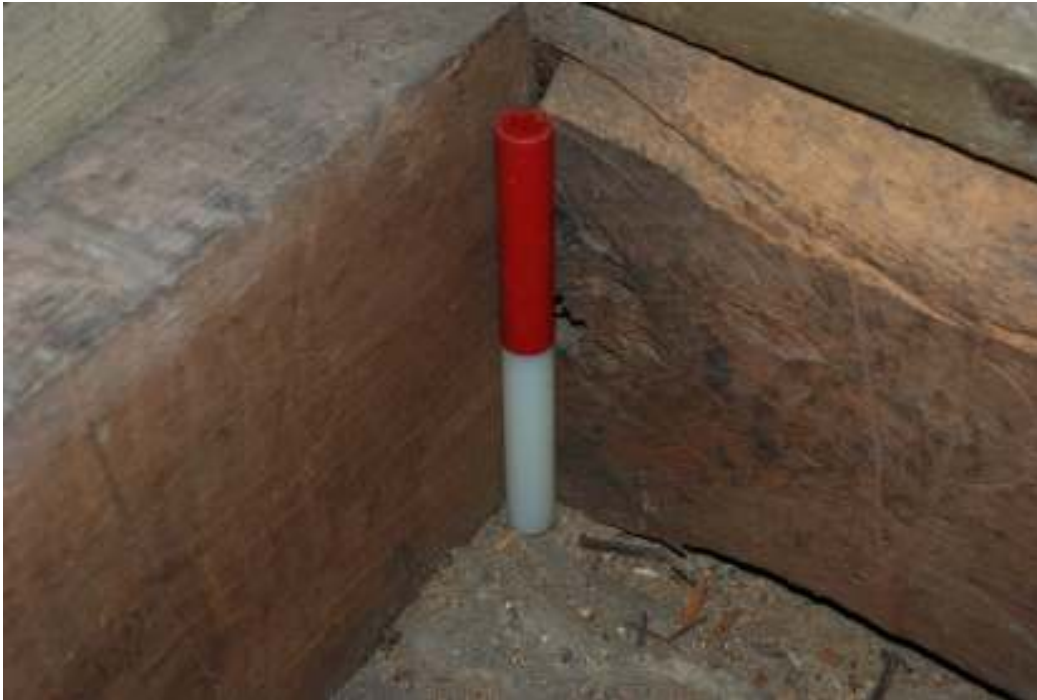
*Fig. 127: Photograph of carpenter's marks on joint of timber 21.*

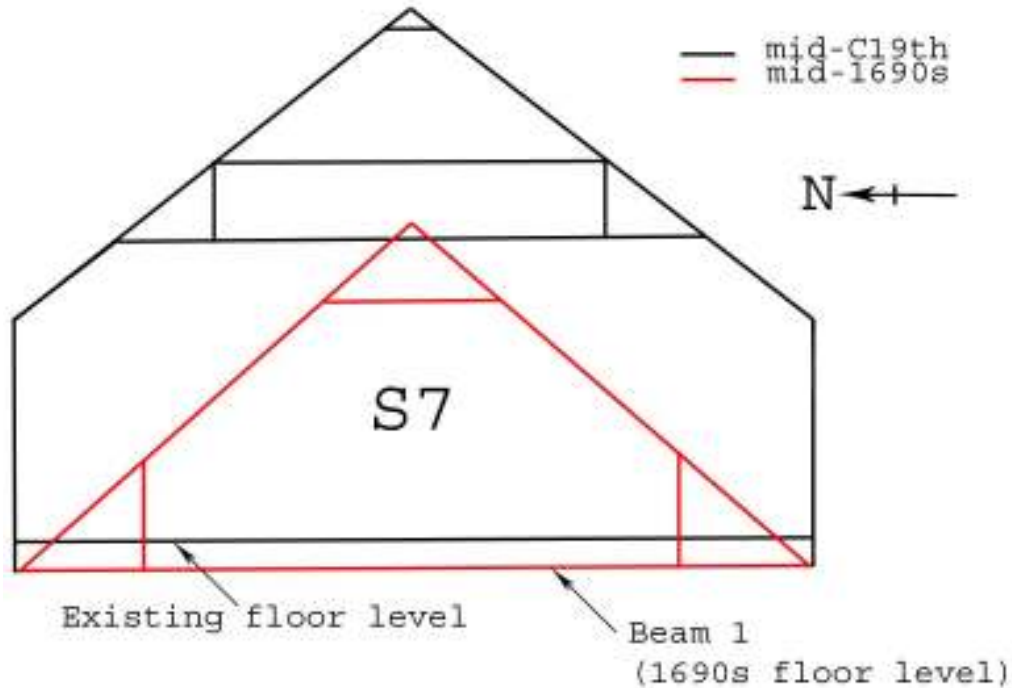
Fig. 128: Conjectured rooflines of the 1690s in build, in comparison with the mid-19<sup>th</sup> Century – in room S7.

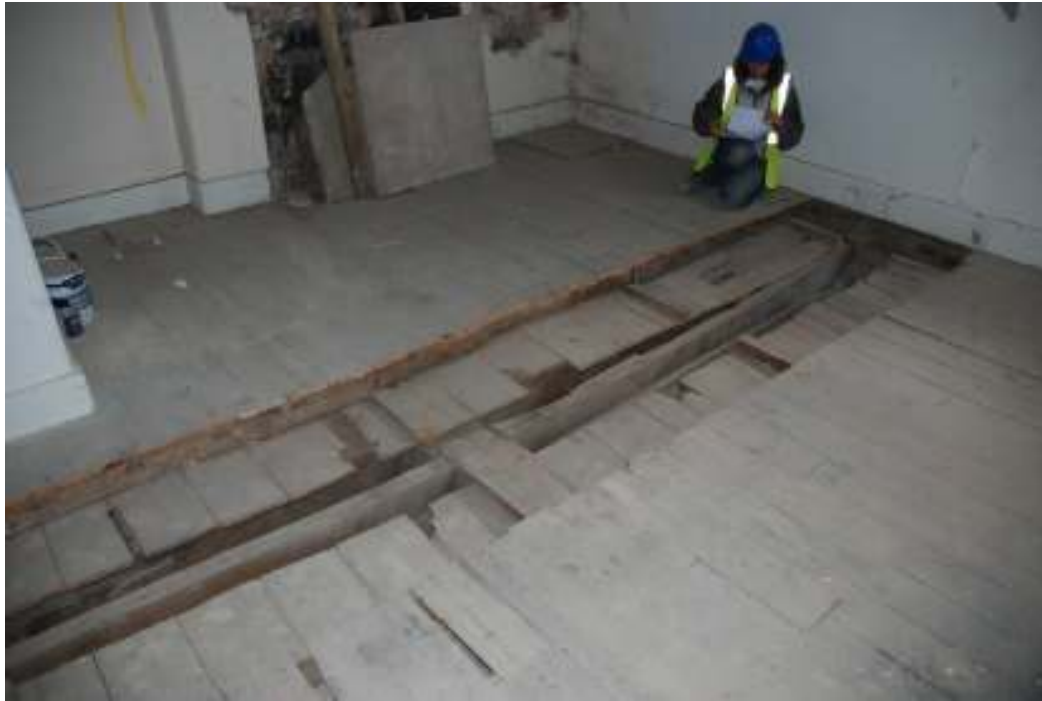
*Fig. 129: Working shot of room S7 (southern side of house). This shows how the modern floor has been cut away to reveal the earlier timbers (including floorboards and an exposed joist in the centre), looking south-east.*

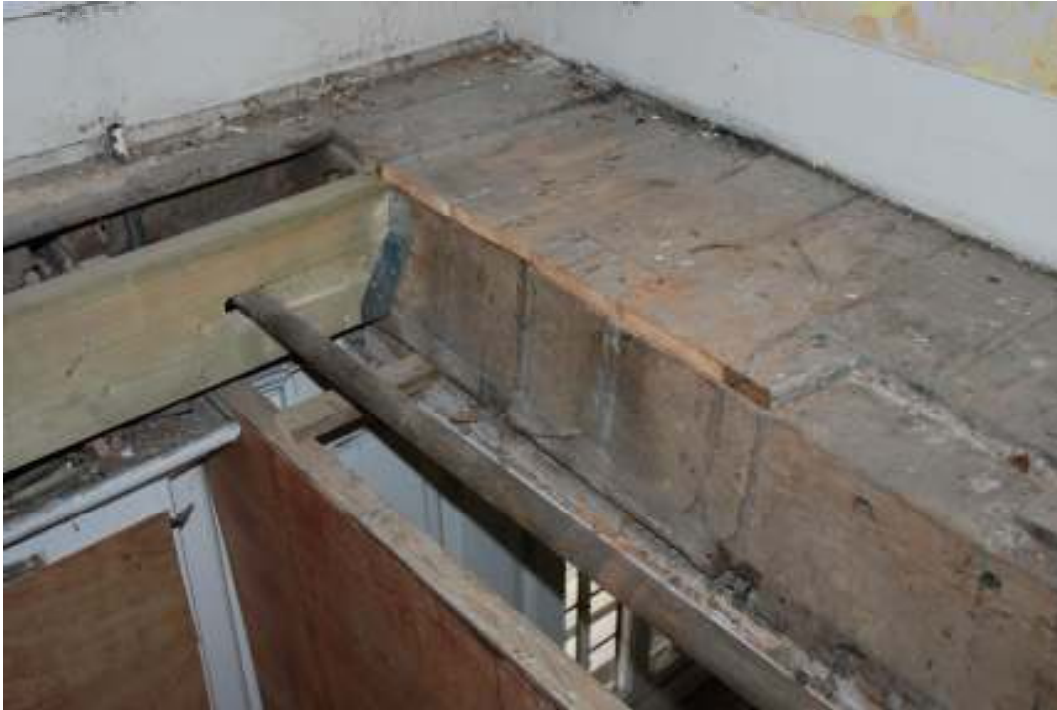
*Fig. 144: Photograph of the west face of timber 10, room S21, looking north-east. The pegs for the probable upright can be seen to the right, and the slot for the rafter in the wall just visible to the left.*

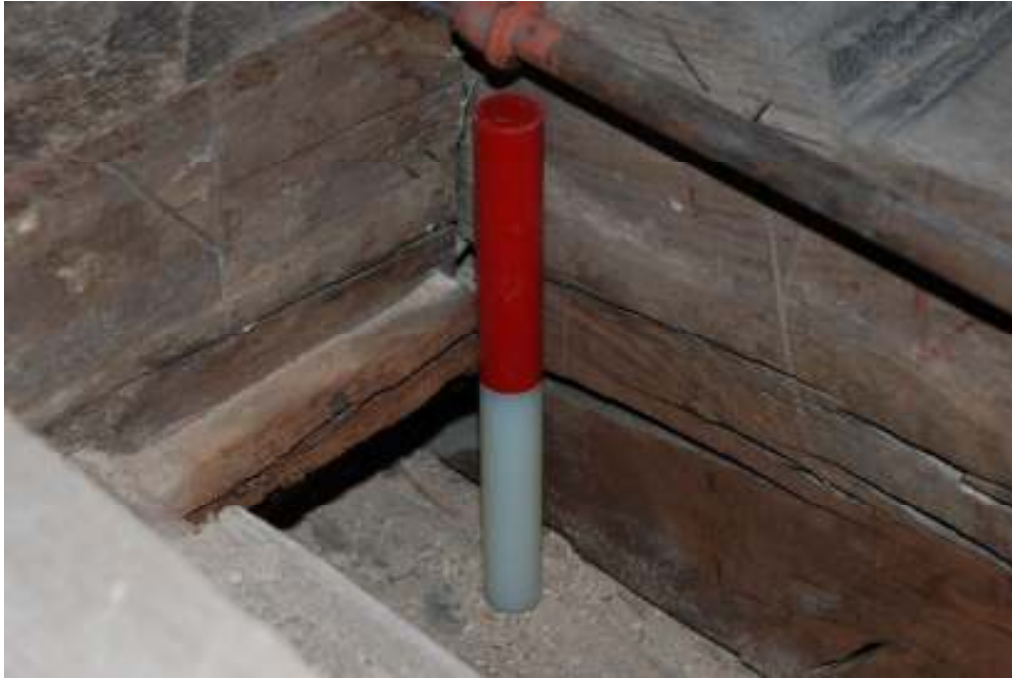
*Fig. 145: Photograph of timbers 12 and 13, room S19, with a carpenter's mark to the north-east.*

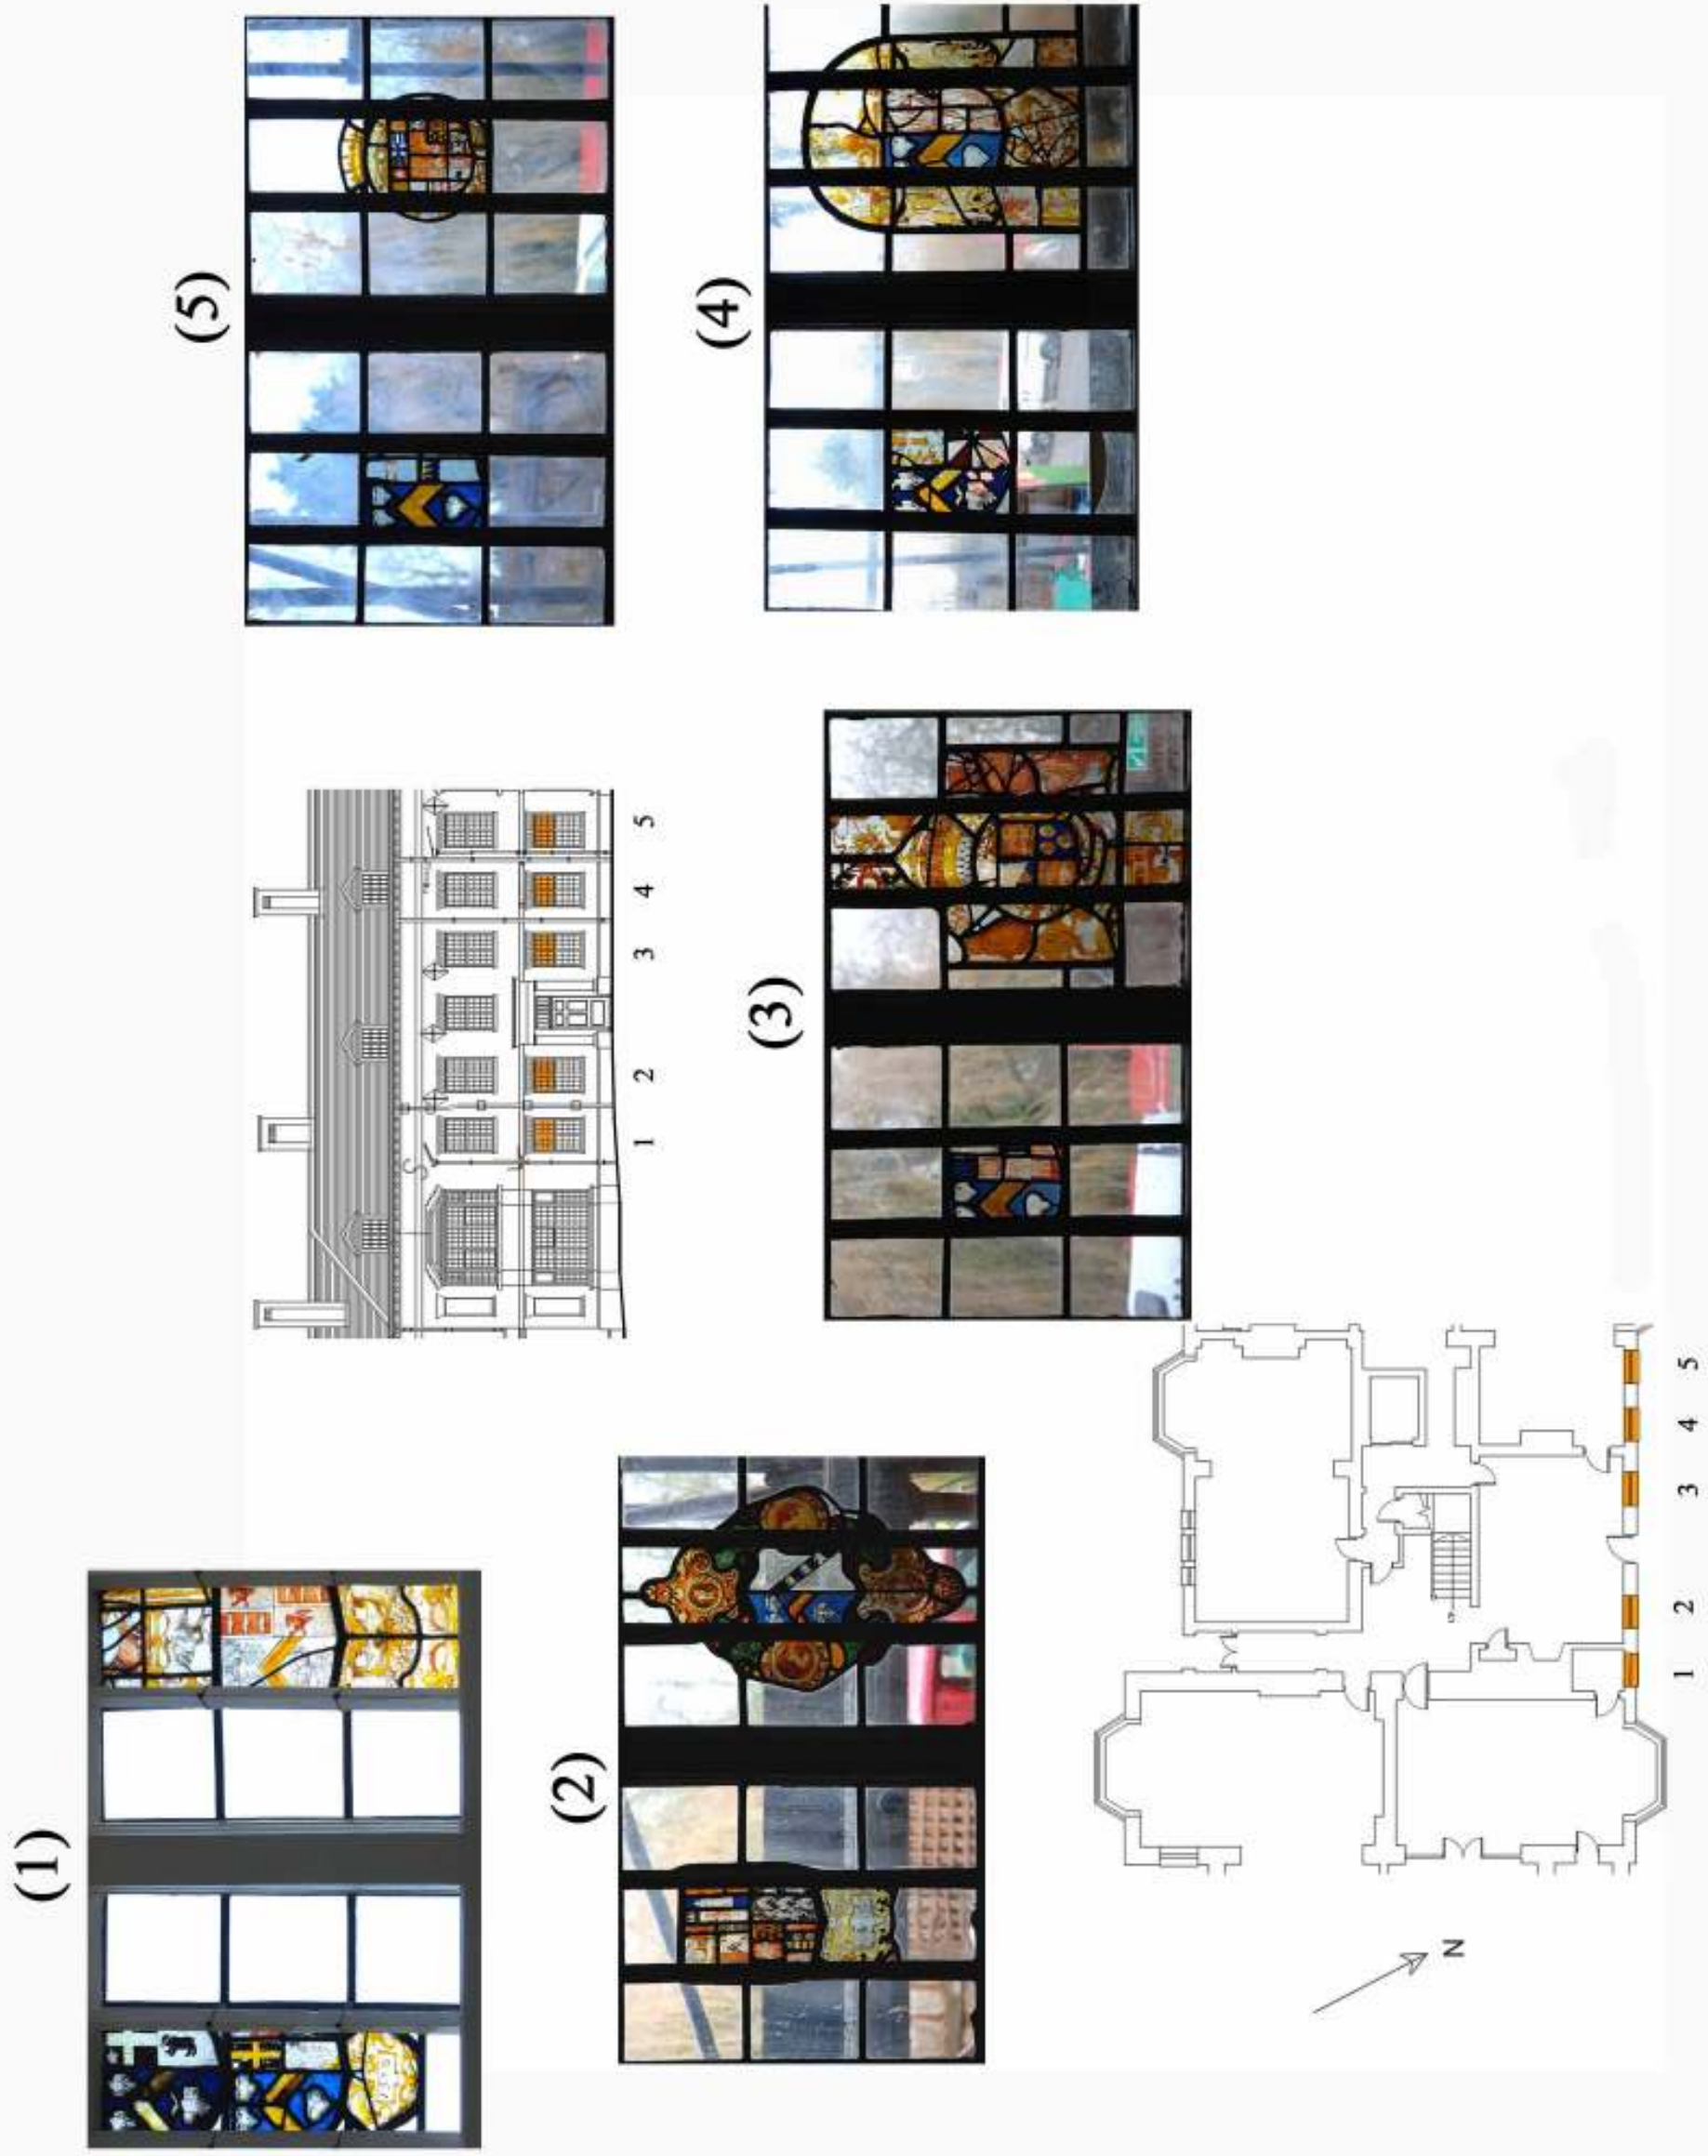
Fig. 151: Location of the stained glass panels (windows 1-5) on the northeast face of the House, shown in plan and elevation.

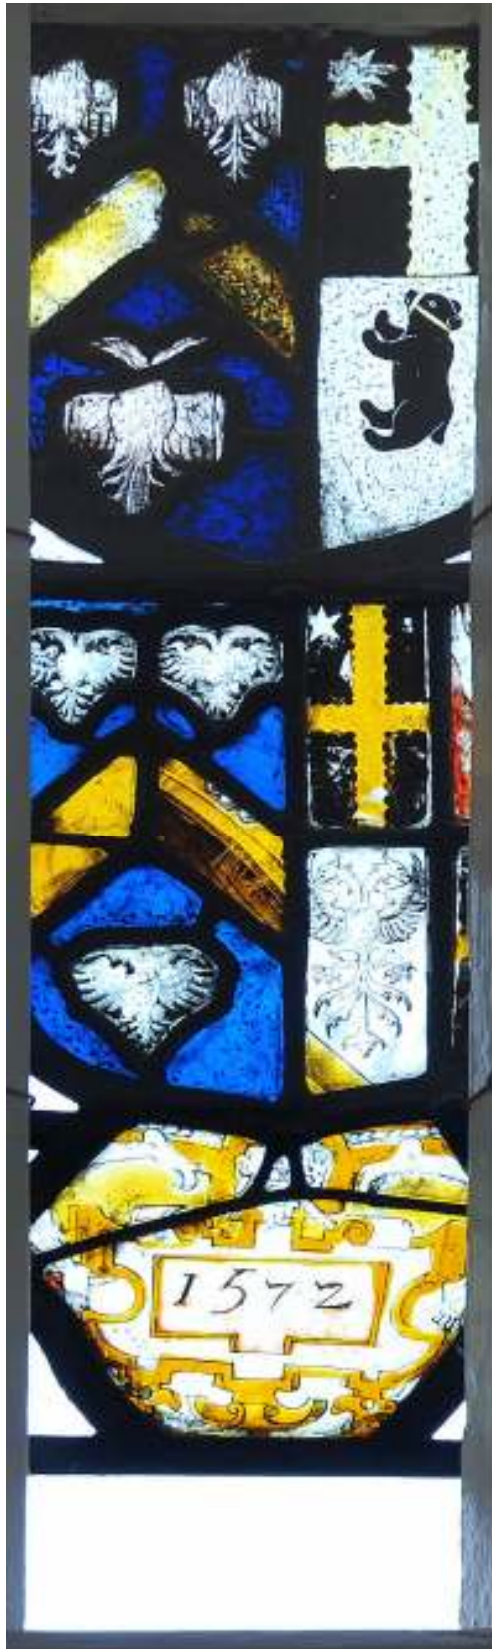
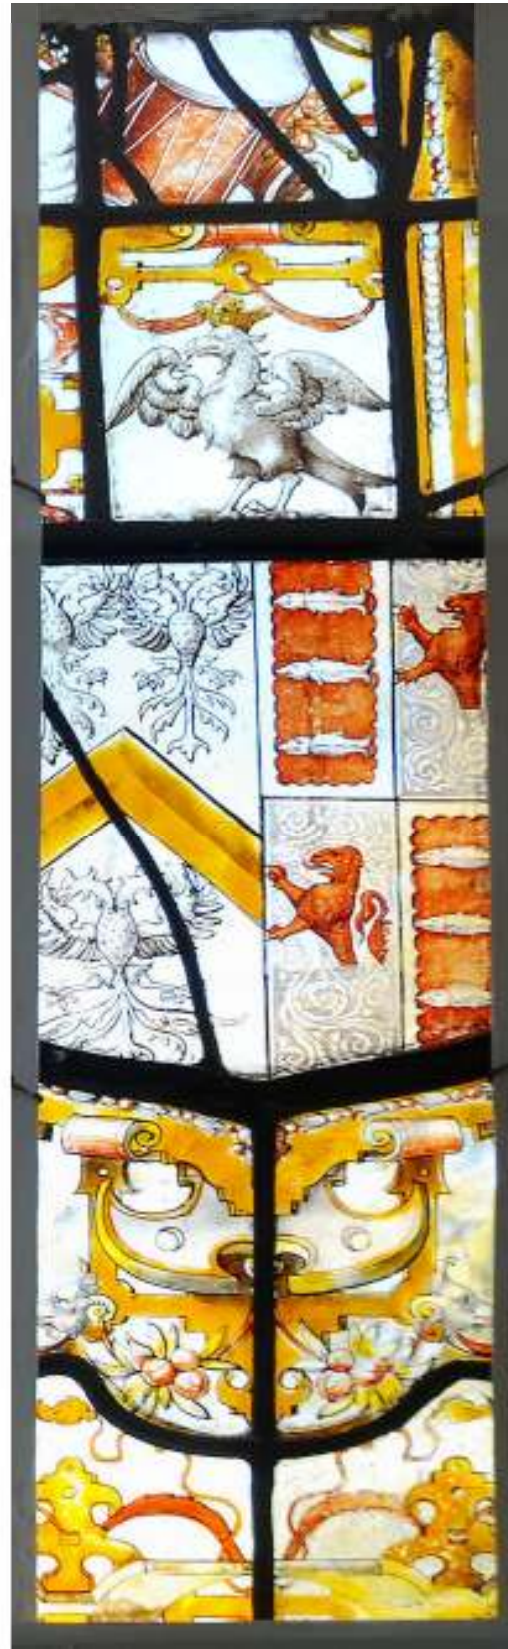
*Fig. 152: The Antechamber: window 1 both panels. The date '1572' is clearly visible in the western panel; and the drum at the top of the eastern panel.*

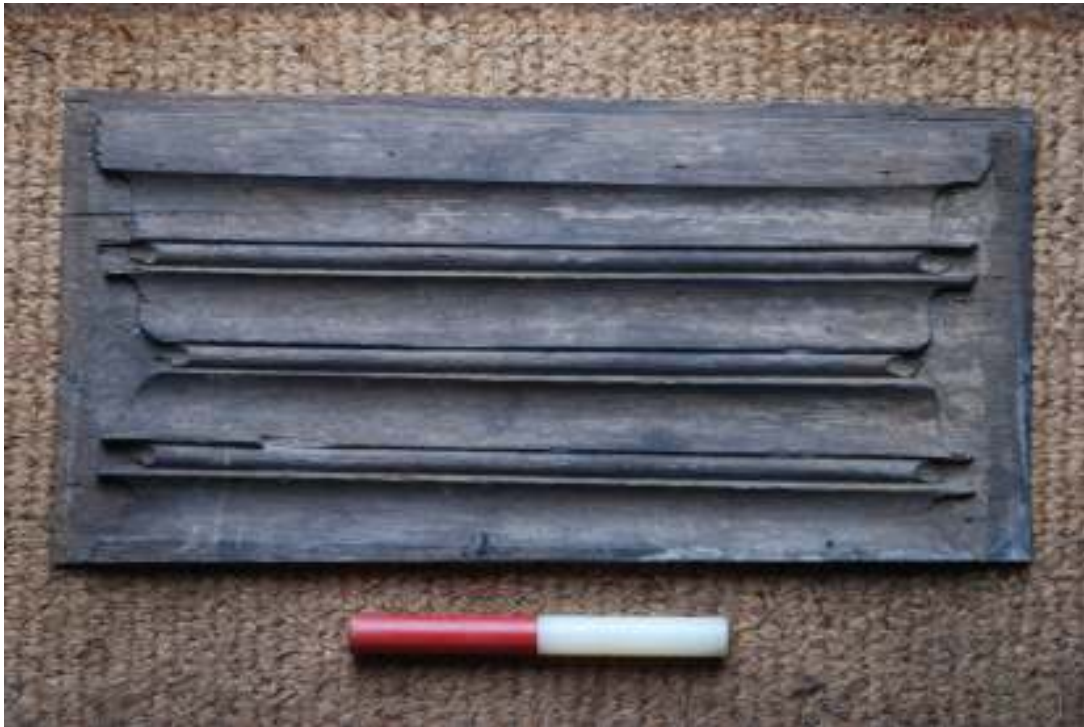
*Fig. 181: Photograph of one of the linen-fold panels.*
