# BREAKSPEARS

## THE EARLY HOUSE

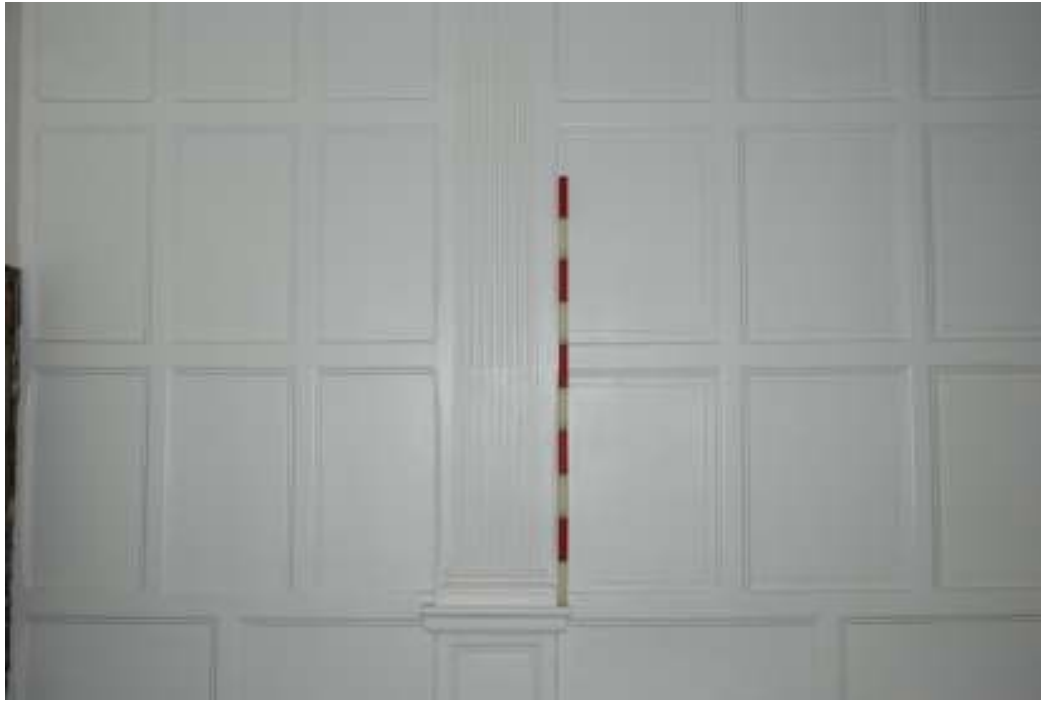
*Fig. 182: Photograph of the panelling in the dining room, within the area of the earlier house, showing its different dimensions and profile.*
