**48-52 QUEEN'S ROAD,  
BRENTWOOD, ESSEX, CM14  
4HD**

**A LEVEL 2 HISTORIC BUILDING SURVEY**

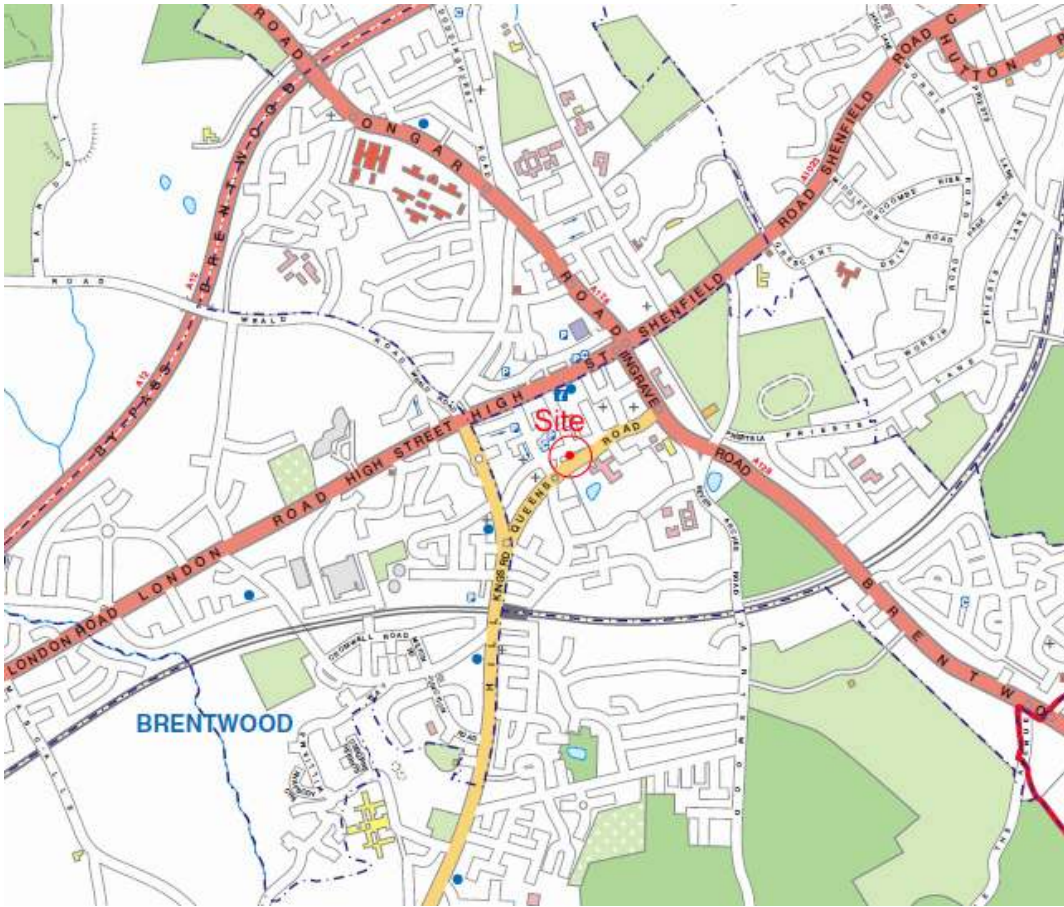
Fig. 1: Map showing general location of the site.

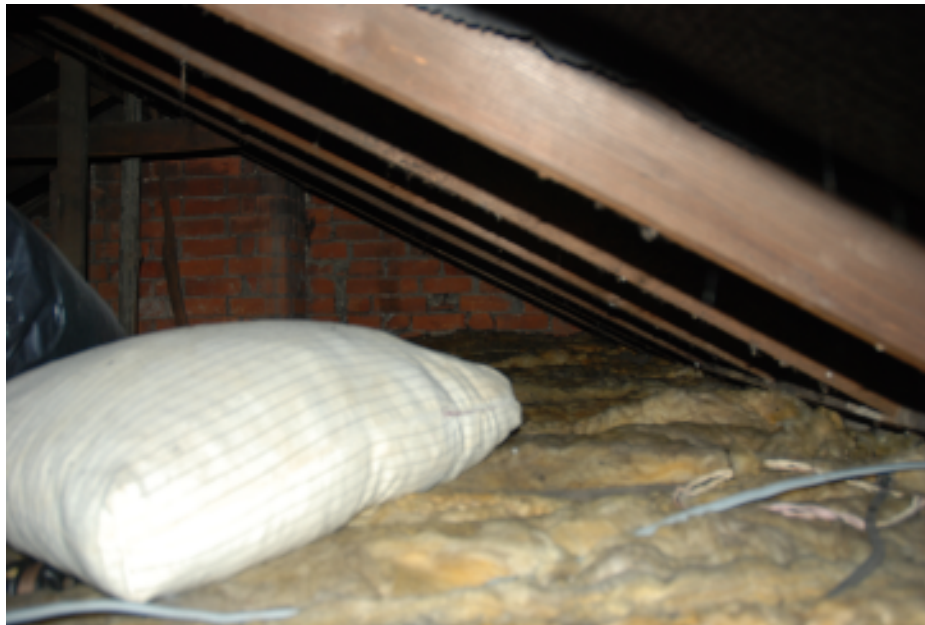
Fig. 21: Photograph of the roof-space above the cottages, looking west and showing the brick wall which separates the two original cottages.

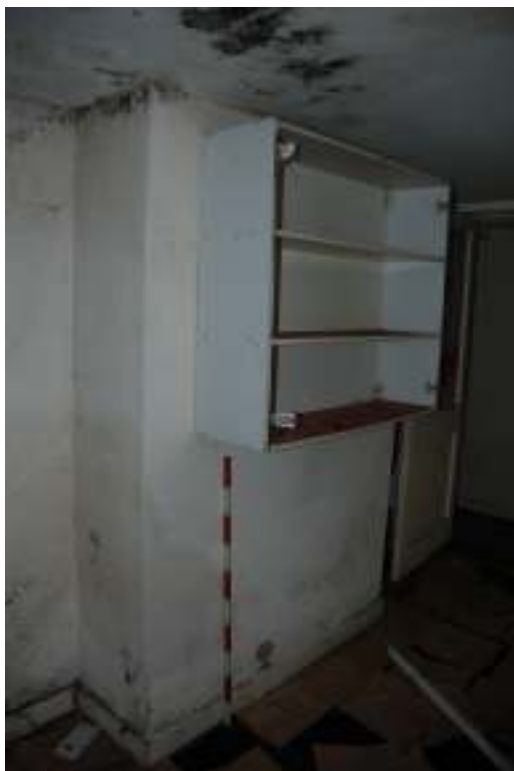
Fig. 22: Photograph of chimney-breast in southern wall of room 15.

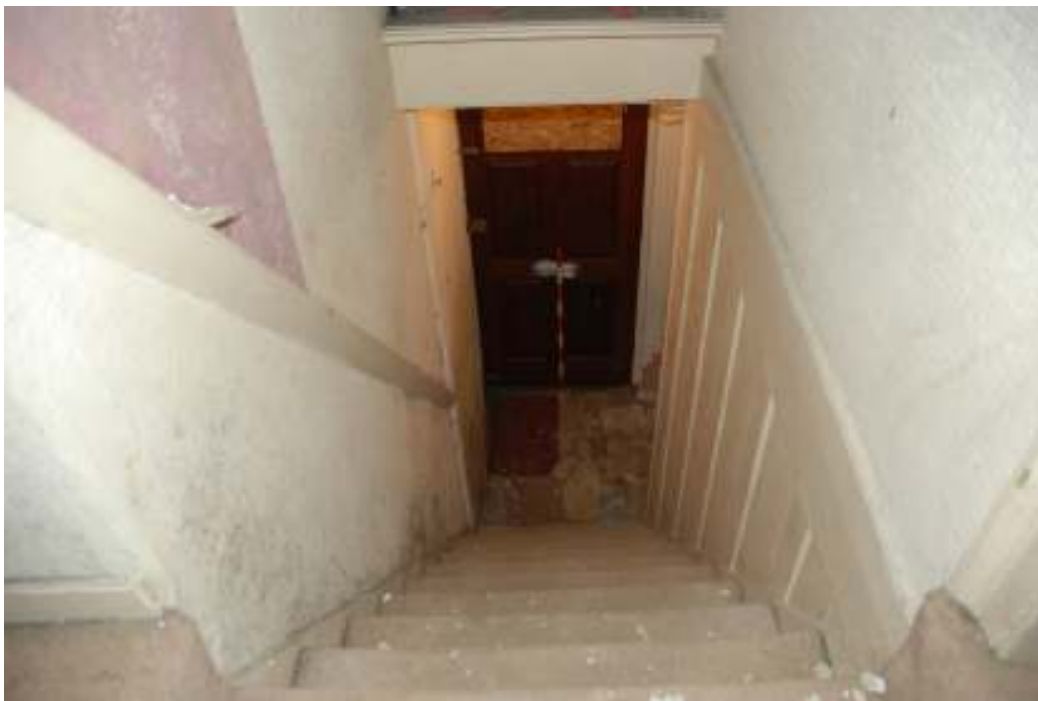
Fig. 27: Photograph of the stairs up from the eastern-most front door, up to the first-floor maisonette. The entrance into room 16 would have been to the right of the scale.

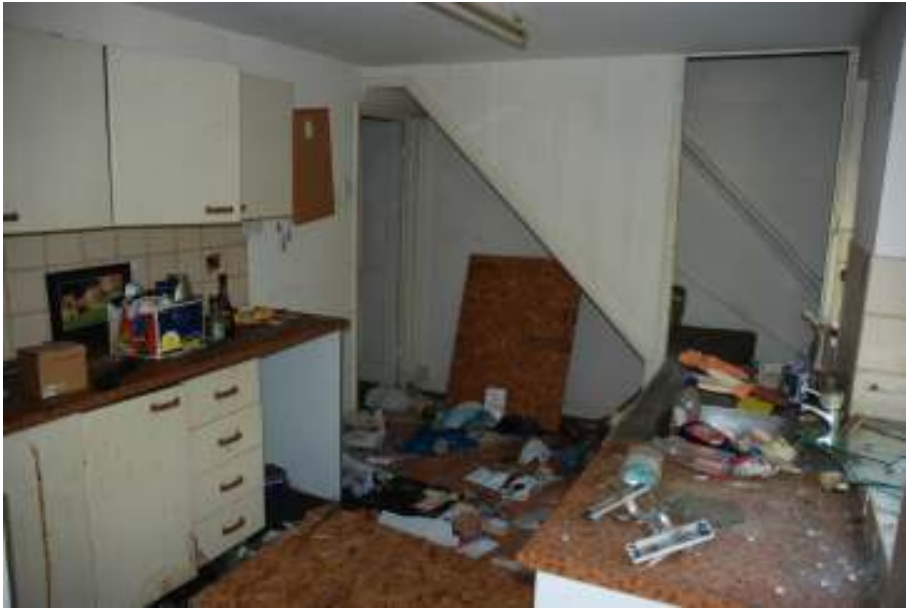
Fig. 28: Photograph of room 10 (kitchen), looking west, and showing the modern fixtures and fittings.

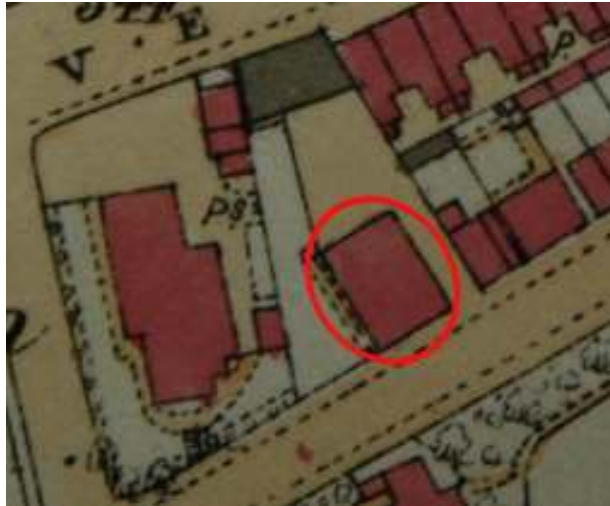
Fig. 33: Extract from the 1872 OS Map, depicting the main building.

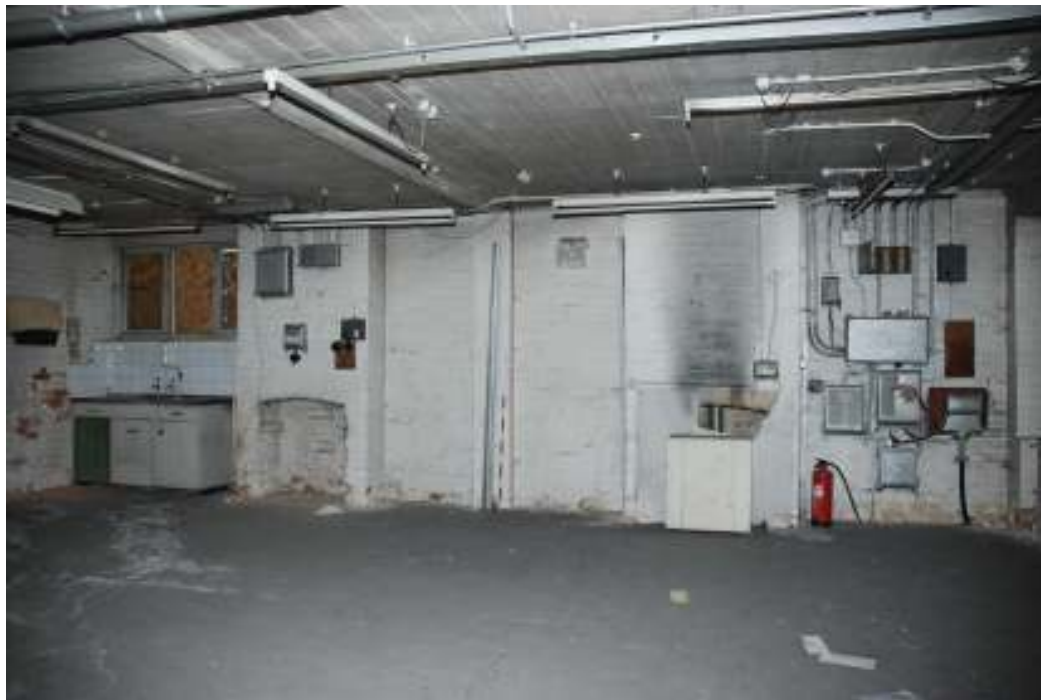
Fig. 36: Photograph of room 32, looking east, and showing its utilitarian nature.

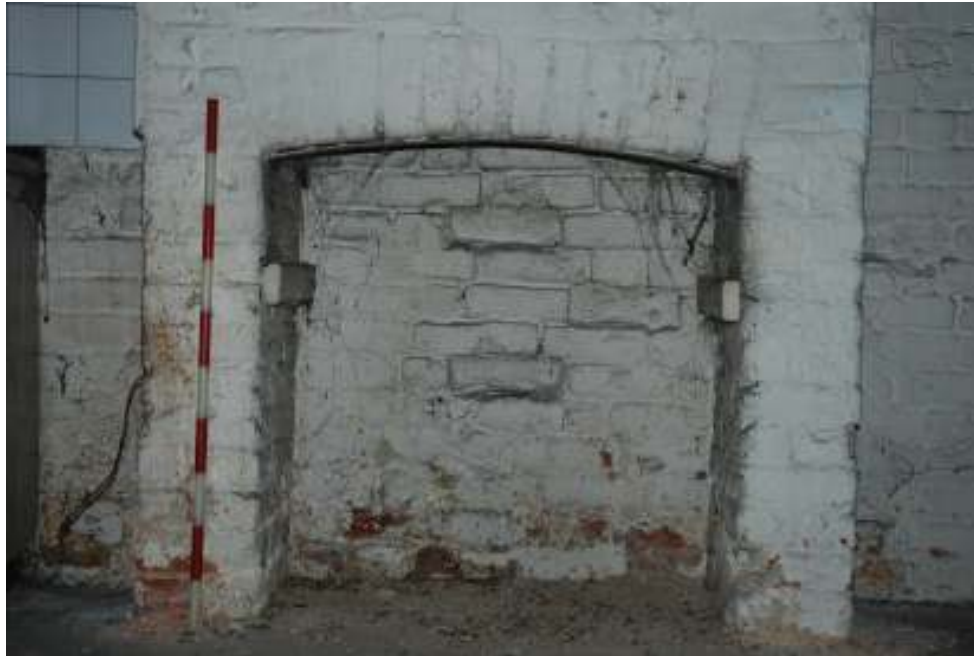
Fig. 37: Photograph of north-eastern fireplace in room 32.

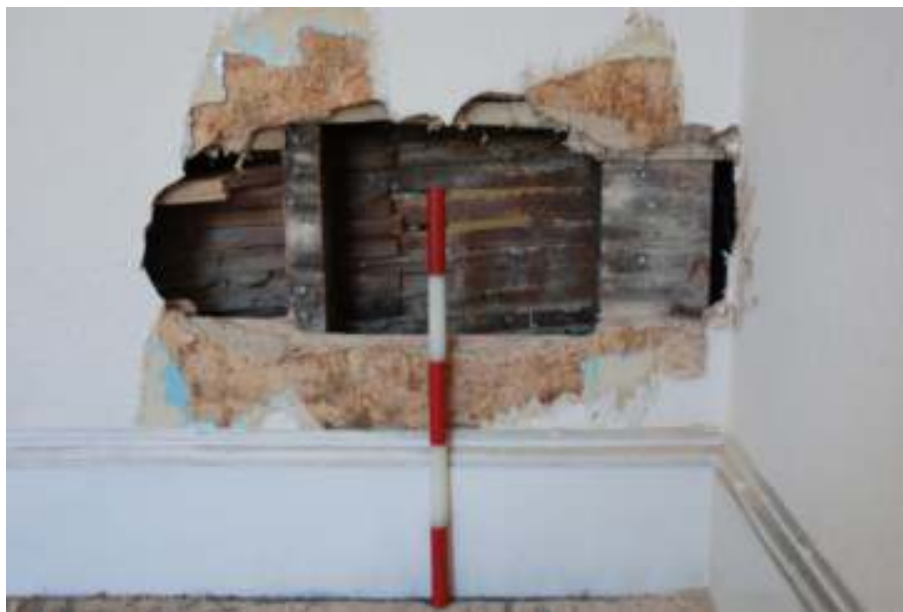
Fig. 41: Photograph of vertical timber post on the first-floor running up from the beam in room 32 (right of scale).

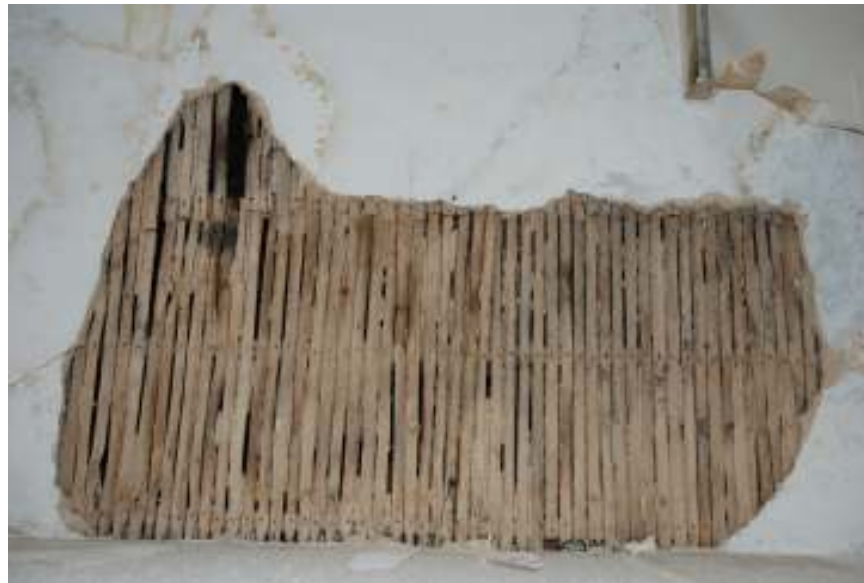
Fig. 42: Photograph of original lathe-and-plaster ceiling, under more modern plasterboard ceiling, in room 25.

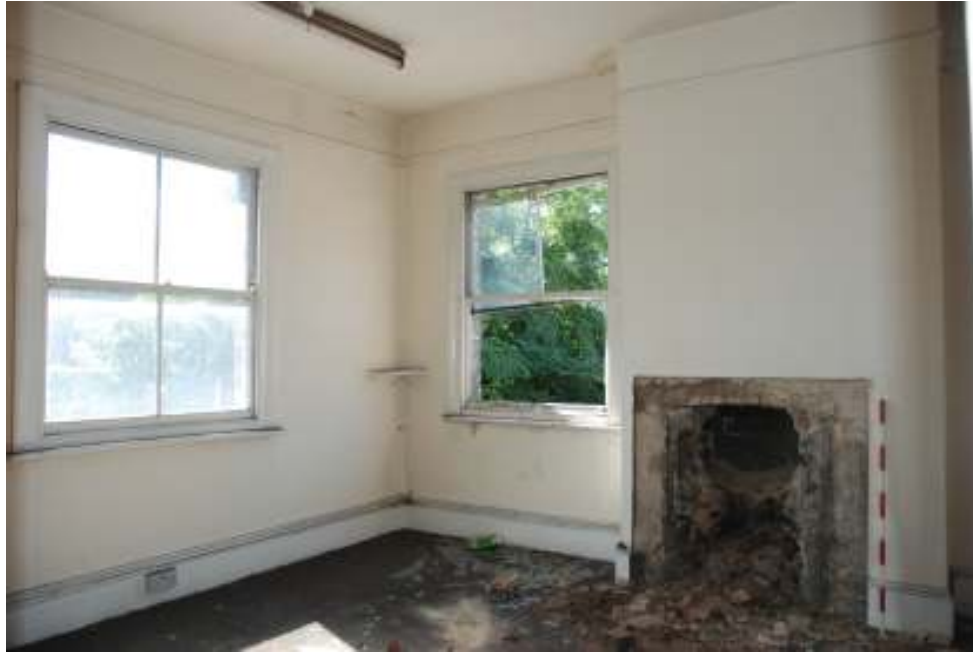
Fig. 43: Photograph of room 27, looking south-west, showing the fireplace (original), original window (right one), and later window (left one).

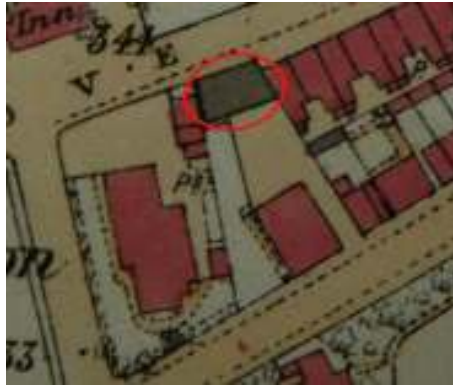
Fig. 62: Extract from 1872 OS Map, with room 2 building depicted in grey and circled.

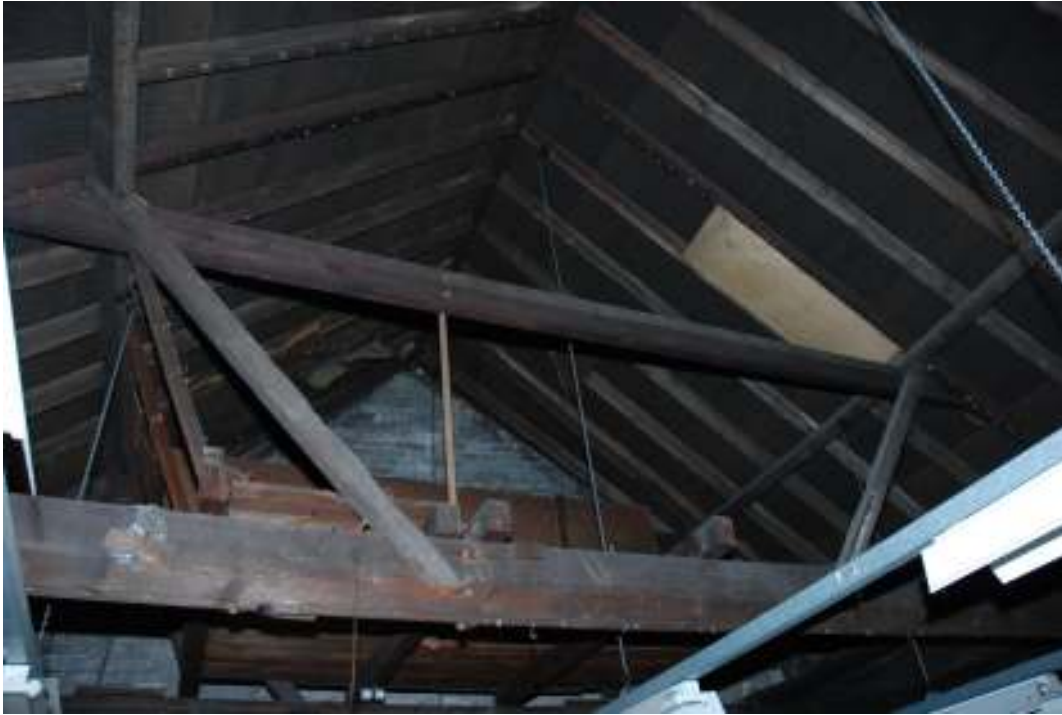
Fig. 70: Photograph of timber-feature (platform holding tank?) in western part of room.

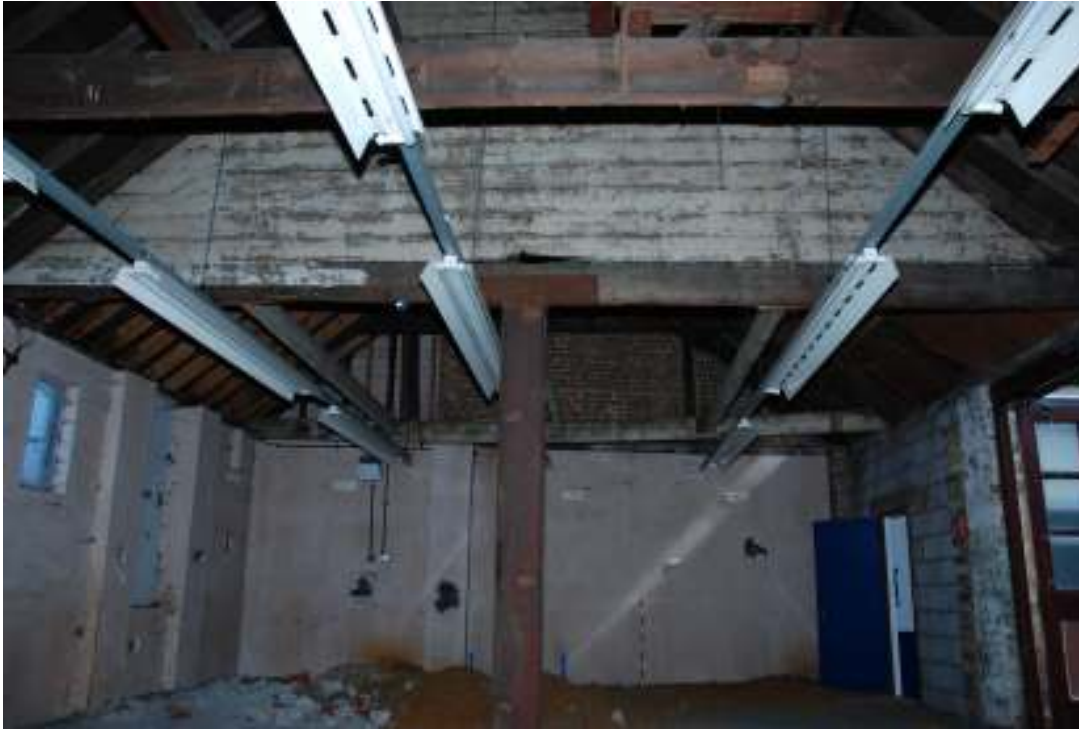
Fig. 71: Photograph of room 2, looking east. The timber 'triangle' in the roof, with large iron supporting beam, can be seen.

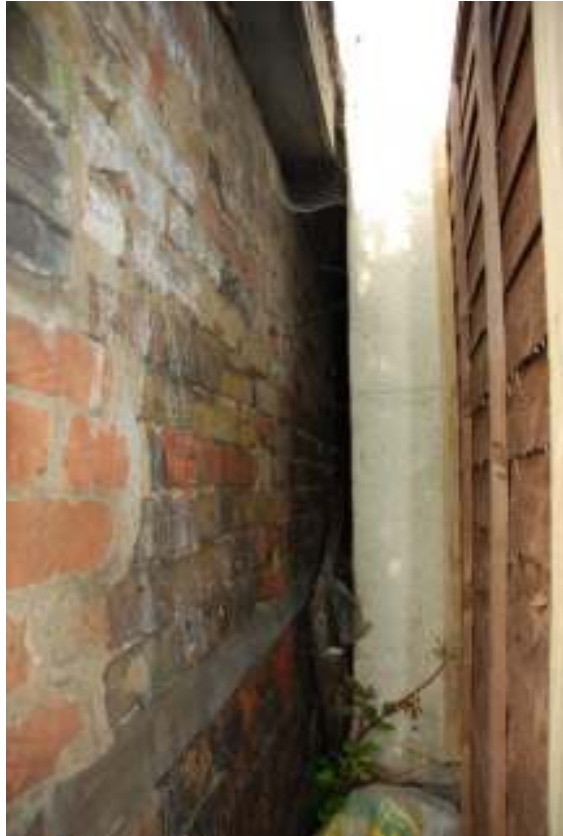
Fig. 78: Yellow stock brick on the eastern wall of room 1.

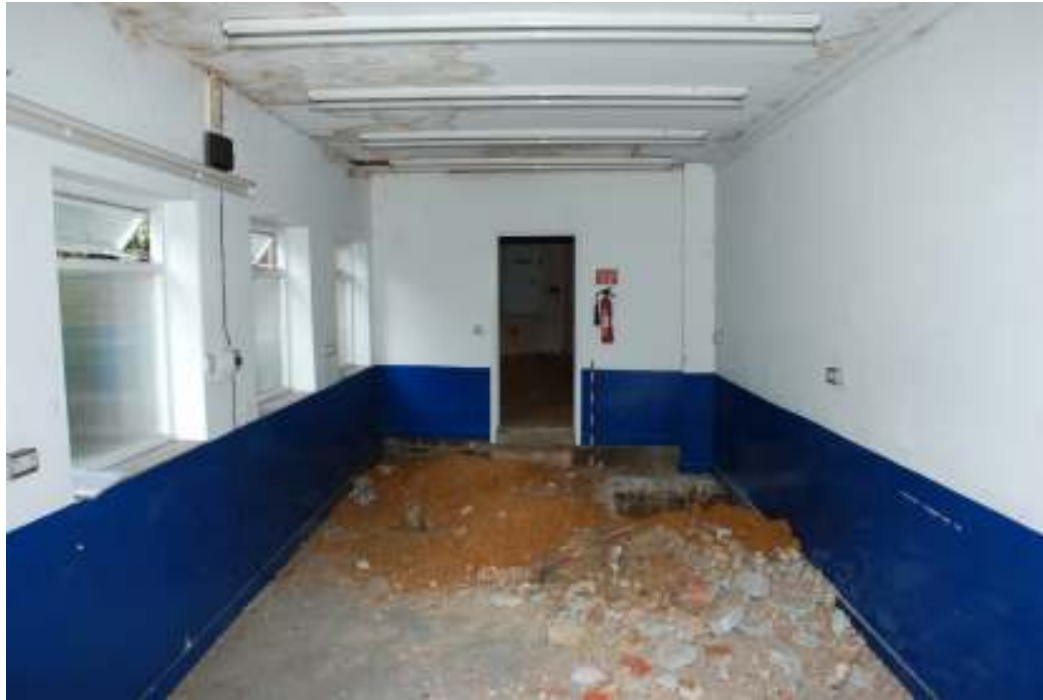
Fig. 80: Photograph of room 1, looking north.

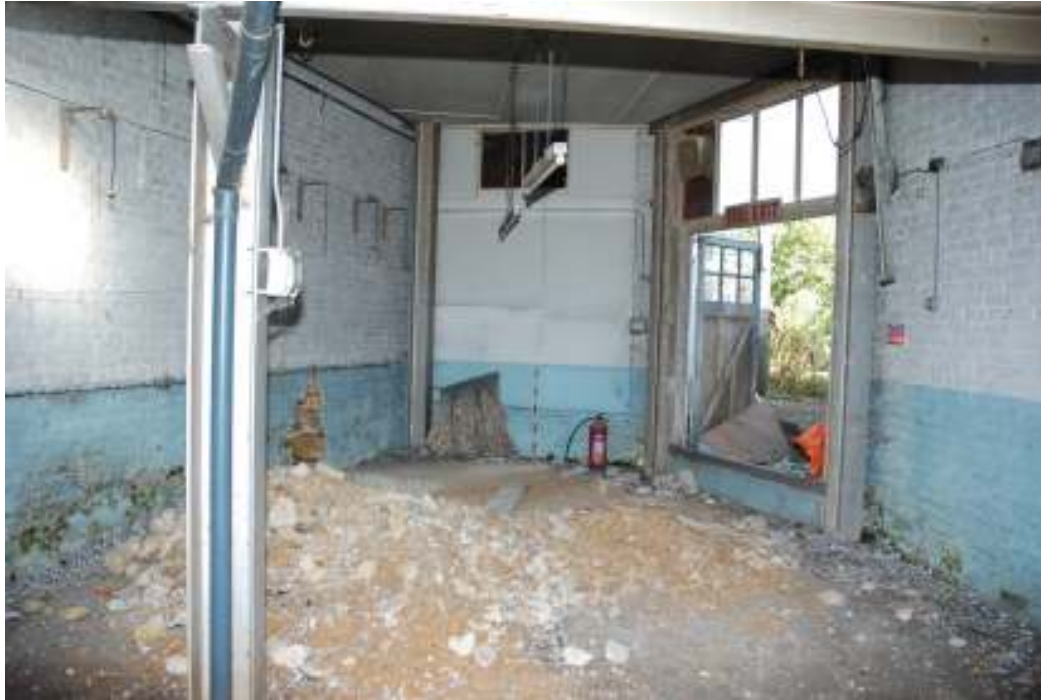
Fig. 97: Photograph of the northern part of room 7, looking north.

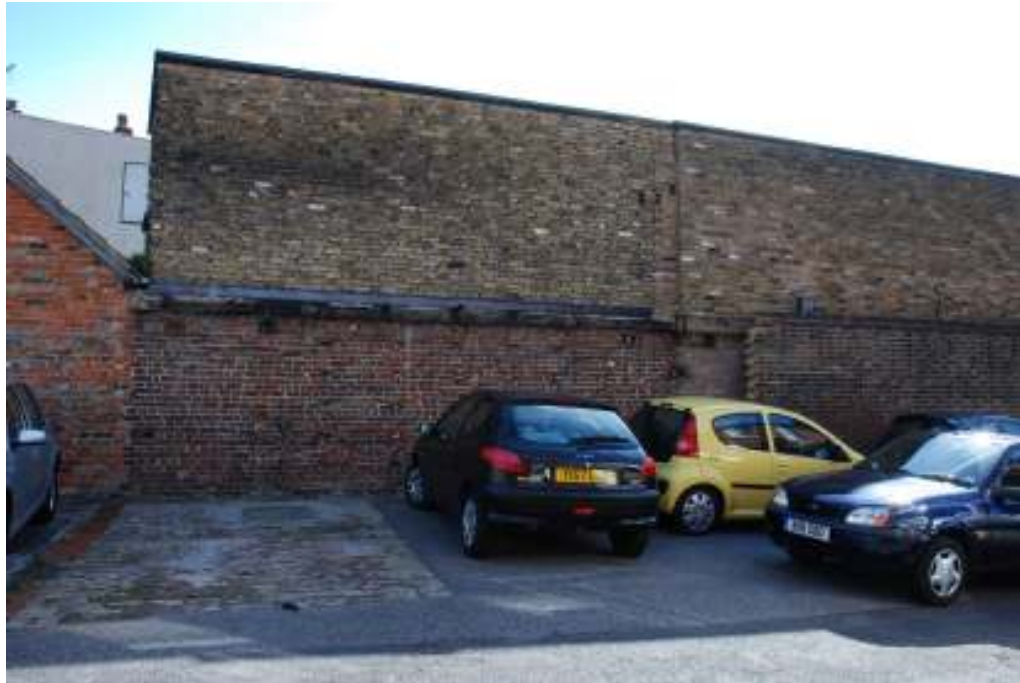
Fig. 100: Photograph of western side of north-south building. The step-back in brickwork, and change in brickwork at the ground-floor level, can be seen behind the yellow car.

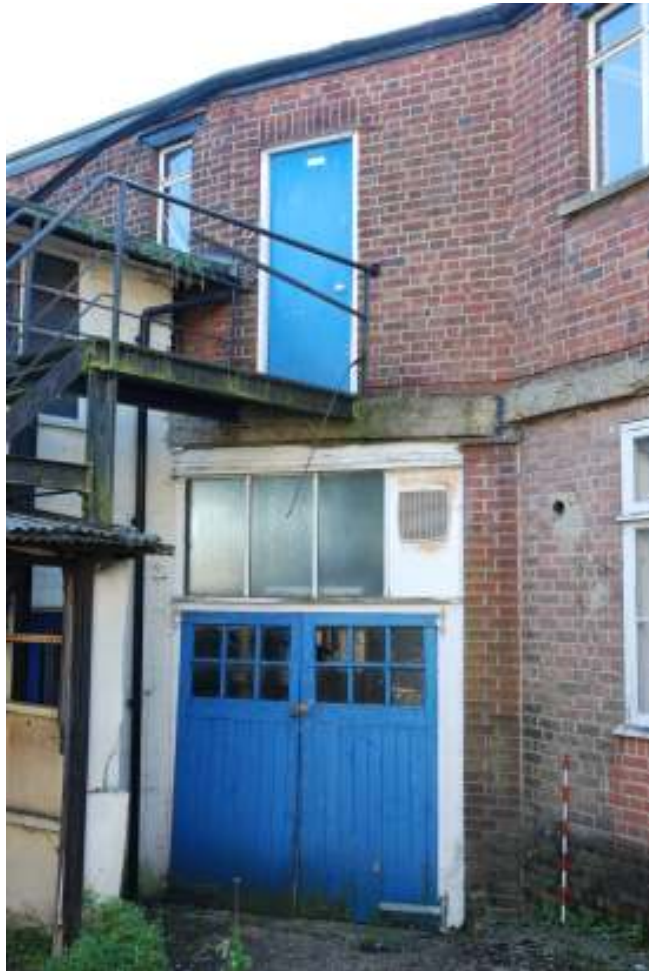
Fig. 108: Photograph showing the keyed-in brickwork at the upper level in the change of angle, and the line in the brickwork at the lower level.

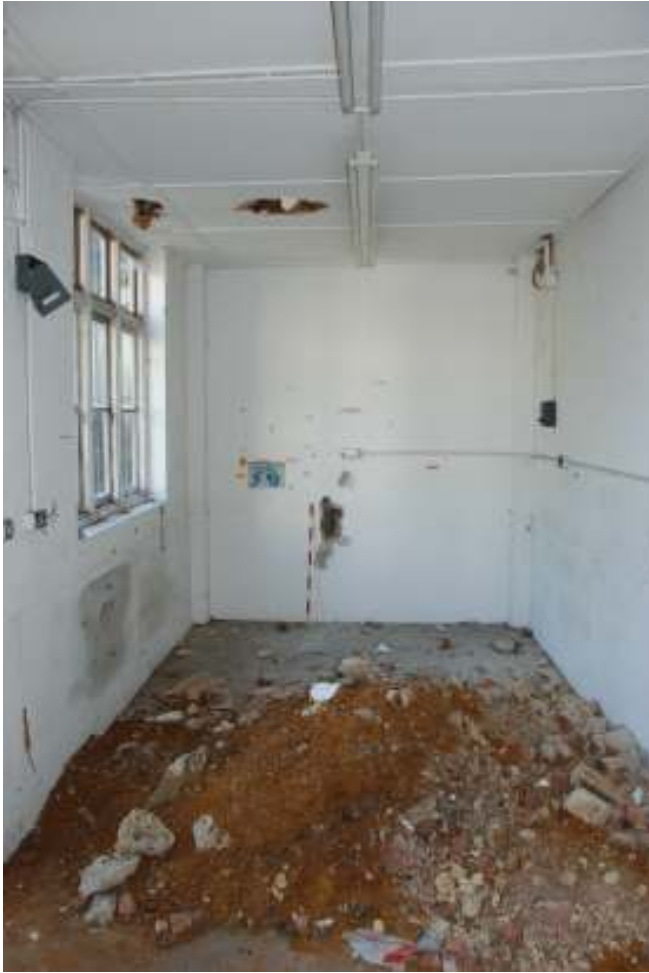
Fig. 109: Photograph of room 5, looking south.

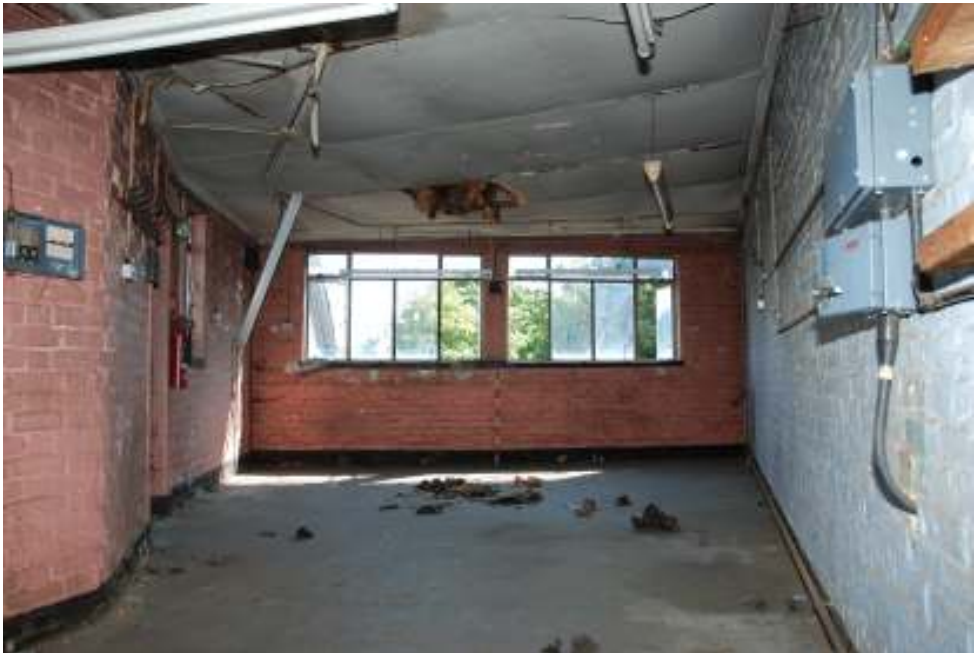
Fig. 113: Photograph of room 6, looking south.

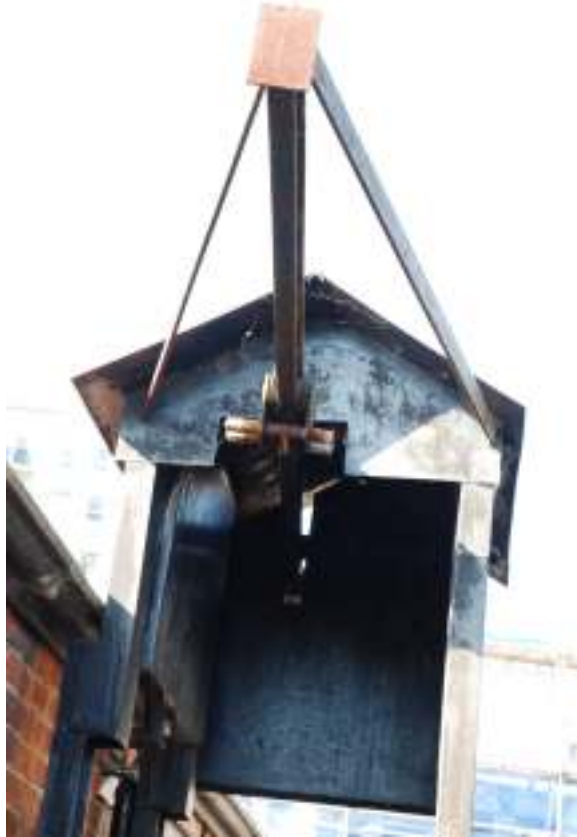
Fig. 114: Photograph of hoist outside room 6.

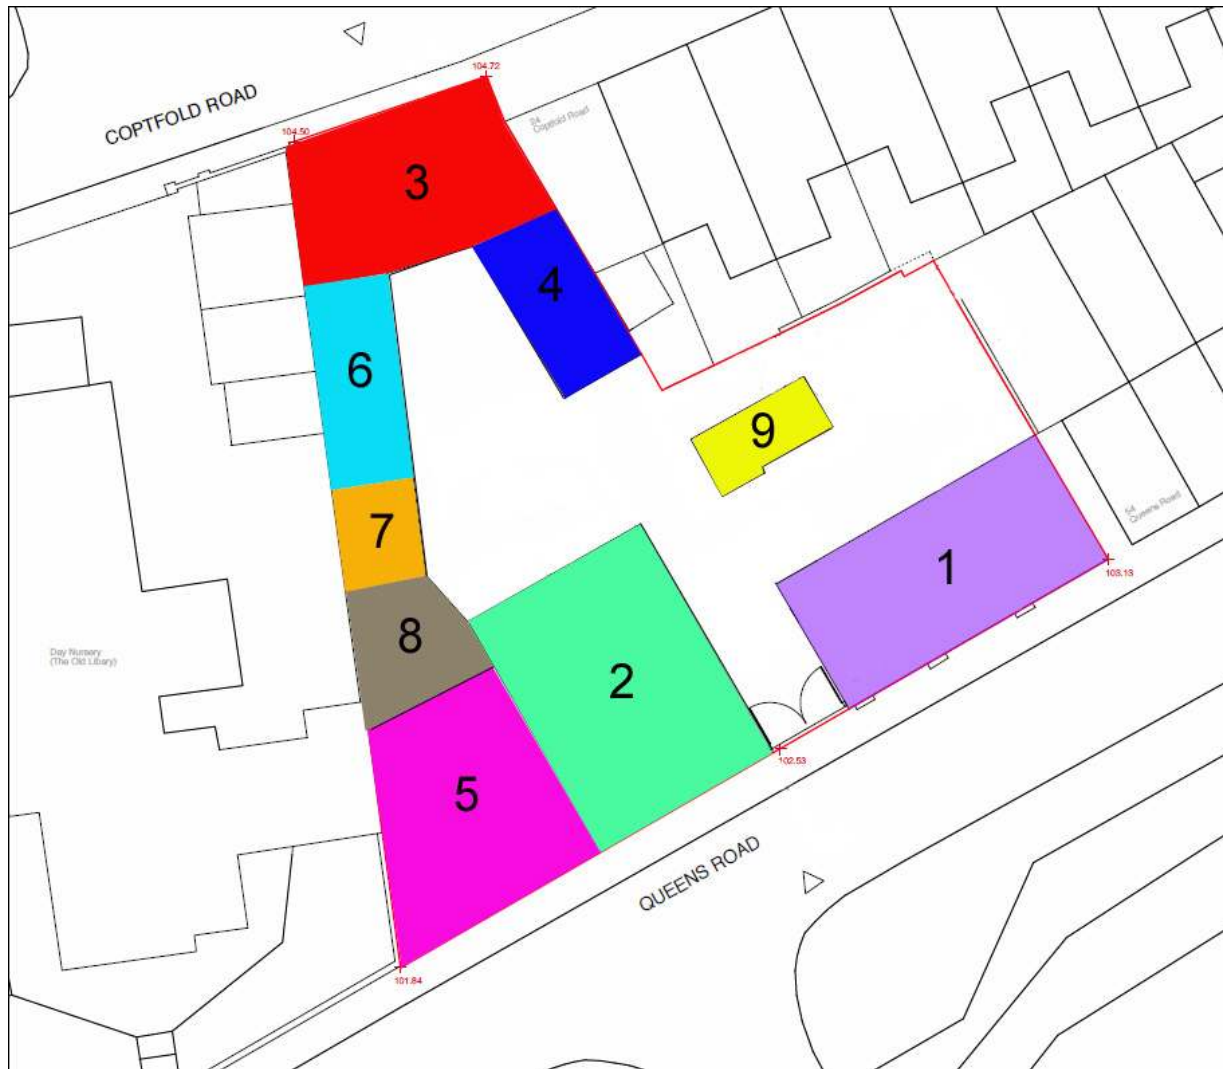
Fig. 121: Phased plan of the site. The different numbers and colours refer to different stages in the development of the site, and are discussed in the text below.
