## Devon County Council Historic Environment Record

Civil Parish & District: Silverton, Mid Devon	National Grid Reference SS 95451 03238		Number:		
Subject: Archaeological watching brief at land to west of Silverdale, Tiverton Road, Silverton, Devon  Photo attached? N					
Planning Application no: 09/01863/FULL		Recipient museum: RAMM			
OASIS ID: exeterar1-83130		Museum Accession no: RAMM 205/2010			
Contractor's reference number/code: EA7275		Dates fieldwork undertaken: 14/09/10

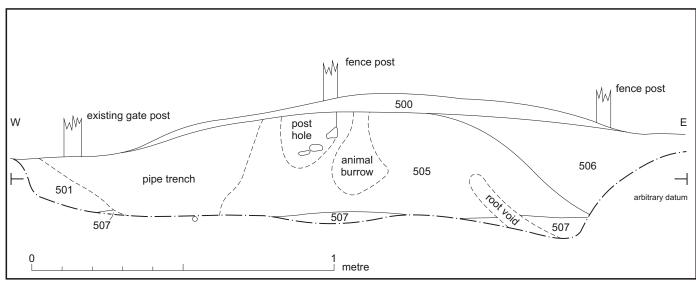
Fig. 2 Section through hedge-bank.

The natural subsoil was a medium brown clay with frequent coarse gravel (507), and was exposed c .0.40m below the highest point of the hedgebank. The core of the hedgebank comprised brown sandy clay loam with stones up to 70mm long (505). On the west side of the exposure a deposit of mid-brown clay loam with occasional gravel (501) may also form part of the hedgebank, but probably represents a later ploughsoil forming over the edge of the boundary. On the east side of the hedgebank a layer of mid-brown clay loam with occasional stones (506) was partially exposed, representing a relatively modern dump of soil possibly associated with the construction of the adjacent residential development.

A blue plastic water pipe was uncovered at the west end of the excavation. The trench for this was cut from near the surface and sliced through the core of the hedgebank. A little to the east was a further intervention comprising a curved profile cut approximately 0.36m deep with some prominent stones within the fill that suggest this may have been a former post hole. To the east of this feature were two further holes: a possible animal burrow and a hollow from a decayed root. A thin layer of very humic topsoil (500) partially overlaid the hedgebank.

The existing access track had been laid on a stony sub-base. This extended at least 0.30m below the surrounding ground level.

No finds were retrieved during the excavation and no evidence for palaeoenvironmental/archaeological deposits was seen. The date of the hedgebank was not established.
