Archaeological Standing Building Recording

**Brickhouse Farm
Chargrove Lane
Up Hatherley
Cheltenham
Gloucestershire
GL51 4XD**

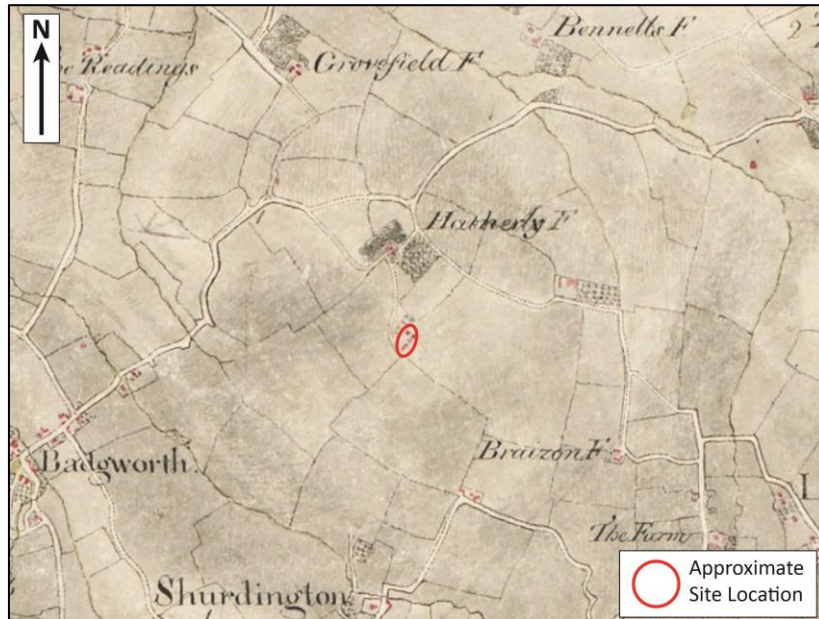
Fig. 5: Extract from the OS surveyor's drawing of 1804 (with site marked in red)
(Reproduced by courtesy of the British Library)

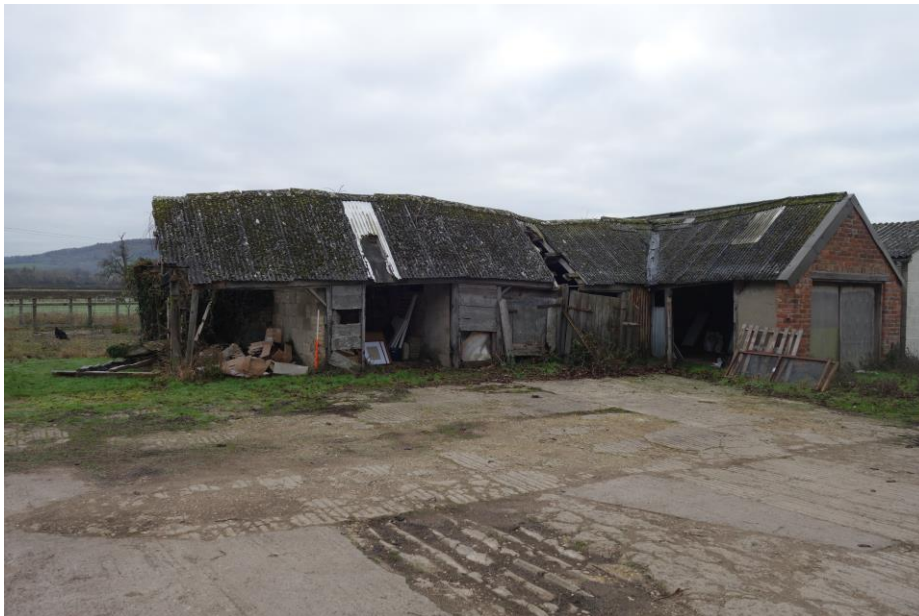
Plate 1: View looking SSE across the yard towards the L-shaped outbuilding at Brickhouse Farm

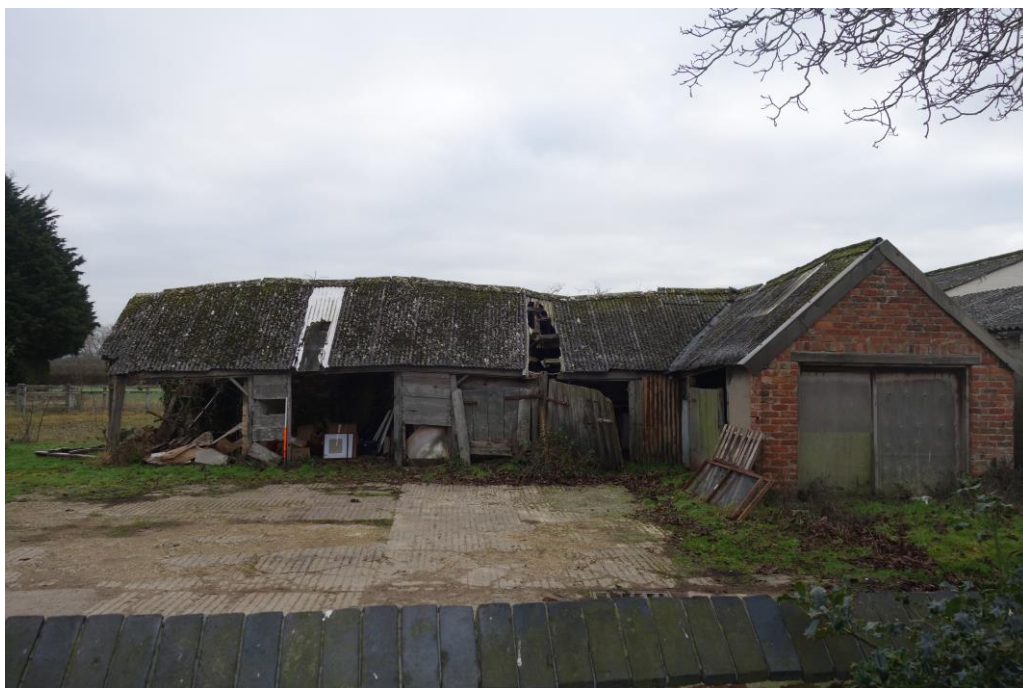
Plate 2: General view looking SE towards the L-plan single-storey outbuilding at Brickhouse Farm

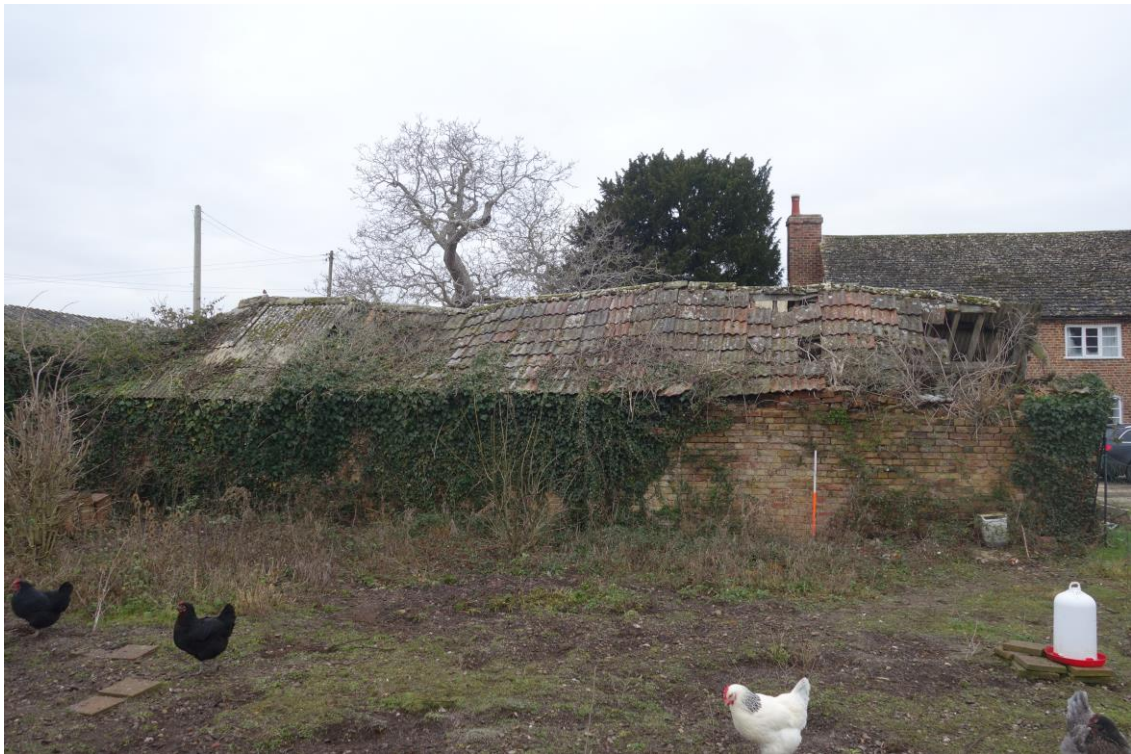
Plate 8: View NW showing the rear (SE) facing elevation of the L-plan outbuilding, heavily obscured by ivy creeper

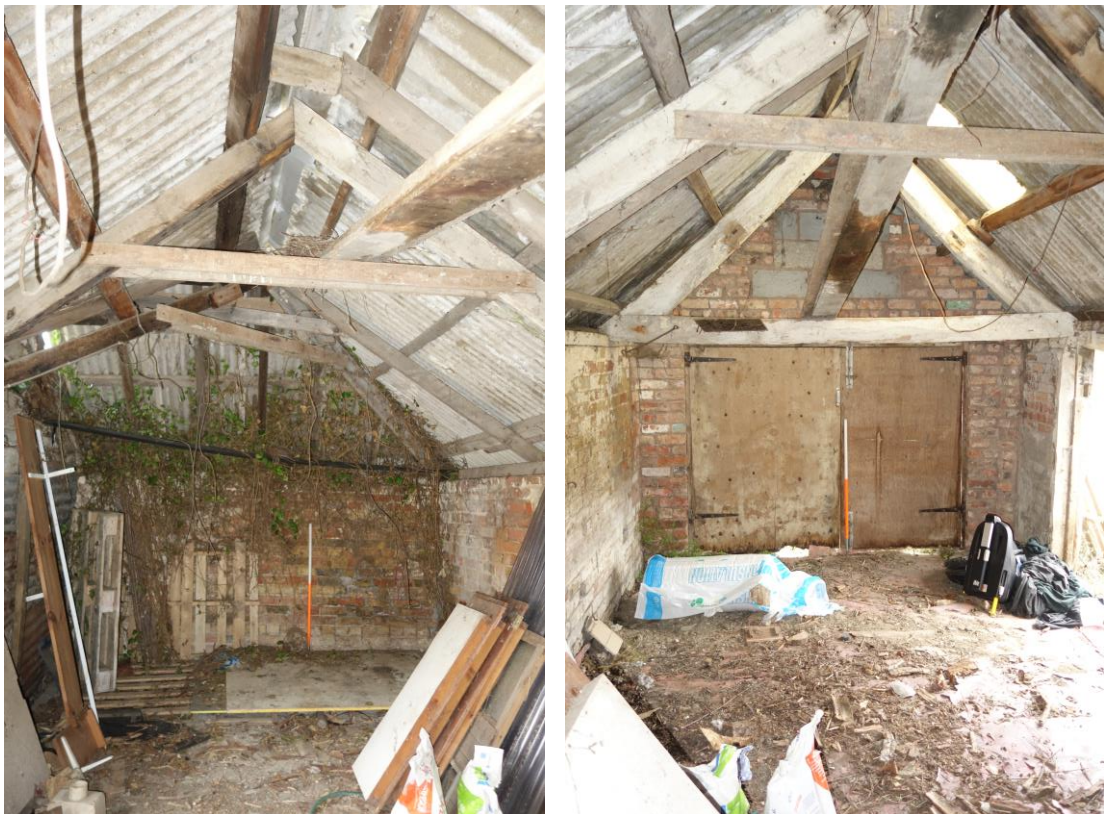
Plate 25: Internal view SE showing southeastern portion of two-bay range and roof trusses
