ARCHAEOLOGICAL INVESTIGATION, RECORDING AND REPORTING AT THE CHURCH OF ALL SAINTS, LITTLE STAUGHTON, BEDFORDSHIRE

Albion Archaeology Project No: LSC1203

Report No: 2007/24

Date: 6th March 2007

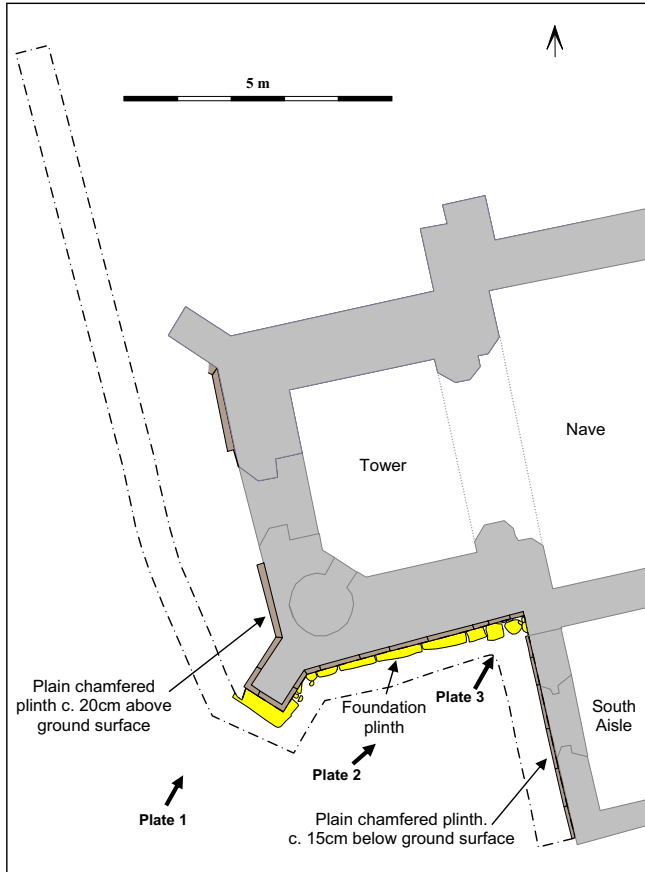
Figure 2: All features

A trench was excavated adjacent to the west end of the south aisle and the south side of the tower (Figure 2). In this section of the trench, loose stonework in the foundations was re-pointed before a perforated pipe was laid prior to filling with gravel. The continuation of the trench was excavated to the west of the tower where it stopped approximately 4.5m from the north boundary of the churchyard. This section of the finished trench contained a perforated pipe laid in gravel and sealed with topsoil and turf.

The finished trench was 22.70m long, 0.60m wide and 0.55–0.60m deep. It was hand-dug throughout its length.
