# TOWN CLOSE, CARTMEL, CUMBRIA

Heritage Assessment

March 2019

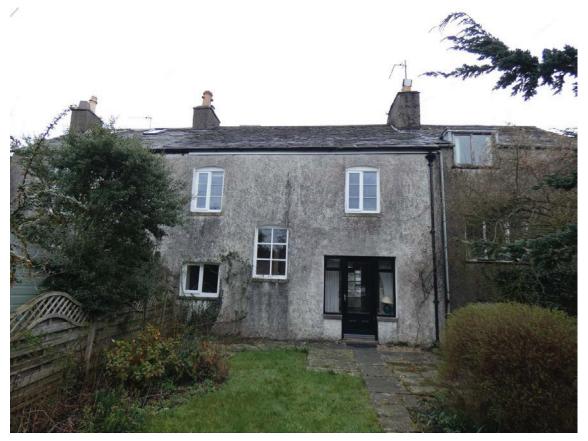
4.2.1 **West external elevation:** the ground floor has and a doorway flanked by windows on the ground floor, all with modern timber casements, and there is a further window at ground floor level to the north with a uPVC casement (Plate 8). On the first floor there is a central stair window of six fixed lights flanked by a single window with two-light hinged timber casements.

Plate 8: The west external elevation, viewed from the west

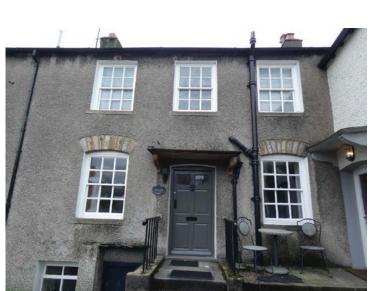
4.2.2 **East external elevation:** this is broadly symmetrical and based around a central doorway with a flat stone canopy on stone corbels with railings attached below leading down a short flight of steps to the yard (Plate 9). The door has four fielded panels and two lights in the top. To the south is a further flight of steps leading down to a second doorway at cellar level with a plank and batten door and a small four-light window to the south (Plate 10). The main elevation has two windows on the ground floor each with a stone voussoir arch and 12-light sash casements and there are three windows on the first floor all with sash casements in the same style. All of the windows have square sills probably formed of render.

Plate 9 (left): The east external elevation, viewed from the east Plate 10 (right): The south side of the east external elevation, viewed from the east

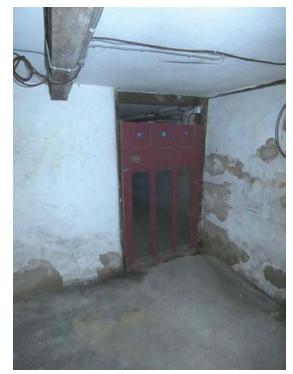
4.3.1 *Cellar:* this is split into two sections north and south by a masonry wall, which has a doorway on the east side with a re-used six panel door (Plate 11). On the east side of the north half there is an alcove that was perhaps formerly a doorway, while in the south-east corner there is a doorway to the exterior with plank and batten door and there is a stoneware sink set in the south-east corner below a small four-light window (Plate 12). To the south there is a chimney breast with no evident fireplace. On the west side is a stone staircase leading up to the ground floor (Plate 13). The beams supporting the ceiling are all hand-finished and some are clearly re-used.

Plate 11 (left): The doorway in the dividing wall of the cellar, viewed from the south

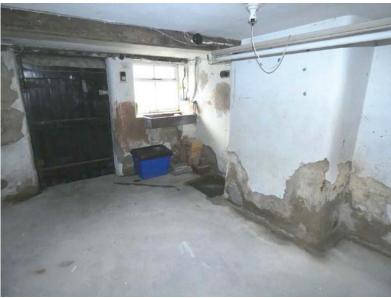
Plate 12 (right): The doorway, window and sink in the south-east corner of the cellar, viewed from the north-west

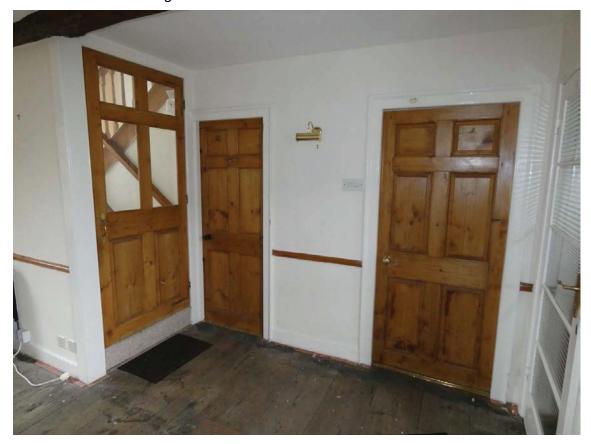
floorboards, with evidence for a stud partition on the west side of the living room, and the beams supporting the ceiling are hand finished and scored for plaster. The living room has two doorways on the north side both with six fielded panels that have been stripped of paint, with L-shaped hinges on the north-east one (Plate 14). The east elevation has a stud wall on the north side with a modern door leading into a porch. Within this the front door has four panels and two lights and is hung on long strap hinges (Plate 15). To the south of this is a window with fielded panel shutters, which have also been stripped of paint, supported by H-shaped hinges and with similar panelling around the window seat (Plate 16 and Plate 17). The south elevation has a central fireplace with a modern fire surround with tiled insert and hearth (Plate 18). To the east is a cupboard built into an alcove with fielded panel doors on H-shaped hinges that have been stripped of paint (Plate 19). At the west end of the living room there is doorway flanked by a pair of windows, both of which have modern timber casements and the doorway is also modern timber and glazed (Plate 20). The west elevation has a modern glazed timber doorway on the north side flanked by windows in the same style, with a return to the north at the stairs, which are accessed by a doorway which is an early six panel door with the scar of an L-shaped hinge, the upper four panels of which have been glazed.

Plate 14: Doorways to the north and north-west in the living room, viewed from the south-east

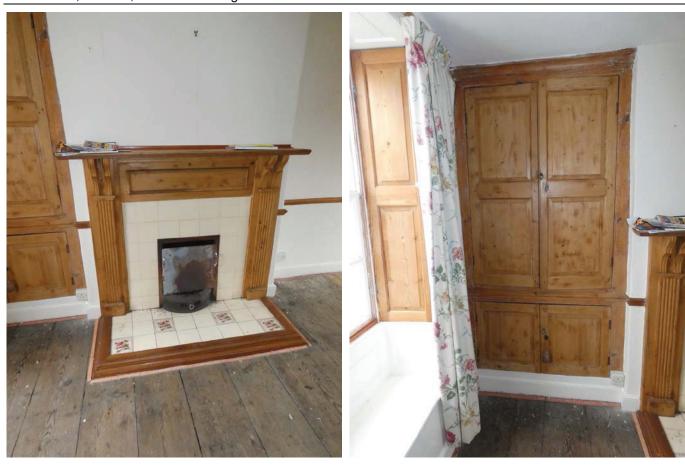
Plate 18 (left): Fireplace on the south side of the living room, viewed from the north Plate 19 (right): Cupboard in the south-east corner of the living room, viewed from the north

- 5.2.1 While much altered the building retains a number of early or original features including the internal doors and main front door and the windows to the south, which form an important part of the façade of the property. Unfortunately the west elevation has had almost all of its windows and its single door replaced with inappropriate modern casements, in some cases very recently. The stripping of the paint from the original internal doors and window shutters is also inappropriate for such historic features and the loss of the fireplaces and a replacement of the living room one with a poor imitation is unfortunate.

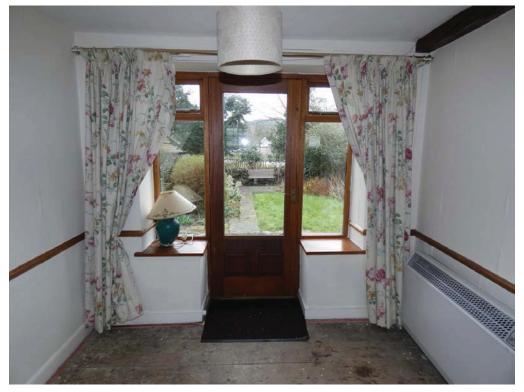
Plate 20 (left): Doorway with flanking windows in the west side of the living room, viewed from the east

- 5.1.2 The building has seen some fairly substantial alterations more recently both internally and externally, some of which are likely to have occurred after the building was first listed in 1970 (see *Appendix 1*). The most substantial of these are found in the west elevation, which has been almost entirely re-fenestrated with modern timber windows and doors and one in uPVC. Internally the most noteworthy alteration has been the loss of all of the original fireplaces, with one being replaced with the modern fireplace in the ground floor living room. Throughout the majority of the original doors have been retained as well as the original shutters and the cupboard in the ground floor living room, although these have invariably been stripped of their original paint. Some later doors have been added in the ground floor living room to improve insulation around the front door and stairs.

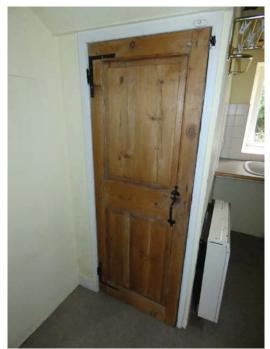
4.3.2 The kitchen has been extensively modernised with fitted units against most of the wall space. There is a window on the west side with a two-light uPVC casement and a doorway to the south of this leading to the cellar with an early door with two raised panels and L-shaped hinges (Plate 21). The parlour to the east is fairly plain. There is filled section in the floorboards against the north side, presumably denoting the location of a hearth for a fireplace (Plate 22), and a window to the east in the same style as that in the living room but with the shutters still painted (Plate 23 and Plate 24).

Plate 21 (left): Doorway on the south side of the west elevation in the kitchen, viewed from the west Plate 22 (right): Filled gap in the floorboards on the north side of the parlour, viewed from the south
