## Archaeological evaluation at Forty Hall, Enfield

Report 10/119

August 2010

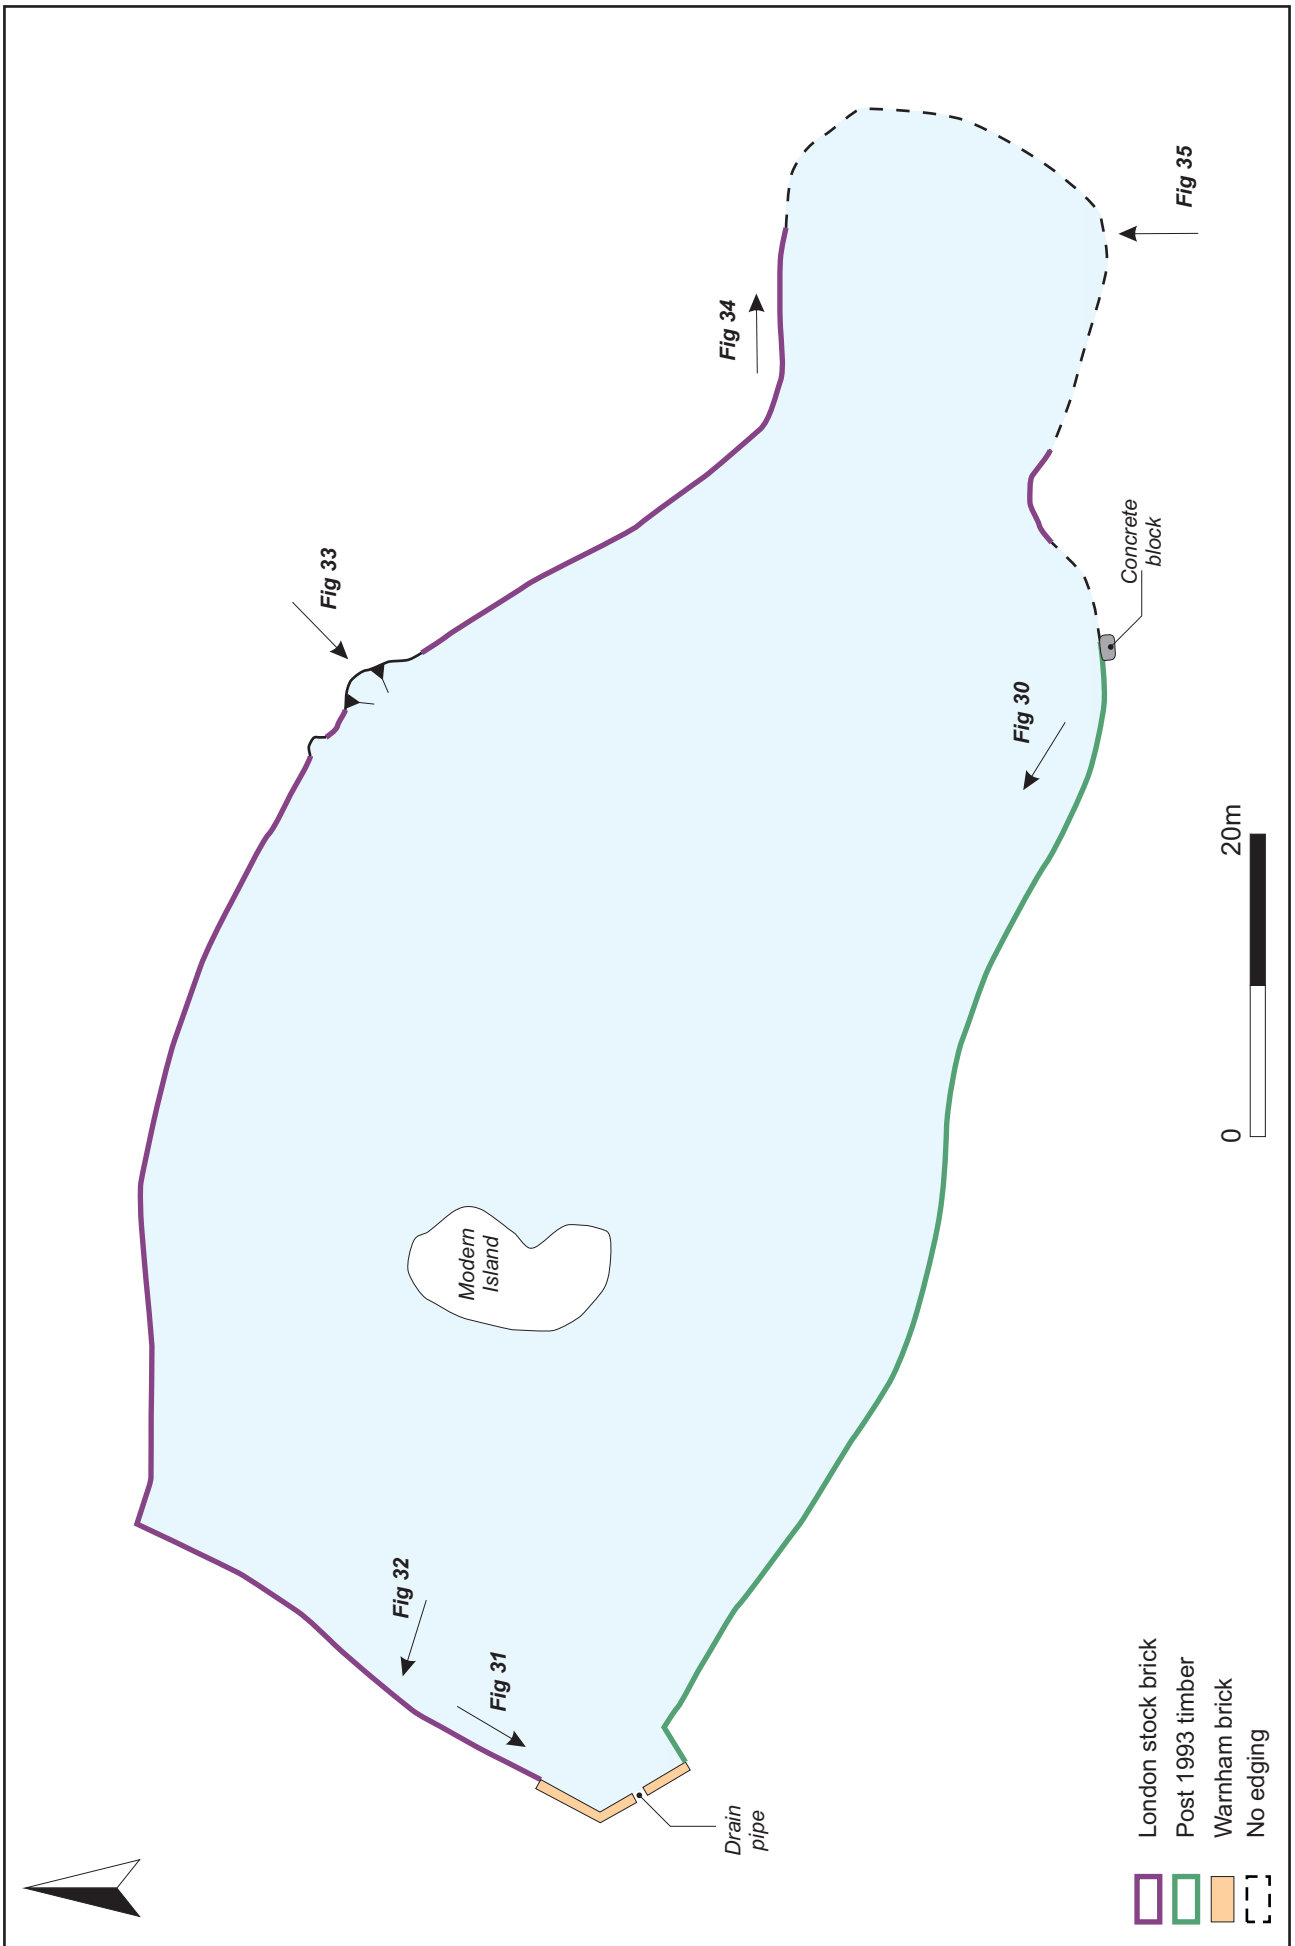
A visual inspection was made of the circuit of the lake to comment on the materials which revett the edge, probable dates and the general condition (Figs 2 and 29). The weather had been dry for a number of weeks before this assessment was carried out after an unusually dry spring, hence the water level was fairly low as indicated by 'tide marks' visible on some of the edging. The lake is depicted on both the 1773 and 1787 Estate plans, and is thought to have originally been a smaller, circular, pond axially positioned at the southern end of the avenue which extends northwards across the park (Figs 3 and 4). Two small inlets located at the north-west and south-west corners of the lake are no longer present having been infilled, although an indication of the one at the north-west corner is depicted on the 1913 Ordnance Survey map.

The present revetment of the Upper Lake is a hotchpotch of materials with repairs of different dates, styles and quality. Whilst not original, the earliest appears to be London stock brick laid for the most part in Flemish Bond with the upper course originally entirely of headers. Some of this retaining wall is in good condition, though much has been degraded by water and root ingress, loss of mortar and in places total collapse. In those areas the soil, which is either cut into or built up (on the north and east sides), has suffered from extensive erosion which has altered the outline of the lake. Whilst ironically this loss of hard edging gives the lake a more natural appearance, it might have an impact on water retention and is unlikely to be sustainable in the long term. Equally incongruous is the modern, post 1993, timber edging which gives the lake an angular outline on the south side closest to the Hall. Whilst this is at least less visible when viewed from the house looking north into the wider parkland, when viewed from the north facing towards the house it is much more obvious as a modern replacement. The Warnham red bricks at the south-west corner is limited in its visual impact due to the small length of walling, and during the summer months at least is obscured by vegetation. However, the bright, shiny red of the bricks is jarring compared to the mellow London stock bricks and in stark contrast to the soft reds of the adjacent stableyard. Silting appears to be a problem at the east and west ends only, and is particularly bad within the bulge at the eastern end, where the slightly narrow neck of the lake outline presumably traps weed, branches, rubbish and leaves perhaps blown in that direction by the prevailing south-westerly winds. Weed trees along the northern edge currently obscure the lower level of view into the park, especially along the avenue (as does the hedge immediately to the north) and neither lines of growth are historically correct. Their roots are causing extensive damage to the brickwork by forcing apart the courses.

Scale 1:500 Upper Lake, plan showing different materials and locations of photographs Fig 29

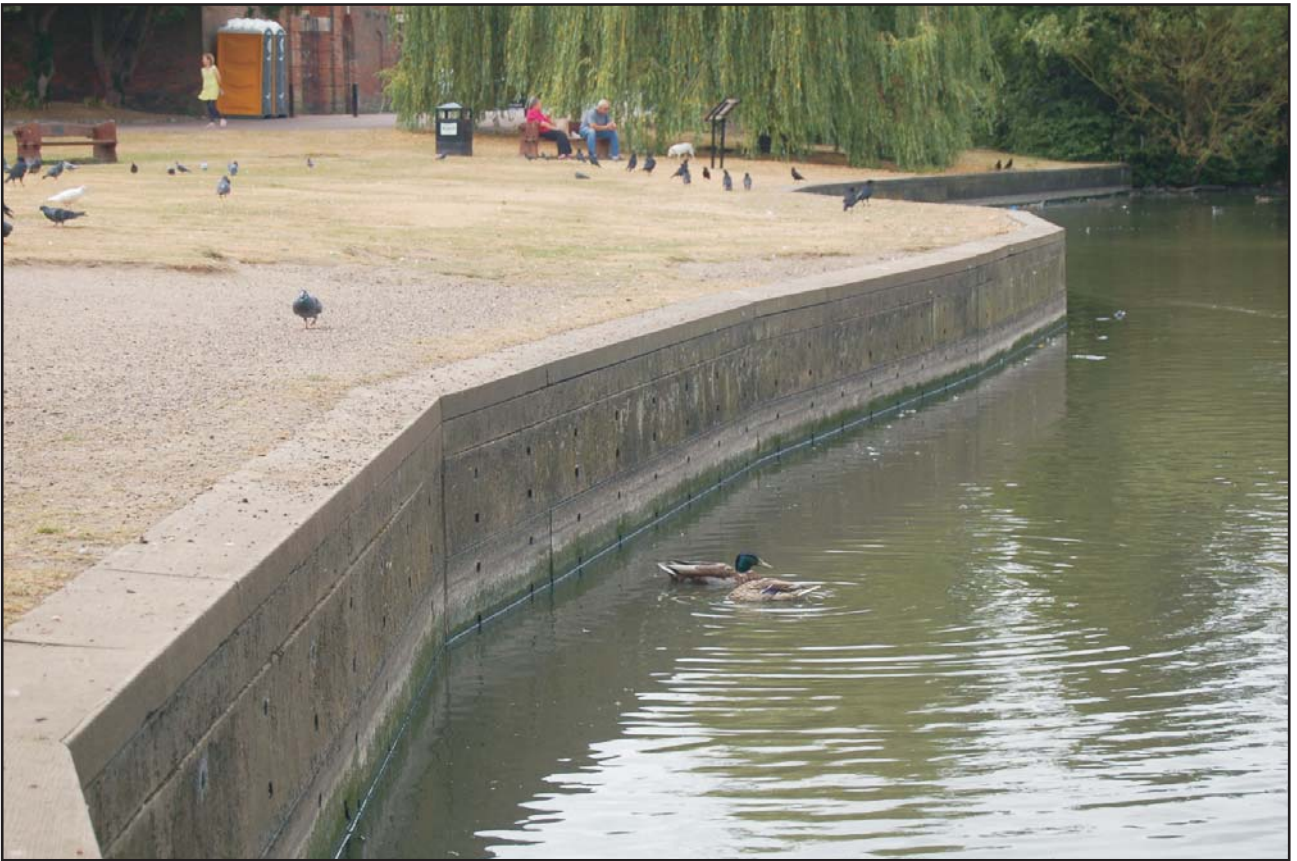
Upper Lake, modern timber edging looking west Fig 30

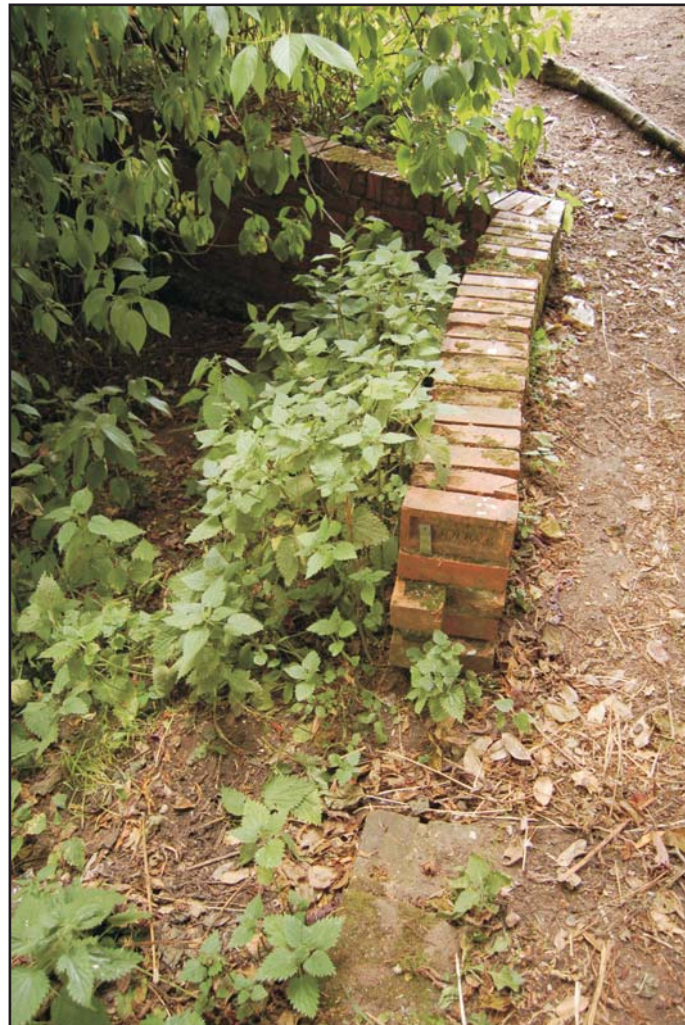
At the south-west corner the timber returns sharply to meet with a section of modern, frogged, red brick revetment, inexpertly laid (Fig 31). The bricks measure 210mm x 60-65mm x 100mm and in the frogs are stamped the names WARNHAM SBC and WARNHAM RB. Warnham bricks are currently available, and are easily found on websites. They are bonded in a hard grey (presumably Portland) cement. A drain pipe outlet, presumably carrying rainwater from the stable yard to the south, is set into the wall on the south side of the corner.

Upper Lake, Warnham brick edging looking south Fig 31

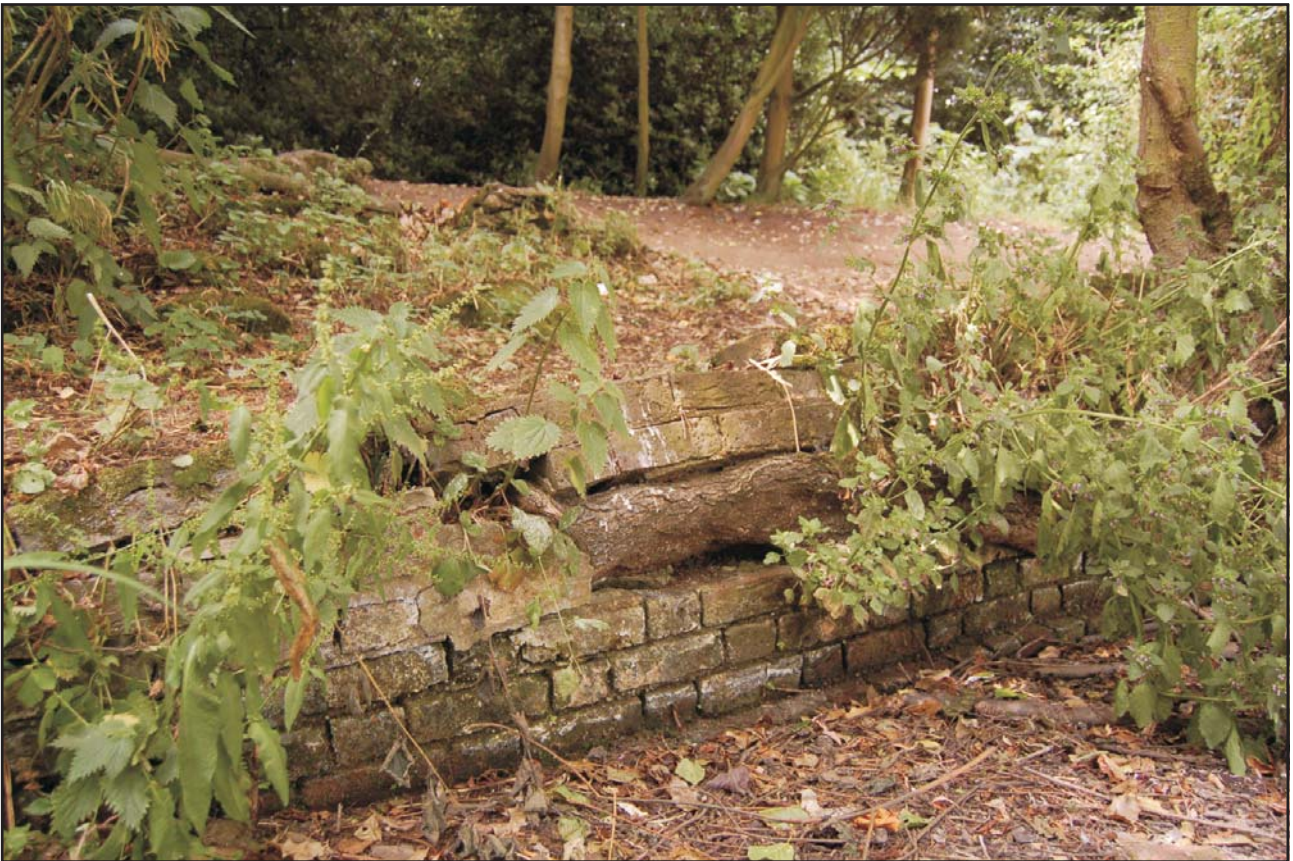
Fig 32

The western side of the lake is bounded with London stock bricks, mostly in Flemish bond, but with some repairs irregularly laid. The term 'stock brick' has three main meanings: one being the name given to any brick made with the aid of a stock board, another the ordinary brick of any particular locality, the third more specifically the yellowish common bricks of the London area (Brunskill 1990). The latter is relevant here. The bricks are 220mm x 60-70mm x 95-105mm in size. This section has been variously re-pointed with cement, though in many places the cement, and possibly earlier mortar (though this cannot at this stage be proved), has eroded out leaving gaps between the courses. The wall is one brick thick (i.e. a nine inch wall) and the upper course consists entirely of headers. Tree roots have grown between some sections forcing apart the courses causing sections to be lifted (Fig 32). Along this length six courses of brickwork are visible above the silting along the lake edge, and the lowest course is slightly offset to form a narrow plinth. It is not known if this plinth continues around the entire stock brick section. Both the north-west and south-west corners of the lake are heavily silted.

Upper Lake, London stock brick on western edge of lake showing root penetration, looking west

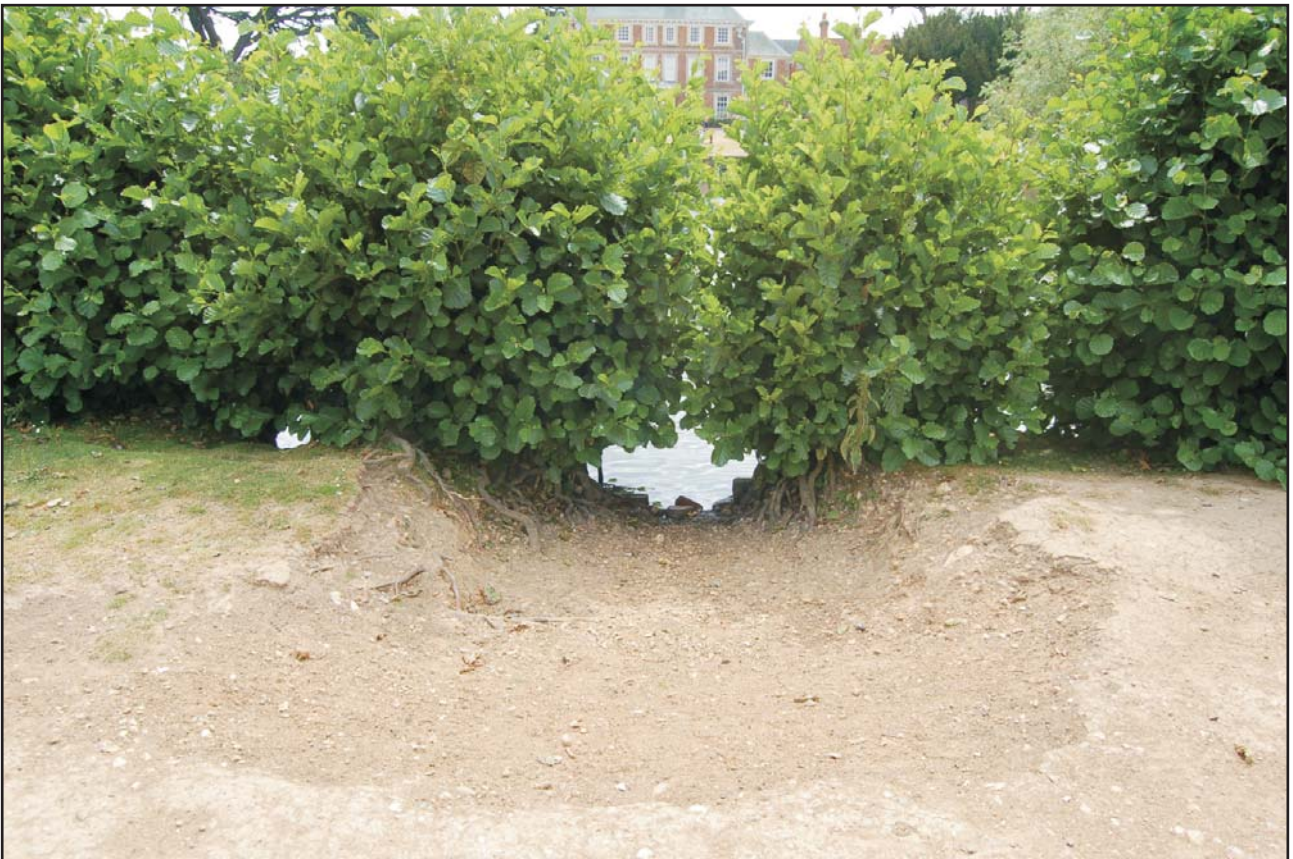
Fig 33

The north side of the lake is of varying condition, with some sections complete with the upper course of headers intact, whilst other sections are almost entirely missing through erosion. Much of the upper edge of this length is overgrown with tree sucker growth which not only hides the revetment, but also obscures the view across the lake in both directions, perhaps most importantly from the main entrance of the Hall northwards across the lake and originally down the avenue in the wider park. The sucker growth along the lake edge has caused considerable damage to the brickwork, forcing apart courses (particularly towards the eastern end), and much of the pointing is missing. In places there is almost total loss of the revetment and it is assumed that at times when the water table is high, wave action erodes away the soft sands and gravels which are present behind the walling (Fig 33). This is no doubt exacerbated by waterfowl entering and leaving the lake through these breaches.

Upper Lake, eroded soil behind lost edging on north side of the lake, looking south

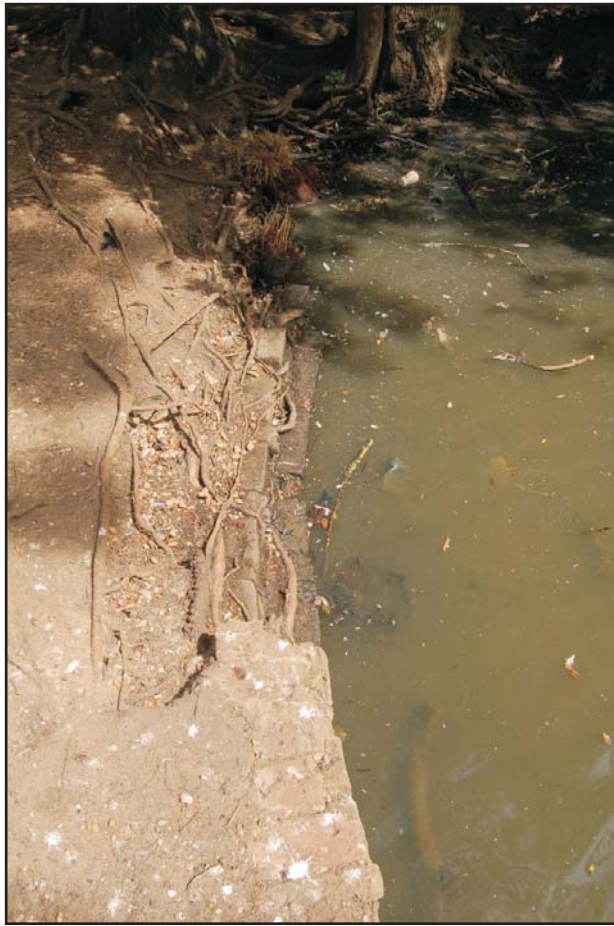
At the eastern end of the lake where the shape narrows and then bulges, there is almost no edging visible, and the majority of the bulge is without edging at all (Fig 34). Large trees shade much of this section and their roots reach into the water. Some sections of the soil edging are undercut by wave action, and there is almost no other vegetation to hold the sandy, gravelly soil together which is presumably also vulnerable to surface erosion during wet weather. Lack of surface vegetation, partly caused by the grazing of geese, and the large numbers of the public which use the park has presumably allowed the edges to further deteriorate. Most of the eastern end of the bulge is choked with organic material comprising branches and leaves which present an unpleasant image of rotting debris (Fig 35). On the south side of the bulge small sections of very eroded stock bricks are present, mostly in poor condition with root penetration and little or no pointing.

Upper Lake, north-eastern edge showing loss of stock brick edging Fig 34

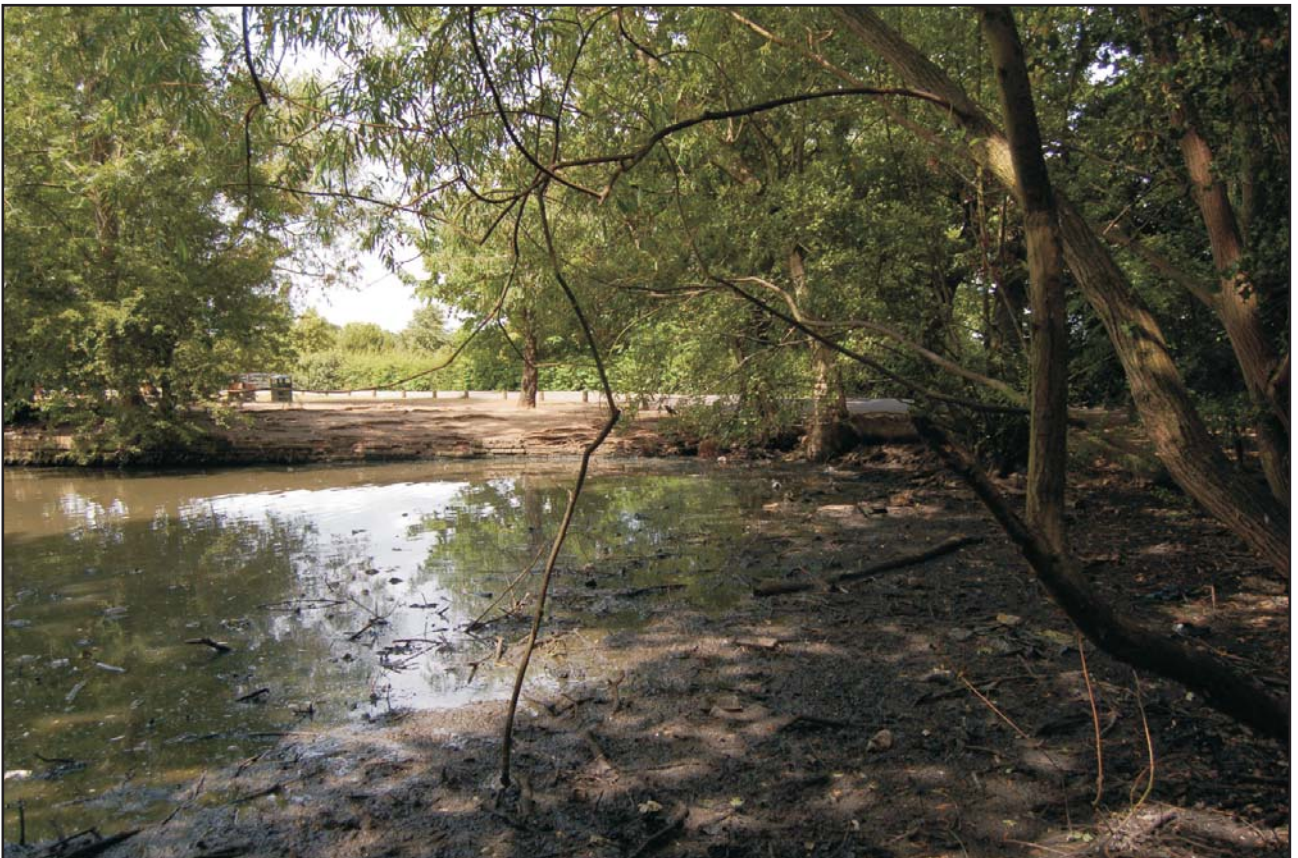
Upper Lake, silting at eastern end looking north-west Fig 35
