Archaeological watching brief during restoration at the Grotto, Stowe Landscape Gardens Buckinghamshire

Joe Prentice Report 12/46 February 2012

AN ARCHAEOLOGICAL WATCHING BRIEF DURING RESTORATION WORK AT THE GROTTO, STOWE, BUCKINGHAMSHIRE **NOVEMBER 2010**

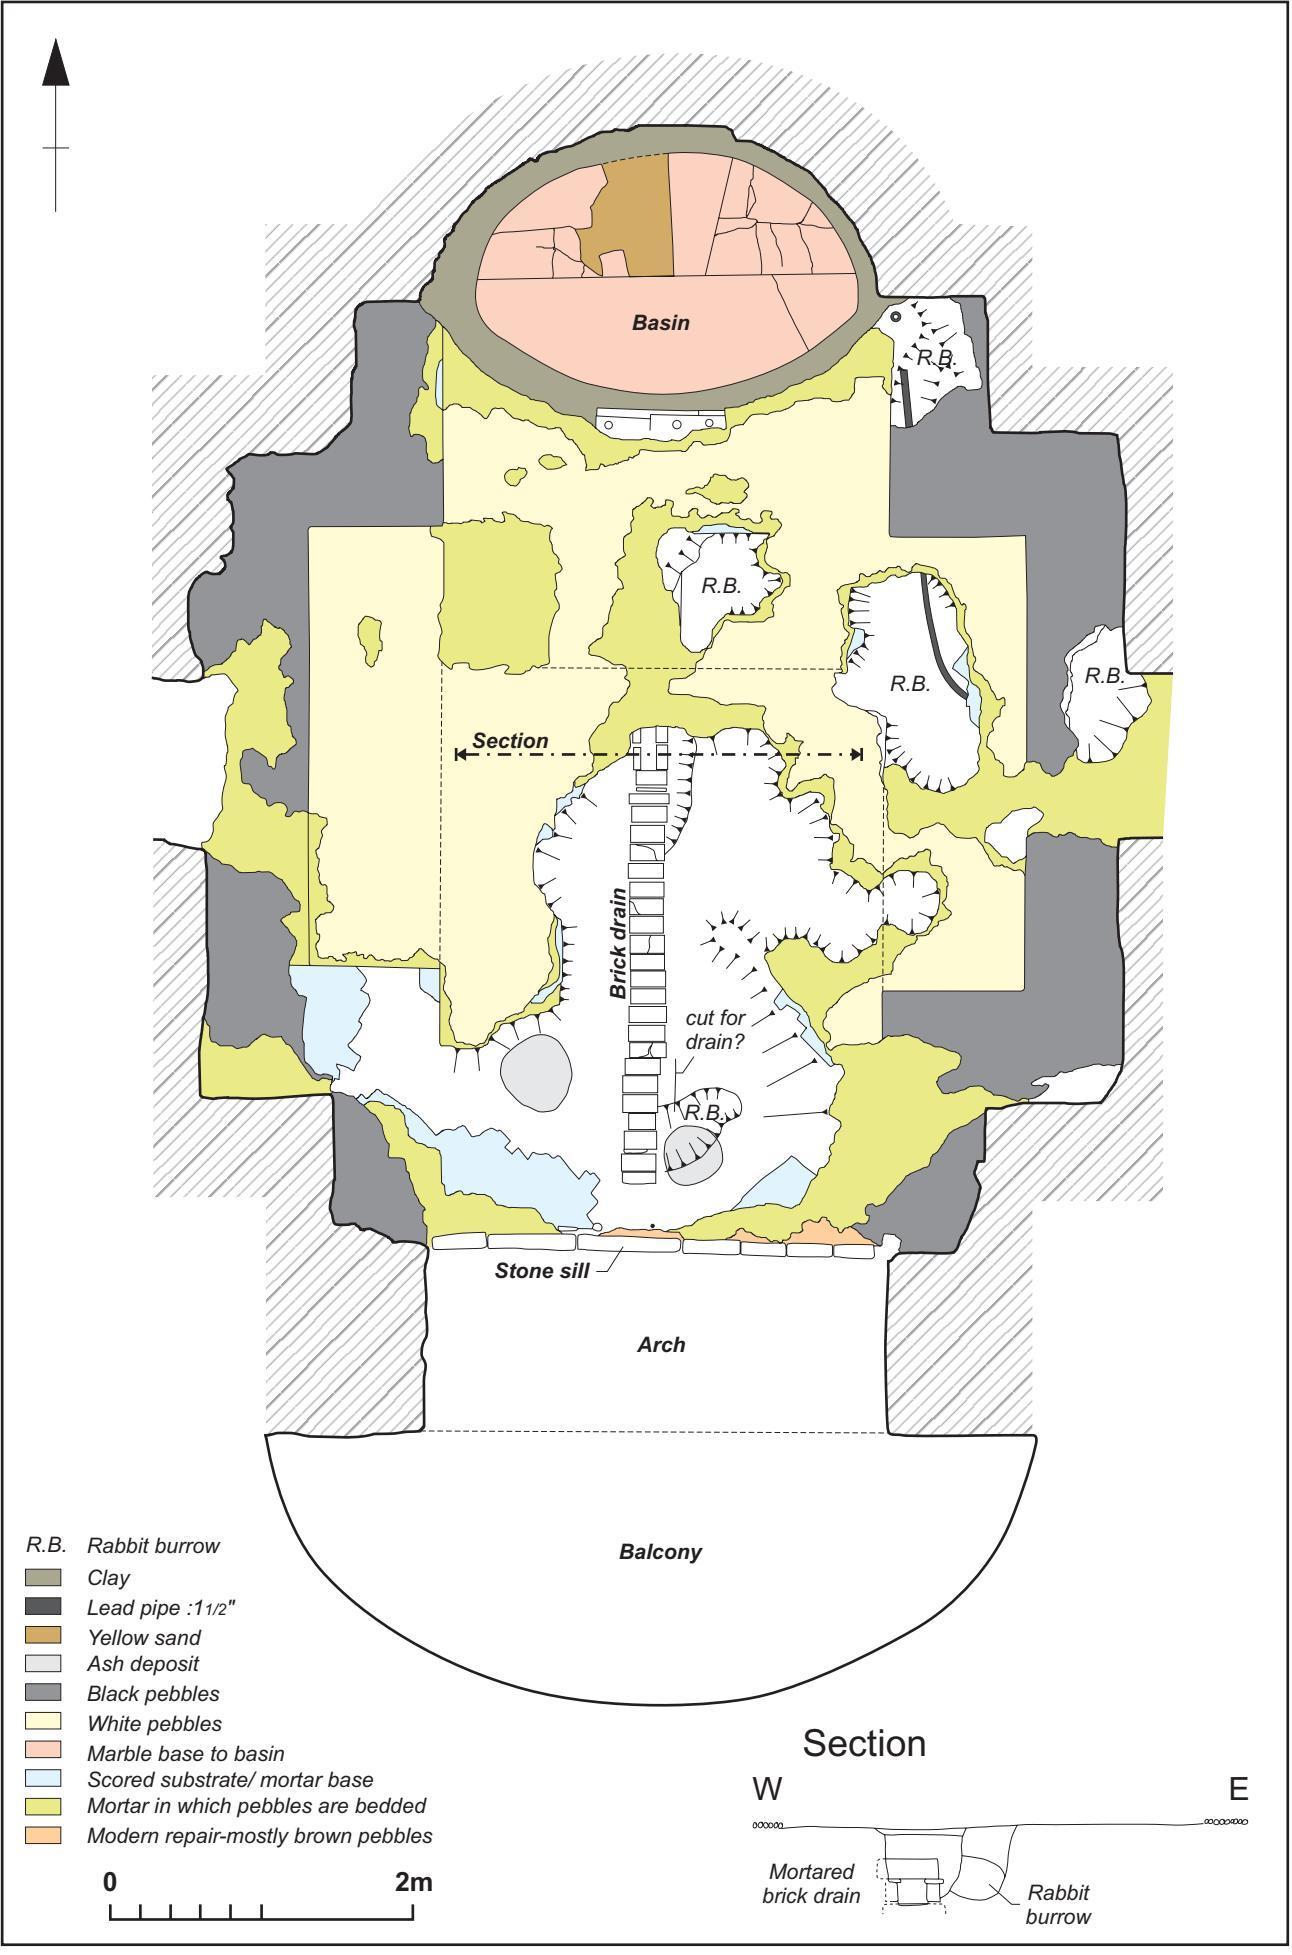
The grotto underwent a campaign of holding repairs and partial restoration in the 1970s before the National Trust took ownership of the gardens (in 1989). In 1997 the side passages were consolidated but the main chamber pebble mosaic floor has suffered damage from rabbit burrowing with large areas now missing and others in danger of collapse.

concealed by that and the overlying final mortar and pebble surface; its presence was only revealed when the pebble surface was disturbed by the burrowing of the rabbits (see Fig 2). The drain comprised a base of bricks with sides comprising a single course of brick laid on edge, end to end and capped by a further layer of brick, all bonded in lime mortar. Since it served the marble basin situated within the niche, this drain must relate to the programme of hydrology added during the 1760s. As the pebble floor overlies this drain and also appears to respect the edge of the marble basin, the floor itself most likely also relates to this phase of works.

Plan of the Grotto floor, showing pebble floor, Fig 2 repairs and damage

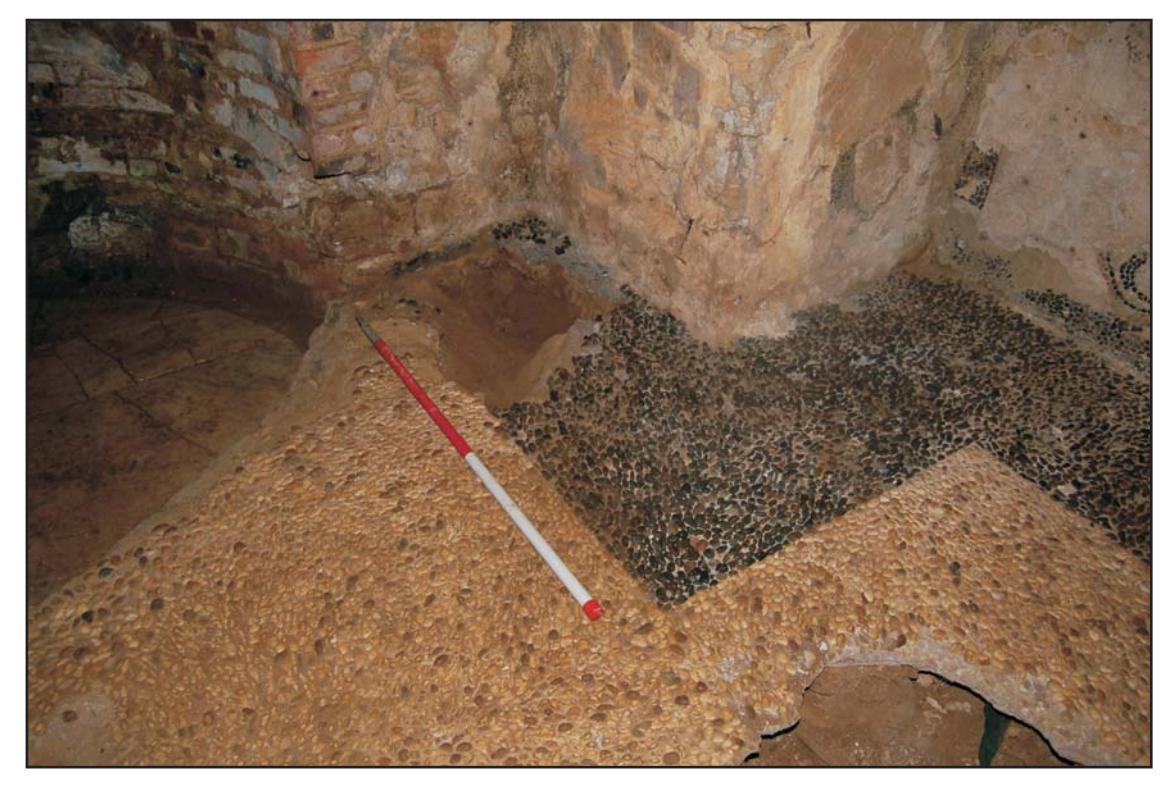
The floor of the central chamber of the grotto was originally covered entirely with a mosaic comprising natural pebbles of carefully selected size and shape and of two colours, white (with variations to almost brown) and black (Fig 2, Plate 1). The pattern of the mosaic was very simple and was basically a broad border of black pebbles around the perimeter of the room with the central part composed of white pebble. Whilst there were large areas missing, it does no appear that any further decorative areas had been present.

The pebbles showing white and black colouring Plate 1

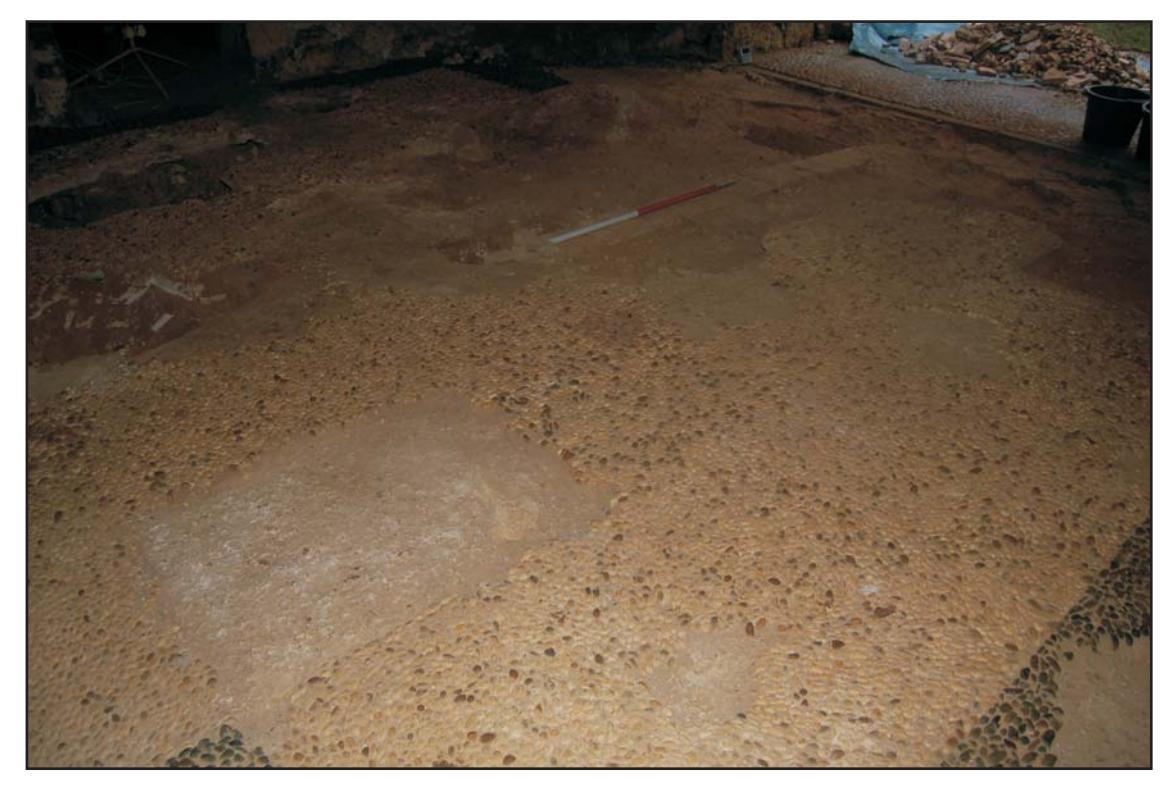
The pebbles, mostly rounded but with a few more angular examples, were set in a layer of lime mortar and appear to have been laid in relatively small but regular areas since straight joins could be discerned within the white areas (Fig 2, Plate 2). This was thought to presumably reflect the working method of the mosaic makers and to indicate the areas which they could lay, perhaps in one day, or at least in one mix of lime mortar (a bit like fresco painters who would only lay an area of plaster on which they knew they could paint in one day). When the floor was being repaired, the craftsman who undertook the work used the following method of working; timber battens were laid around an area that was to be worked upon and then levelled. Lime mortar was laid within the battens and the pebbles roughly pressed into the surface. A detached batten was then run across the fixed, levelled, battens which had the effect of pushing down the pebbles fully into the mortar and at the same time producing a perfectly level surface. Once hardened, the battens were removed and the gaps they had left were infilled with mortar and pebbles creating lines identical to those observed in original sections of flooring (this commentary on the working methods of the repairing of the floor was observed by Mr G Marshall and conveyed to the author of this report). It therefore seems that this method was used originally and thus explains the straight lines which were visible within the floor surface.

White pebble flooring showing area of loss with straight edges indicatingPlate 2method of laying

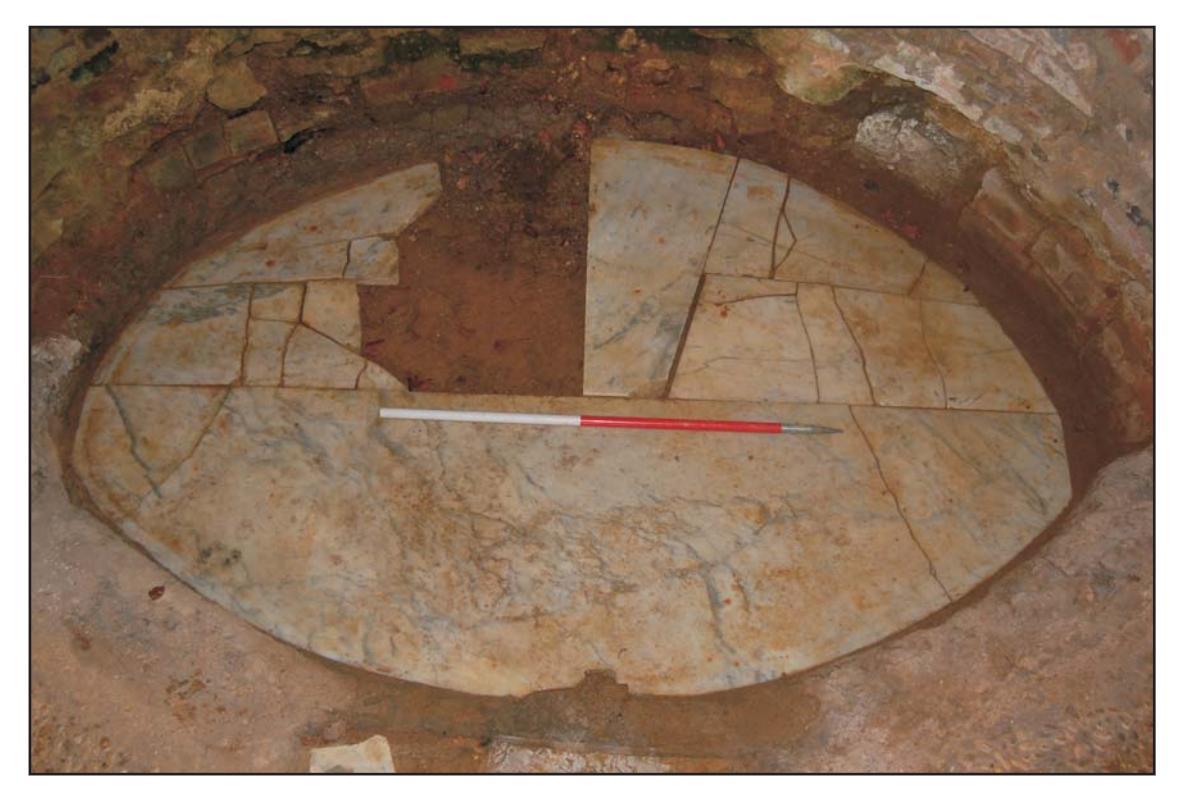
At the north side of the chamber only parts of the oval grey/white veined marble base of the basin remained *in situ* (Fig 2, Plate 3). The marble base comprised a number of slabs which had been subsequently broken, and is now incomplete. The slabs of marble were approximately 35mm thick. It is possible that this marble was re-used, since when parts of the slabs which had been moved outside of the basin were refitted, it was seen that on one piece at least were remains of tooled-off raised rib, perhaps originally moulded (Plate 4). None of the sides of the basin remained but its original depth could be tentatively determined by the presence of slabs of finely grained stone along the southern edge with three holes in which are thought to represent the drainage holes for the overflow (Fig 5). These stones also appear to have been reused having a simple cavetto moulding along their inner edge, although this might have been a deliberate part of the design.

The marble basin Plate 3

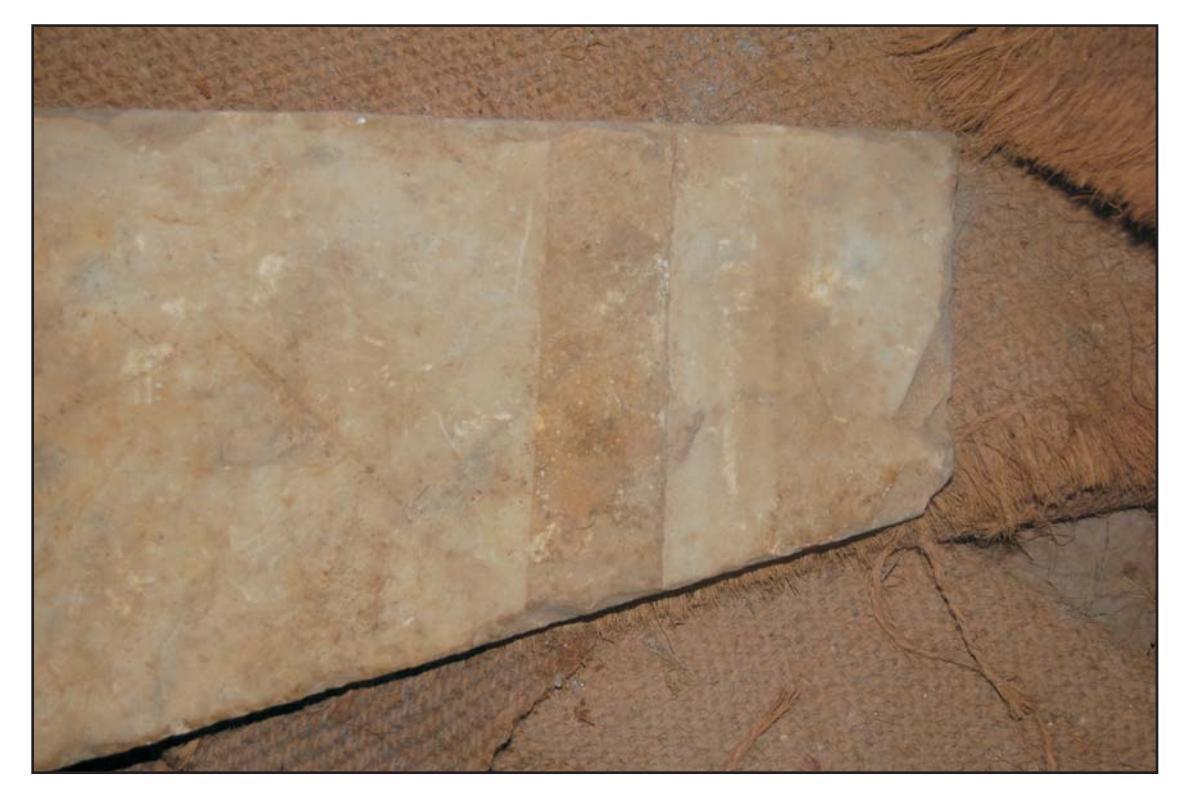
The back of a marble slab fragment showing evidence of former moulding Plate 4 since tooled off

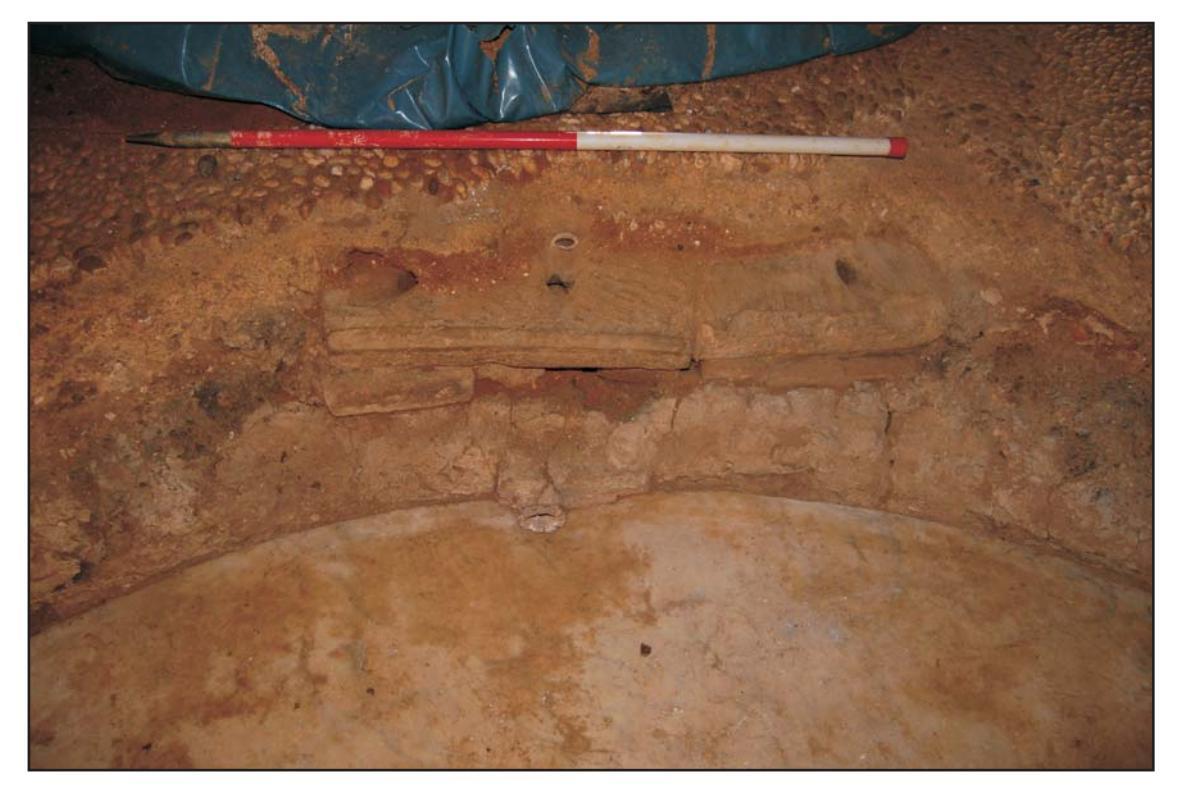
Below the pieces of stone on the southern edge of the basin and flush with the marble slab of the base is the end of a lead pipe, splayed where it presumably sat flush with the internal face of the side of the basin (Plate 5). It is assumed that this acted as a drain for when the basin needed to be drained, since if it was open all of the time the basin could not have held water. It presumably connects with the brick drain beneath the pebble floor. The height of the floor above the base of the basin suggests that when complete (though not including any raised lip which may have been in place) the basin was *c*0.3m deep. It is not known how the edges of the basin were finished, nor can it be determined whether its upper edge was flush with the pebble floor or stood proud of it, though perhaps the latter is the most likely. All of the above mentioned pieces of stone and marble are set within a blue/grey clay which acted as a waterproof lining.

Re-used stone blocks with overflow holes on the south side of the marble rim Plate 5 basin rim and lead pipe flush with the base of the marble basin, looking south

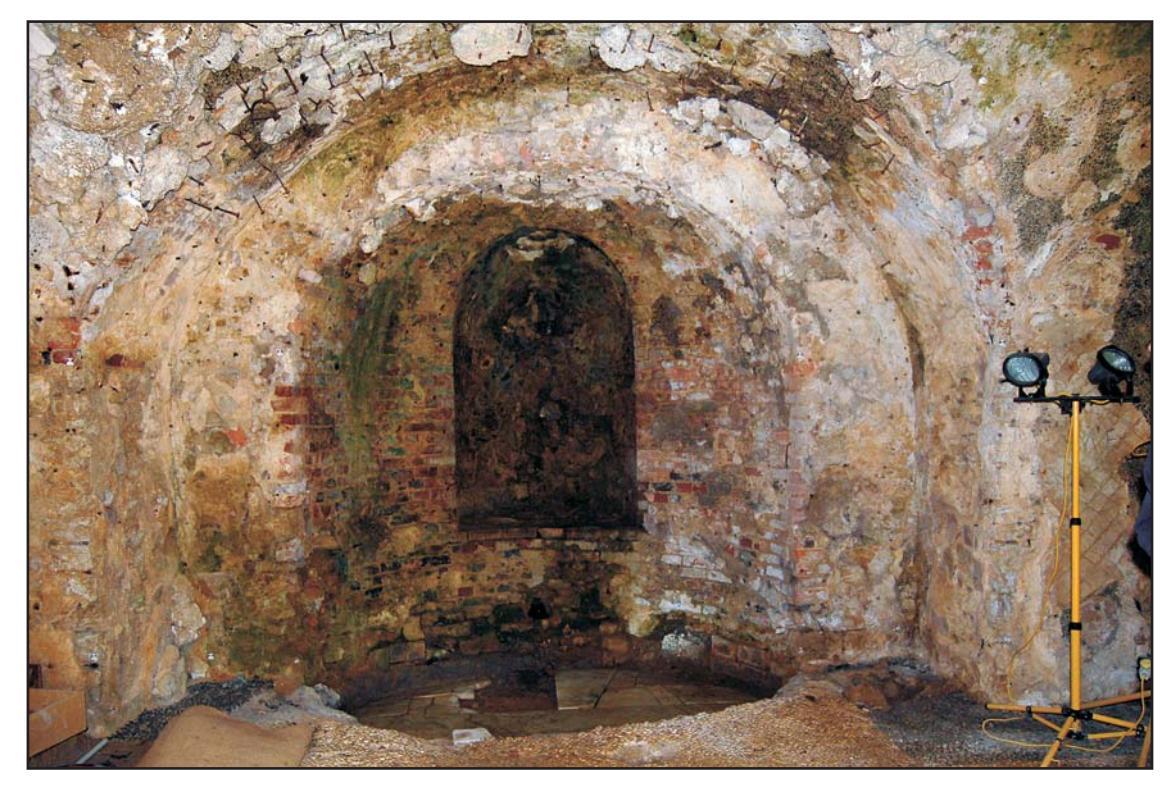
Plate 6

The curved niche at the rear (north side) of the chamber comprises two parts; the large, almost semi-circular round topped niche in which the lower marble basin was positioned and which fills most of the rear wall, and a second, smaller niche set within in the larger niche at a higher level (Plate 6). The latter is thought to have contained the statue of Venus. Both the large and small niches are formed of a combination of brick and stone (though most of the arris's to each niche are formed of brick) and both retain fragments of surface mortar render. Almost no surface decoration remains, though a very few pieces of tufa pegged into the walls remain at the outer edges close to the ceiling and floor. There are some isolated areas of the first phase of decorative scheme, most clearly seen at the top right of the smaller arch soffit where it appears that crushed glass, and possibly also quartz, has been set into the surface of the mortar render (Plate 7). The glass and quartz appears to be a variety of colours; muddy brown/green, turquoise green, orange, brown and pink. Though now dull, originally this surface must have sparkled quite brilliantly.

The large and small niches at the rear (north side) of the grotto

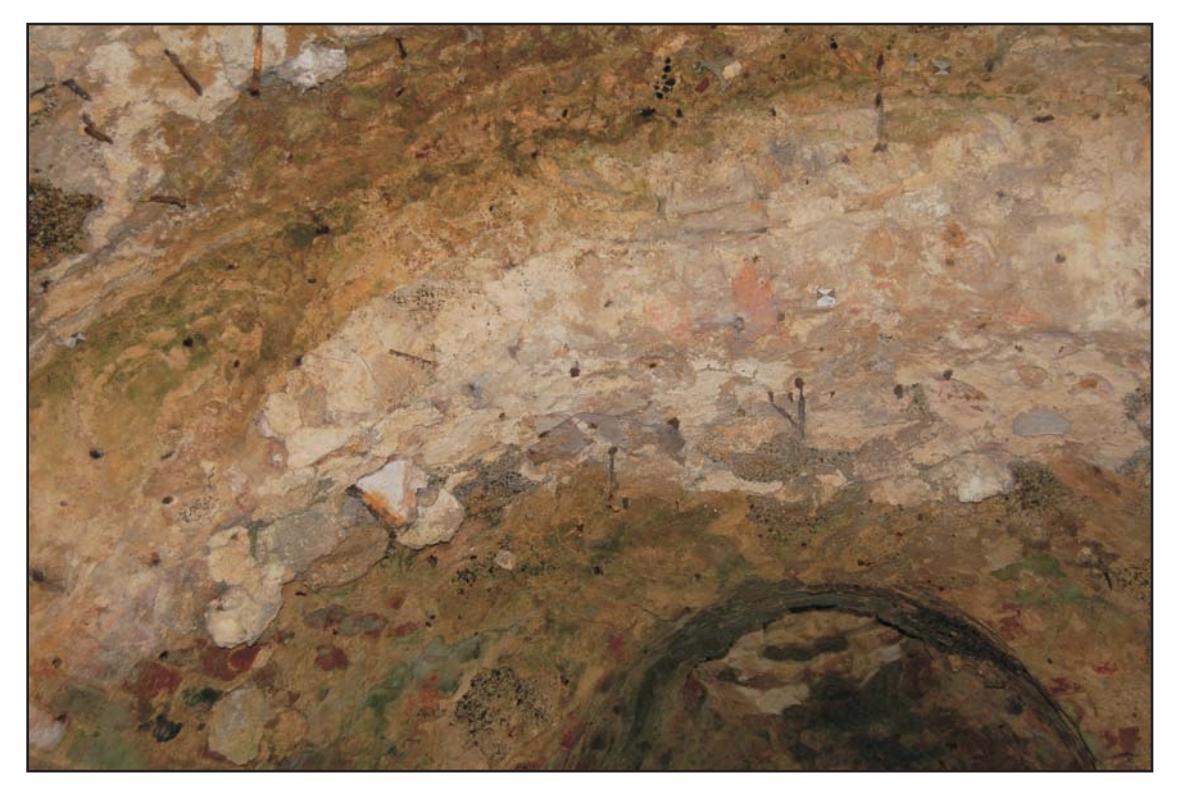
Fragments of surface decoration within the upper niche Plate 7

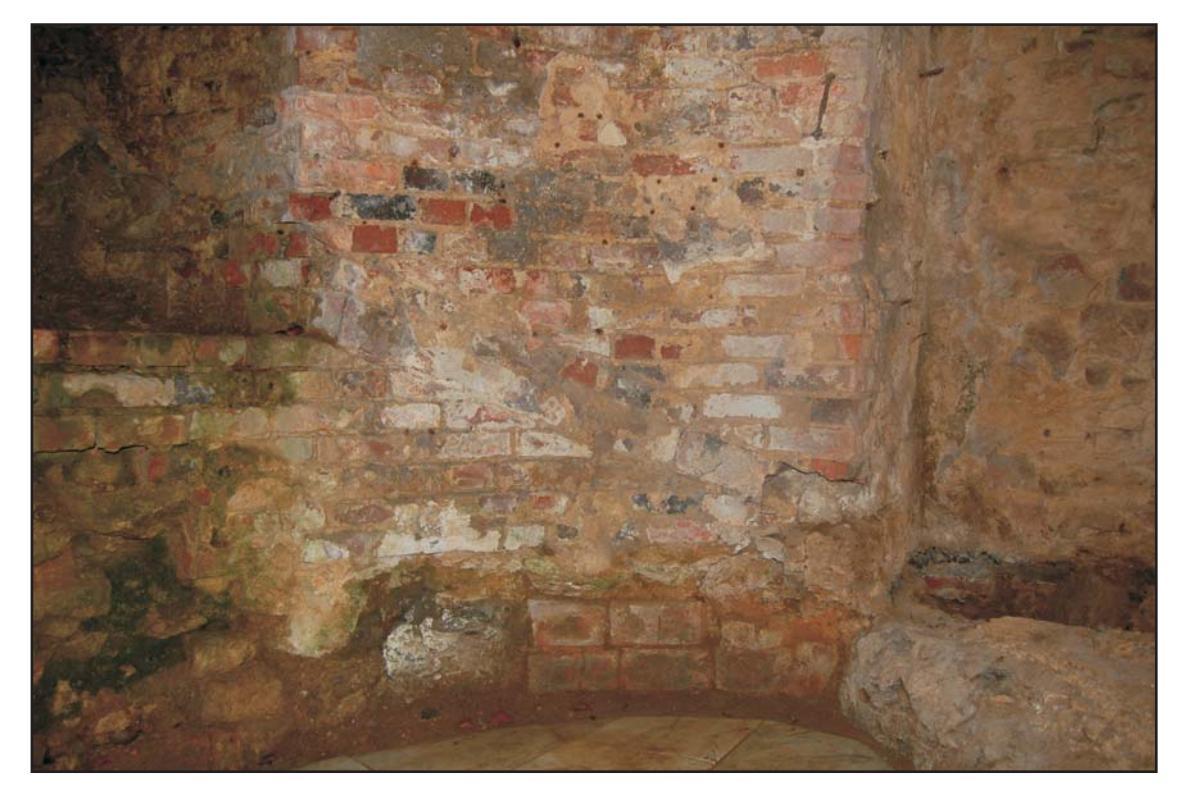
In the eastern side of the larger niche an angled line of bricks, set on edge flush with the wall face indicate the position of a channel set into the wall (Fig 3, Plate 8). It is thought that this might have either conducted water freely through it (perhaps acting as an overflow?), or perhaps more likely, was the channel in which the lead pipe seen in the floor at the south-eastern end was set. The channel leads from the lower right-hand side of the upper niche to the lower right-hand side of the larger niche (Fig 3).

Brick channel in the east side of the large niche, looking east Plate 8

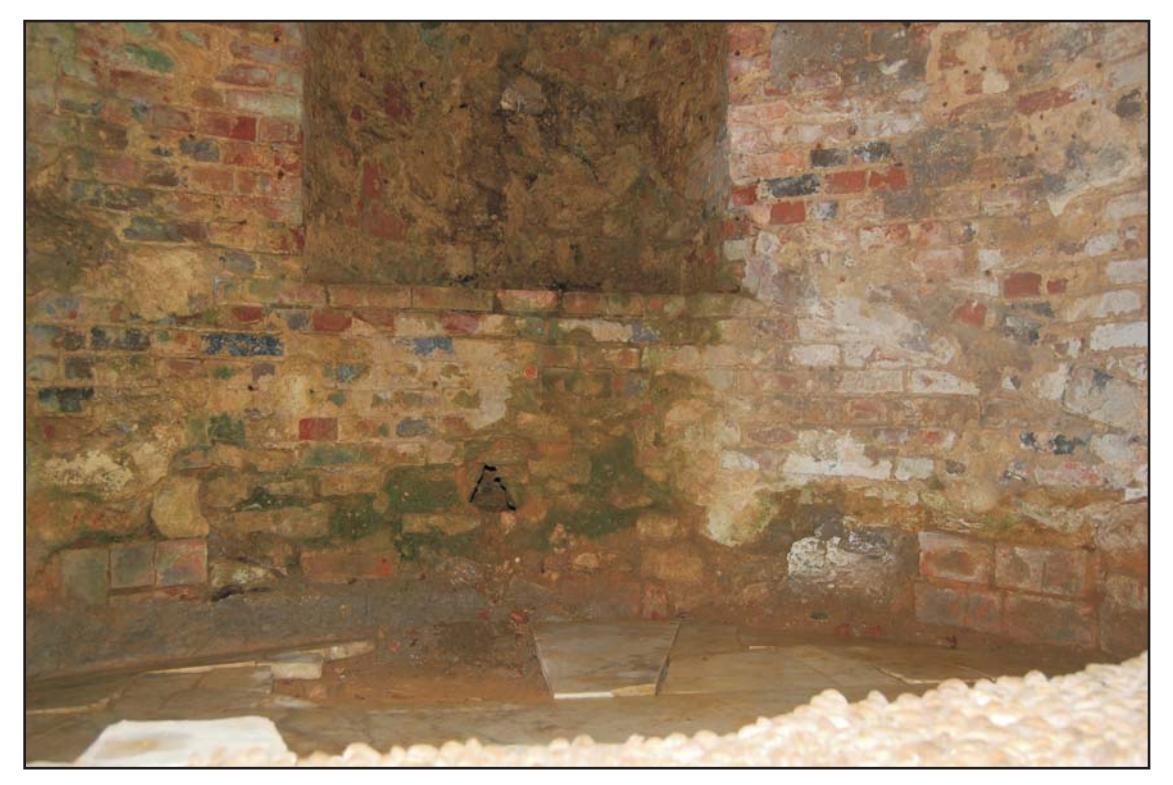
In the rear wall of the larger niche, beneath the upper niche is a hole in the brick- and stonework (Fig 3, Plate 9). This has previously been reported upon (Prentice 2004) and since the opening was not opened further, nor additional information gleaned, nothing further can be added. In summary, it appears that an arched culvert is positioned behind the rear wall at this level and appears to carry water. It may, therefore, simply be a drain which carries water from and to unknown sources/destinations, or it might have a bearing on the water supply to the lower basin. The latter appears to be unlikely since the present opening though which the limited investigation has been carried out, appears not to be original. If this is the case there does not appear to be any way in which the water it carried could be utilised. Thus, its function remains a mystery, and unless, or until more of it is exposed no more can be said.

Hole beneath the upper niche leading into the brick culvert Plate 9

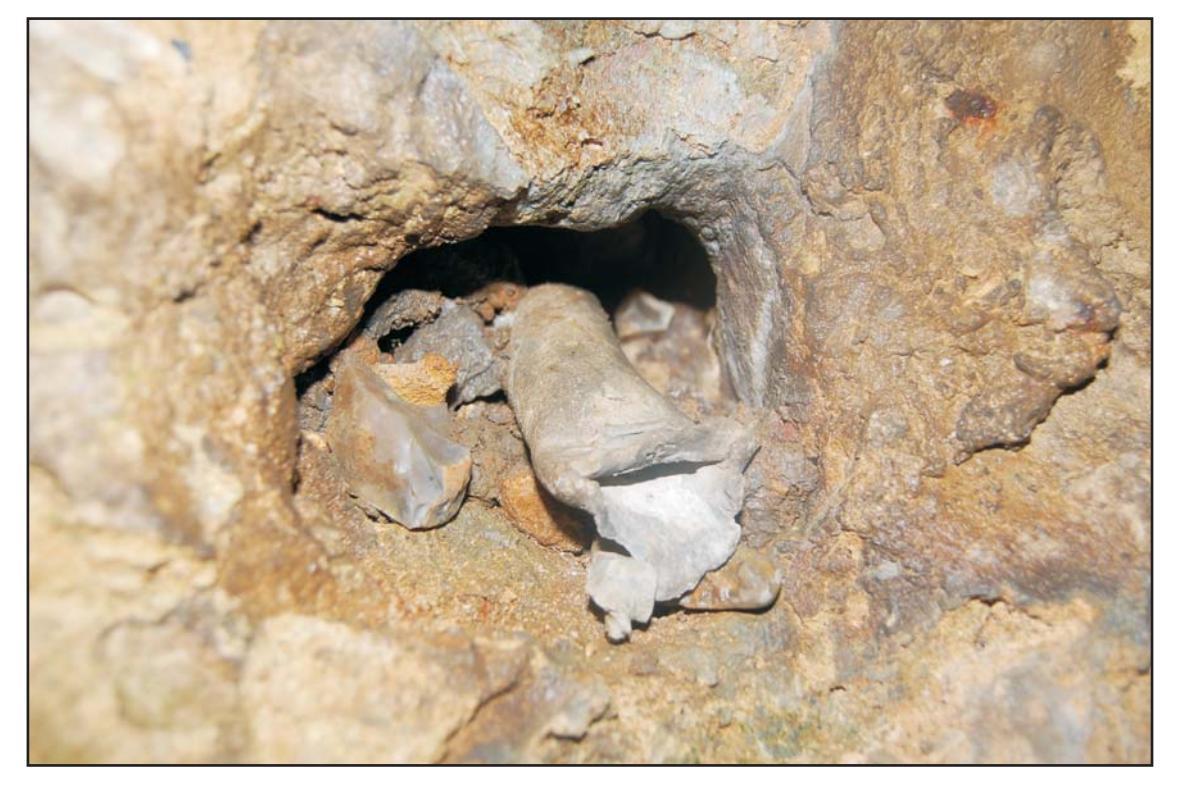
The smaller niche retains a single piece of lead pipe projecting slightly from the rear, curved wall, towards the top (Plate 10). It is thought that this connects with the lead pipe exposed previously when a trench was opened at the rear of the grotto. If this is the case it seems that this would have carried the water into the grotto from a source as yet un-confirmed, and on to the top of the statue of Venus. The water would then have fallen over the figure and, it is thought, into a smaller basin (now lost) situated at the base of the upper niche. From there the water either cascaded over the front edge into the lower oval basin, or was piped, perhaps through the lead pipe set into the eastern wall via the sloping brick channel, into the lower basin, or out via the pipe found beneath the pebble floor.

Lead pipe at the top of the upper niche Plate 10

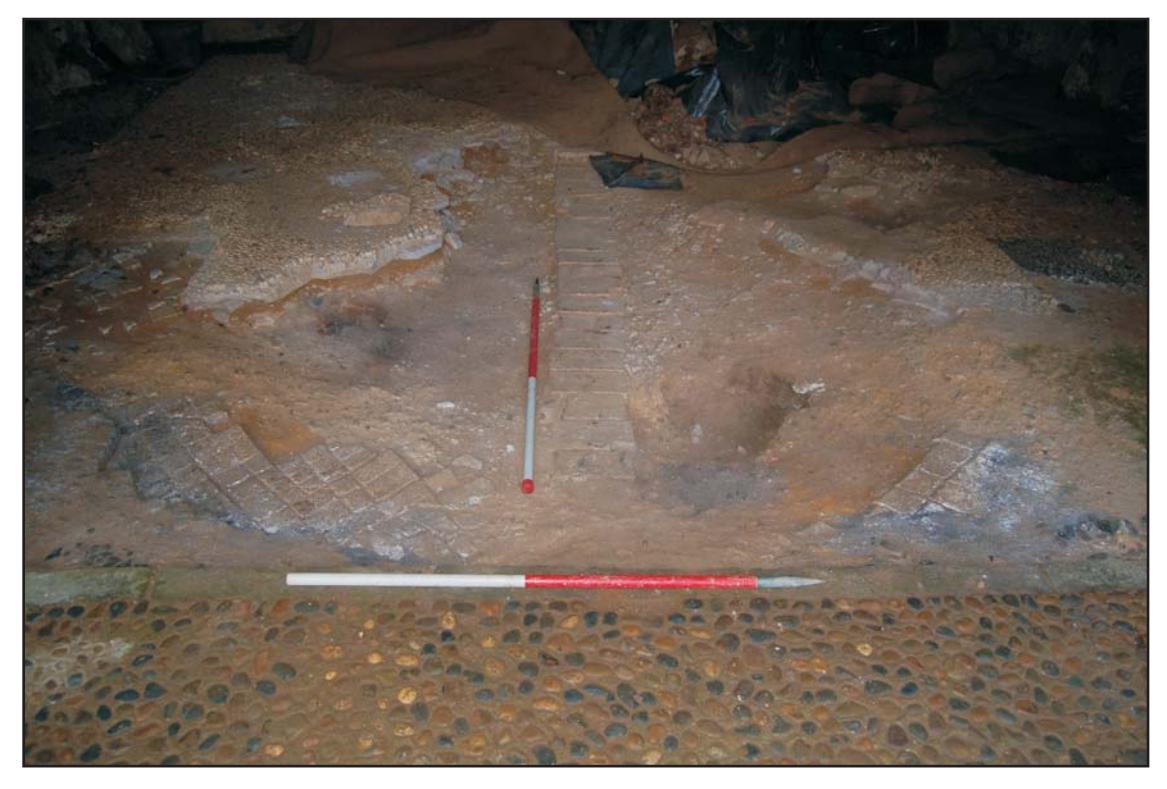
The floor of the balcony, both beneath the southern arch and externally, has been relaid. It is thought this was carried out when the grotto was repaired during the 1970s. The balcony floor is separated from the interior of the grotto chamber by a sill, or kerb, of fine grained stone blocks (Plate 11). It is not clear if this sill is an original feature, though it is thought that it probably is as the stones which form it are deeply set (their bases were not seen) and there appears to be no clear cut for their insertion which would be seen if they were added recently. The pebbles on the balcony floor are well laid, though of a larger size than within the grotto, and they do not appear to have been sorted by colour.

Stone kerb between the balcony and interior flooring, looking north P

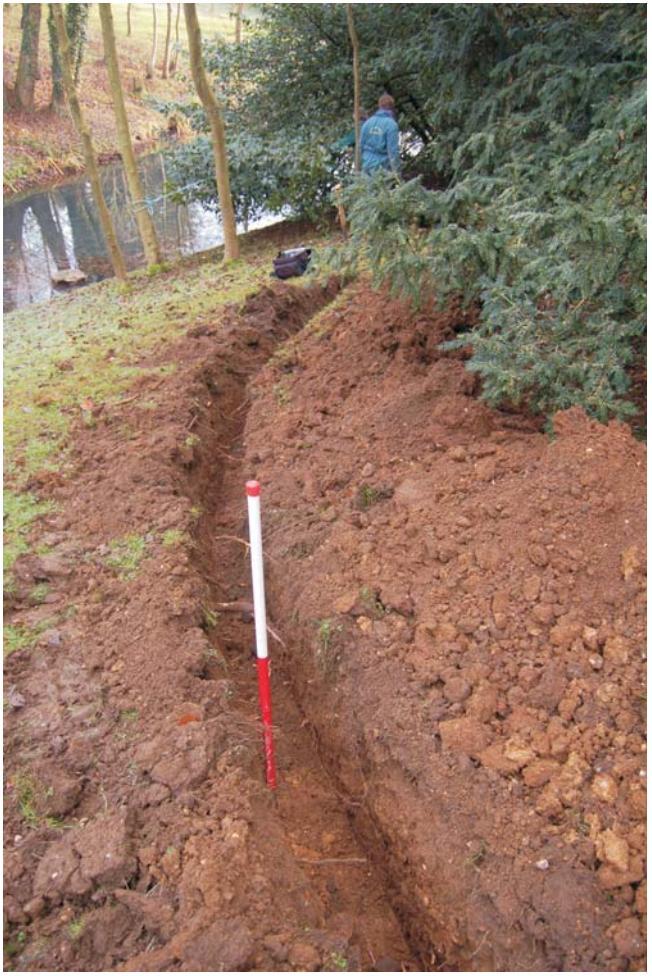
Trench 2 was located to the east side of the gravel path and dog-legged towards the edge of the Alder River to the east. The unconventional route was dictated by the presence of a large yew tree whose roots were to be avoided where possible. This section of trench was excavated by mini-digger, though the very lower end close to the waters edge was hand dug due to the fact that the machine could not get a grip on the steep slope and started slipping into the water. Beneath a distinct introduced topsoil layer of clay loam there were mixed underlying layers of either fairly clean sands and gravels or almost clean orange/brown clay (Plate 12). A small dump of late nineteenth-/early twentieth-century bottles was revealed. They were of a variety of shapes, colours and materials (white and coloured glass and stoneware) and appeared to be medicine bottles. Only one was named, this had the raised moulded label of 'SLOAN'S LINIMENT' on the side. This was, according to Wikipedia, a liniment primarily used for horses to relieve stiff and aching muscles. It was first sold in the 1870s in America, though appears to have become a world-wide business by the early years of the twentieth century.

Service trench leading to the Alder River, looking south-east Plate 12
