# **Monument Cottage, Alloway, Ayr, South Ayrshire: Archaeological Mitigation**

Data Structure Report

issued 15th July 2014

on behalf of The National Trust for Scotland

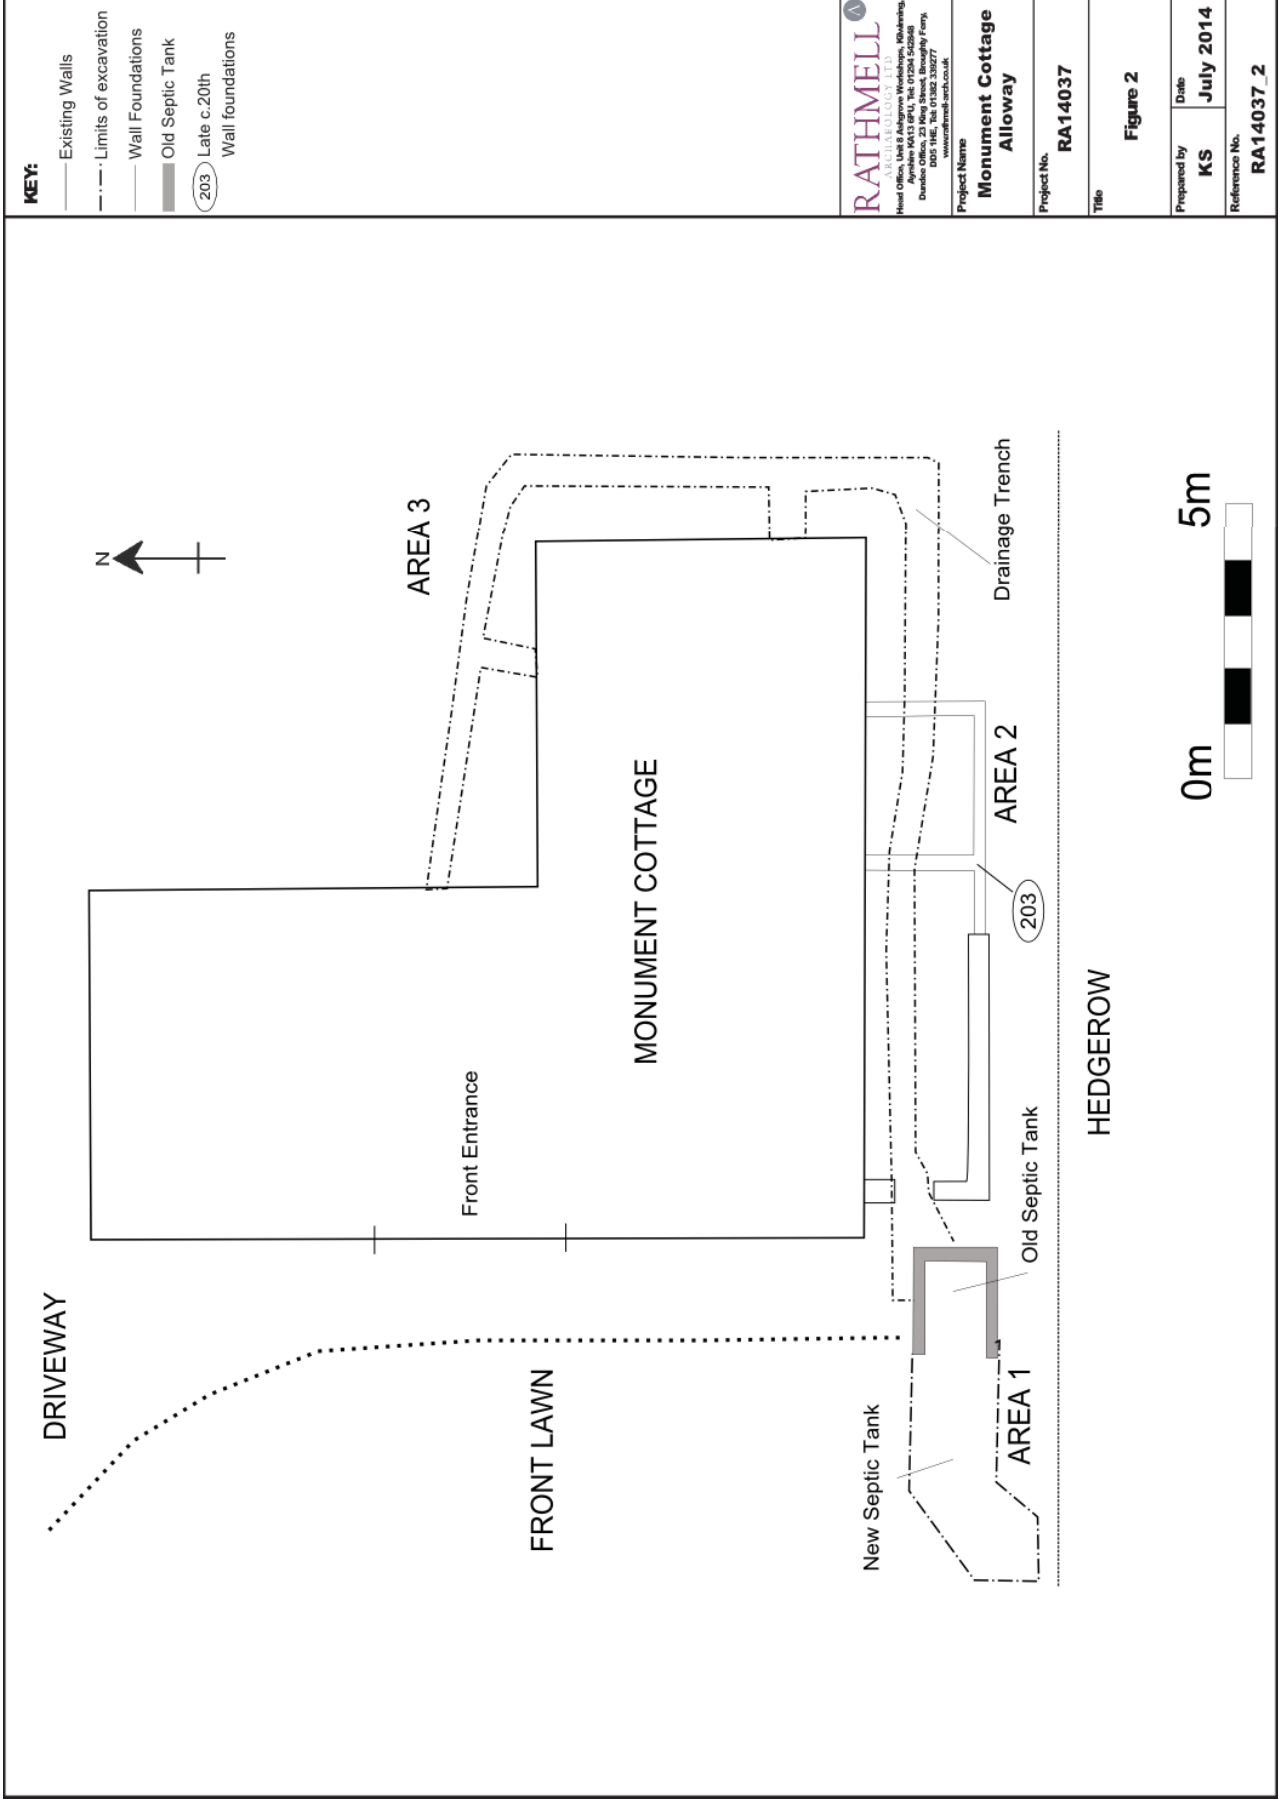
Figure 2: Plan showing location of excavated drainage trench and septic tank trench

11. Figure 2 depicts all excavation works onsite. A trench was excavated for the renewal of a septic tank in the south-western corner of the front lawn (Figure 3a and Figure 3b). The trench measured 1.75m by 6m by 2m in depth. Turf / topsoil (101) extended to a depth of 100mm and was removed to reveal a re-deposited natural subsoil (102). (102) extended to a maximum of 640mm in depth above natural subsoil (103). Modern glazed white earthenware was recovered from the topsoil deposit. The eastern end of the new septic tank trench abutted the existing red-brick septic tank, which measured 2m by 1.5m by up to 1.2m in depth. The eastern side of this tank was removed during ground-works to allow access for the new drainage pipe.

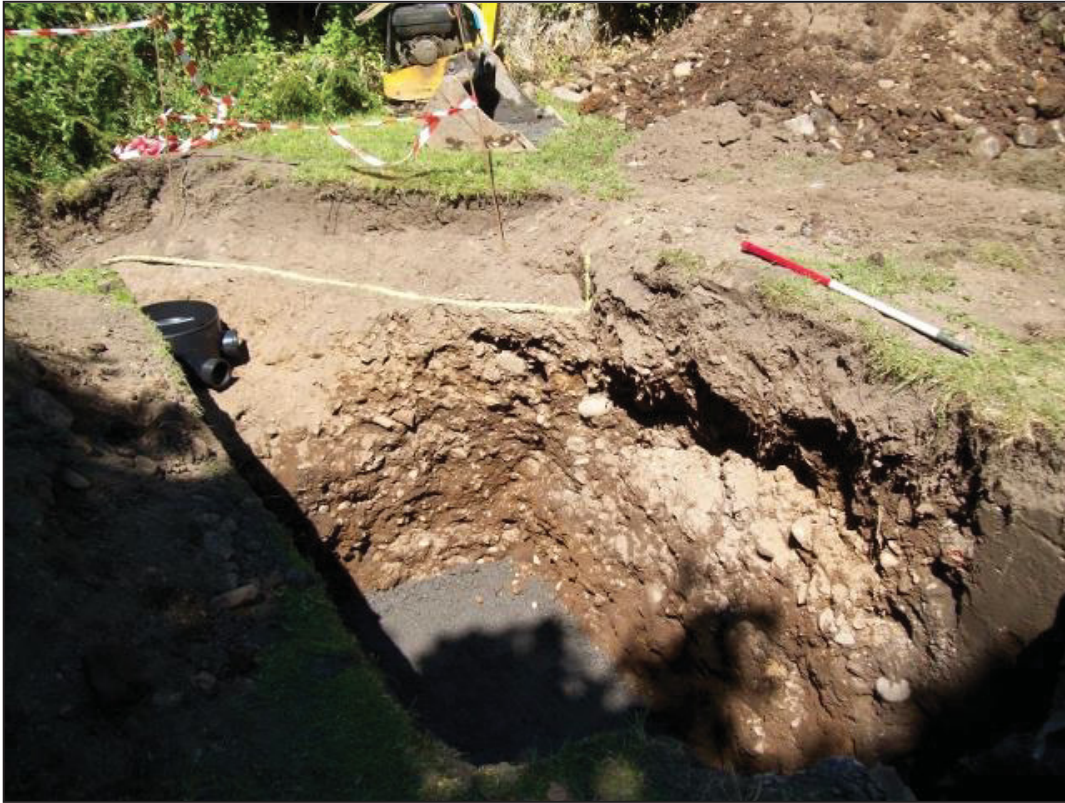
12. The ground level was reduced around the old tank including the ground immediately adjacent to the southwest corner of the cottage building to a maximum depth of 600mm. The foundations of the cottage extended to a depth of at least 600mm but were not fully exposed. This comprised Area 1 of excavations onsite.

Figure 3a: General Shot Post Ex of New Septic Tank Trench Area 1

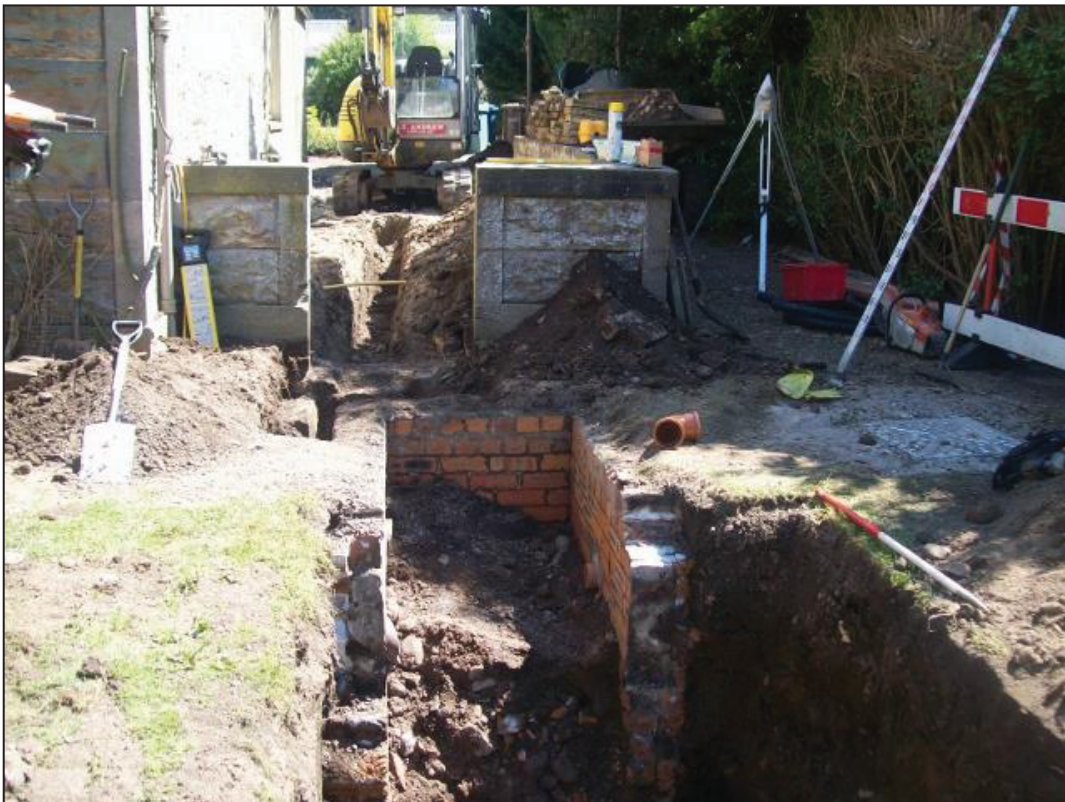
13. The new drainage trench ran eastwards from the east end of the old septic tank in Area 1, passing through an entrance gap in the wall of an extension abutting the south elevation of the cottage. This latter feature comprised a low rectangular yellow sandstone wall with square holes in the coping and evidence of a raggle in the adjacent gable end wall of the cottage above. It appears to represent the remains of a greenhouse or glasshouse, contemporary with the cottage and taking the form of a lean-to structure.

Figure 3b: General shot looking East towards Area 2 Pipe Trench

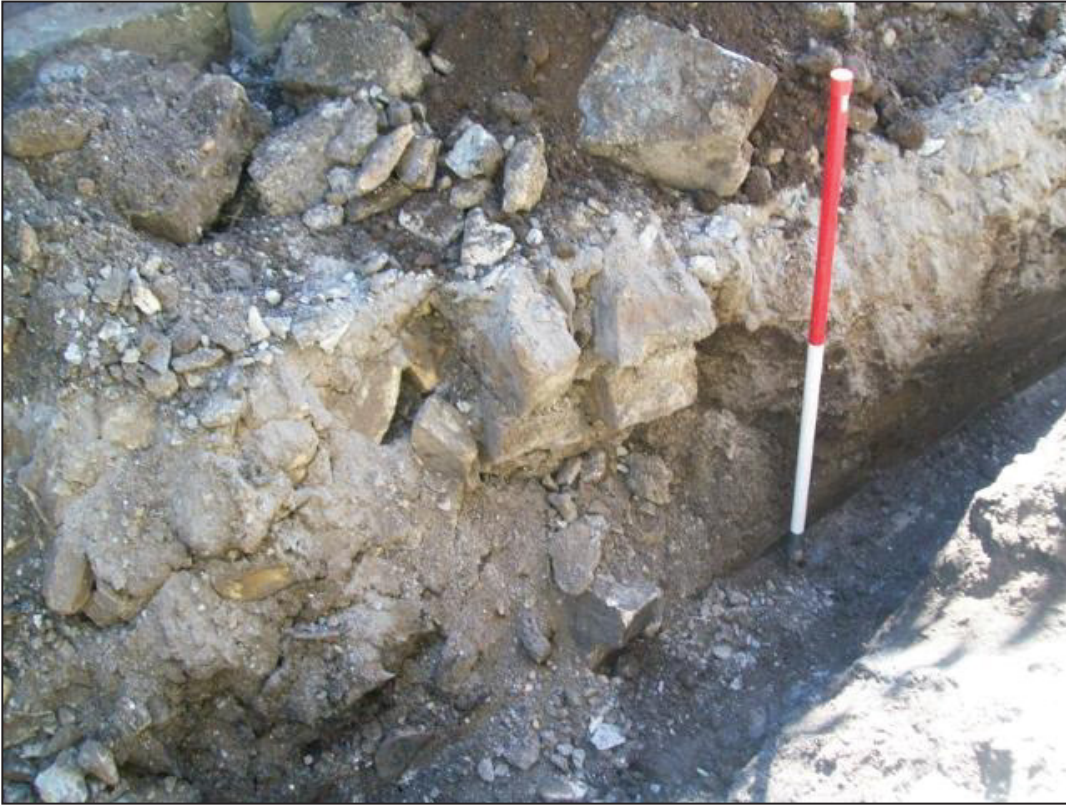
14. Area 2 comprised the section of drainage pipe that ran through the largely extant greenhouse structure described above. It also cut a smaller, later, extension (203) which abutted the greenhouse along its eastern edge. Together, these ancillary structures measured a total of 9m in length and extended beyond the south elevation of the cottage for a distance of 2.25m. The original extant extension had substantial foundations extending to a depth of at least 600mm, not fully exposed by groundworks, while the later extension (203) was encountered as reduced foundations, which extended to a maximum depth of 500-600mm in depth, visible within the pipe trench running east (see Figure 4a). The drainage trench measured 400mm wide by 600mm deep by up to 32m in length through the 3 Areas.

15. In Area 2 the ground surface comprised of a disturbed demolition deposit (202) which extended to a depth of 200mm above (203); a mixed re-deposited natural or possible buried garden soil extending to a depth of 500mm. Natural subsoil (205) was encountered at a depth of 600mm below ground level. No previously unknown features were encountered within the natural subsoil here.

Figure 4a: Oblique of North Facing Section of Pipe Trench in Area 2 showing Wall founds of 'Green House' (East side)

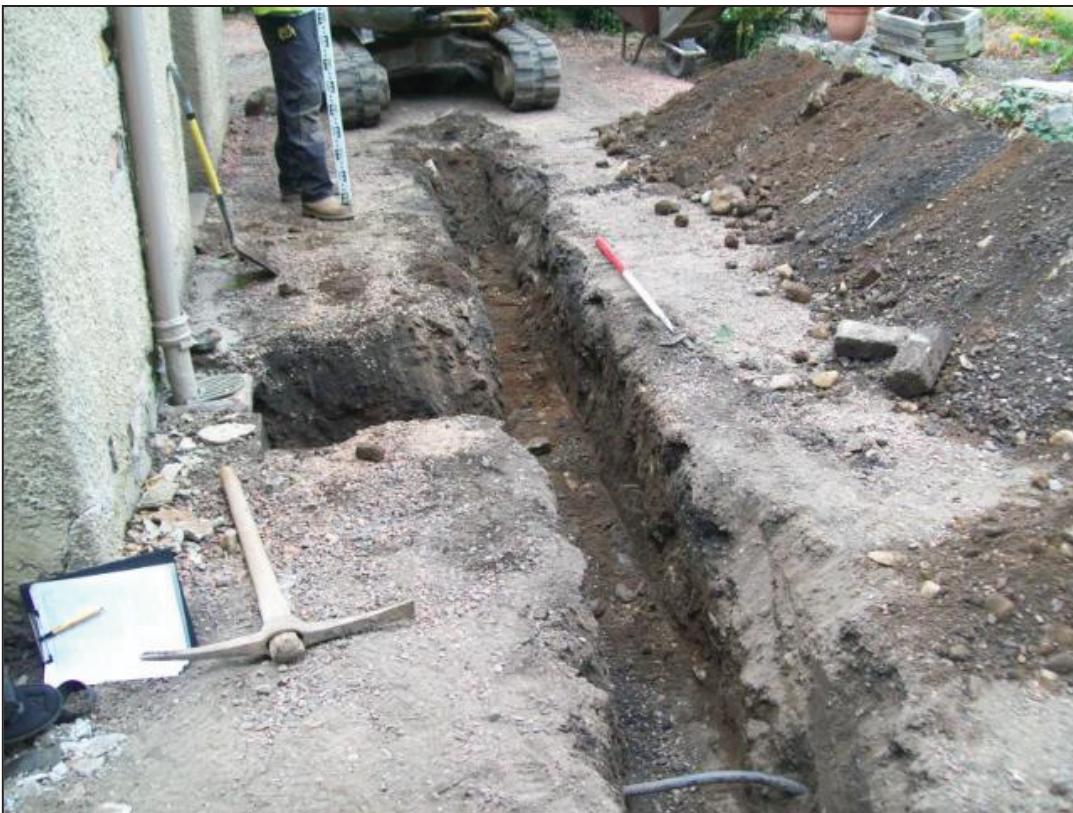
Figure 4b: General Working Shot looking North-northeast along N-S leg of Pipe Trench Area 3

16. Area 3 comprised the section of drainage trench running north and northwest towards the cottage's north-eastern elevation. The deposits in this area were consistent with those in Area 2. The ground comprised 200mm of a mixed gravel pathway (301) above a re-deposited natural (302) up to a depth of 500-600mm. The drainage trench in Area 3 encountered previously unmapped sub-ground service cables, pipes and lines; a total of 8 including those from the periphery of Area 2. None were disturbed or broken by excavations.
