WESTMOOR BARN

ST. BURYAN

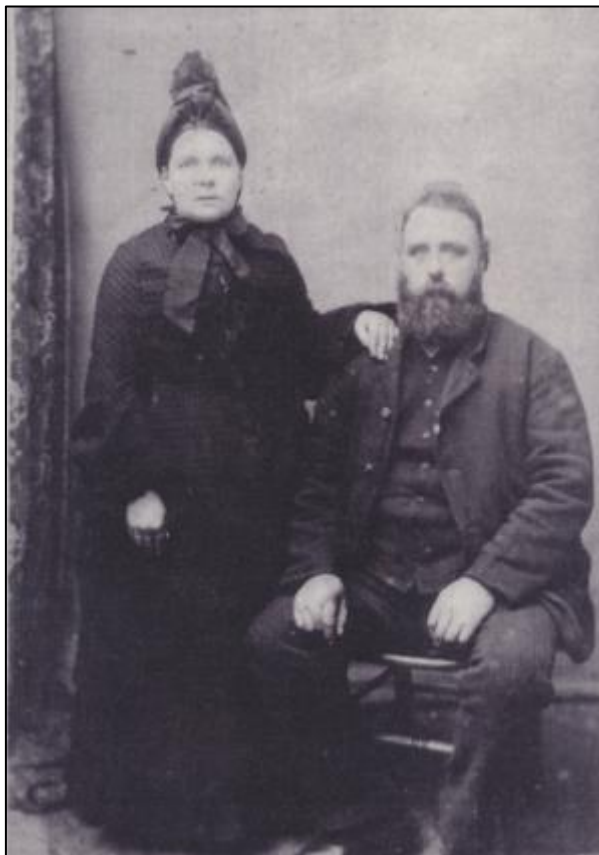
FIGURE 2: AN IMAGE OF JOHN OSBORN AND HIS WIFE GRACE, AS FOUND ON WIKITREE, ACCESSED 2022.

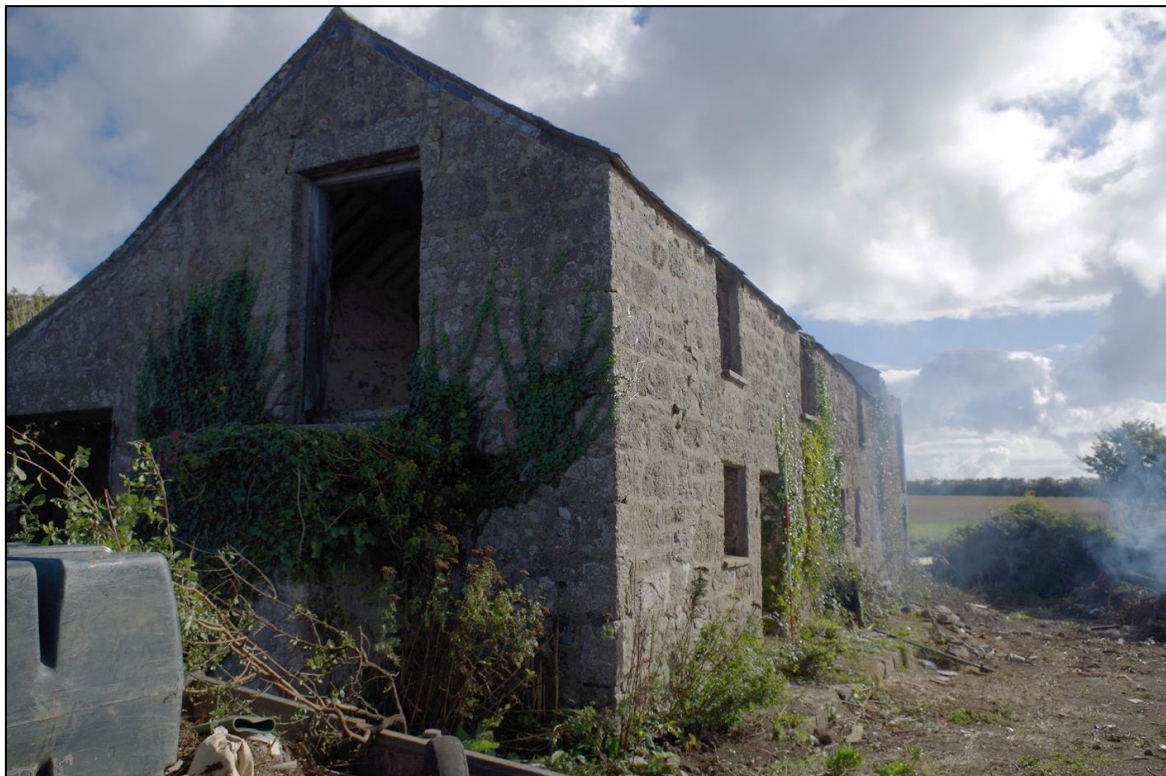
FIGURE 10: SOUTH AND WEST GABLED END OF B1 LINEAR RANGE, SHOWING GRANARY STEPS, SLATE-HANGING TO EAVES AND A PERSPECTIVE THAT SHOWS THE VARYING STONEMWORK TO SOUTH ELEVATION; FROM THE SOUTH-WEST (2M SCALE).

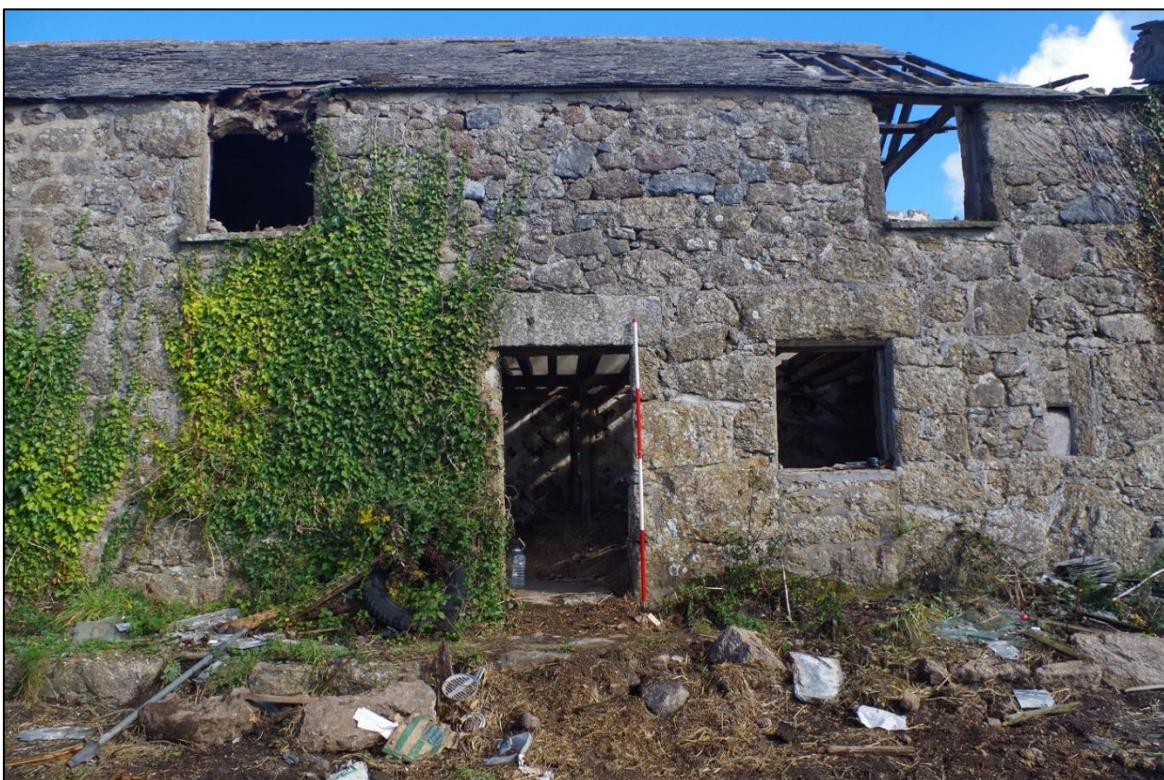
FIGURE 11: THE CENTRAL SECTION OF THE SOUTH ELEVATION. A CRUDER, HEAVIER BUILD CAN BE IDENTIFIED TO THE BASE, AND A SLIGHTLY DIFFERENT STONEWORK TO FF WITH ODD SLATESTONES, WHICH COULD REPRESENT A LATER RAISE TO THE RANGE. BLOCKED DOORWAY (W5) AND REDUCED SLIT VENT (W6) SEEN TO GF (EAST SIDE); FROM THE SOUTH (2M SCALE).

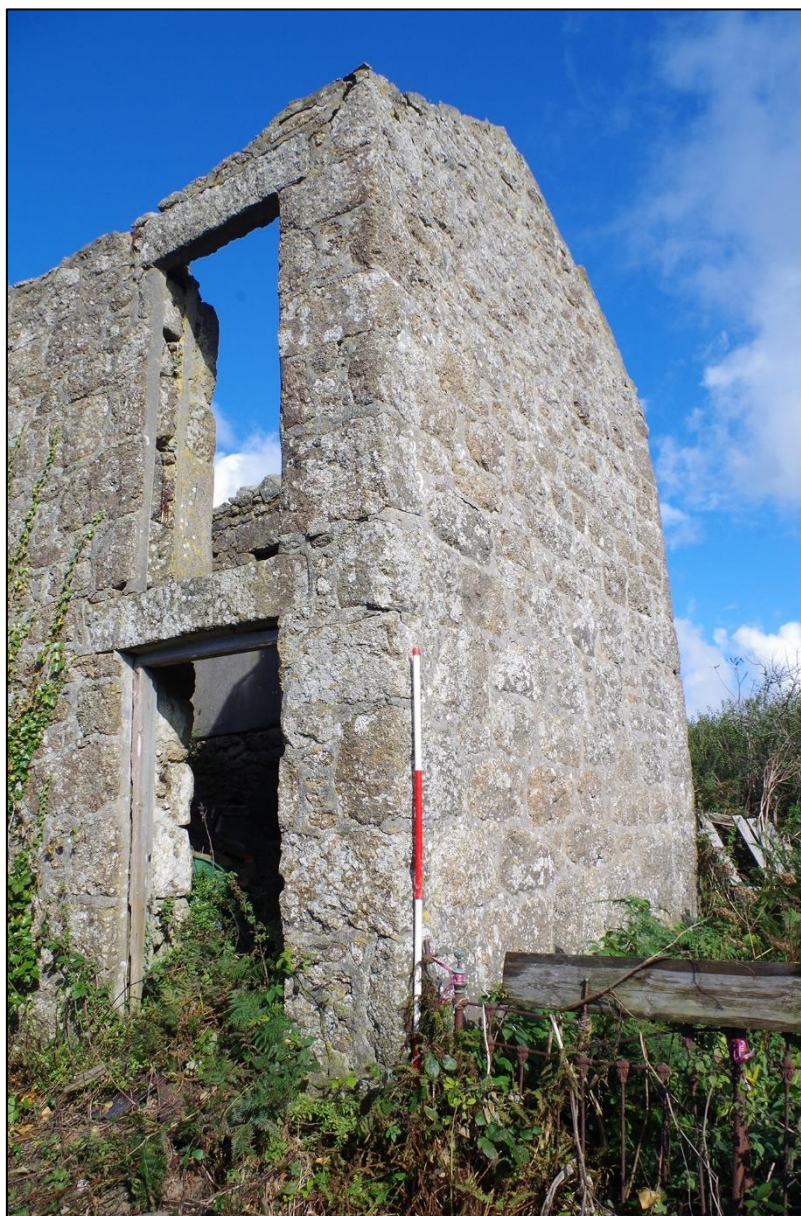
FIGURE 12: BLIND EAST GABLE END, BUILT WITH CONSISTENT STONEMWORK, RAISE NOT APPARENT, SUGGESTING THIS END REBUILT AS PART OF ONE PHASE, POSSIBLY REUSING FOOTPRINT OF EARLIER STRUCTURE; FROM THE SOUTH-EAST (2M SCALE).

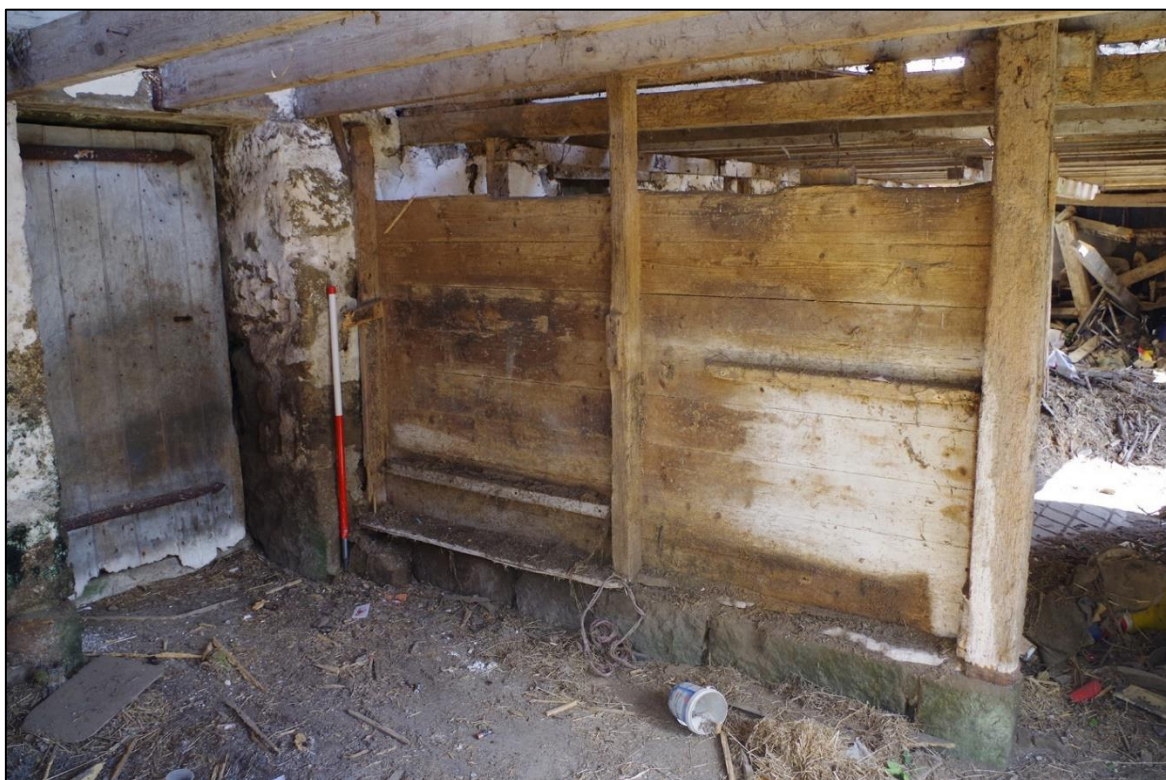
FIGURE 13: D5 LEADING FROM B1B (ONLY DOOR FITTING SURVIVING TO SITE), AND THE TIMBER PARTITION ALONG EAST ELEVATION OF B1C ON A SINGLE RUSTIC COURSE OF GRANITE BLOCK; FROM THE SOUTH-WEST (1M SCALE).

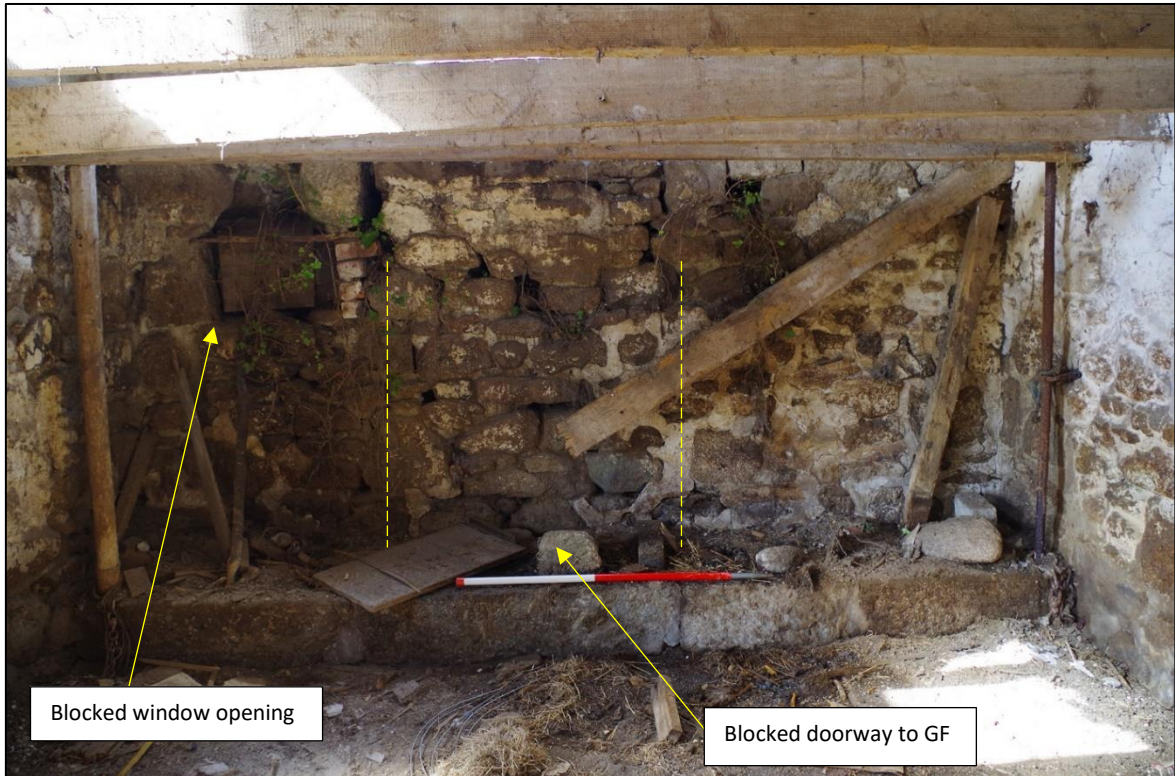
FIGURE 14: WEST ELEVATION OF B1C, POSSIBLE BLOCKED DOORWAY TO GF BELOW D12 AND BLOCKED WINDOW OPENING TO SOUTH SIDE LABELLED; FROM THE EAST (1M SCALE).

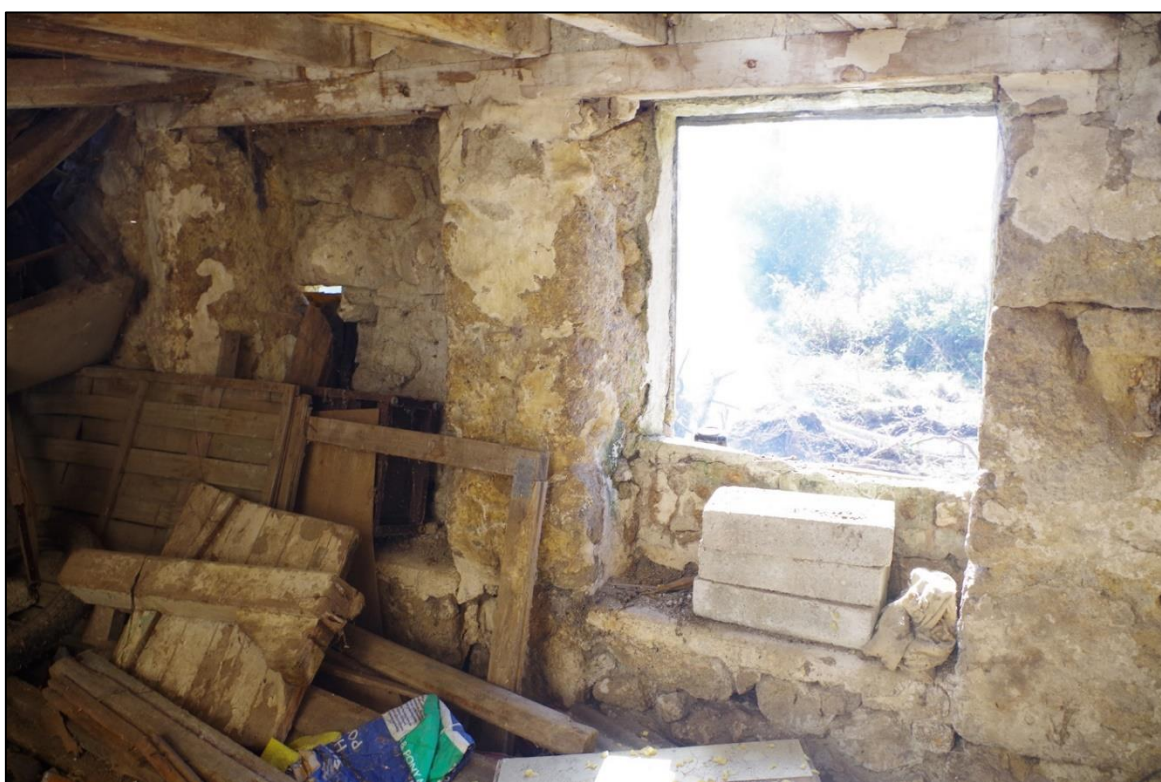
FIGURE 15: W5 AND REDUCED SLIT VENT W6 IN SOUTH ELEVATION OF B1D. TAKEN FROM NORTH-WEST.

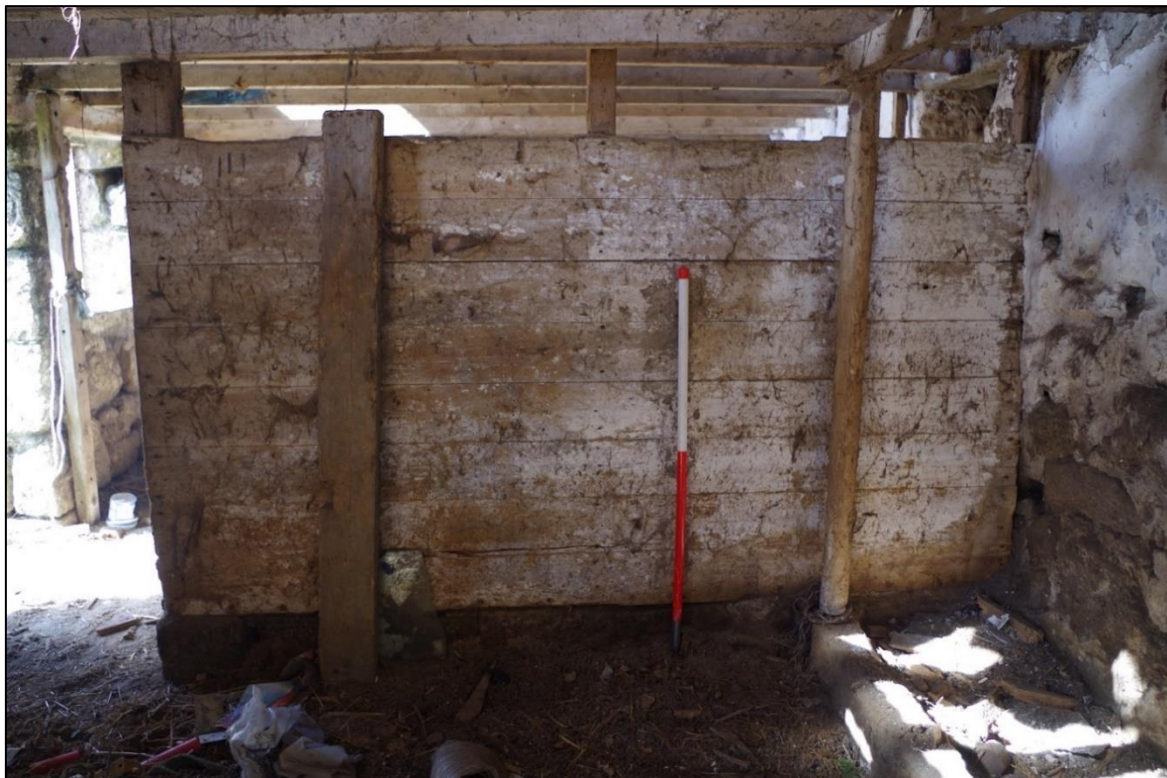
FIGURE 16: THE FACED SIDE OF TIMBER PARTITION OF GOOD 19TH CENTURY AGRICULTURAL CHARACTER, CREATING WEST ELEVATION FOR B1D, WITH GRANITE LINED TROUGH AND ROUNDED TIMBER POSTS WITH REMAINING CATTLE CHAINS INDICATE THIS SPACE WAS USED FOR ANIMAL HOUSING DURING 19TH CENTURY; FROM THE EAST (1M SCALE).

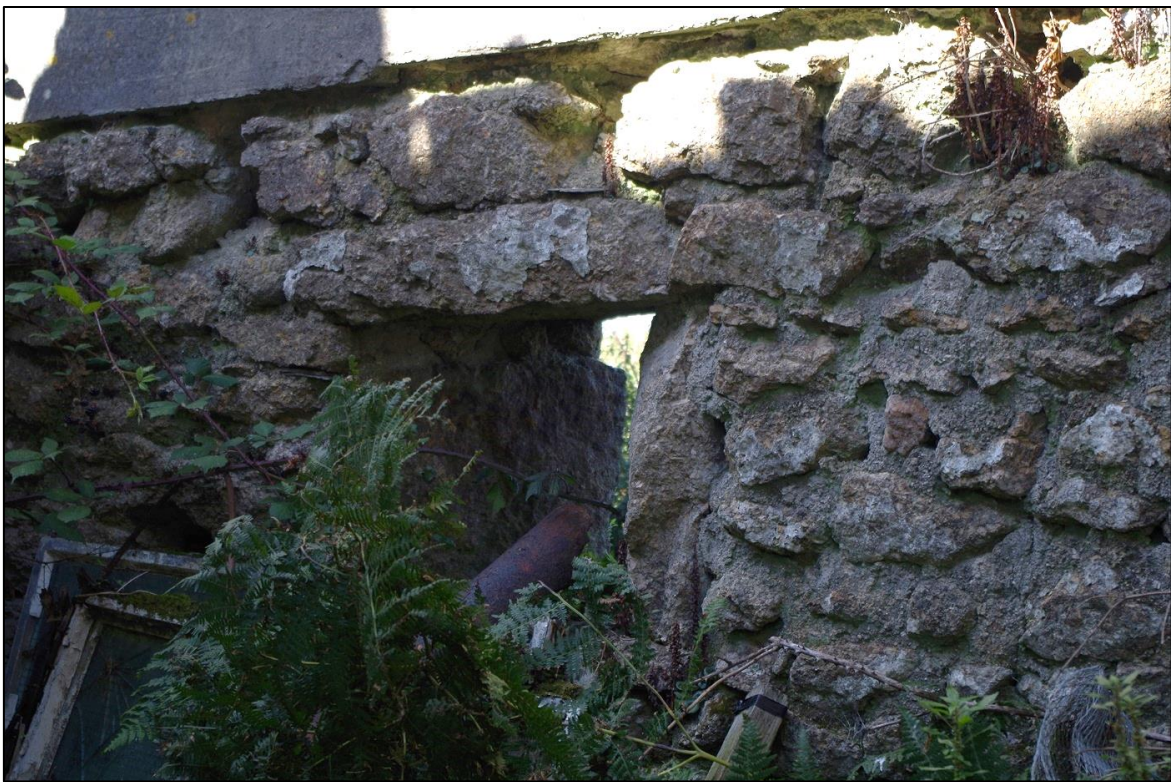
FIGURE 17: VERNACULAR IN APPEARANCE W13 TO GF NORTH ELEVATION OF B1E; FROM THE SOUTH-EAST.

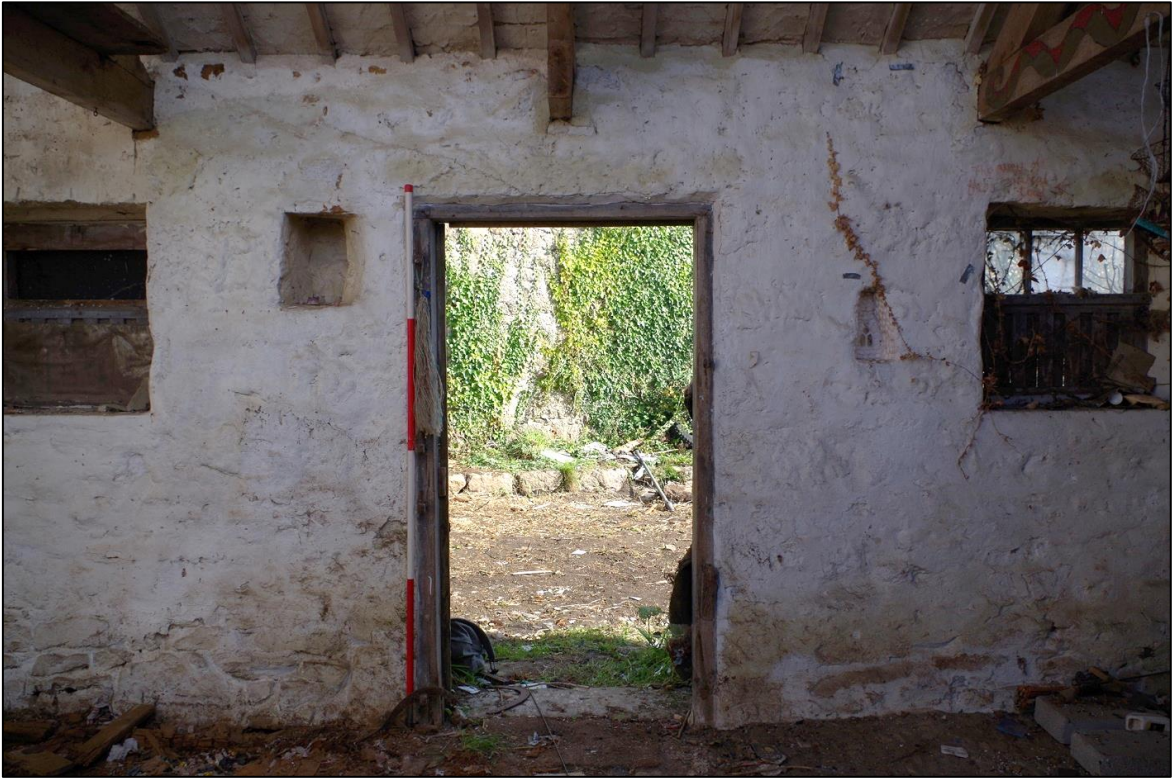
FIGURE 18: TWO 19TH CENTURY WINDOWS BETWEEN SINGLE-WIDTH WIDE, CENTRAL DOORWAY, WITH LARGE KEEPING PLACE TO WEST SIDE, AND A LATER ARTISTIC, SMALLER KEEPING PLACE TO THE EAST SIDE; FROM THE SOUTH (2M SCALE).

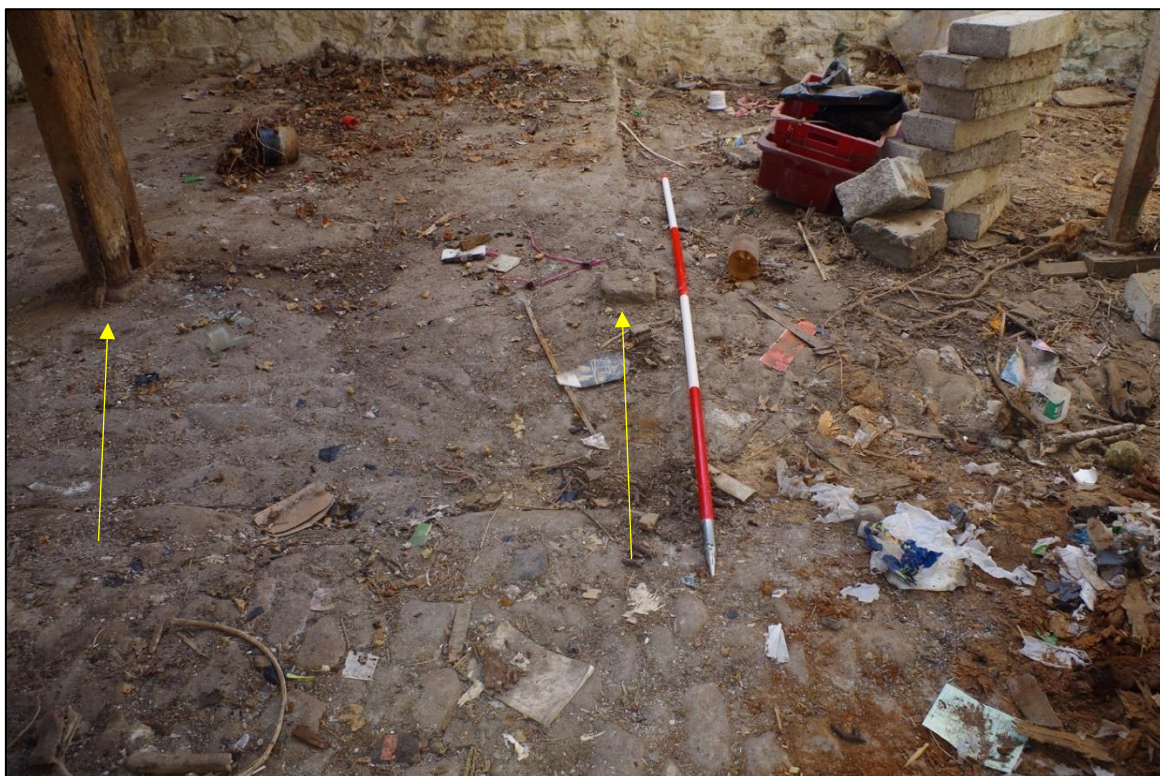
FIGURE 19: STONE PADS SURVIVING AMONGST SPLIT SLATE FLOOR; FROM NORTH (2M SCALE).

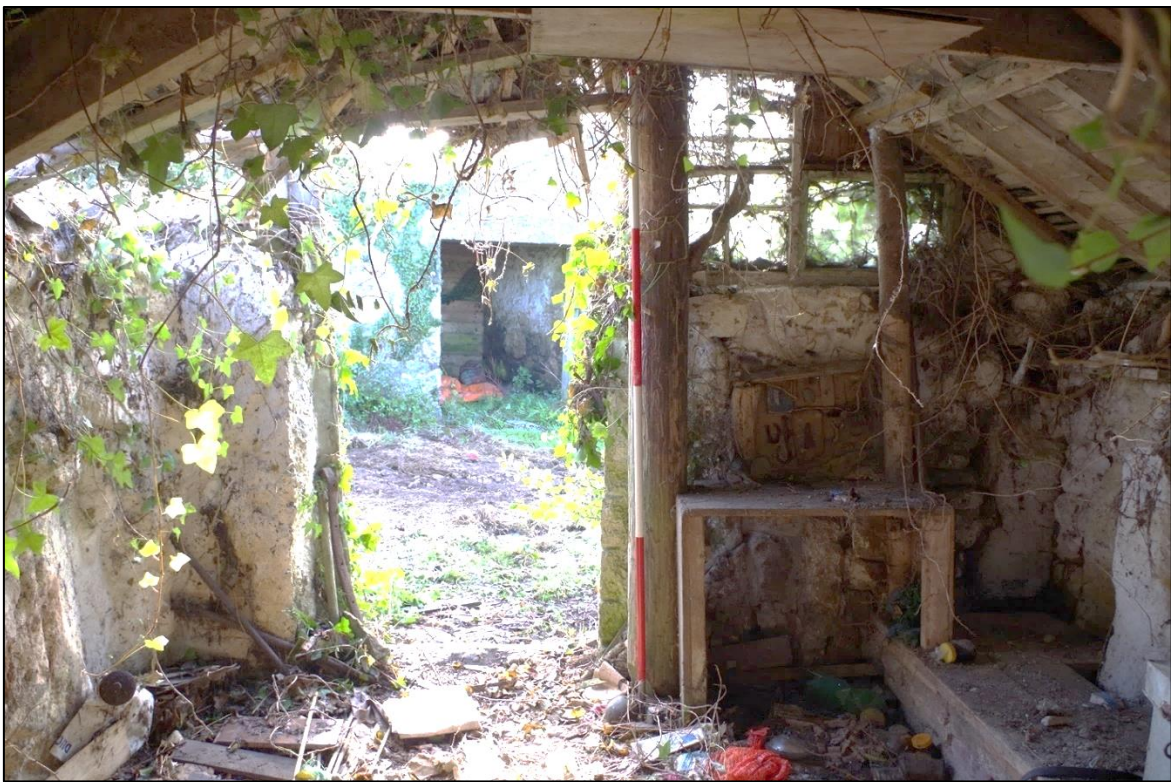
FIGURE 21: THE EAST ELEVATION OF B3 LOOKING THROUGH TO B1A; FROM THE WEST (2M SCALE).

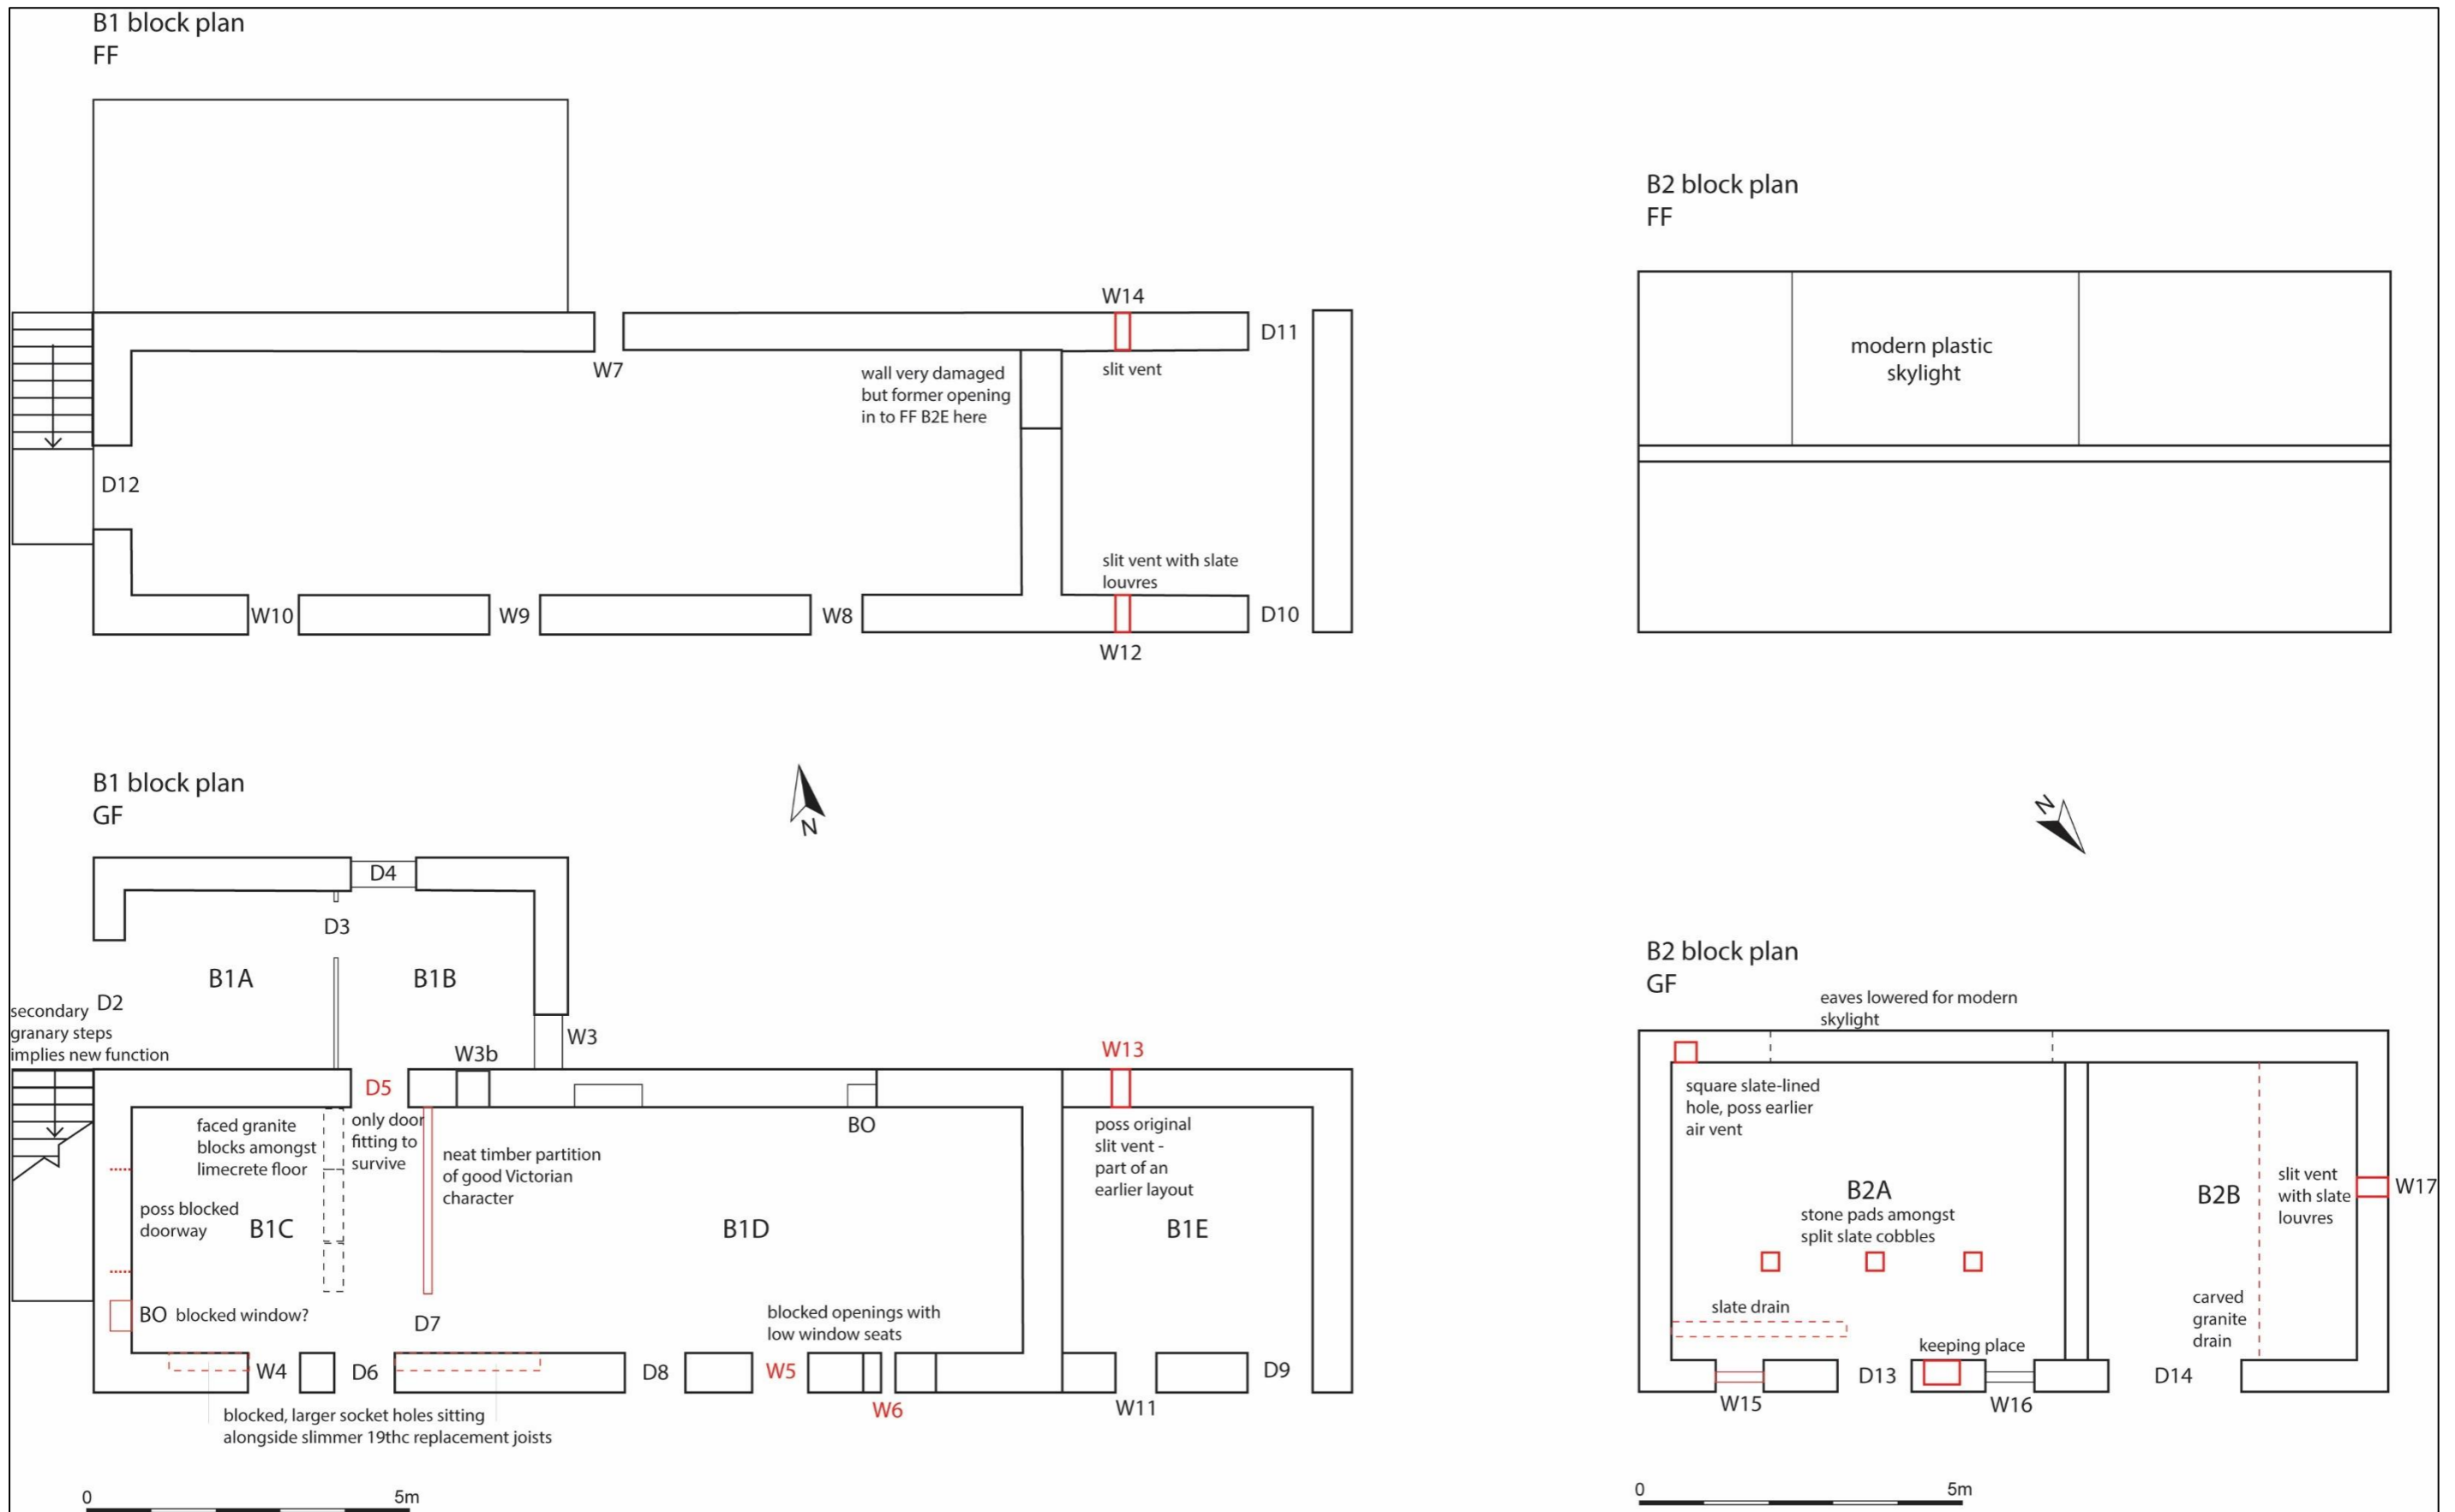
FIGURE 22: PLAN SHOWING FEATURES FOUND TO B1 AND B2.

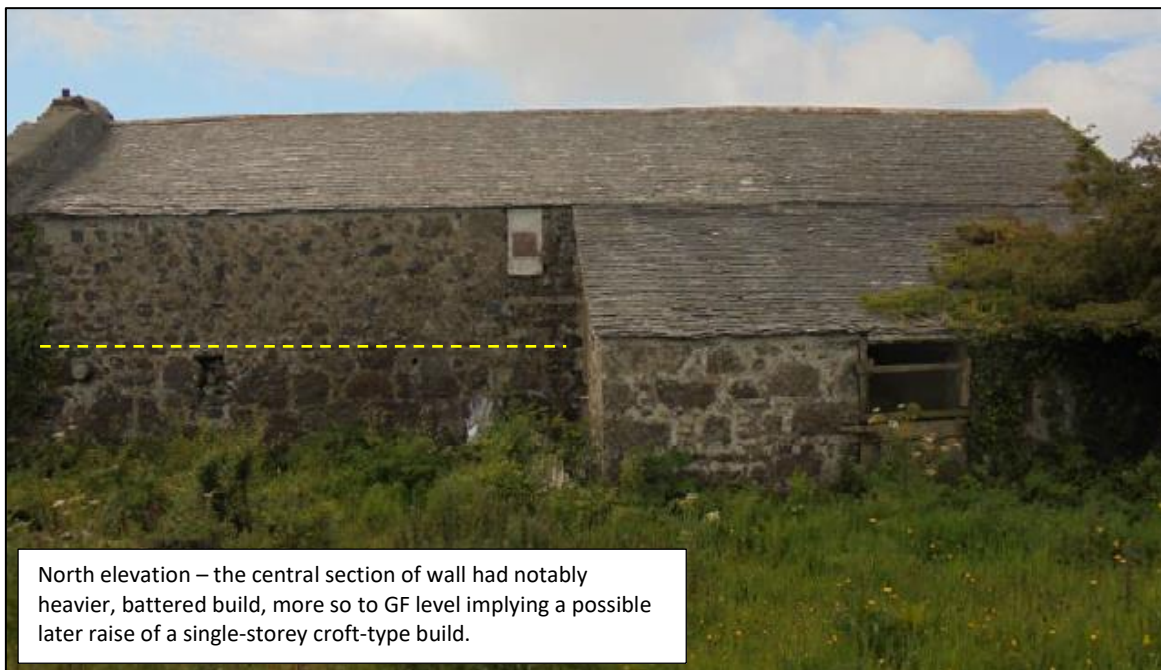
North elevation – the central section of wall had notably heavier, battered build, more so to GF level implying a possible later raise of a single-storey croft-type build.

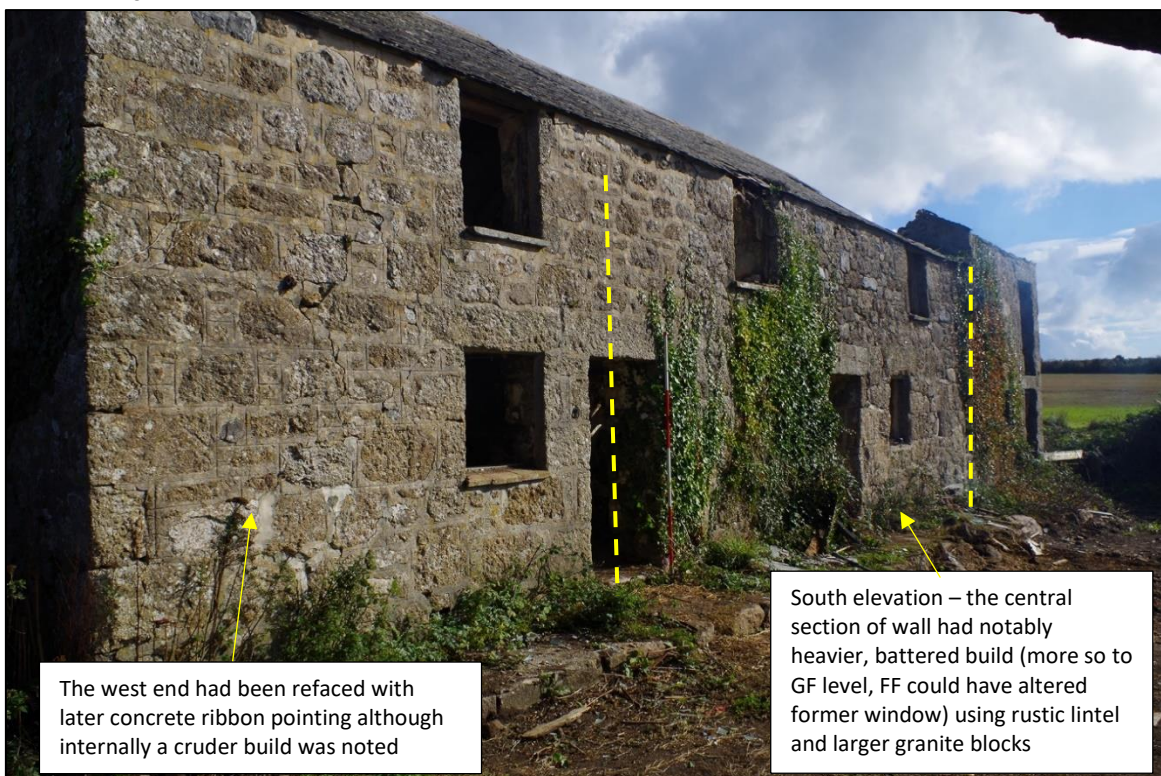
The west end had been refaced with later concrete ribbon pointing although internally a cruder build was noted

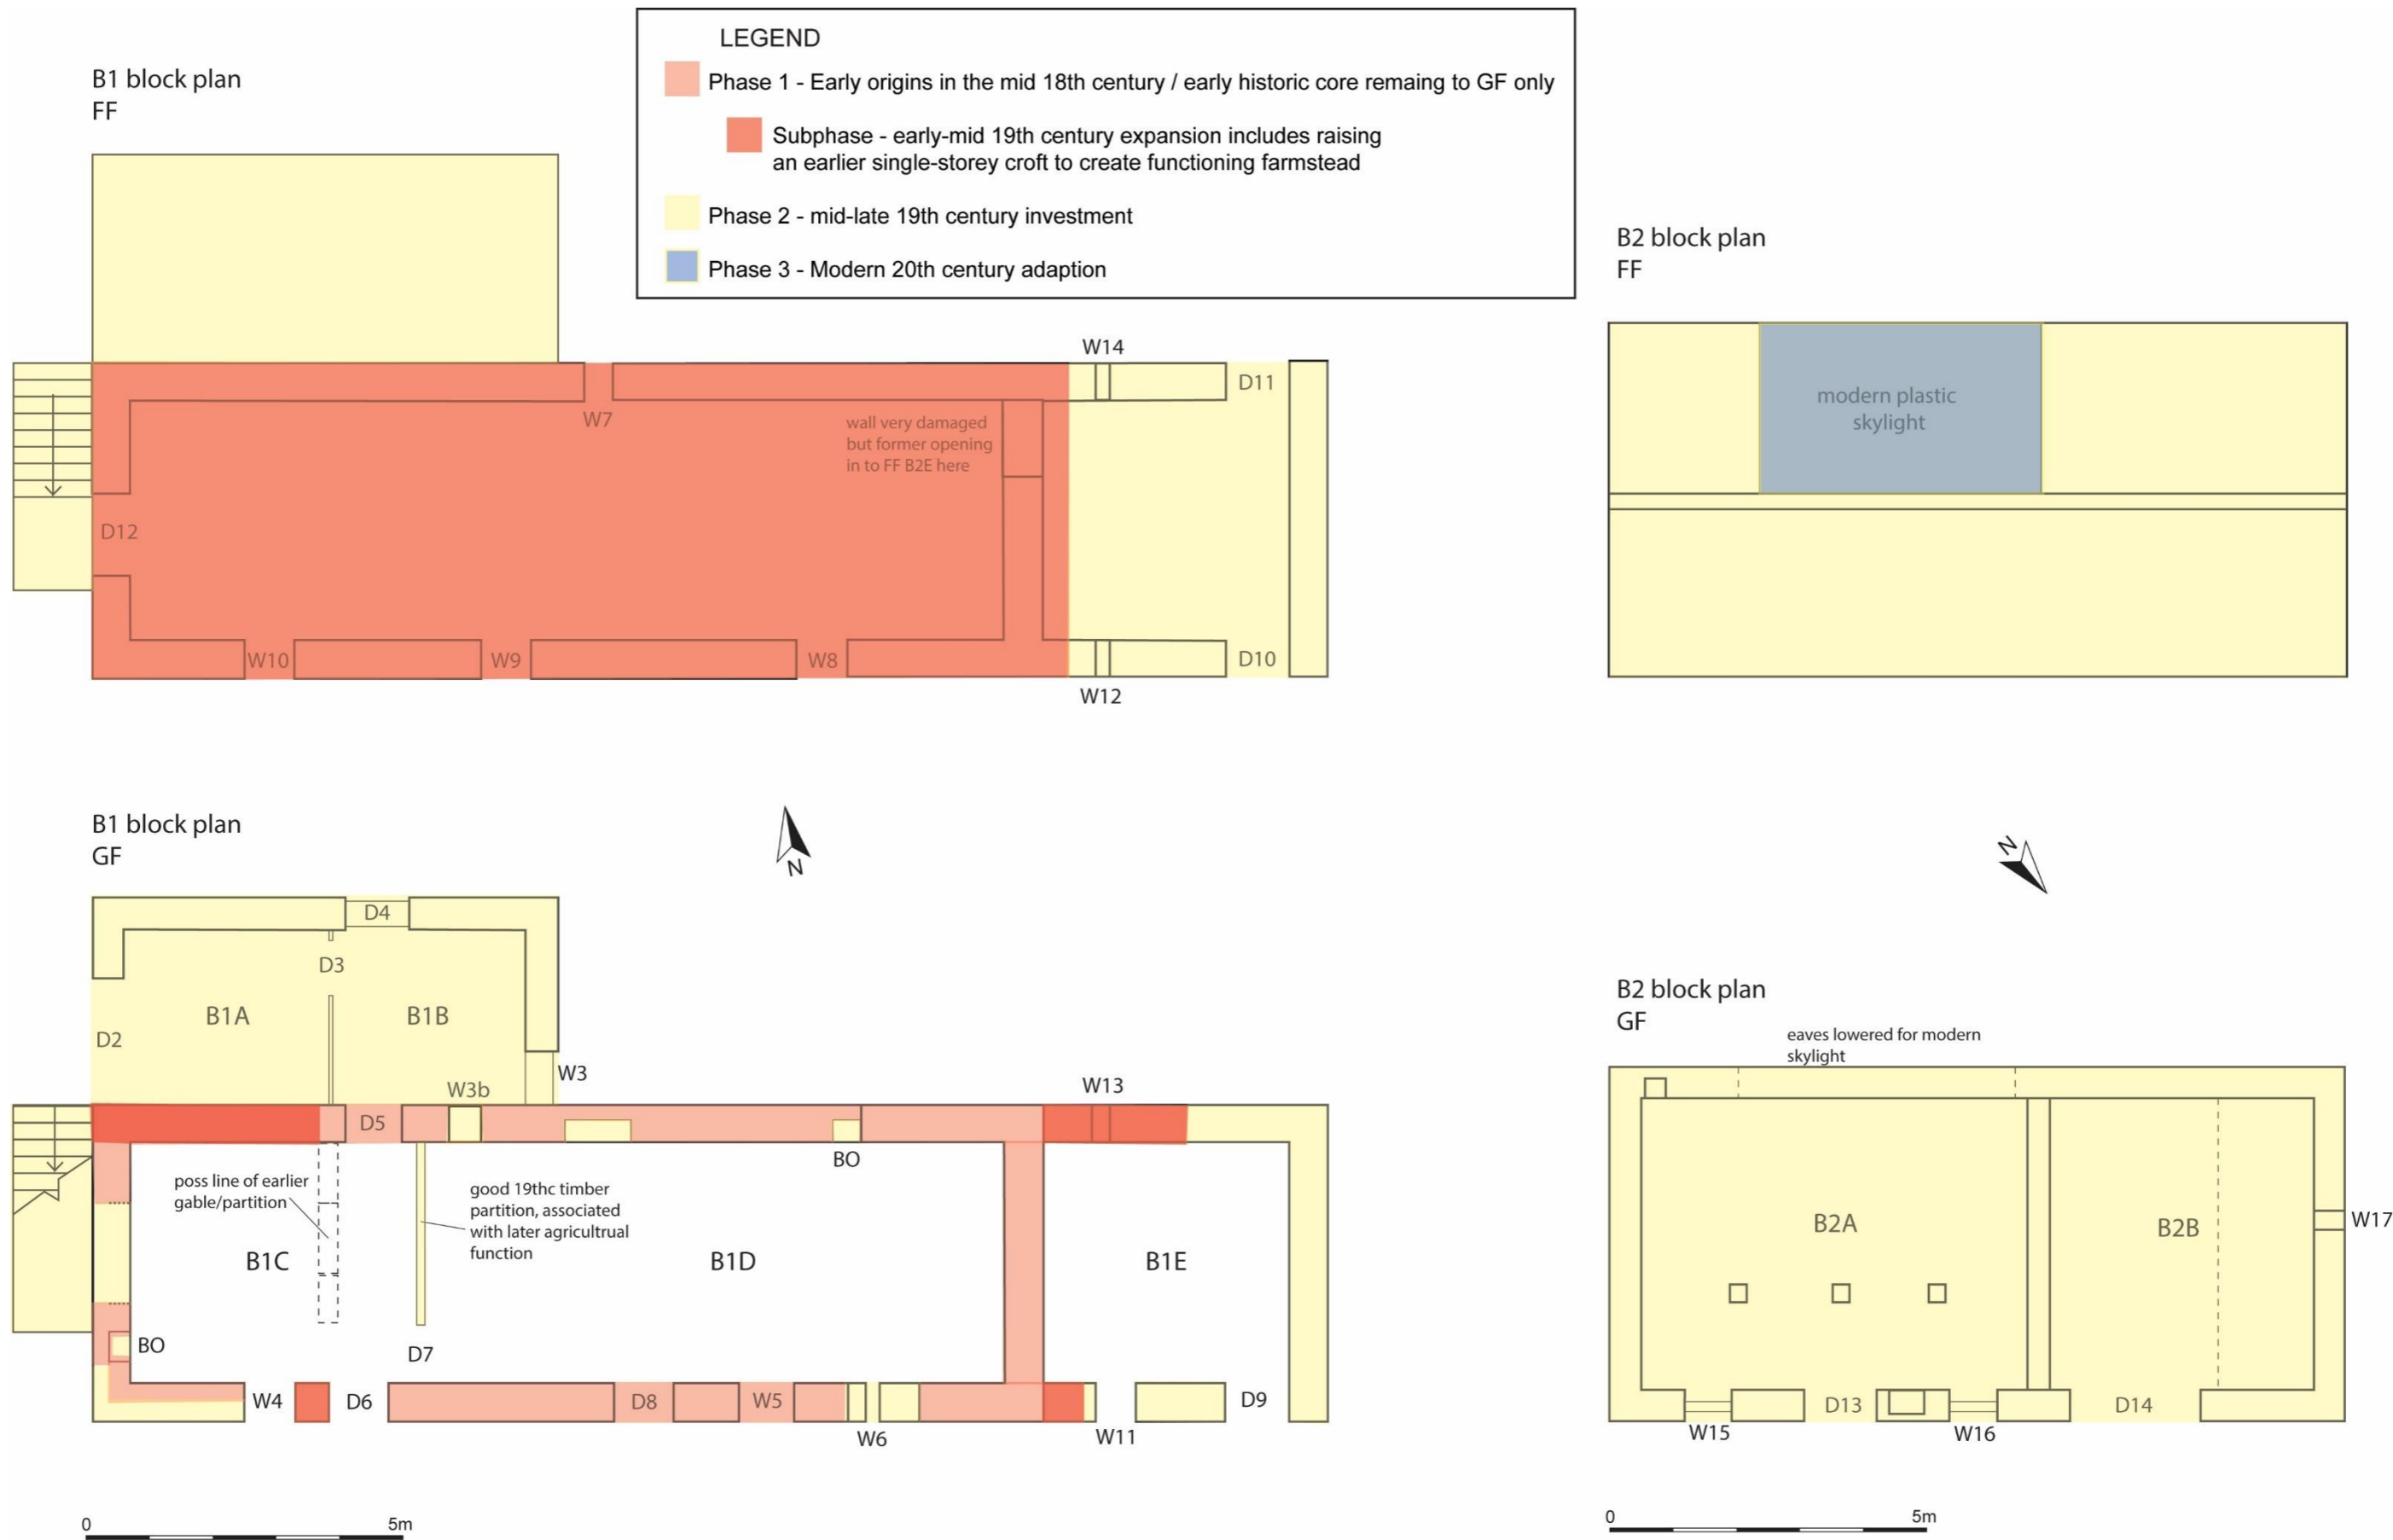
Most of the buildings on the site are 19th century in date. A comparison between the 1840 tithe map and the 1st edition OS map (Figure 5) indicates the farmstead underwent significant change during the period 1840-1906, presumably in parallel with the consolidation of several small holdings and the creation of a single large farm. However, the obscured character of the granite stonework, and the complete renewal of roofs in the later 19th century, largely rob any significant dateable features.

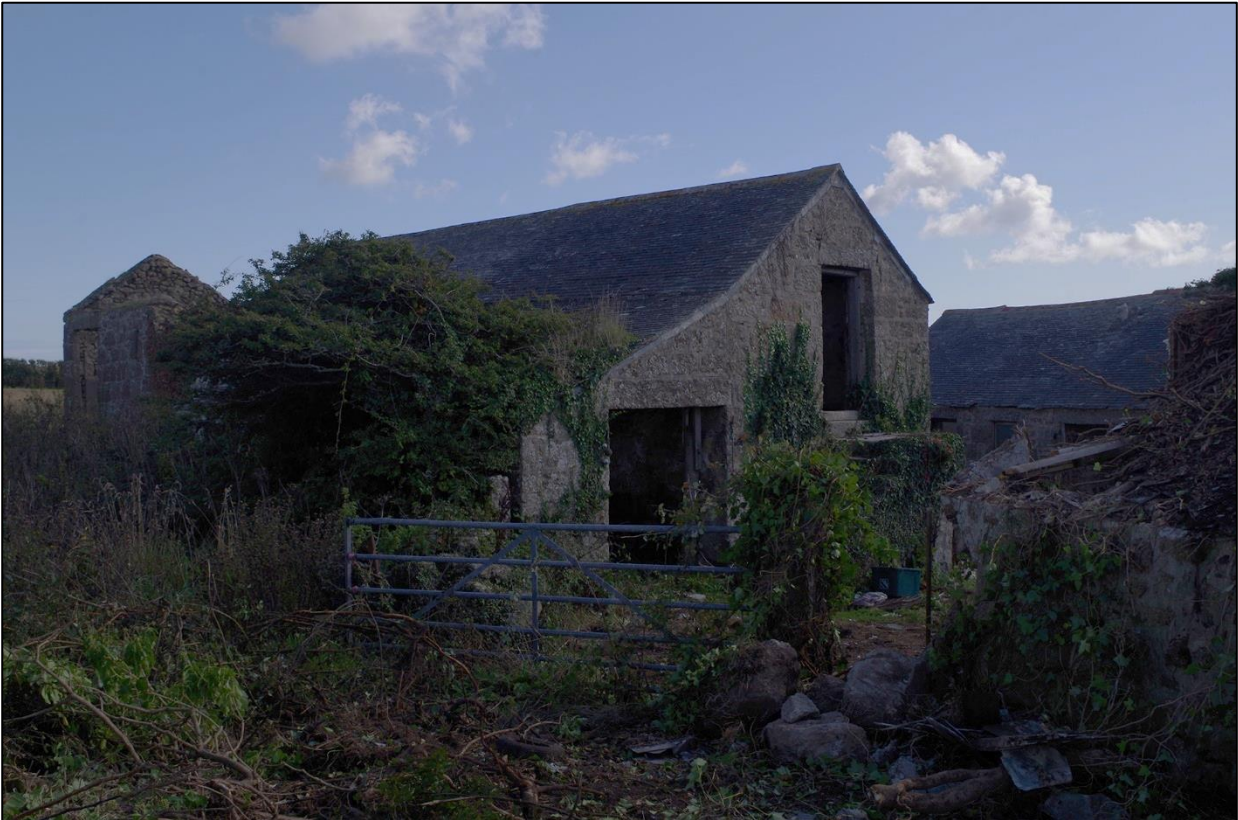
1. B1, NORTH AND WEST ELEVATION; VIEWED FROM THE NORTH-WEST. B2 ROOF TO REAR, AND B3 SOUTH OF GATE.

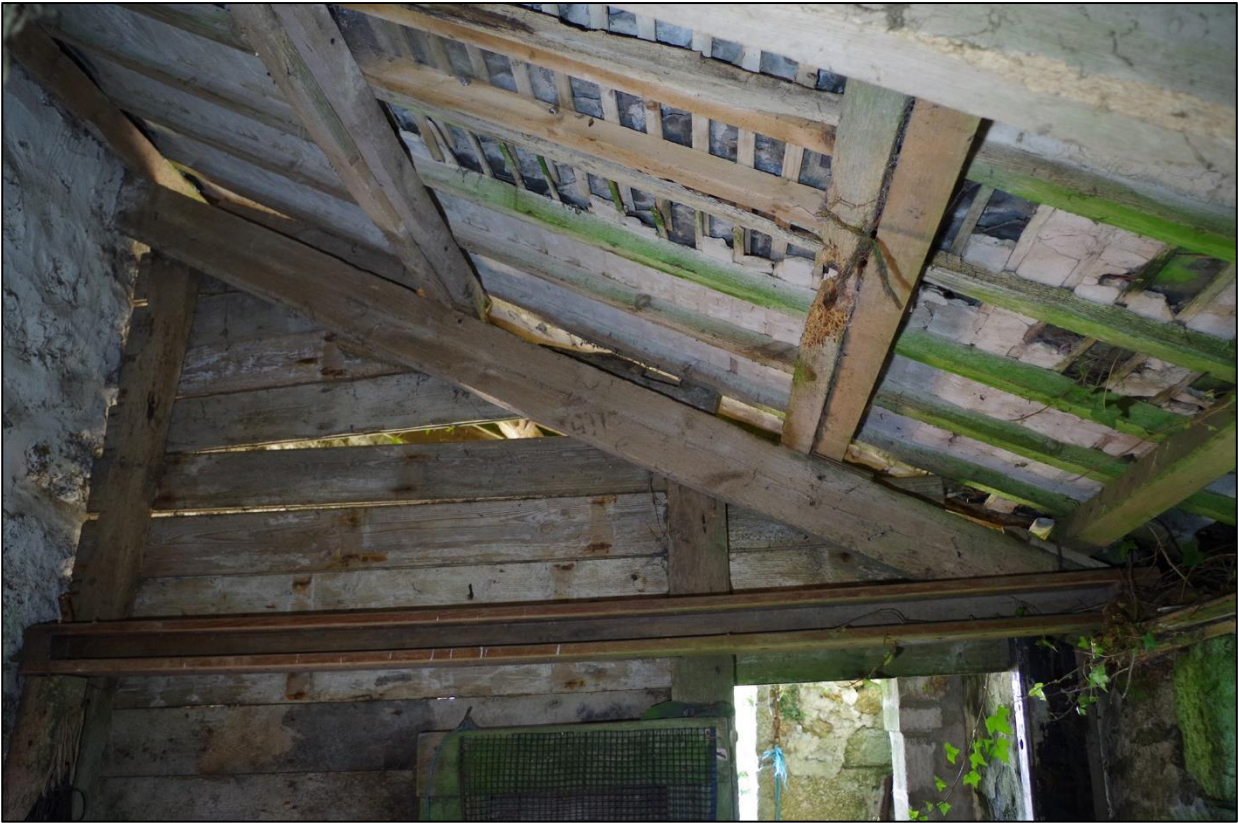
22. B1B, THE EAST SIDE OF TIMBER PARTITION AND RUSTIC ROOF WITH PLASTER SURVIVING BETWEEN RAFTERS; VIEWED FROM BELOW.
