WESTMOOR BARN

ST. BURYAN

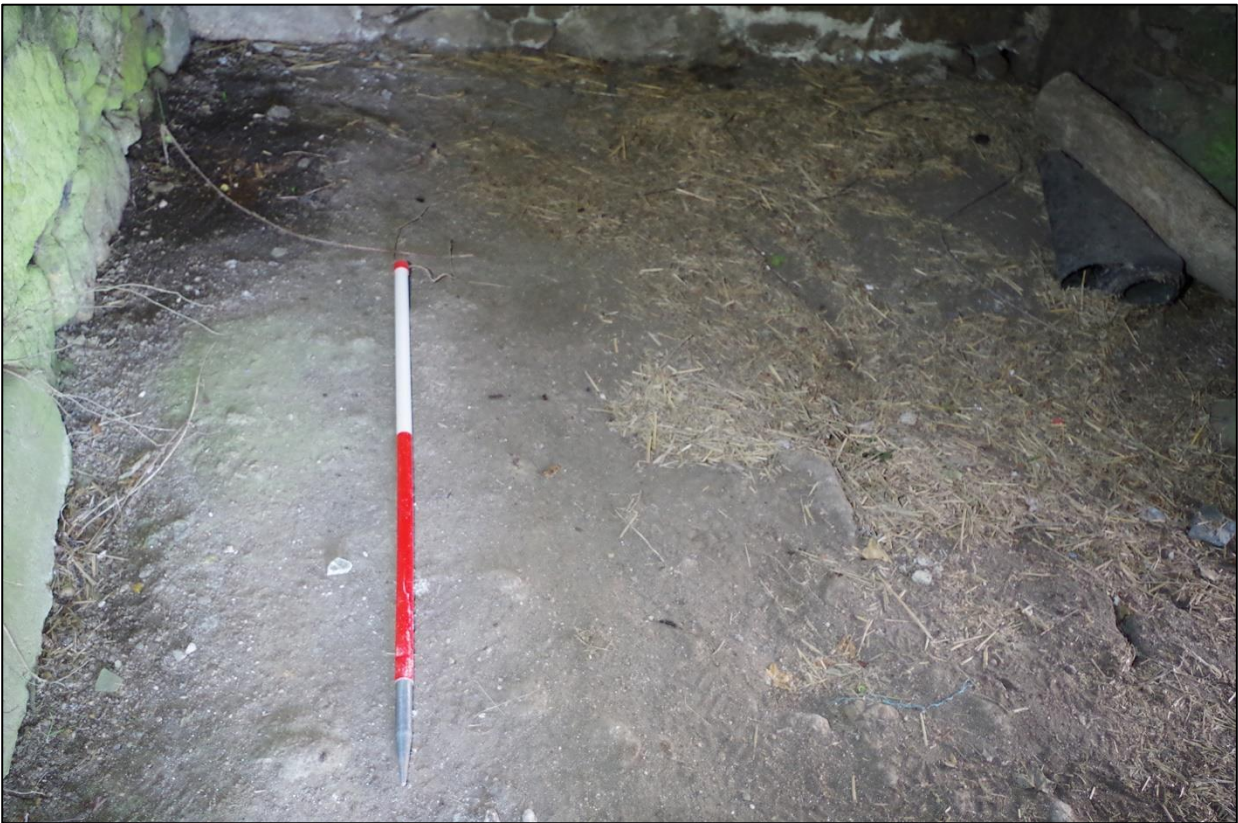
23. B1B, SLOPING EARTH AND STONE FLOOR SLOPING TO SOUTH; VIEWED FROM ABOVE.

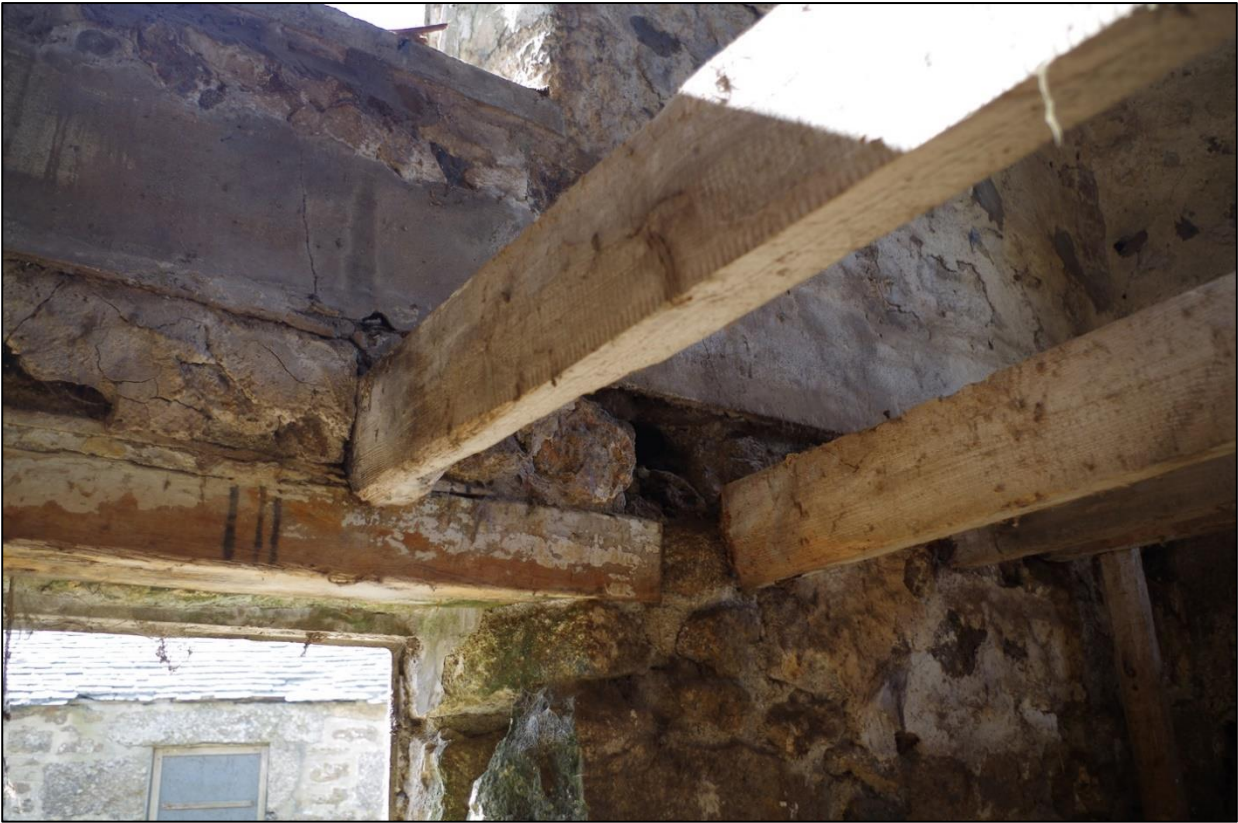
34. B1C, SOUTH ELEVATION, AND BLOCKED LARGER SOCKET HOLES AGAINST SLIMMER 19THC REPLACEMENT JOISTS; VIEWED FROM THE NORTH-EAST.

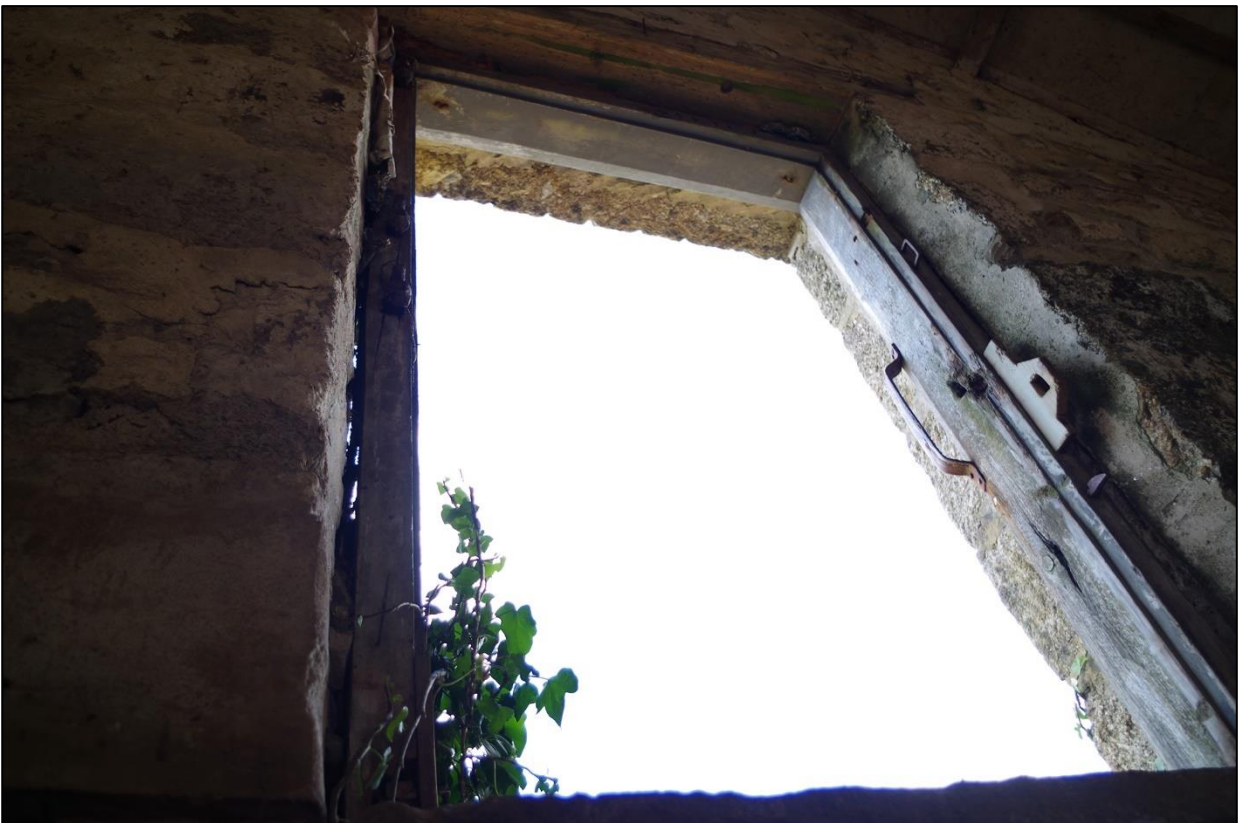
35. B1C, D12 INNER FACE AS SEEN FROM GF.

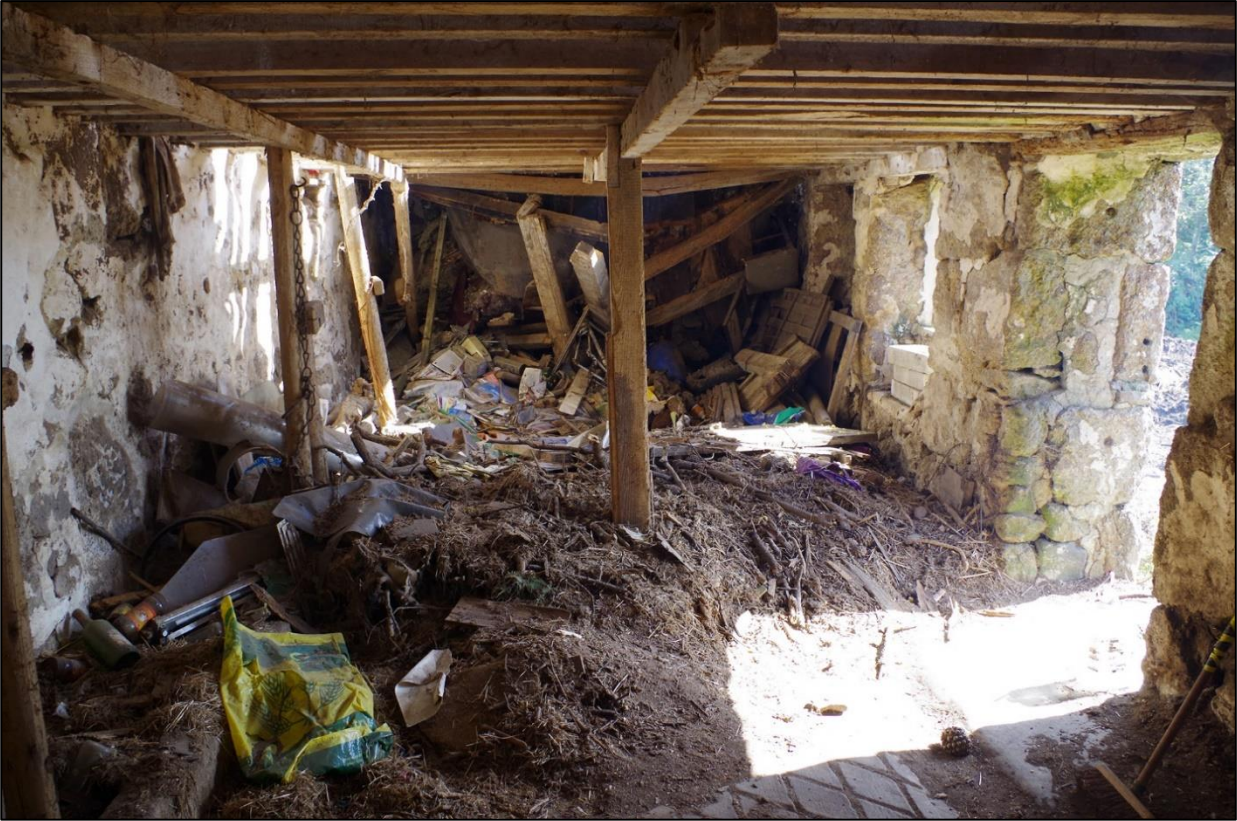
42. B1D, EAST END WAS INACCESSIBLE/UNSAFE; VIEWED FROM THE WEST.

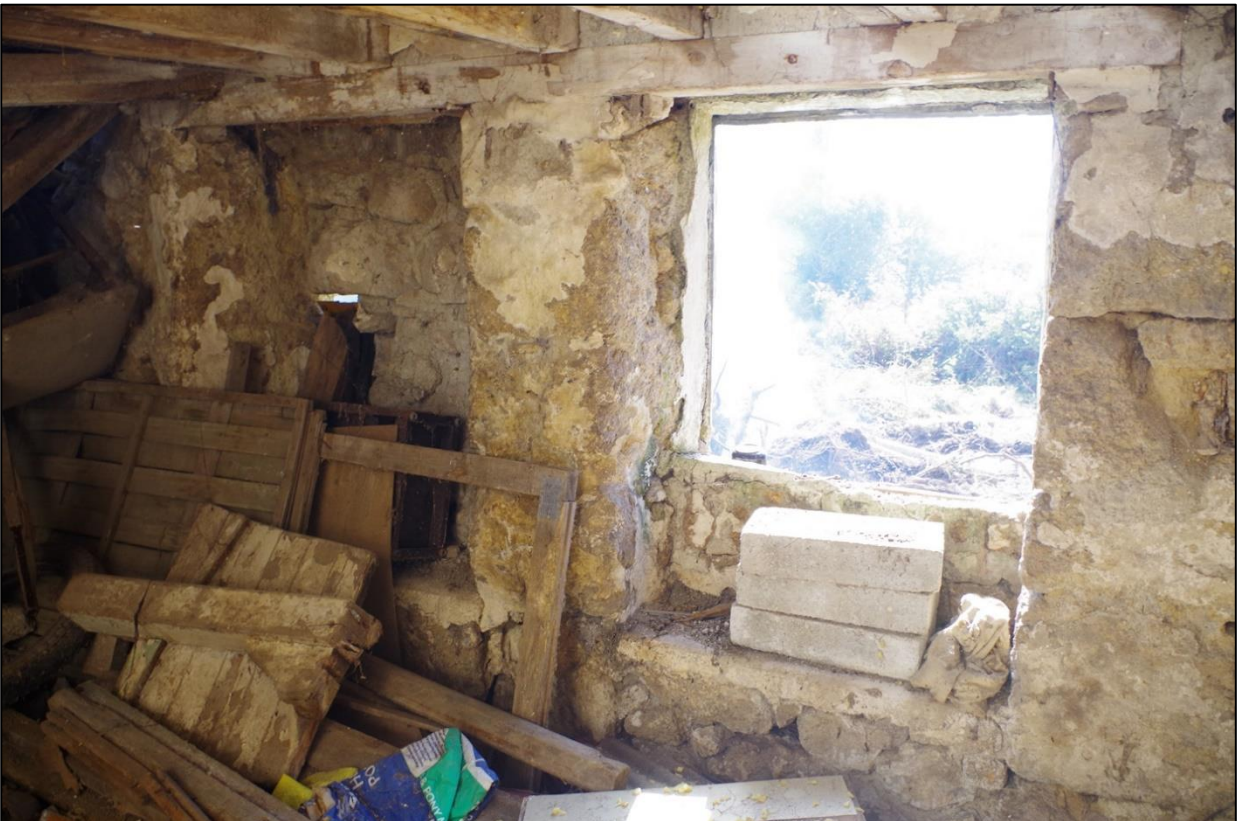
43. B1D, W6 TO EAST FORMER BLOCKED DOORWAY, REDUCED AGAIN TO SLIT VENT, AND W5 – BOTH WITH LOW WINDOW SEAT BLOCKING; VIEWED FROM THE NORTH-WEST.

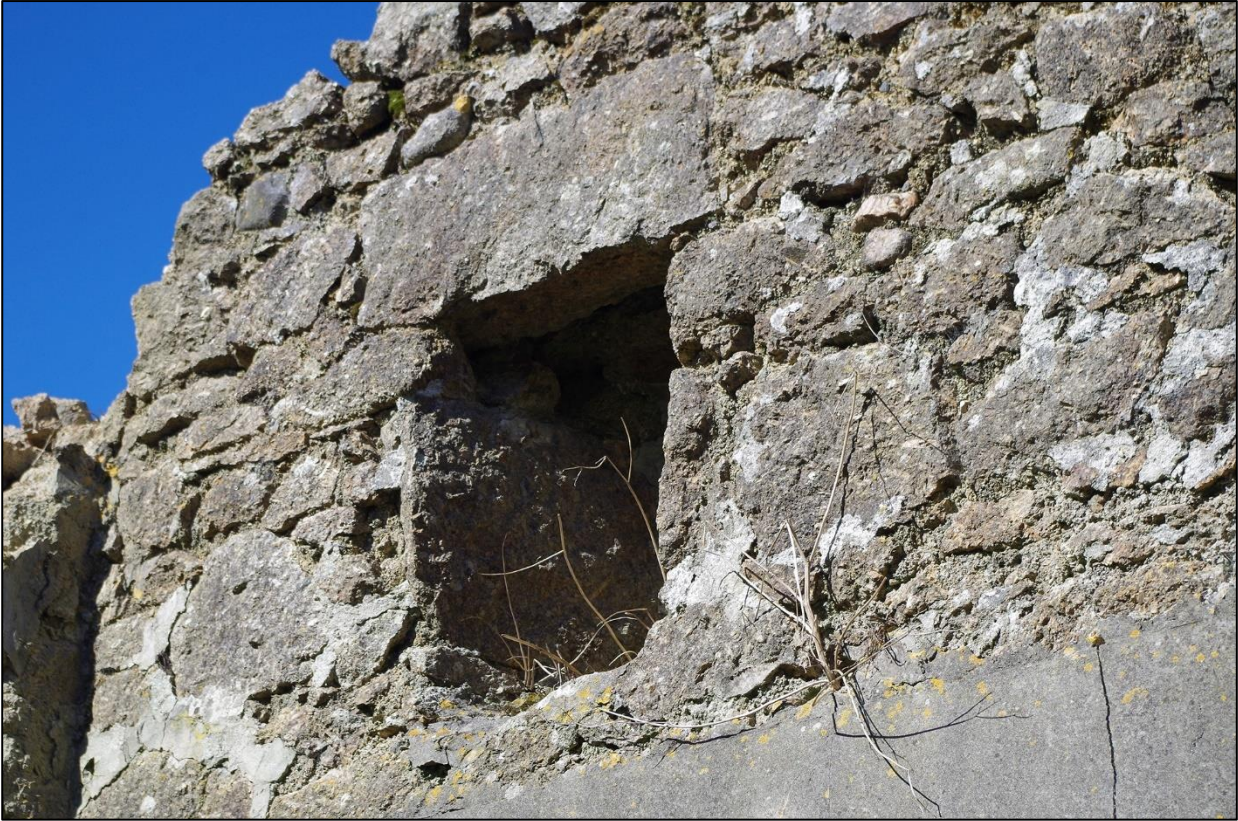
56. B1E, W14 WITH FACED AND DRESS LINTEL, IN COMPARISON TO ITS RUSTIC GF COUNTERPART W13.

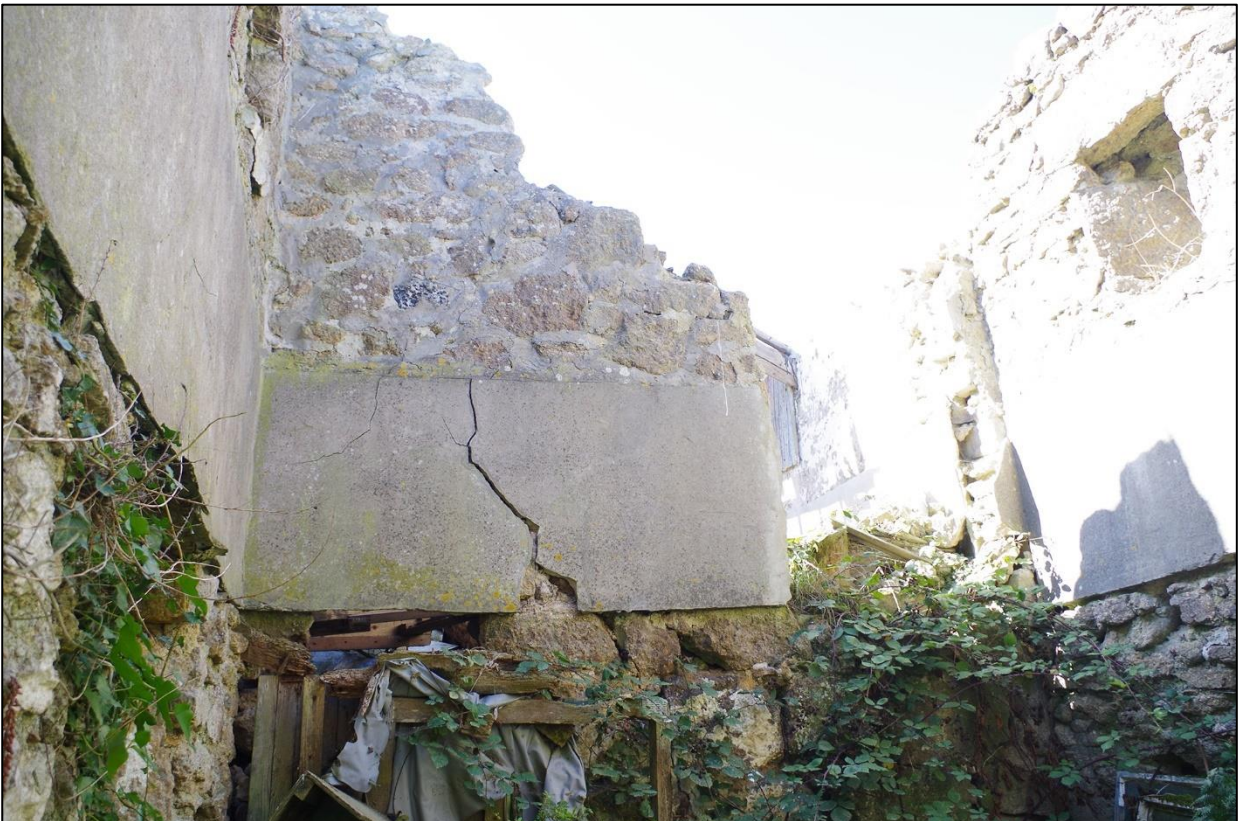
57. B1E, WEST GABLE ELEVATION, SUFFERED LARGE COLLAPSE, HARD TO DECIPHER FEATURES TO GF DUE TO UNSTABLE RUBBLE, BUT HEAVIER BUILD TO BASE IS VISIBLE.

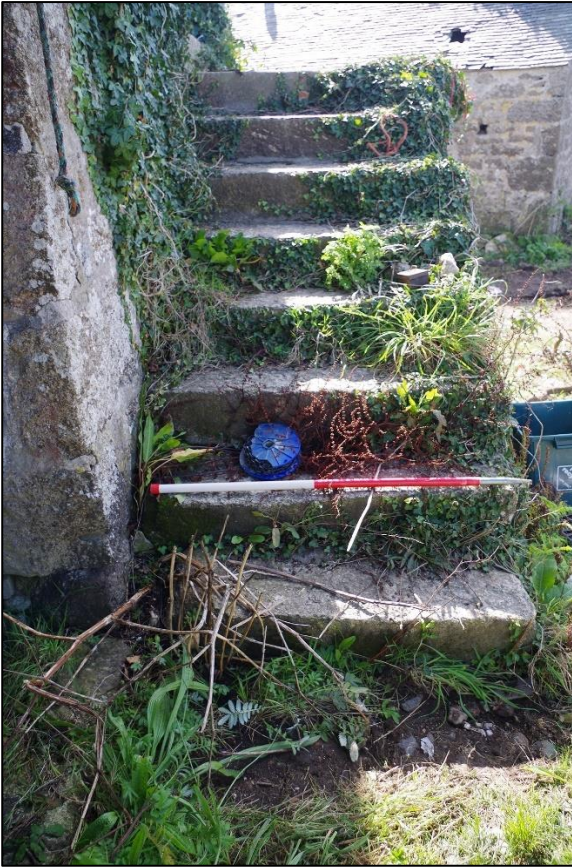
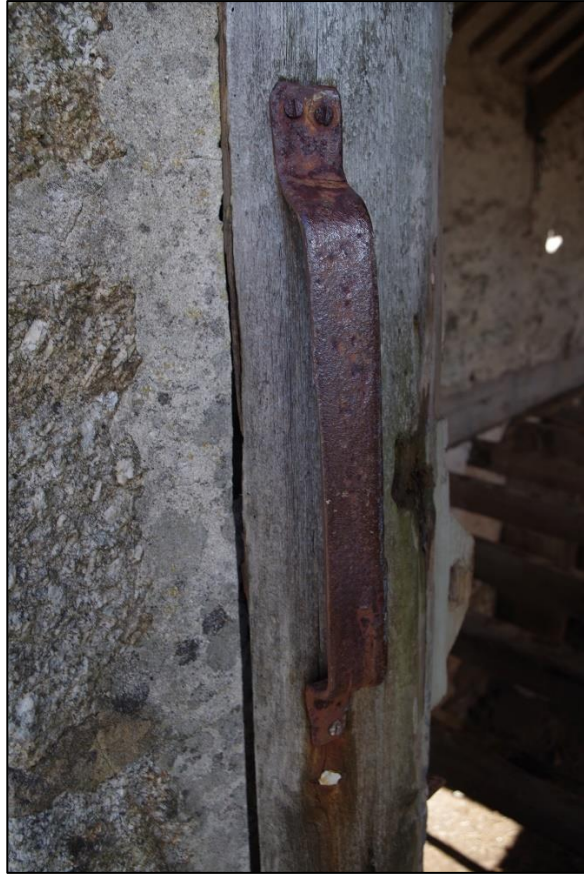
60. LEFT: B1C, SECONDARY GRANARY STEPS AGAINST WEST ELEVATION; VIEWED FROM THE NORTH (SCALE 1M).

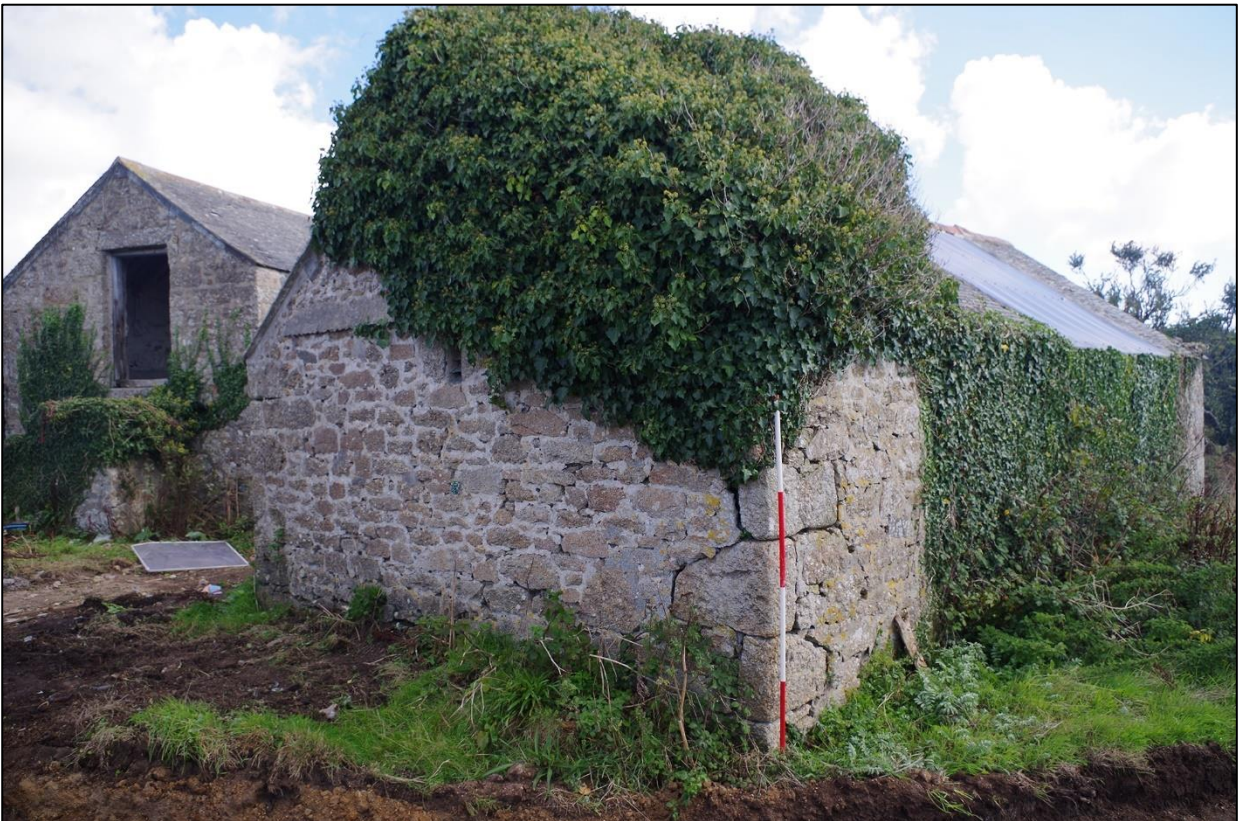
62. B2B, WEST EXTERNAL ELEVATION, SHOWING CONCRETE CORRUGATED SCARRING BELOW EAVES AND SLIT VENT; VIEWED FROM THE SOUTH-WEST (SCALE 2M).

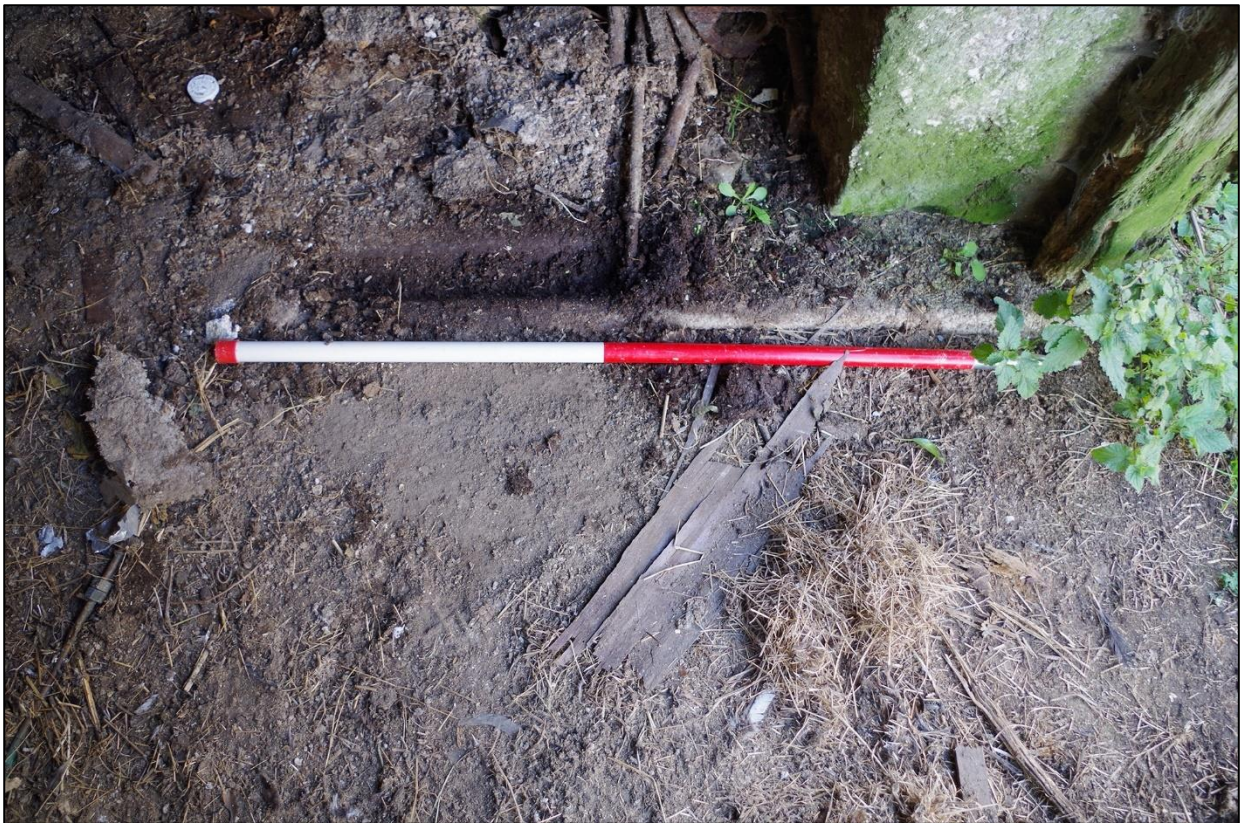
91. B2B CARVED GRANITE DRAIN FOUND TO THE NORTH AGAINST WEST SIDE OF D14 (1M SCALES).

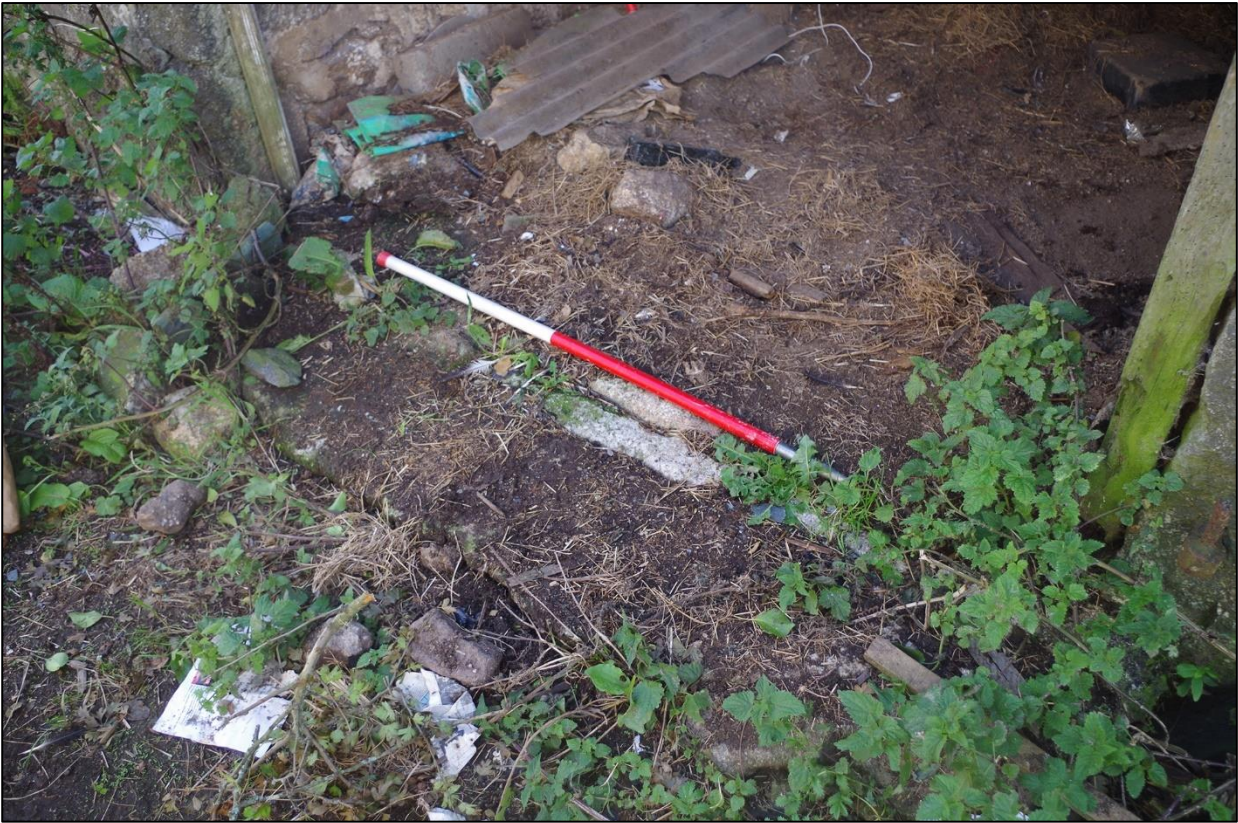
92. B2B GRANITE THRESHOLD AGAINST CARVED GRANITE DRAIN; VIEWED FROM THE NORTH-WEST (SCALE 1M).
