9 – 11 MARKET PLACE BIDEFORD DEVON

Results of a Desk-Based Study
Historic Building Assessment,
& Site Inspection

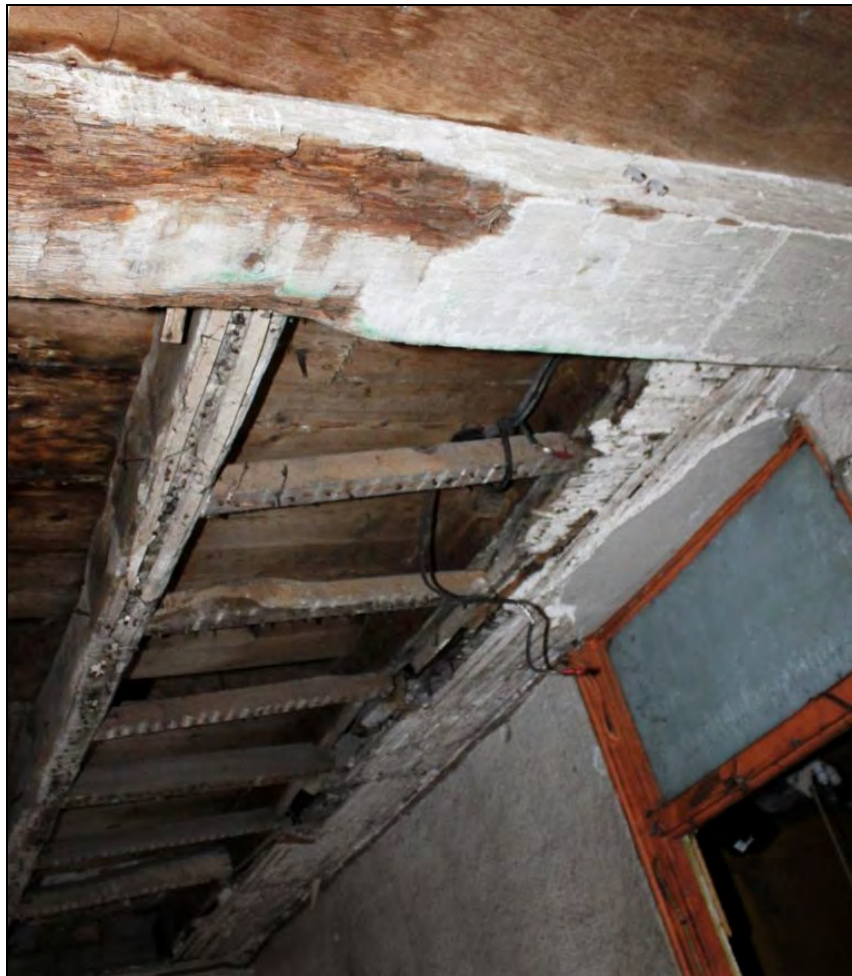
Figure 11: Ceiling above central passageway in Building 1, from the northwest.

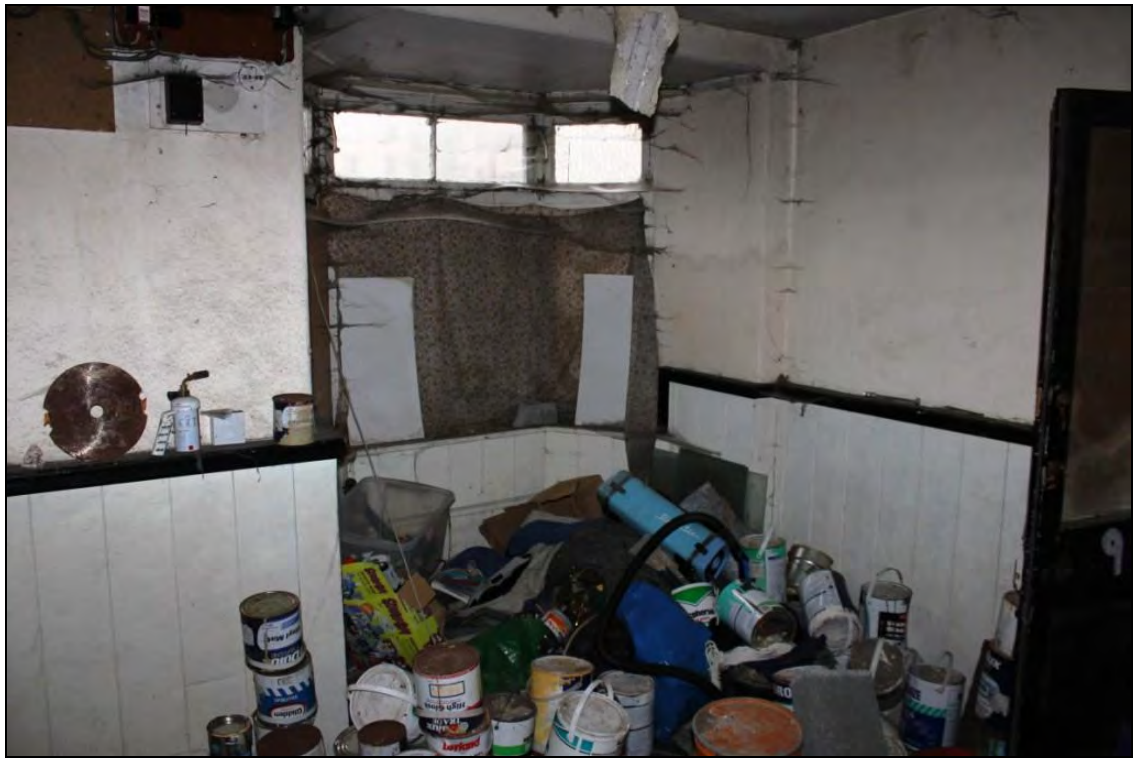
Figure 13: Bay window in Room 2, viewed from the northeast.

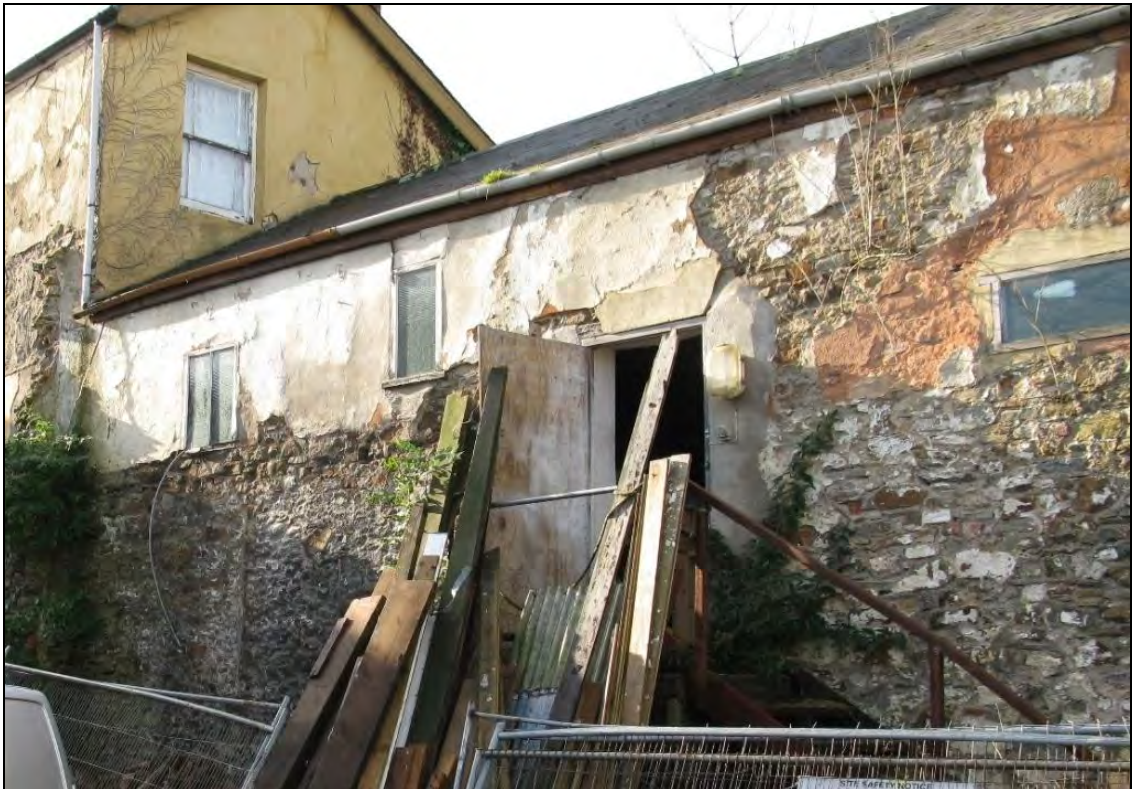
Figure 19: East elevation of Building 3, viewed from the north-west.

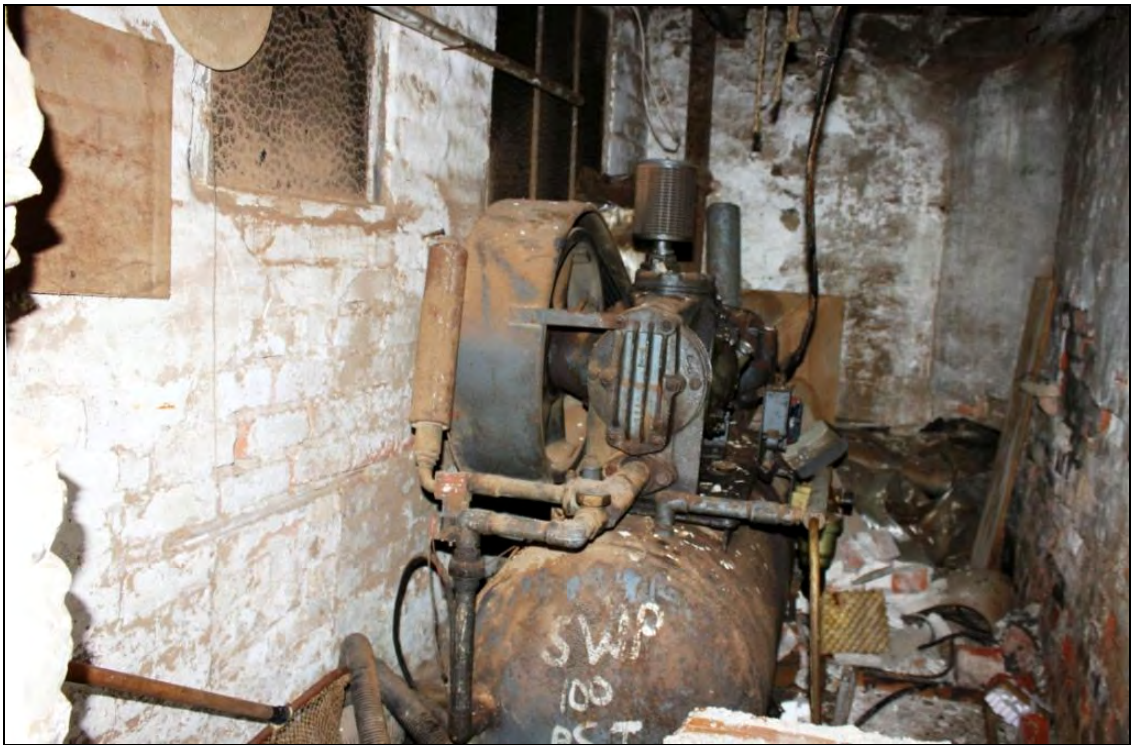
Figure 25: Engine Room and engine at south end of Building 6, viewed from the west.

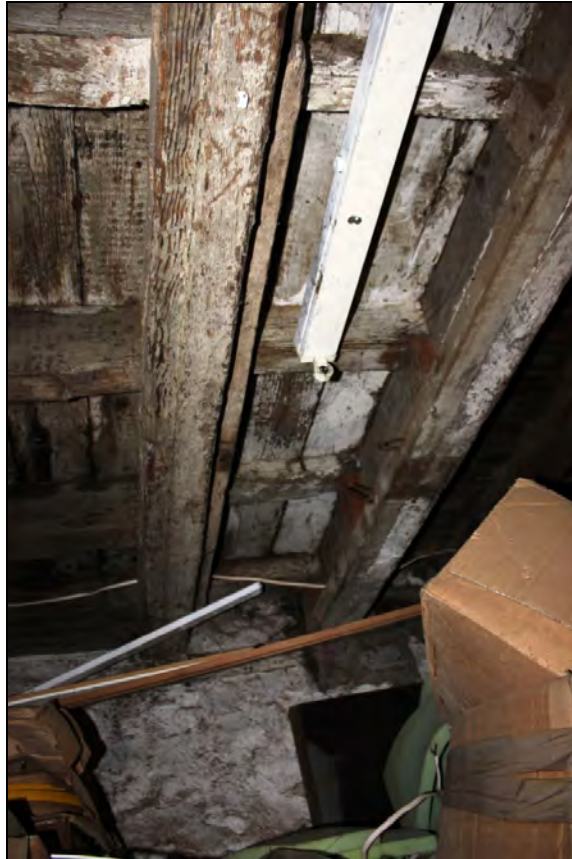
Figure 26: Loft floor timbers of Building 6, heavy chamfered cross beam visible to the left, with large flat-laid joist to the foreground and large on-edge joists to the background, with later 19th century timber floor joists to the right hand side, with smaller timbers, viewed from the east.

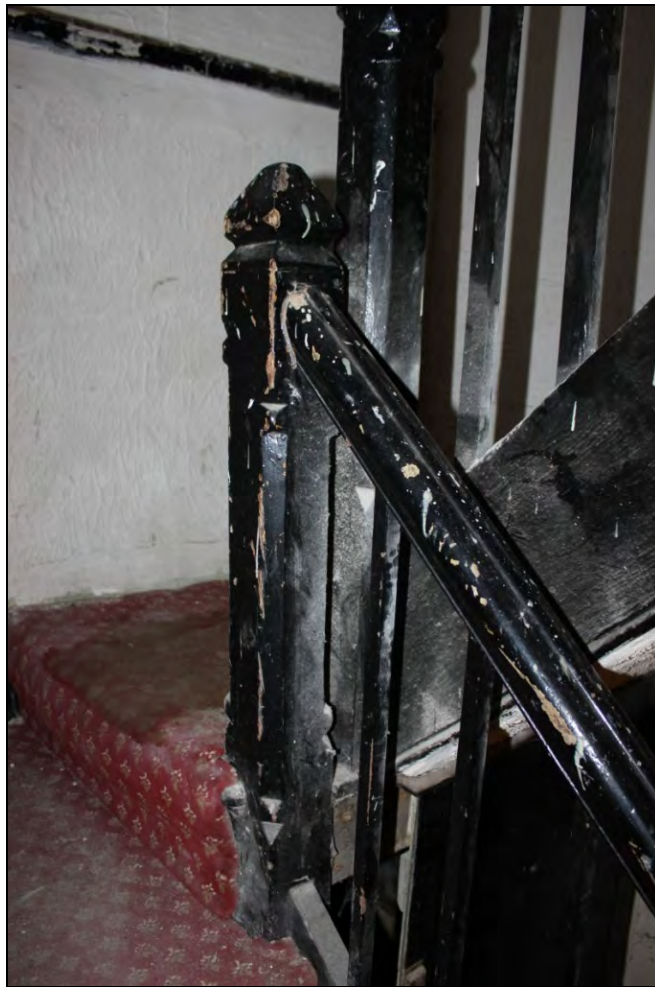
Figure 32: Detail of stair to Building 7, viewed from the east.

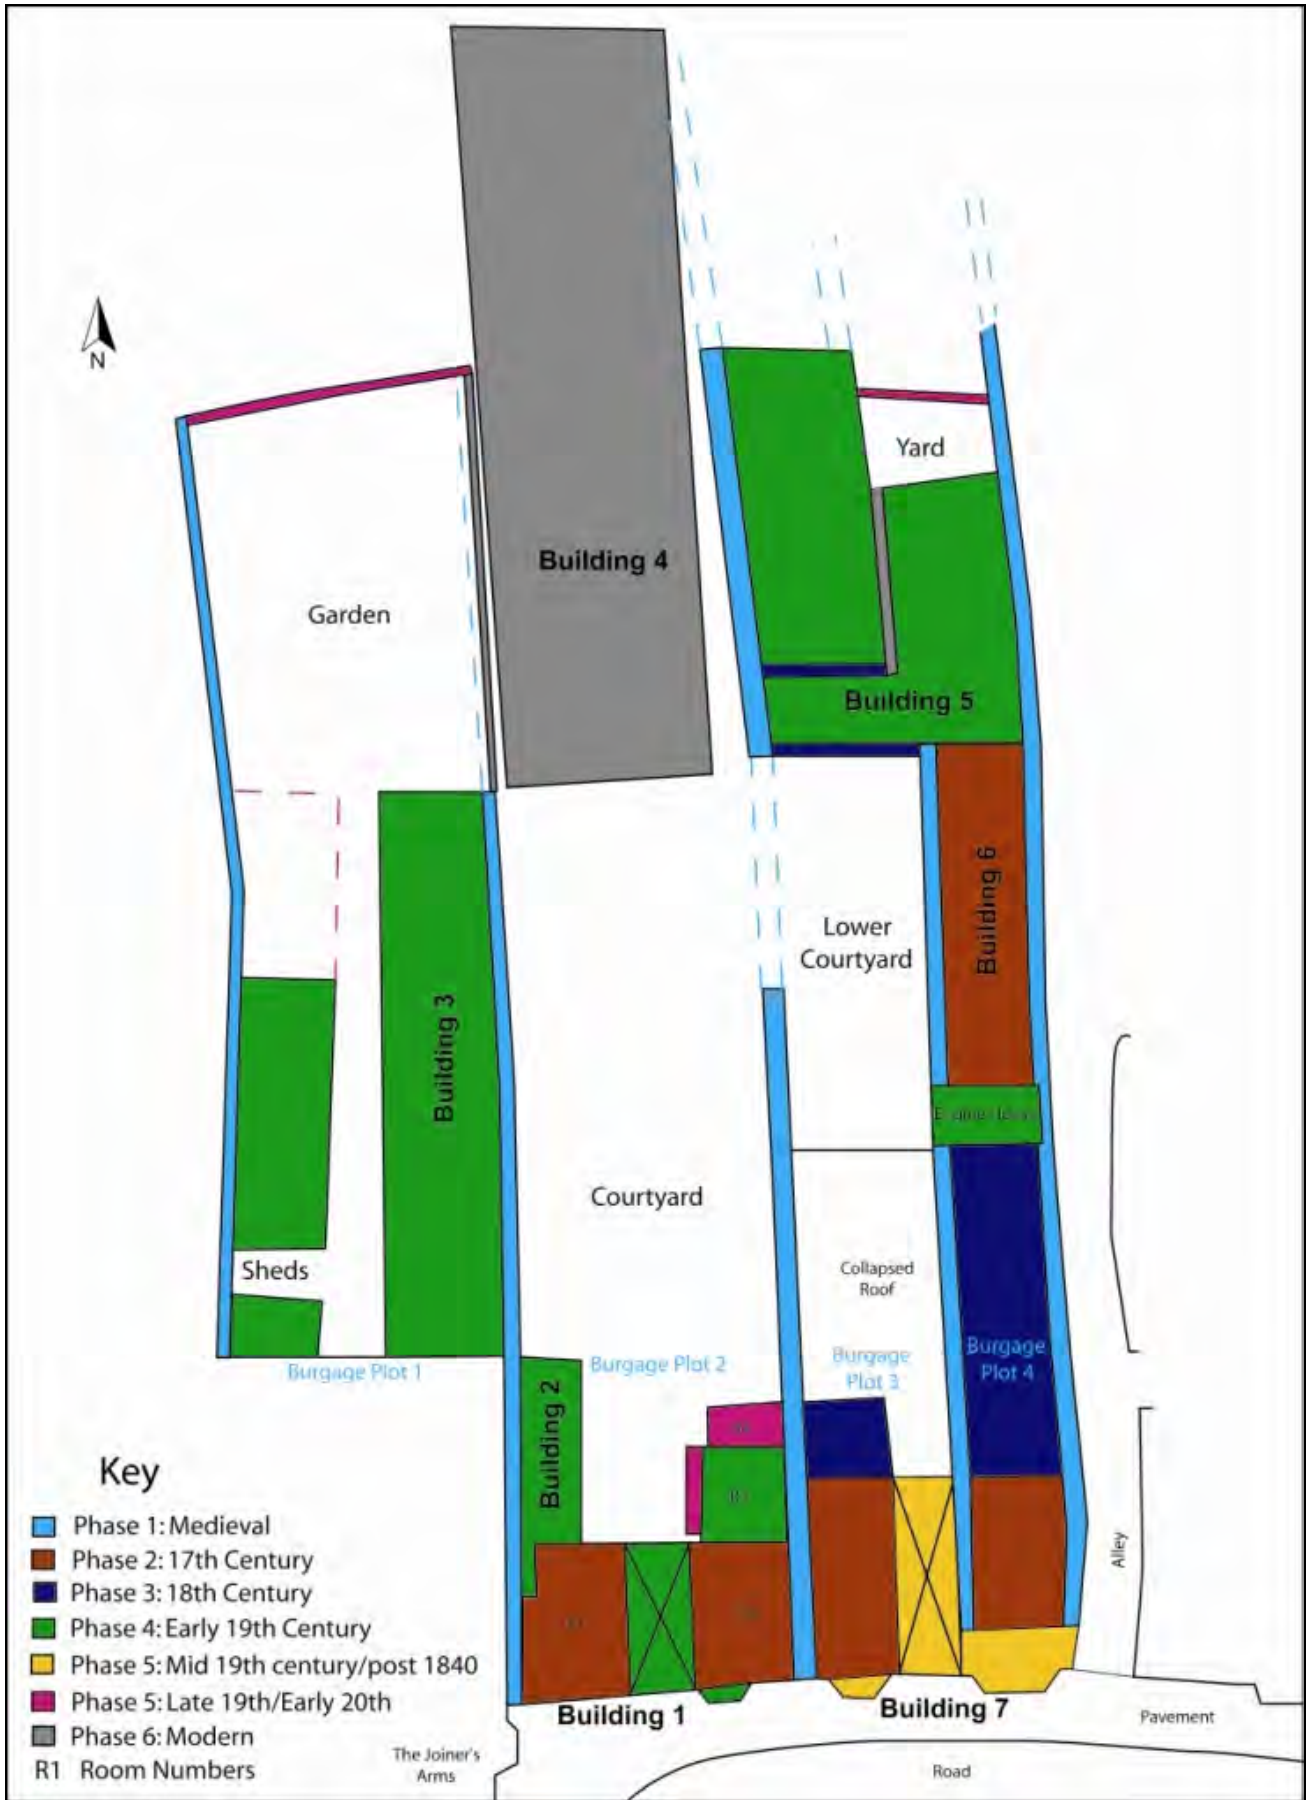
Figure 36: Phased ground floor plan of the development site.
