**SOUTH HOLE FARM
GEORGEHAM
NORTH DEVON
DEVON**

Historic Building Assessment & Statement of Significance

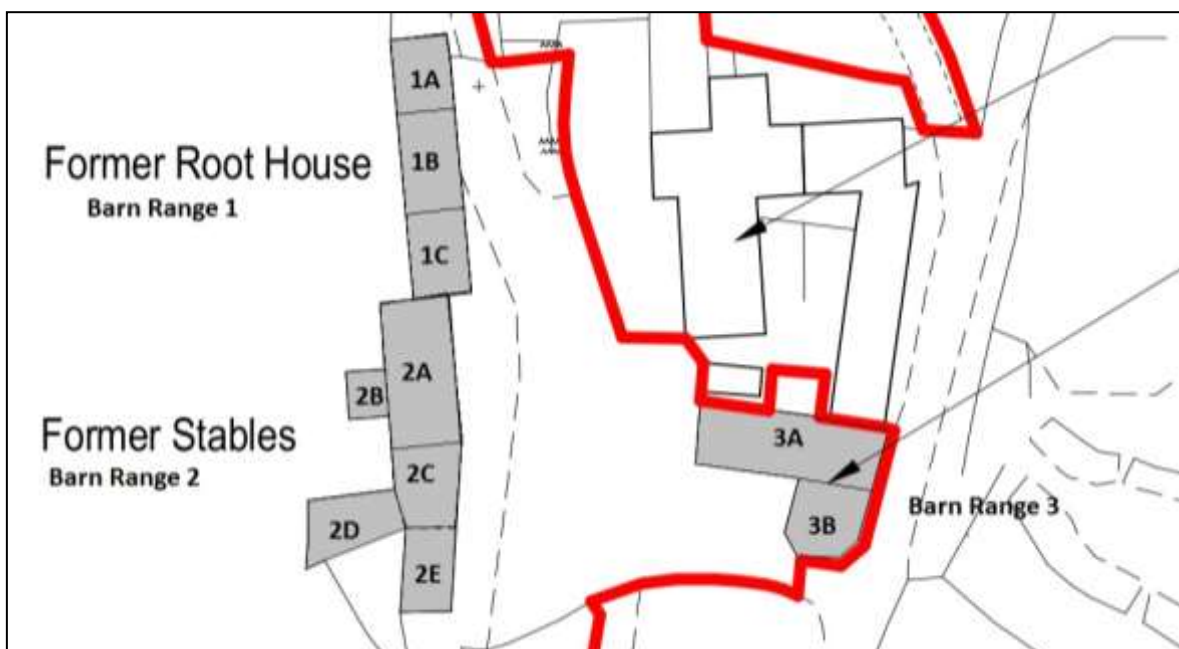
FIGURE 5: SCHEMATIC SITE PLAN SHOWING THE LOCATION OF THE BUILDINGS DISCUSSED HEREIN (THE RED LINE INDICATES THE LIMIT OF OWNERSHIP) (PLANS SUPPLIED BY THE ARCHITECT).

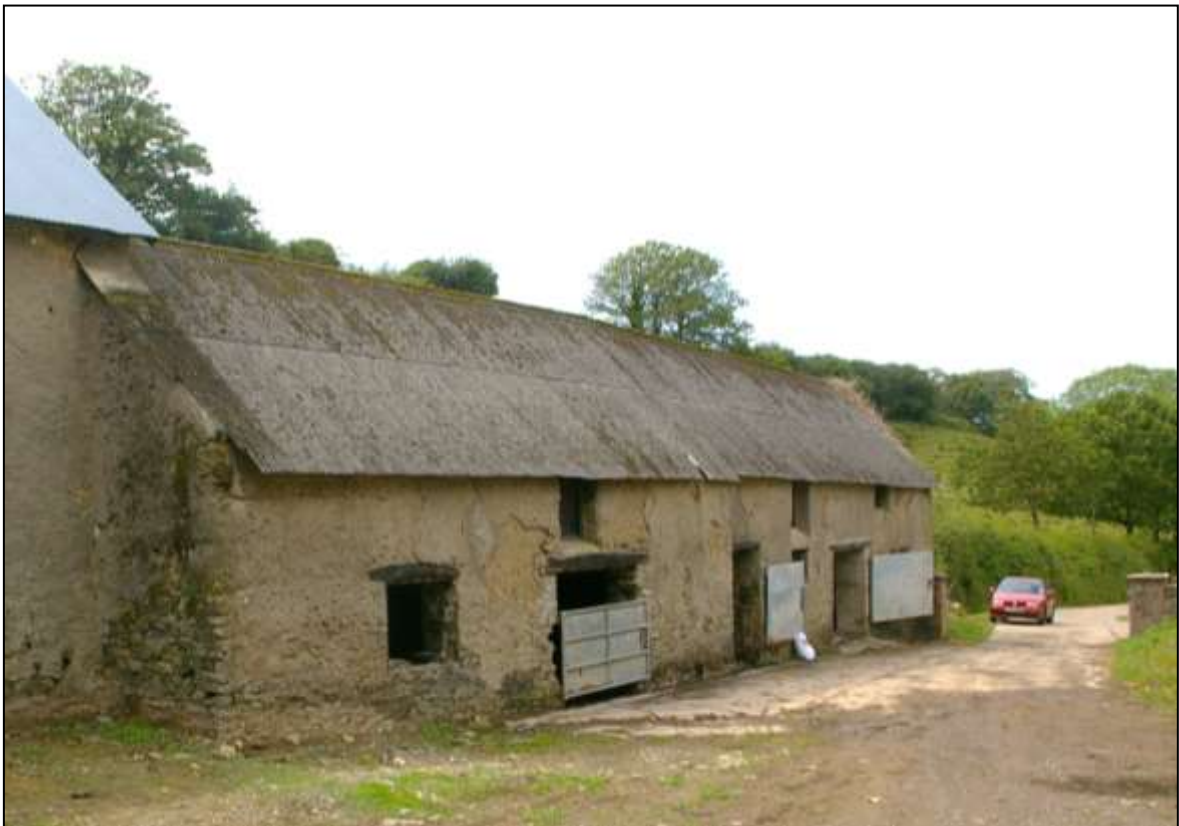
FIGURE 8: EAST FRONT OF B1; VIEWED FROM THE SOUTH-WEST.

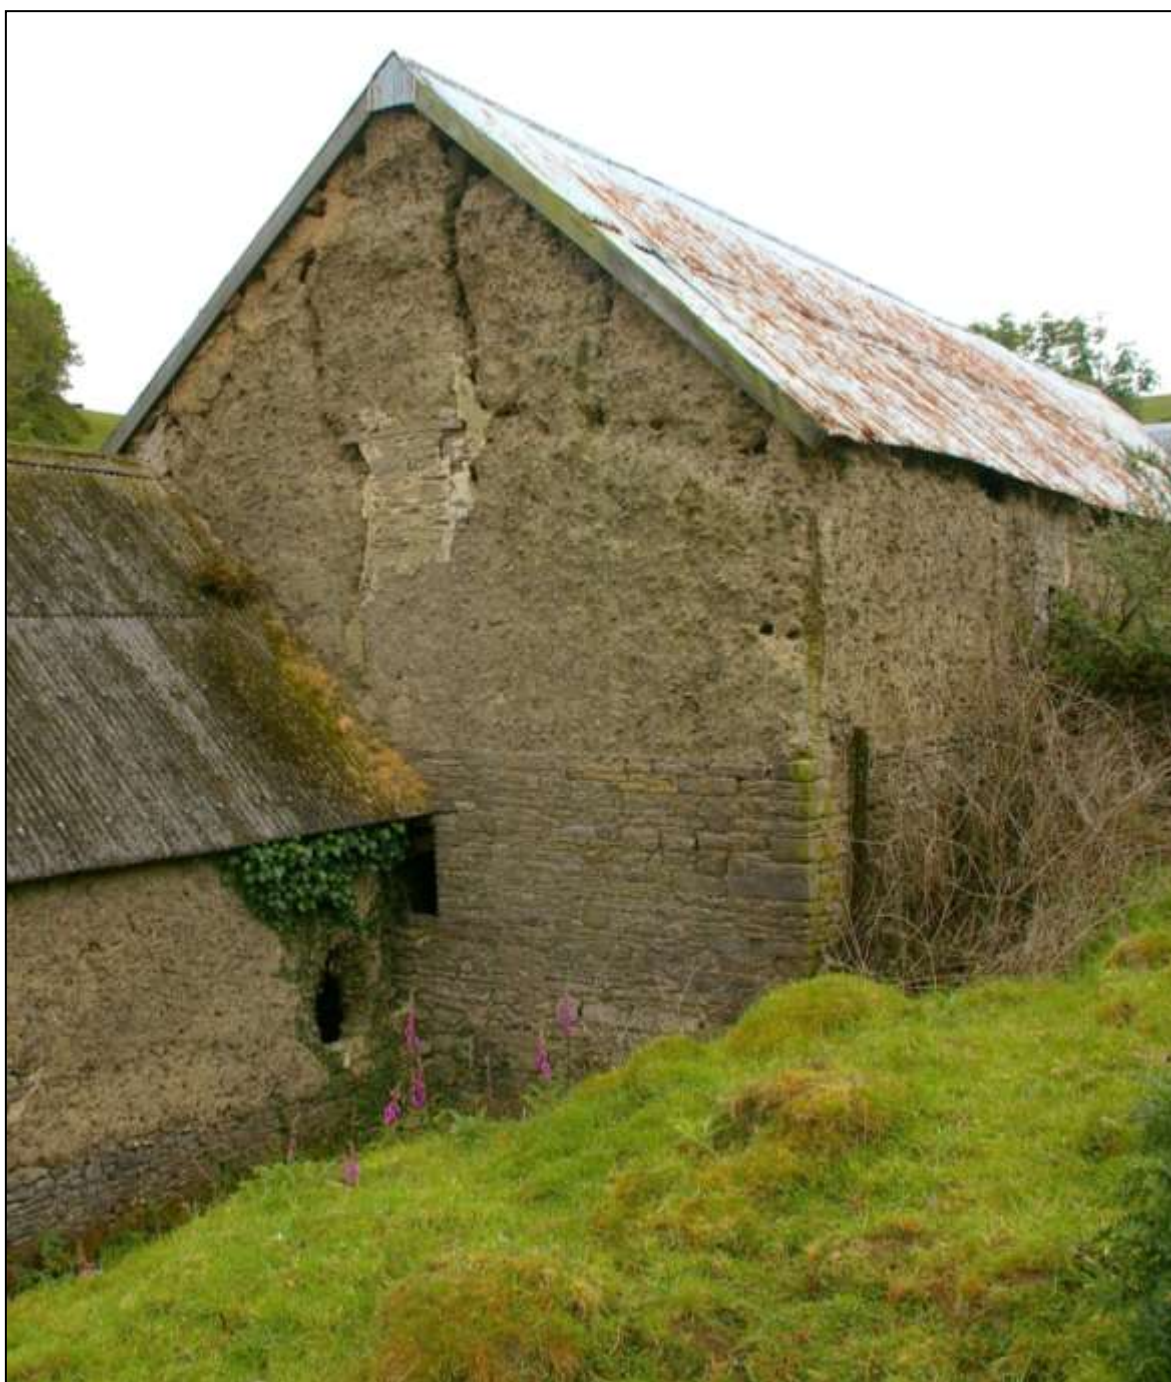
FIGURE 20: THE NORTH GABLE OF B2A; VIEWED FROM THE NORTH-WEST. NOTE THE STRUCTURAL CRACKS.

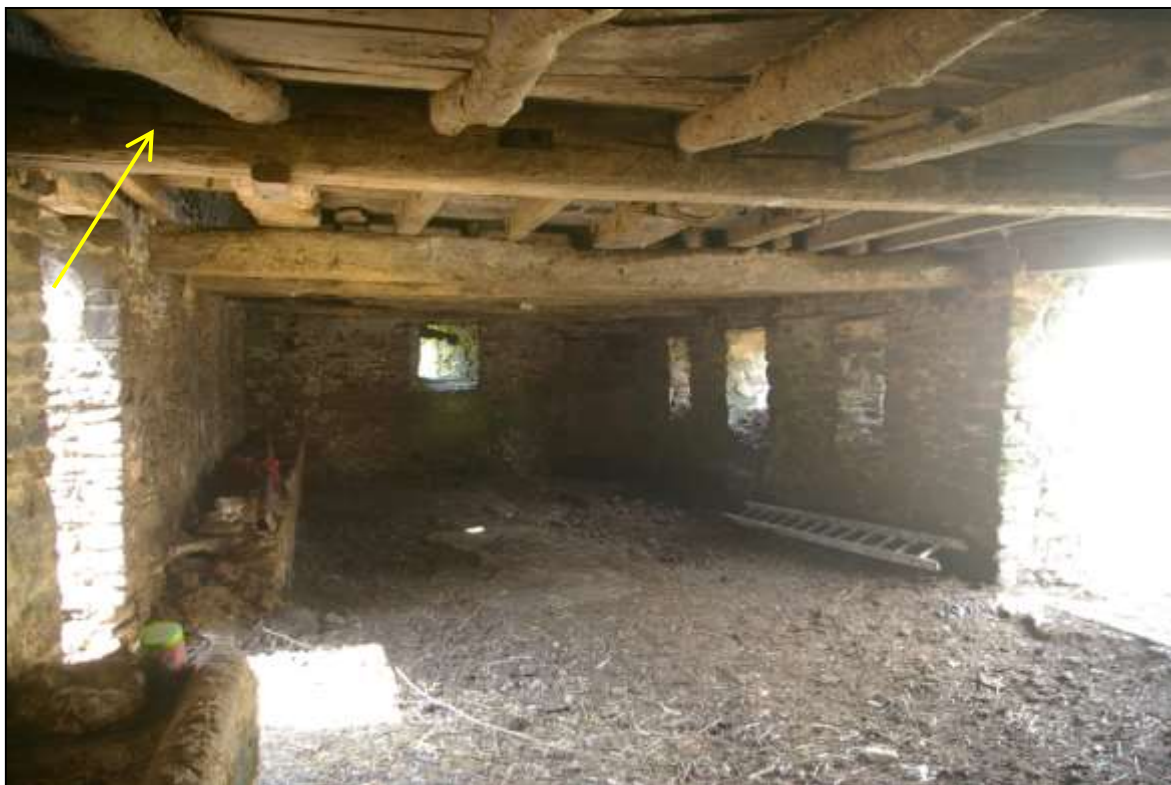
FIGURE 21: THE GROUND FLOOR IN B2A, SHOWING THE 15TH-16TH CENTURY DOMESTIC SCREEN RAIL WITH MULTIPLE MORTICE HOLES (INDICATED) REUSED AS BEAM; VIEWED FROM THE SOUTH.

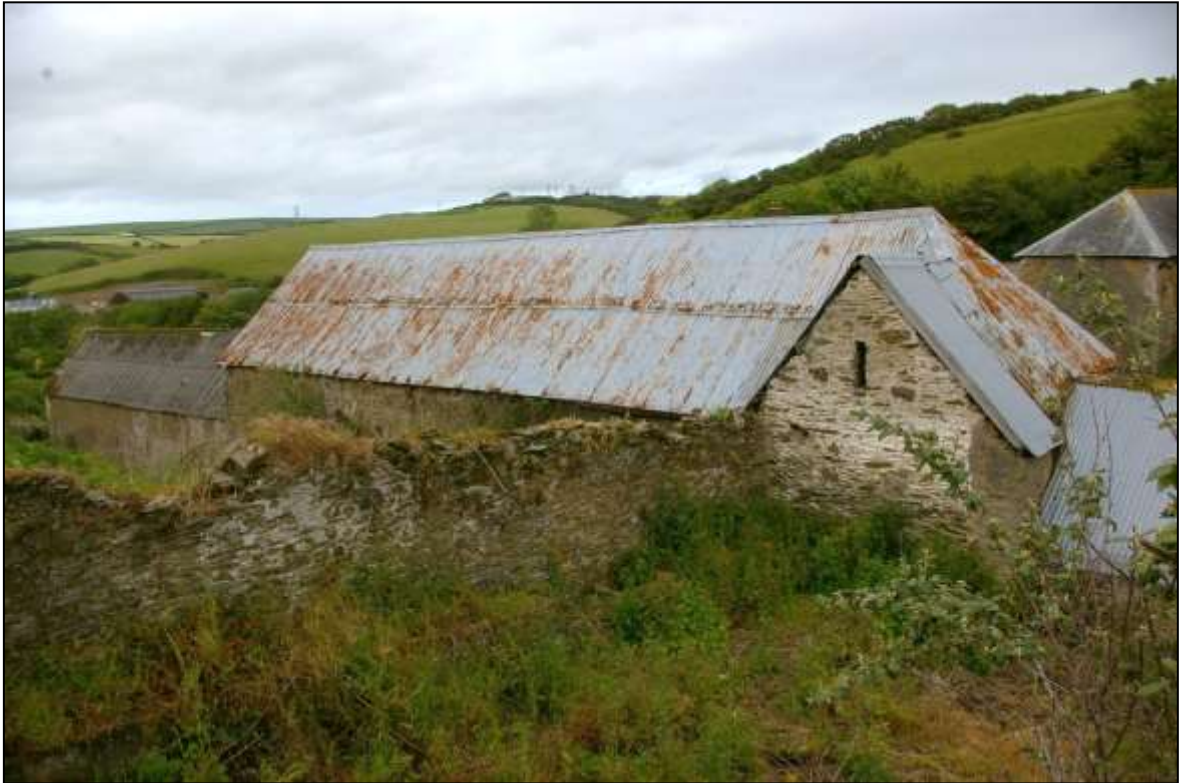
FIGURE 26: THE RUINS OF B2D, WITH B2A & B2C BEYOND; VIEWED FROM THE SOUTH-WEST.

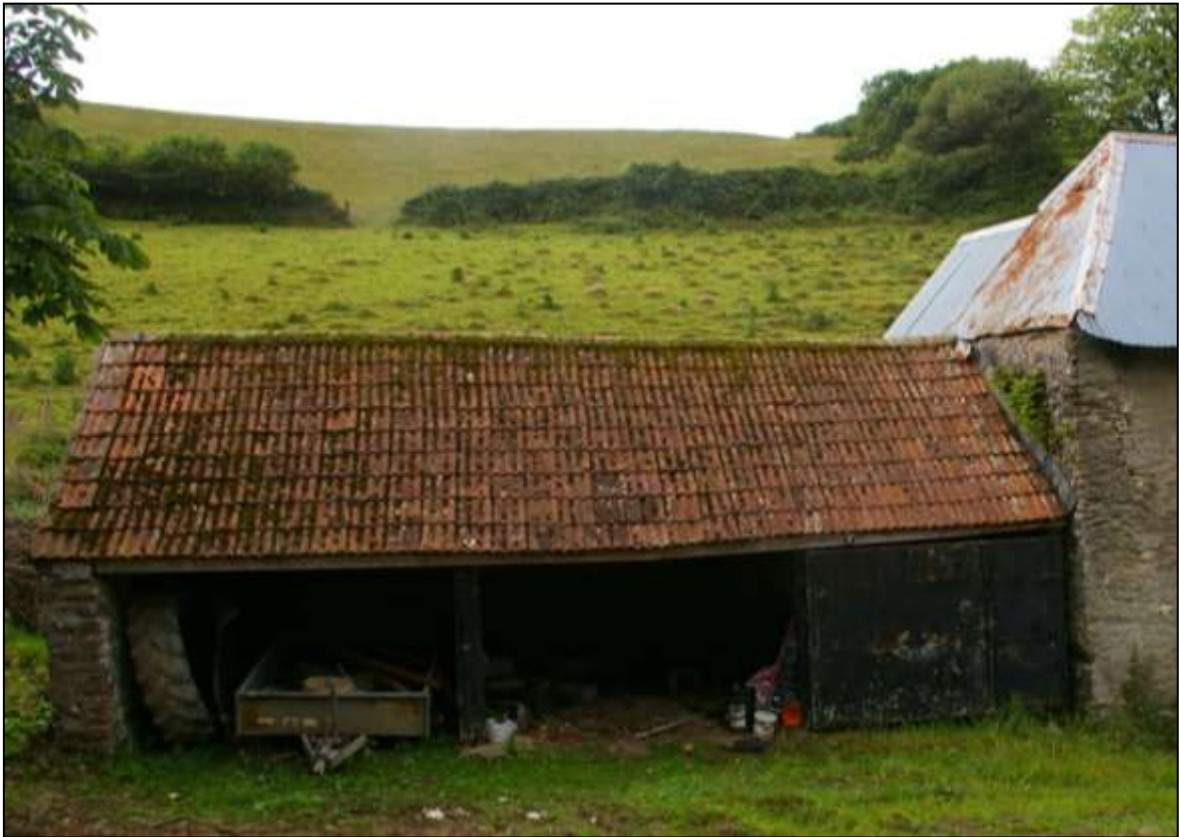
FIGURE 27: EAST FRONT OF IMPLEMENT SHED B2E, WITH B2C TO RIGHT.

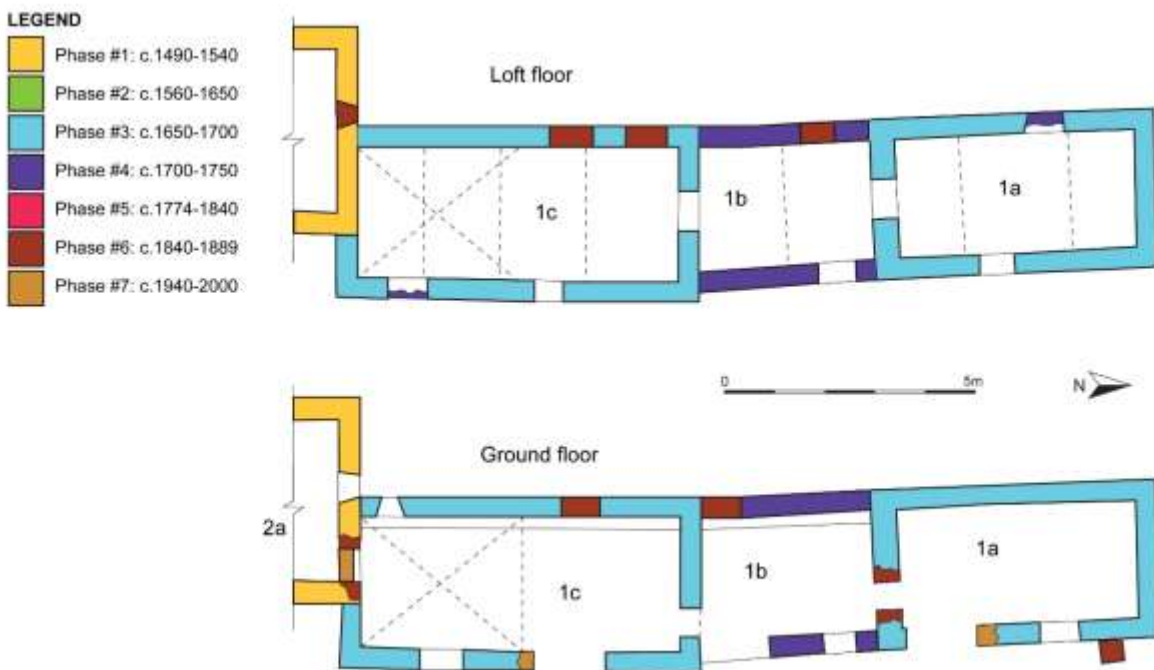
FIGURE 33: PROVISIONAL PHASED PLAN OF BUILDING 1 (BASED ON SUPPLIED DRAWINGS). NORTH IS TO RIGHT.

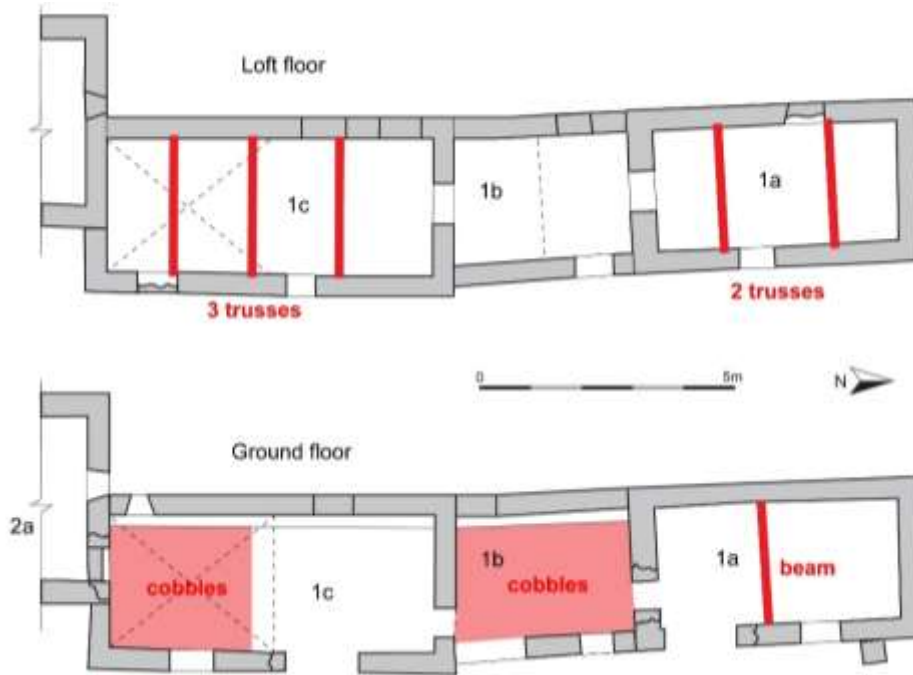
FIGURE 36: BUILDING 1, WITH AREAS OF SENSITIVITY HIGHLIGHTED IN RED (BASED ON SUPPLIED PLANS).

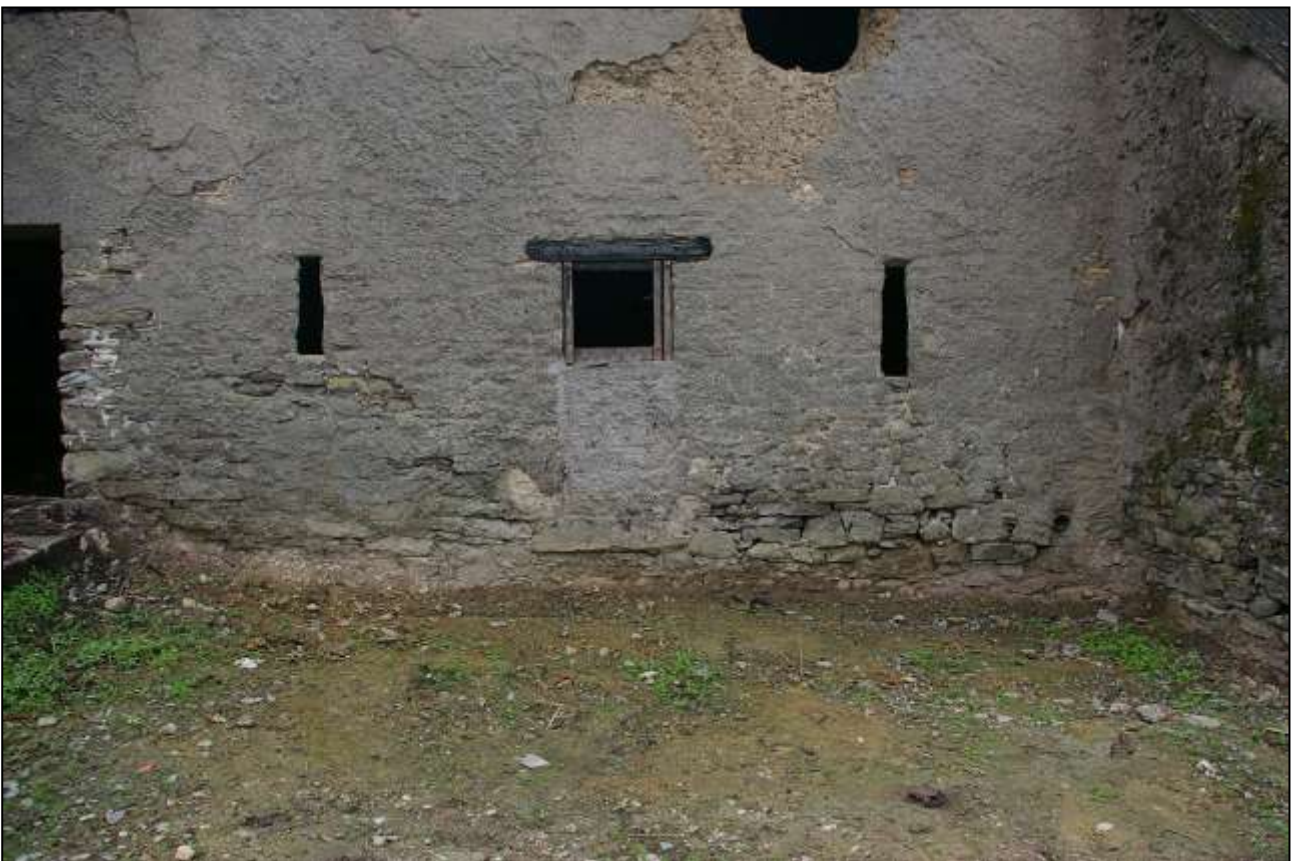
29. BLOCKED DOORWAY AND FLANKING SLIT VENTS IN THE EAST WALL OF B2A, WITH A LARGE HOLE IN THE COB TO TOP RIGHT A VERY WORN PITCHING HATCH; VIEWED FROM THE EAST.

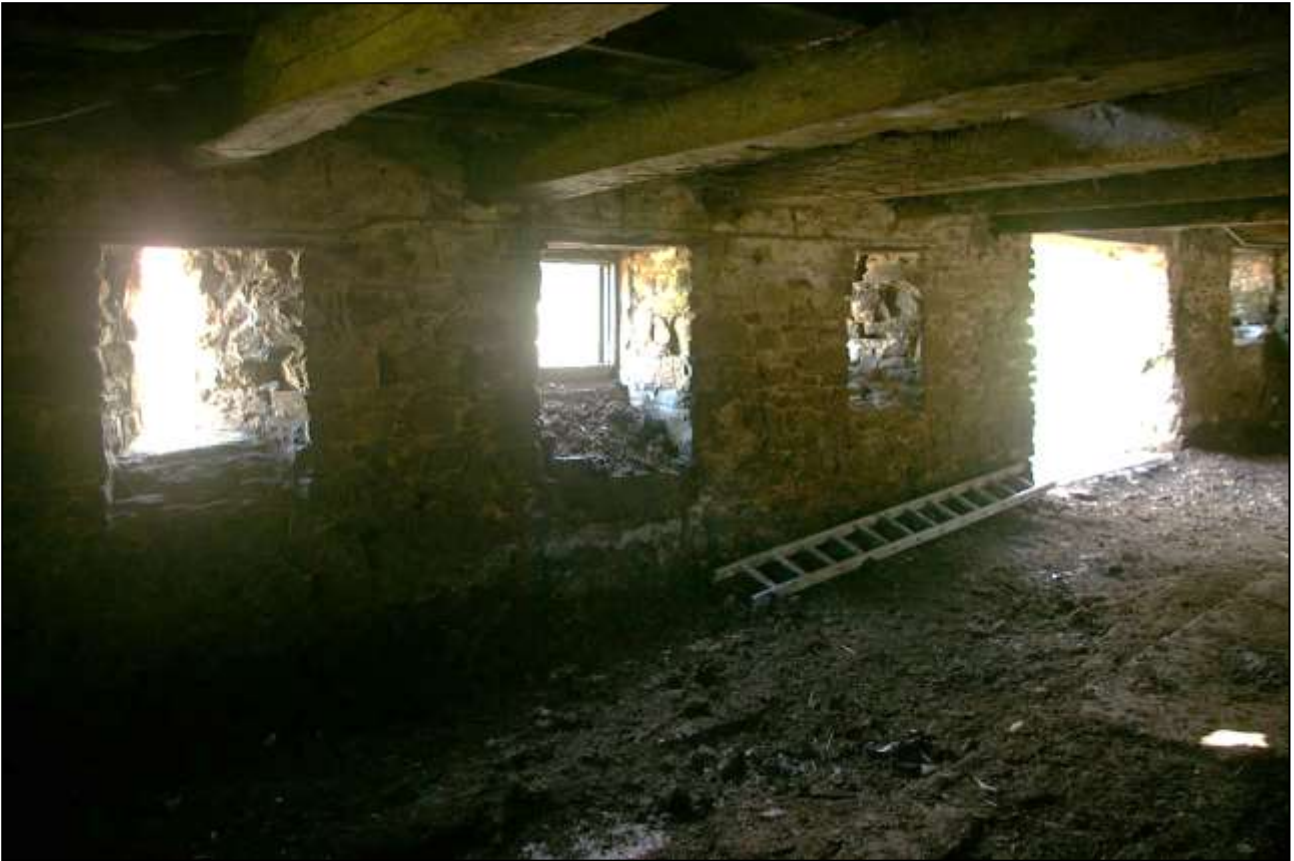
30. SLIT VENTS AND BLOCKED DOOR INSIDE B2A; VIEWED FROM THE NORTH-WEST.

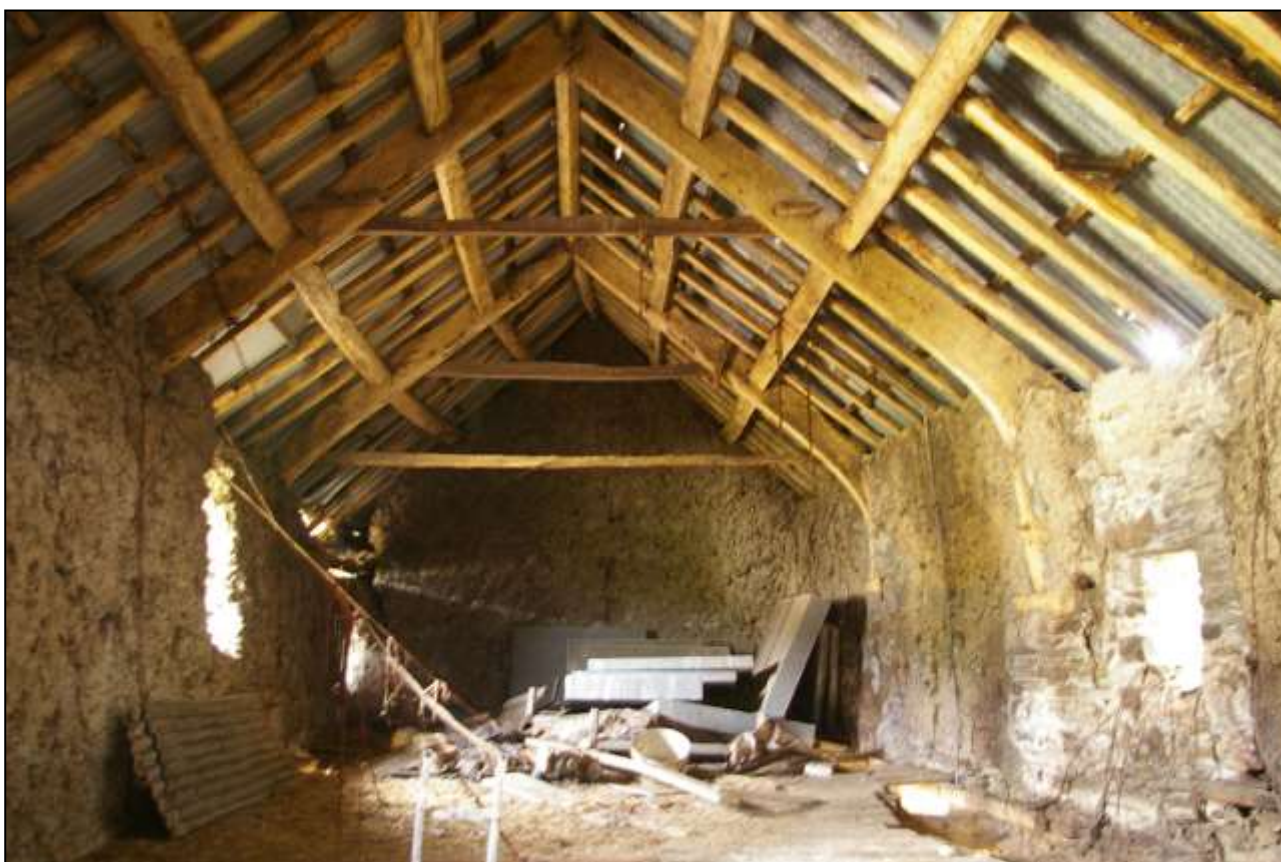
39. THE LOFT IN B2A. A SUBSTANTIALLY COMPLETE LATE 15TH TO MID-16TH CENTURY ROOF, FORMERLY WITH CRUCK FEET ON BOTH SIDES. THE EAST WALL (TO LEFT) LATER REBUILT AND FEET LOST AND TRUSS BLADES ALTERED. ORIGINAL COLLARS REMOVED AND REPLACED CRUDELY IN C20. VIEWED FROM THE NORTH.

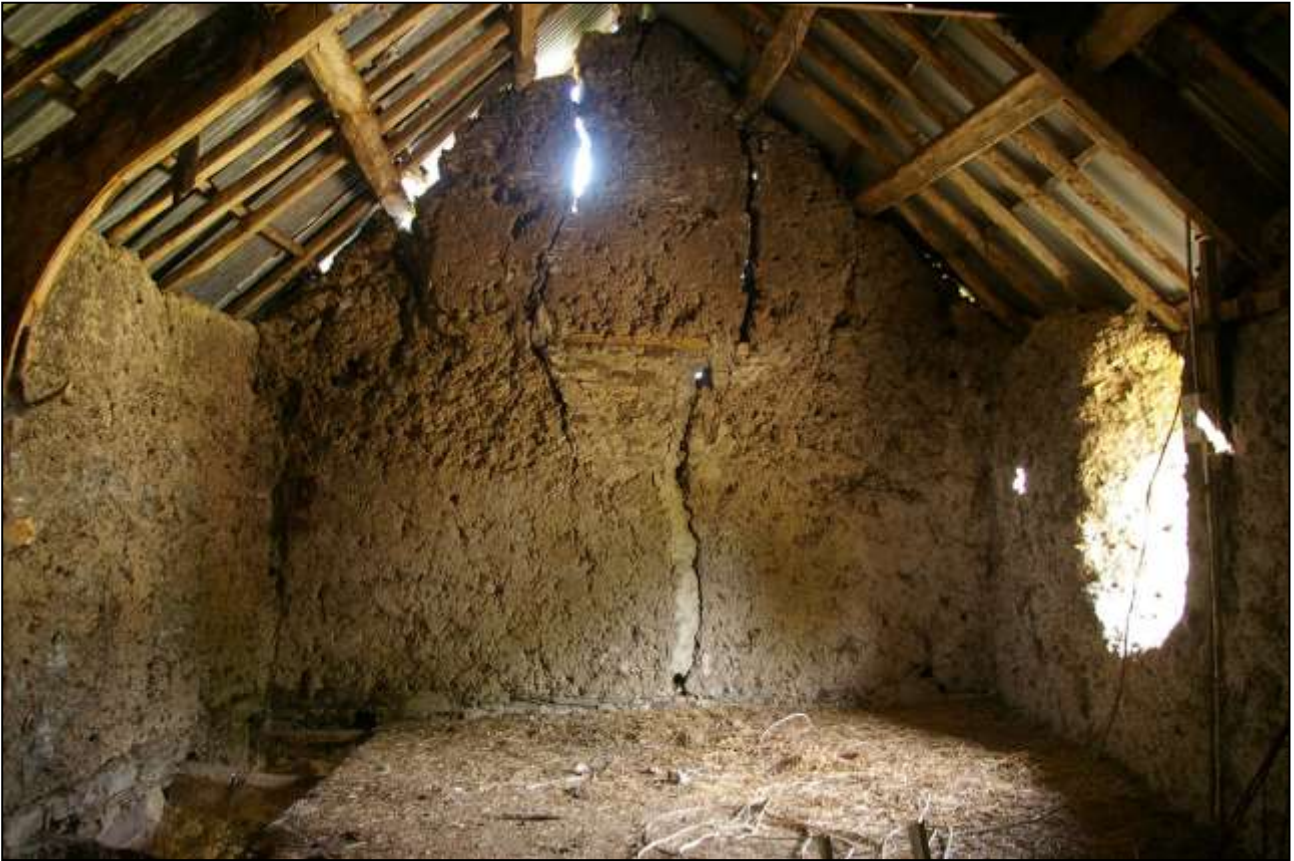
40. THE NORTH END OF LOFT IN B2A. STRUCTURAL CRACKS IN THIS NORTH WALL PROBABLY AROSE DUE TO MOVEMENT OF THE EAST WALL. NOTE THE PRIMARY WINDOW, WHICH MAY HAVE CAUSED THE CRACKS TO START. VIEWED FROM THE SOUTH.

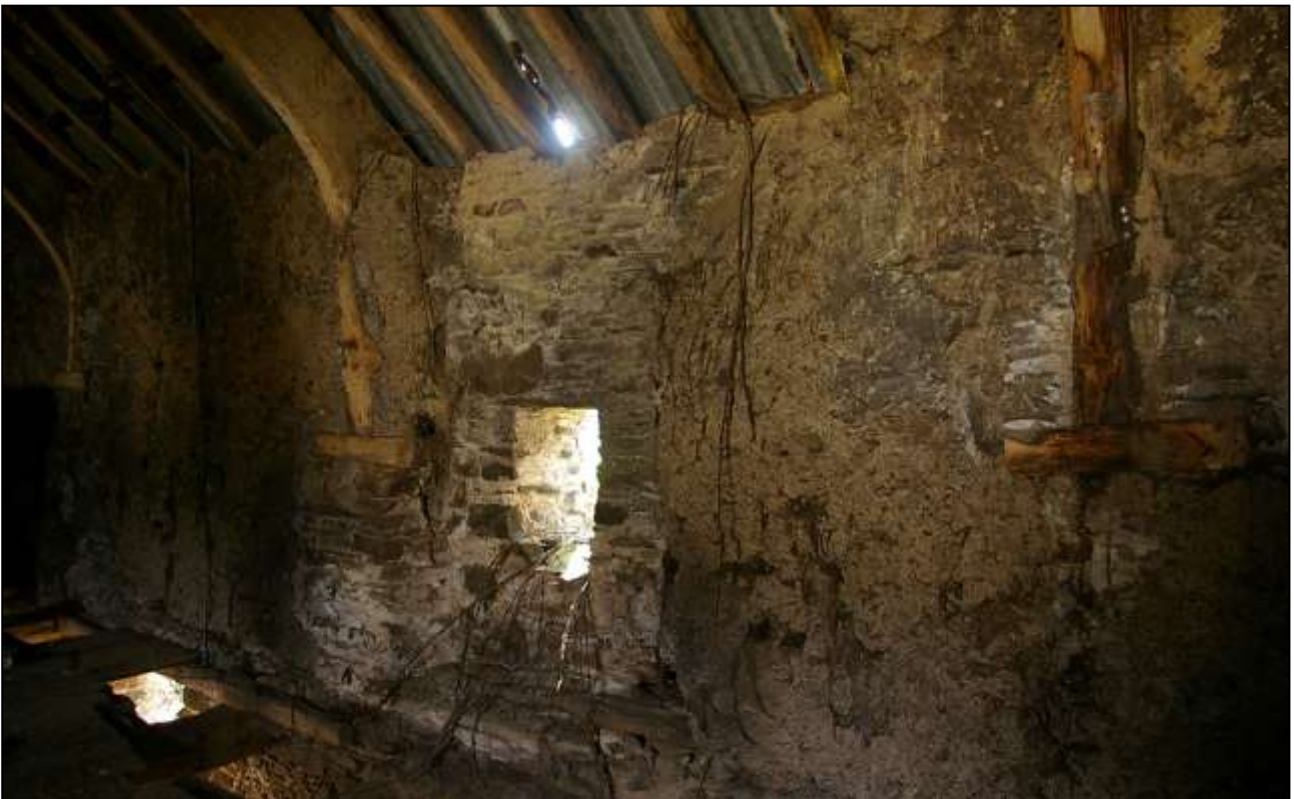
41. THE WEST WALL IN B2A WITH RAISED CRUCK FEET ON TIMBER PADS. NOTE THE BLOCKED LOADING DOOR WITH SMALL WINDOW AND MORTARED RUBBLE UNDERPINNING OF TRUSS FOOT. VIEWED FROM THE NORTH-EAST.

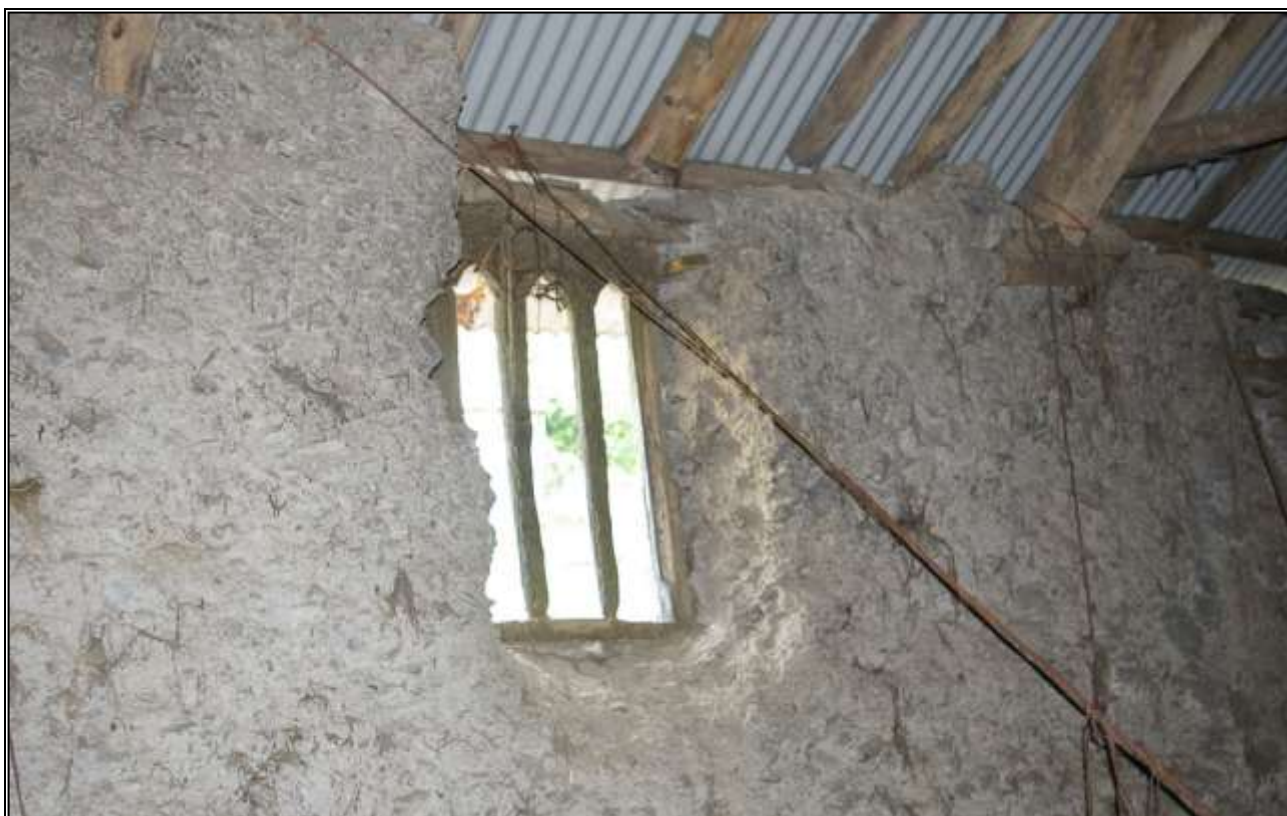
44. RESET 15TH CENTURY SMOKE-STAINED DOMESTIC WINDOW FRAME IN THE EAST WALL OF B2A; VIEWED FROM THE NORTH-WEST.

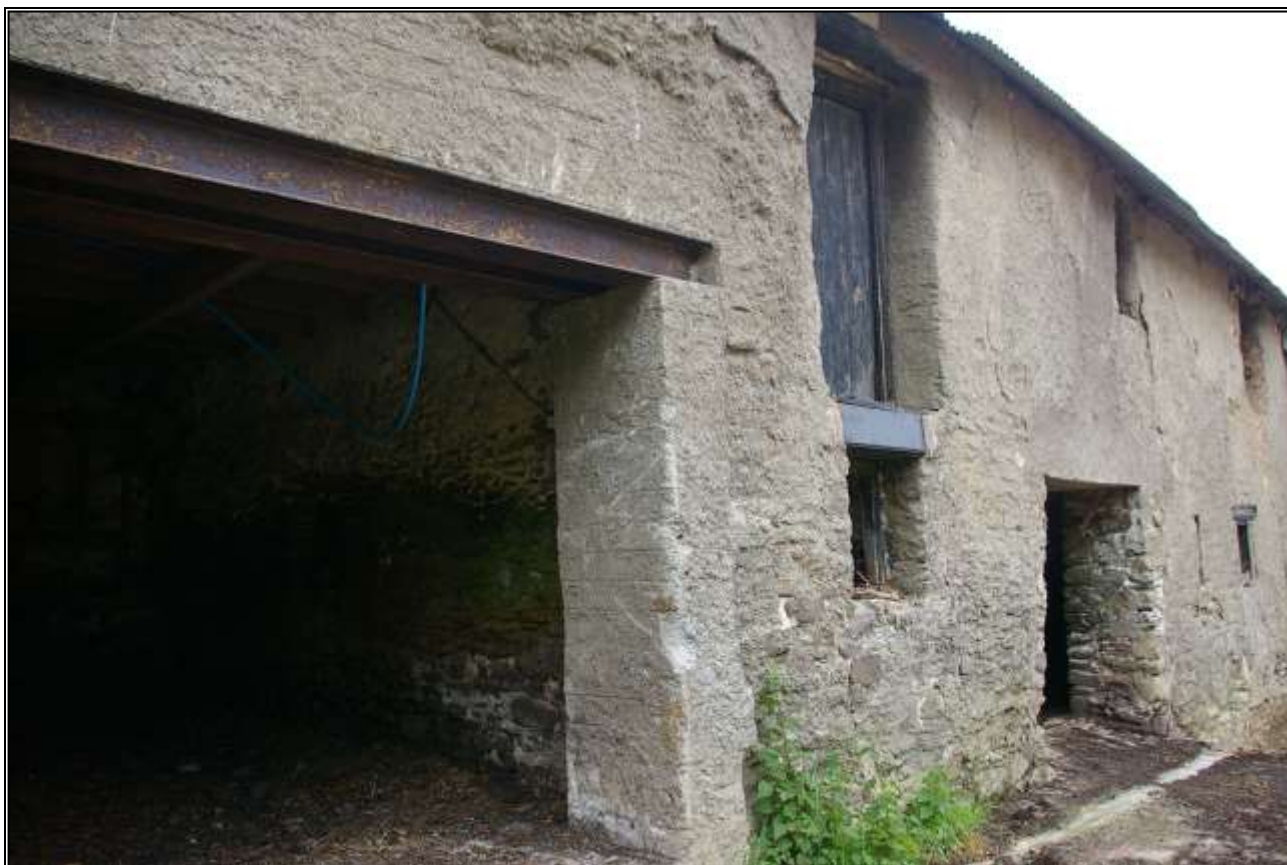
45. THE SOUTH-EAST CORNER OF B2A WITH CONCRETE JAMB OF MODERN OPENING TO B2C (CENTRE LEFT) OBSCURING THE QUOIN STONES; VIEWED FROM THE SOUTH-EAST.

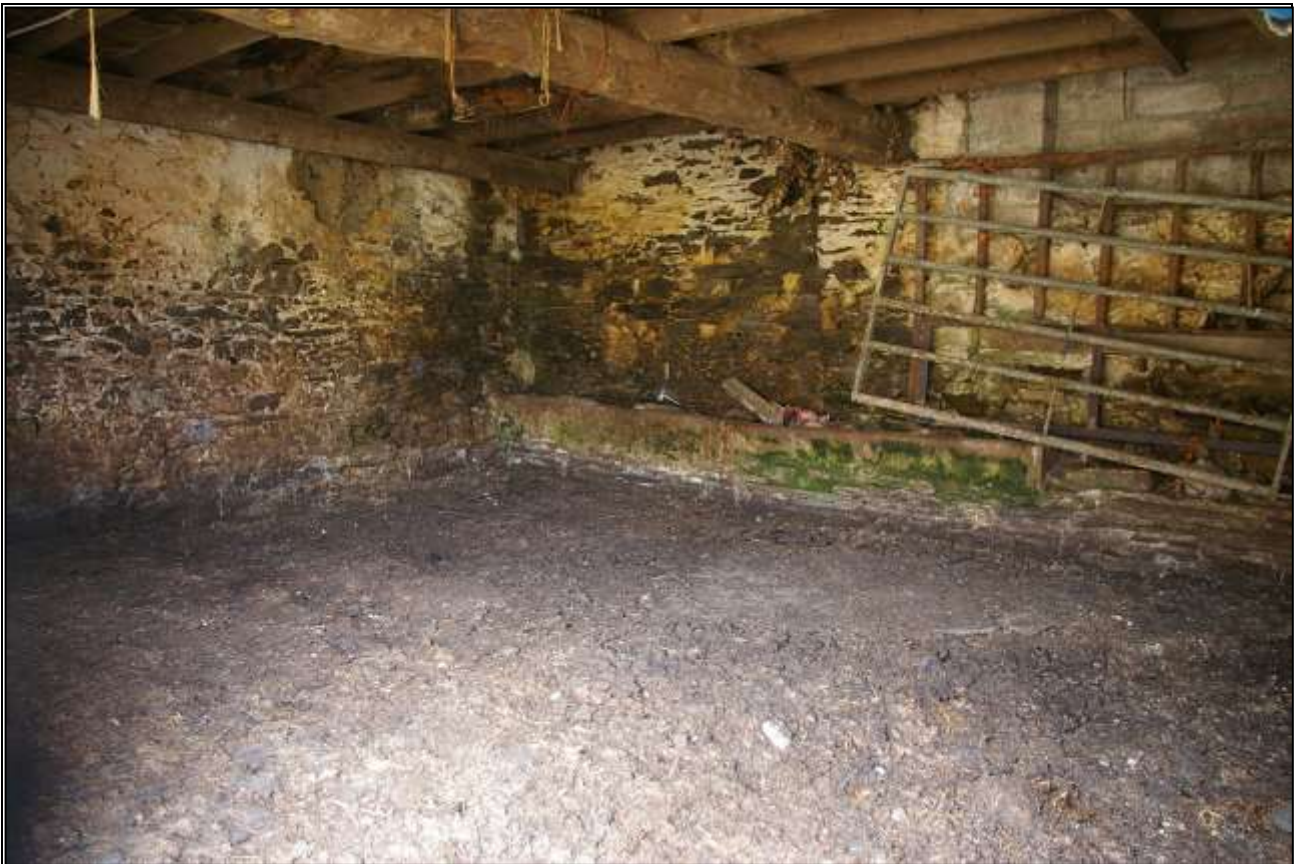
50. THE SOUTH-WEST CORNER OF B2C, WITH CONCRETE BLOCKWORK TO RIGHT REPLACING FAILED COB; VIEWED FROM THE NORTH-EAST.

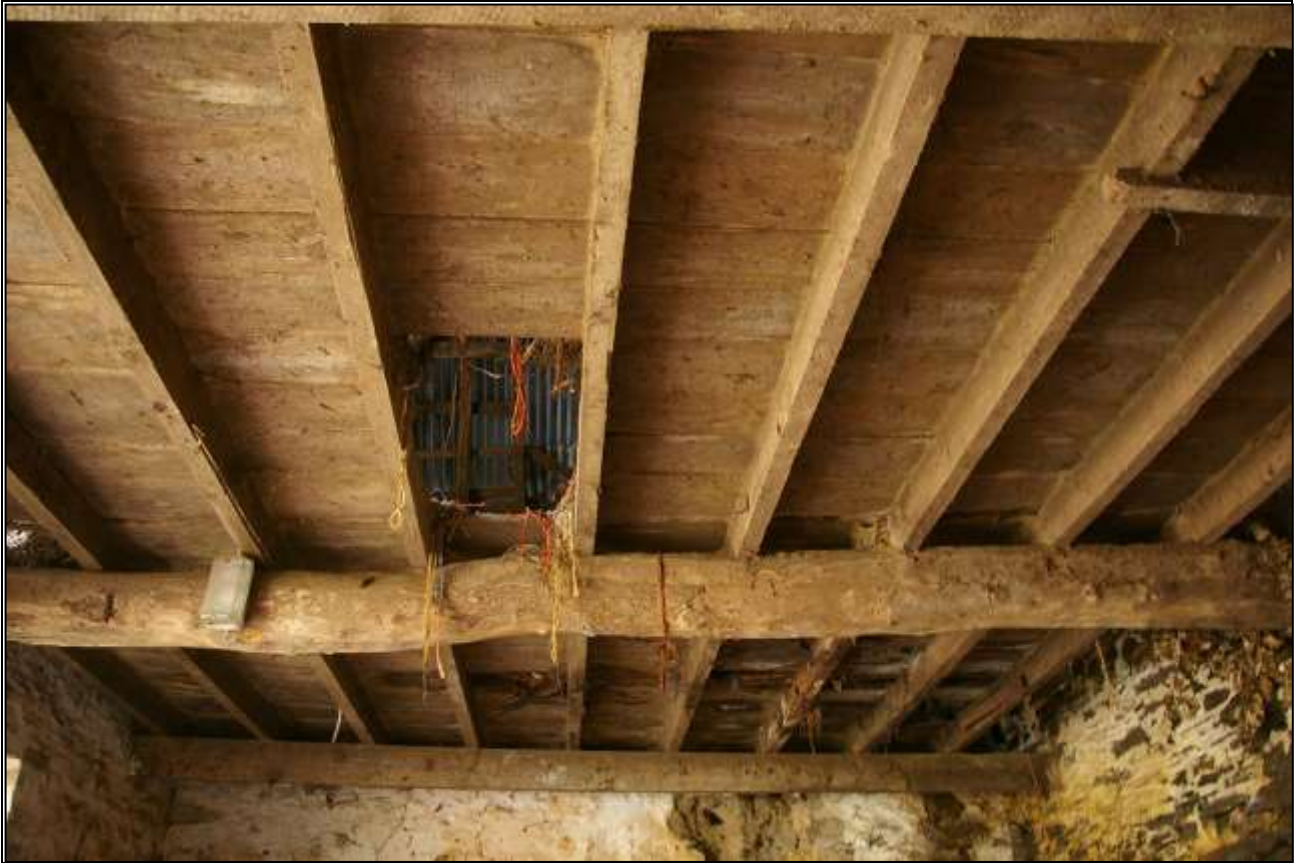
51. THE CEILING STRUCTURE IN B2C, WITH OLD BEAM TO CENTRE AND 20TH CENTURY LOFT FLOOR ABOVE; VIEWED FROM THE NORTH.

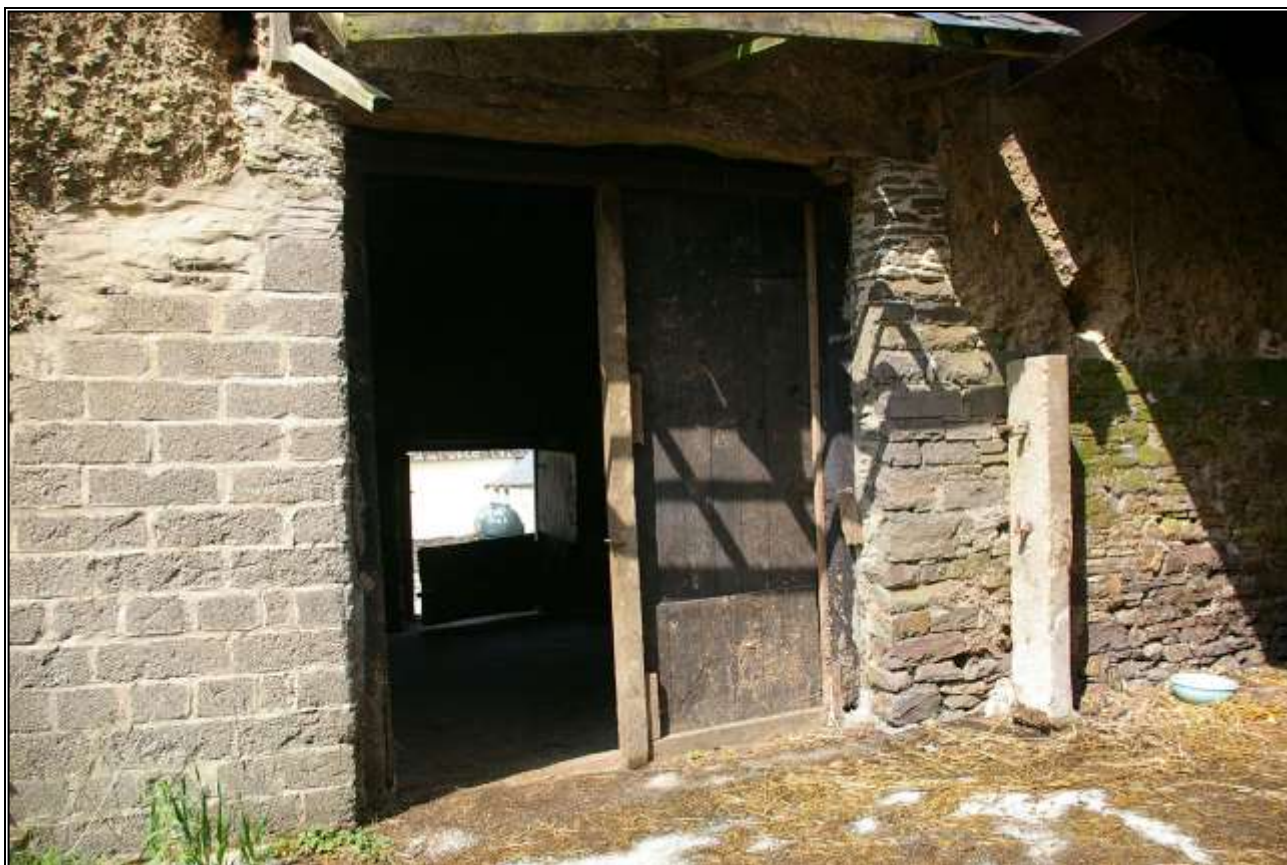
57. THE LARGE DOUBLE THRESHING DOORS IN THE SOUTH WALL OF B3A. NOTE THE LINTEL RAISED ON MORTARED RUBBLE CHEEKS IN THE 19TH CENTURY, WITH 19TH CENTURY SLATED PENTICE ABOVE. 20TH CENTURY CONCRETE GATEPOST ON RIGHT AND LARGE JAMB REPAIR TO LEFT. VIEWED FROM THE SSW.

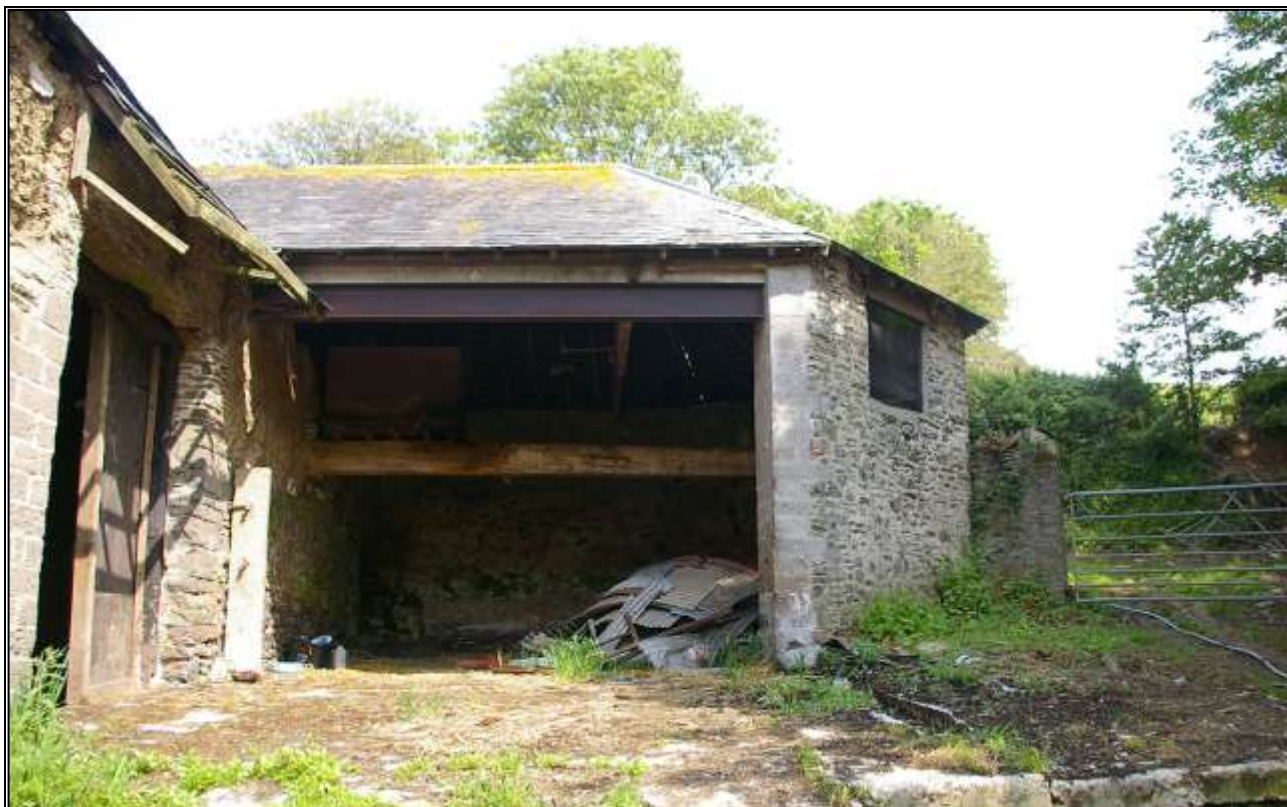
58. WEST ELEVATION OF 19TH CENTURY HORSE ENGINE HOUSE B3B, WITH LARGE 20TH CENTURY OPENING IN FORMERLY CLOSED WALL. NOTE MORTARED RUBBLE GATE PIER ABUTTING ON RIGHT, CLOSING THE SOUTH-EAST CORNER OF THE FARMYARD. VIEWED FROM THE WEST.

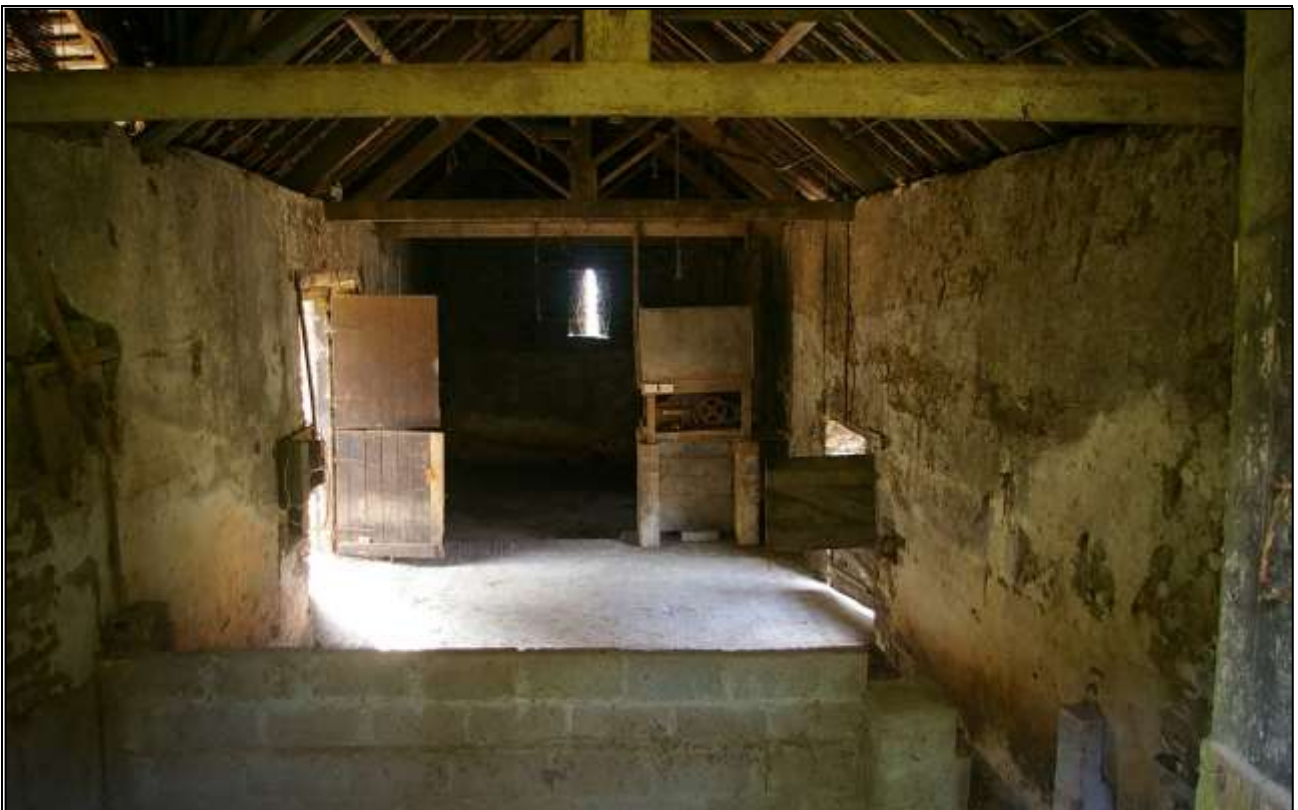
64. THE INTERIOR OF B3A, WITH PLASTERED COB AND STONE RUBBLE WALLS AND REPLACEMENT 19TH CENTURY TIE BEAM AND KINGPOST ROOF TRUSSES ABOVE. VIEWED FROM THE EAST.

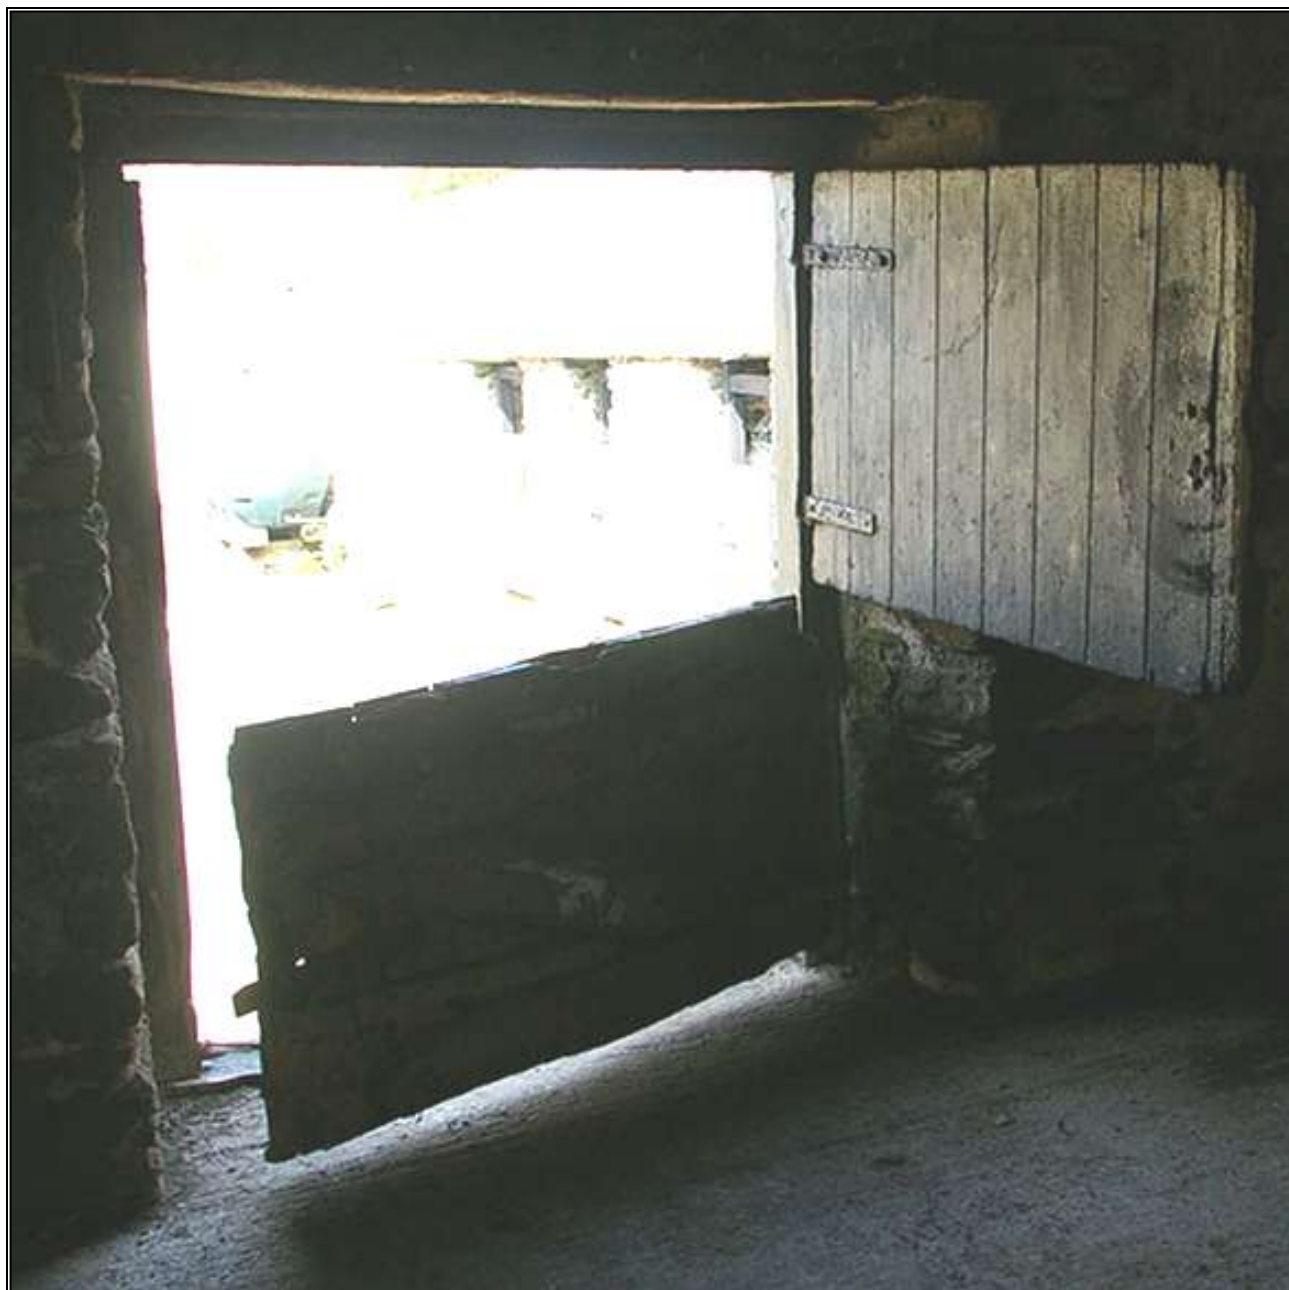
65. 19TH CENTURY DOUBLE-LEAF DOORS IN THE DRAUGHT DOORWAY ON THE NORTH SIDE OF B3A; VIEWED FROM THE SOUTH.
