CHALLICE GATE COTTAGE & HONEY COTTAGE

Historic Building Appraisal

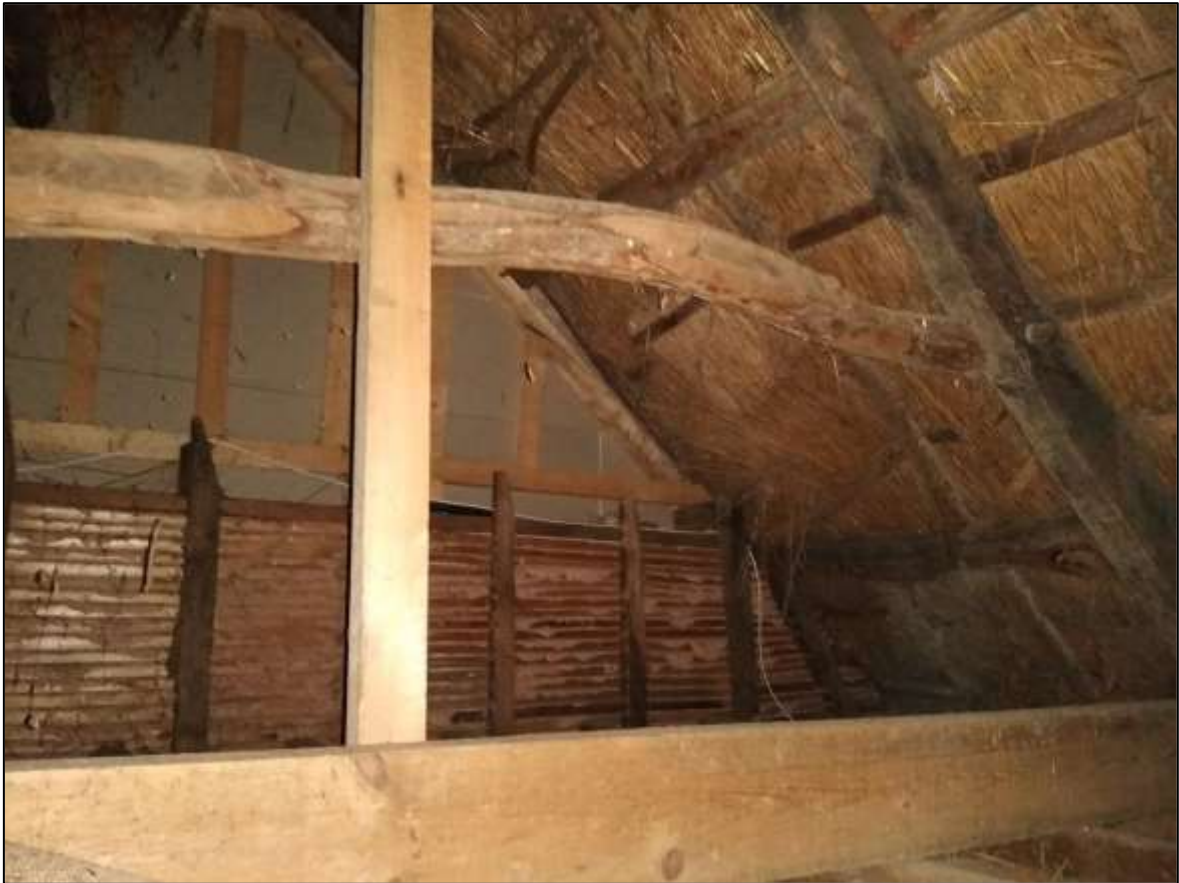
FIGURE 10: CHALLICE GATE COTTAGE: C17 ROOF TRUSS OVER R7, FROM SOUTH-EAST. NOTE SMOKE STAINED NORTH TRUSS BLADE AND CLEAN WANNEY SINGLE-PEGGED COLLAR. C19 LATH AND PLASTER PARTITION TO HONEY COTTAGE RE-USES OLDER TIMBERS, SOME SMOKE-STAINED.

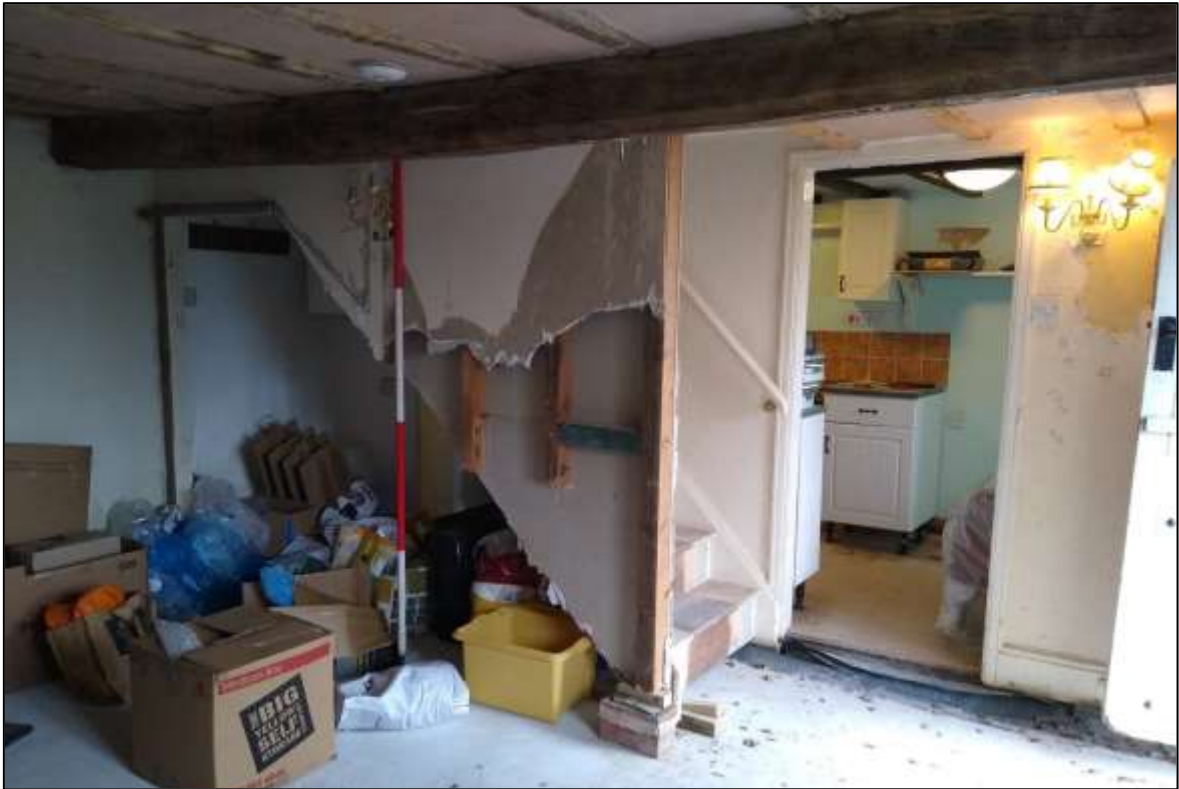
FIGURE 11: HONEY COTTAGE: GROUND FLOOR R1 & R2, LOOKING THROUGH DOORWAY TO R3; VIEW FROM SOUTH-WEST. ALL PARTITIONS ARE MODERN, IN POSITIONS OF LATER C19 ONES, BUT BEAM ABOVE IS C17. RECENT LIMECRETE FLOOR.

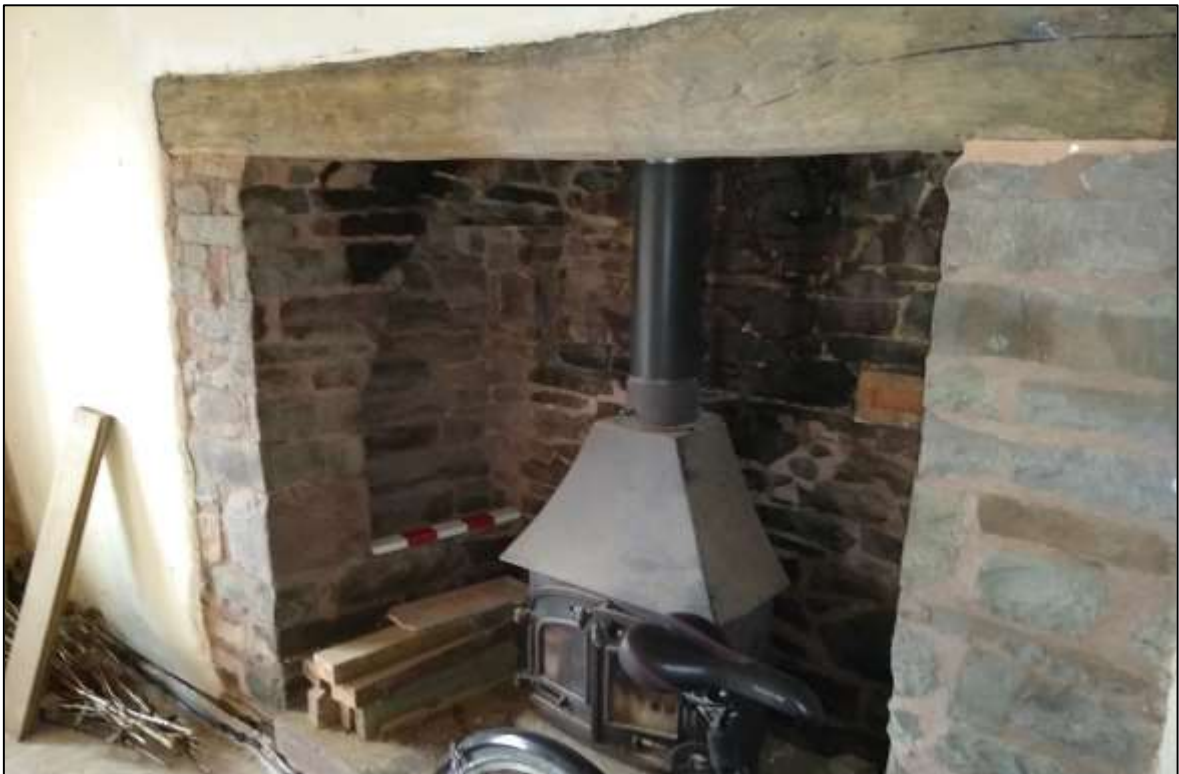
FIGURE 12: HONEY COTTAGE: C17 FIREPLACE IN GROUND FLOOR R2, FROM NORTH-EAST. 50CM SCALE BAR IS IN CORBELLED RECESS FOR C17 OVEN IN SOUTH JAMB; RECYCLED C17 CEILING BEAM REPLACED ORIGINAL LINTEL IN C19/C20.

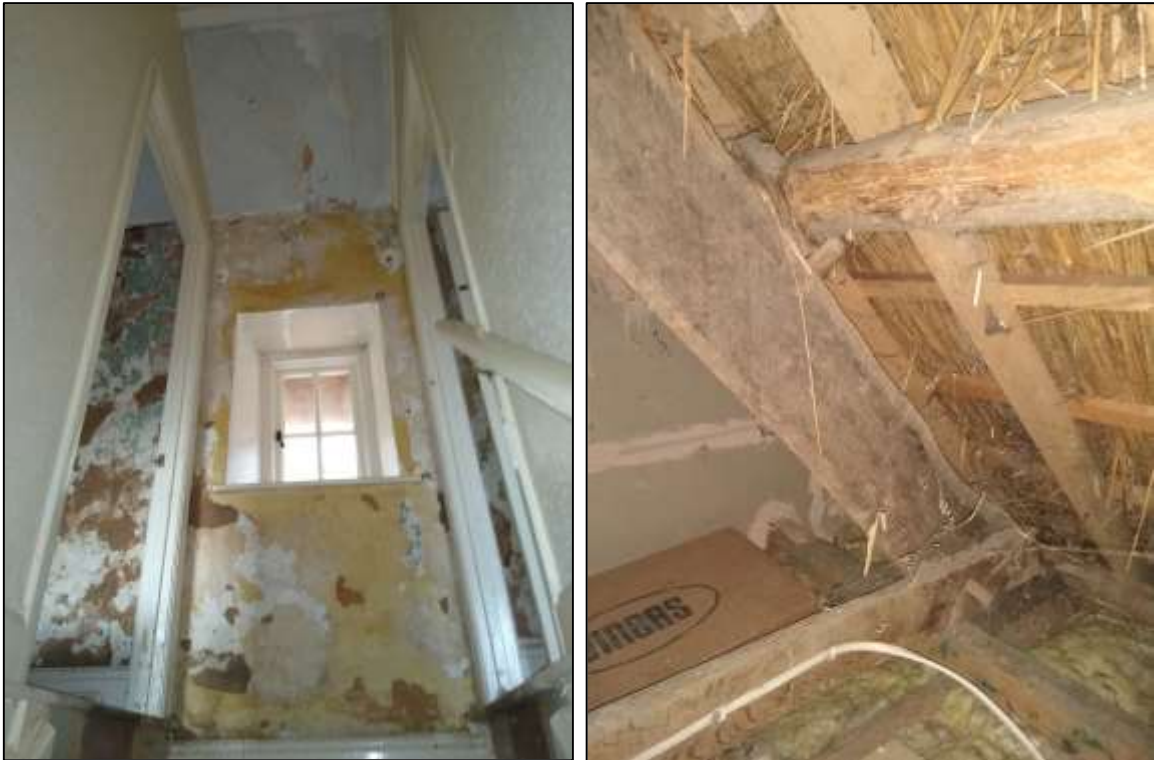
RIGHT: FIGURE 13: HONEY COTTAGE: FIRST FLOOR LANDING R4 LOOKING UP LATER C19 STAIRS FROM SOUTH WITH INSERTED WINDOW OF SAME DATE, CUTTING ACROSS TRACES OF OLDER PARTITION.

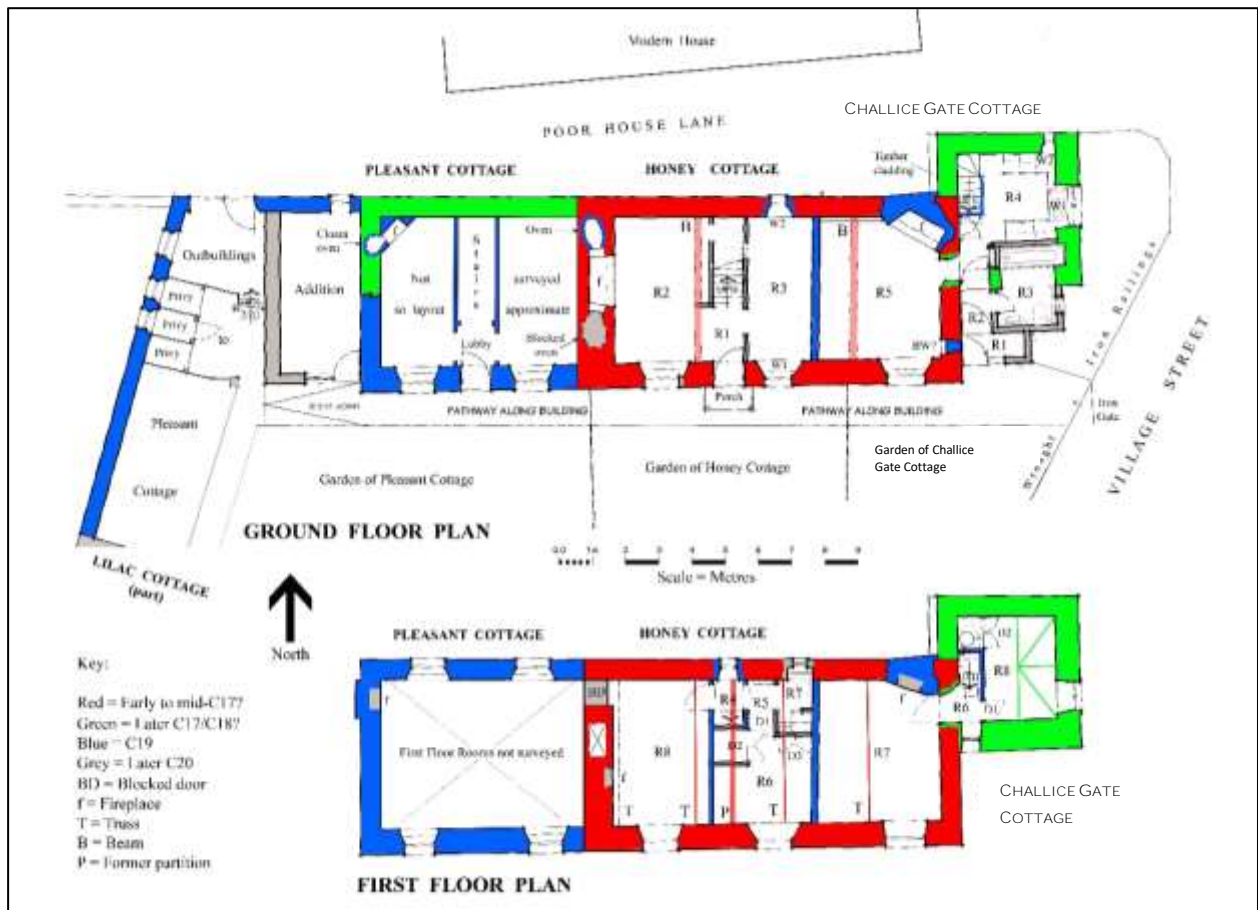
FIGURE 16: PROVISIONAL PHASED PLANS (BASED ON SUPPLIED DRAWINGS).
