## Land at Pyworthy, Holsworthy, Torrridge, Devon

### Walkover Survey

By F. Balmound MCIfA, South West Archaeology Ltd.

Issued 12.09.2020

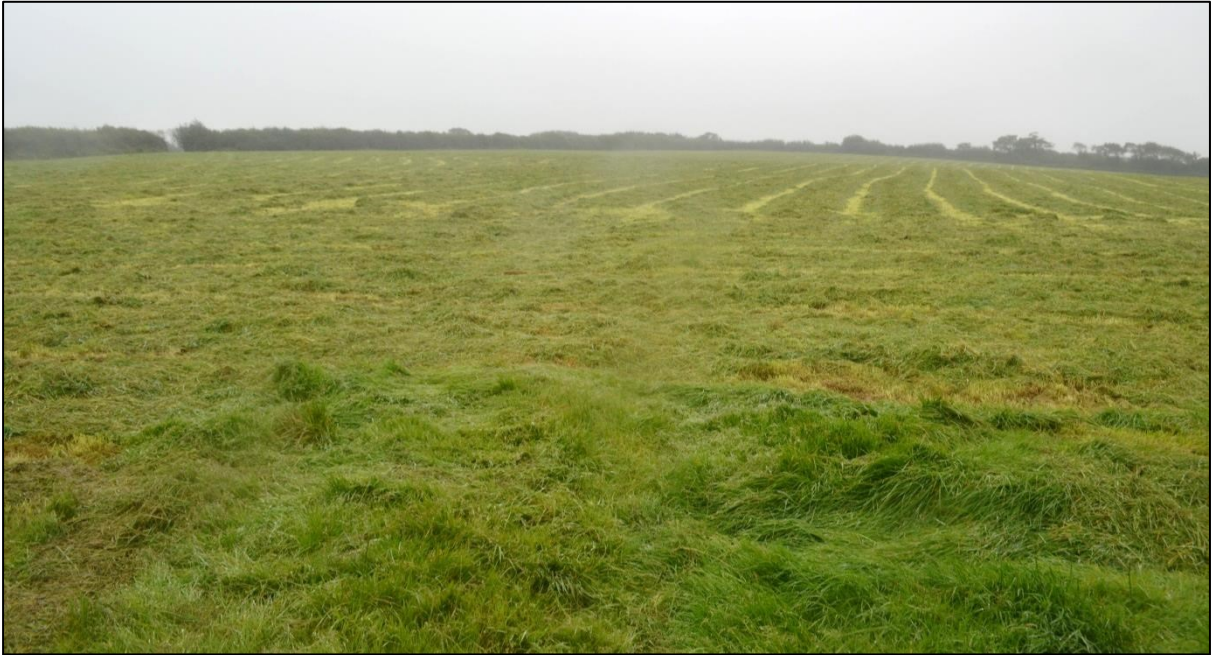
Figure 3: Field 2 cut for silage but with grass still lying on ground. A number of the fields were in this condition at the time of the survey.

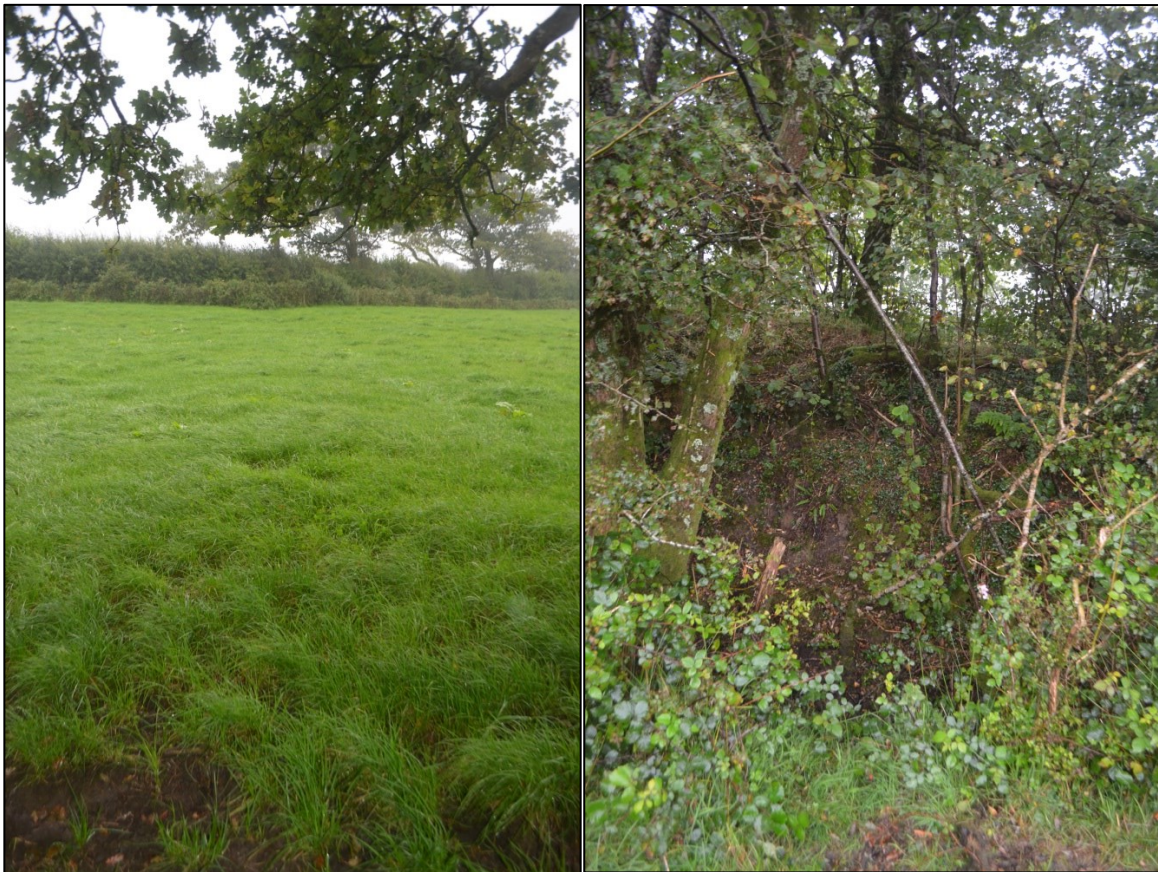
Figure 4 (Left): Slight linear feature running from northern boundary to tree in Field 3, possibly a former boundary.  
Figure 5 (Right): High boundary bank on east side marking edge of land holding between Fields 9/10 and 11/12/13.

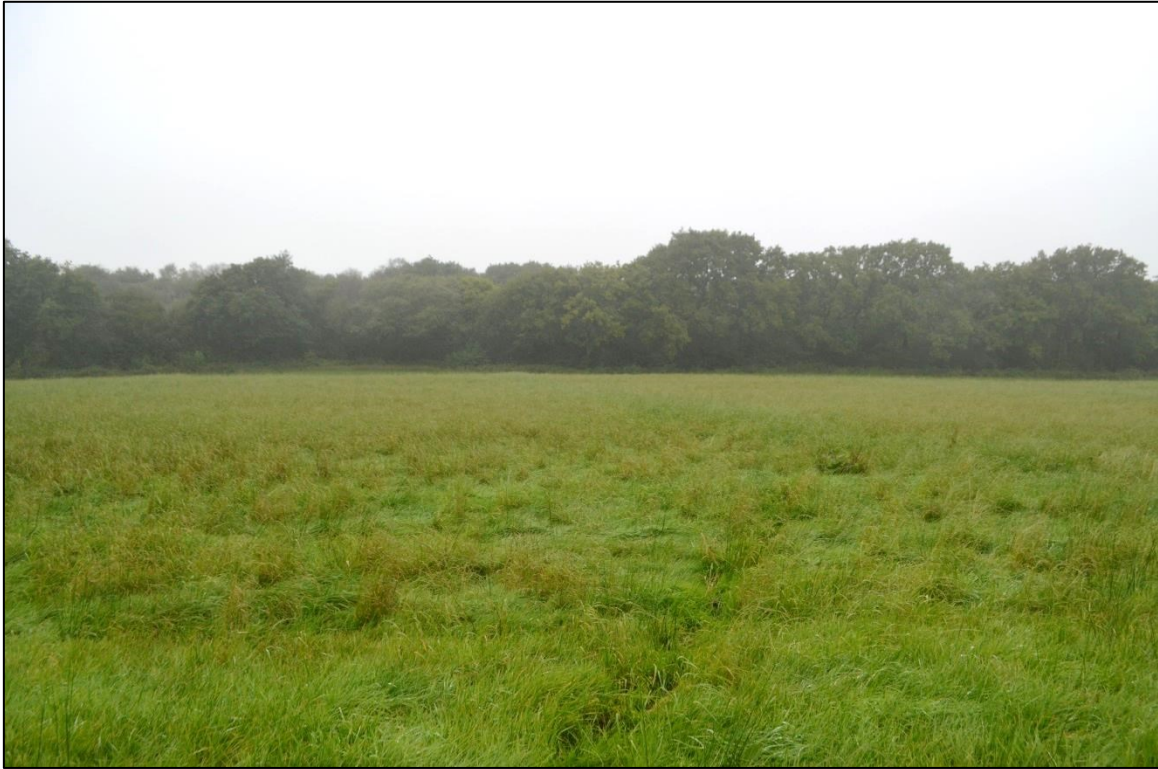
Figure 6: Possible very slight traces of former boundaries or ridge and furrow ploughing oriented NW-SE on eastern side of Field 20.

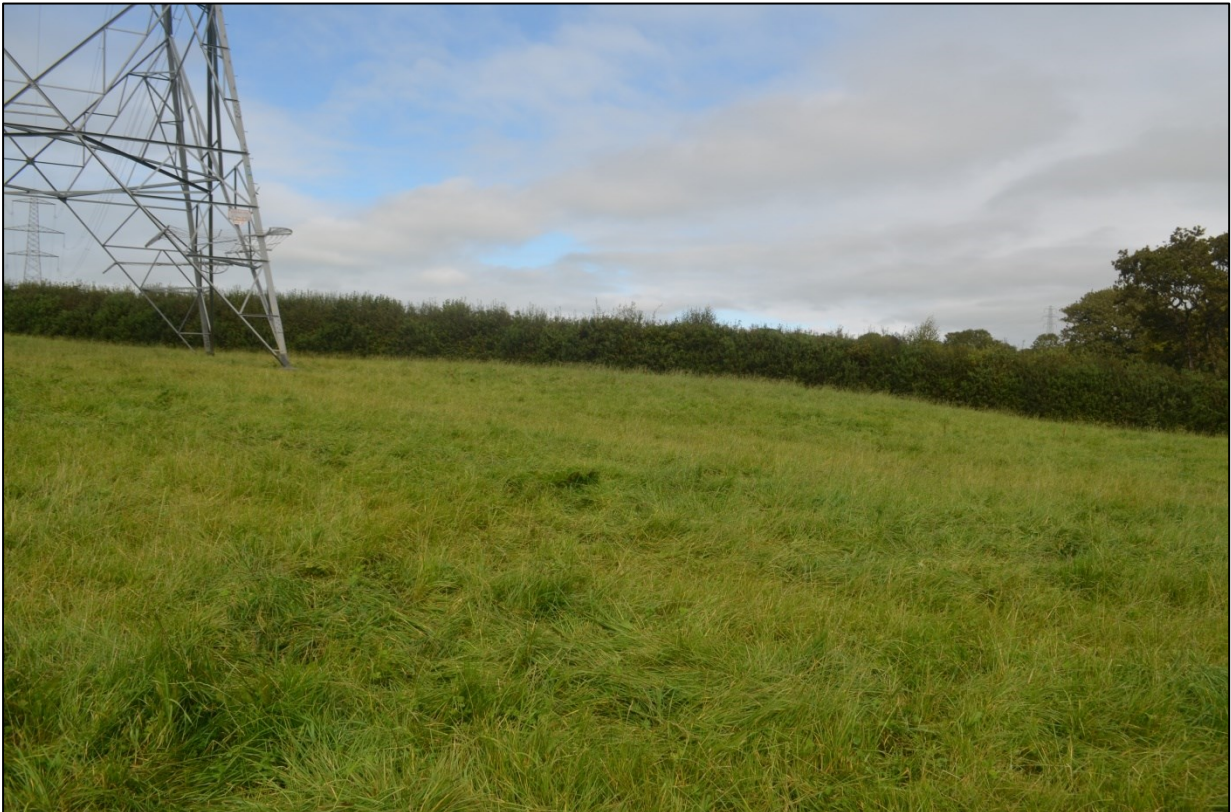
Figure 7: Slight cut platform into slope above and below electricity pylon in Field 47, probably associated with the construction of the pylon

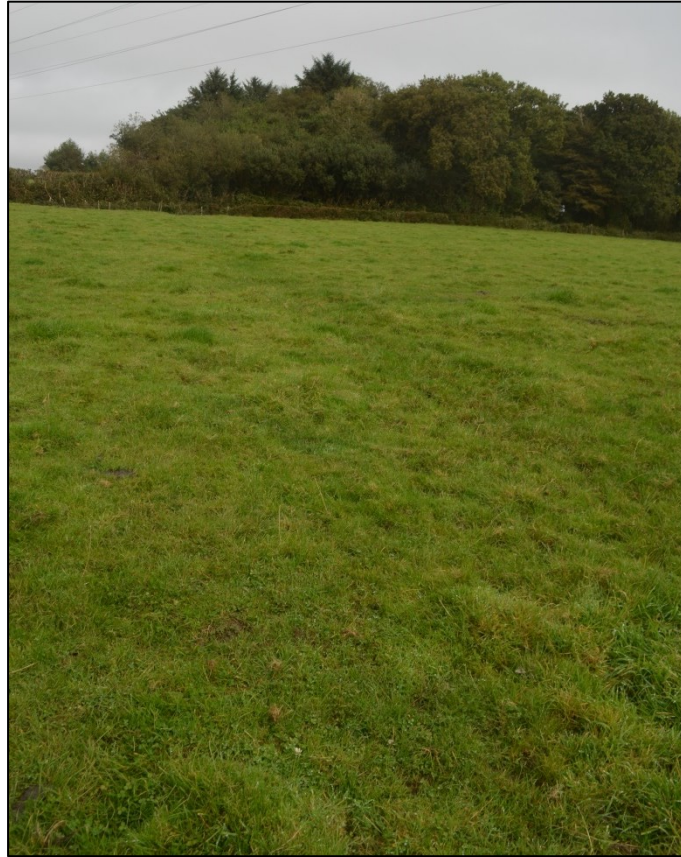
51	Long Grass	No visible features.
52	Grass	No visible features.
53	Grass	No visible features.
54	Grass	Cows in part of field. PROW passes through southern part of field. Possible slight linear E-W across central area of field - former boundary? (Figure 8)
55	Grass	Cows in field, ground trampled. No obvious visible features
56	Wood	Wet wooded area surrounded by boundary banks. No visible features.
57	Long Grass	No visible features. Gateway with 58 constructed of reused concrete block quoins. (Figure 9)
58	Long Grass and Reeds	Boggy in places. No visible features.
59	Grass	Cows in field. No visible features. Stone quoined gateway entrance.
60	Grass	Cows recently moved out of field, ground slightly trampled. No visible features. Stone quoined gateway. (Figure 10)
61	Grass	Cows in field, ground trampled. No obvious visible features.
62	Very Long Grass	No visible features. No trace of boundary across field shown on OS

Figure 8: Slight linear E-W across central area of Field 54, a possible former boundary

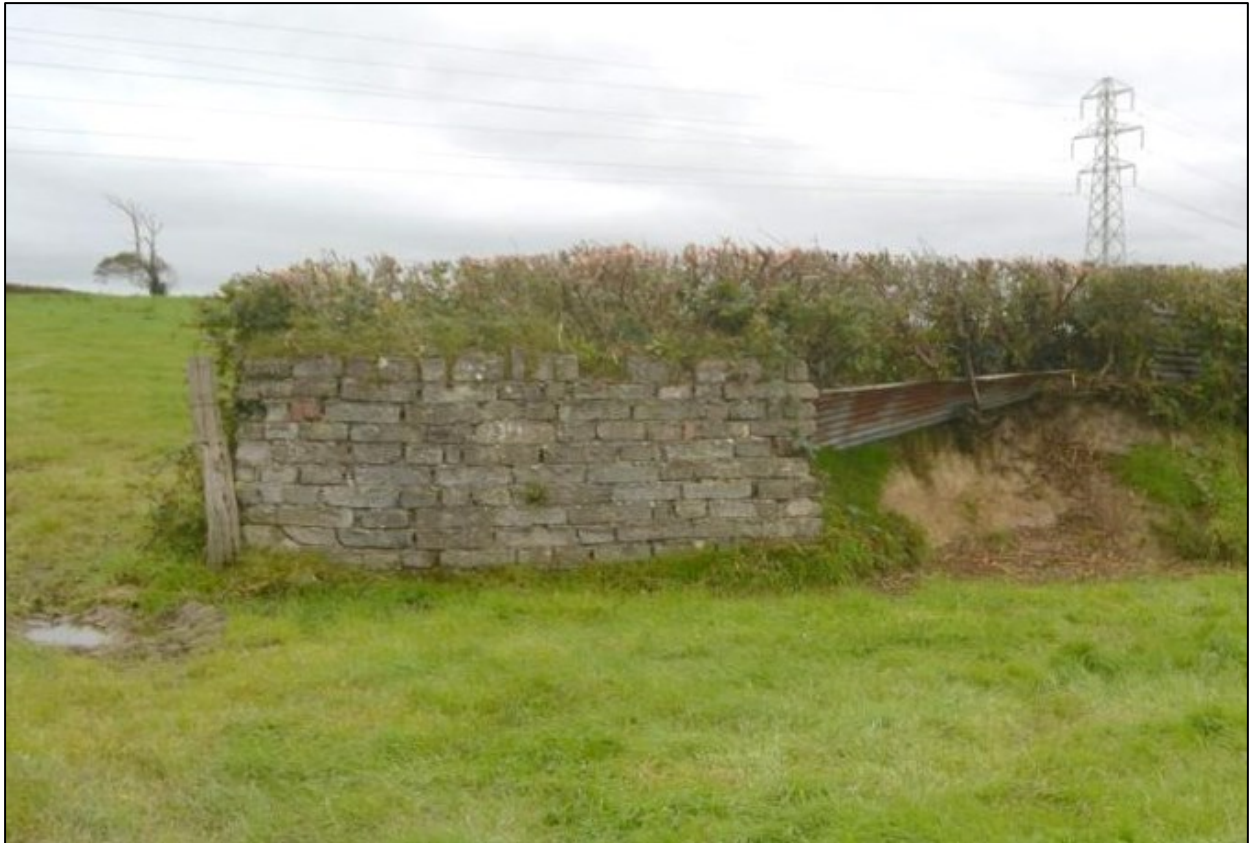
Figure 9: Gateway between Fields 57 and 58 constructed of reused concrete block quoins.

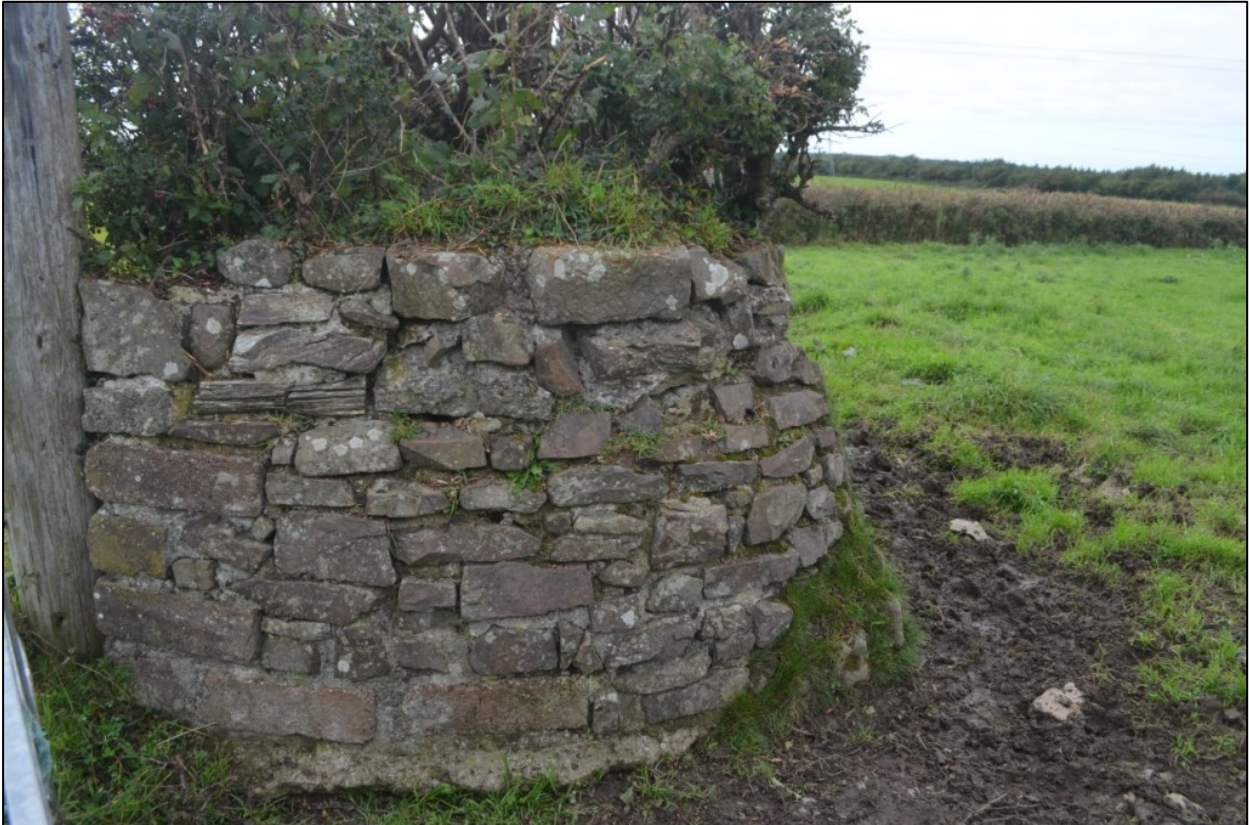
Figure 10: Stone quoin gateway at entrance to Field 59.

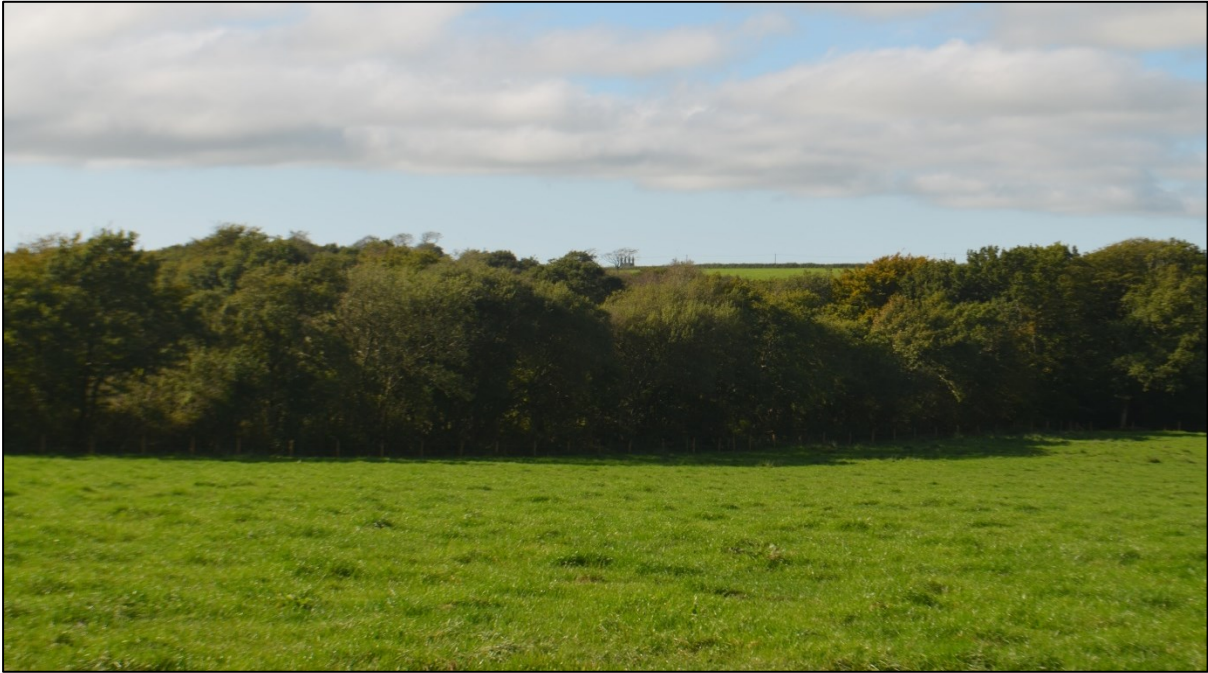
Figure 11: View from north west of site (Field 9) to Bridgerule. The top of the Grade I listed church tower is just visible in the centre of the image.

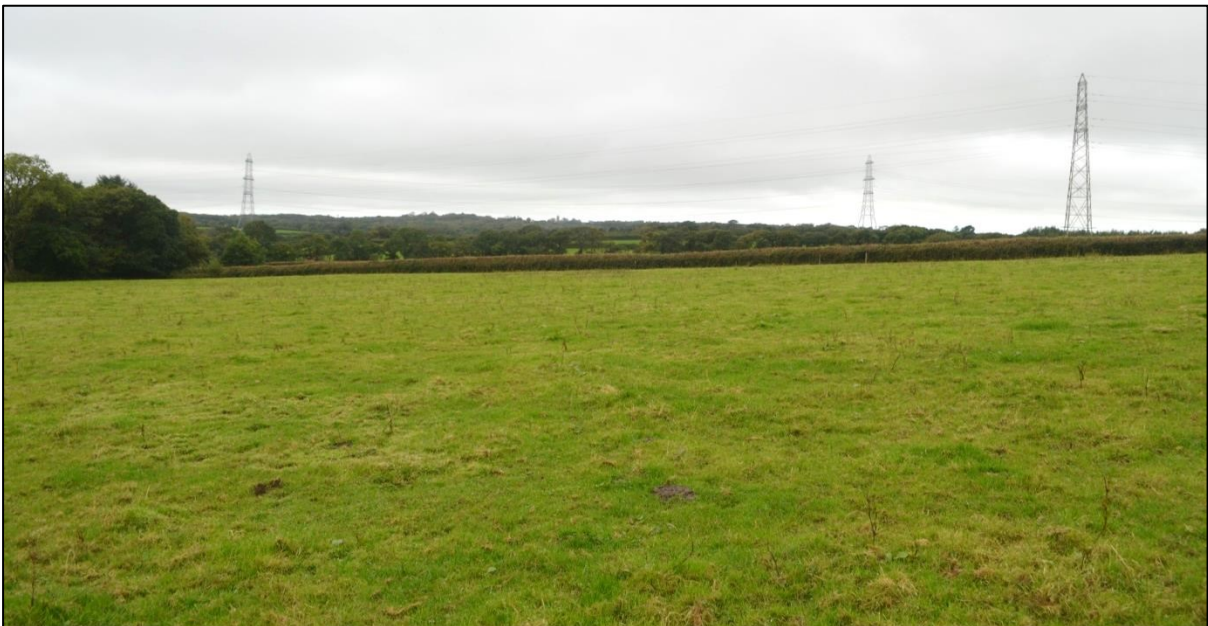
Figure 12: View towards Bridgerule from the north east of the proposed site (Field 60). The Grade I listed church is visible in the centre of the image.

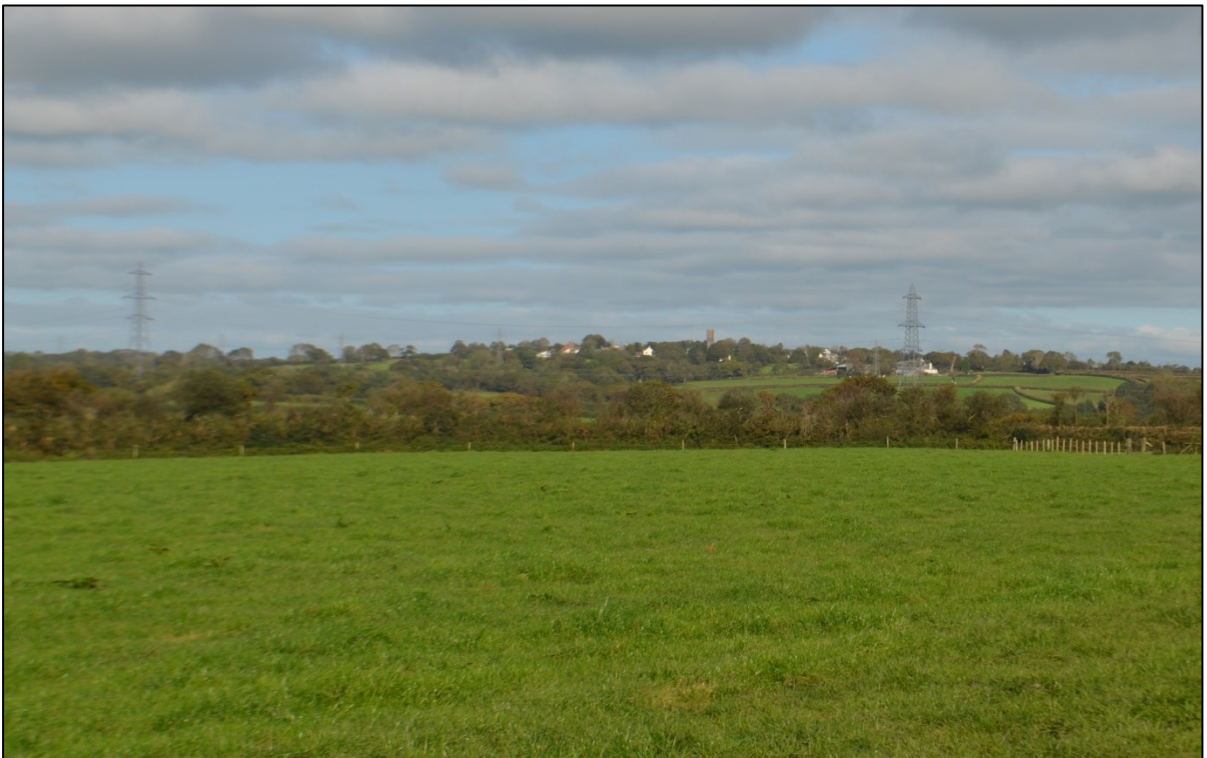
Figure 14: View from the north west of the proposed site (Field 9) towards Pyworthy. The church tower is visible in the centre-right of the image.

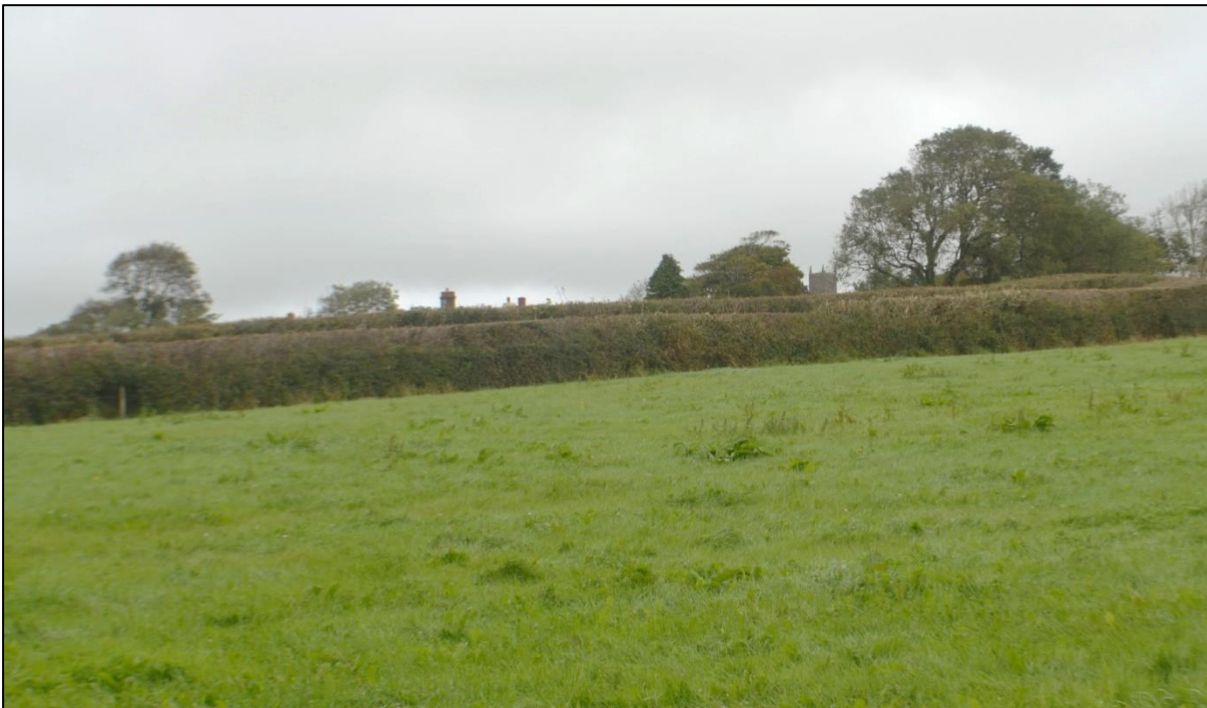
Figure 16: View from the eastern area of the proposed site (Field 62) towards Pyworthy. The Church tower is visible on the right side of the image.
