CHURCH VIEW TUCKINGMILL CAMBORNE CORNWALL

Historic Building Recording & Archaeological Evaluation Trenching

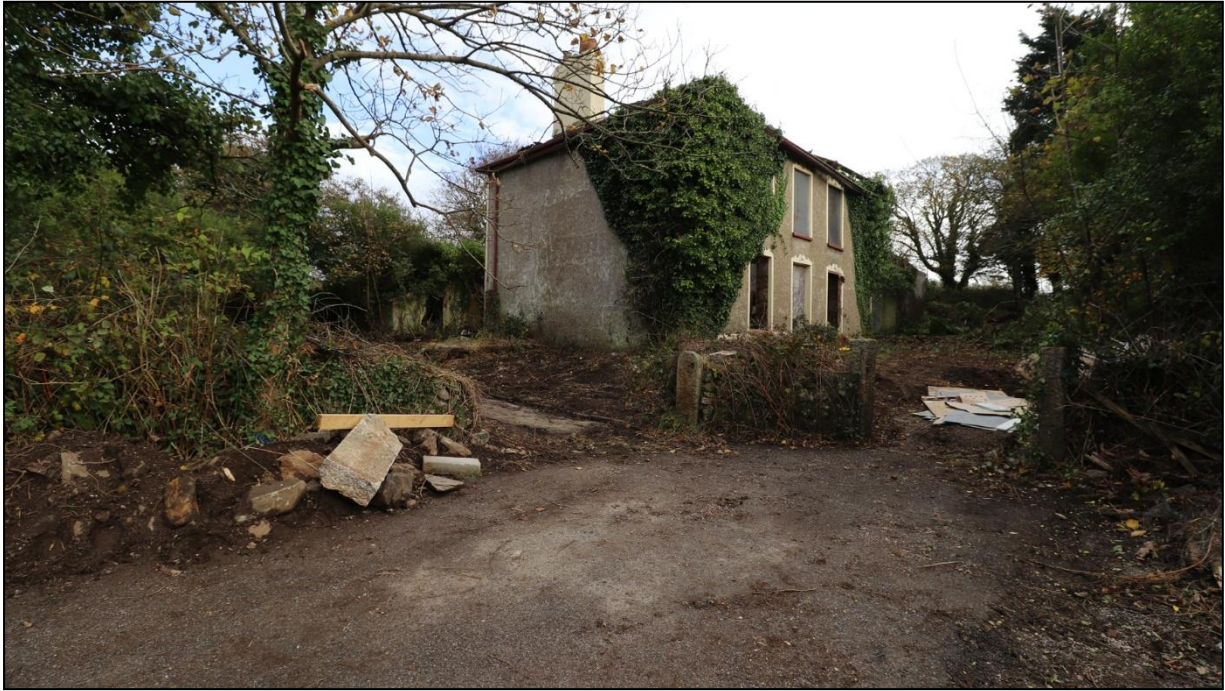
FIGURE 3: THE HOUSE, FROM THE DRIVE TO NORTH-WEST.

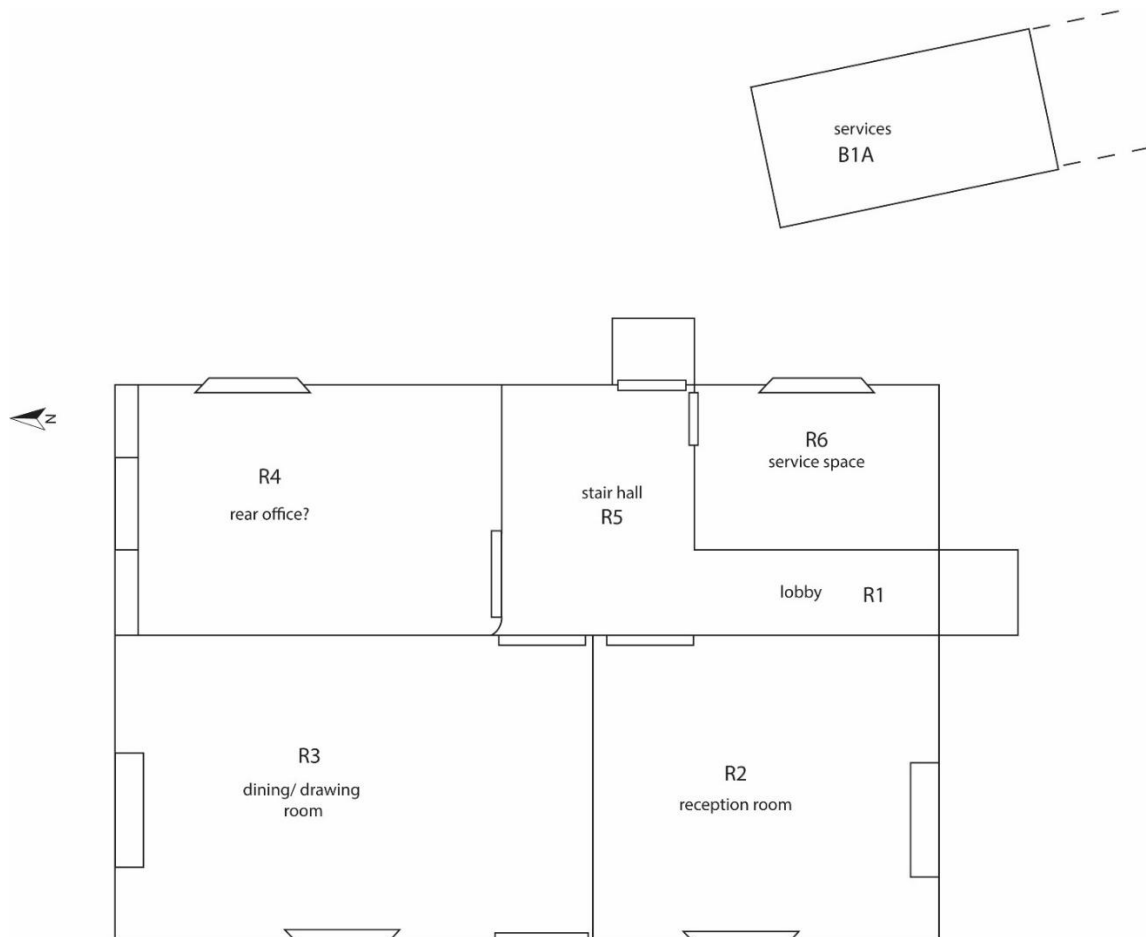
FIGURE 7: SCHEMATIC SHOWING THE BUILDING AS IT CURRENTLY STANDS – CURRENT PLANS PROVIDED BY AGENT WERE INCORRECT.

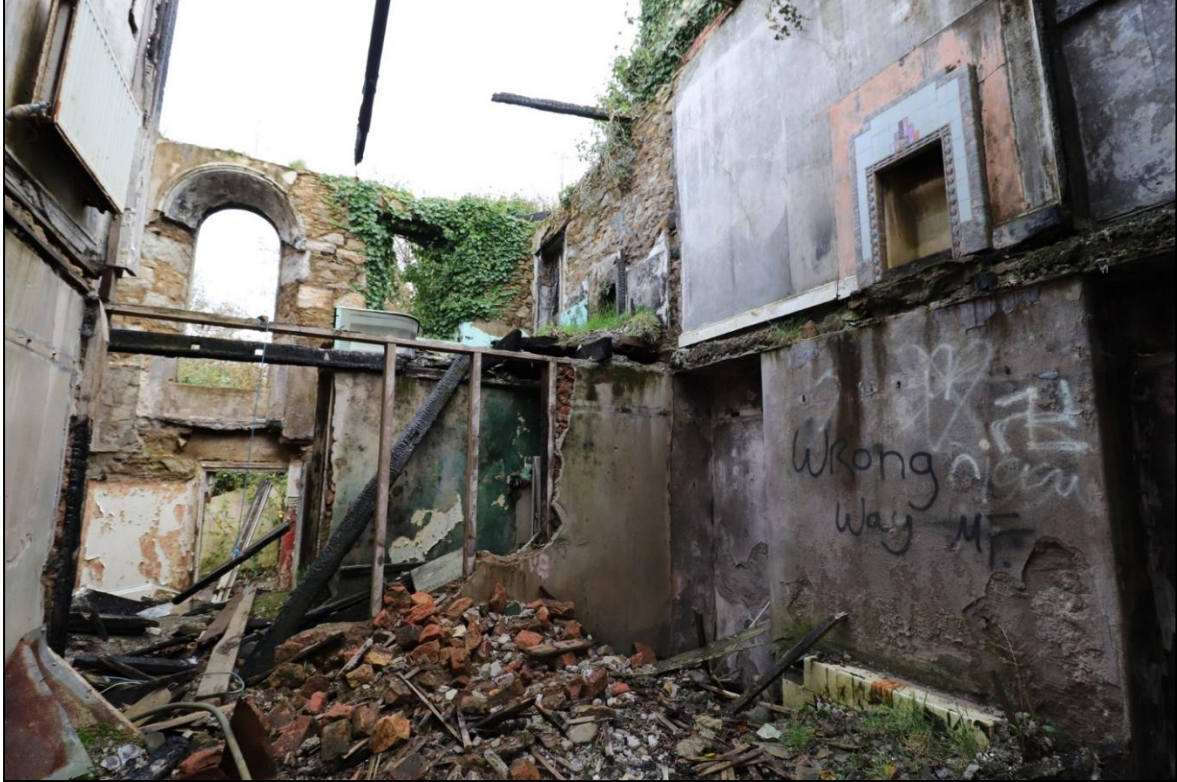
FIGURE 8: R2 RECEPTION ROOM, FROM THE EAST, WITH WIDE-ANGLED LENS.

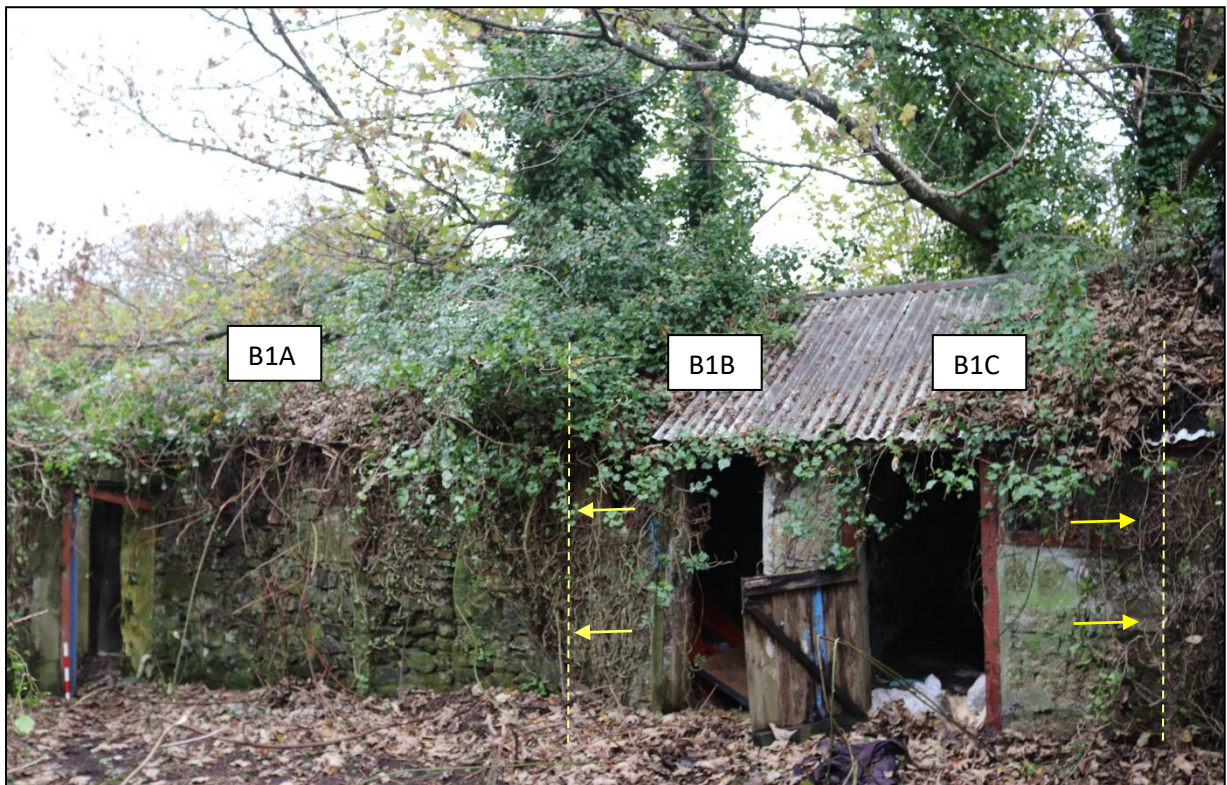
FIGURE 13: B1, LOOKING AT SOUTH-WEST FACING ELEVATION, FROM THE SOUTH-WEST WITH 0.5M SCALE.

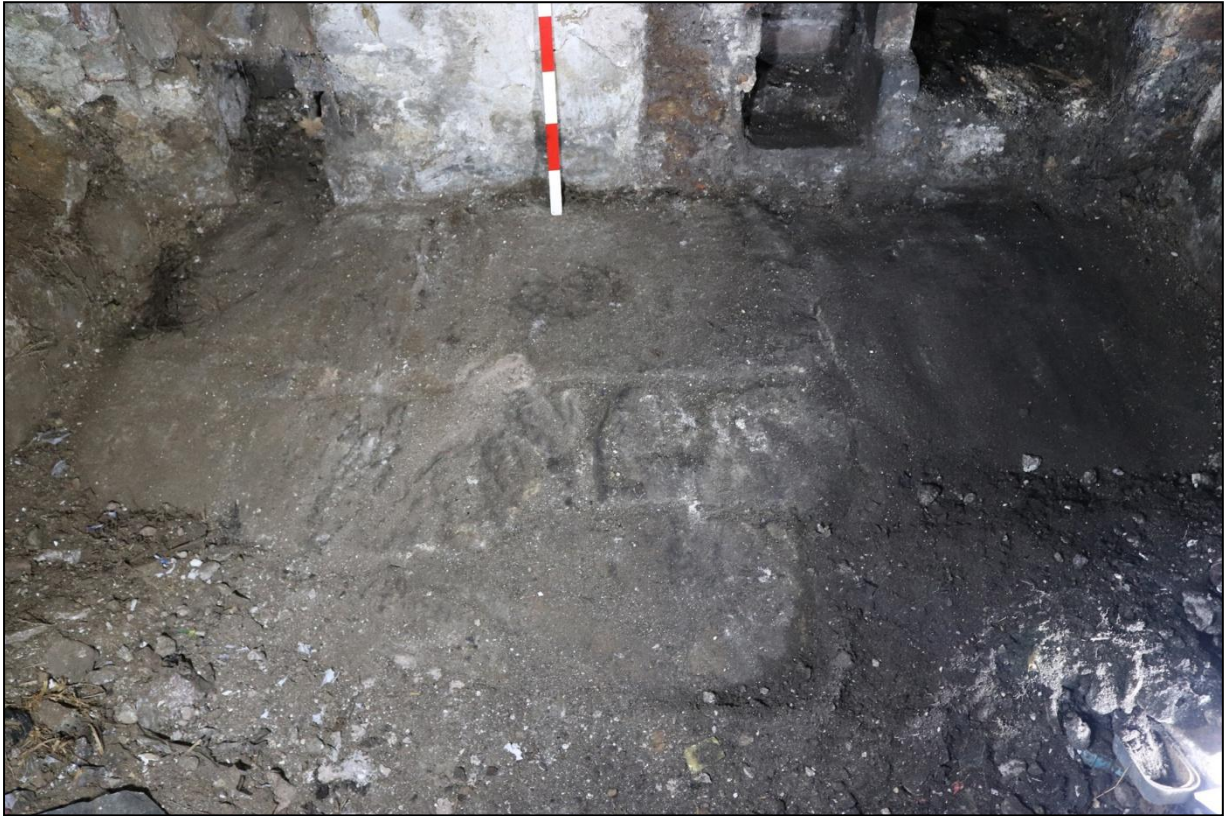
FIGURE 16: THE EXTENT OF THE RUSTIC GRANITE PAVERS WHICH COULD BE UNCOVERED. IT WAS UNCLEAR IF THEY EXTENDED THROUGHOUT THE SPACE. FROM THE NORTH WITH 0.5M SCALE.

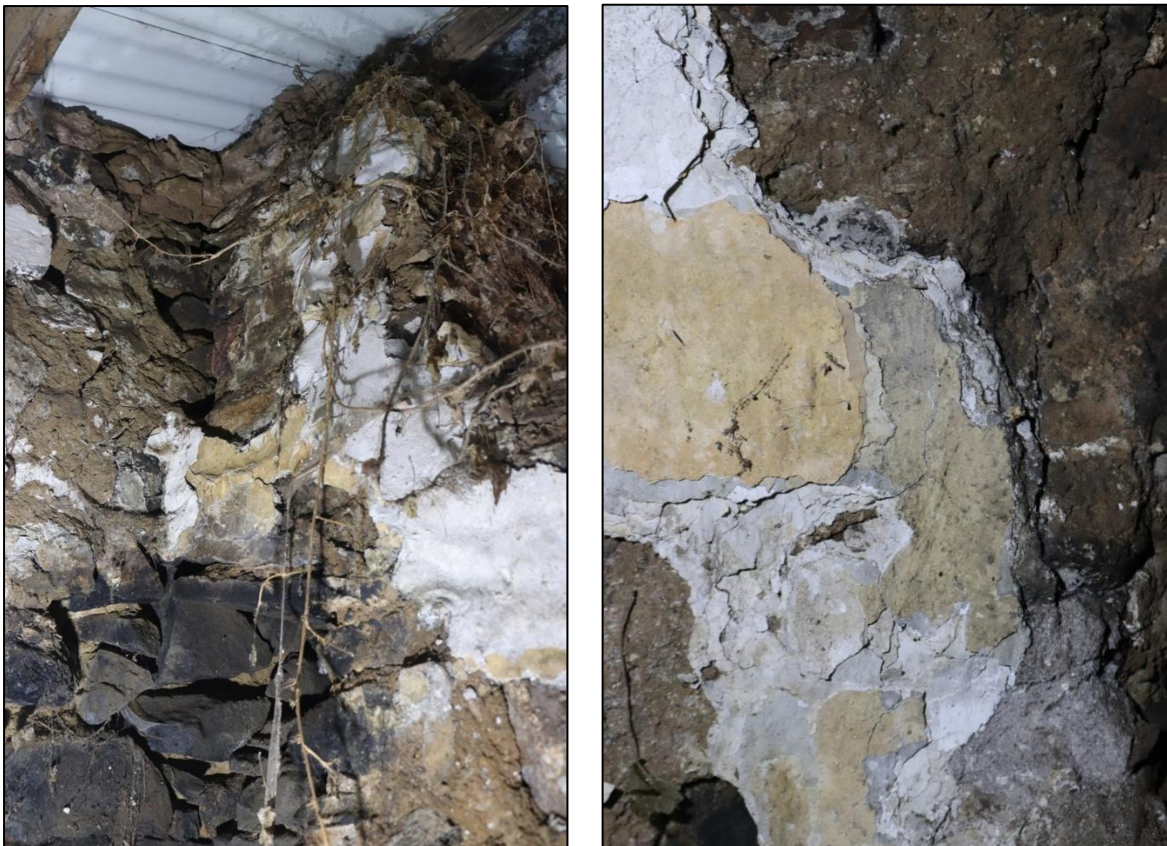
FIGURE 17: LEFT – STACK ADDED AGAINST THE SOUTHERN ELEVATION, VERY POORLY TIED. RIGHT- LAYERS OF LIMEWASH OVER EARTH PLASTER, WHICH INDICATES MORE VERNACULAR ORIGINS AND THE VALUE OF MAINTENANCE EVEN TO A SECONDARY SPACE.

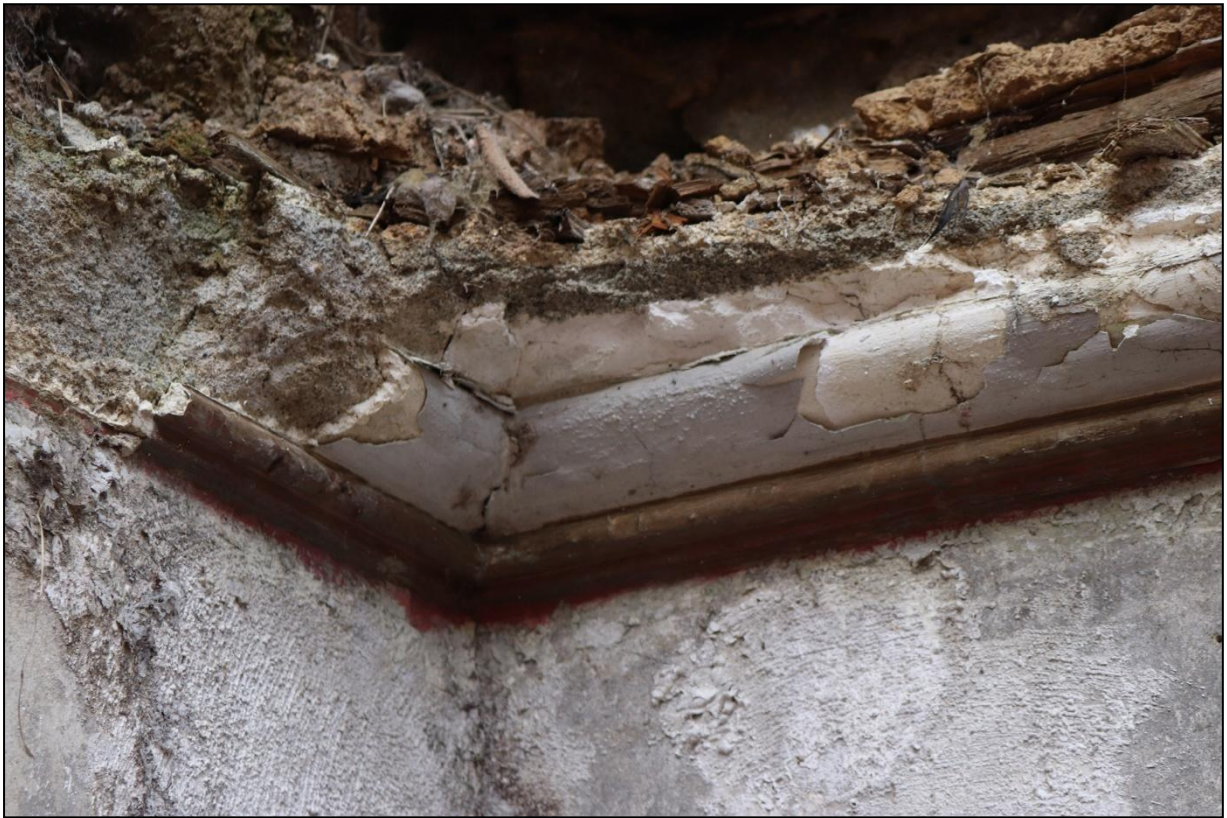
FIGURE 31: DETAIL OF CORNICE FOUND TO R3 INCLUDING EARLIER PAINT SCHEMES OVER A REFINED LIME PLASTER.

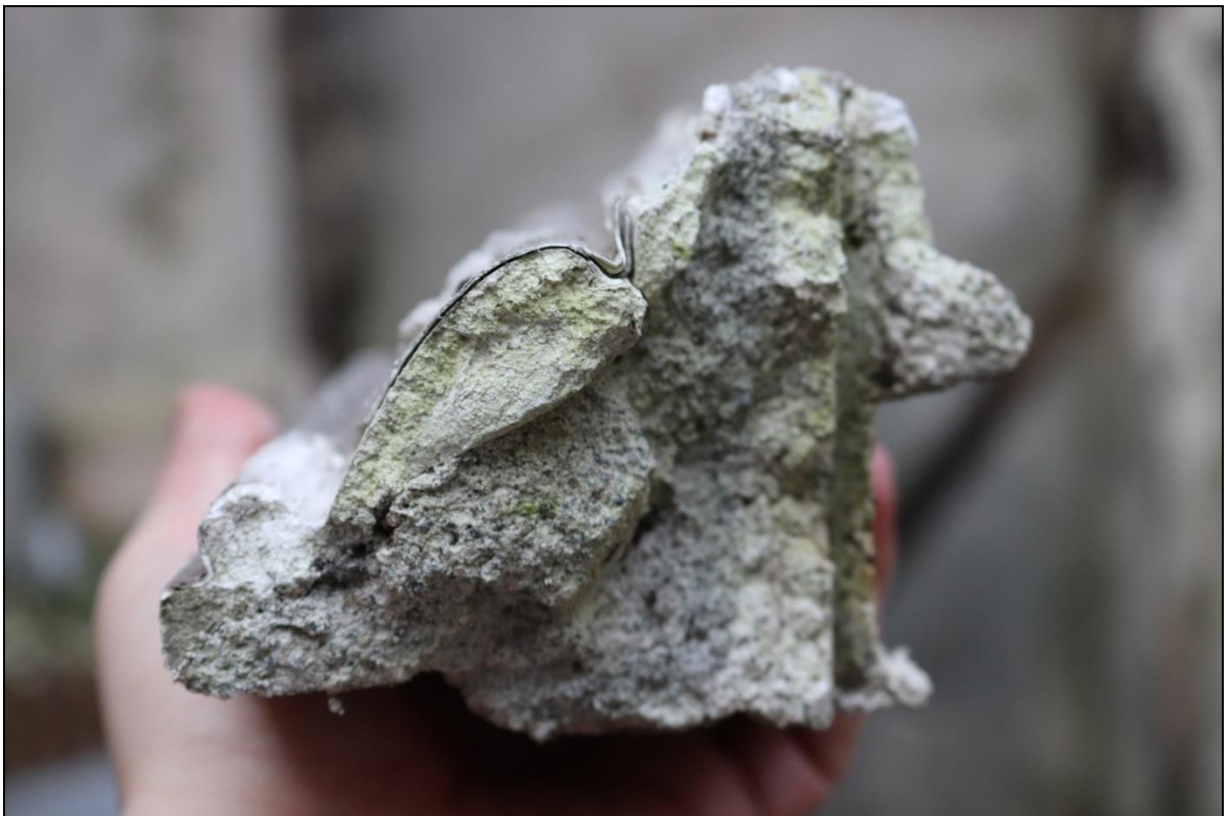
FIGURE 32: CORNICE IN PROFILE.

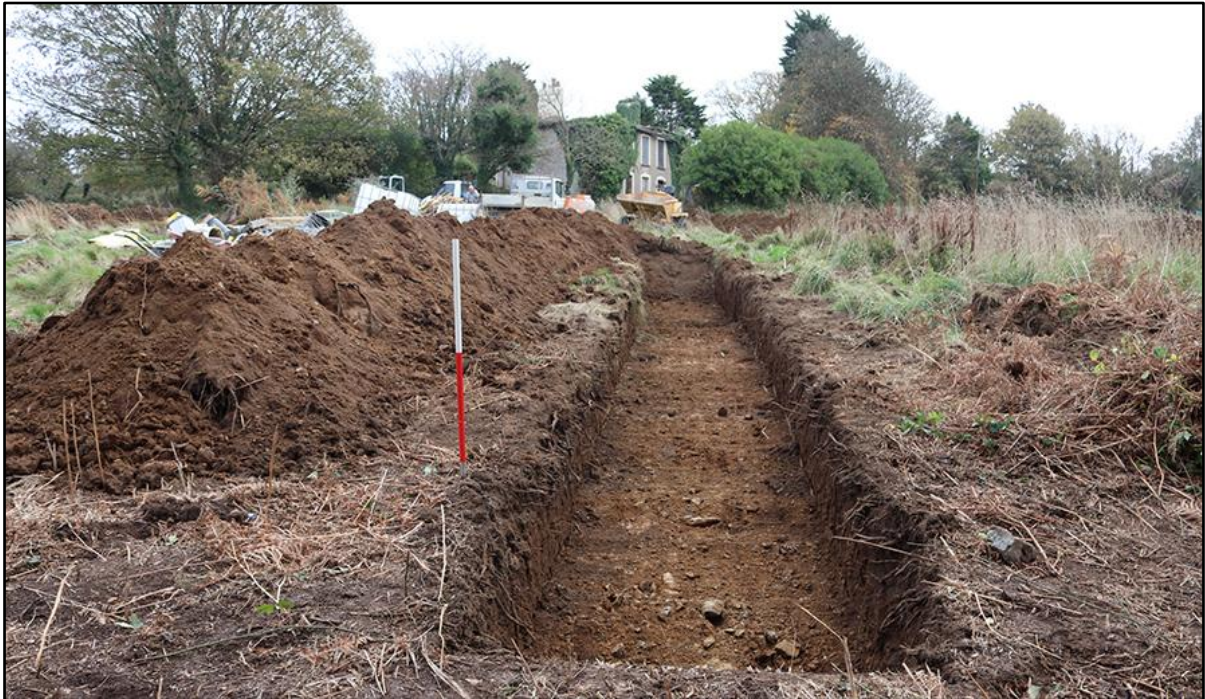
FIGURE 39: TRENCH 2 FROM NW (1M SCALE)

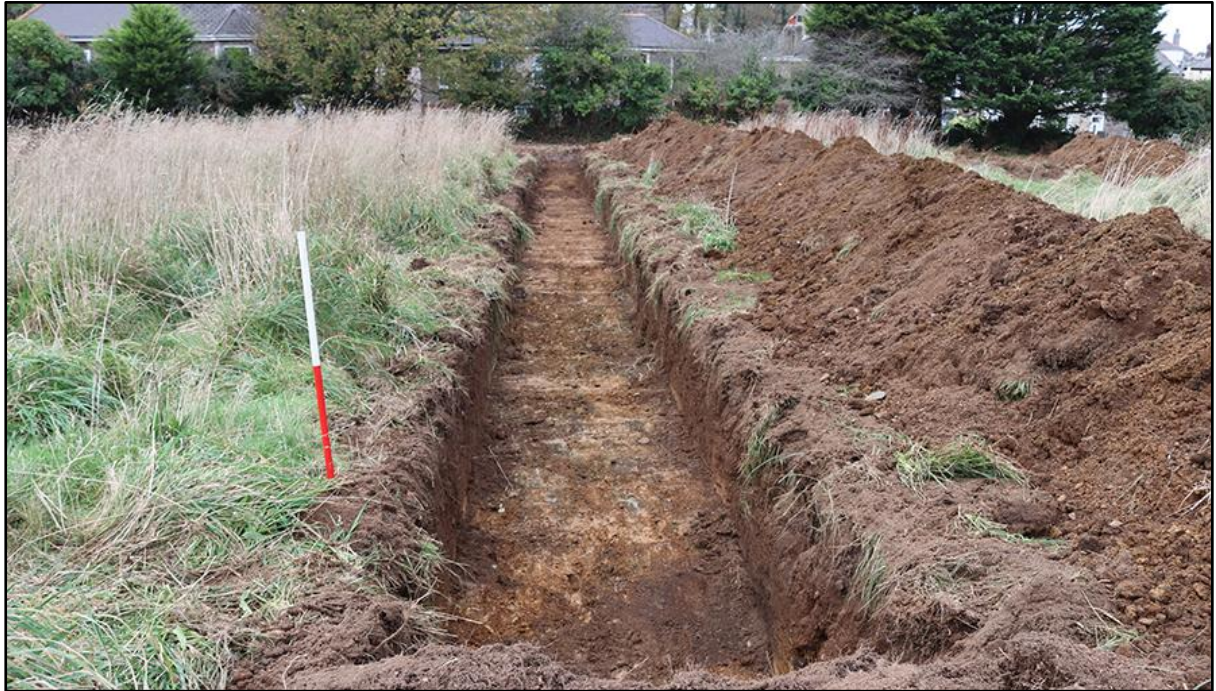
FIGURE 41: TRENCH 3 FROM ESE (1M SCALE)

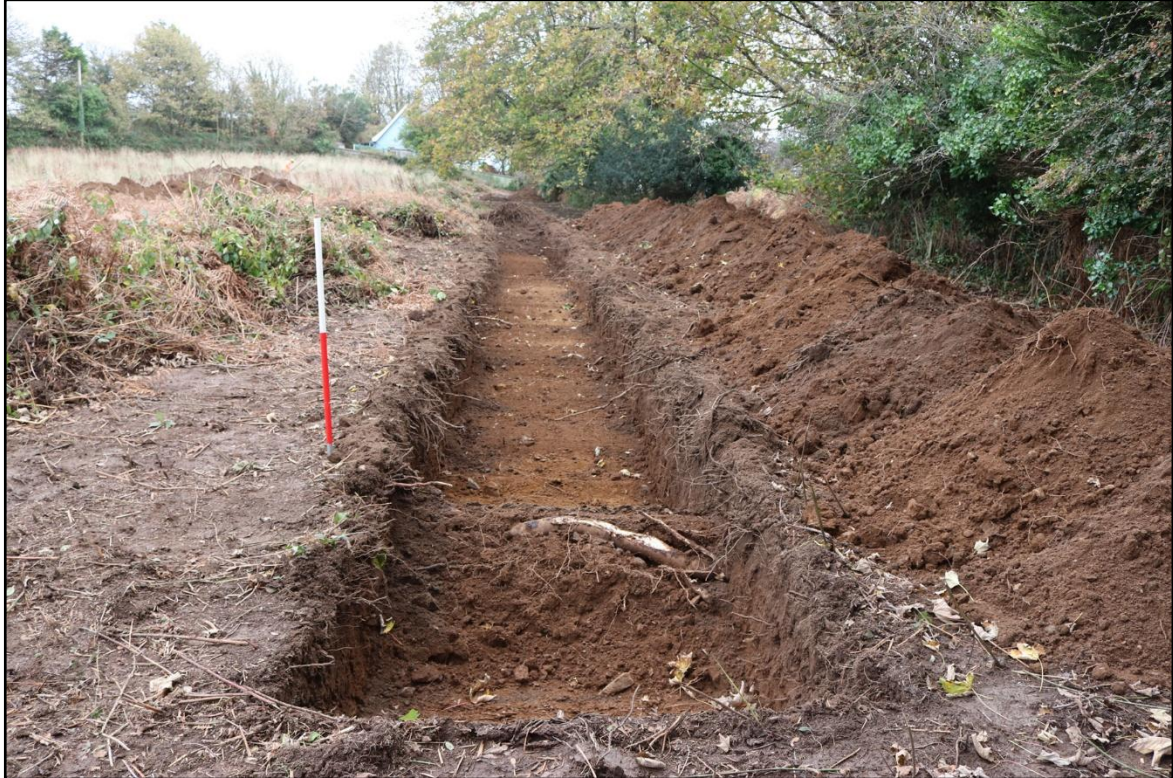
FIGURE 43: TRENCH 4 FROM WNW (1M SCALE)

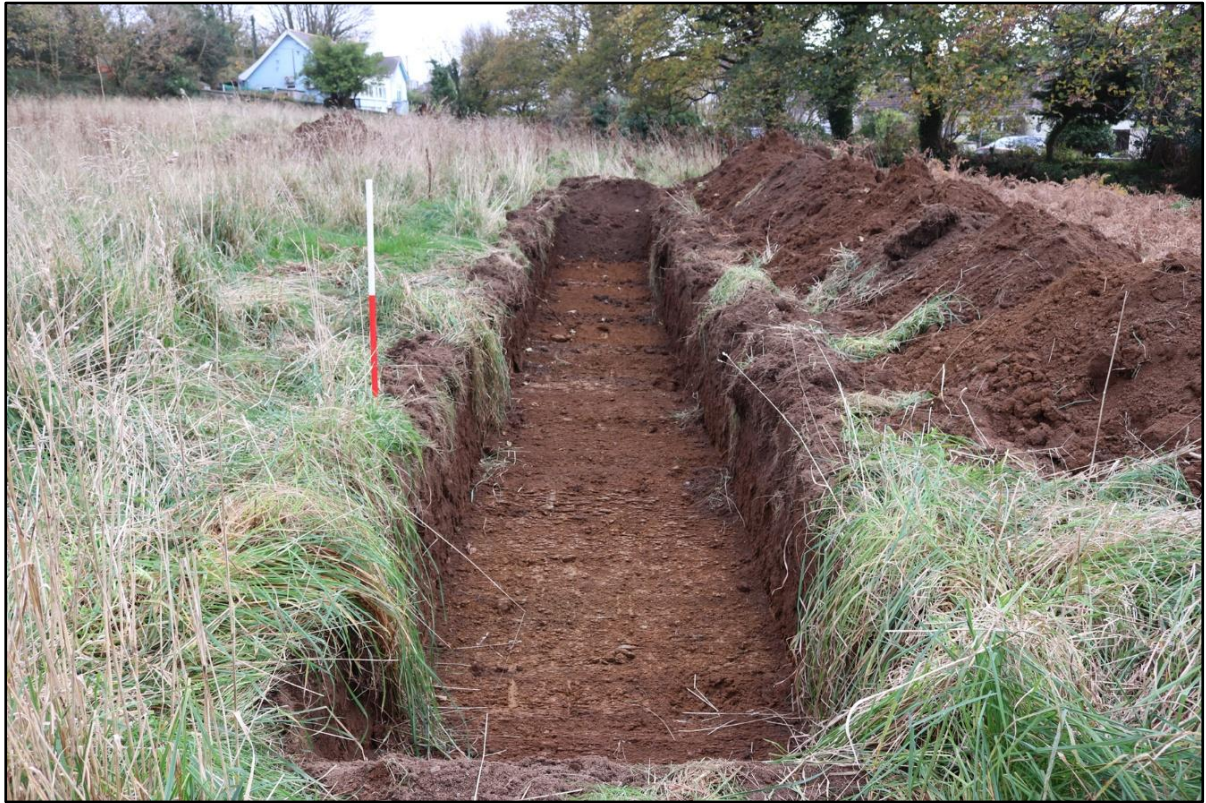
FIGURE 45: TRENCH 5 FROM NNE (1M SCALE).

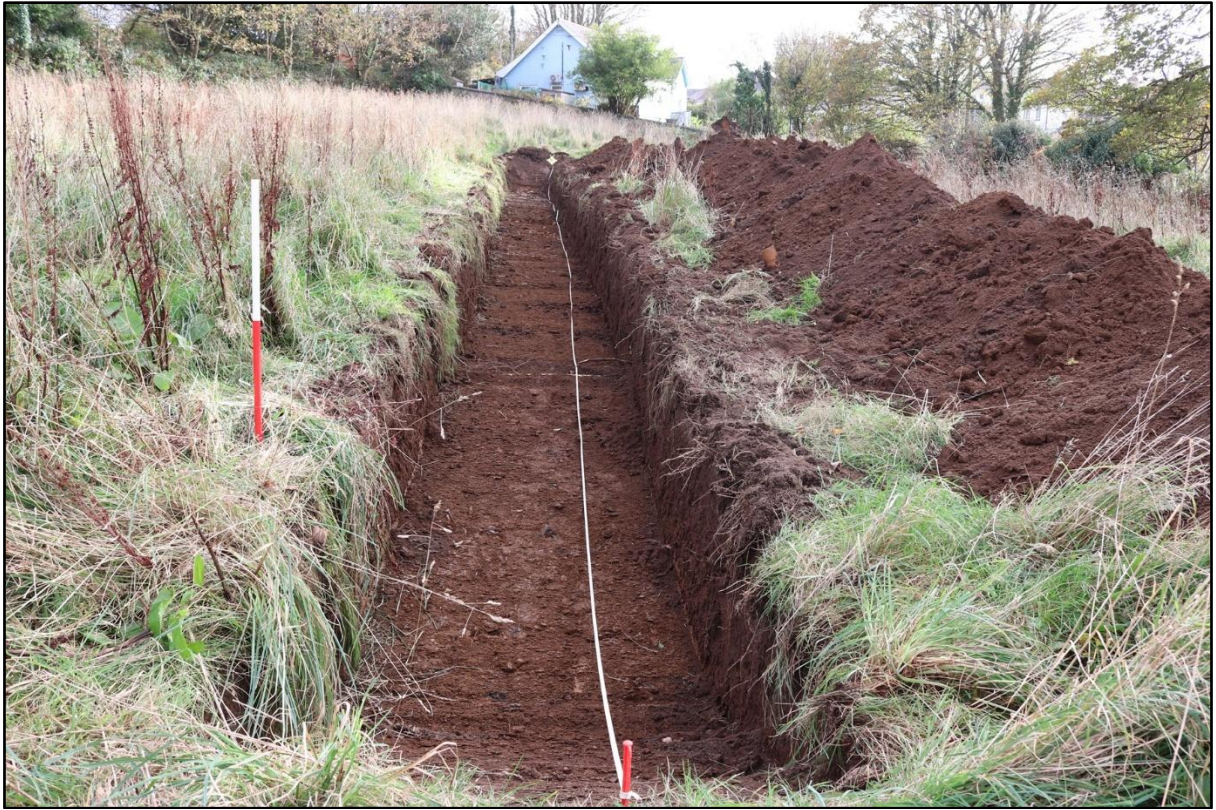
FIGURE 47: TRENCH 6 FROM NNW (1M SCALE)

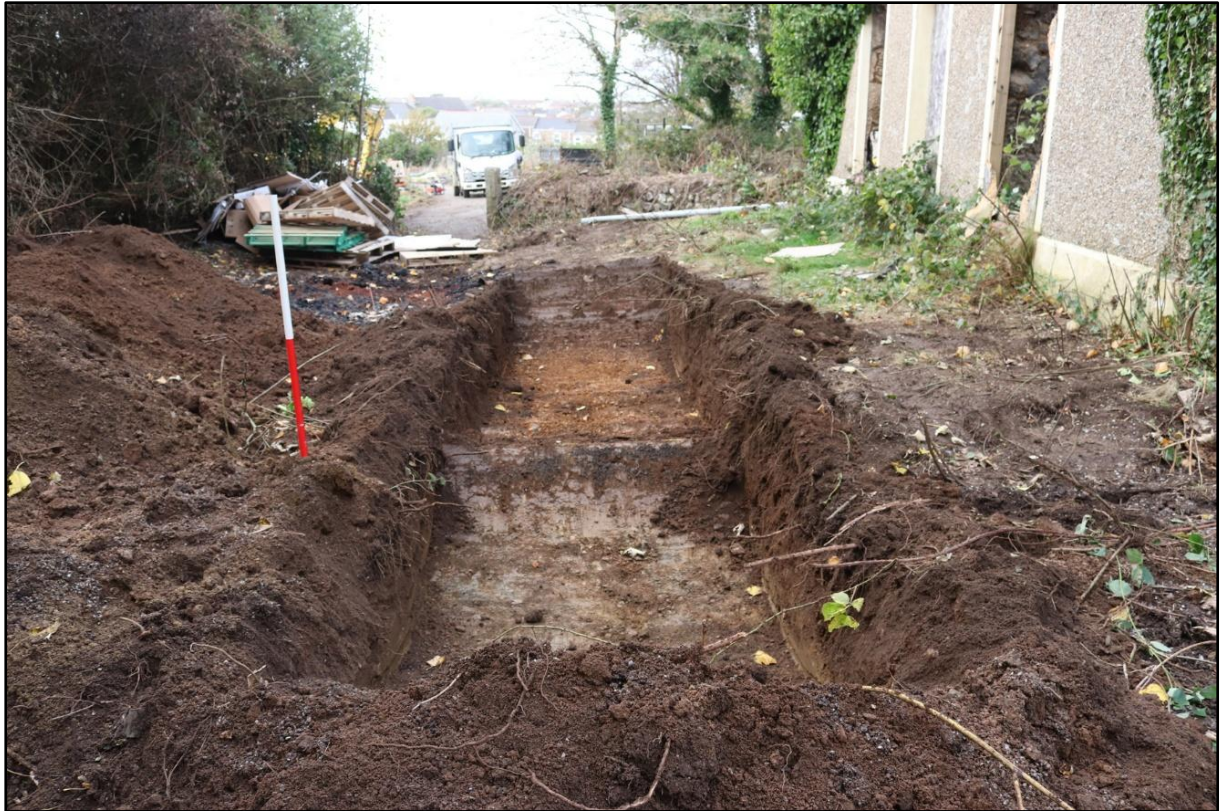
FIGURE 55: TRENCH 9 WITH GAS PIPE FROM SSE.
