Archaeological Services & Consultancy Ltd

WATCHING BRIEF: GLEBE HOUSE, LEIRE LEICESTERSHIRE

By
David Fell BA MA MIFA
September 2004

ASC: 599/LGH/2

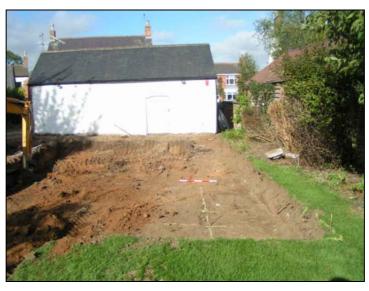
Plate 3: View of the footprint of the swimming pool, during stripping (scale = lm)

The soil was c.0.65m deep and, in the southern part of the area, excavation to the level of the pool apron (0.95m) involved removal of the entire depth of soil. The underlying natural strata, which comprised orangy brown sand, was revealed in this area. Due to the slight slope in the ground, the base of the soil was not reached on the north side (It appears as a grey area on the right in Plate 3).

The swimming pool measured 12.2 by 5.5m and its excavation involved removal of the natural sand. The east part of this area was undisturbed. An area of modern disturbance was present in the west, adjacent to the garage. It comprised a subrectangular pit and continued to the south and west, beyond the limits of the area. It was filled with a deposit of mixed building debris, concrete fragments, bricks, etc. This is a modern feature and is not archaeologically significant.
