**ARCHAEOLOGICAL SCHEME OF WORKS REPORT:
HISTORIC BUILDING SURVEY AND WATCHING BRIEF, TEDNAMBURY FARM,
SPELLBROOK, HERTFORDSHIRE**

Planning Reference: 3/15/0831/FUL
NGR: TL 4910 1686
AAL Site Code: SPTF 15
OASIS Reference Number: allenarc1-242451

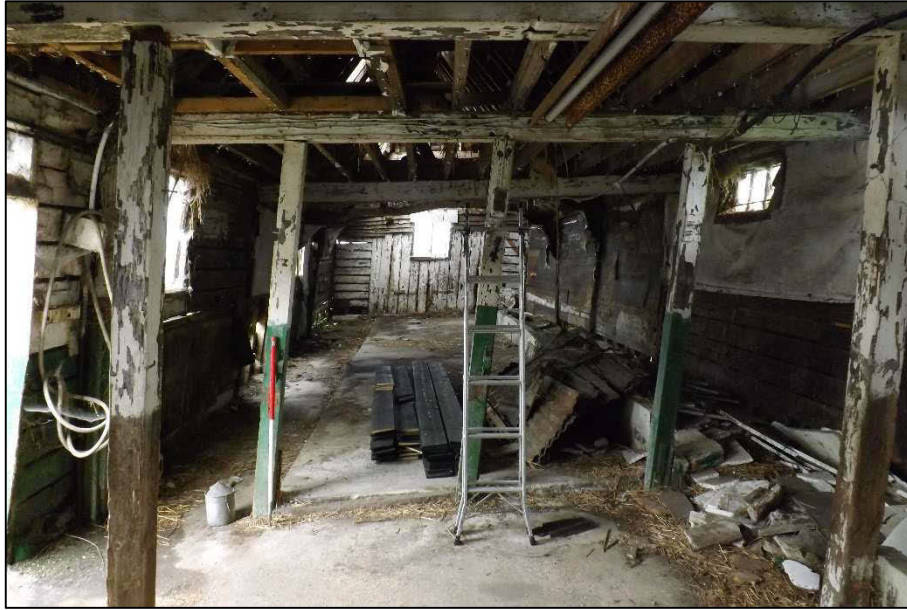
Plate 4 (shot 16): The internal frame is visibly racking. Posts appear to be supporting replacement tie beams, looking northwest

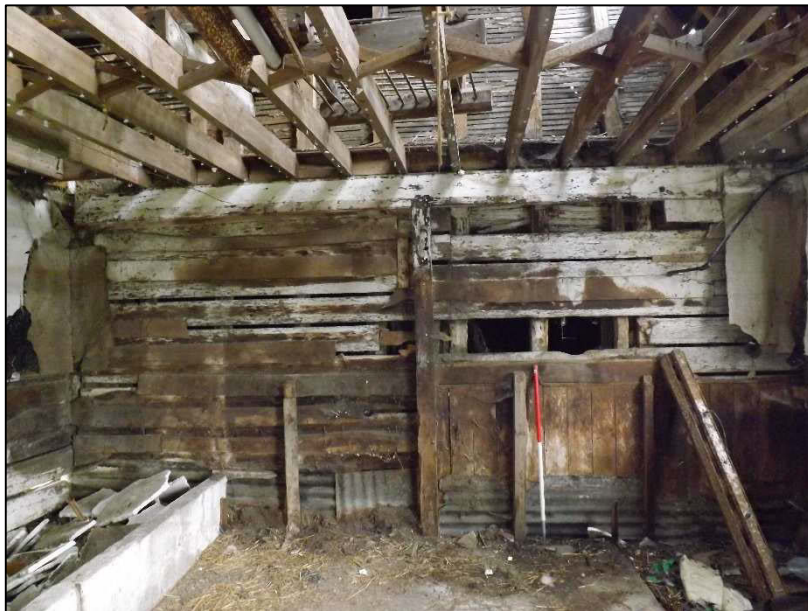
Plate 5 (shot 21): Northwest-facing internal elevation, looking southeast

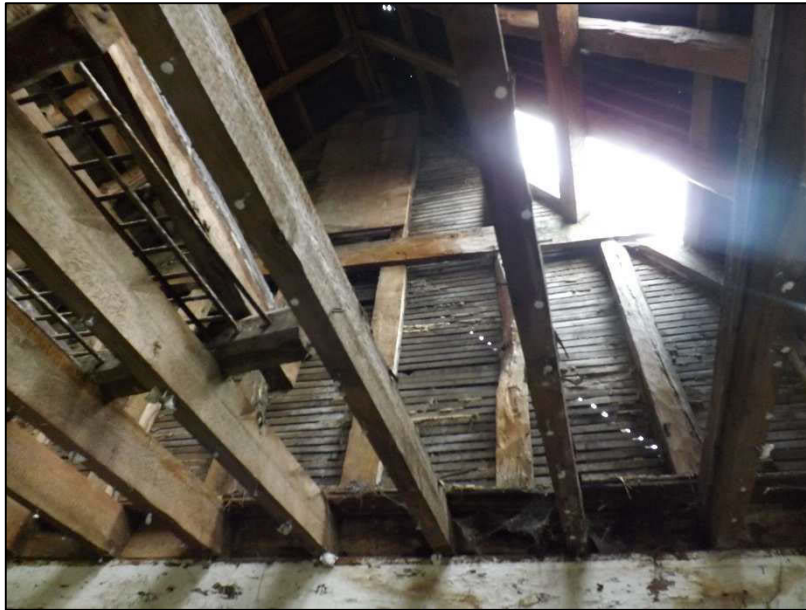
Plate 6 (shot 23): Northwest-facing internal elevation, within in the roof, looking southeast

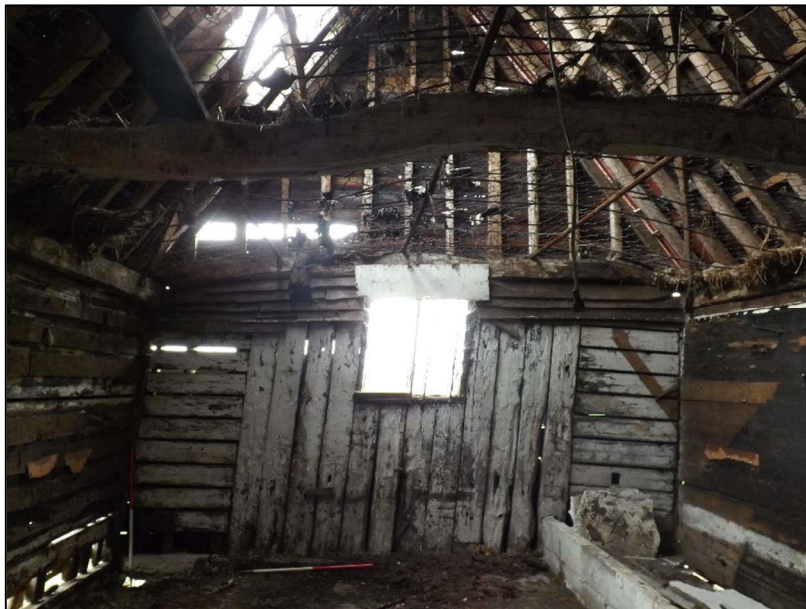
Plate 7 (shot 39): Southeast facing elevation, looking northwest

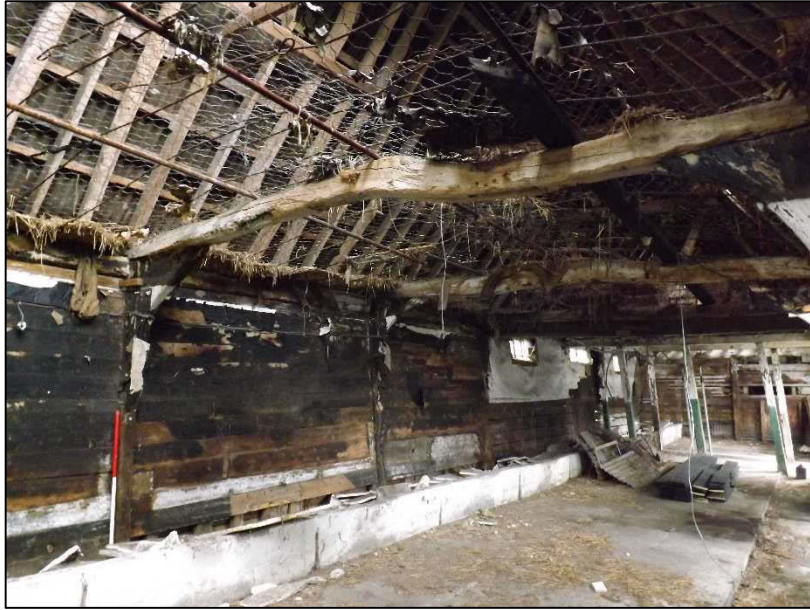
Plate 8 (shot 45): Southwest-facing elevation, looking east

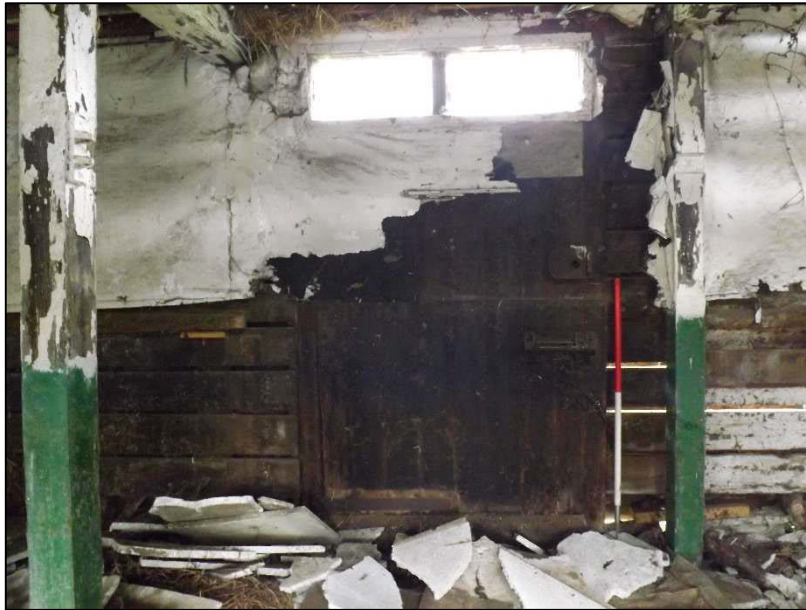
Plate 10 (shot 26): Doorway in the southwest-facing elevation, looking northeast

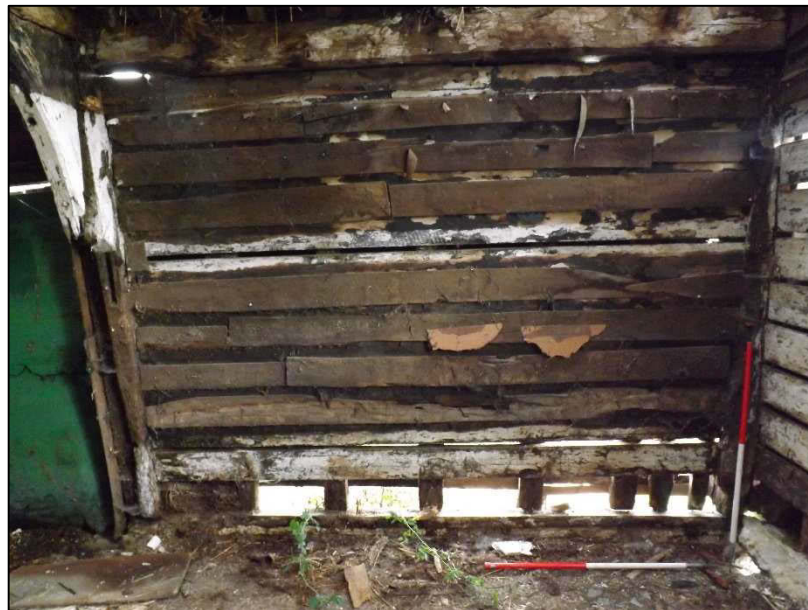
Plate 11 (shot 38): Northern bay of the northeast-facing elevation, studs are visible beneath the weatherboarding, looking southwest

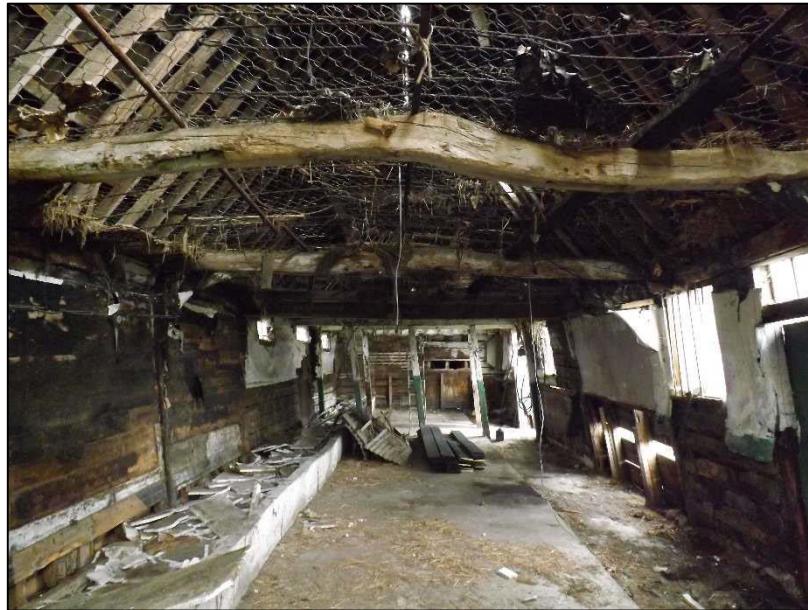
Plate 12 (shot 43): Tie beams at the north end of the building, both are clearly cracked, looking southeast

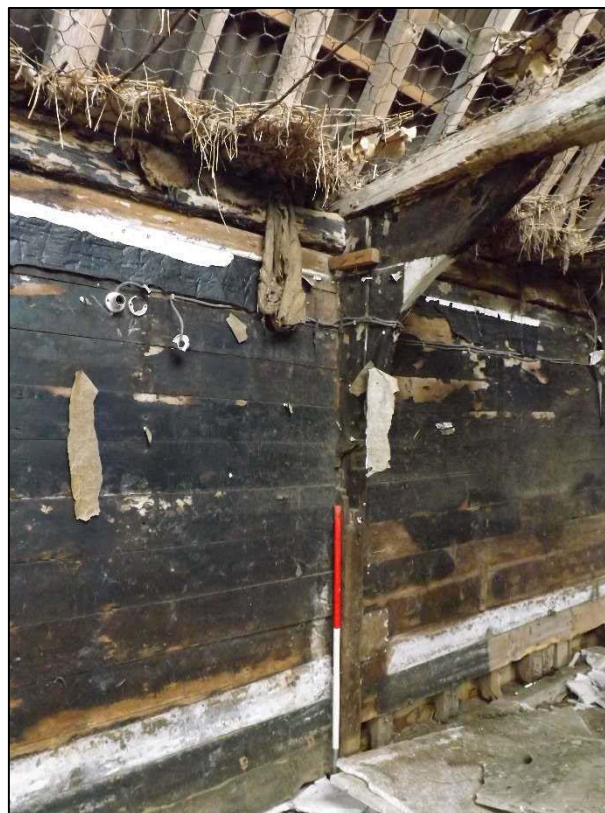
Plate 13 (shot 46): Original tie beam joint to post and wall plate. The joint has been reinforced in a number of places, looking east

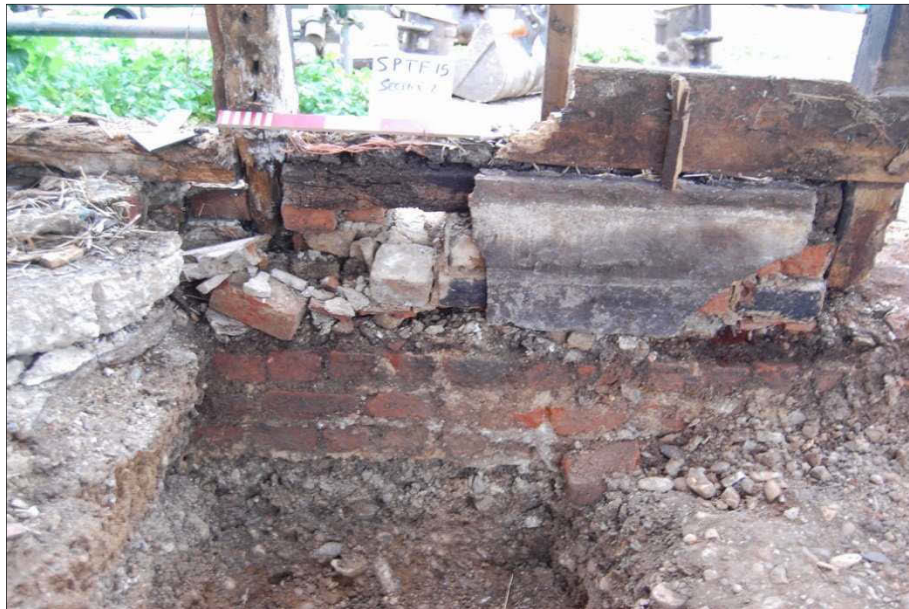
Plate 14: Northeast facing section of walls 03 and 08, scale 0.5m

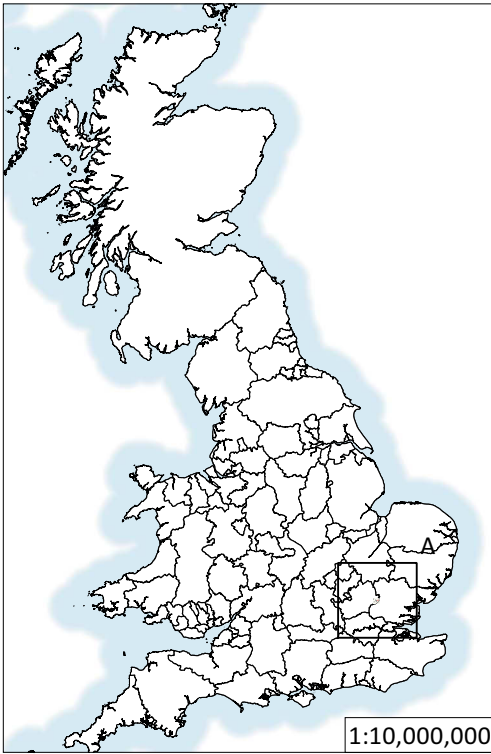
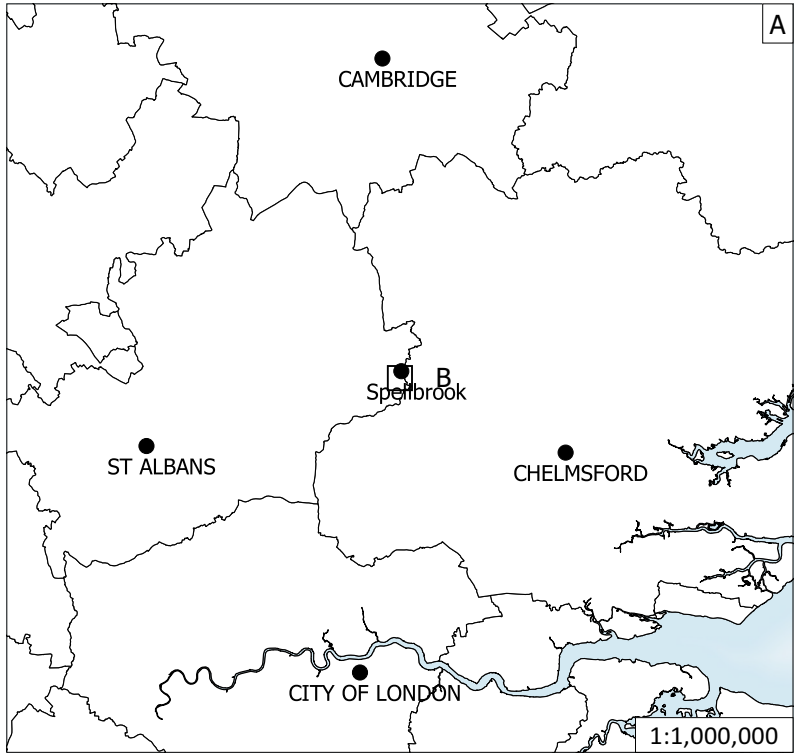
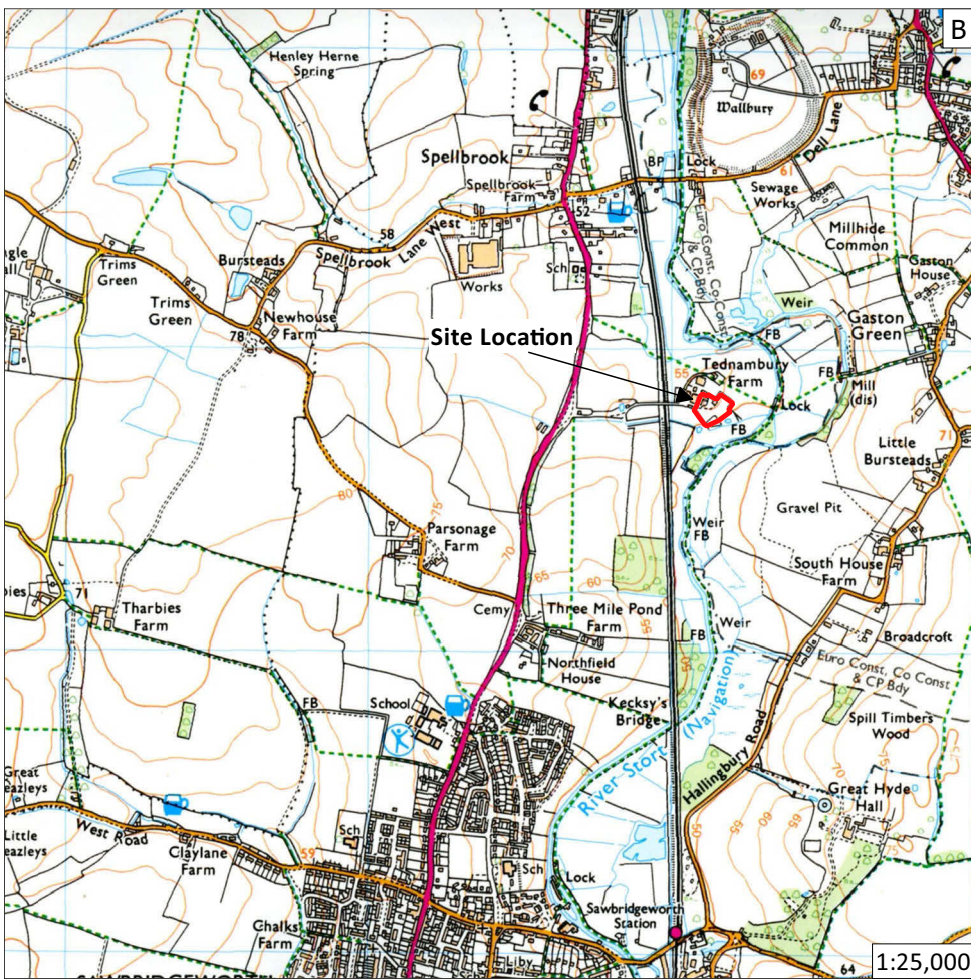
Figure 1: Site location outlined in red
