HISTORIC BUILDING SURVEY REPORT:

CARR HOUSE FARM, PRESTON ROAD, INSKIP, LANCASHIRE PR4 0TE

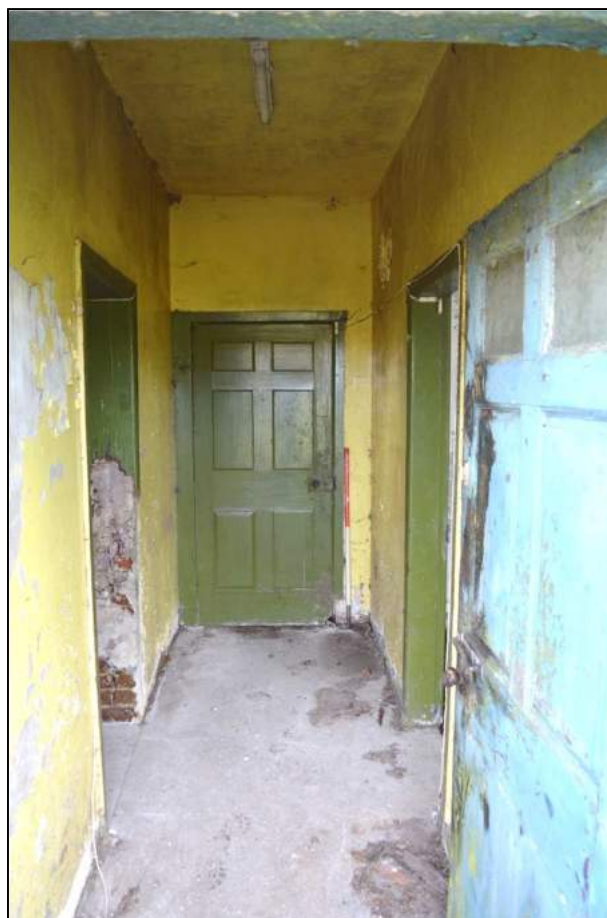
Plate 9: (Shot 127) Interior of Farmhouse A, entrance hall Room 1 viewed from north external door, looking south (1m scale)

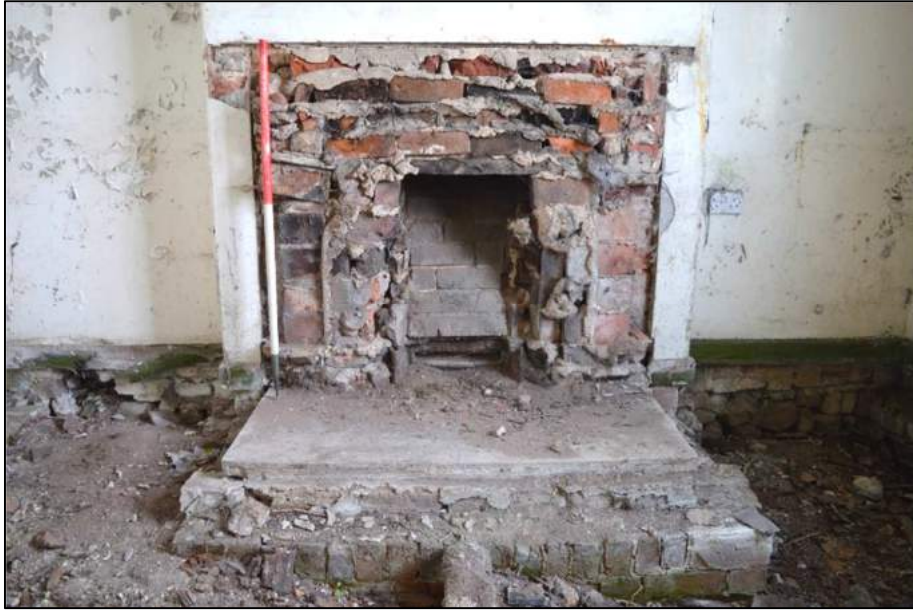
Plate 10: (Shot 131) Chimneybreast, hearth and stone wall foundations in ground floor Room 2 of Farmhouse A, looking west (1m scale)

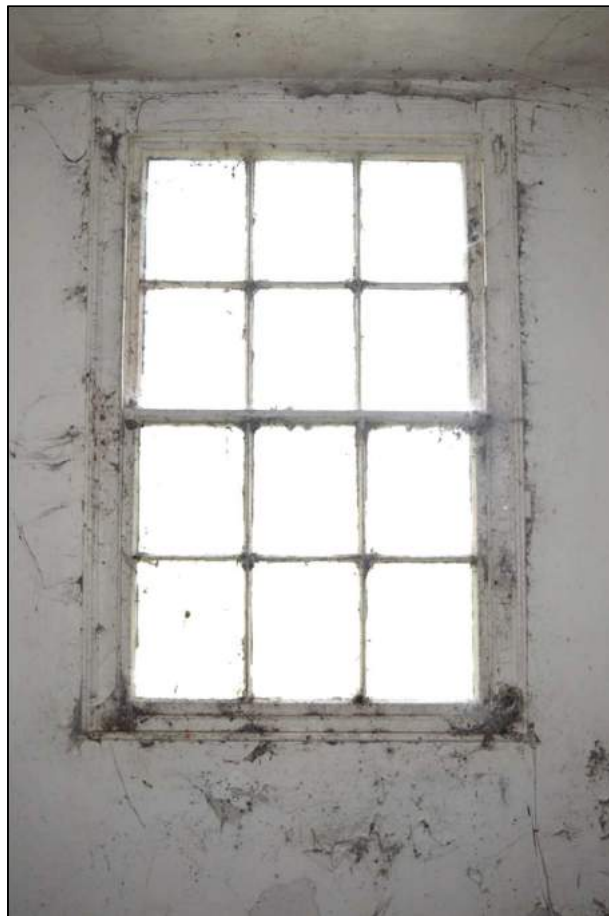
Plate 11: (Shot 134) Window to ground floor Room 2, Farmhouse A, looking north

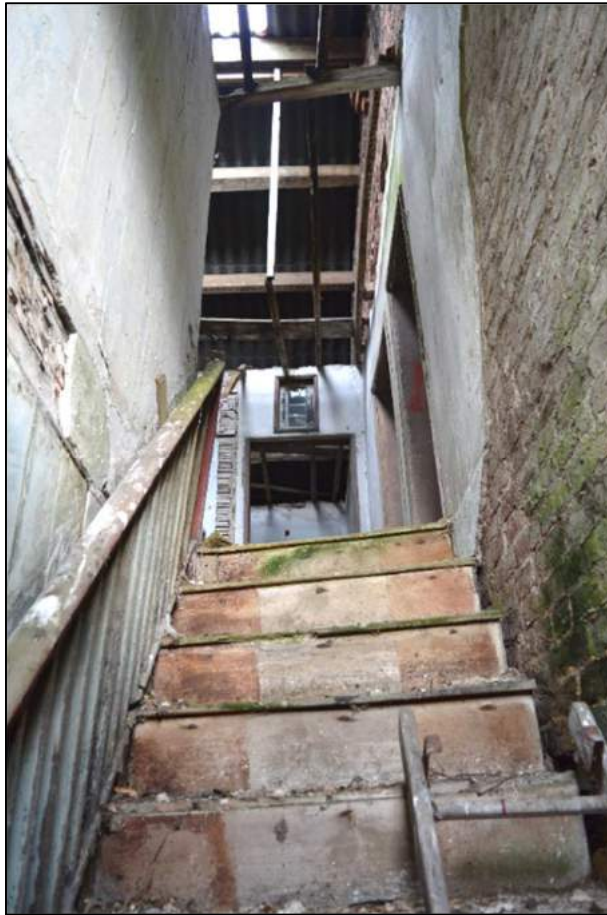
Plate 19: (Shot 165) View up the stairs in Farmhouse A, looking north

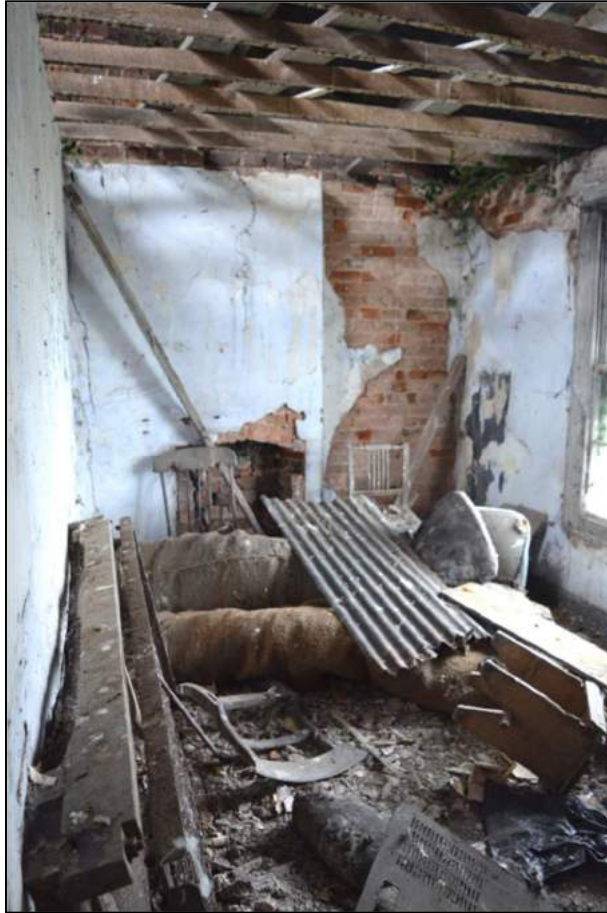
Plate 25: (Shot 181) First floor Room 8 of Farmhouse A, looking west towards chimneybreast

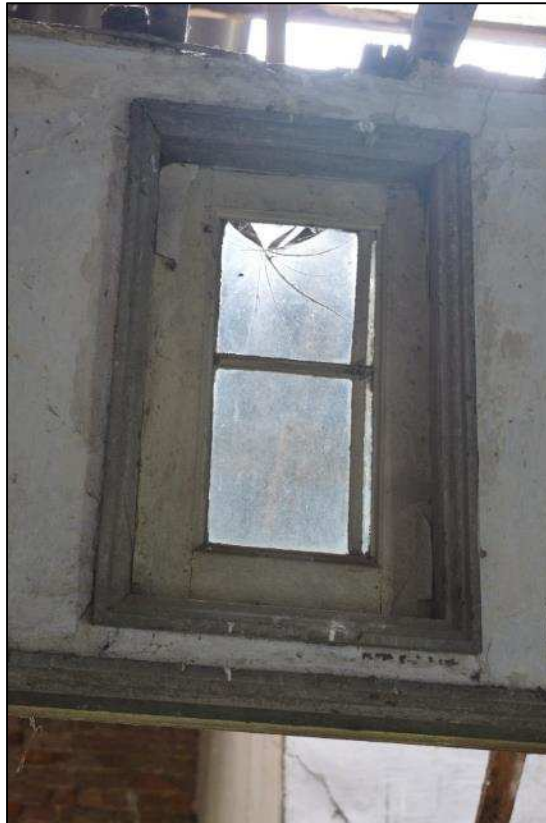
Plate 26: (Shot 186) Light above internal door to first floor Room 8 of Farmhouse A, looking south towards landing and stairs

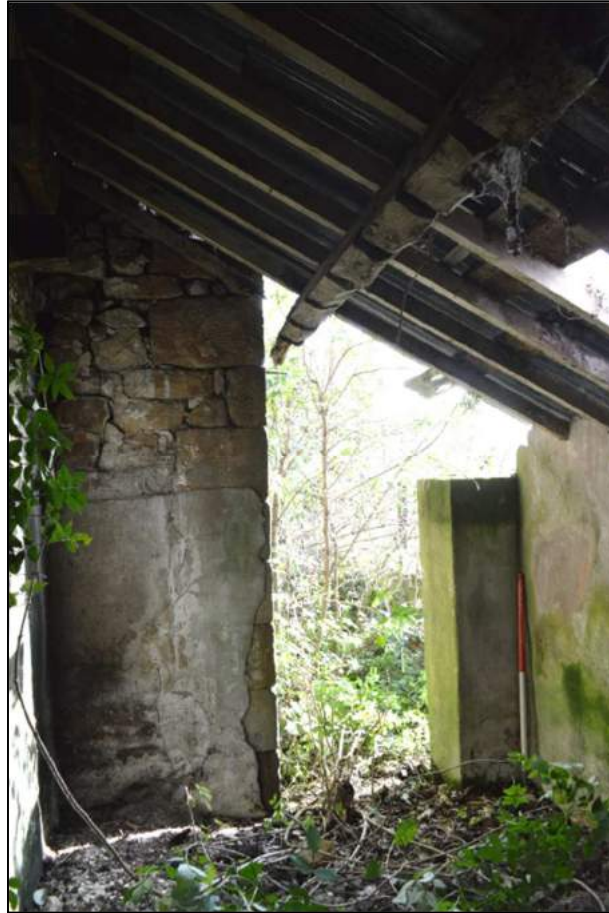
Plate 36: (Shot 65) Stone quoins of Barn B at southwest corner of Room 6, viewed from interior of Structure D, looking east (1m scale)

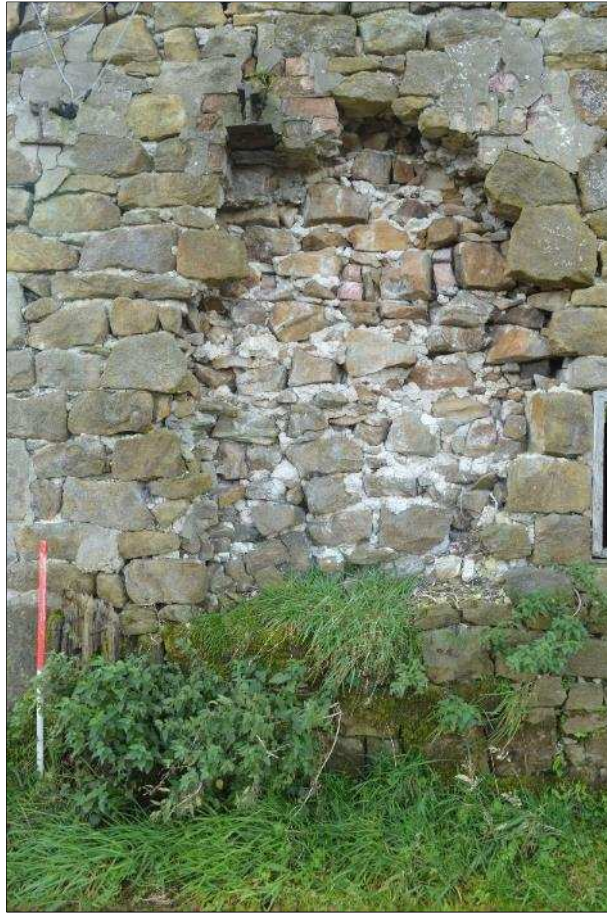
Plate 37: (Shot 36) Deterioration of facing stonework of north elevation of Barn B, looking south (1m scale)

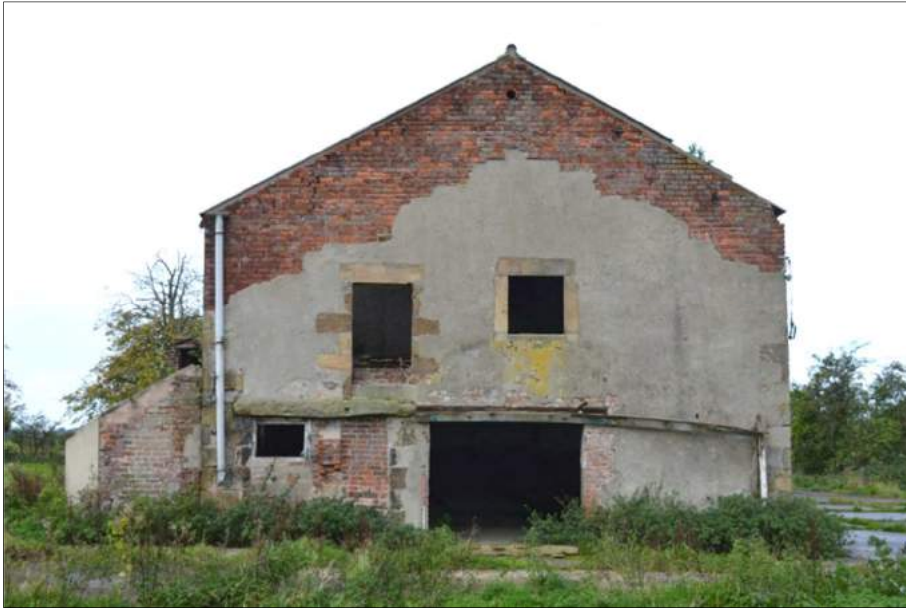
Plate 38: (Shot 39) East gable of Barn B, looking west (1m scale)

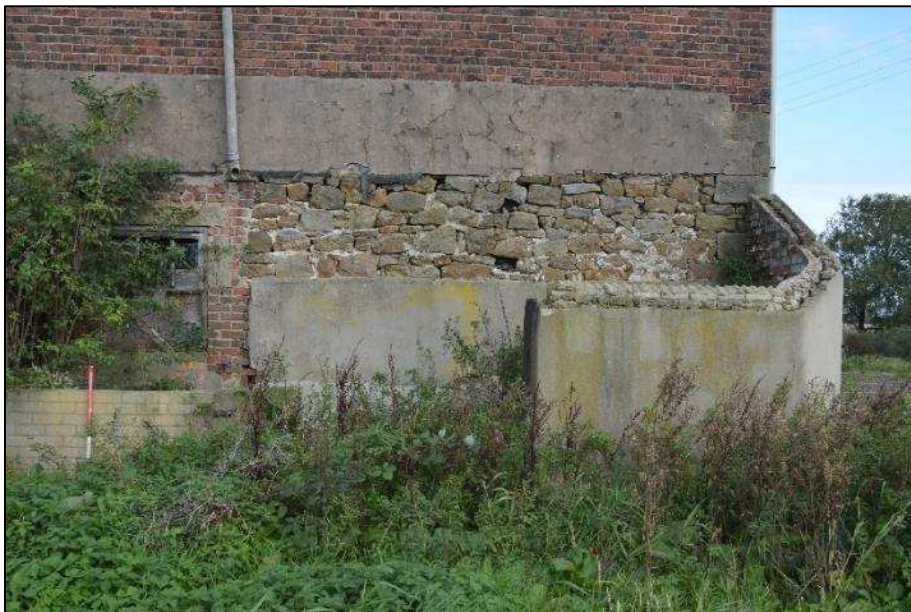
Plate 67: (Shot 56) Lean-to Building F, looking north (1m scale)

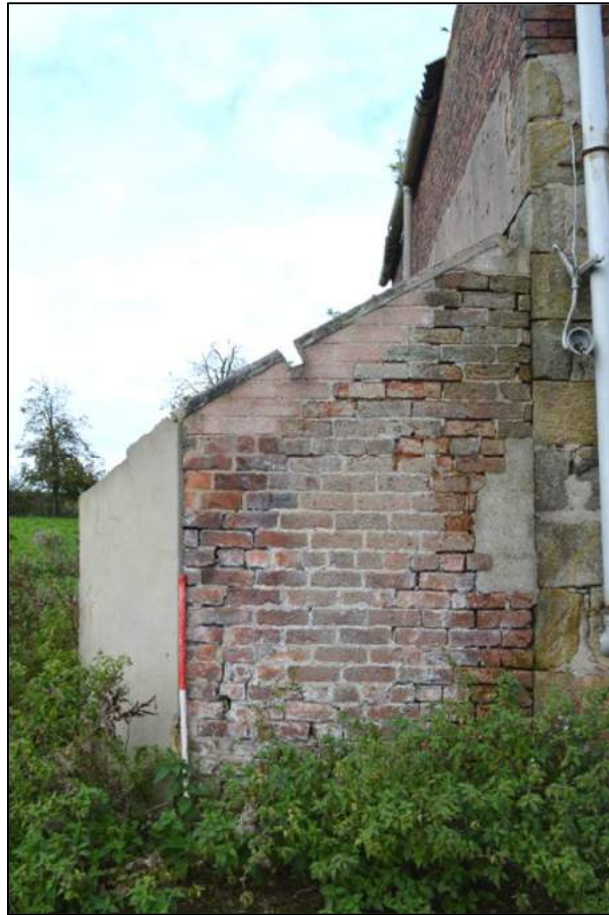
Plate 68: (Shot 45) East gable of lean-to Building F at junction with southeast corner of Barn B, looking west (1m scale)

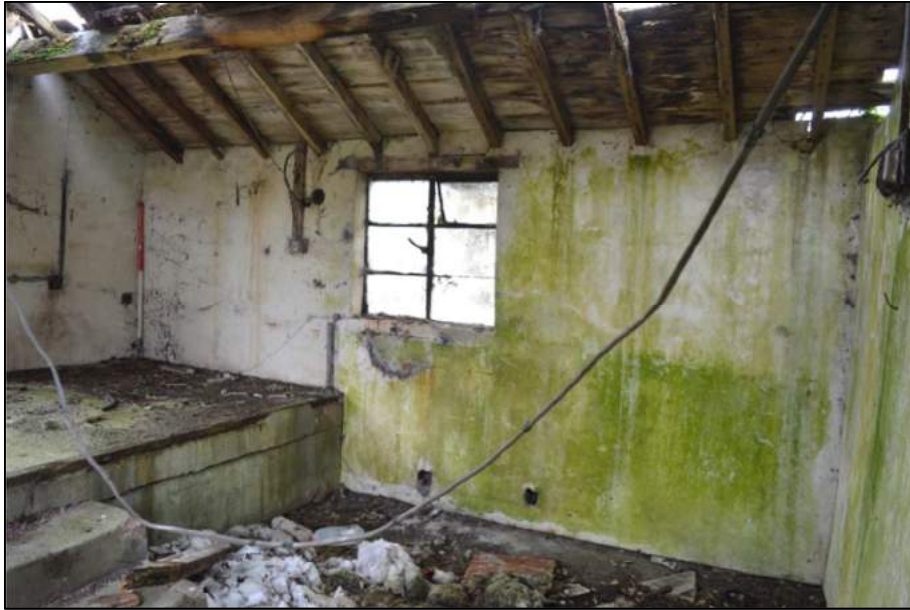
Plate 71: (Shot 219) Interior of Building G, Room 16, looking northwest (1m scale)
