Middleton Wind Farm, **East Renfrewshire**

Archaeological Watching Brief

Report No. 2113

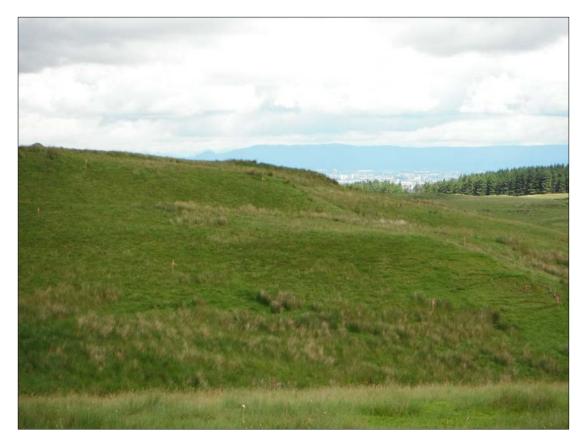
A 10m buffer zone was set up around the Scheduled Monument of Bannerbank using wooden stakes placed at regular intervals around a perimeter and sprayed with orange paint (Fig. 2). The use of temporary fencing was not possible due to livestock activity in the area.

There was no impact on the site throughout the duration of the construction works.

Fig. 2 - View of the Scheduled Monument Bannerbank, from south, with buffer in place

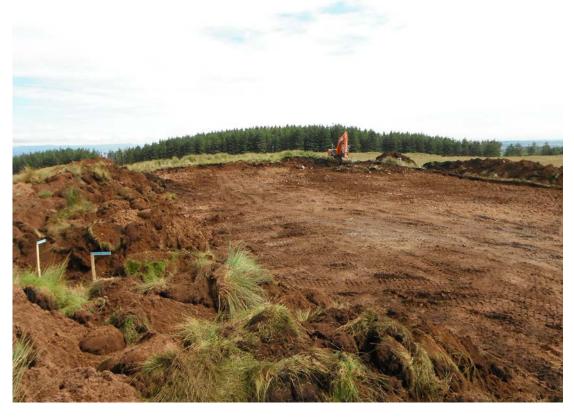
Fig. 3 - View of Turbine 6 base, from SW

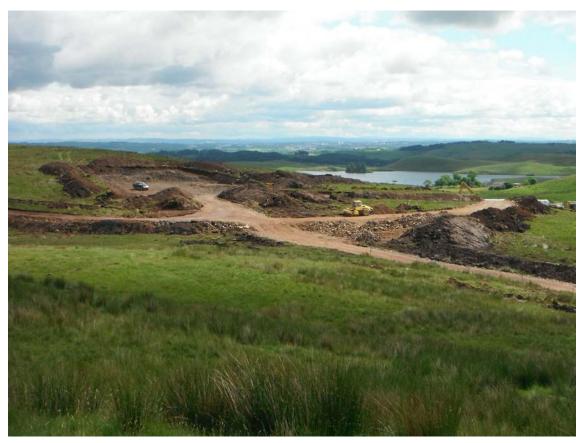
Fig. 4 - View of Turbine 3 base and junction stripped , as seen from Turbine 1

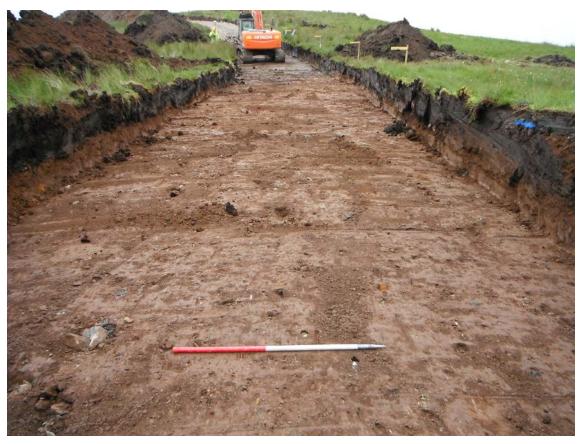
Fig. 5 - Stripped access track at chainage 670 between Turbines 1 and 2

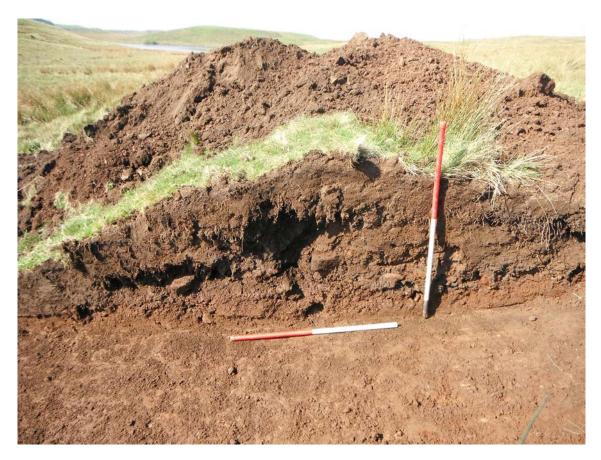
One feature was identified within the area for the construction compound (Fig. 6-7). This was a discontinuous linear bank (**1002**), between NGR NS 48989 52744 and NS 49020 52764, at about 245m AOD. A 2m wide section was excavated by hand across this bank prior to topsoil stripping within the compound, and then its removal during topsoil stripping was monitored as part of the watching brief.

The feature measured 3.5m in width, and up to 1m at its maximum height measured from the natural, and a section measuring 16m long was removed during topsoil stripping operations, crossing the SE corner of the compound area (Fig. 1).

Fig. 6 - Field bank (1002) NE-facing section

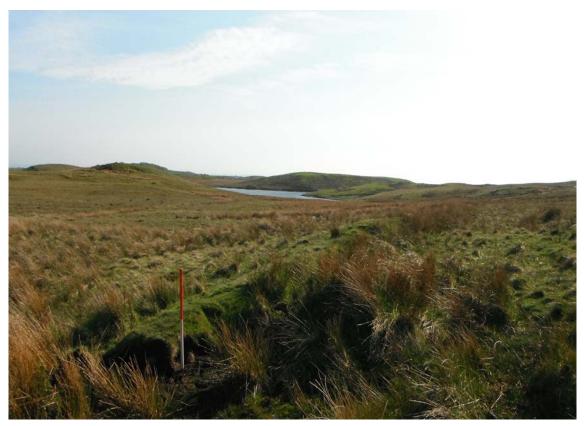
The bank was made up of a grey-brown sandy clay with orange mottling and stone inclusions (1003) covered in turf; the stones were less than 0.3m across and were sparsely distributed through the bank material (Fig. 7). It overlay natural and there was no peat seen in the section either beneath the bank or abutting it; topsoil here was 0.3m of sandy clay. This turf and stone feature was likely to have been a field boundary. No finds were recovered from or beneath this feature and there was no visible ground surface preserved beneath the bank.

The bank extended beyond the area of the compound, visible as an upstanding feature for c.80m towards White Loch from the compound, on a NE-SW alignment with some breaks (recorded as lying between NGR NS 49033 52773 and NS 48944 52713).

Fig. 7 - View of upstanding field bank (1002). Looking south-west from construction compound
