The Mill Weir Bridge & General Tam's Smokehouse House of the Binns, West Lothian

Standing Building Recording Survey

Report No. 2133

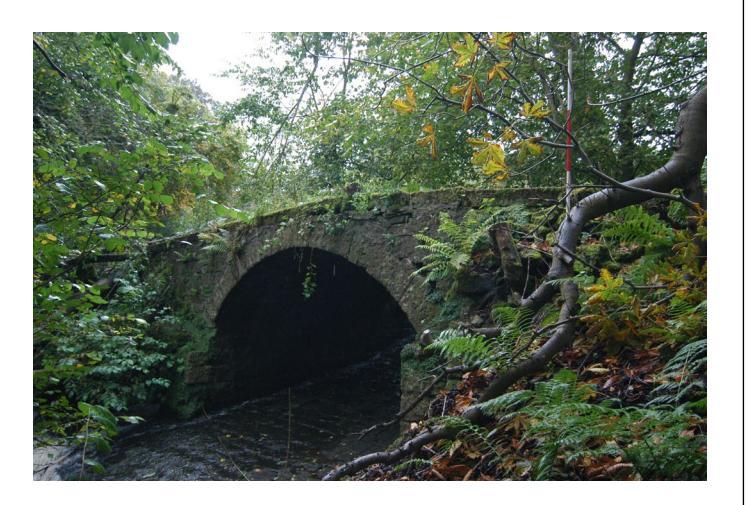
Plate 1: Mill Weir bridge east-facing elevation taken during the winter (source NTS)

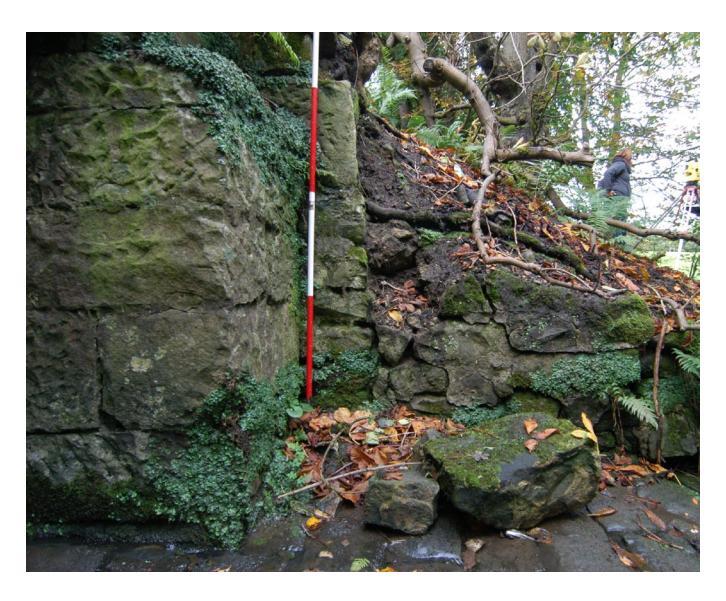
Plate 2: Mill Weir bridge east-facing elevation taken during the early Autumn

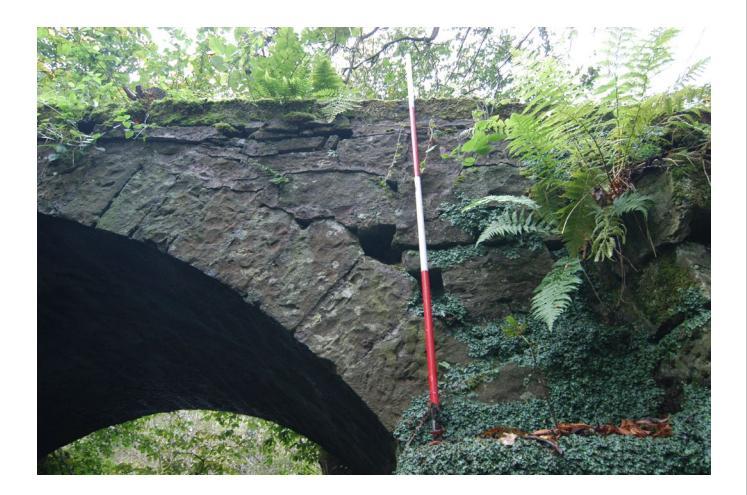
Plate 3: South-facing abutment showing erosion and stone displacement

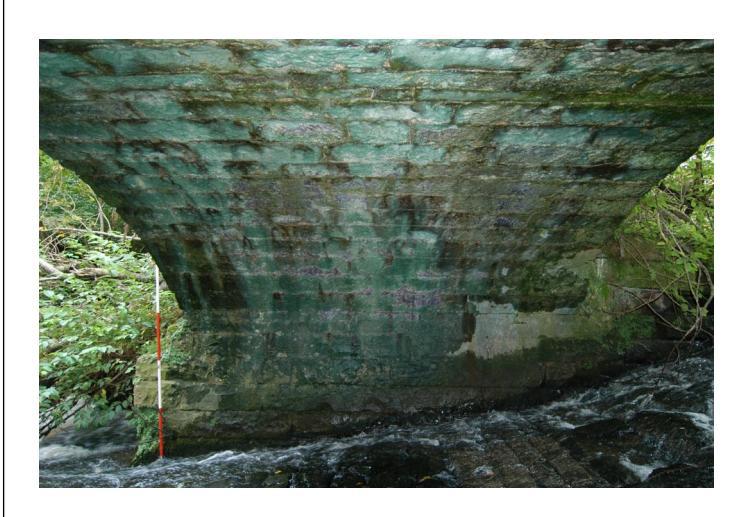
The south abutment (E6, Plate 7) comprises large blocks of sandstone which are heavily colonised by moss, making it difficult to assess its condition. The stonework below the bridge is in good condition with regular coursed stonework to a height of 1.2m at the east end. The coping/kerb stones (E7) on the east-facing elevation comprise dressed blocks of sandstone bonded with lime mortar (Plates 14-15). They differ in size with larger stones (1.1m x 0.3m x 0.2m) used at the north end whilst towards the south end the stones are smaller (0.35m x 0.3m x 0.2m). At the immediate south end the coping stones have been displaced by a fallen tree.

Plate 7: South abutment, north-facing ashlar stonework below the bridge and soffit stonework above

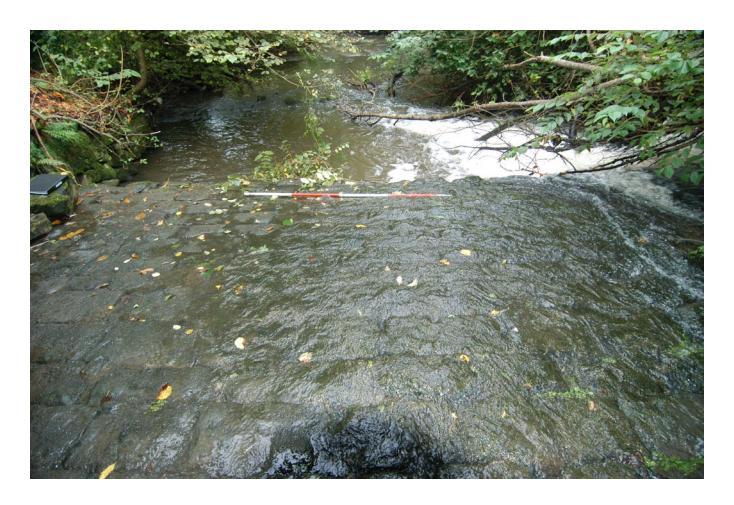
Below the bridge and extending downstream for about 2m is the stone-built overflow weir (**E8**, Plate 8). This consists of large blocks of stone laid north to south in regular courses. The vertical edge where it surmounts the burn is eroded slightly with only minor displacement of some of its stones. The soffit stonework below the arch comprises regularly coursed ashlar blocks of sandstone laid east-west.

Plate 8: Overflow weir stonework on the east side of the bridge

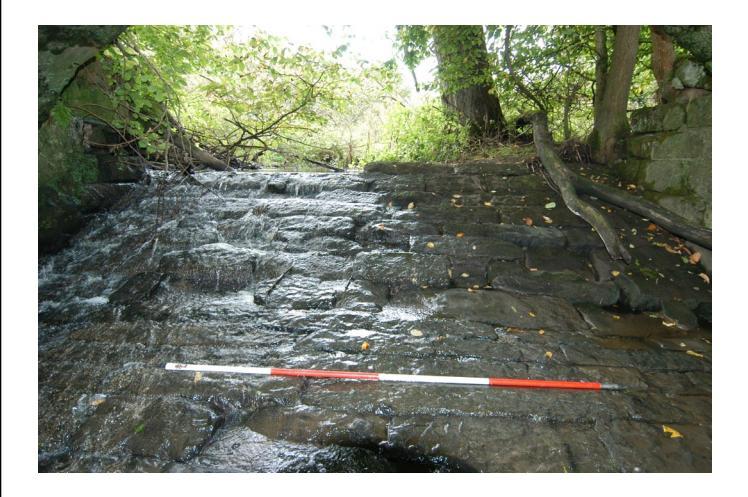
The bridge coping stones (W6) have a combined length of 8.9m and comprise regularly laid blocks of rectangular sandstone bonded end-on with lime mortar. The stones are in good condition but are poorly bonded to spandrels and top of the arch. Below the arch is the upstream section of the overflow weir (W7). Its outside vertical edge is irregular owing to the loss of stonework (Plate 9).

Plate 9: Overflow weir stonework on the west side of the bridge

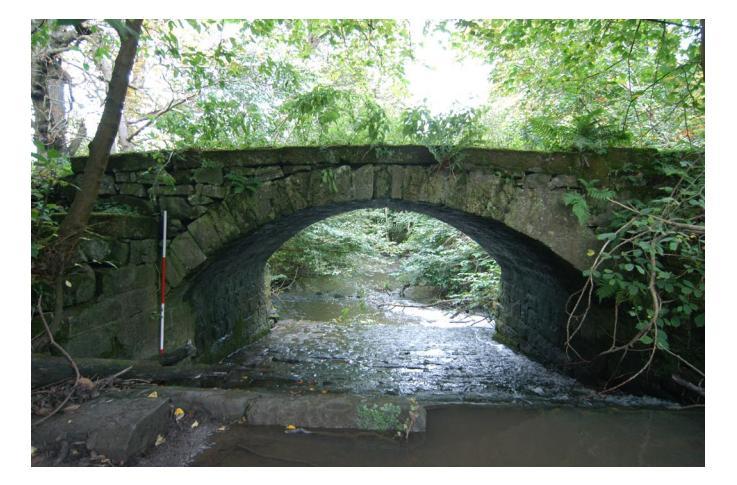
The north spandrel and parts of the top section of the abutment are eroded. The latter is being affected by tree roots that have grown within the joints in the stone resulting in displacement. The tree roots are thriving on the lime mortar. The stonework associated with the culvert is also eroding, with large gaps now present where the mortar has failed.

Plate 10: Mill Weir Bridge west-facing elevation

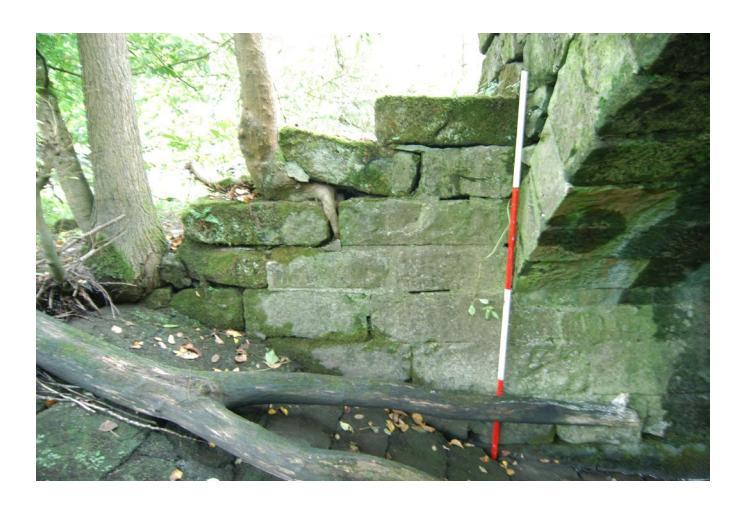
The north abutment (W1) comprises seven courses of individual blocks of stugged sandstone measuring 0.6m x 0.4m x 0.4m (Plate 12). The top two courses are heavily impacted by a tree root. One block of stone is tilting upwards by the pressure of the root. The north spandrel (W2, Plate 11) comprises coursed rubble which has large gaps where the mortar has degraded. The exact number of segmented arch vouisors is

Plate 12: North abutment, west side showing tree root impact

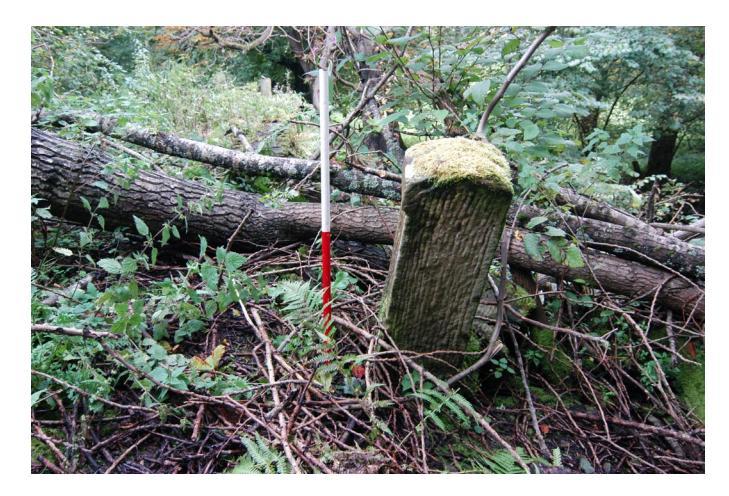
On top of the deck approximately 2.5m from the edge of the bridge is a marker stone (**E9**, Plate 16). The stone is in good condition, it measures 0.98m high x 0.3m x 0.23m and has been droved on its west and north-facing sides. The stone has been displaced from the vertical by the fallen tree.

E9	Marker stone	Single orthostat marker stone measuring 0.98m high x 0.3m x 0.23m. Droved on the west and north sides with vertical lines.	<i>Good.</i> The marker stone is in good condition but it has been displaced by a falling tree and now leans away from the vertical

Plate 16: A droved sandstone marker stone displaced by a fallen tree at the south end of the deck
