**Todmorden Wind Farm,
Flower Scar Road, Todmorden**

**Aerial Photograph Transcription
and Walkover Survey**

Report No. Y052/12

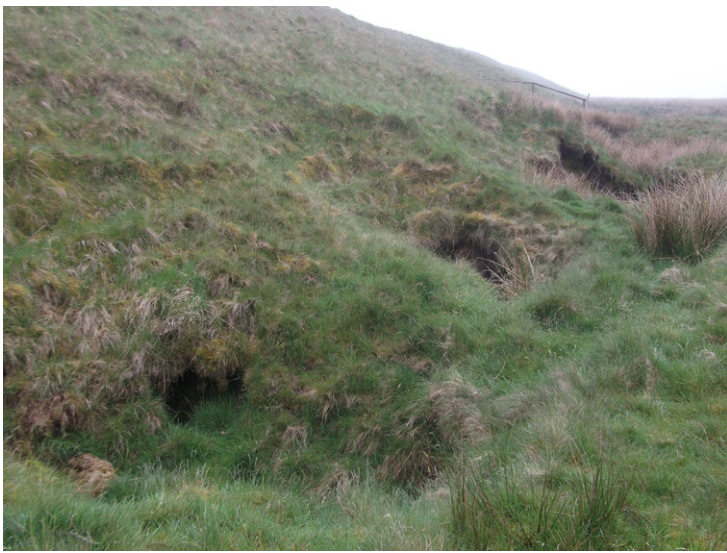
The typical sites recorded were drifts, vents, and collapsed galleries (Fig. 3); some of which were open with sheer drops.

Fig. 3 - Shot of open workings associated with Clough Head Fireclay Mine Sites 45-45.3

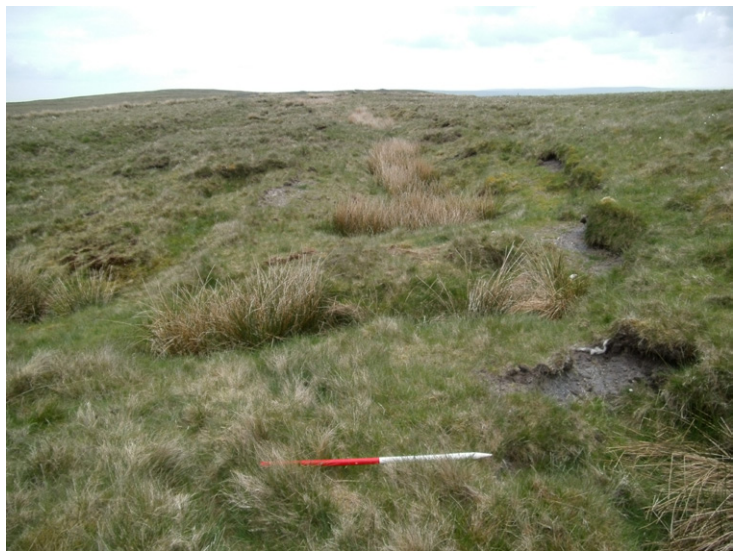
Fig. 4 - Shot of sinkholes: Sandy Road Colliery

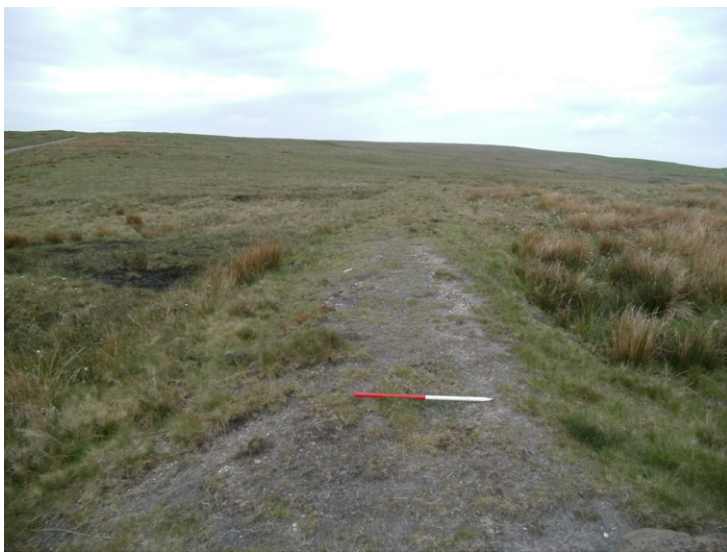
Fig. 5 - Shot of Site 8

| Site No. | Type | Source | Description |
|---|---|--|---|
| 8 | Track or waggonway | Field survey; aerial photography | Field survey recorded the remains of possible track, road or waggonway. The feature ran for some length in a NW-SE orientation and may have provided the access to a large number of mining related features in this area. The feature was seen as a raised bed. There was some visible frogged brick which appeared to provide a make shift surface or possibly a repair to an existing surface. Low vegetation along its length suggested that a surface or deposit of hard standing was present. The linear earthwork is in good condition to the SE but peters out to the NW. Probably associated with the workings at Sandy Road Colliery. |

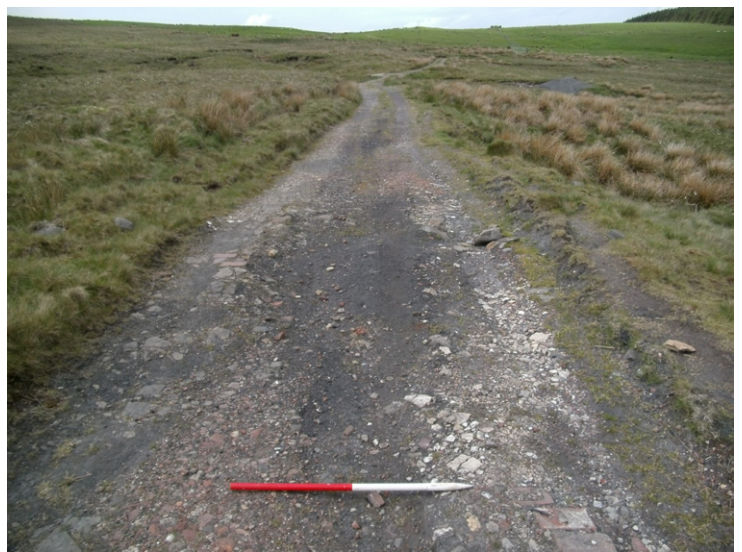
Fig. 6 - Shot of Site 72

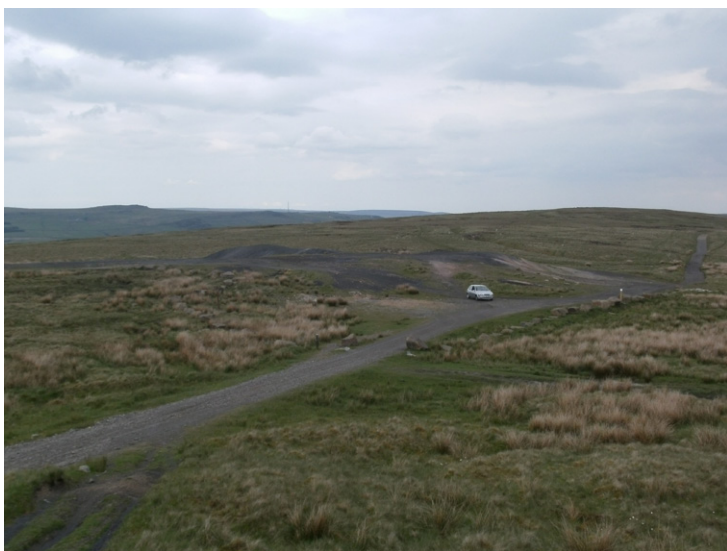
Fig. 7 - Shot of Site 28 viewed from Site 29

| Site No. | Type | Source | Description |
|---|---|--|---|
| 28 | Bing, above ground mining related remains | Field survey; maps; aerial photography | The remains of a bing of mining origin which is visible on Ordnance Survey mapping and aerial photographs. The bing largely comprised shale which formed the bulk of the feature. Other materials noted within the matrix were rubble, concrete and bricks. The area can be divided into three mounds of material, all of which have been eroded by recreational motor biking and other vehicles. The area is presumed to have been the centre of activity for coal mining in this area. It is located immediately north of FSR. The abandonment plan NW587 shows a series of buildings' in this area a track or road, and the termination of the tram or waggonway from the mine working to the North-west. The area is probably a focus of activity for the Sandy Road Colliery. A number of sites within the general curtilage and were surveyed separately. |

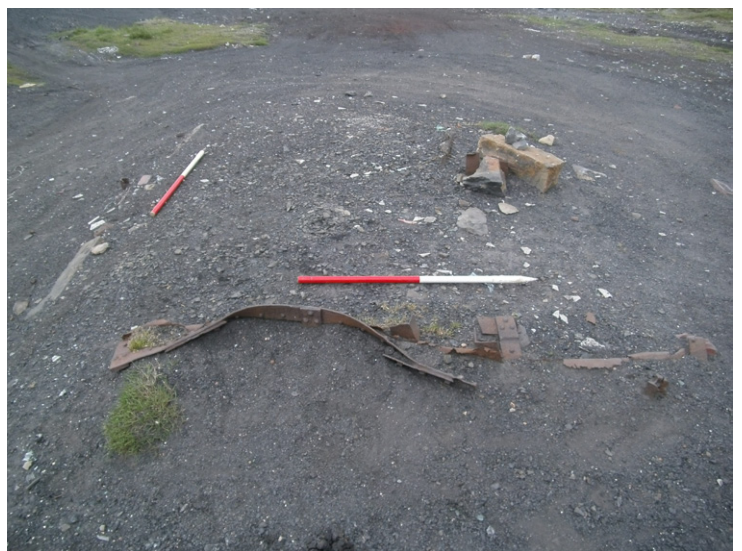
Fig. 8 - Shot of structural remains of Site 28.1

| Site No. | Type | Source | Description |
|---|---|--|---|
| 28.1 | Metal structure | Field survey | Field survey recorded the remains of a metal structure, stance or base within the curtilage of Site 28. The metalwork is warped and twisted but is largely still in situ. Some angled metal uprights are visible which presumably continue into the deposits associated with Site 28. Wood is also noted. The feature is approximately 4m square. It remains possible that more extensive remains associated with this continue below the current ground surface. The abandonment plan NW587 shows a series of buildings in this area and the area in general appears to have been the focus of activity for the Sandy Road Colliery. |

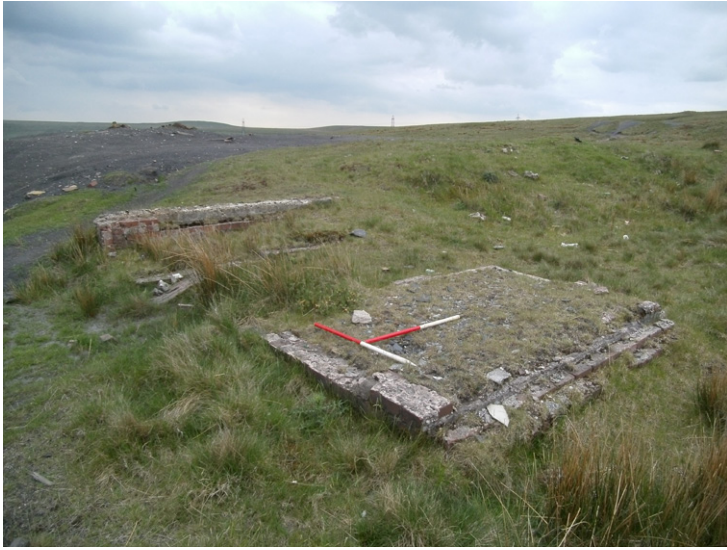
Fig. 9 - Shot of structural remains of Site 28.2 and 28.3

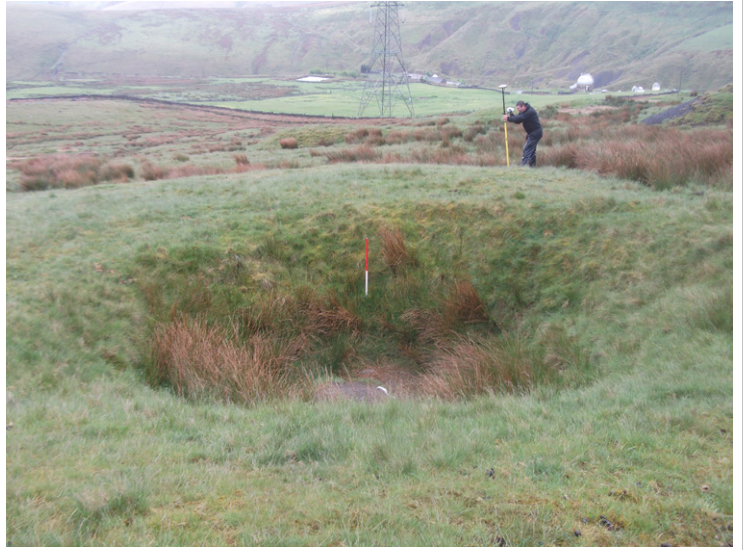
Fig. 10 - Shot of Site 35.27

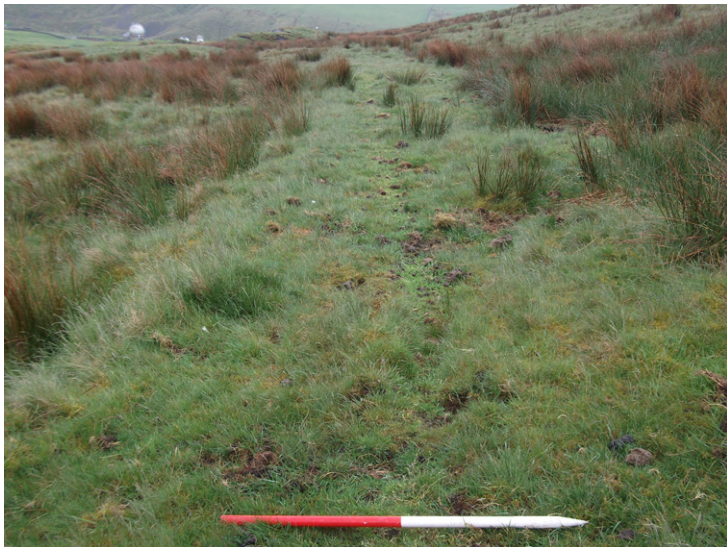
Fig. 11 - Shot of Site 35.10

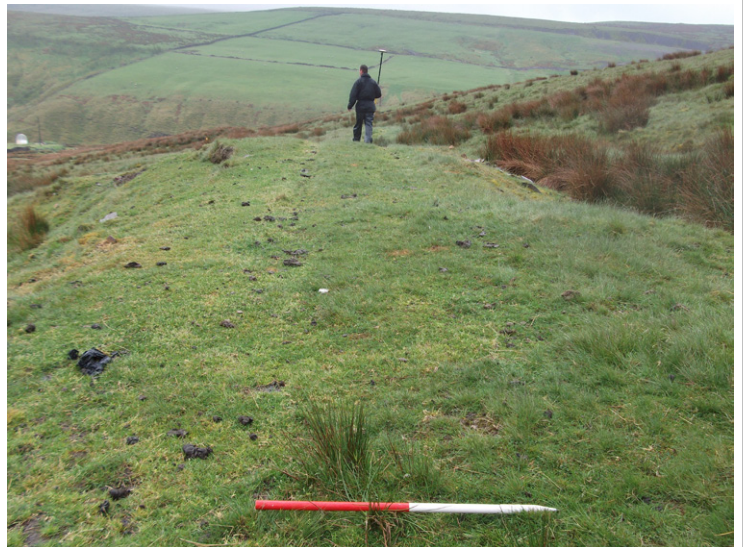
Fig. 12 - Shot of Site 35.16

| Site No. | Type | Source | Description |
|---|---|--|--|
| 35.16 | Probable track | Field survey; maps; aerial photography | The remains of a track or access route orientated roughly N-S. This may be a continuation of 35.10 a trackway noted on the same orientation to the north of here. The feature is c. 3.5 wide and probably has a surface or deposit of hard standing under the current low lying vegetation. The feature was possibly the main route from the mining activity located immediately to the north and Bacup Road to the south |

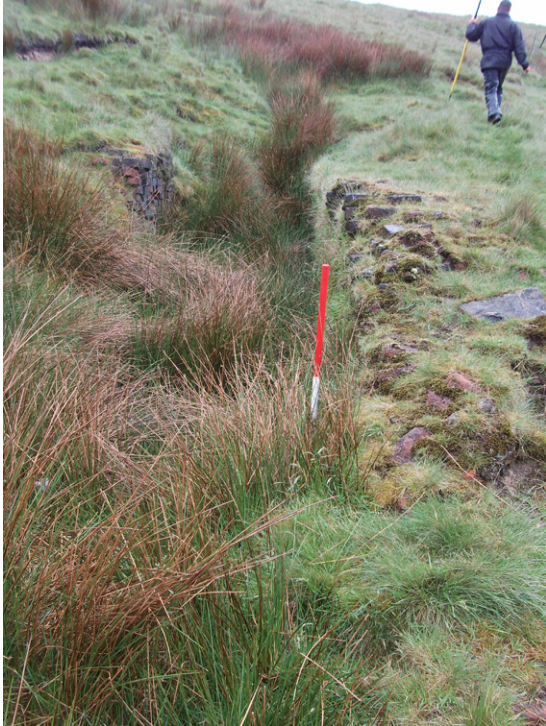
Fig. 13 - Shot of Site 35.12

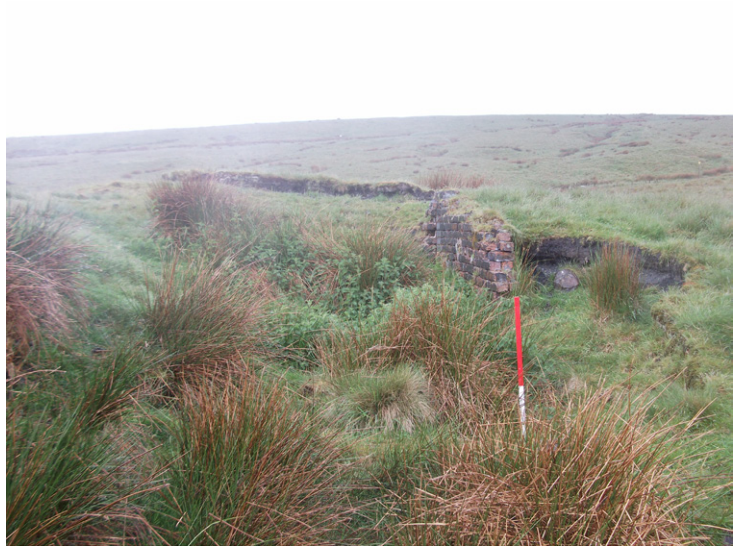
Fig 14 - Shot of Site 35.22

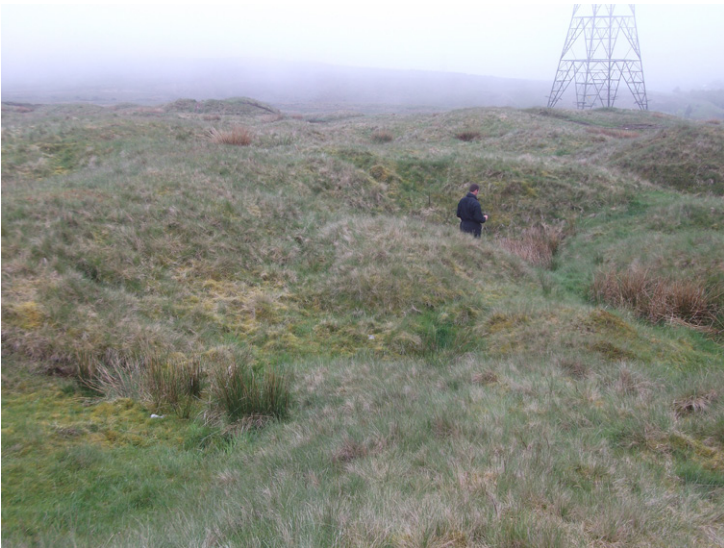
Fig. 15 - Shot of Site 46

| Site No. | Type | Source | Description |
|---|---|--|---|
| 46 | Area of former mine works | Field survey; maps; aerial photography | A large area of former mine workings although some quarrying may have taken place. The area is characterised by many scoops or sink holes which are then exaggerated in height by upcast and surrounding spoil. In total there are greater were least 40 scoops noted. Other features within this area include the continuation of a road from the north of Flower Scar Road which passes N-S through the site (46.1). A bell mouth entrance (Site 46.2) which provided access to the site from Bacup Road and a hexagonal concrete plinth (Site 46.2) adjacent to Site 46.1. The majority of the scoops are located to the east of Site 46.1. The area has been used for off road biking. The abandonment plan 593/3 shows that the area was mined as part of the Clough Foot Colliery. The map shows extensive galleries under this area and the depressions seen at ground level may relate to collapsed galleries underneath. |

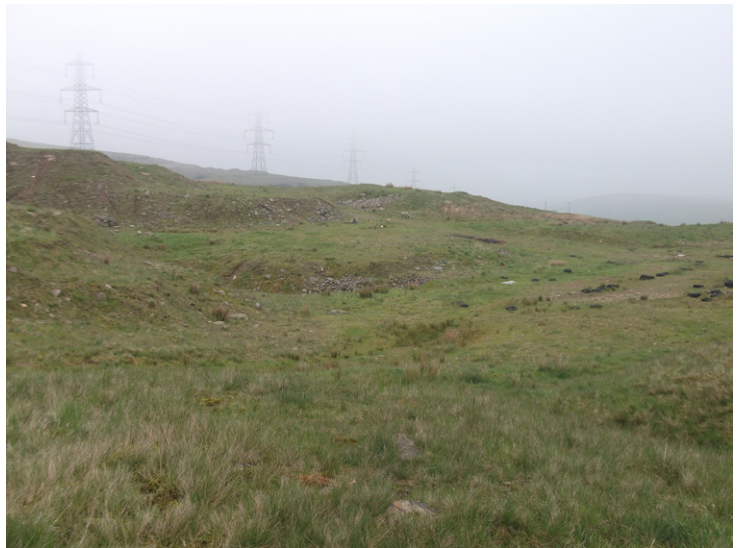
Fig. 16 - Shot of Site 49

| Site No. | Type | Source | Description |
|---|---|--|---|
| 49 | Area of former quarry works | Field survey; maps; aerial photography | A large area of former quarry works. The area had a large number of spoil heaps some of which consist of elongated tips of spoil comprising stone fragments. Some deeper depressions are noted and some of the sides are very steep. Shelving bedrock protrudes or is visible in places. There is an entrance road of concrete construction which runs off the main Bacup road (Site 49.3). The Ordnance Survey, Lancashire and Furness 1:2500 Edition 1893-94 shows this area to be Clough Head Quarry and is annotated as disused. |

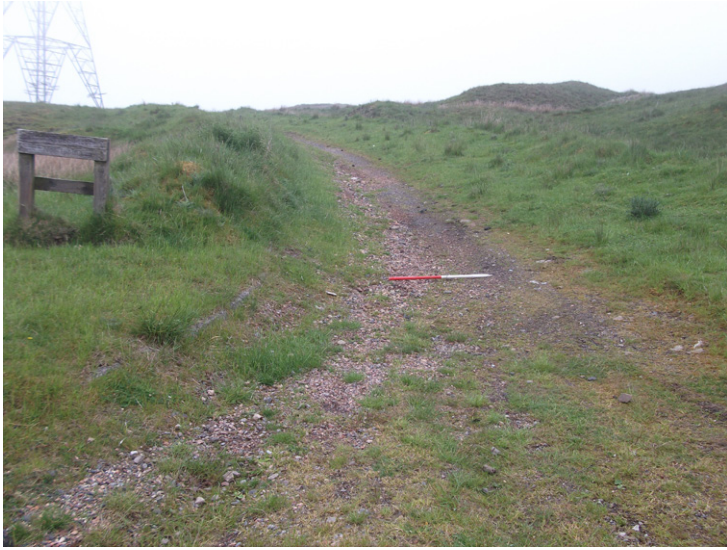
Fig. 17 - Shot of Site 46.1

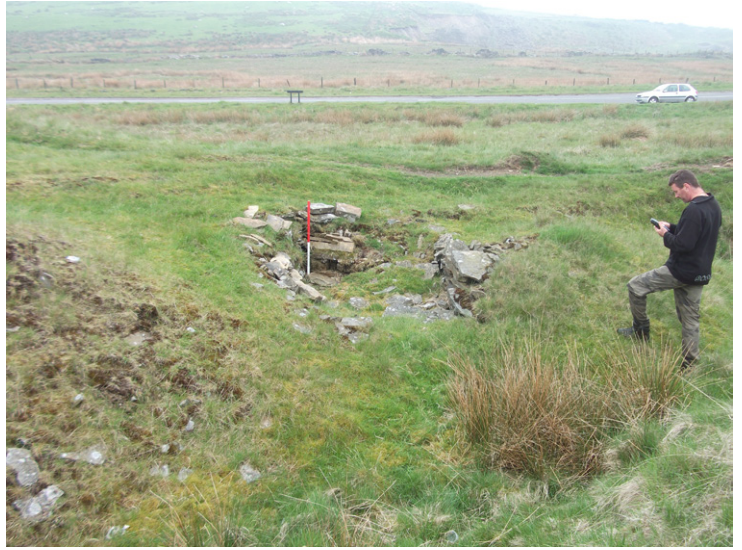
Fig. 18 - Shot of Site 49.8

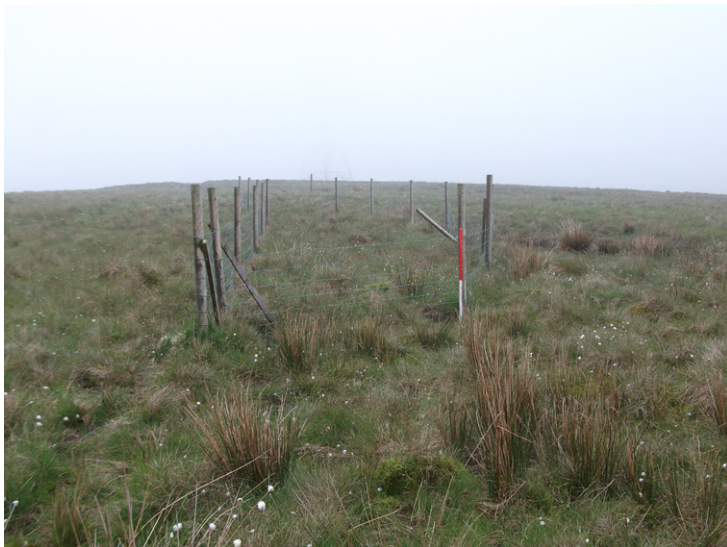
Fig. 19 - Shot of Site 60

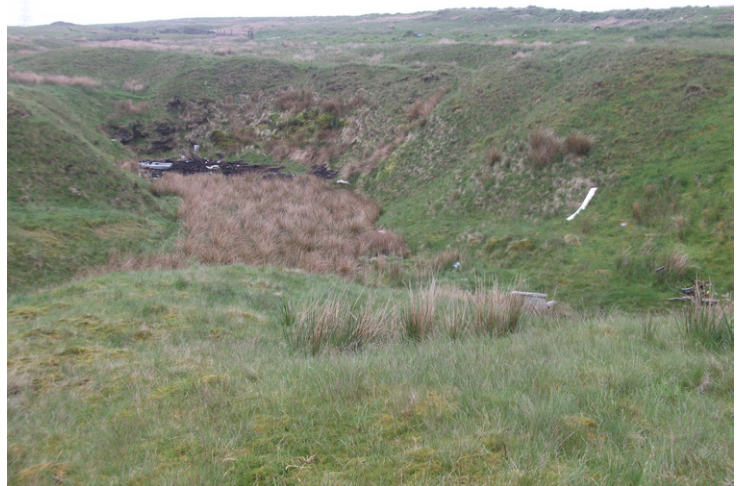
Fig. 20 - Shot of Site 48

| Site No. | Type | Source | Description |
|---|---|--|---|
| 48 | Area of former mine or quarry works | Field survey; aerial photography | The remains of a large man made excavation to the west of the development area, and a series of small scoops. The large feature may be a quarry or pit head and has very steep sides; occasionally vertical. The interior was filled by discarded tyres. A narrow channel provided access to the feature from the west which was heavily overgrown although the partial remains of a revetting wall of drystone construction was noted in places. |

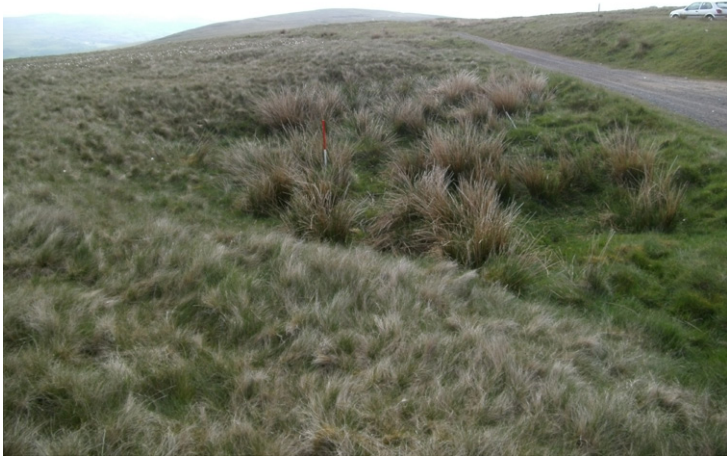
Fig. 21 - Shot of Site 1

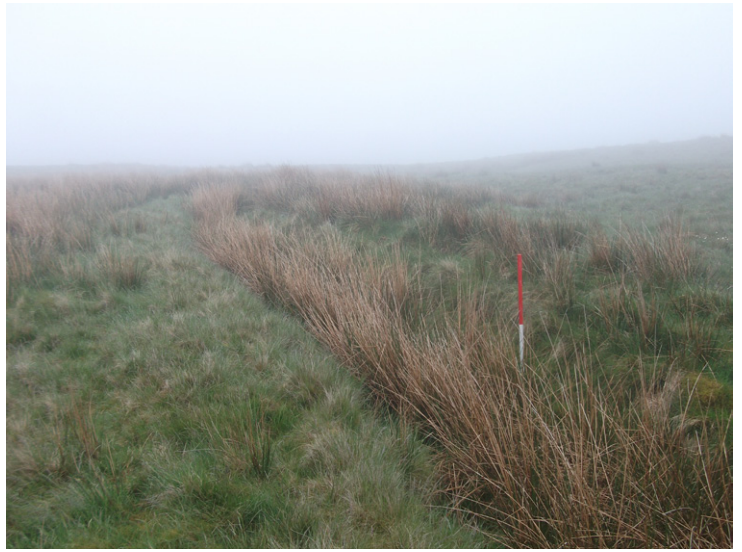
Fig. 22 - Shot of Site 62

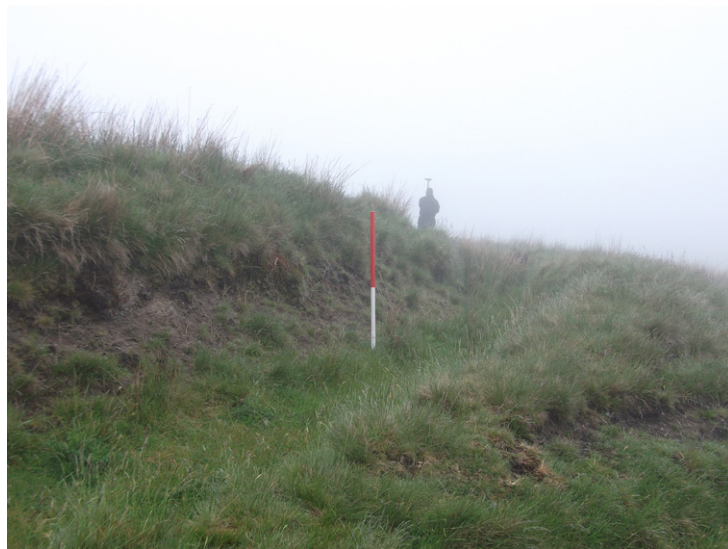
Fig. 23 - Shot of Site 66
