**Land at Hadrians Stud  
Kirkandrews-on-Eden  
Carlisle  
Cumbria**

**Archaeological Watching Brief  
Report No. Y133/14**

**Archaeological Watching Brief**

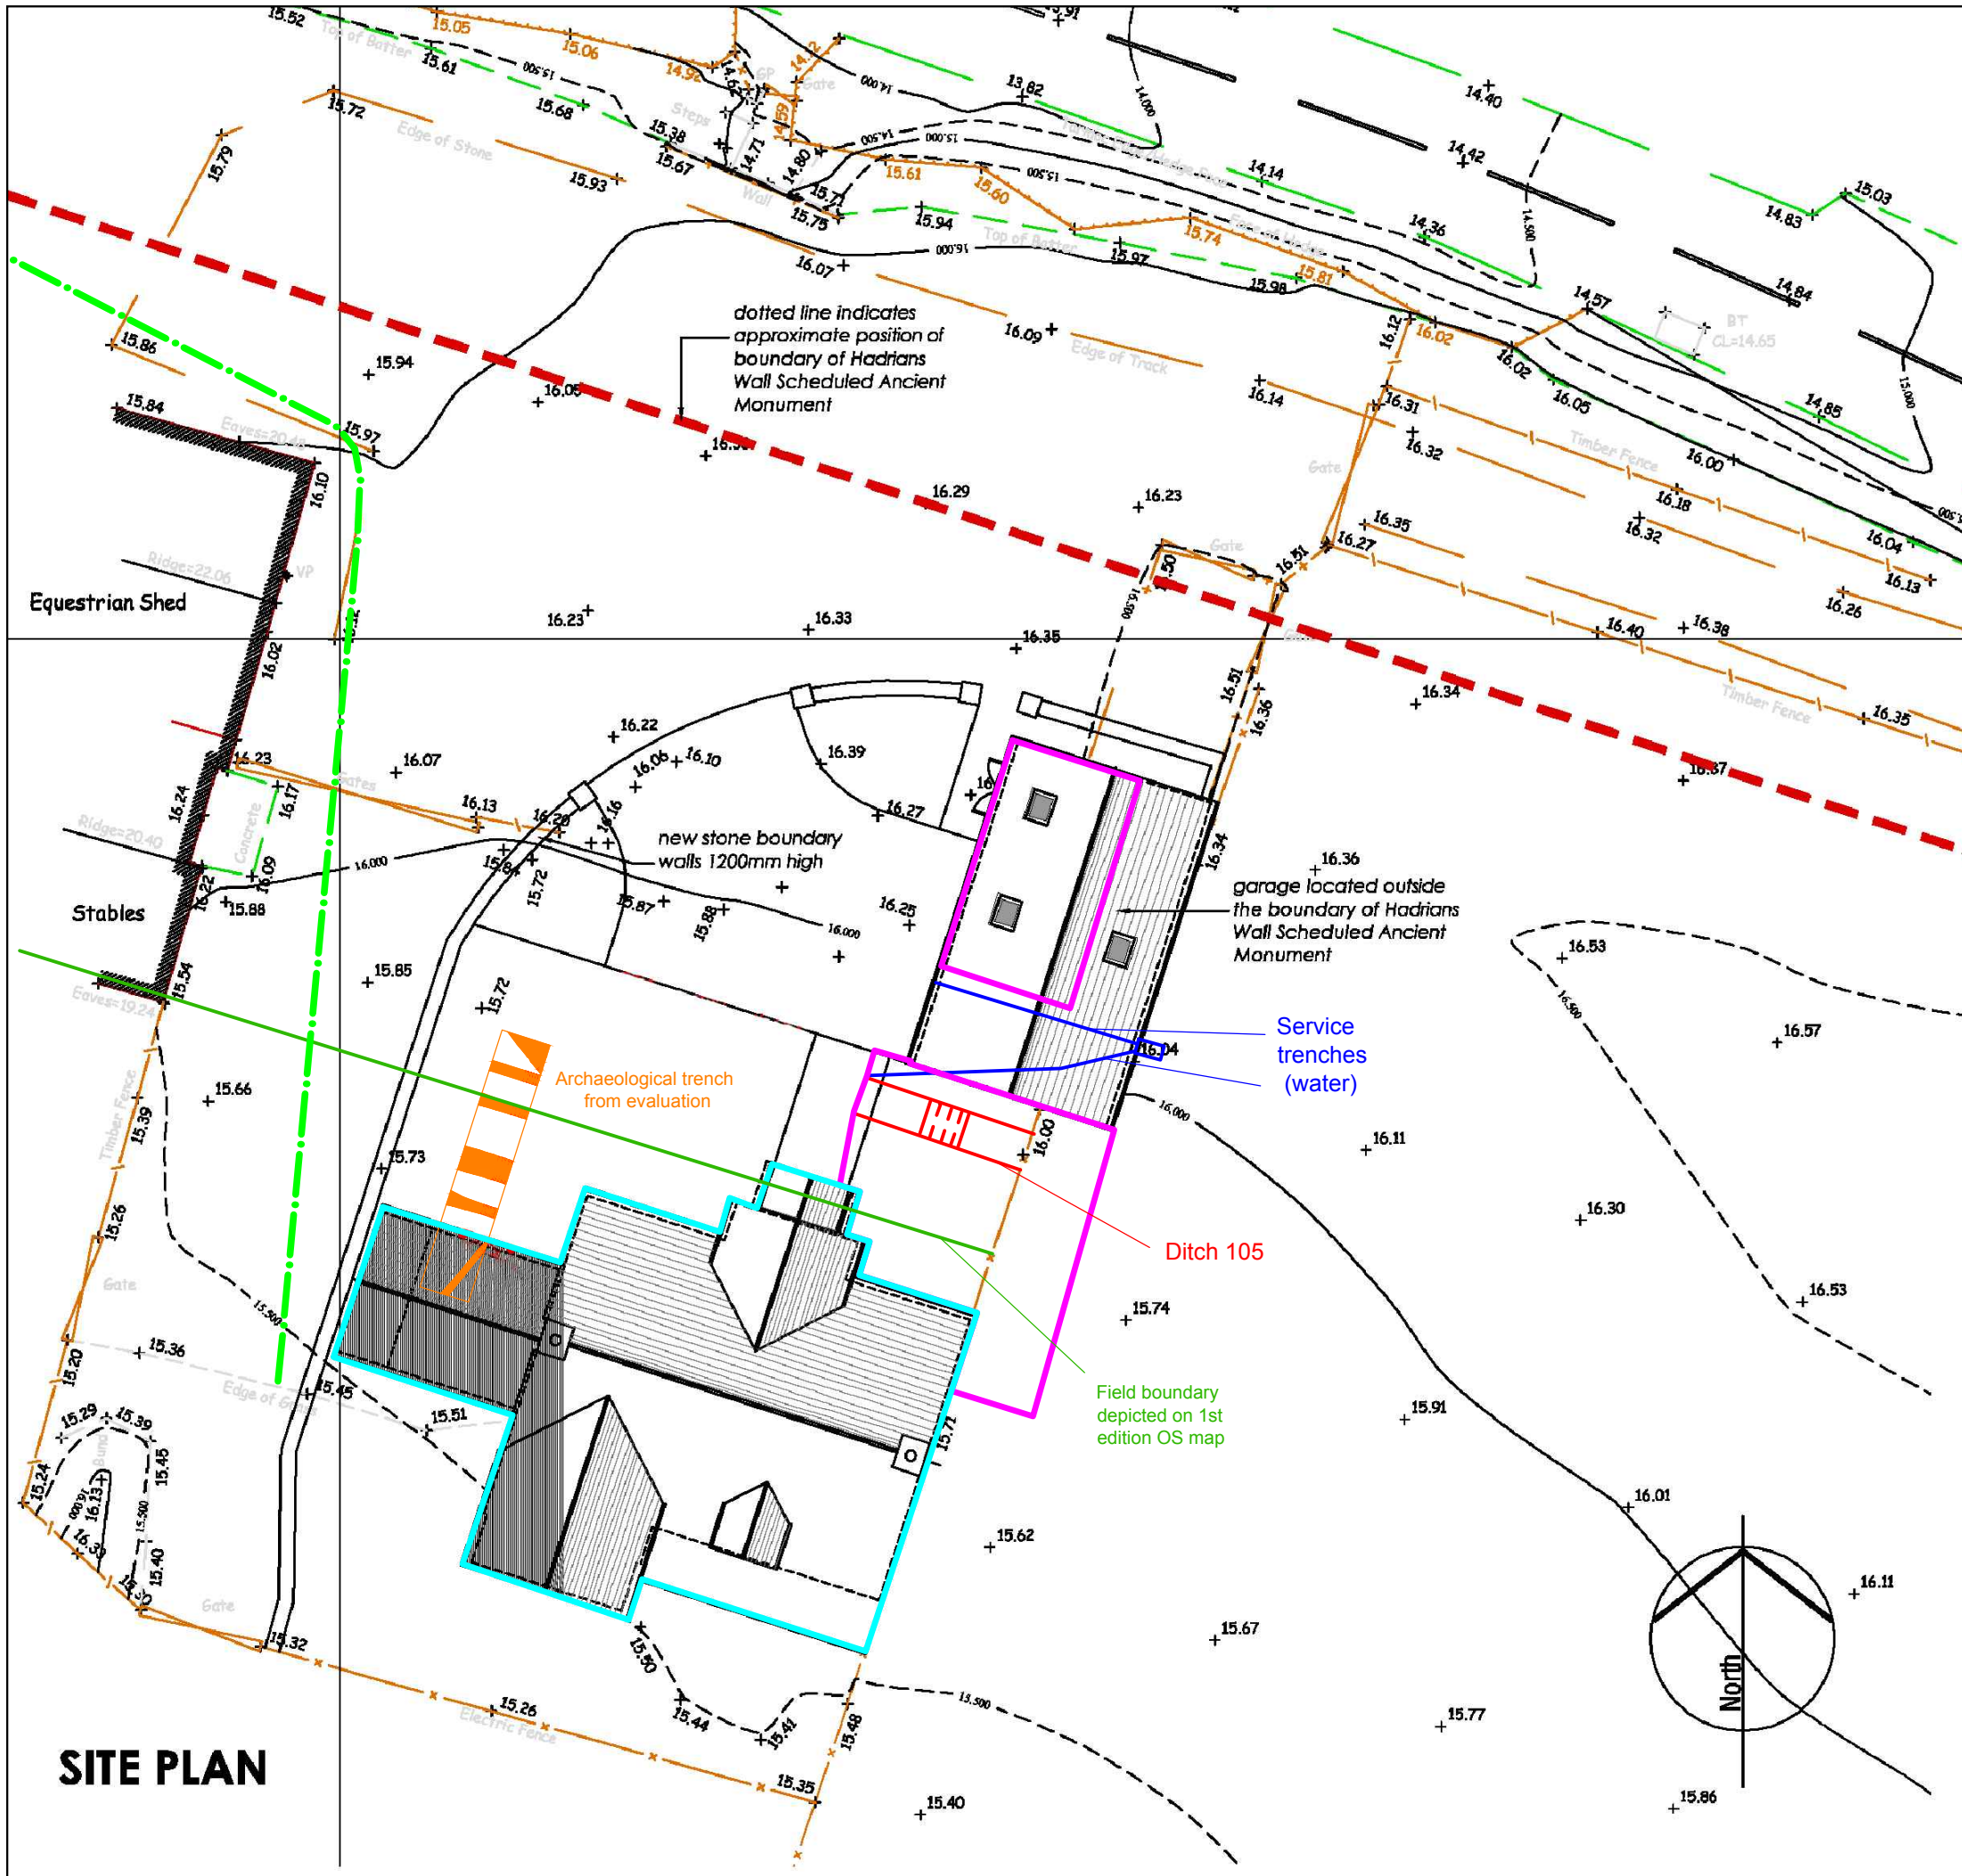
Fig. No:	2	Revision:	A
Title: Plan of areas stripped and sections			
Project: Land at Hadrian's Stud, Kirkandrews-on-Eden, Carlisle, Cumbria			
Client: Lloyd Ltd and Lloyd Motors Ltd			
Scale at A3: Plan, 1:200, Sections, 1:40

The foundations for a new building were excavated with the position and stratigraphy of these trenches fully recorded (Fig. 2).

SE facing section of ditch 105

Sample section of water service trench

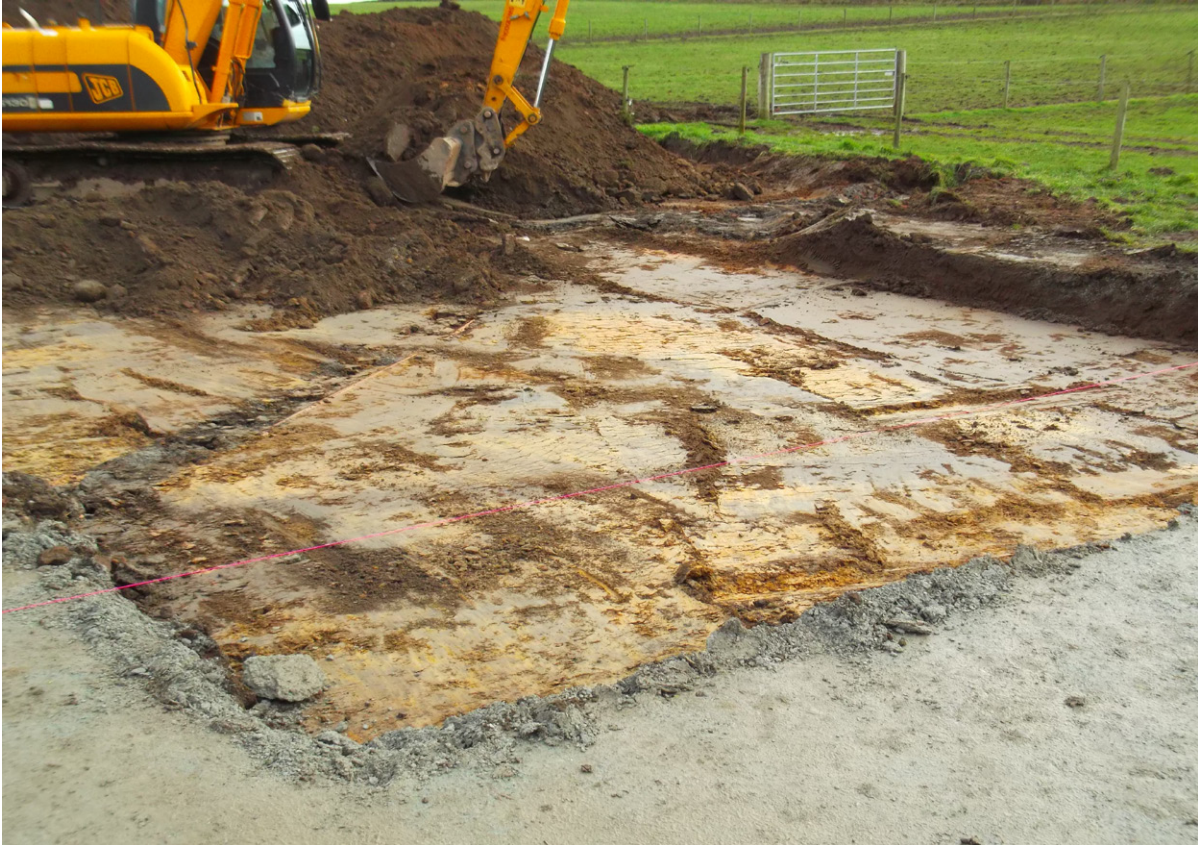
Prior to the excavation of foundation trenches the site area was stripped of all topsoil and subsoil down to the natural substrate to provide a firm working area (Plate 1). No archaeological features were visible during this strip, with only a number of modern land drains related to a previously existing caravan and the existing equestrian building noted during this process.

Plate 1: General site shot taken after topsoil strip, south facing shot

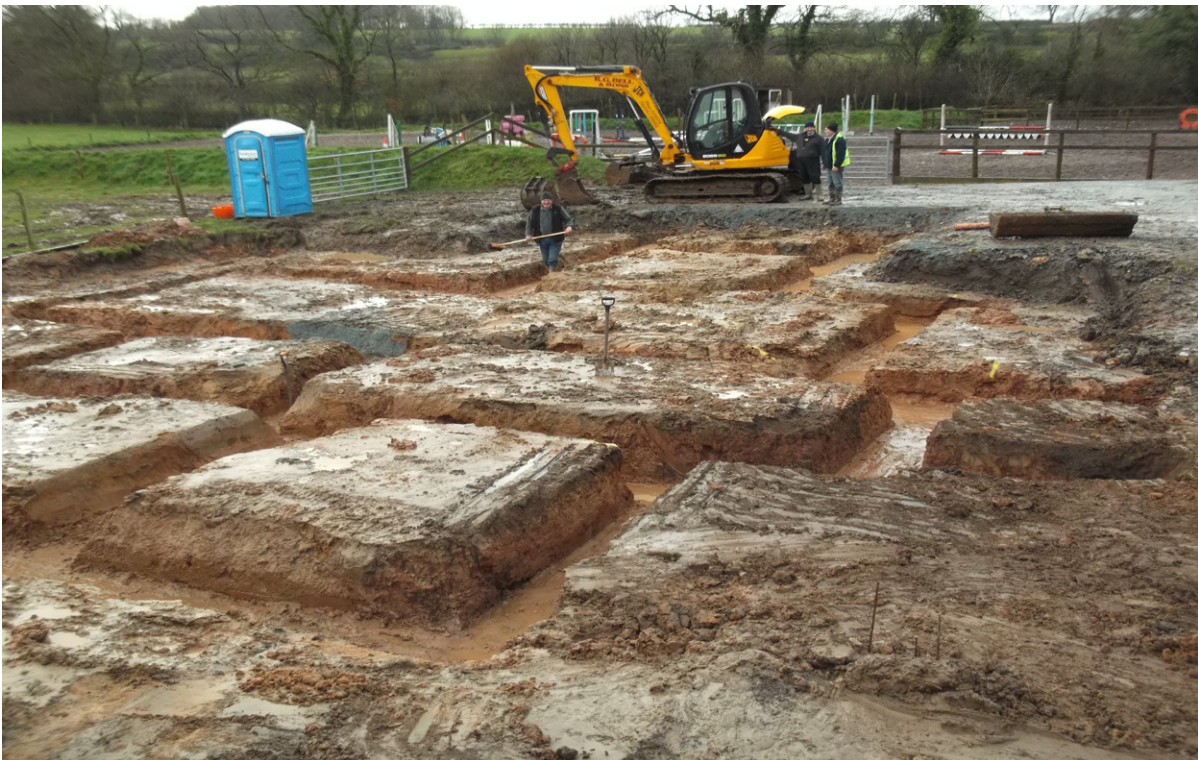
Foundation trenches were then excavated for the new buildings on the site (Fig. 2), with the majority of these having a depth of 0.5m (Plate 2).

Plate 2: Site after excavation of foundation trenches, south-west facing shot

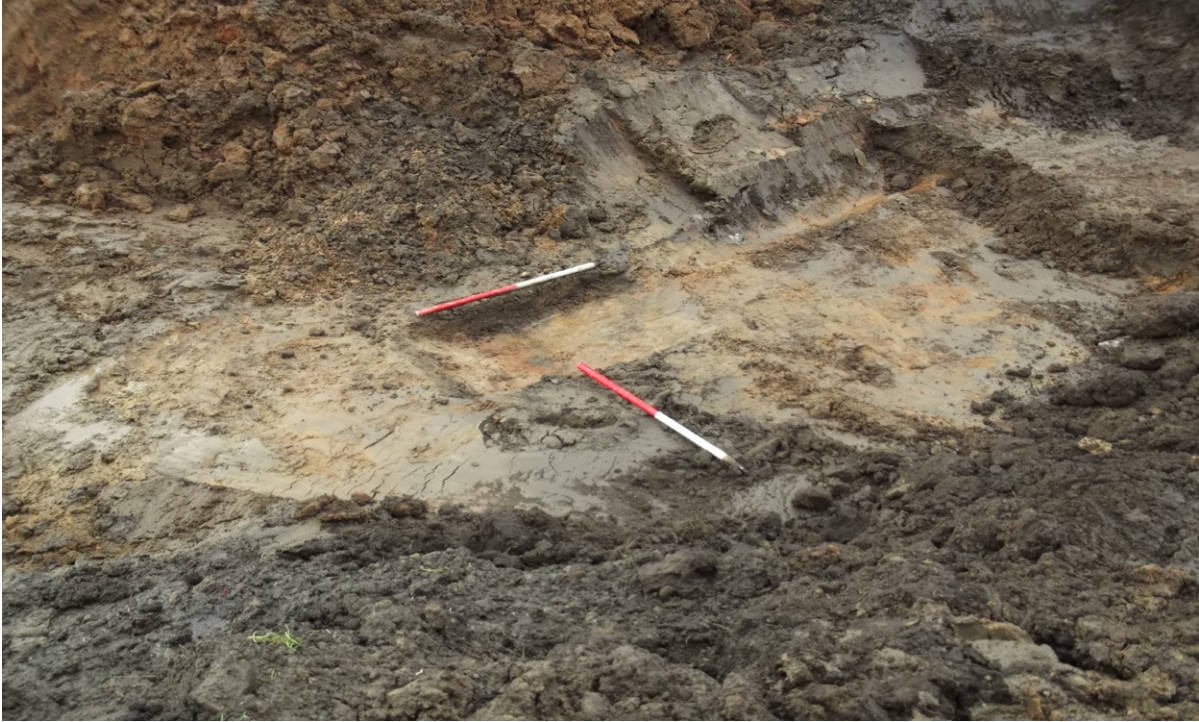
To the north of the foundations area a shallow, roughly north-west to south-east orientated ditch (Plate 3, 105) was excavated. This ditch measured 1.15m in width by 0.15m in depth and was filled by dark brown silty clay (104). No finds were recovered from this feature. The alignment of the feature is similar to those of the shallow ditches recorded during the previous evaluation of the site, and it is likely this feature is contemporary with these, and as such represents evidence of earlier farming practices.

Plate 3: South-east facing section of Ditch 105

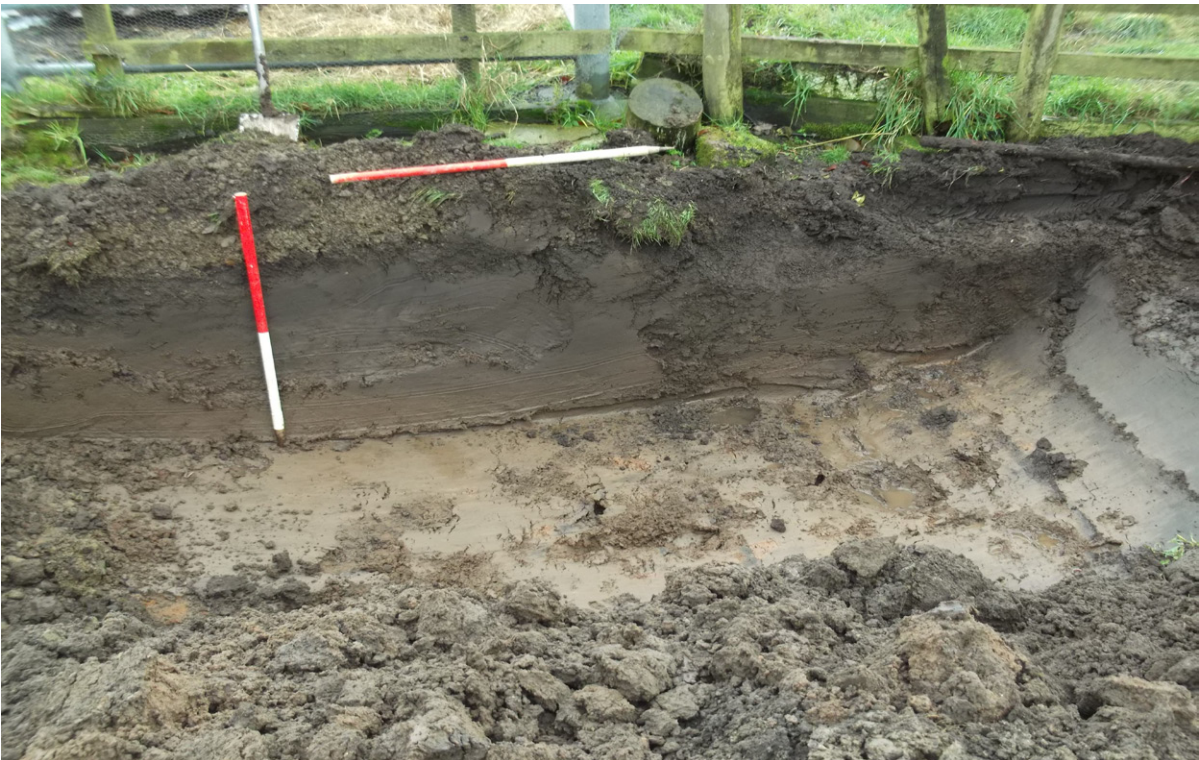
The area of the new a garage was disturbed by a modern water pipe running through it. Here the topsoil had been sealed by a layer of stone hardcore (103) that formed the existing yard surface for the equestrian centre (Plate 4). No archaeological remains were recorded in this area.

Plate 4: West facing section of stratigraphy of proposed garage area

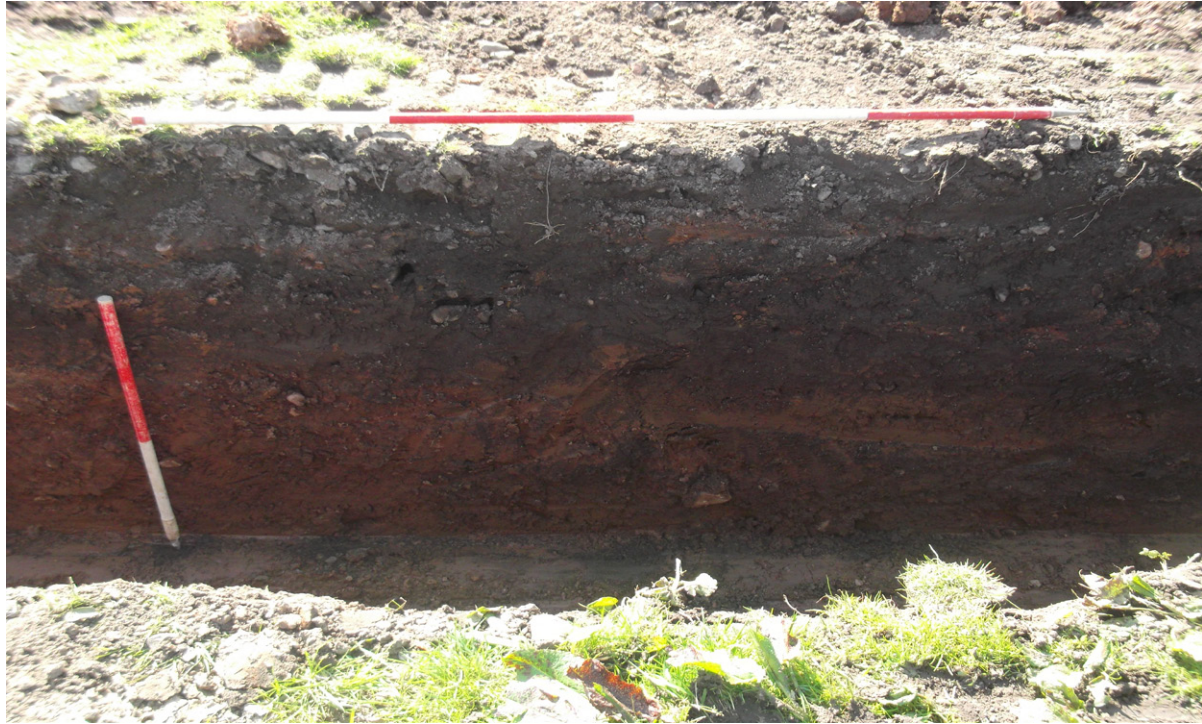
A service trench was dug for a number of pipes from the proposed new building towards the current road location (figs 1 and 2). This trench was 1m in width and was dug to a depth of 1m below the current ground surface (Plate 5).

Towards the south of the trench the ground had been heavily truncated by recent building work and the inclusion of two modern service pipes (water and sewage) that fed the previous buildings in the area.

The northern extent of the service trench crossed into the boundary of the scheduled monument of Hadrian's Wall and sloped towards the current road. Towards the northern end of the trench the depth increased to 1.8m. Here there was evidence for modern dumping of redeposited natural material and gravel hardcore in order to form a level platform, with the earlier topsoil and subsoil sealed below. No archaeological features were identified below this sealed subsoil layer.

Plate 5: East facing section of service trench within property area

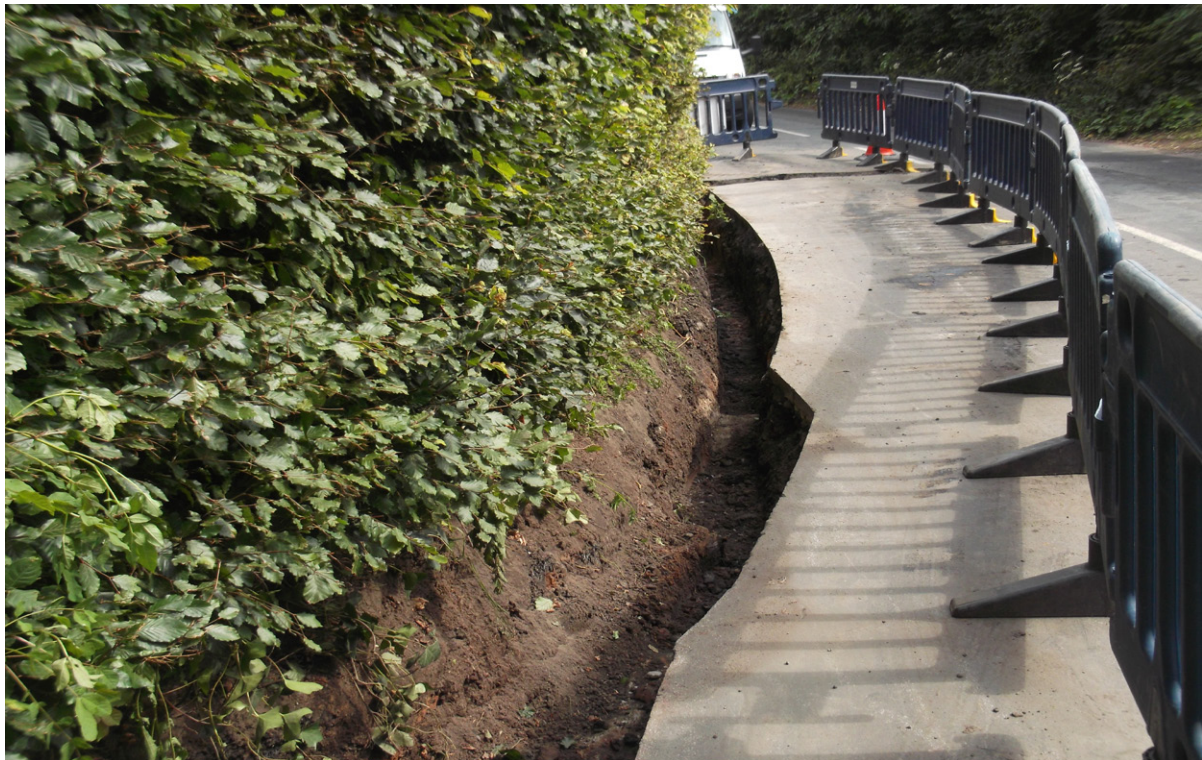
The service trenches within the existing road were dug to a depth of c.0.4m and were targeted on existing services in the area (Fig. 1 and Plate 6). These areas had been truncated by the installation of the original gas and electricity pipelines, and no archaeological features were recorded in these areas.

Plate 6: Service trench within existing road, looking south-east
