Mosstown Water Main Elgin, Moray

Watching Brief

May 2007

Report No.	HAS070610
Project	HAS-MWM07
Client	Halcrow Group Ltd
Planning Ref	N/A
Date / revised	10 August 2007
Author	John Wood

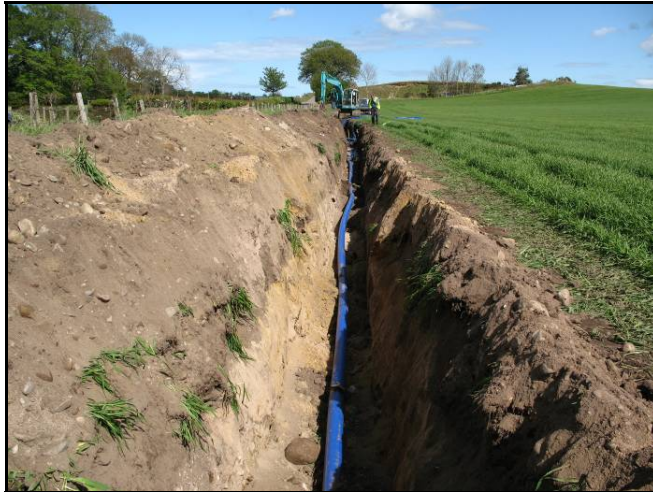
Figure 4 View E on arrival from W edge of field, showing open trench

The following day (16 May) she attended again, and noted that the trench already opened but not yet backfilled was 1.0m wide at the top; 0.45m wide at the bottom; with a maximum depth of 1.15m (See Fig 4). This was inspected but no archaeological features could be seen.

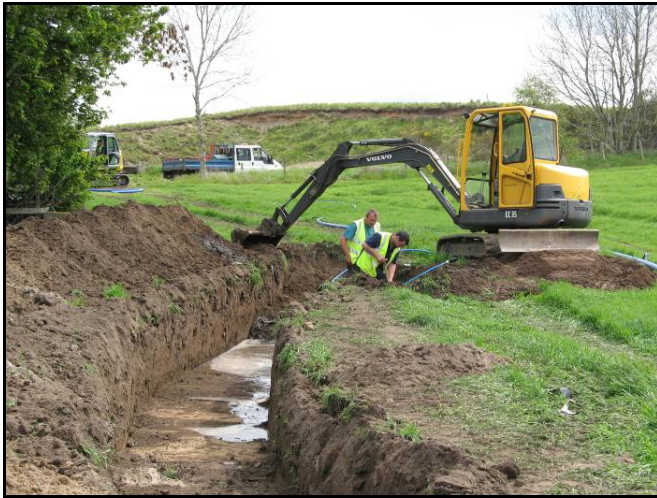
A back-acting digger fitted with a straight-edged ditching bucket was then used to continue the open trench under archaeological supervision, with 1 archaeologist watching one excavating machine. This section of trench measured 1.4m wide x 0.9m deep, and cut through clean plough-soil onto pale sand. Unfortunately, the contractor accidentally cut two existing water mains, flooding part of the trench (See Fig 5 below).

Figure 5 Excavation of watching brief trench - repairing water main

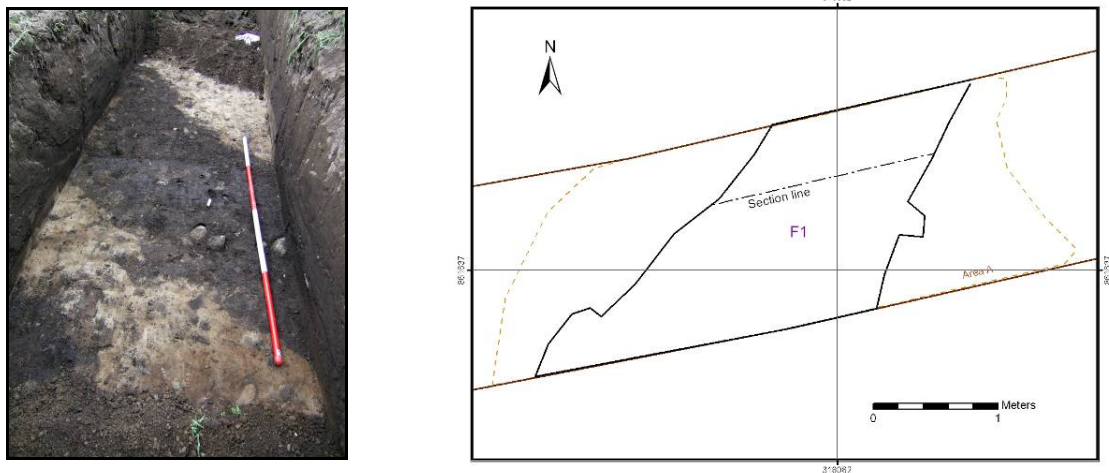
Figure 8 Feature 1: sketch plan and photo before excavation

A linear feature, crossing the trench. This was the most clearly defined feature recorded. A section was therefore cut, set out 53cm from N side of the trench (see Fig 5). The feature was found to be 24cm deep x 130cm wide. Its water staining, pebbles, and irregularity strongly suggest a natural watercourse. No dating evidence was found. The fill was of mixed silt with topsoil and much water staining.

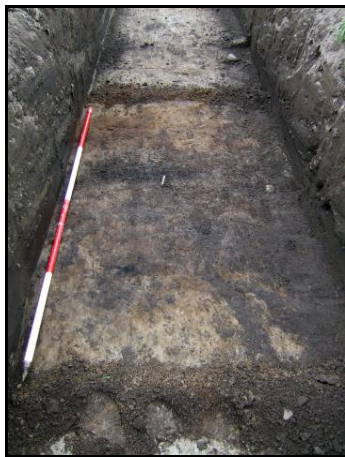
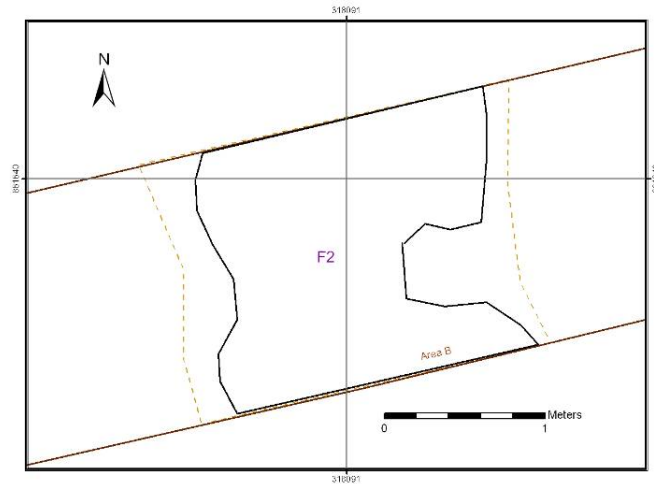
Figure 10 Feature 2

An ill-defined area of dark staining with indications of possible burning. This had a maximum depth of 2cm. No finds or other diagnostic evidence.

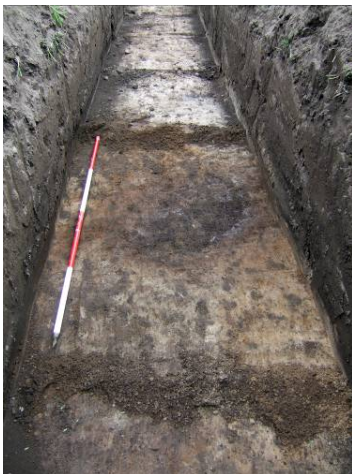
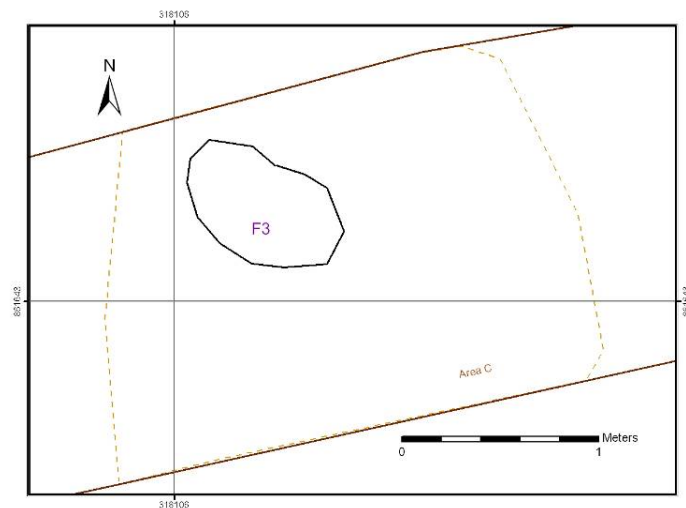
Figure 11 Feature 3

A roughly oval burnt area in the surface of the subsoil. The maximum depth was 3-5 cm. No finds or other diagnostic evidence.

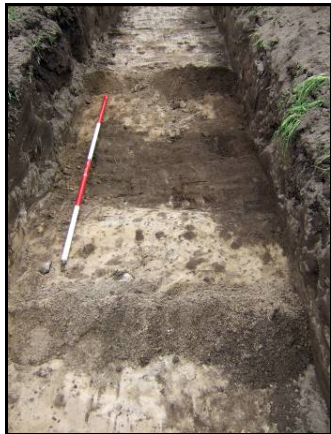
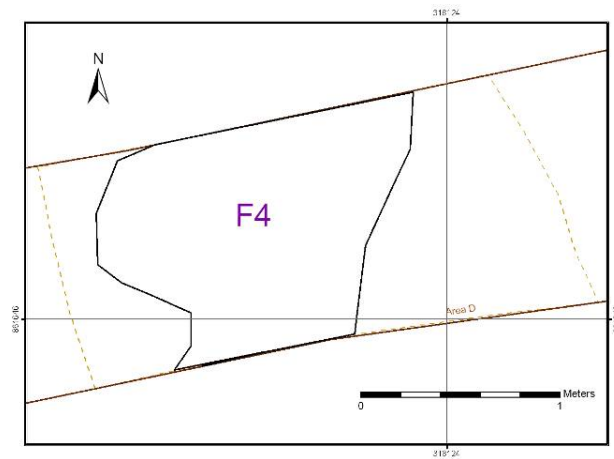
Figure 12 Feature 4

An ill-defined and irregular linear feature, crossing the trench. (see Fig 8). This feature was found to be only about 10cm deep x up to 130cm wide. No dating evidence was found and with its shallow profile it appears to be a natural hollow or former watercourse. The fill was of topsoil.

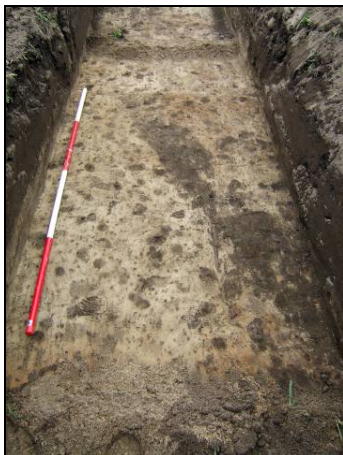
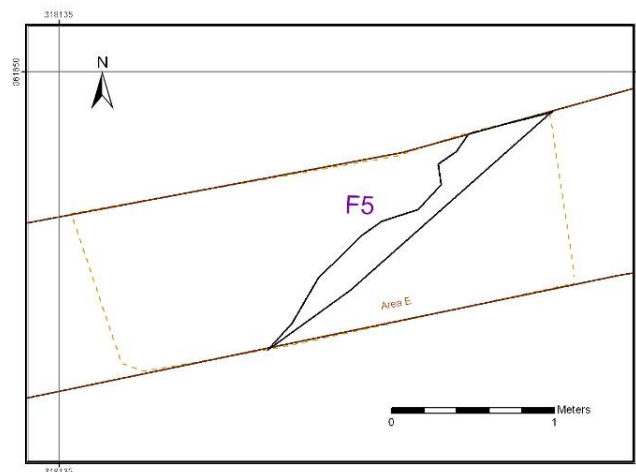
Figure 13 Feature 5

A feature showing as a cut filled with darker topsoil, well-defined to W, shallow to E. This was investigated and interpreted as the result of deep ploughing for drainage.

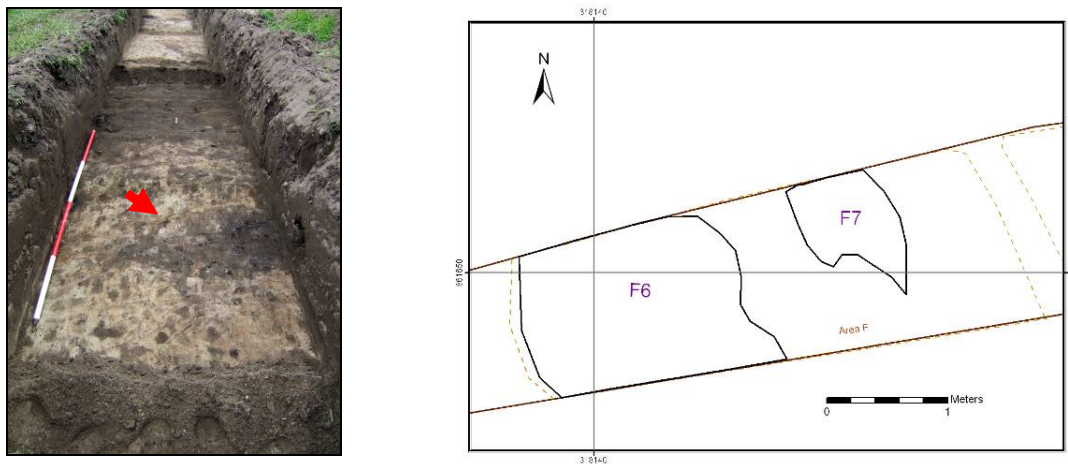
Figure 14 Features 6 and 7 (arrow)

F6 was a spread of topsoil, containing some small fragments of charcoal and wood, as well as corroded iron and slag in the surface, in addition to burnt, crumbling sandstone fragments and very small fragments of charcoal. However it appeared on further investigation to be a remnant of topsoil, and the material in it appeared to be related to steam ploughing. See Fig 11 below.

F7 was an ill-defined, dark red and black burned patch (see Fig 11, arrow).

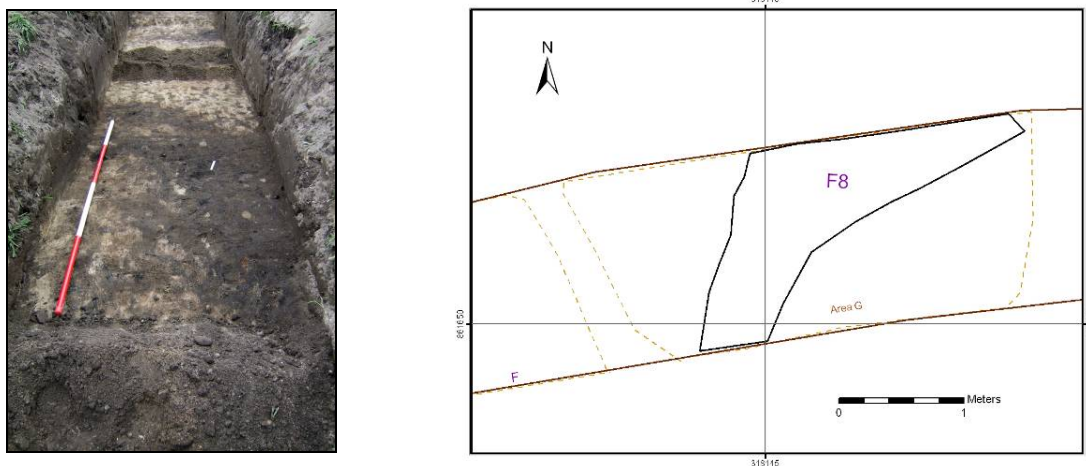
Figure 15 Feature 8

An ill-defined, dark red and black patchy area, containing some small fragments of charcoal and wood. This was cleaned and investigated and found to have a maximum depth of 2-3cm representing an area of burned subsoil. The interpretation was unclear but it did not represent a cut or structural feature.

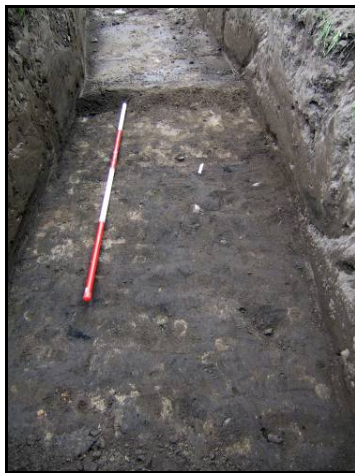
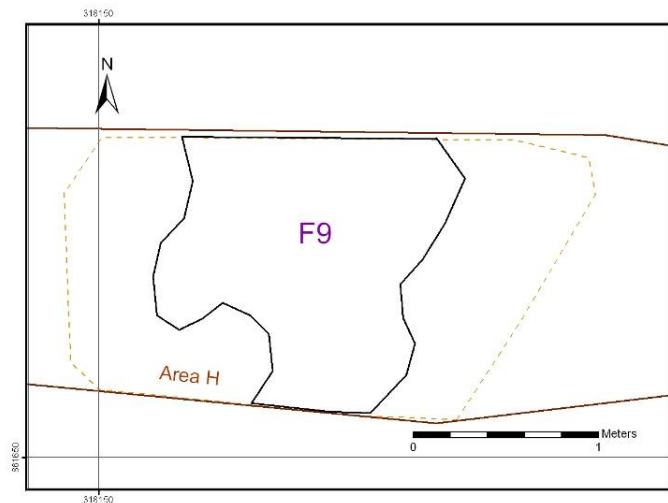
Figure 16 Feature 9

An ill-defined, dark red and black patchy area, containing some small fragments of charcoal and wood. This was cleaned and investigated and found to have a maximum depth of 2-3cm representing an area of burned subsoil. The interpretation was unclear but it did not represent a cut or structural feature.
