Highland Archaeology Services Ltd

Field Monitoring

Kyle Water Main Renewal

Report No.	HAS070711
Project code	KYL07
Client	Halcrow PLC
Planning Ref	N/A
Date / revision	14 August 2007
Author	John Wood

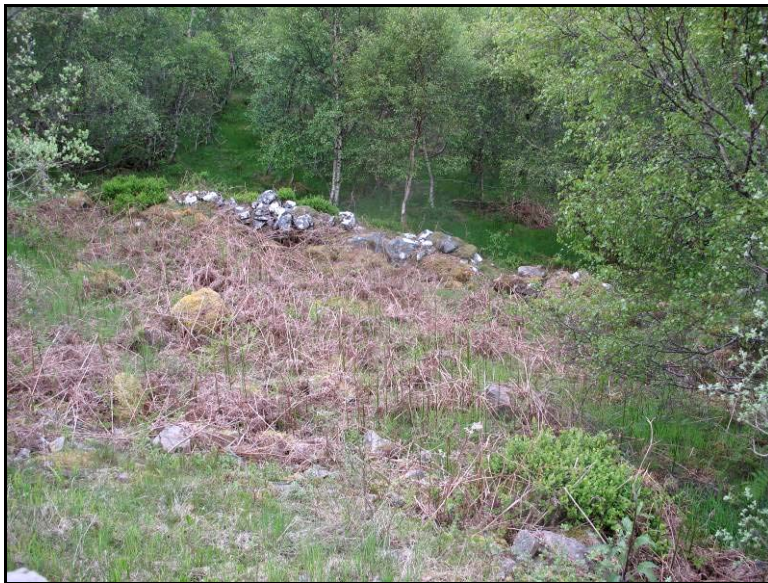
Figure 2 Dyke recorded N of pipeline route – possibly SMR NG73NE0054?

SMR NG73SE0054 Coire A' Mhuilt

A boulder dyke was noted north of the pipeline route (See Fig 2 above). This may be the dyke referred to in the records. A dyke was also found cut by the pipeline as it left the public road (see photographs 1055-1060). It is not clear whether or not these sections of wall join as the area between these points is covered by trees and very thick undergrowth.

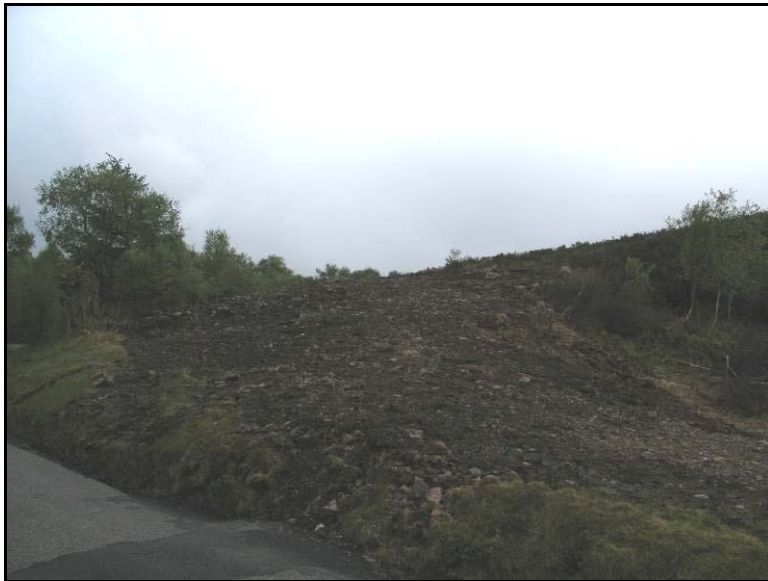
Figure 7 Backfilled pipeline leaving road towards Treatment Works

The north-western end of the water main is at the Kyle Water Treatment Works. Archaeological survey and excavation was carried out there in 1999 and 2000 by CFA, who noted the potential for further archaeology nearby (see above). Unfortunately it did not prove possible to observe the water main excavations in this area. We carried out a further excavation prior to construction of an extension to the Treatment Works in July 2007, but this did not locate any new features there (See Report HAS070802).

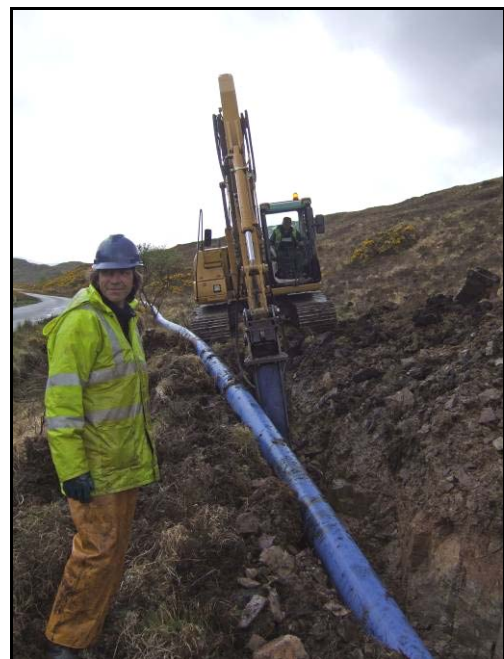
Figure 8 Excavation of pipe trench N of Balmacara - Duirinish road

Buried sites could occur almost anywhere within the peat moorland, so there was believed to be some potential in the section north of Balmacara. However the soils were found to be very thin and much of the water main had to be excavated through bedrock (see Fig 8 above).

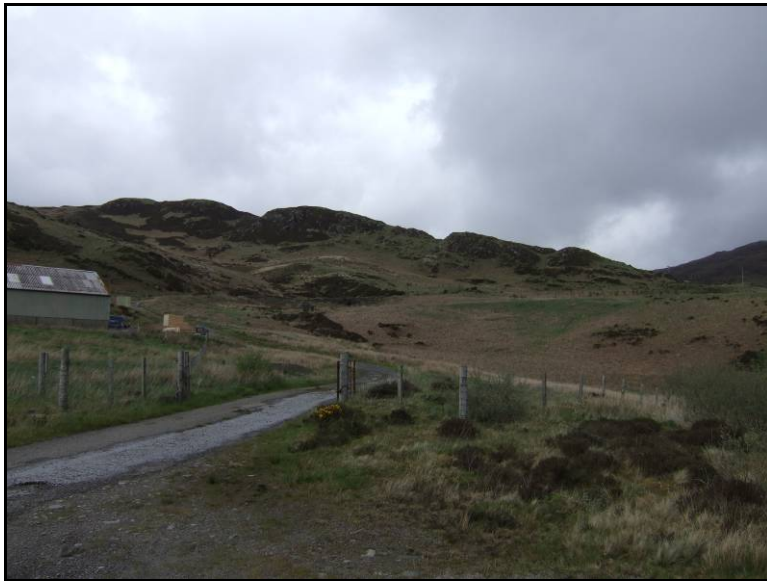
Figure 9 Old road N of Auchtertyre, before excavations

The line of the new pipe runs along a section of old road just north of Auchtertyre, where it was thought recorded Bronze or Iron Age roundhouses and field systems could be affected. However excavations for the pipeline in this area were observed in July 2007 and the line taken did not affect any archaeological sites.

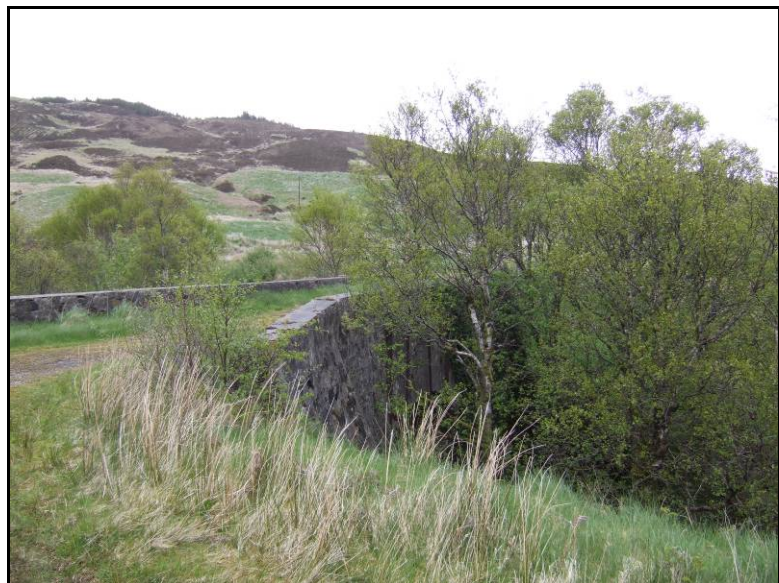
Figure 10 Old road bridge and view towards Carn Fada

Surveys have noted some features near the north-eastern end of the pipeline south of Carn Fada. It was difficult to establish from the records whether these would be affected, but a site visit clarified that these were well away from the proposed works.
