Edintore Wind Farm

Cultural Heritage Baseline Survey (Direct Impacts)

Summary of Findings and Recommendations

Client	Cube Engineering for Vento Ludens
Date (revision)	21 April 2010
Report No.	HAS100306
Project	HAS/EDT10
Author	John Wood

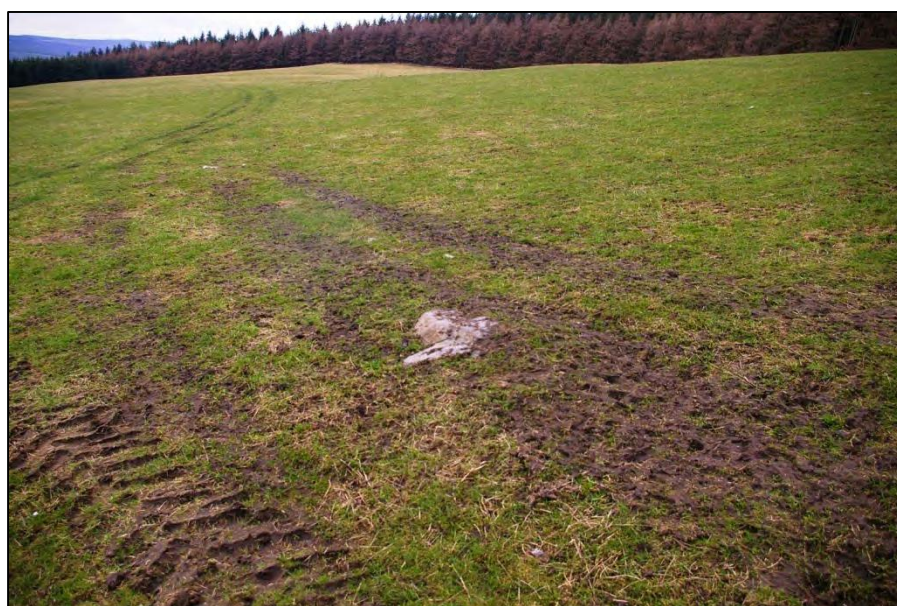
Plate 1 Bedrock visible

The site was found to occupy improved arable and pasture land where any archaeological evidence is likely to have been severely truncated by many years of ploughing. This was interspersed with coniferous woodland and shelter belts. Extensive stone heaps within the edges of these wooded areas indicated past field clearance and the removal of former dry stone walls to be replaced by post and wire fencing. Soil depth appears variable, with bedrock apparently visible at one location.

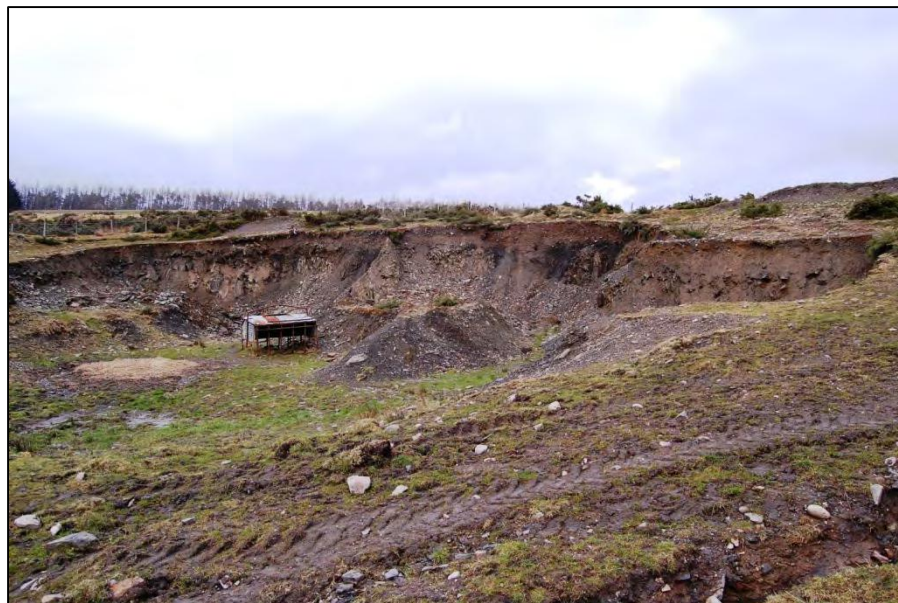
Plate 2 CH2: Quarry

This quarry is apparently entirely 20th c. in origin and still in use. There are no archaeological concerns.

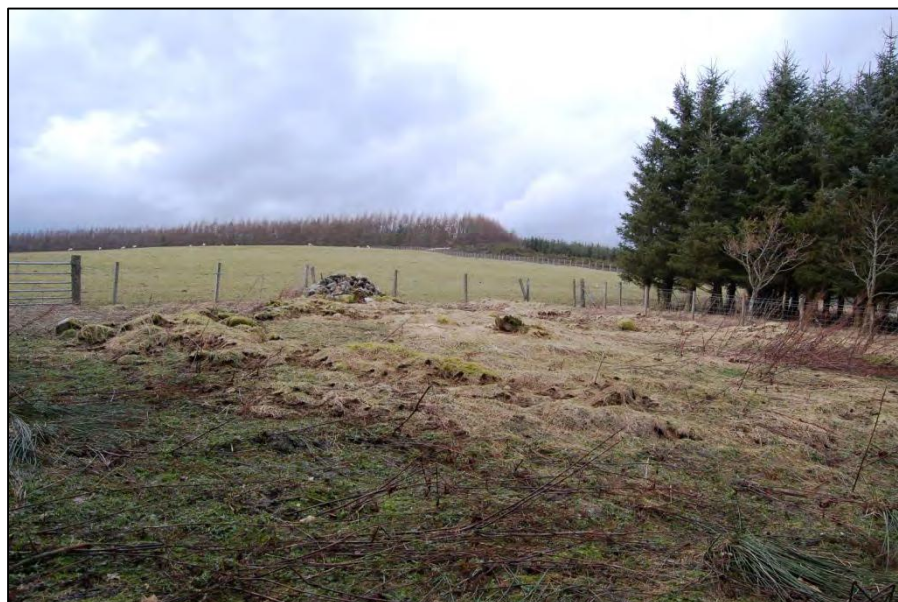
Plate 3 CH3: Former Cairn

This cairn is almost completely destroyed. The stone has been removed, probably for building the drystone walls that themselves have now been removed. Some of it is in a heap by the fence. It seems likely that it has also been planted over with conifers although the trees have subsequently been cleared. Although this site is very damaged, its presence could indicate the existence of associated, buried features or artefacts nearby so a precautionary watching brief is recommended for turbine 5 and the access track in this area.

In view of the presence of one, possibly two cairns (features CH3, CH8) in the vicinity of turbines 4 and 5, topsoil removal for the access road, turbine bases, cabling and crane standings should be subject to a precautionary archaeological watching brief.

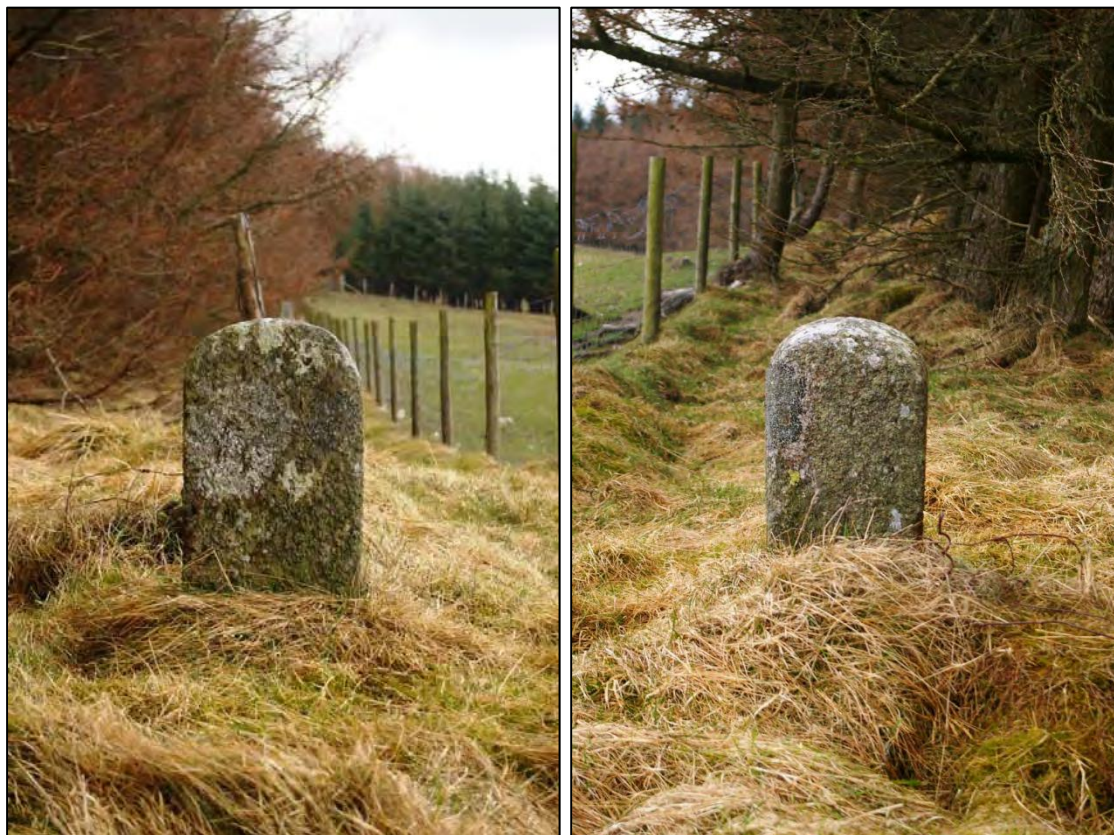
Plate 4 Boundary Stone CH4

These appear to date from the early – mid 19th c.. They have a flattened front and a more rounded back face but no sign of any carving or lettering. Stone CH4 faces west, while CH5 and CH6 face

south, so it seems they define the southern boundary of the block of woodland on Caird's Hill to the north of the site. CH7 was inaccessible at the time of the survey.

Left: from west; right: from east.

Direct impacts on recorded cultural heritage features are not expected, although there is always some potential for buried archaeology in farmland. The boundary stones should be clearly marked and safeguarded to avoid damage during construction work.
