Witley Court

The Excavations

1996

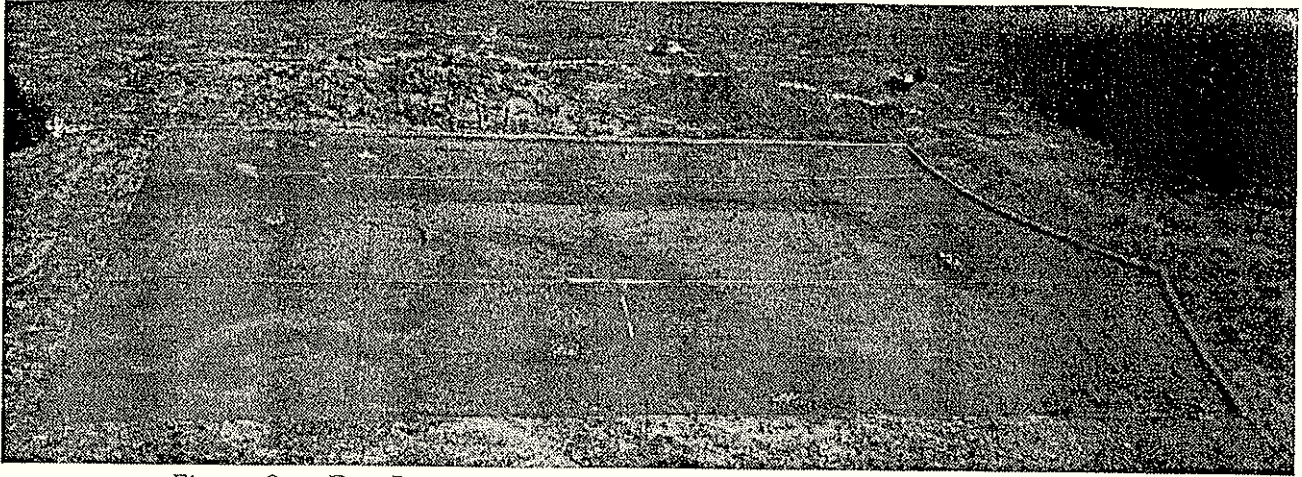
Figure One: East Parterre, tower shot of EPA after deturfing and initial cleaning

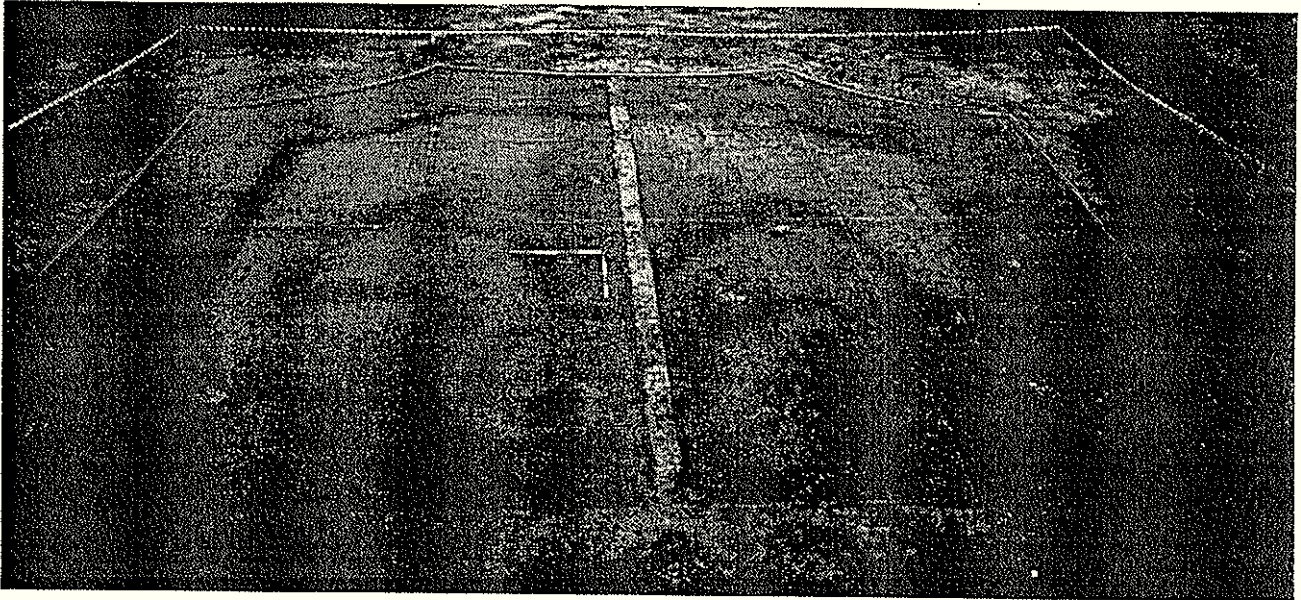
Figure Two: East Parterre, EPA and EPB after deturfing and cleaning

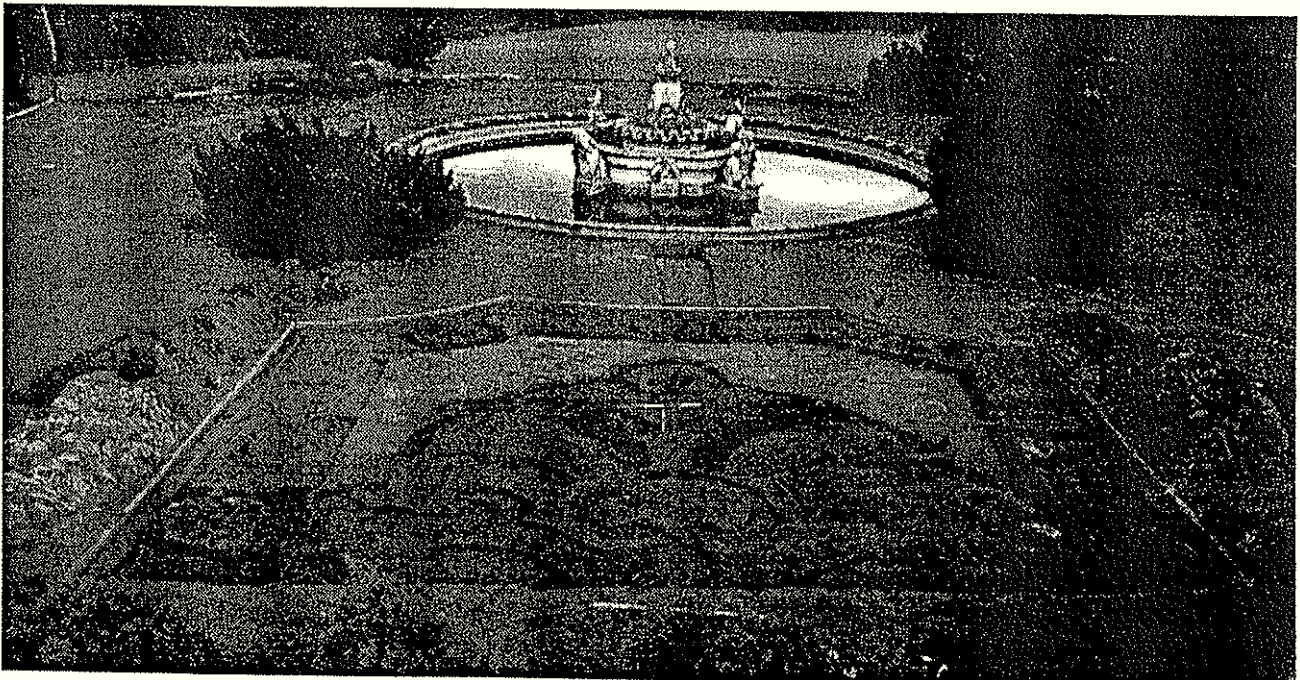
Figure Three: Completed excavation of East Parterre showing all features

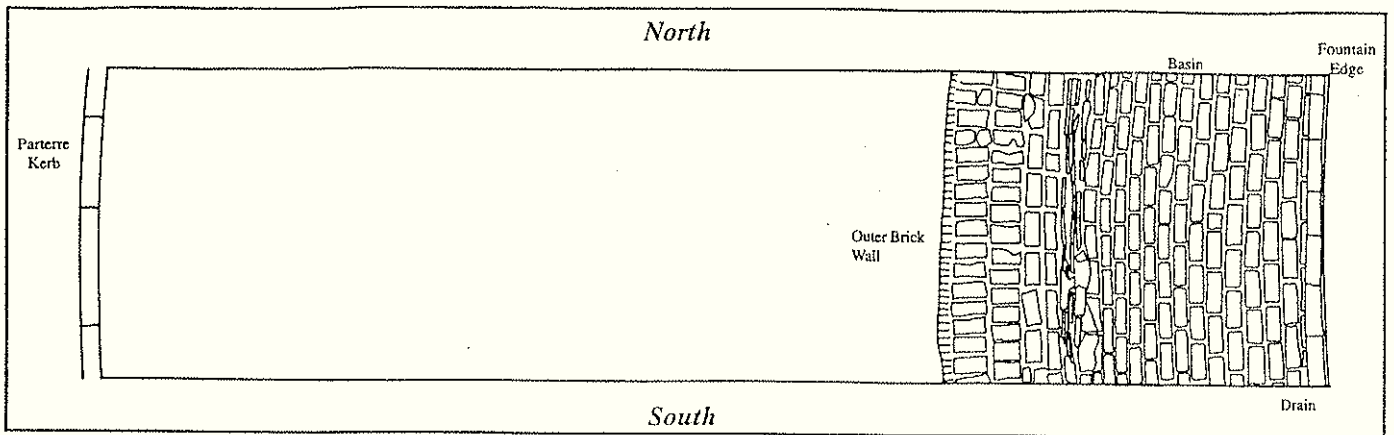
The construction of this larger bowl consisted of a brick built outer wall, some 0.7m thick, which had been demolished to well below ground level. The exterior course had been laid headers outwards, as had the next inner course. The two inner courses of brick were laid as stretchers.

Figure Nine: Plan of T3 showing demolished fountain basin, 1:50

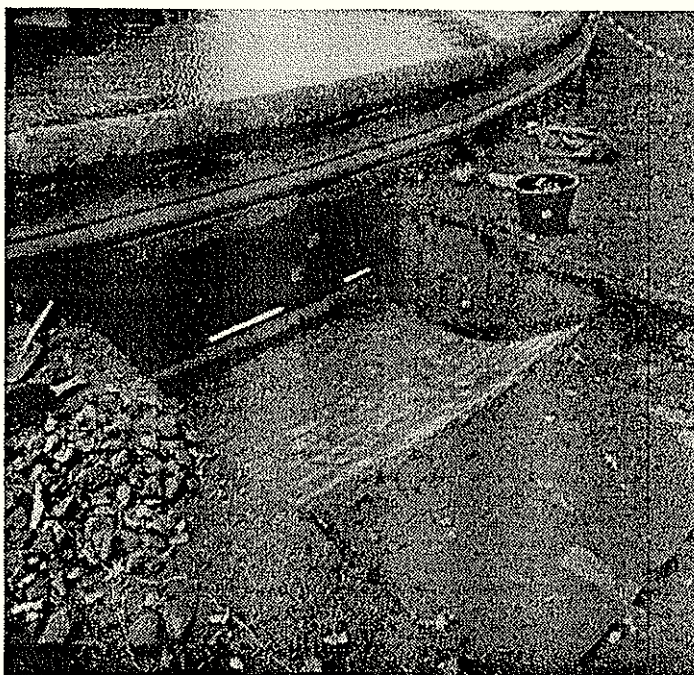
Figure Ten: Bowl of Fountain showing Ceramic Drain

At the junction of the base of the current fountain and the larger bowl beneath there was a round ceramic drain mortared into position, Figure Ten, presumably this drain must break out of the larger bowl at some point and is intended to prevent soil becoming waterlogged around the fountain perimeter. The existence of this fountain bowl was unknown prior to excavation and raises some questions as to why it is there. To date there has been no documentary evidence to suggest that there was an ear-

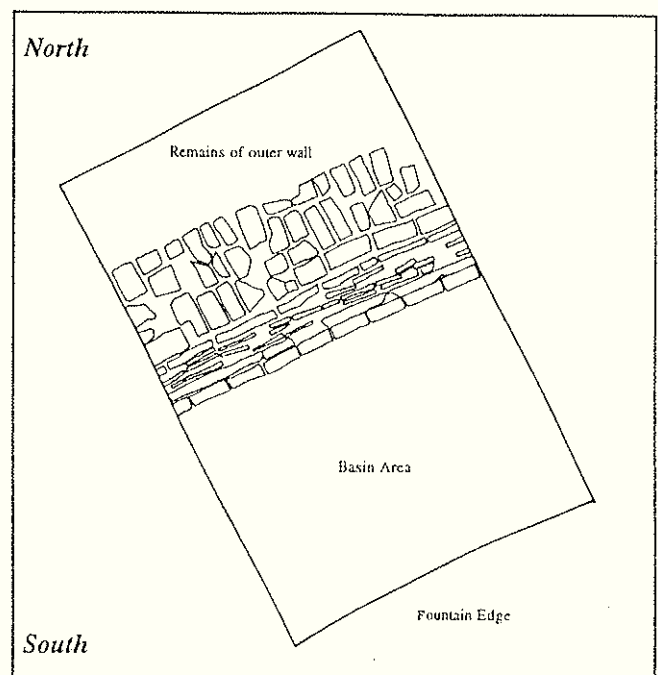
Figure Eleven: Plan of T4, 1:50

This trench was excavated to check that the larger fountain bowl carried around the diameter of Flora. The larger bowl was quickly found, but was not fully excavated. Only enough was revealed to confirm that the constructional technique was the same as that seen in T3, Figure Eleven. The condition of the outer wall was comparatively poor here.

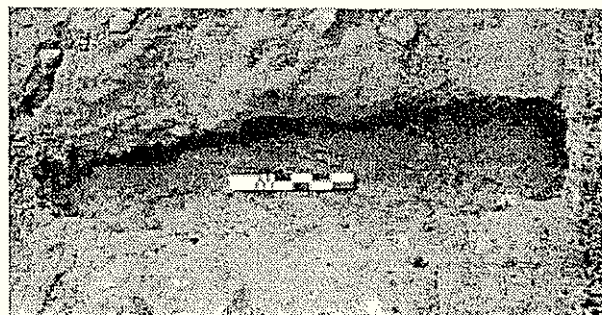
Figure Twelve: Beam slot in terrace, western end of Trench F

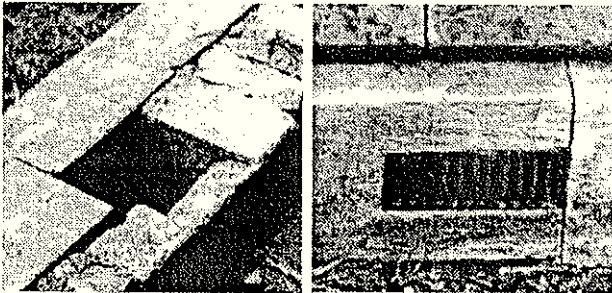
Figure Thirteen: Left; Slot in wall top, Right; Grille at base of outer wall face

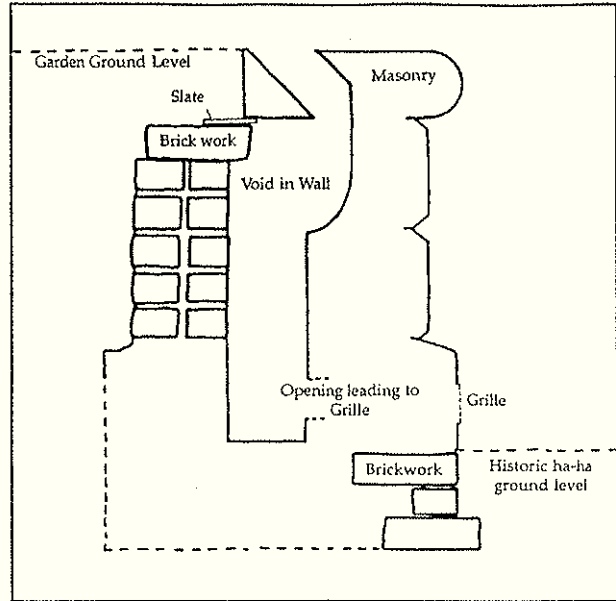
Figure Twenty One: Presumed cross-section through wall structure, not to scale

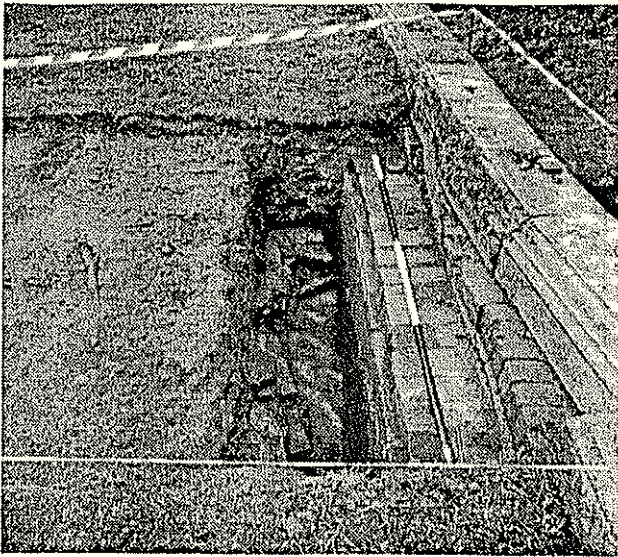
The wall was built by digging a foundation trench, in places cutting into bedrock, Figure Fourteen. Within this cut the brick footings supporting the wall were laid, these footings being slightly wider than the wall itself. The number of courses of bricks constituting the footings varies around the perimeter, depending upon the nature of the foundation cut. Those cutting into bedrock having only one course of brickwork in places. The inner face of the wall is of brick and is concealed by the landscaping of the garden. The outer face is of masonry, consisting of a plinth resting on the footings, normally with two courses of masonry above. Where the difference in levels between the garden and the ha-ha decreases this is reduced to one course of masonry.

Figure Fourteen: Foundation cut into bedrock, Trench D

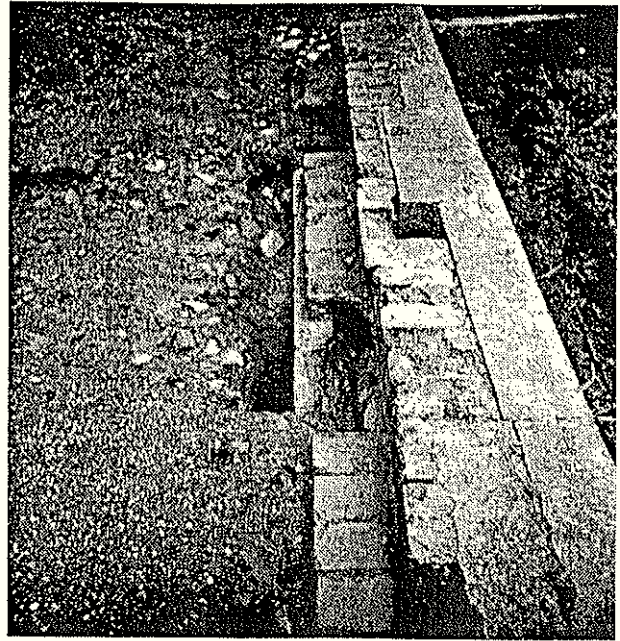
Evidence for a vertical pipe was found against the wall in trench G. This took the form of an almost vertical cut, O21, which had a quite compact fill but which clearly represented the position of a since removed vertical pipe, Figure Twenty. This pipe would have fed into the run of pipe found on the outside of the balustrade wall at this point, which is probably a continuation of the pipe found on the outside of the balustrade in trench F.

Figure Twenty: Hole showing position of removed vertical pipe in Trench G

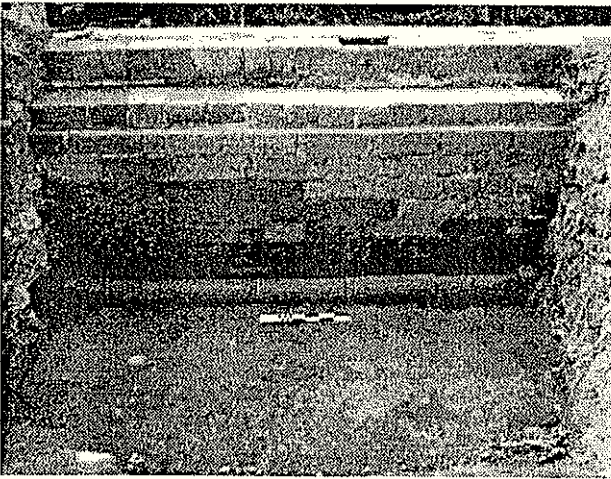
At the bottom of trench B, against the base of the wall inside the garden, several lengths of circular ceramic drain were found in situ, O11. These ran east-west and disappeared into the section on either side of the cut, Figure Sixteen.

Figure Sixteen: East-West drain in Trench B

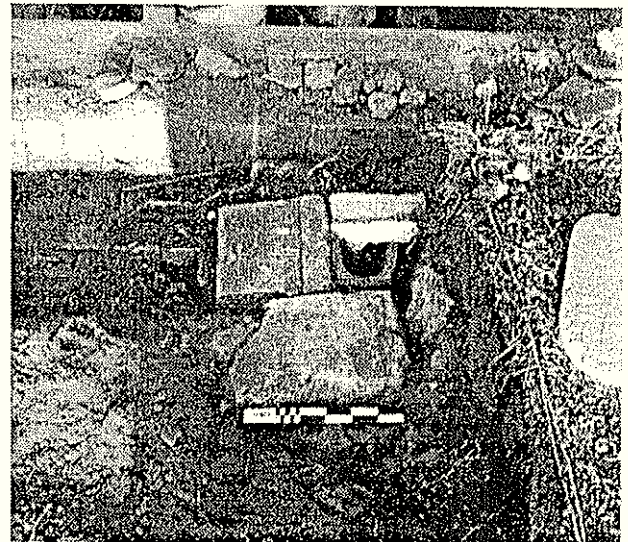
In trench C two separate drains were found. The first was a vertical U shaped drain mortared to the inner surface of the balustrade wall, Figure Seventeen, which ran down to the base of the wall, at which point there was a hole in the wall into which the drain ran. On the outside of the wall, in the "ha-ha", there was no continuation of this drain. However, there were several lengths of U shaped drain which were

Figure Seventeen: Top of vertical drain in Trench C

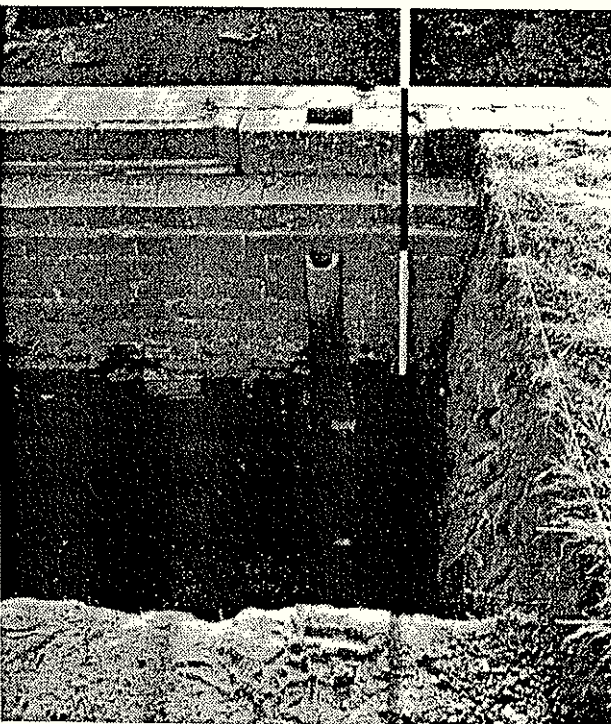
Figure Eighteen: Vertical drain pipe in Trench E

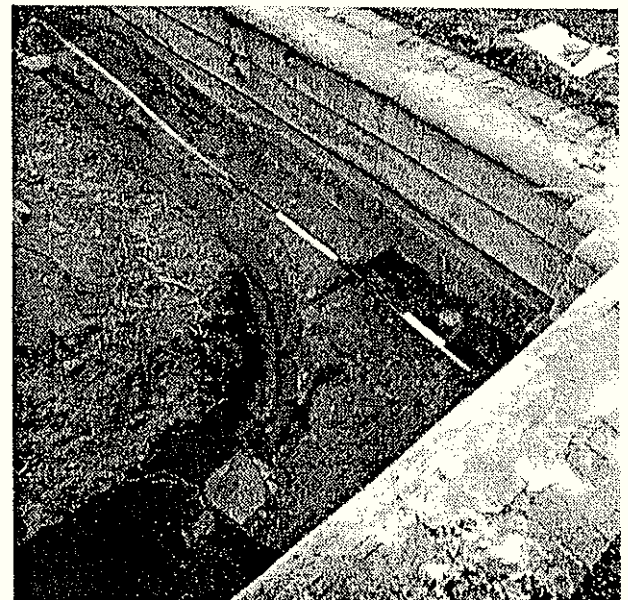
Figure Nineteen: Drain turning corner at K
