REPORT ON ARCHAEOLOGICAL FIELDWORK PITFODELS, NEW INTERNATIONAL SCHOOL, ABERDEEN

Alison Cameron Assistant Archaeologist Aberdeen City Council Archaeological Unit Whitespace 60 Frederick Street Aberdeen AB24 5HY (01224) 523654 alcameron@aberdeencity.gov.uk

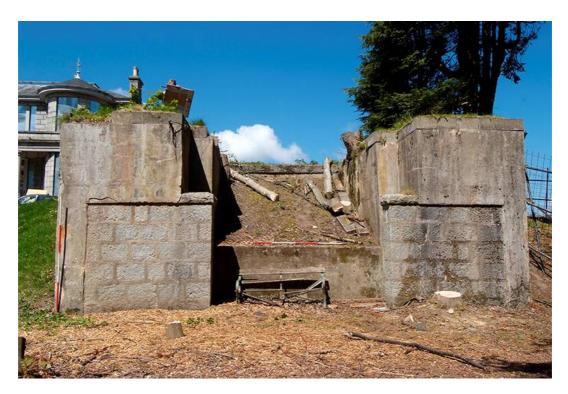
The bunker (III 6) is 8.82 m along the south-facing frontage and 9.34m along its N-S axis. The south wall is 0.42m thick and faced with granite blocks.

III 7 South facing frontage of bunker

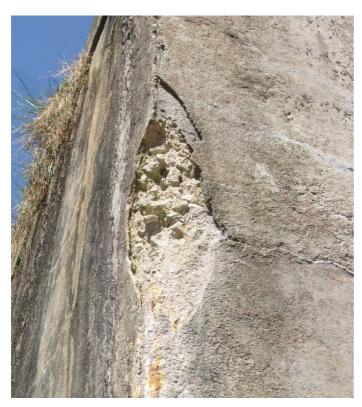
III 19 Detail of concrete exposed on south-west corner of bunker

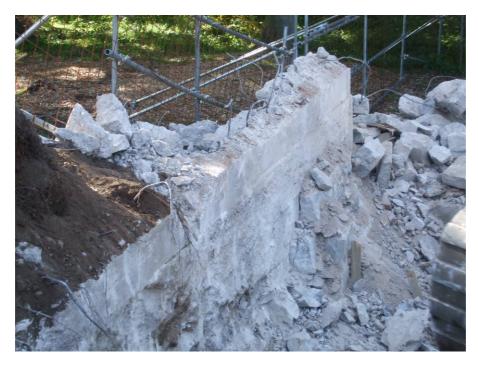
III 20 During demolition it was confirmed that the concrete was reinforced with substantial metal rods.

During the demolition of the building, it was determined that the roof was constructed of layers of reinforced concrete and layers of sand which would have been a very bomb-proof structure.

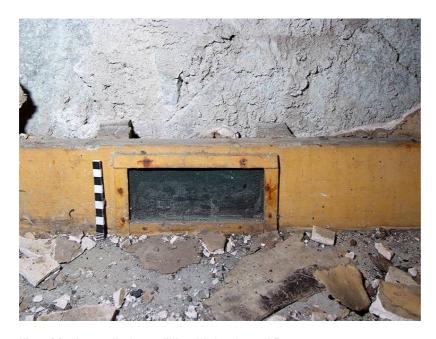
III 27 Mesh ventilation grill in skirting board Room 1

Metal mesh ventilation grills (above) are present in the skirting board of Rooms 1 and 2; it is probable that they are earlier than the plasterboard stud walls and may be contemporary with the World War II use.

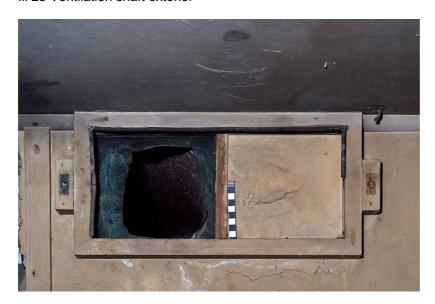
III 29 Ventilation shaft interior

Fresh air diffused into the rooms by two vents (Vents 1 and 2;) consisting of 0.18m diameter concrete water or sewage pipe laid just below ceiling level in each room and exiting the structure in the earthen roof.

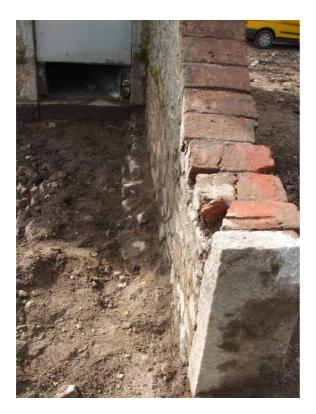
III 36 Garden wall BC with wall foundation of earlier house BD, below

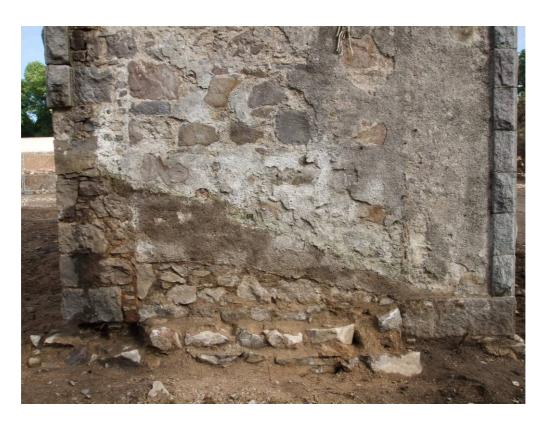
III 37 South face of tower showing wall foundation of earlier house, BB, below and scar of wall 2.28m wide on wall.

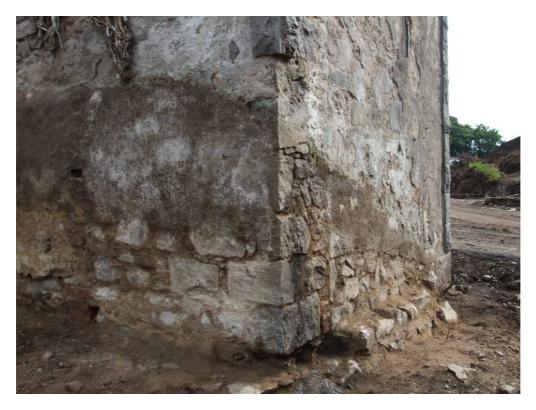
III 38 SW corner of tower showing original Phase 1 quoins (above) and Phase 2 quoins inserted (top)

If the tower is to be picked and pointed I will come along and record after picking and before repointing as this will reveal further architectural details

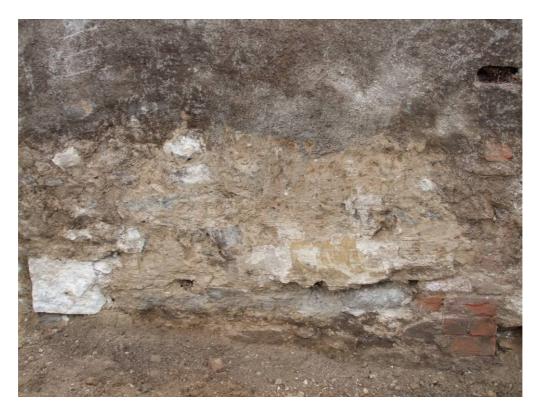
III 40 Brick ?fireplace BI (right) and plaster (centre)

Brick structure BI (III 40) may be the remains of a Phase 1 fireplace; harling on this wall is obscuring most of the details of this wall; its removal will help with the interpretation of this feature.

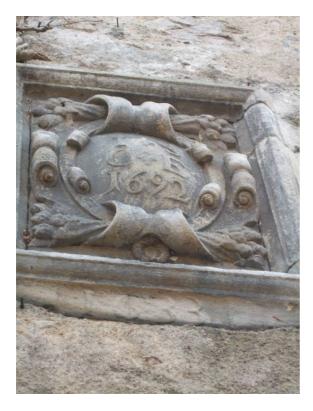
After the house was demolished a window/door () was infilled on the west face of the tower and armorial panel (dated 1633/1692) was inserted in that blocking.

III 45 Armorial panel in W face of tower with dates 1633 (below in low relief) and 1692 (centre).
