FAS
HERITAGE

BRETTON HALL LANTERN

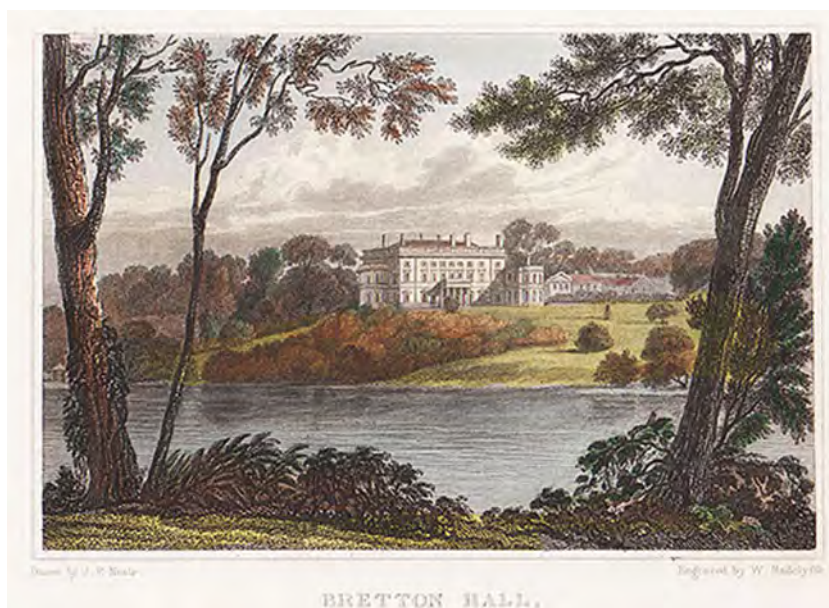
Plate 3 J P Neale's view of Bretton Hall, published c.1821, after Jeffry Wyatt's alterations

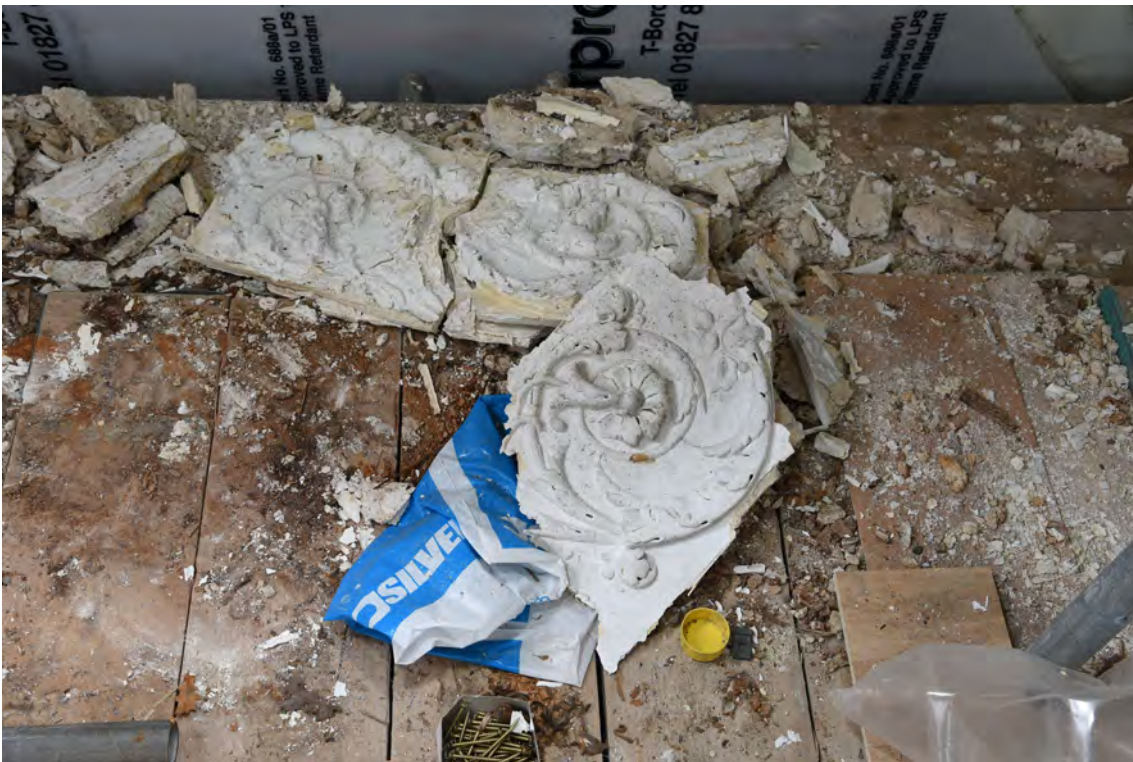
Plate E20 View of deteriorated decorative plasterwork from frieze (BRH064)

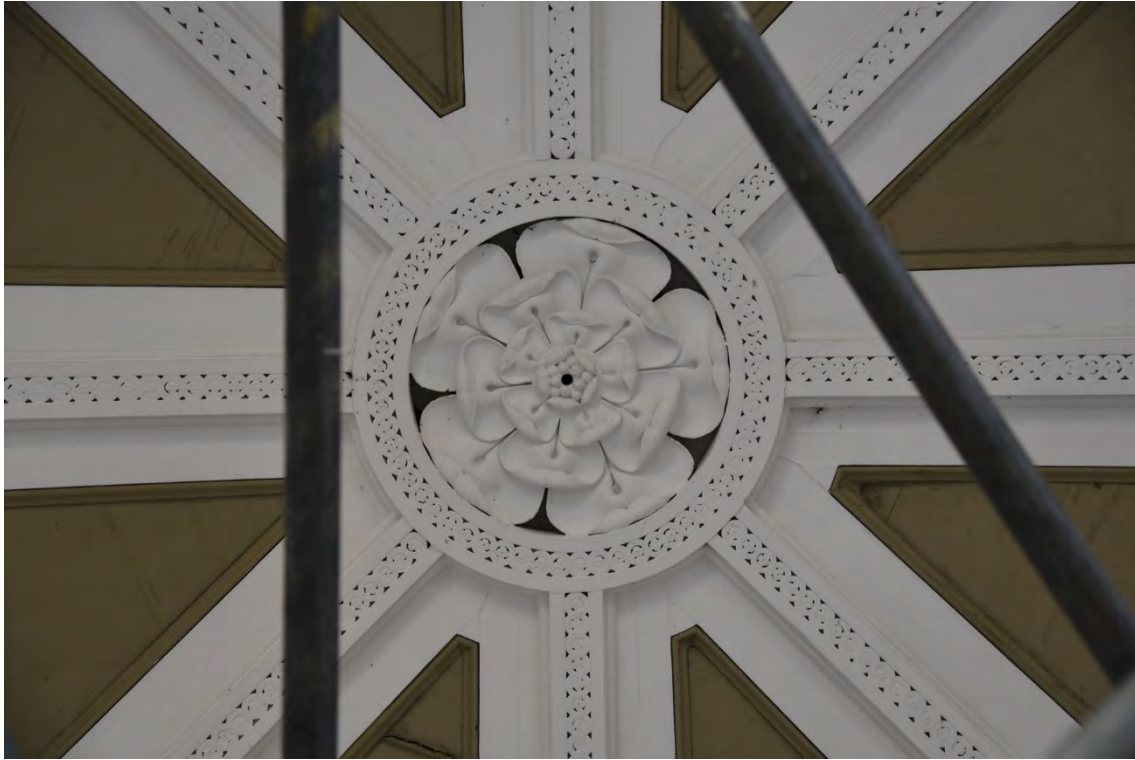
Plate E21 Detail of lantern ceiling (BRH050)

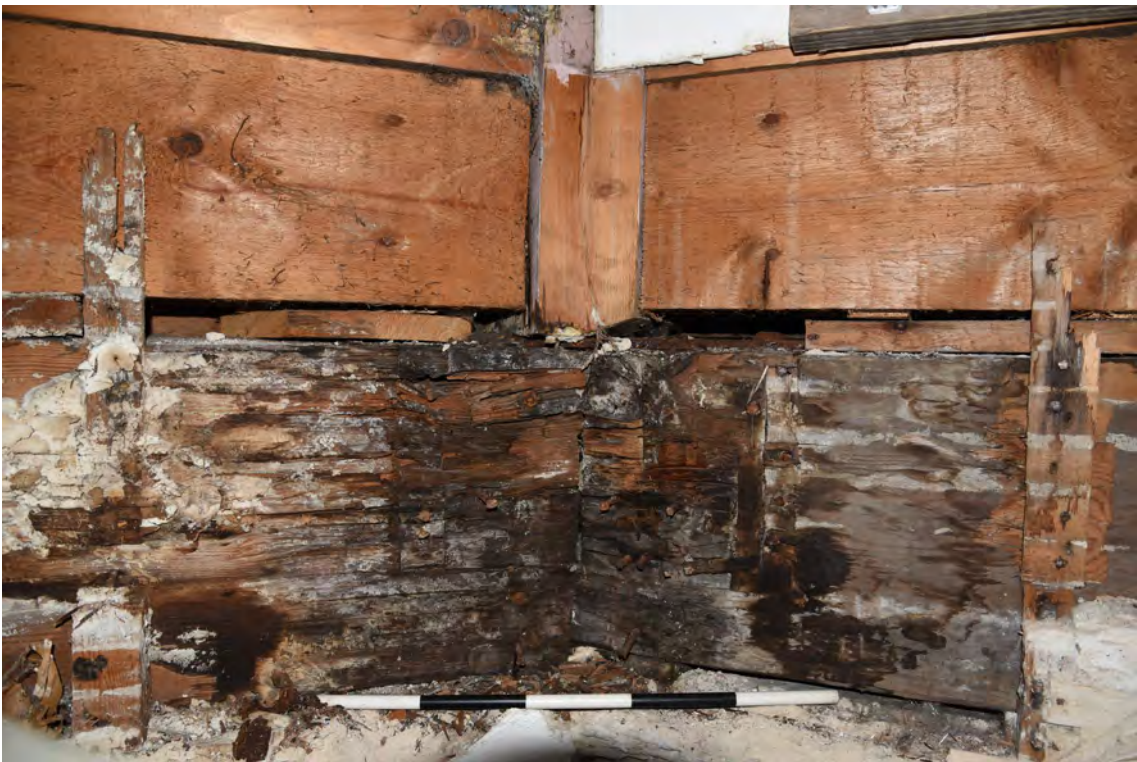
Plate E70 Detail of exposed timberwork of lantern base at junction between N and NW elevations showing decay, looking NW, scale 50cm (BRH052)

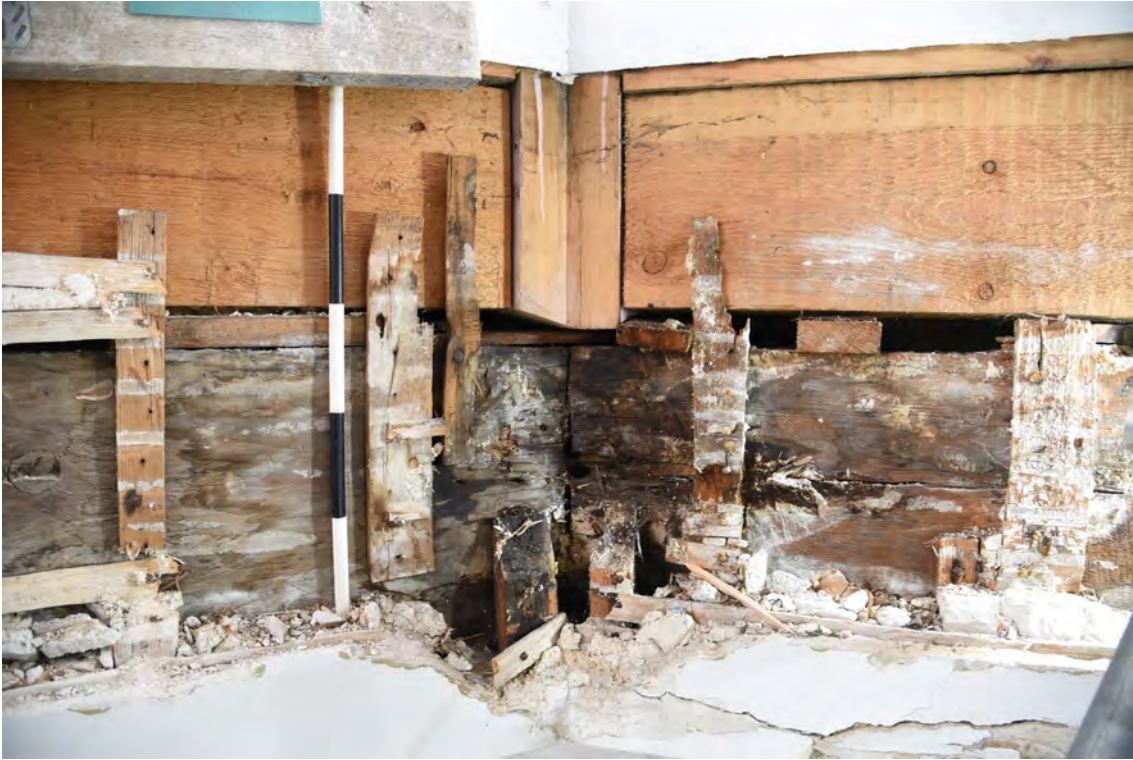
Plate E71 Detail of exposed timberwork of lantern base at junction between N and NE elevations showing decay, looking NE, scale 50cm (BRH053)

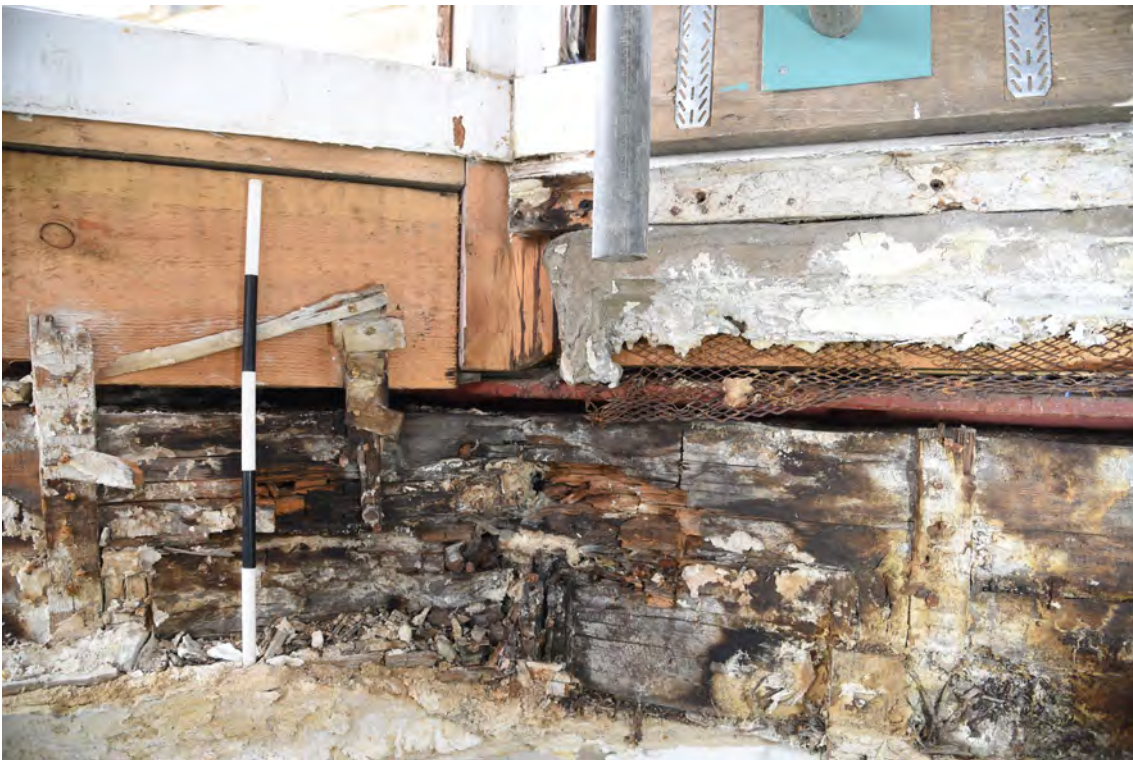
Plate E72 Detail of exposed timberwork of lantern base at junction between NE and E elevations showing decay, looking NE, scale 50cm (BRH054)

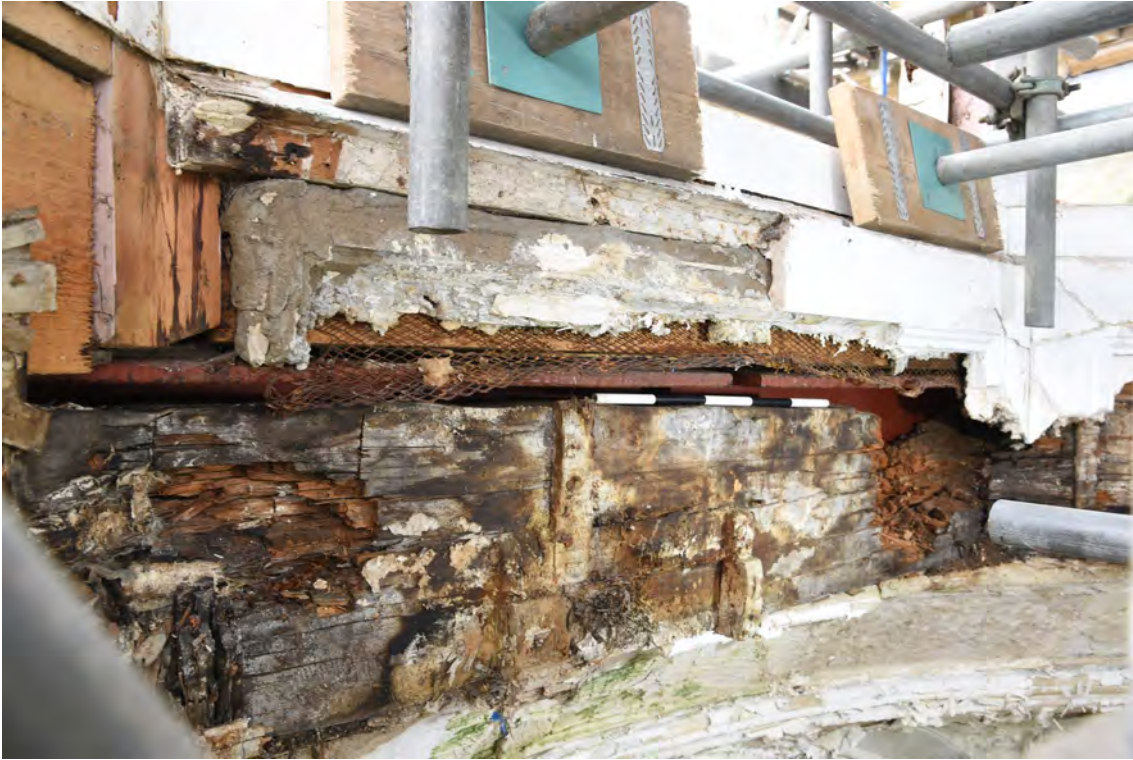
Plate E73 Detail of lantern base E elevation showing later steel reinforcement and extent of wood decay, looking SE, scale 50cm (BRH055)

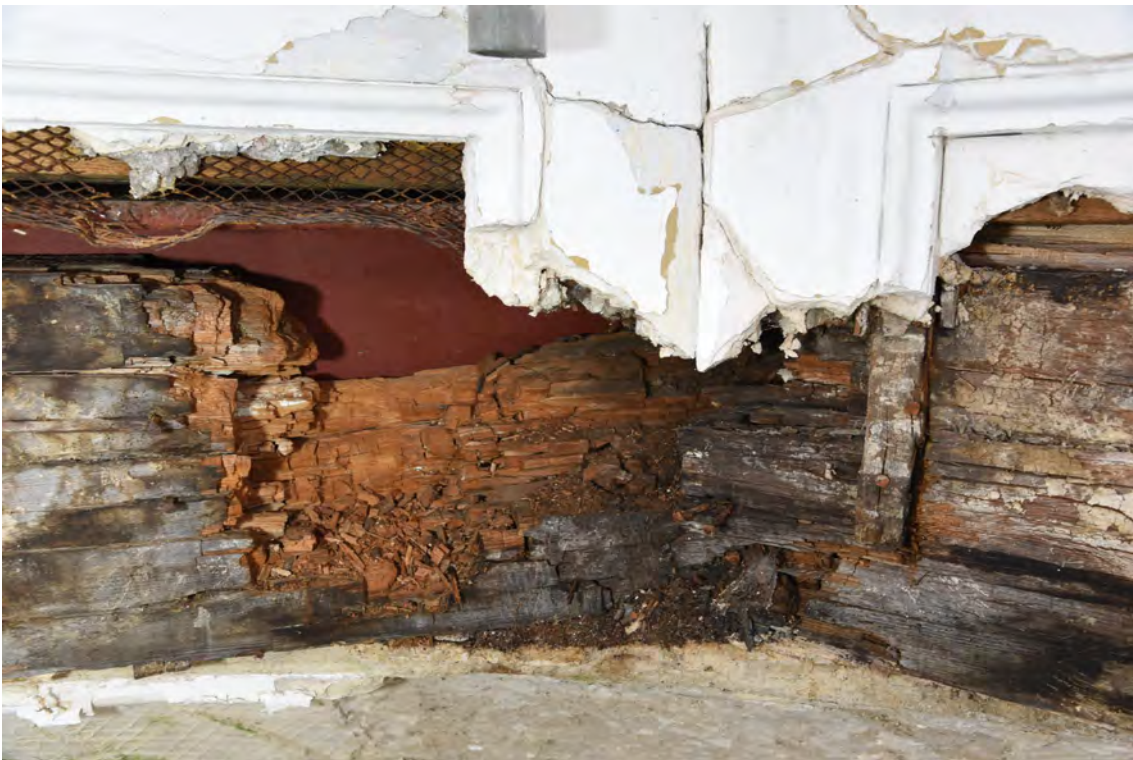
Plate E74 Detail of exposed timberwork of lantern base at junction between E and SE elevations showing decay, looking SE (BRH056)

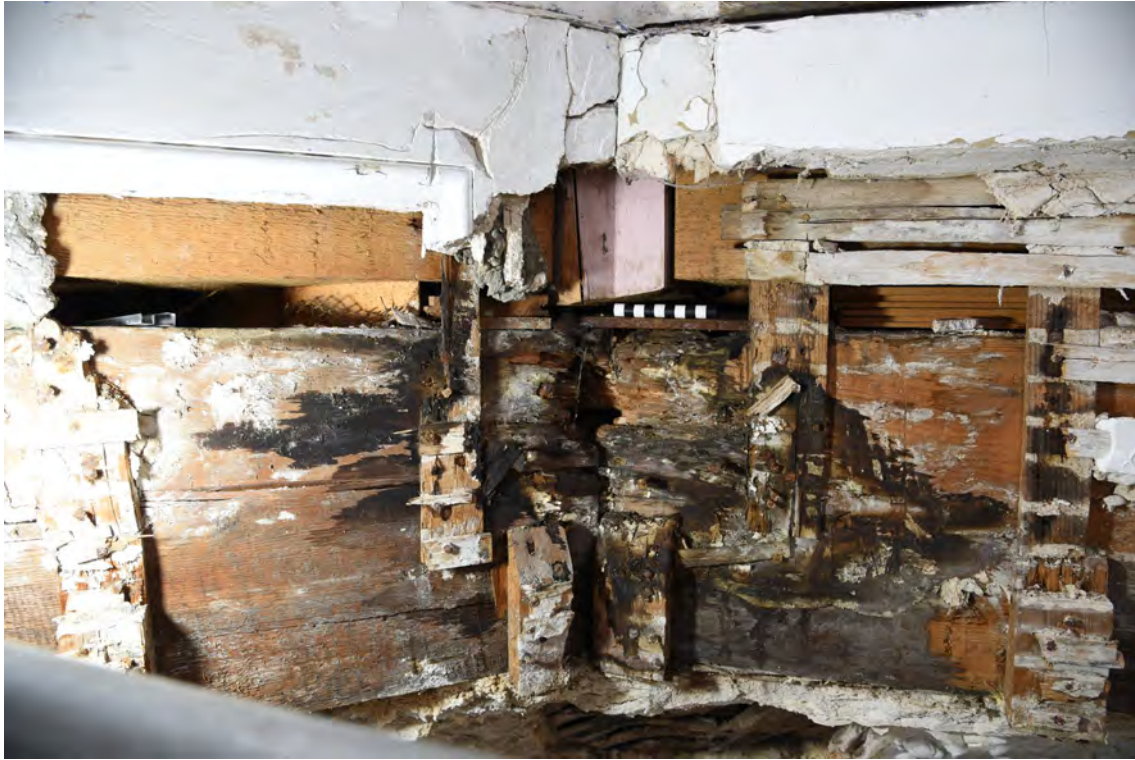
Plate E75 Detail of exposed timberwork of lantern base at junction between SE and S elevations showing decay, looking S, scale 10cm (BRH057)

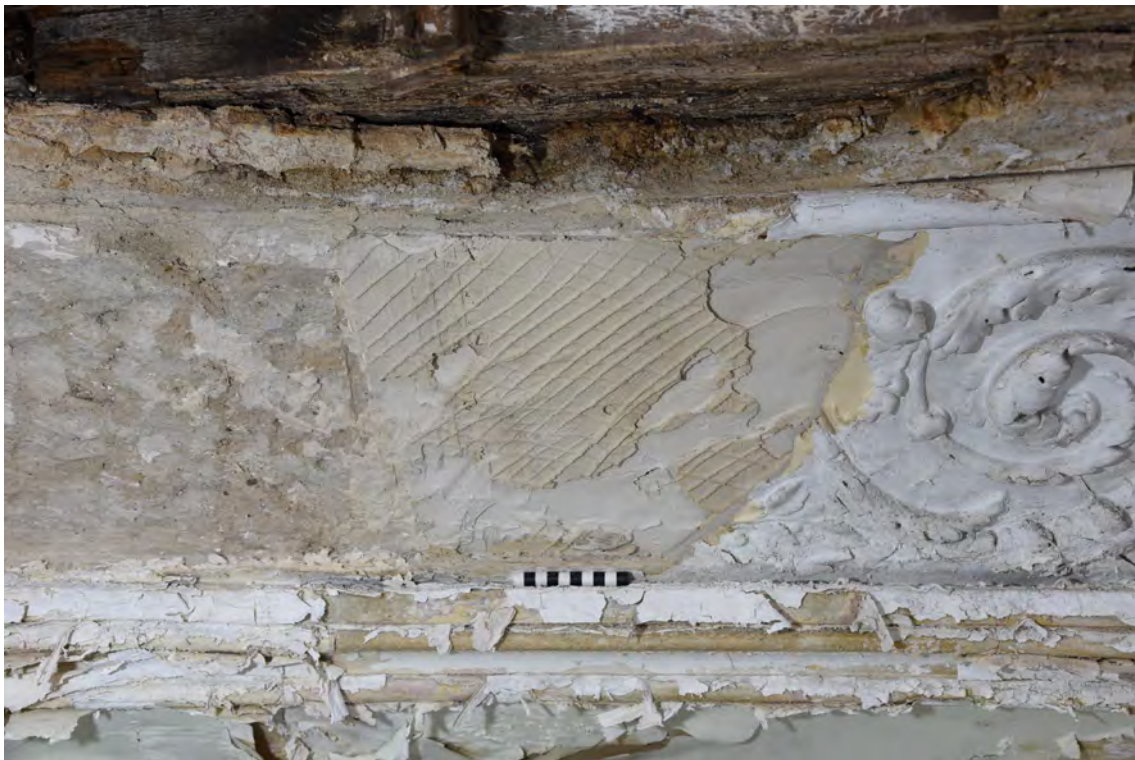
Plate E76 Detail - Removal of decorative plasterwork revealing keying pattern beneath, looking SE, scale 10cm (BRH058)

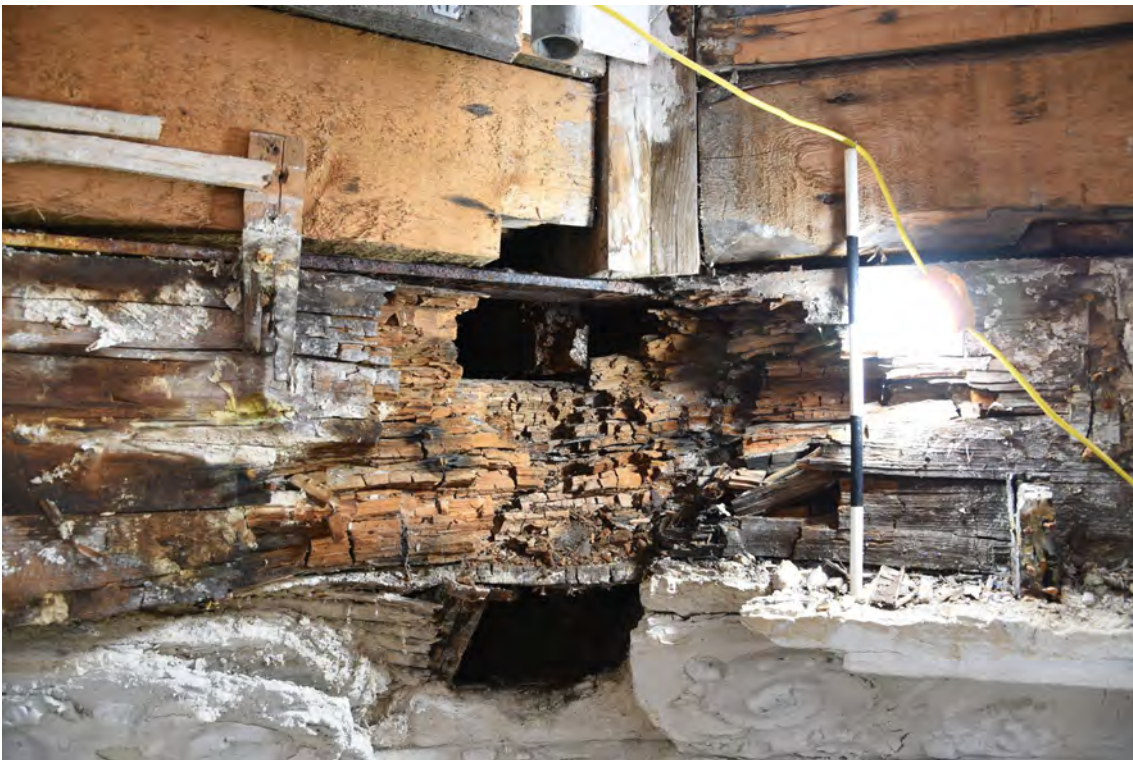
Plate E80 Detail – Exposed timberwork of lantern base at junction between W and NW elevations showing wood decay and later steel plate reinforcement, looking W, scale 50cm (BRH063)

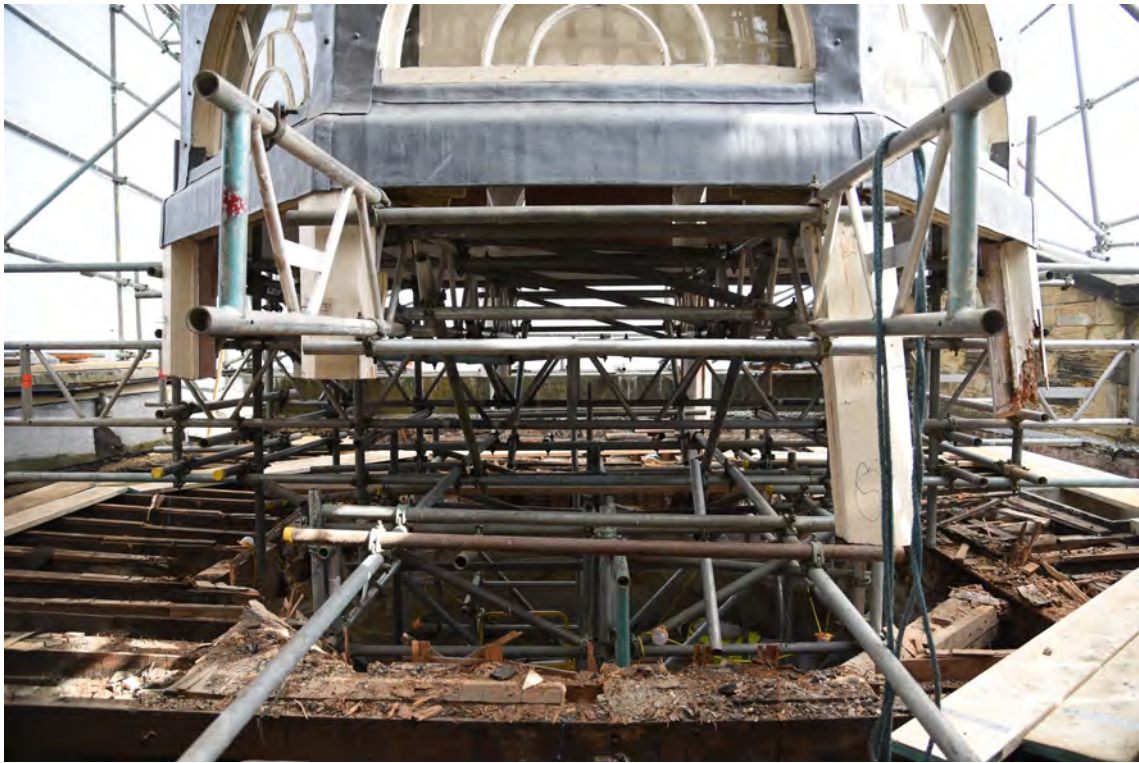
Plate E81 View of lantern following removal of rotten timbers, looking N (BRH118)

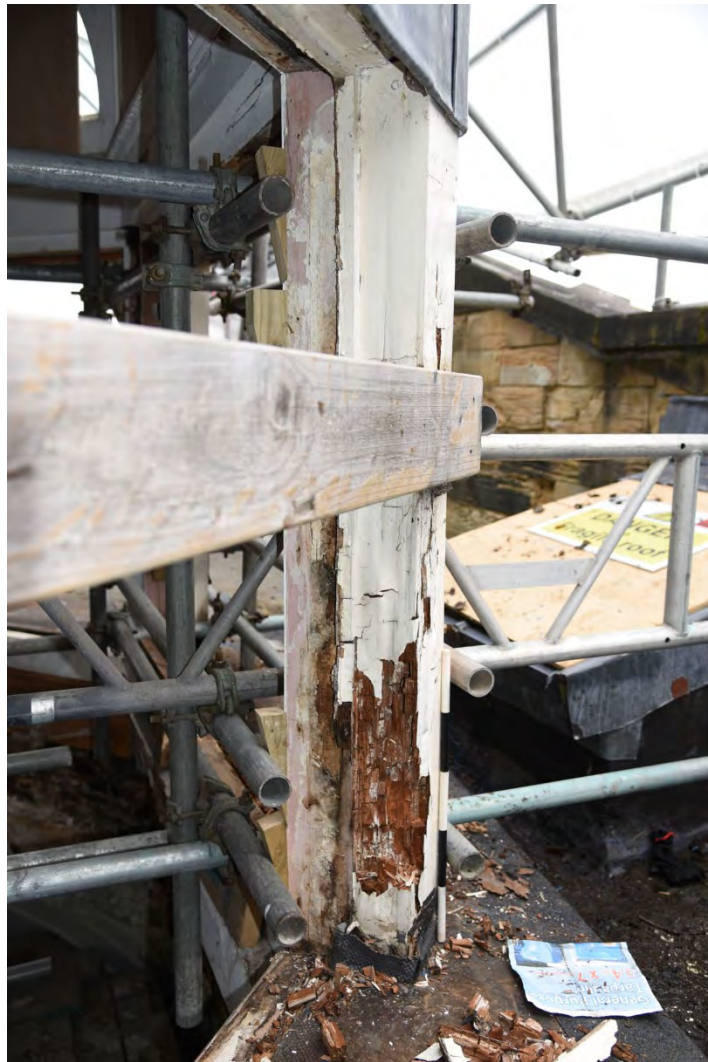
Plate E110 External window frame upright timber showing decay, looking NE, scale 50cm (BRH073)

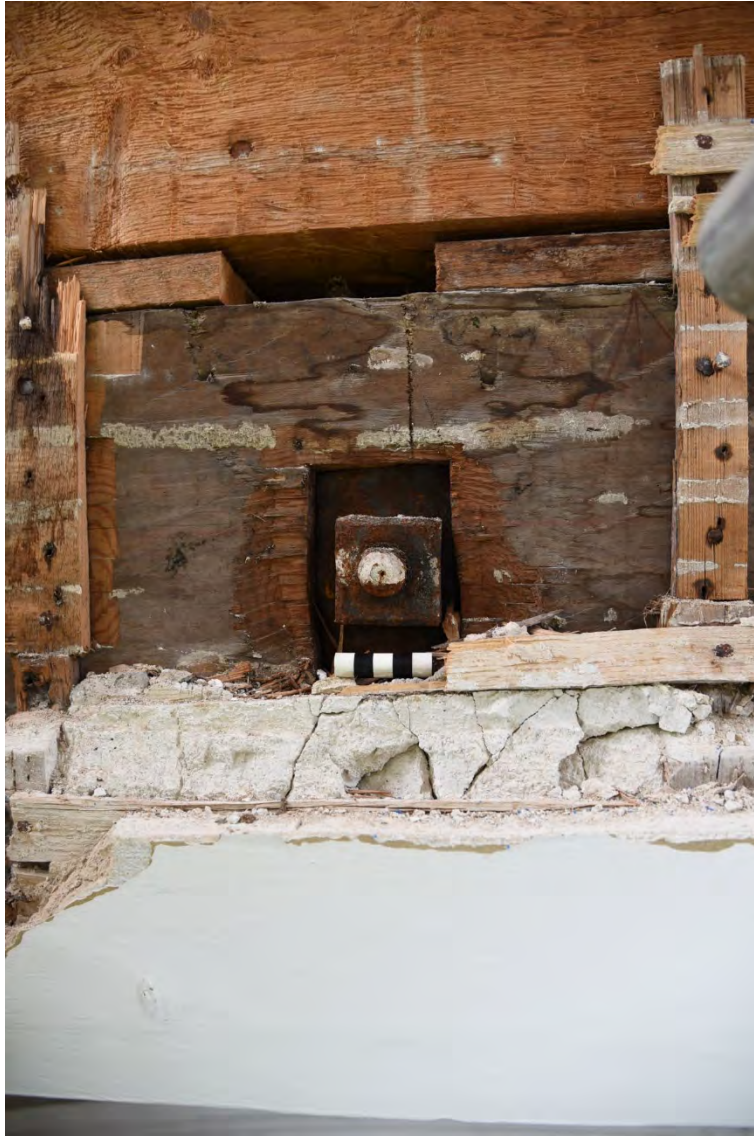
Plate E111 Detail – Ironwork bolt fastening through timber base of lantern, N elevation, looking N, scale 5cm (BRH051)

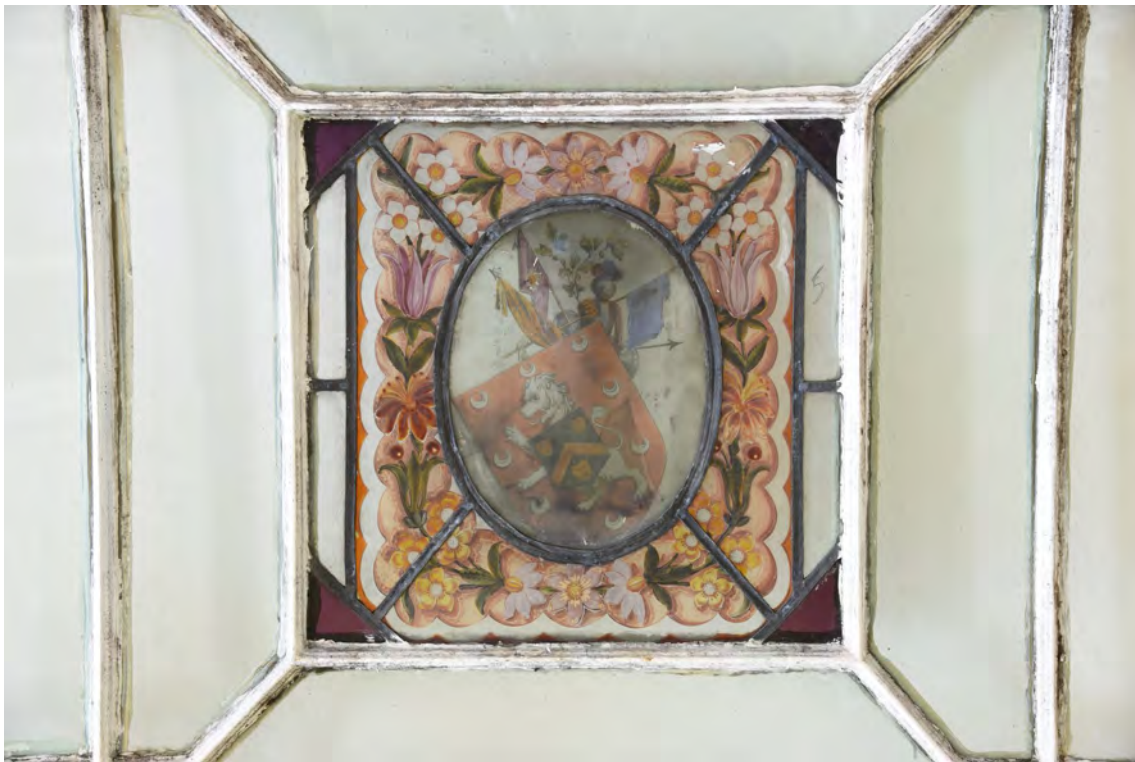
Plate E132 Detail of central stained-glass panel (BRH170)

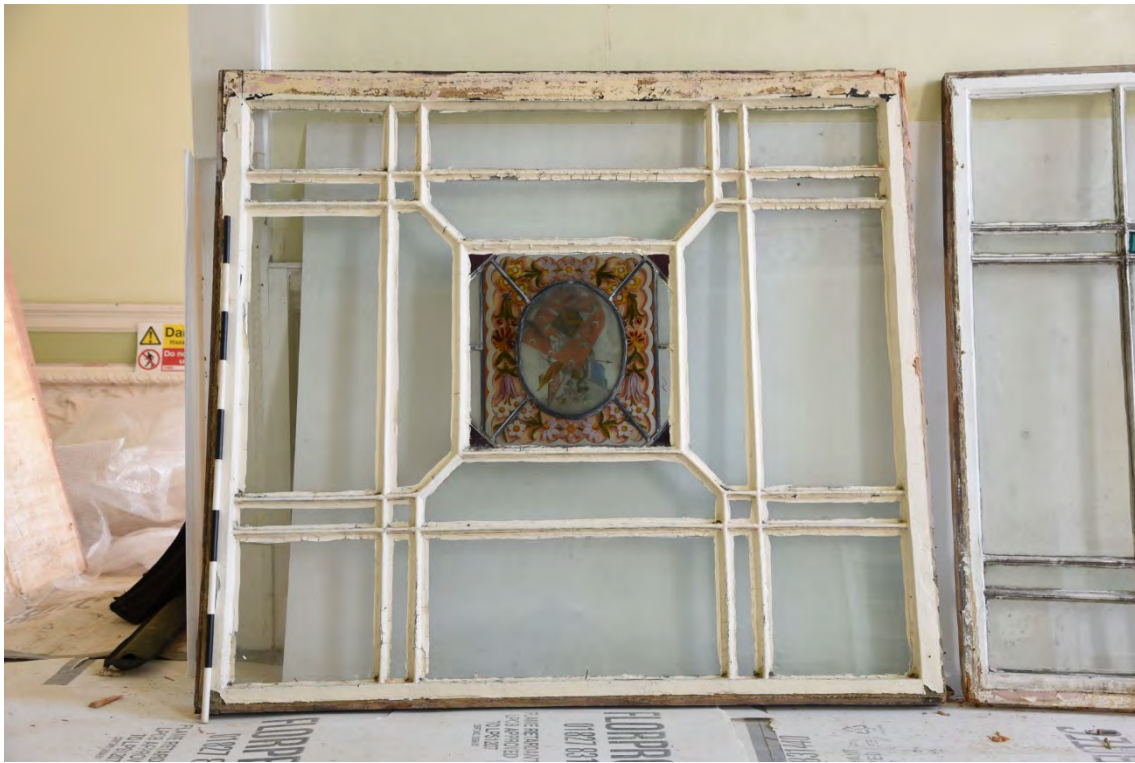
Plate E133 Window panel removed from the lantern's N elevation, exterior view (BRH171)

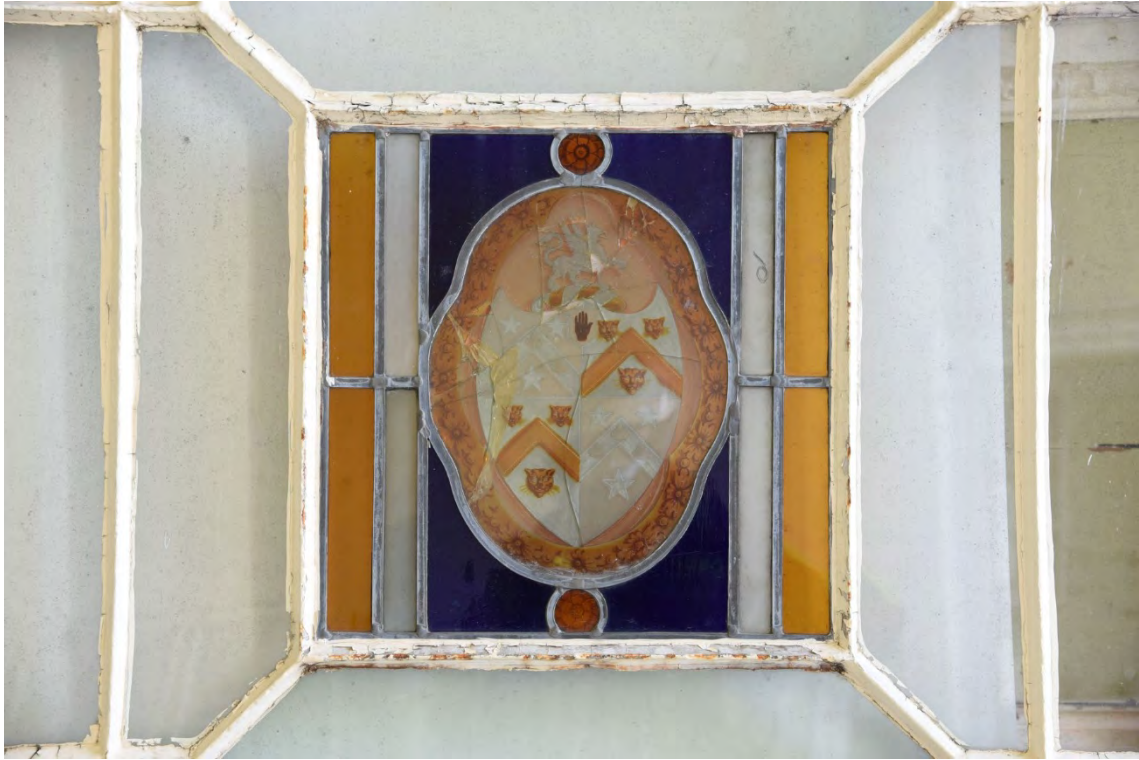
Plate E137 Detail of central stained-glass panel (BRH173)

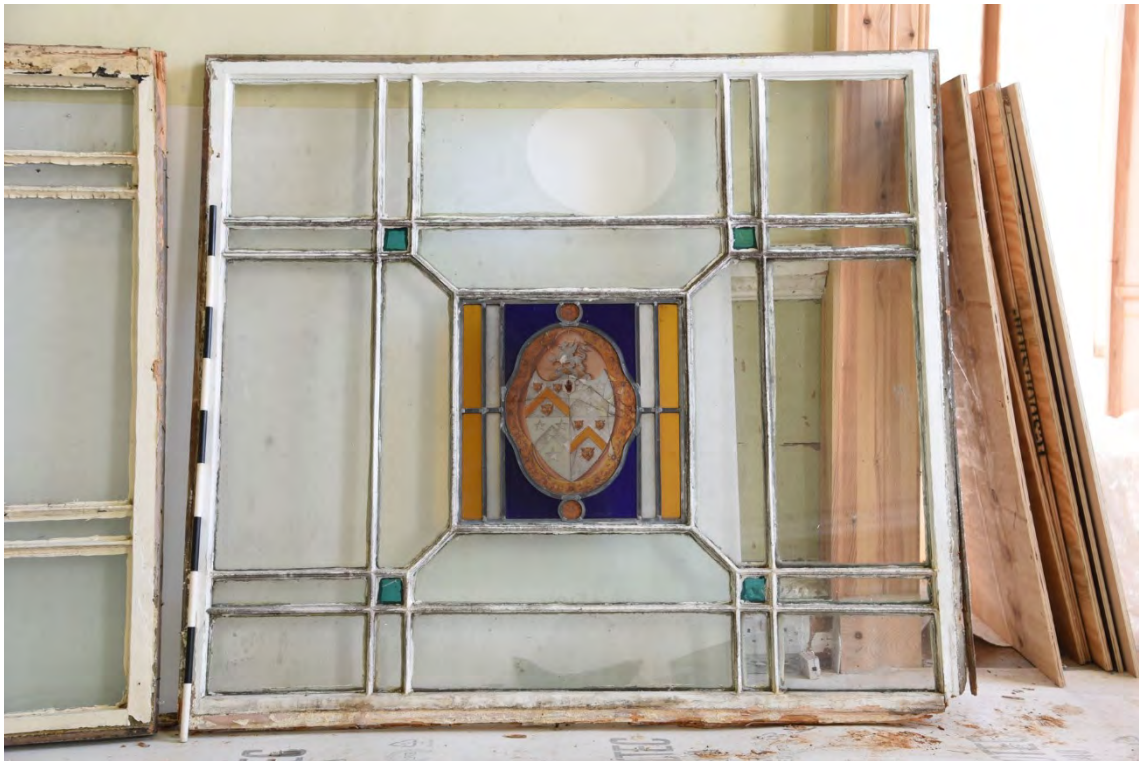
Plate E138 Window panel removed from the lantern's NE elevation, interior view (BRH174)

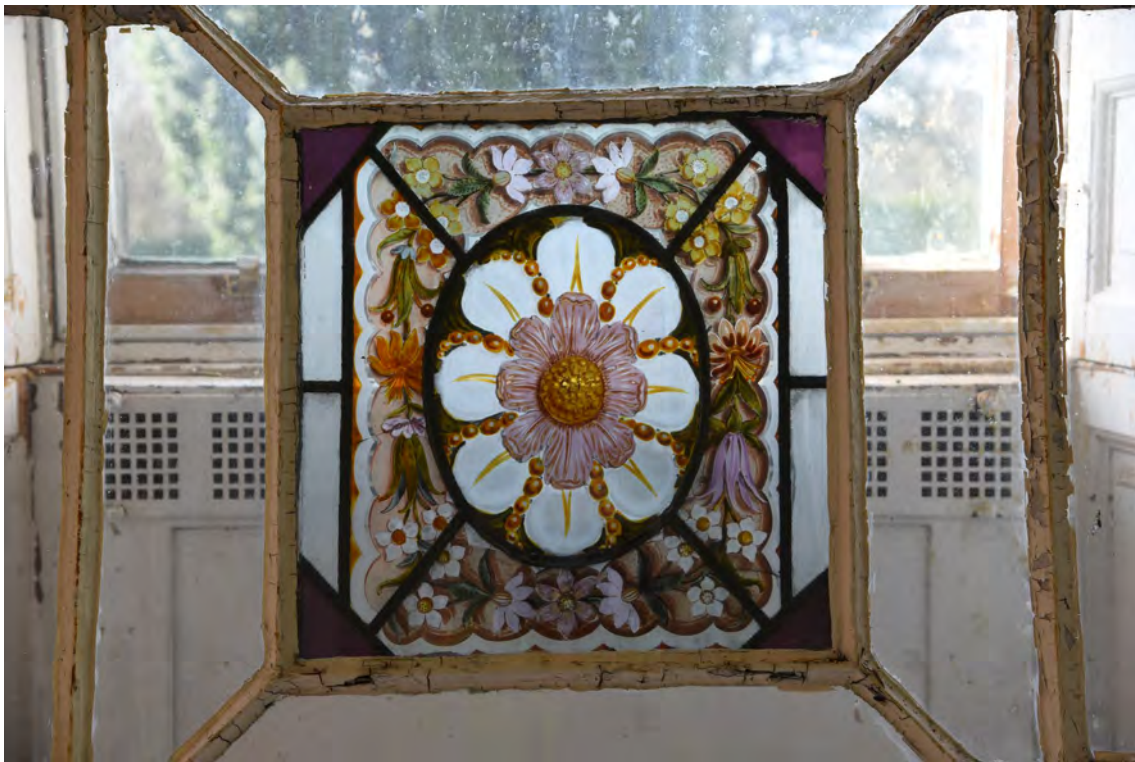
Plate E140 Detail of central stained-glass panel (BRH178)

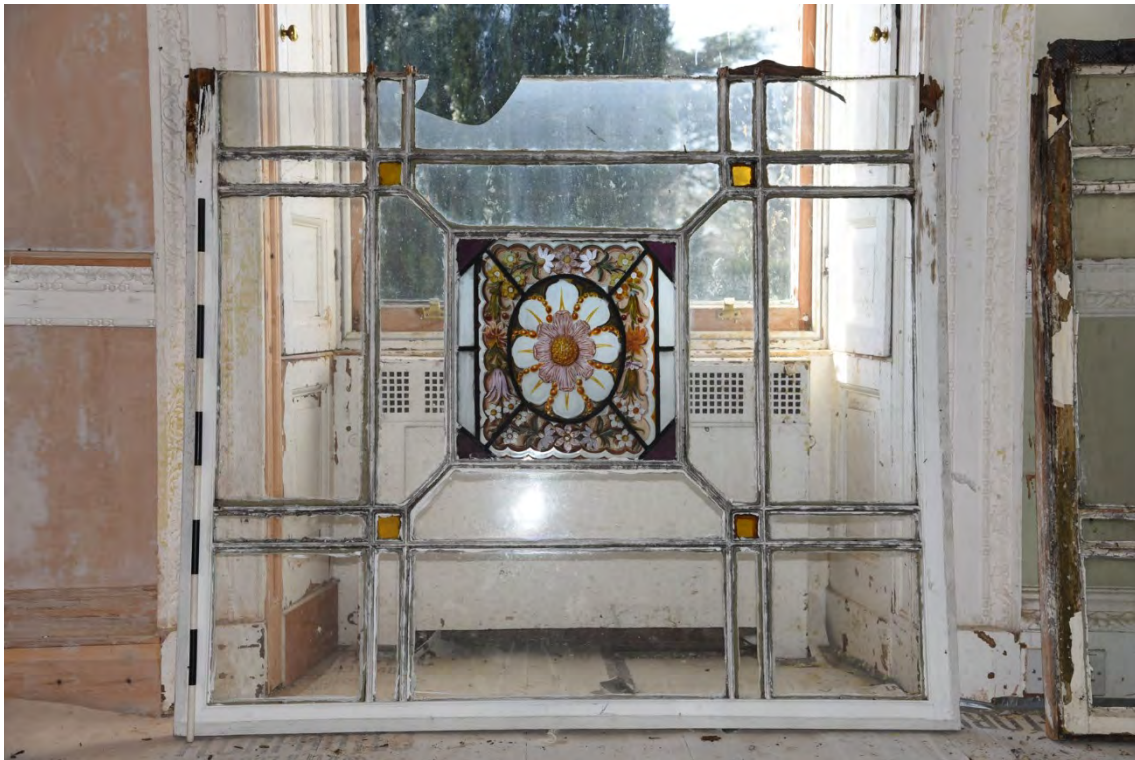
Plate E141 Window panel removed from the lantern's E elevation, interior view (BRH179)

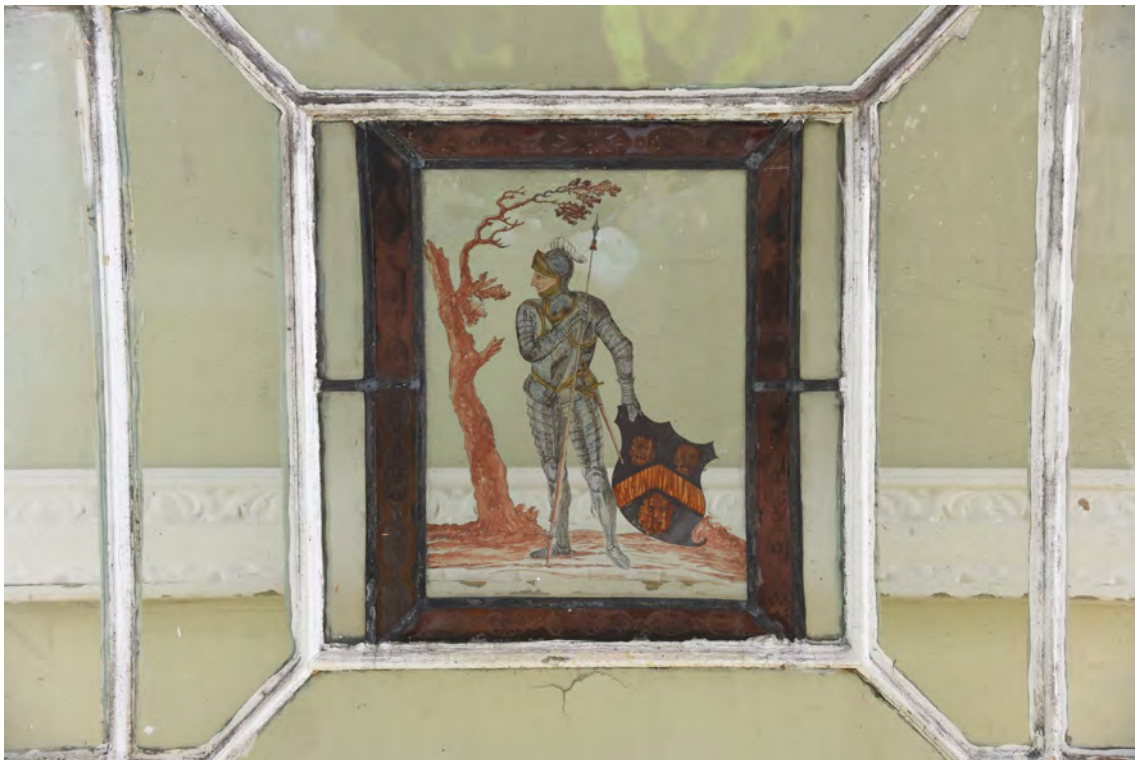
Plate E144 Detail of central stained-glass panel (BRH182)

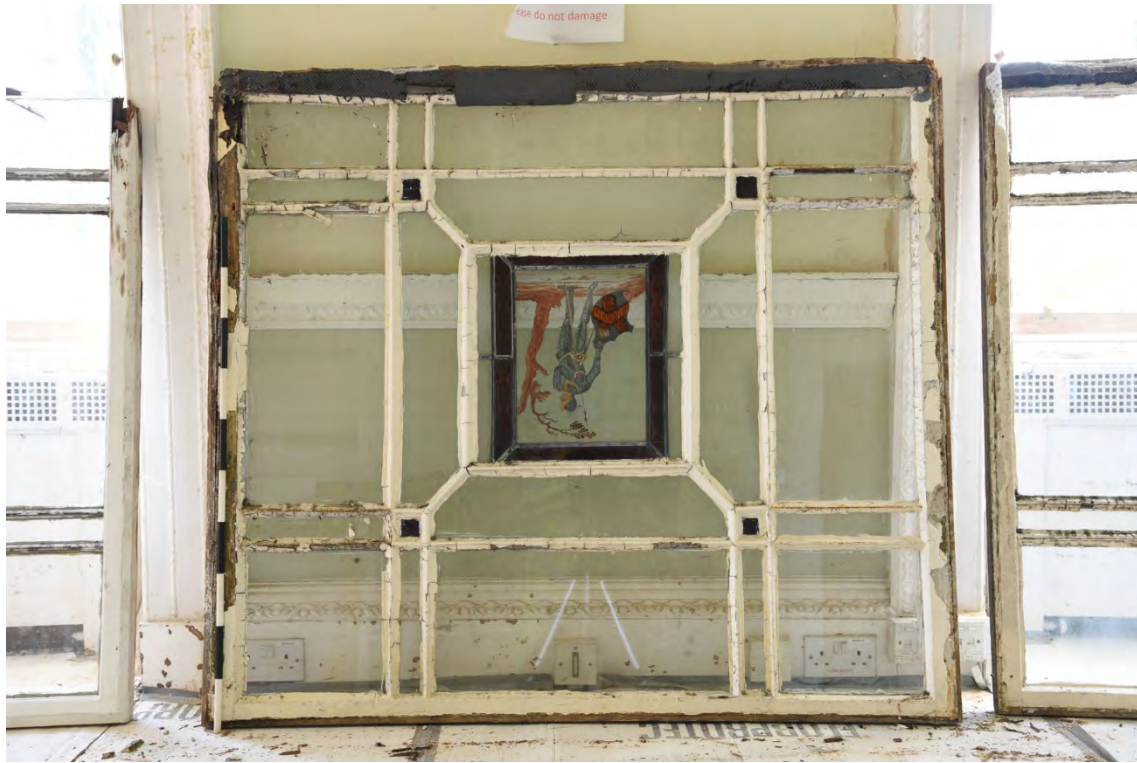
Plate E145 Window panel removed from the lantern's SE elevation, exterior view (BRH183)

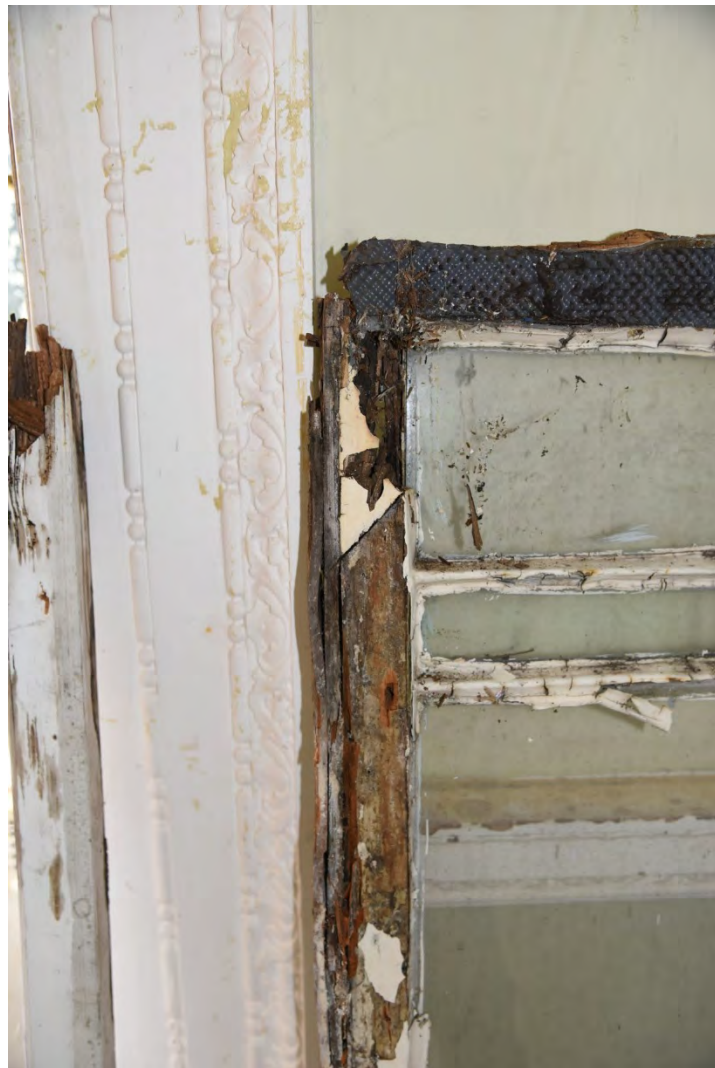
Plate E146 Detail of spliced repair in timber window frame (BRH184)

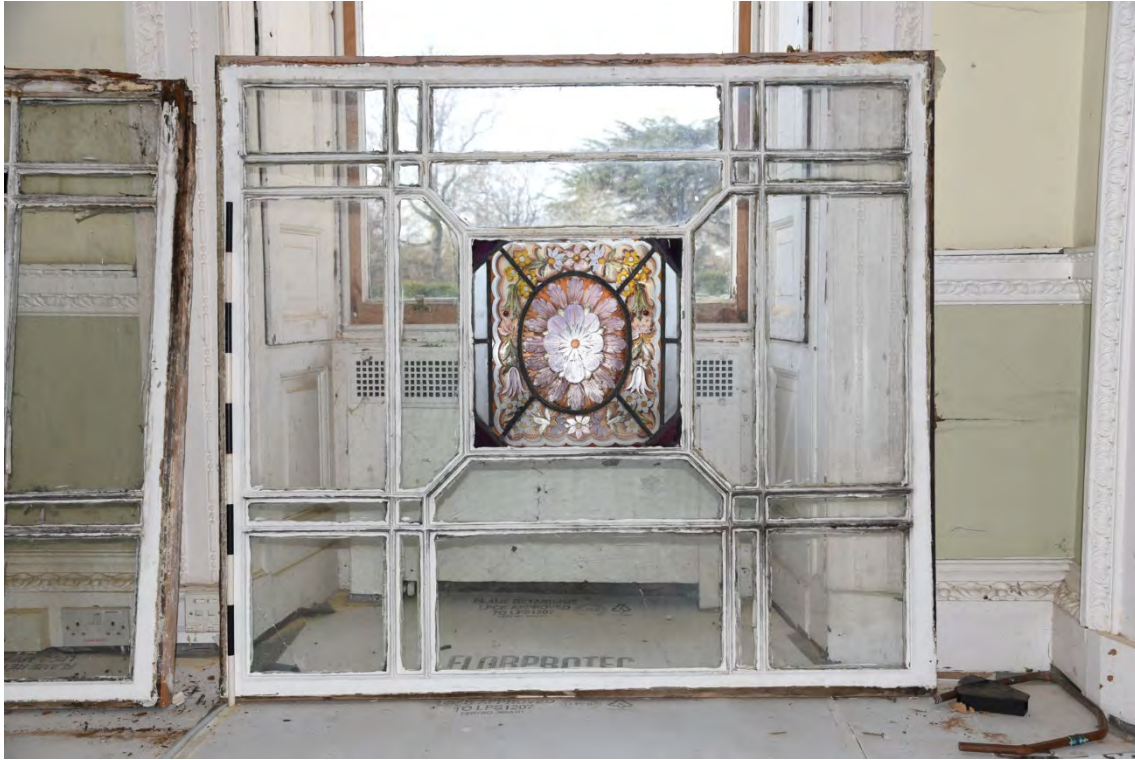
Plate E147 Window panel removed from the lantern's S elevation, interior view (BRH185)

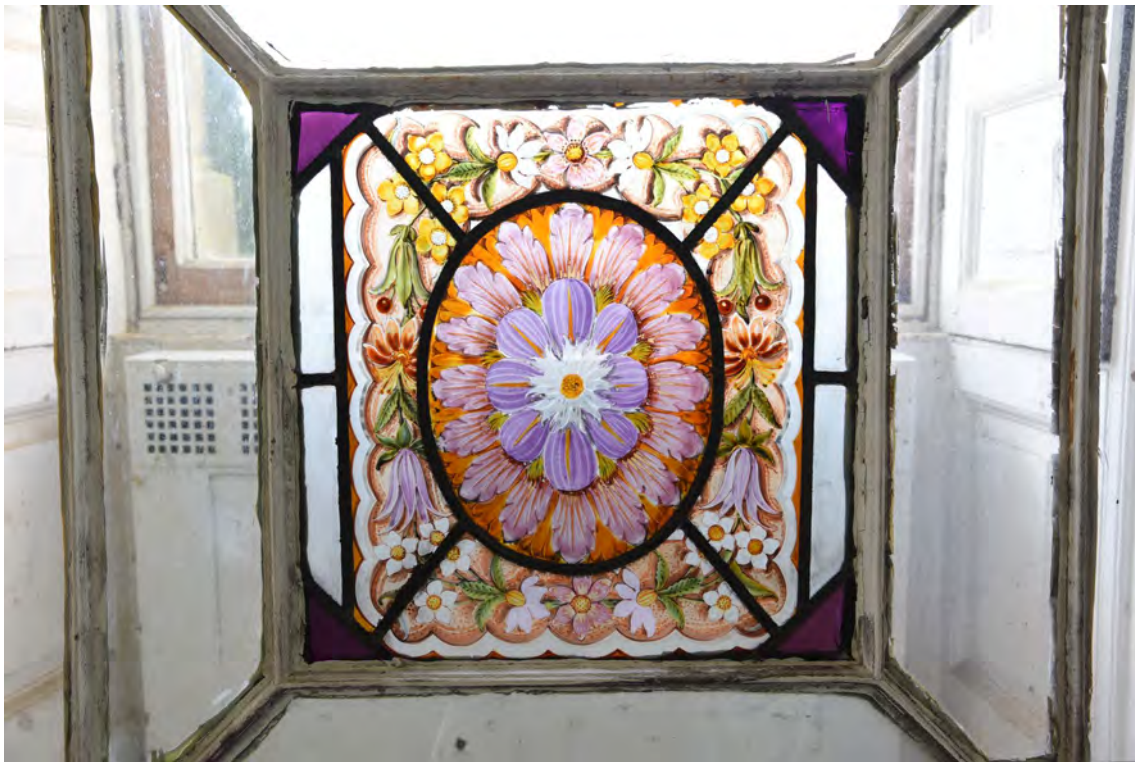
Plate E148 Detail of central stained-glass panel (BRH186)

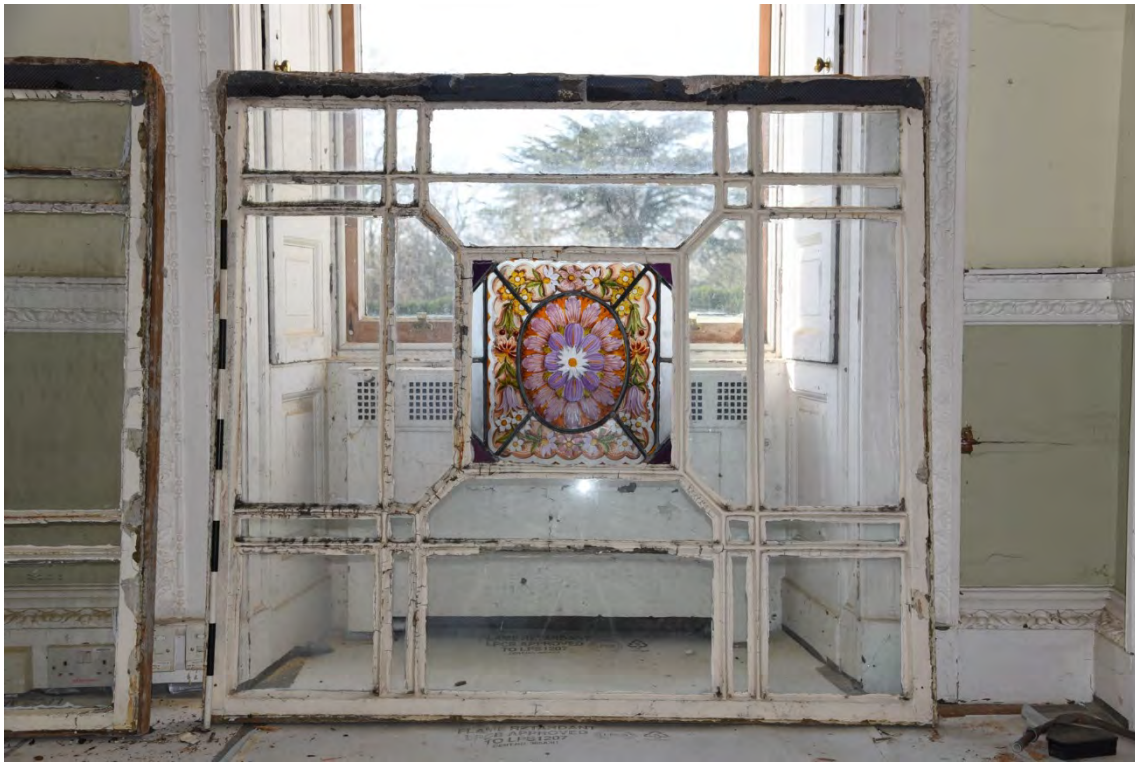
Plate E149 Window panel removed from the lantern's S elevation, exterior view, looking - (BRH187)
