FAS
HERITAGE

BRETTON HALL LANTERN

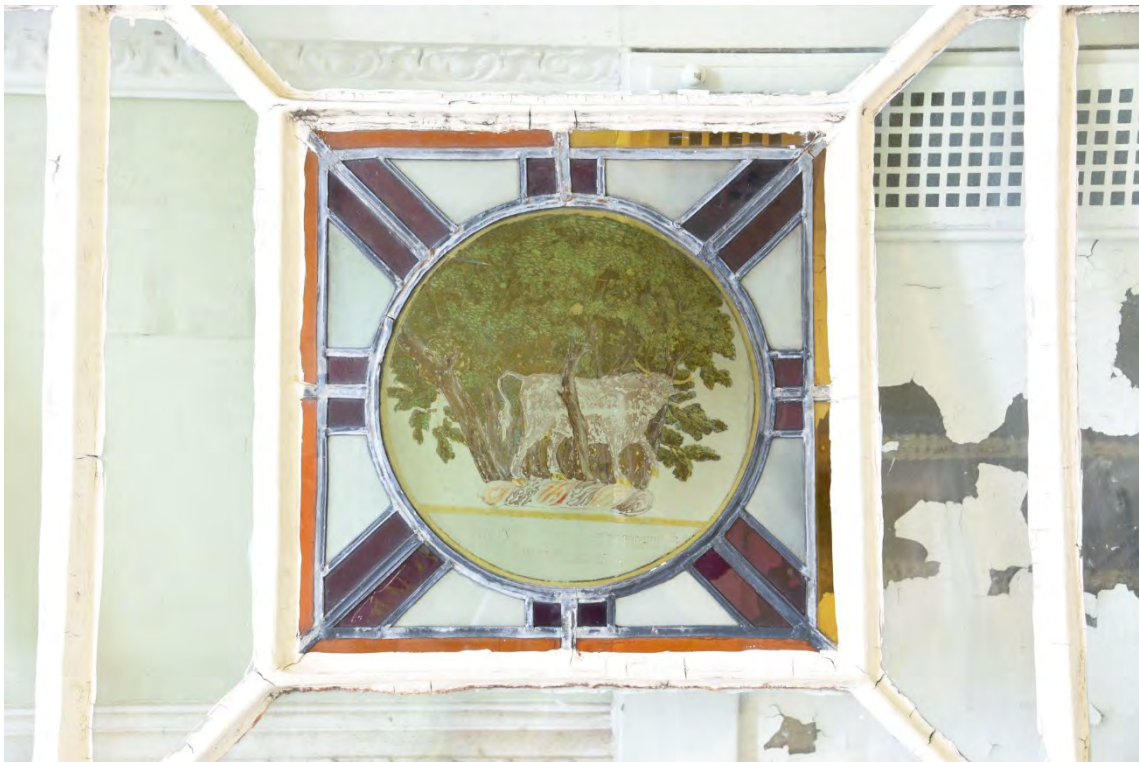
Plate E152 Detail of central stained-glass panel (BRH190)

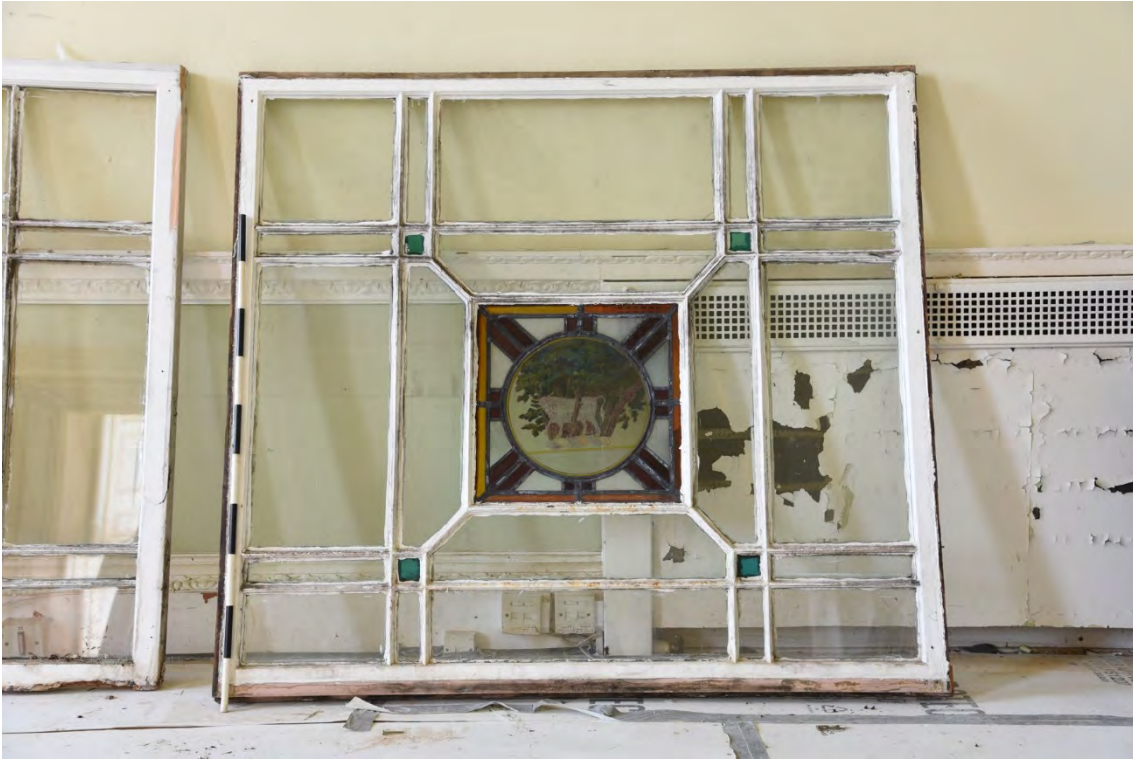
Plate E153 Window panel removed from the lantern's SW elevation, interior view (BRH191)

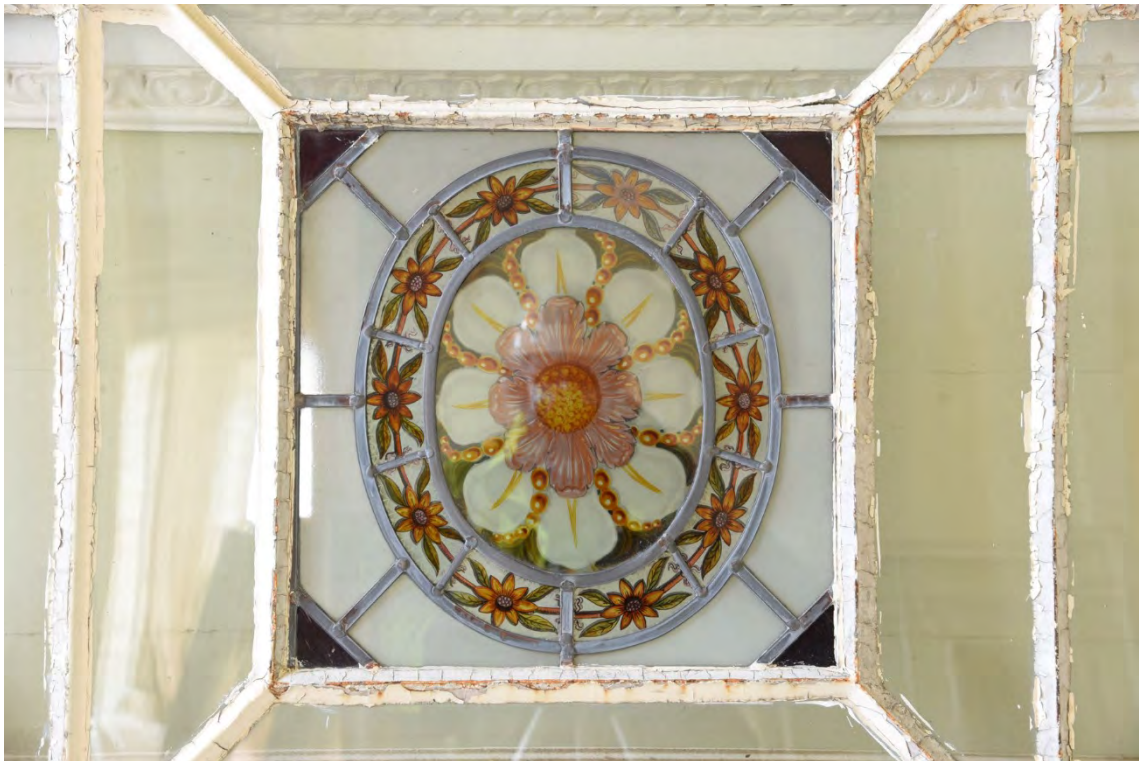
Plate E156 Detail of central stained-glass panel (BRH194)

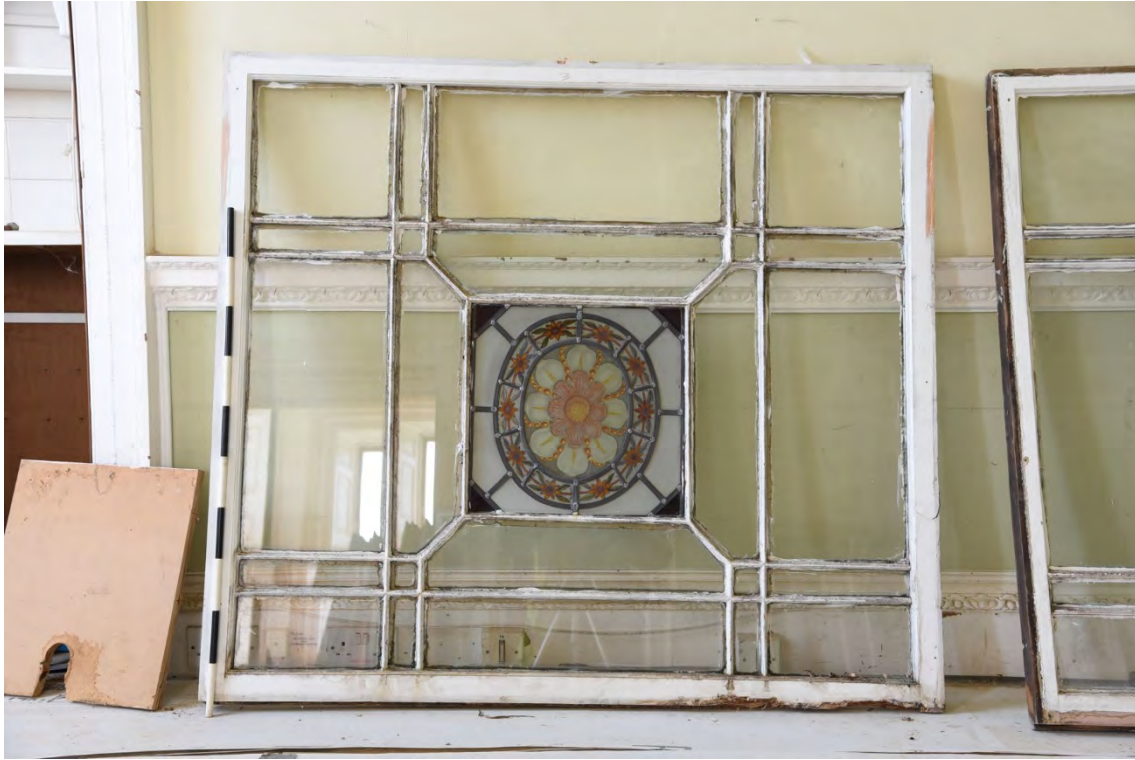
Plate E157 Window panel removed from the lantern's W elevation, interior view (BRH195)

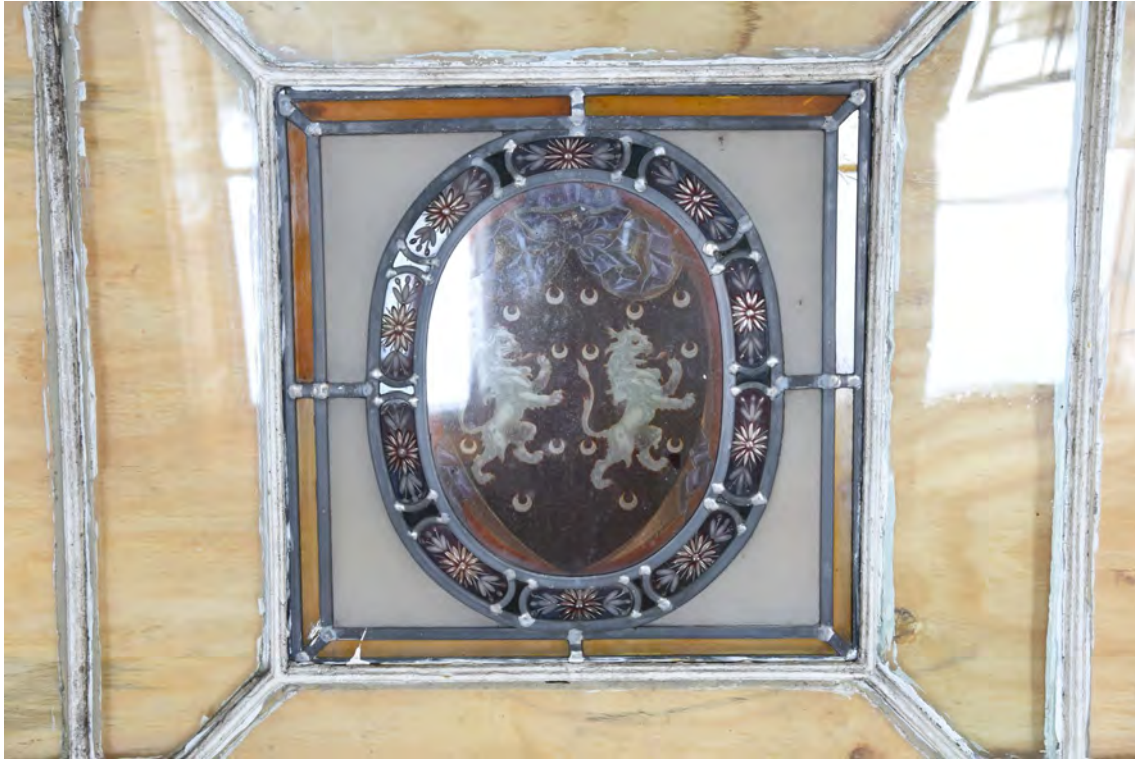
Plate E159 Detail of central stained-glass panel (BRH197)

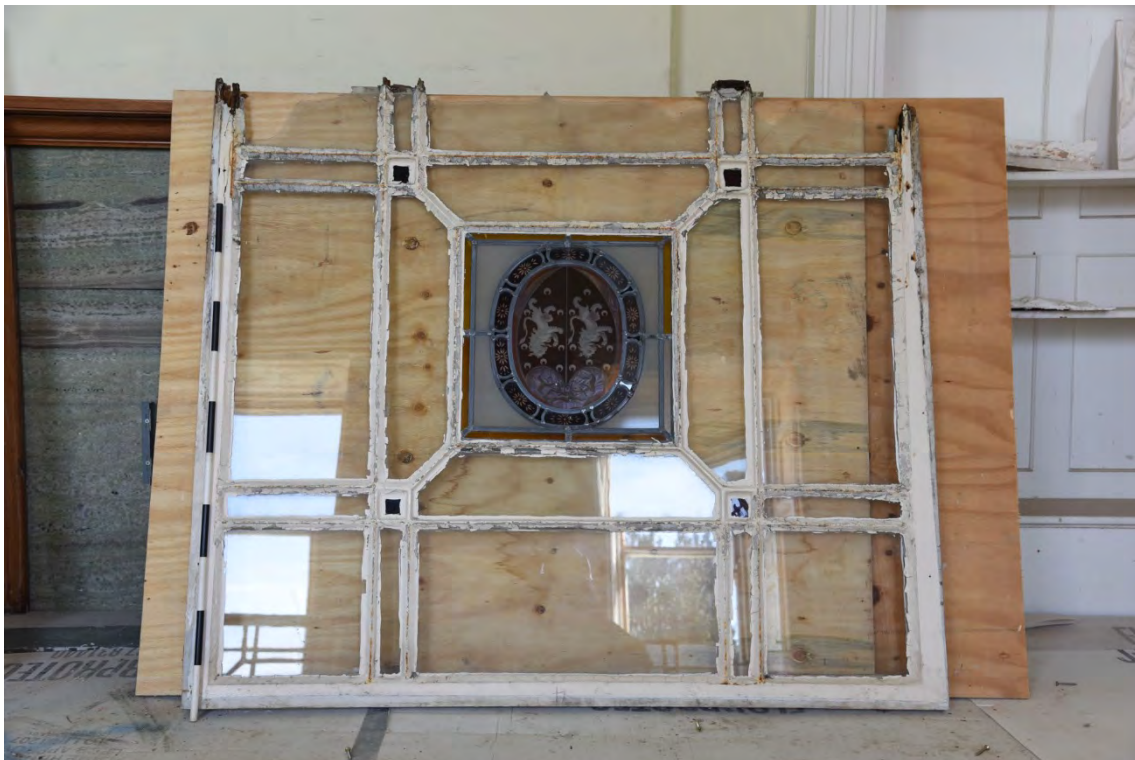
Plate E160 Window panel removed from the lantern's NW elevation, exterior view (BRH198)

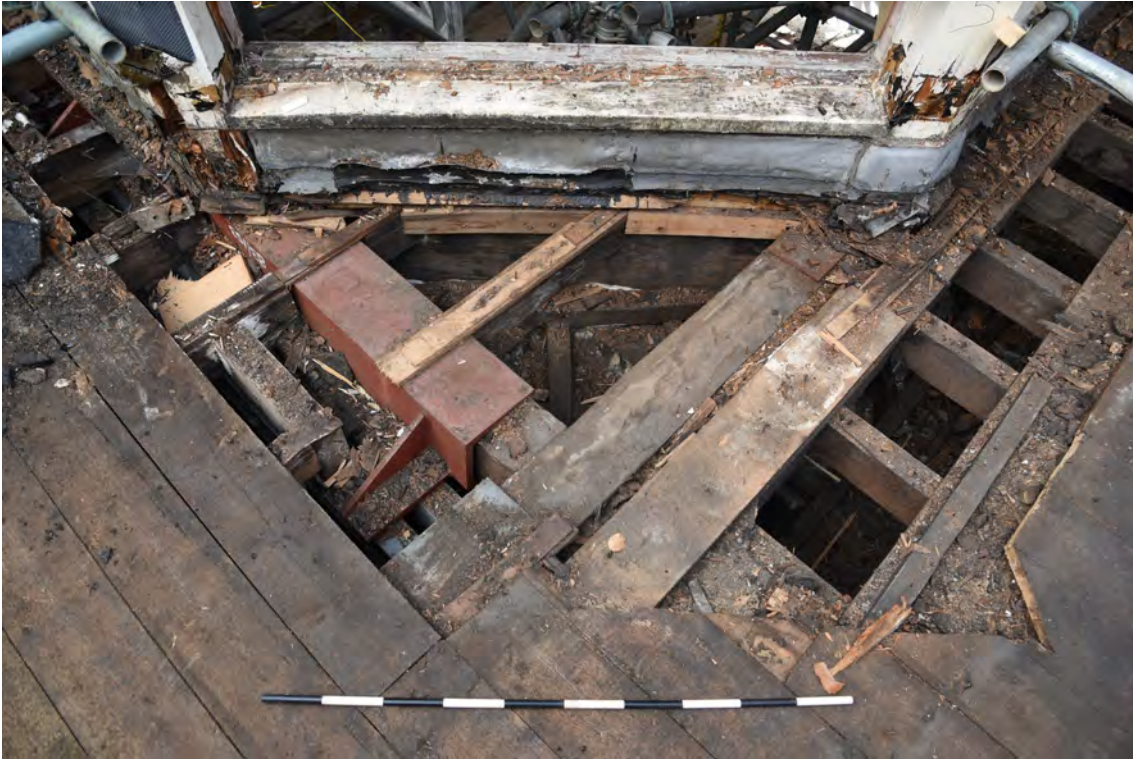
Plate E171 View into roof space following board lift showing modern steel repairs, looking SW, scale 1.0m (BRH080)

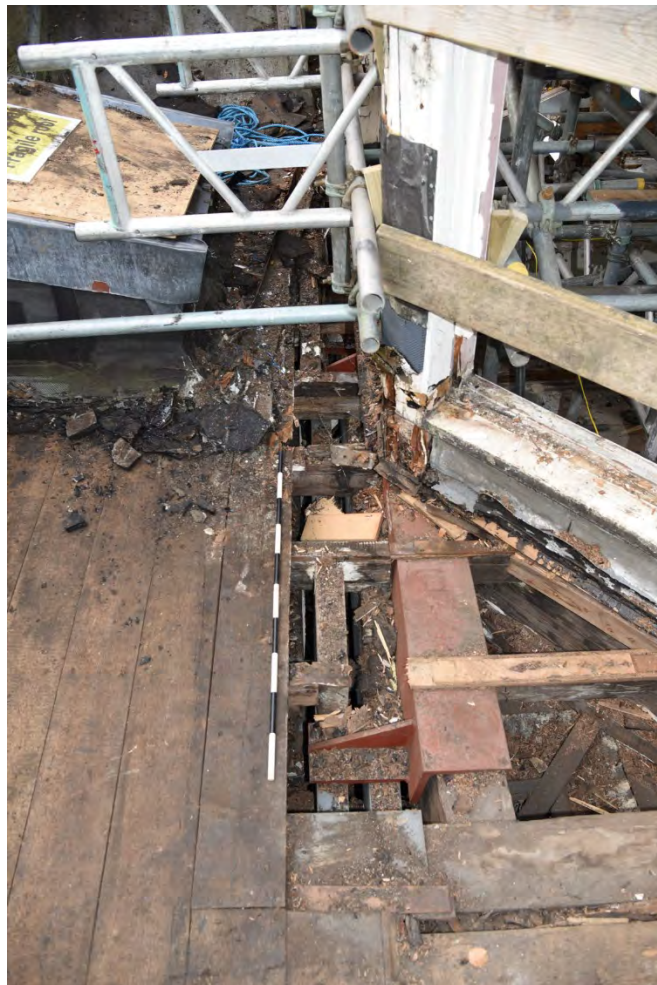
Plate E172 View into roof space following board lift showing modern steel repairs, looking S, scale 1.0m (BRH081)

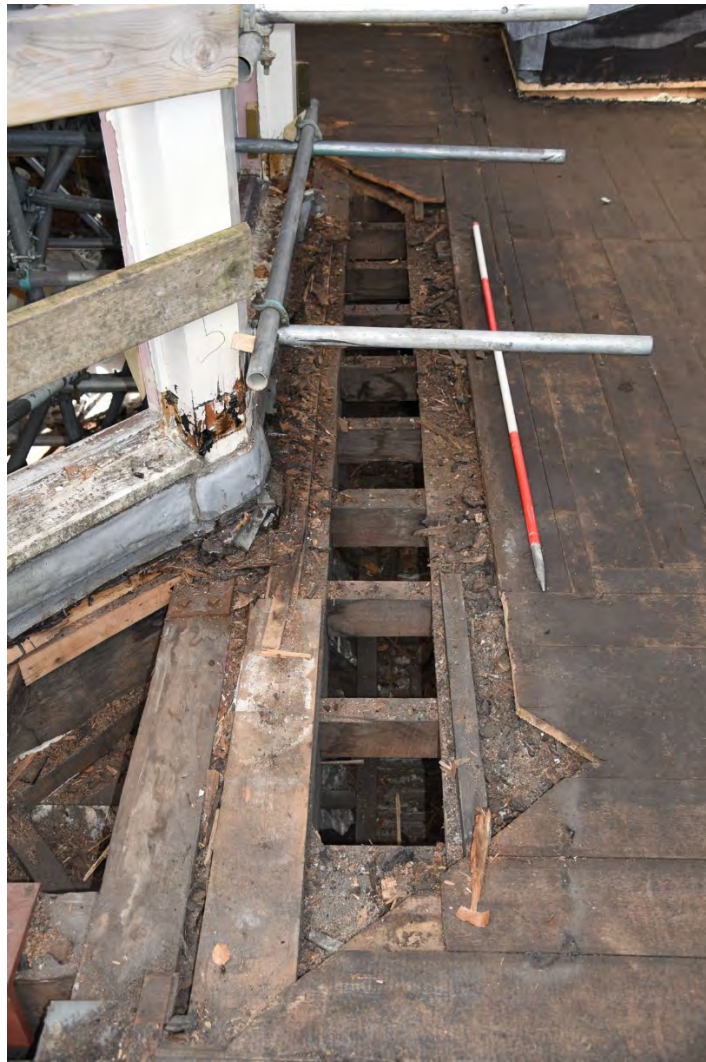
Plate E173 View of roof joists and tie beam following board lift, looking W, scale 1.0m (BRH082)

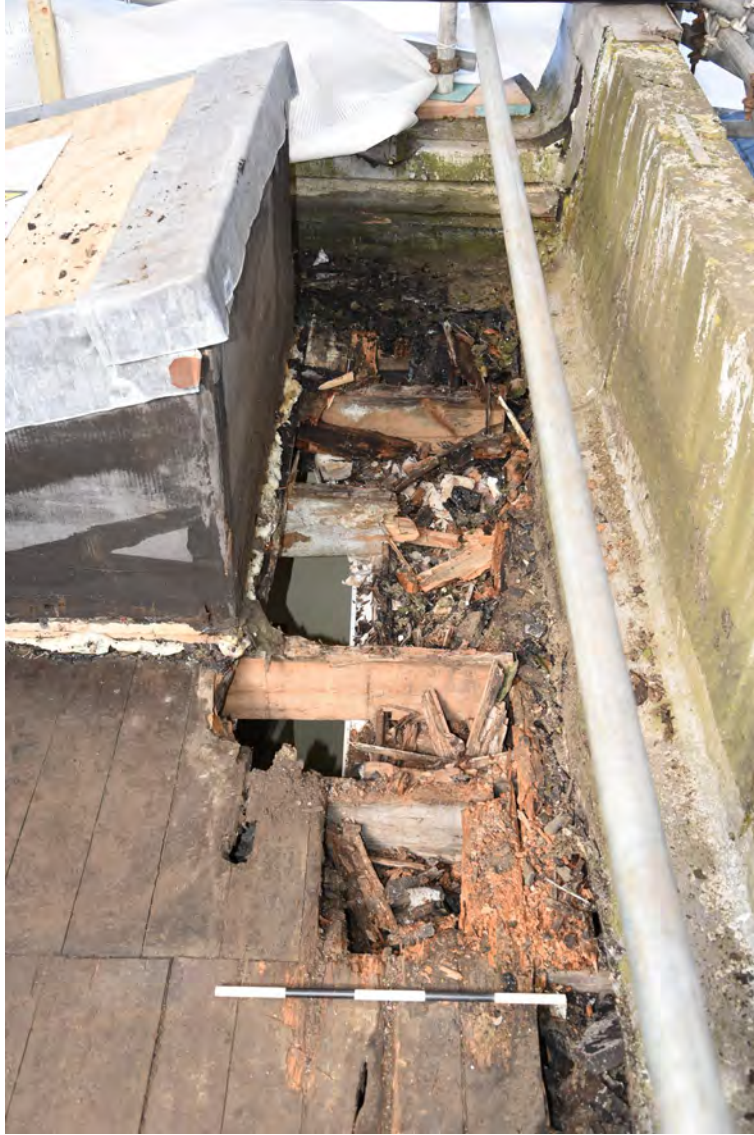
Plate E179 Flat-roof N of NW skylight showing timber decay, looking W, scale 1.0m (BRH088)

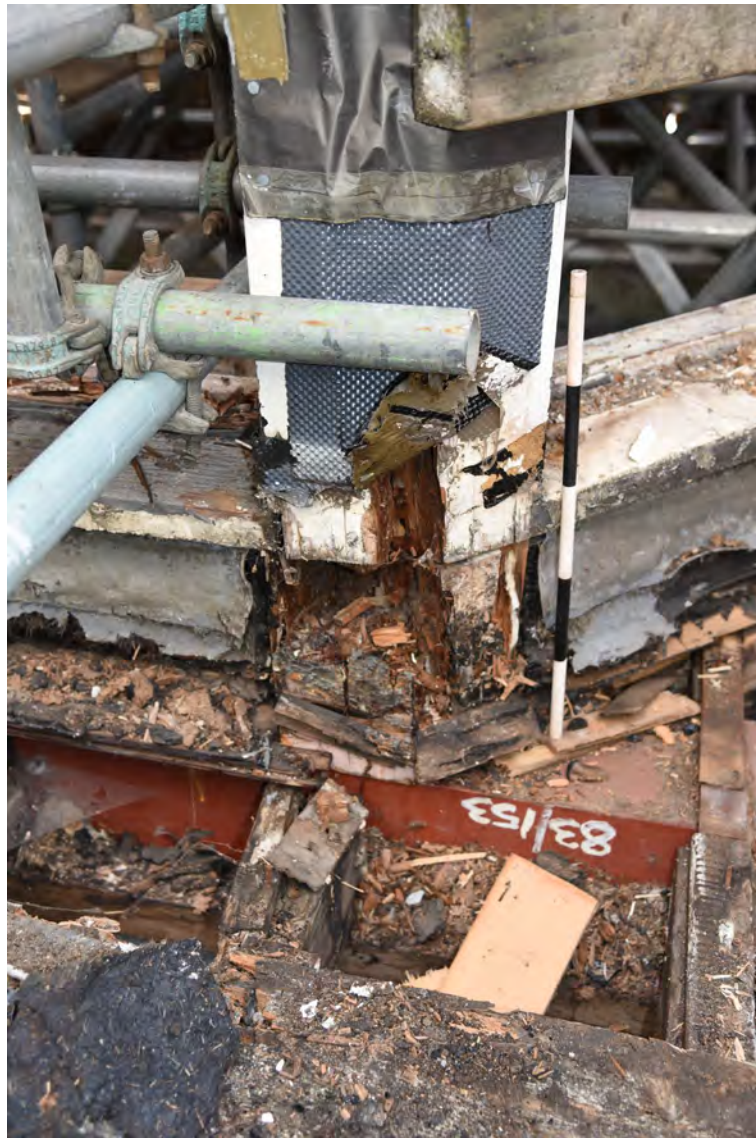
Plate E180 External window frame upright timber showing decay, looking W, scale 50cm (BRH089)

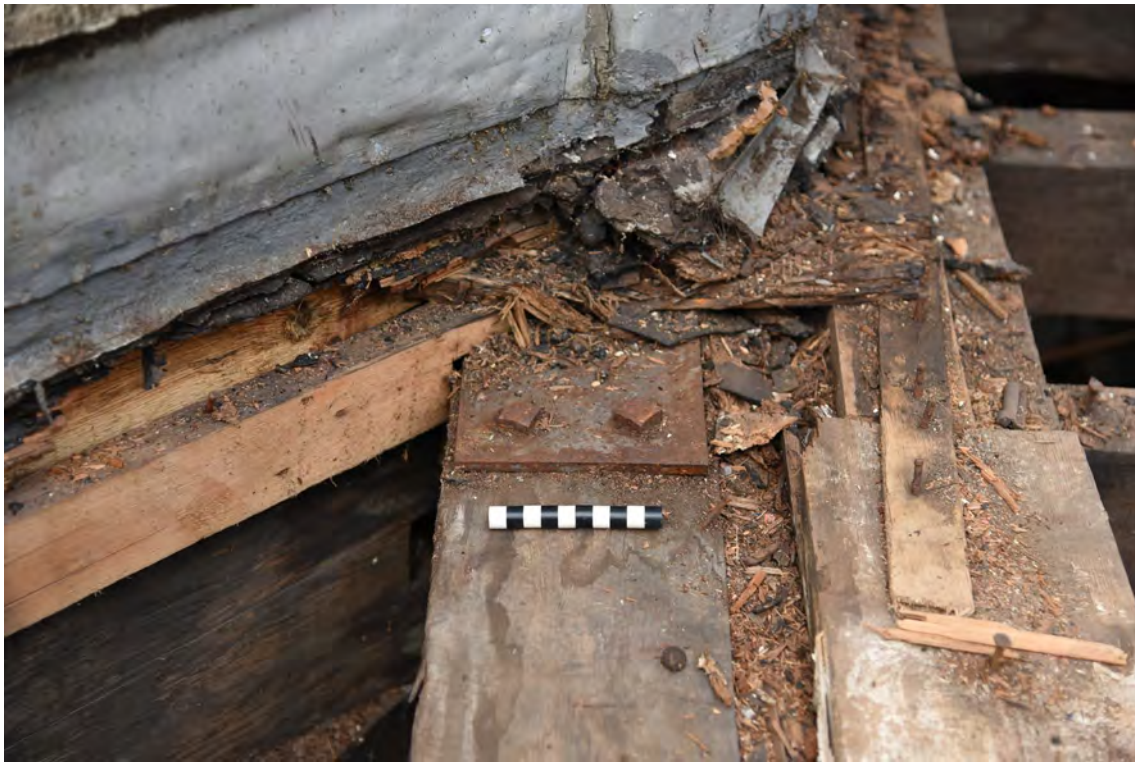
Plate E181 Detail of steel plate repair, looking W, scale 10cm (BRH090)

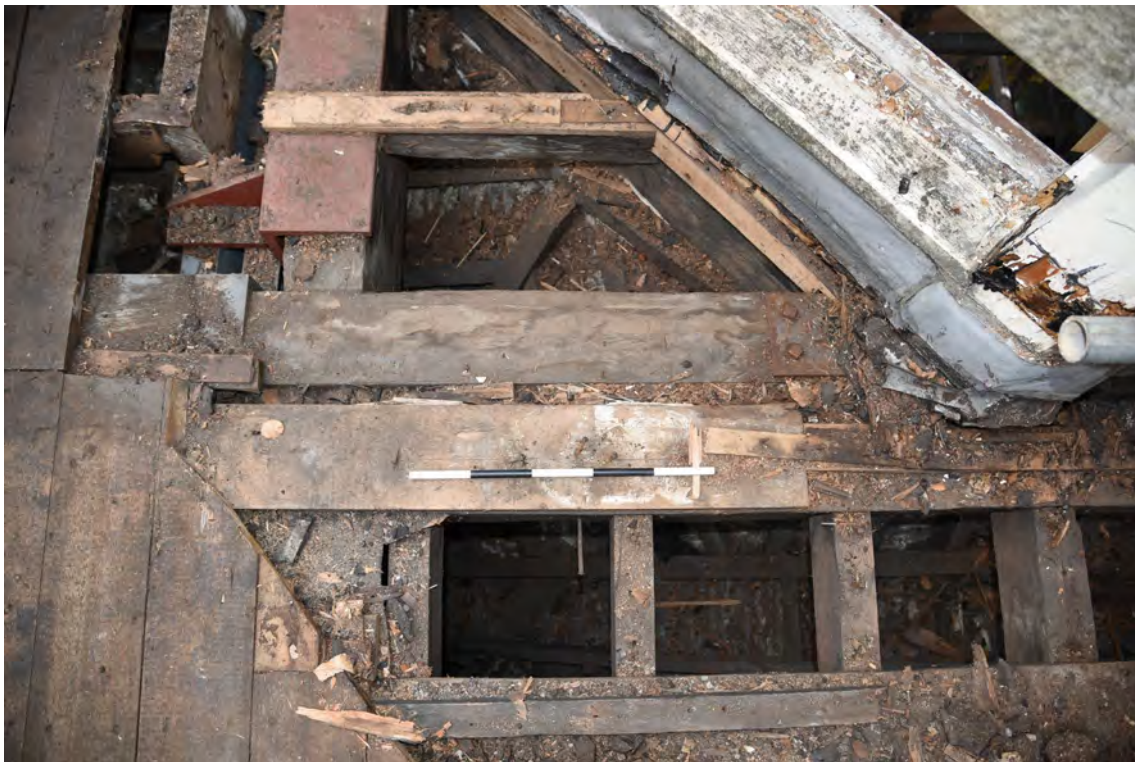
Plate E182 Detail of modern steel and steel plate repairs, looking S, scale 50cm (BRH091)

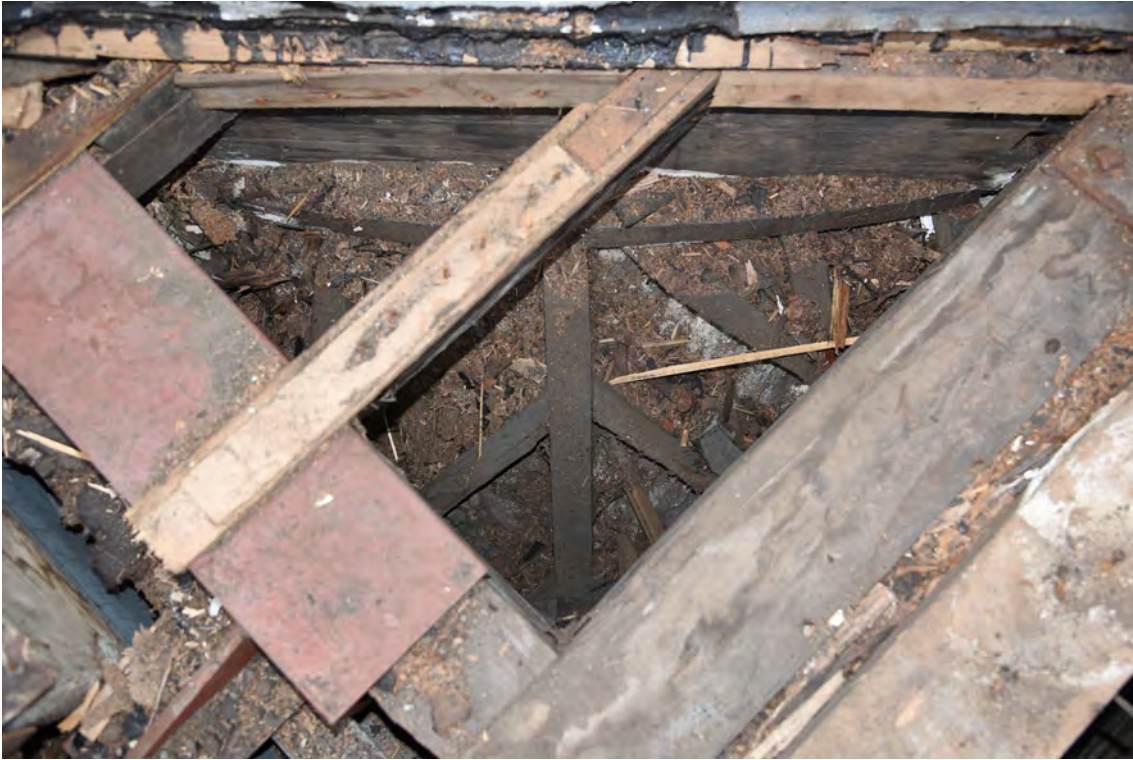
Plate E183 View into roof space overlying the NE pendentive illustrating construction, looking SW (BRH092)
