# ABBEY COTTAGE, MEAUX ABBEY, WAWNE, EAST YORKSHIRE

# ARCHITECTURAL AND ARCHAEOLOGICAL SURVEY

Report no:2008/327.R01Version:FinalDate:December 2010Author:Ed Dennison & Shaun Richardson

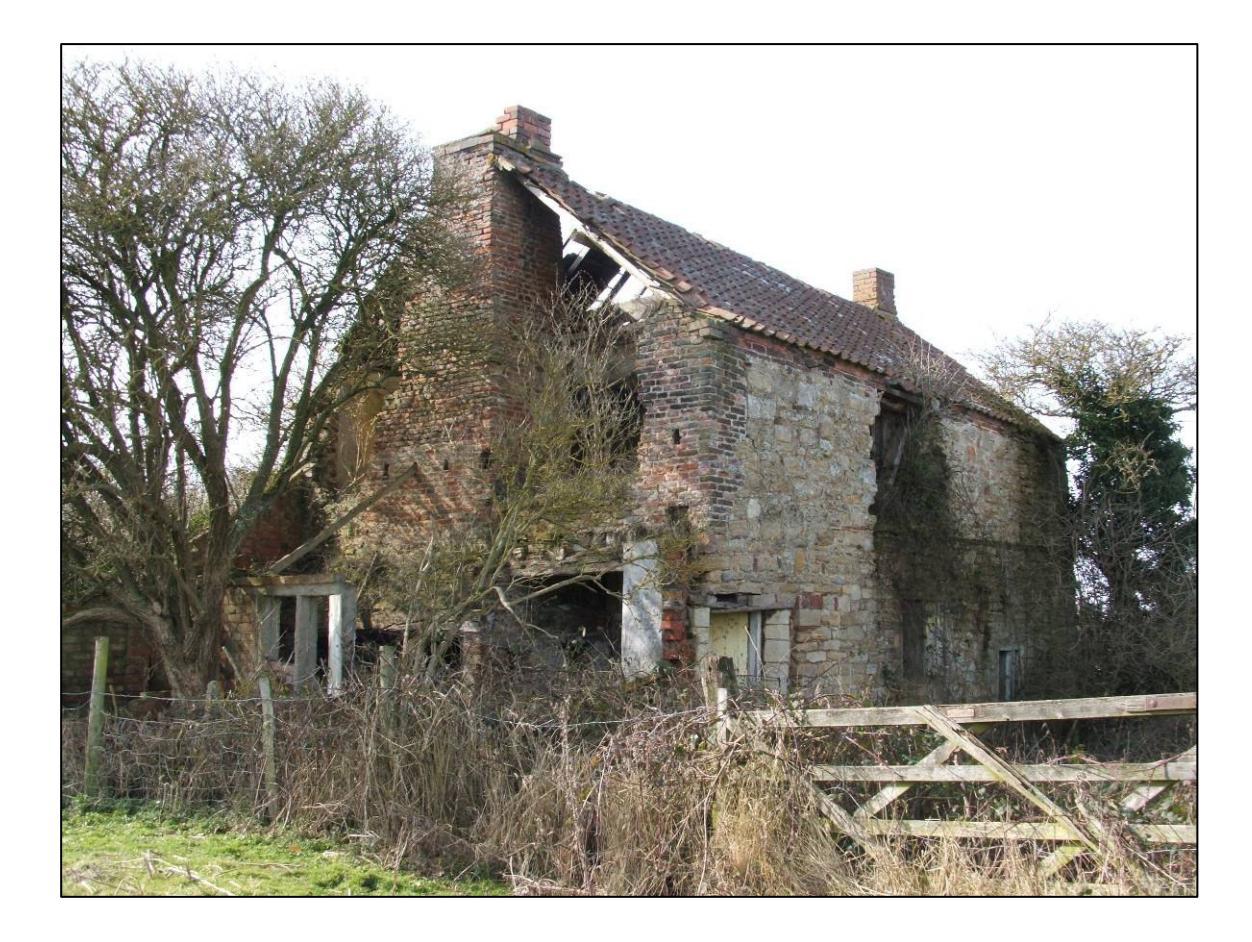
- 3.4 The building is of two storeys, with a pitched pantiled roof (see plate 1). There is a short brick stack to the west end of the ridge, and a very large brick firehood to the east end. This was formerly partly enclosed by a lean-to structure, which has subsequently largely collapsed. The structural framework of the building is formed by load bearing external walls with wooden beams and joists supporting the internal floors.

Plate 1: Abbey Cottage, looking SW.

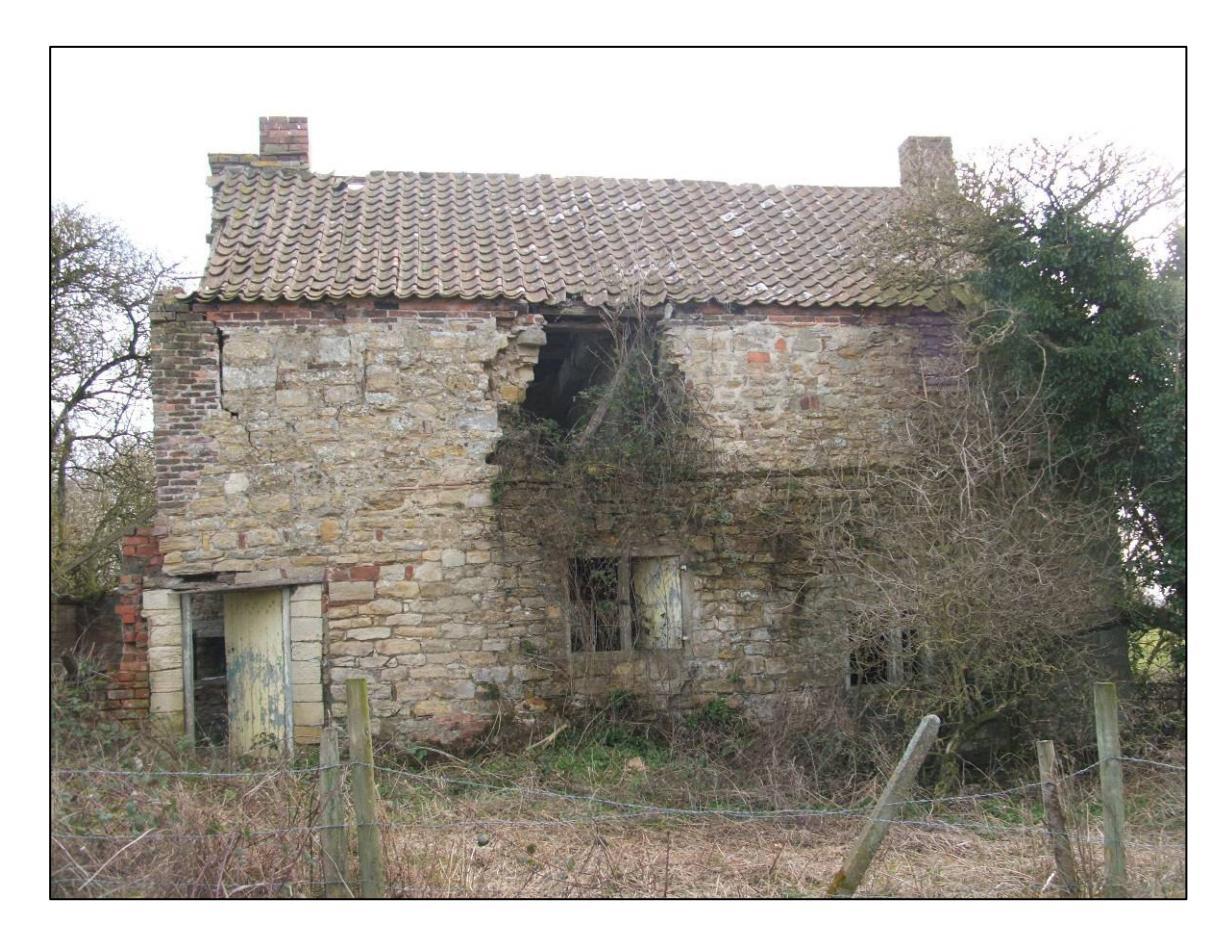
- 3.6 The most highly visible elevation of the building when approached from the east, and that least obscured by vegetation, is the north elevation (see plate 2). The majority of the elevation is built of oolite and limestone, better coursed to the ground floor than to the first. For part of its length, the elevation rises from a chamfered drip course, slightly hollow to the underside, although this is lost towards the western end due to the rising external ground level.

Plate 2: North elevation, looking S.

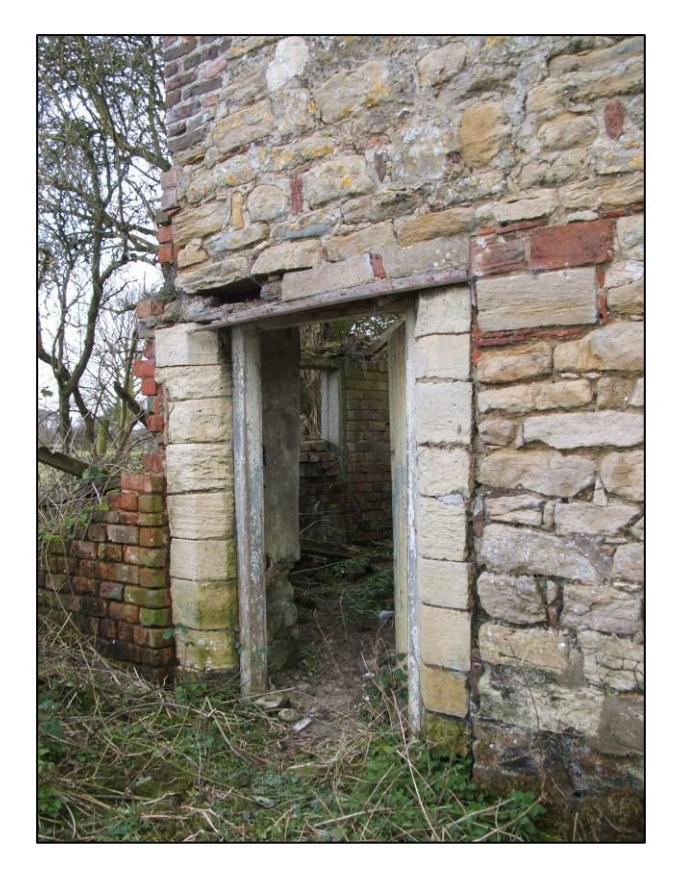
- 3.7 At the east end of the ground floor, there is a doorway with jambs formed from Magnesian limestone blocks, widely chamfered to the exterior and rebated and splayed to the interior (see plate 3). The doorway lacks a proper head, having a shallow timber lintel, and it appears to have been inserted into a wider opening here. It is presumably re-used from elsewhere within the abbey precinct and retains a plank and batten door. To the west, there is a two-light window; unfortunately, like all other windows within the building, the original frames have been replaced by modern concrete sills, lintels and divisions. To the west side of the window, there is a similar smaller example, again with a concrete frame. However, a close examination reveals that this has been created by blocking a former doorway. The doorway was relatively low and also broke the chamfered drip course properly, rather than cutting through it. The north-west corner of the building is quoined.

Plate 3: East doorway in north elevation, looking SW.

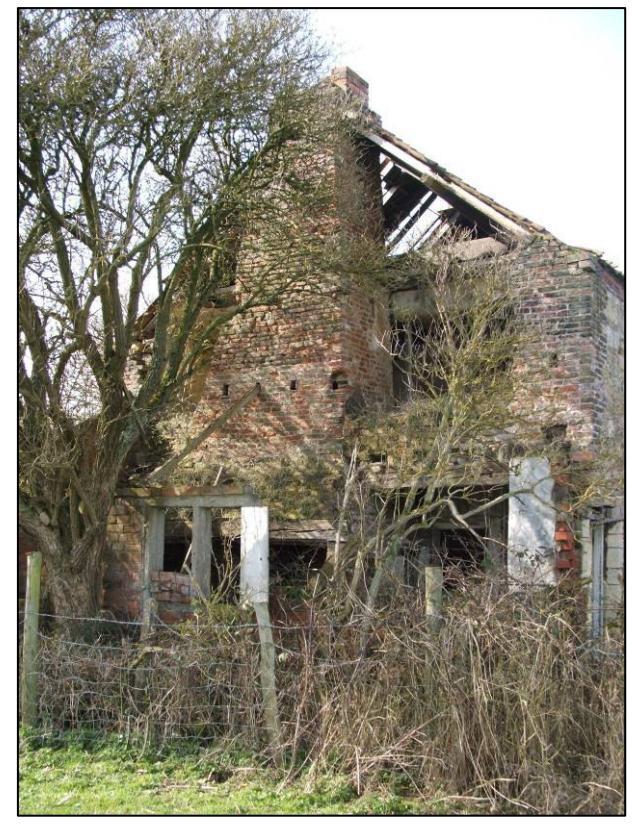
- 3.17 The removal of the lean-to has left the formerly internal brick firehood open to the elements (see plate 4). A more detailed description of the different parts of the firehood are given in the circulation description below, but broadly it comprises two large ground floor fireplaces set back to back, both retaining substantial bressumers, and with a tall brick stack over tapering inwards to the first floor; the uppermost part has been rebuilt. Externally, the firehood is built of light red handmade bricks (average dimensions 200mm-240mm by 120mm by 40mm-50mm) set with a buff lime mortar but laid in no particular bonding pattern. There is a mixture of stone rubble and brick lining to the interior, which is heavily sooted.

Plate 4: East gable and stack, looking SW.

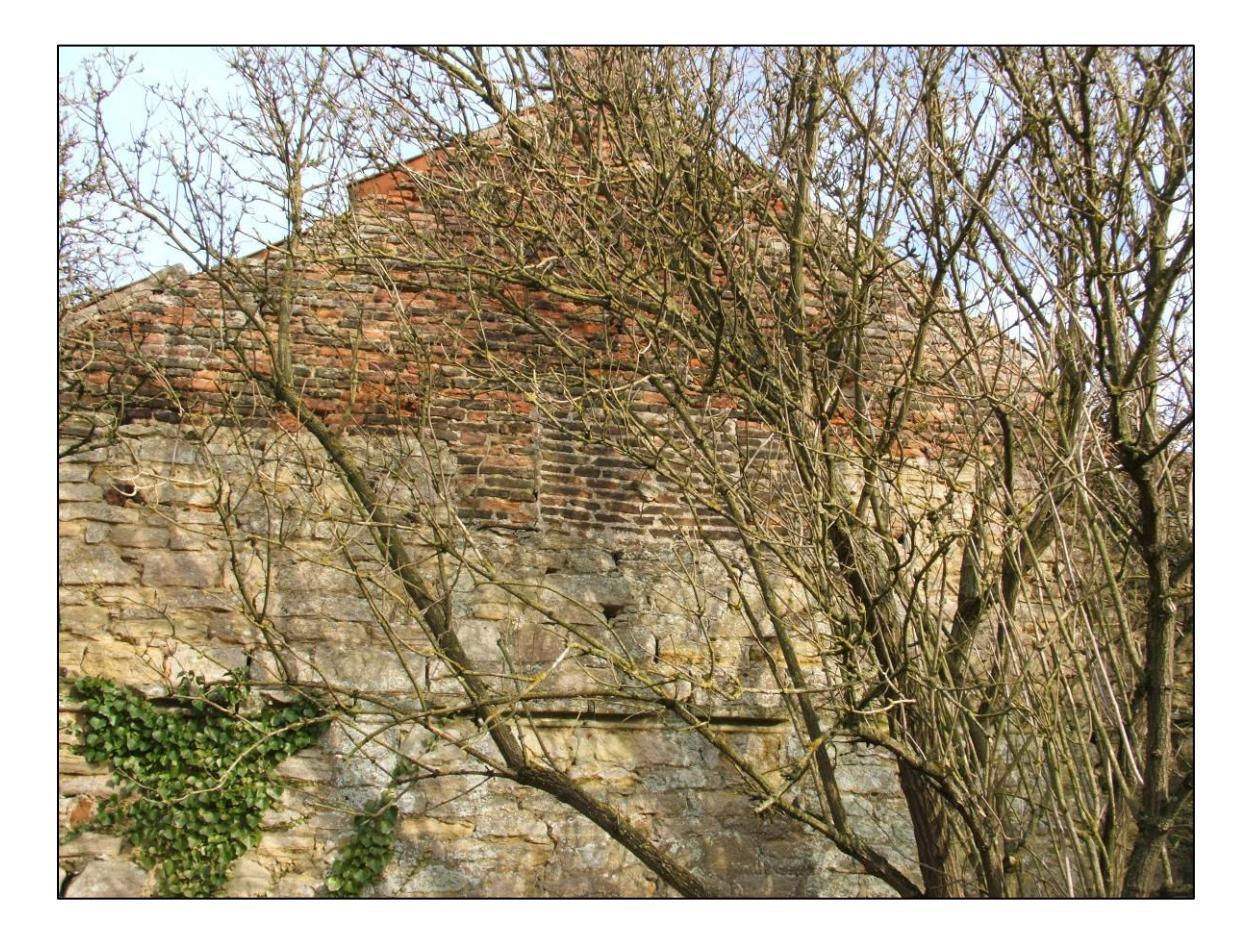
Plate 5: West gable, looking E.

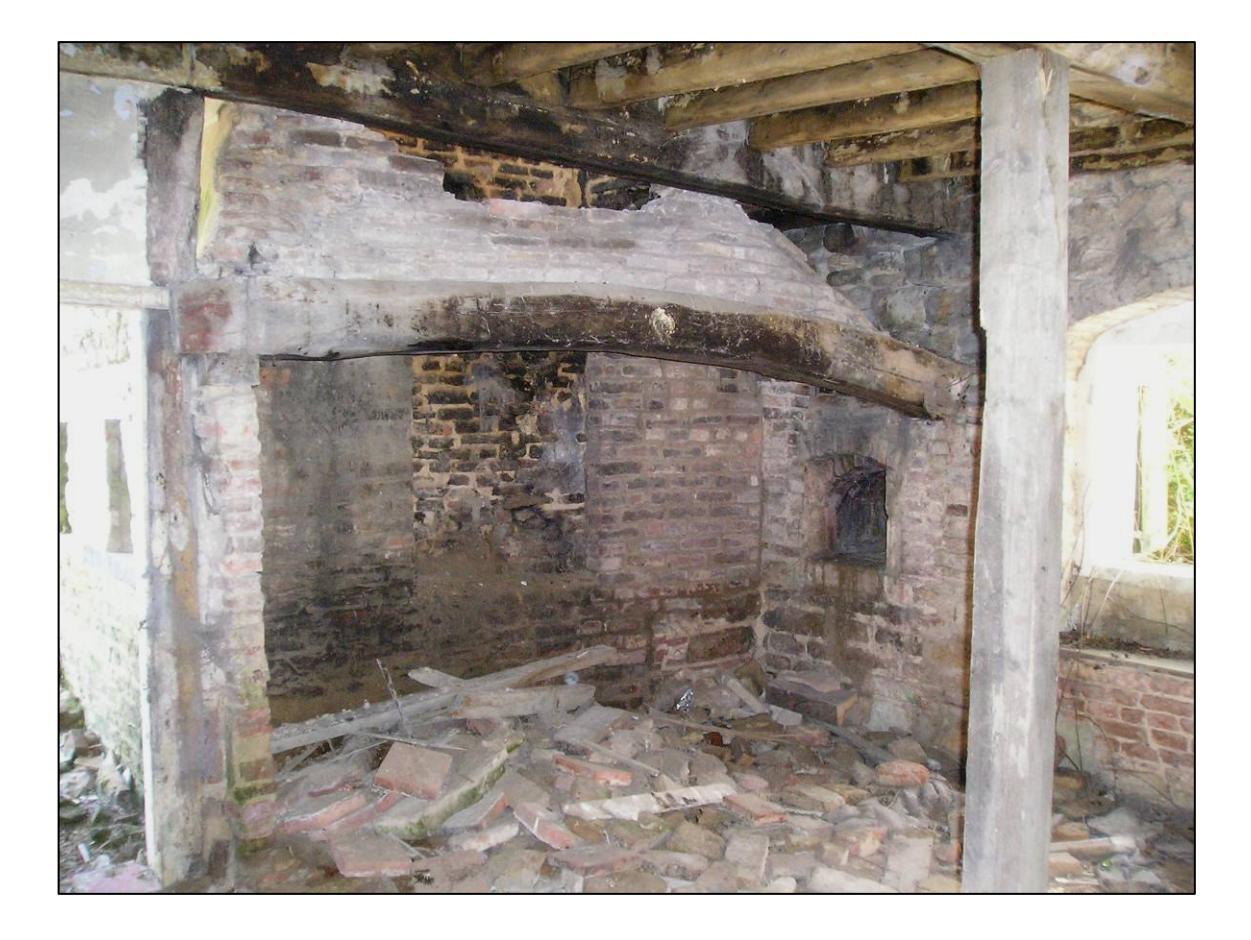
Plate 6: West internal fireplace, bressumer and bread oven, looking SE.

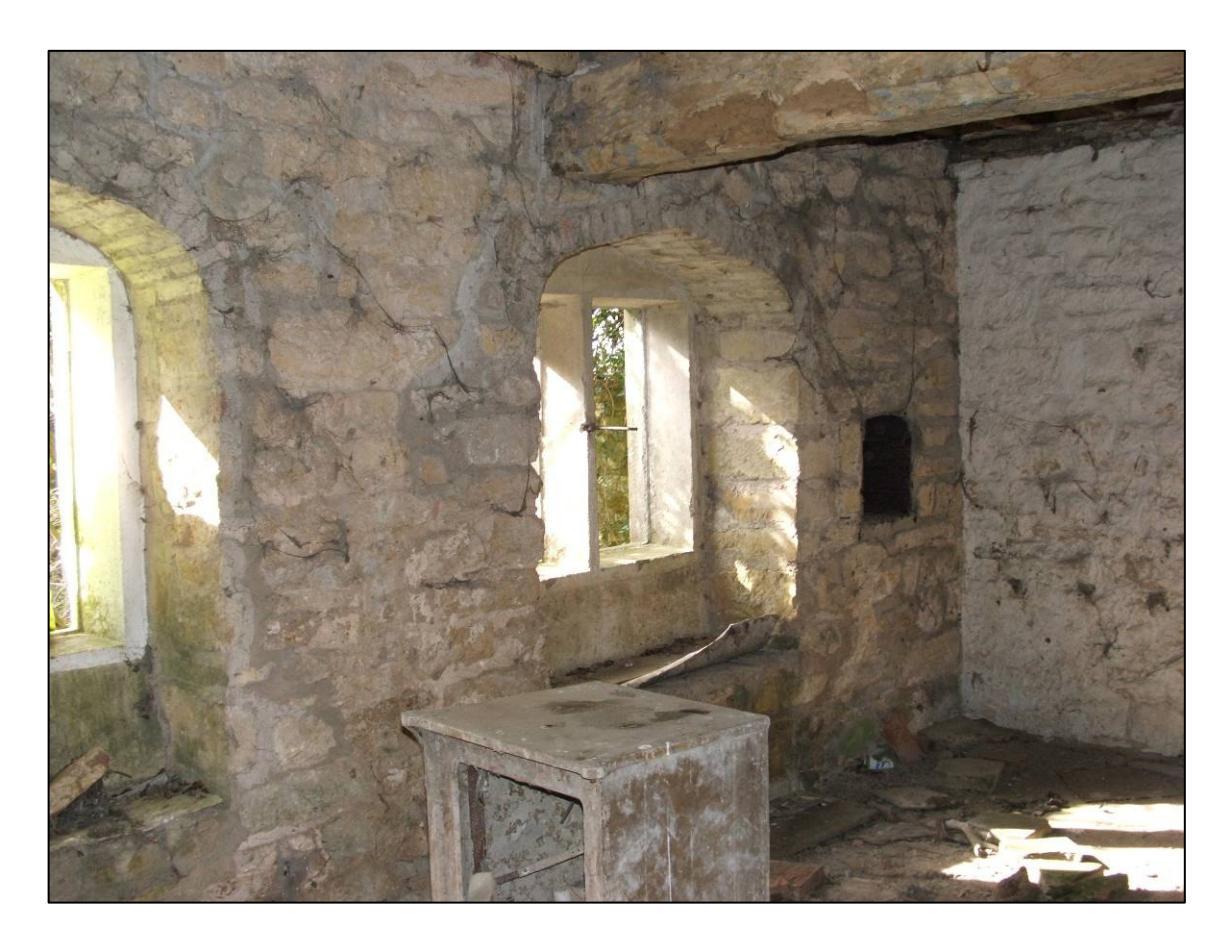
Plate 7: Ground floor of main building, looking SW.
