ST MARY'S PRIORY CHURCH, OLD MALTON, NORTH YORKSHIRE

ARCHAEOLOGICAL OBSERVATION, INVESTIGATION AND RECORDING

Report no: Version: Date: Author: 2012/419.R01 Final May 2013 Ed Dennison & Doug Jobling

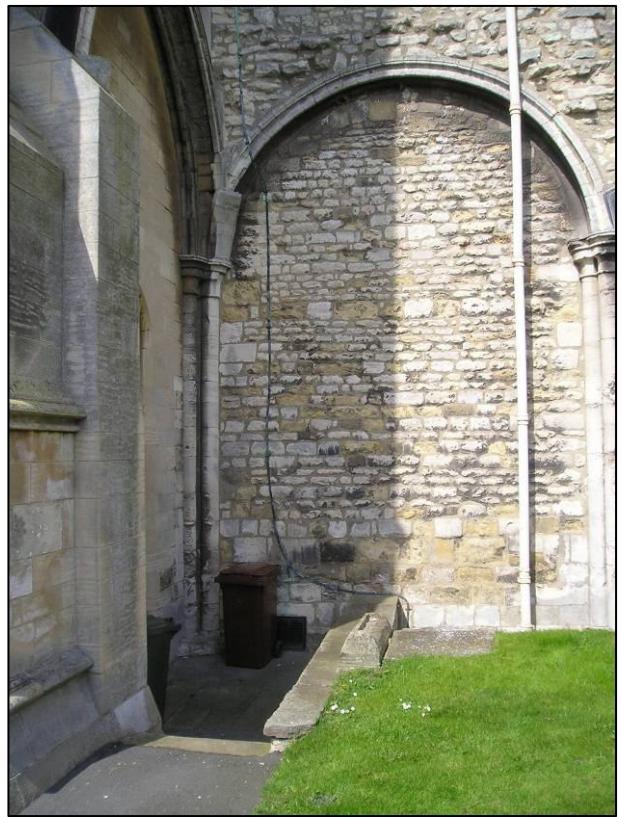
Plate 2: Location of proposed new extension, showing blocked bay of south arcade, looking north.

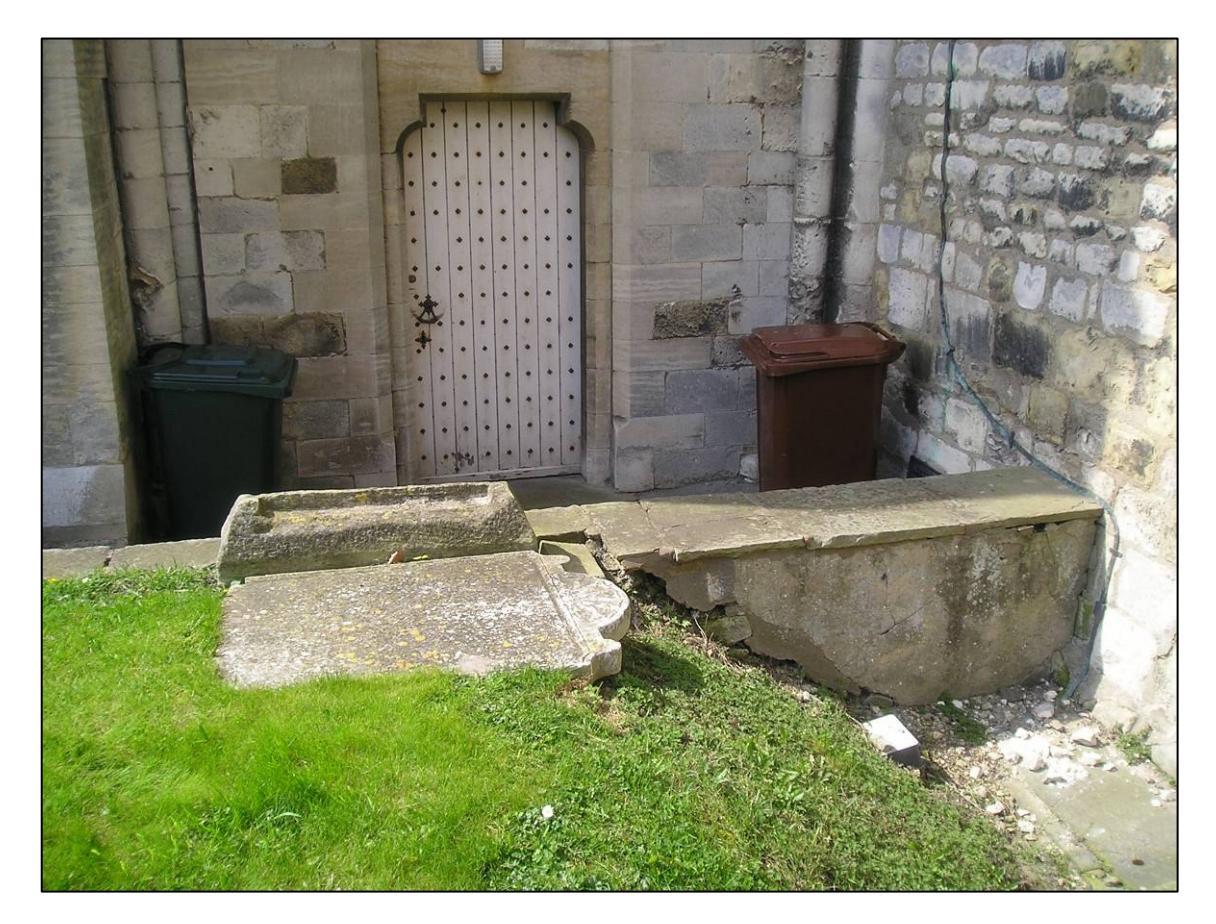
Plate 3: Location of proposed new extension, showing differences in ground levels and existing door into south-west tower, looking north-west.

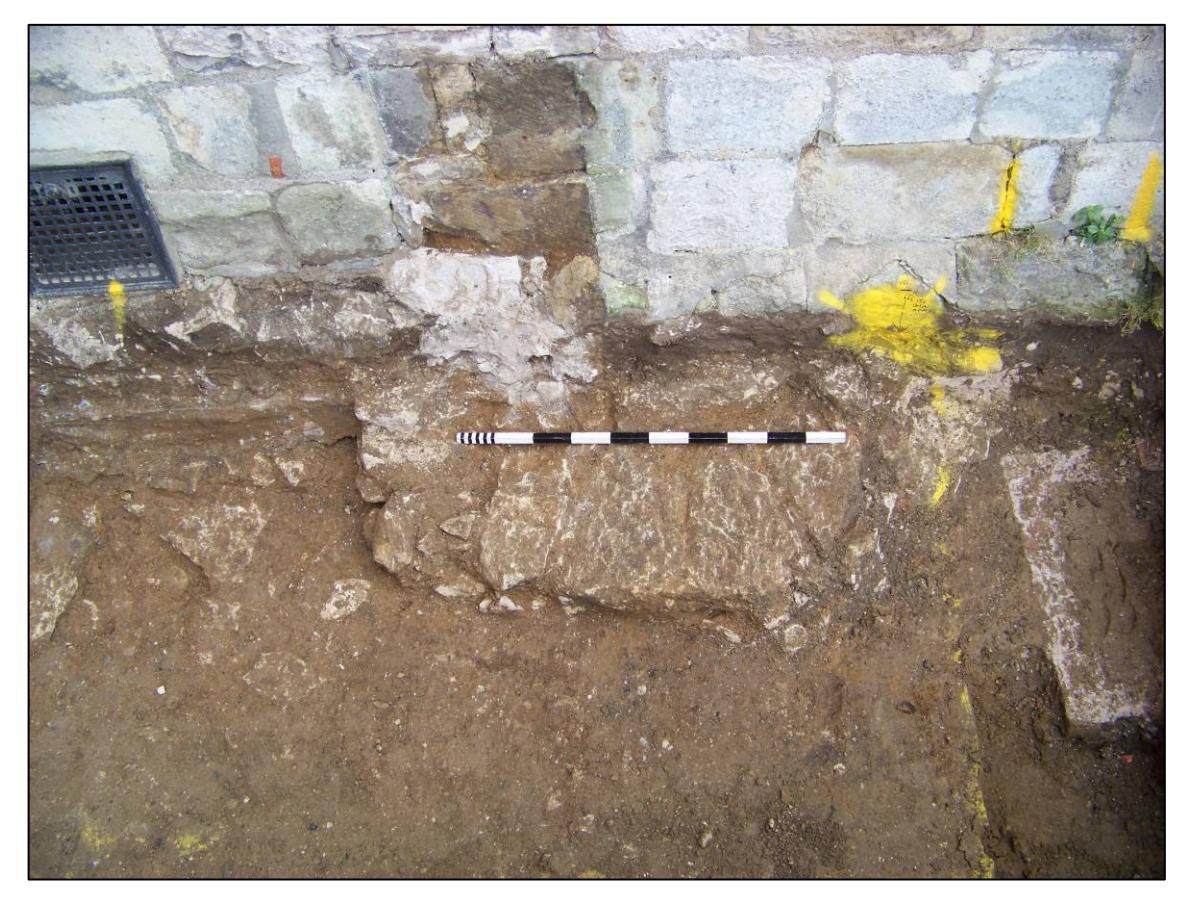
Plate 4: Chalk foundations [113] beneath blocking of south arcade, with brick-built soakaway [105] to right, looking north.

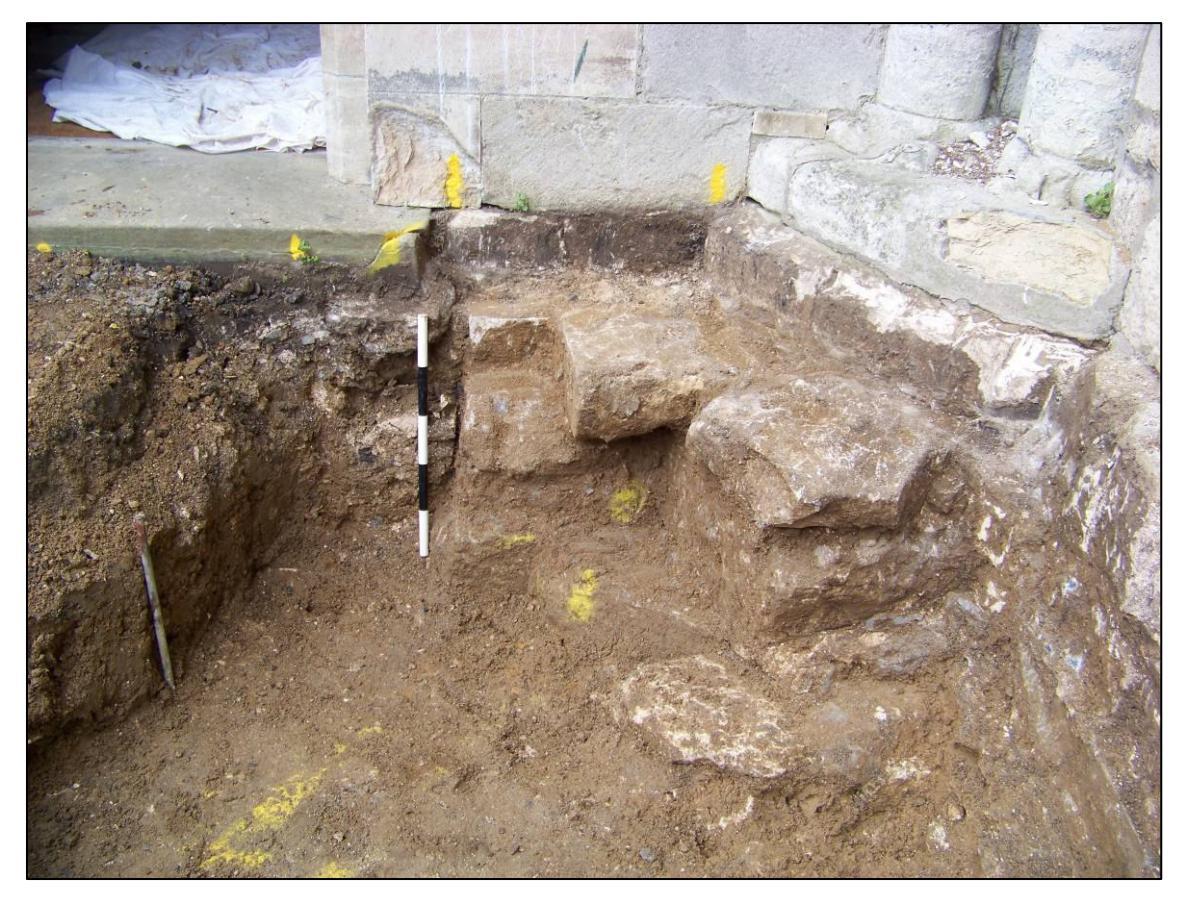
- 6.8 Cutting into this deposit, in the north-west corner of the trench, was the foundation for a pier base; the extant pier is dated to the late 12th-early 13th century (Russell 1914, 539). The cut [119] was partially circular in appearance in plan with exposed dimensions of 0.73m north-south and 0.65m east-west, and it continued further to the east along the blocked arcade for 0.75m before being cut through by the chalk foundation [112/113]. Set within the cut [119] was the foundation for the pier base which comprised semi-regular generally unworked blocks of stone, probably limestone [118], set within a moderately hard mid-yellow brown sandy clay [117], which extended for a depth of at least 0.98m below the level of excavation (see plate 5); the top of this foundation lay at 21.44m OD. Above this was the extant pier base which is not recorded here.

Plate 5: Foundations [118] of late 12th-early 13th century pier, looking north-west.

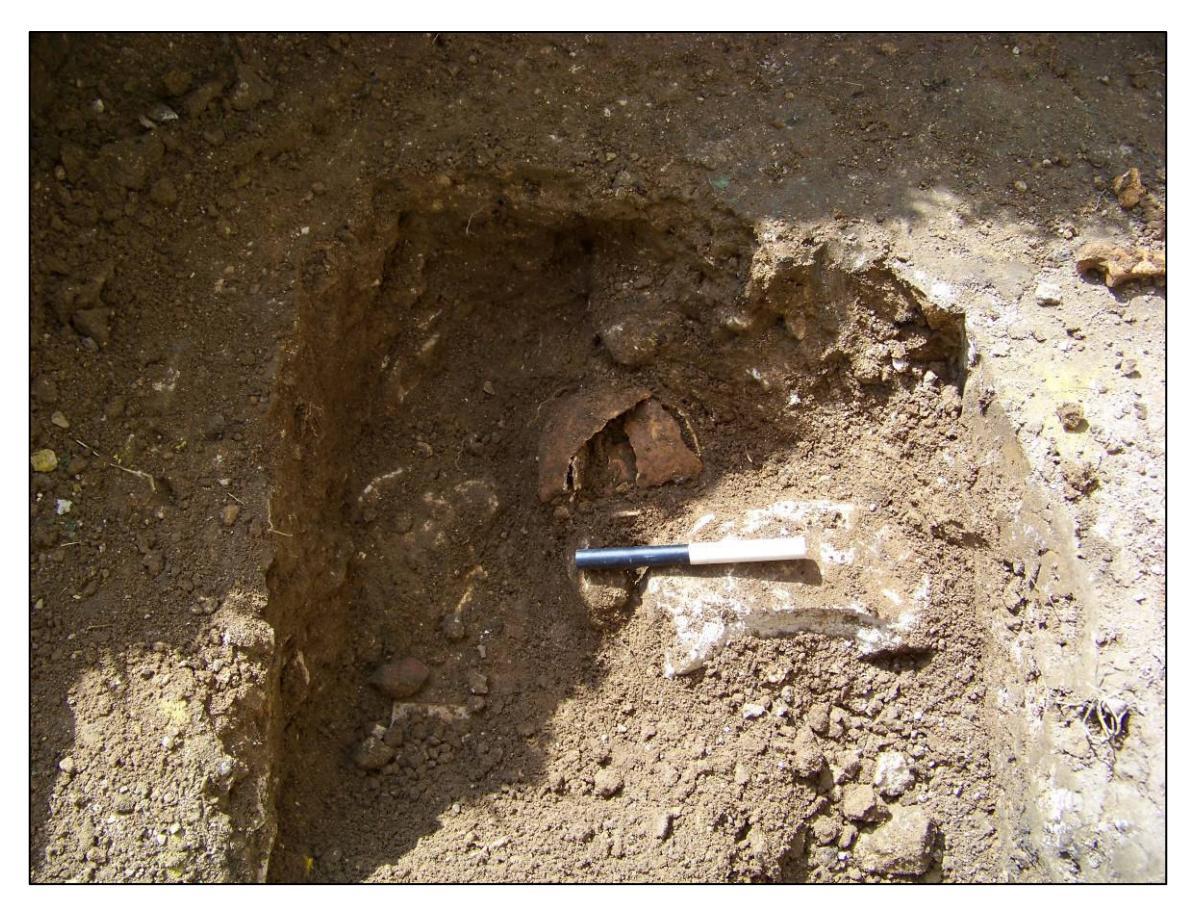
Plate 6: Burial [107] in grave cut [109], looking west.

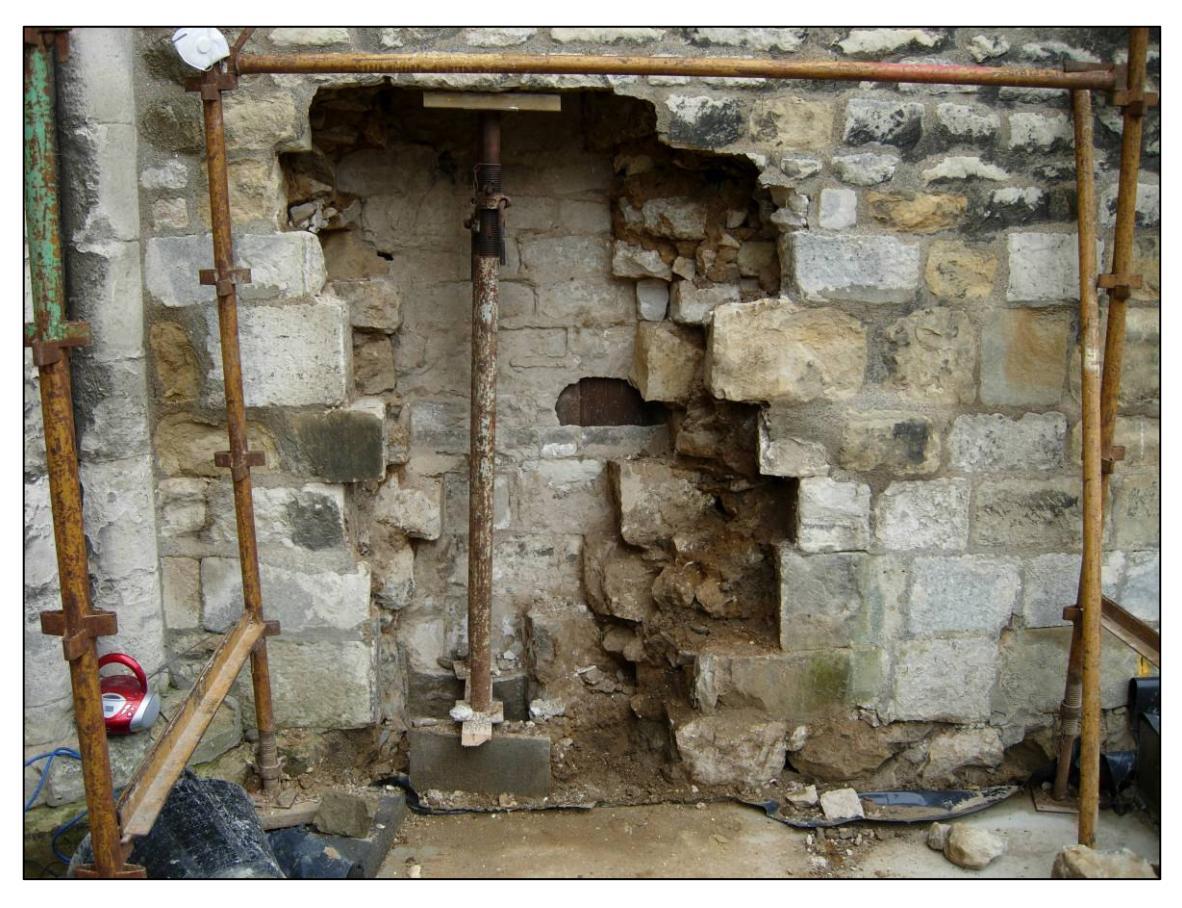
Plate 7: Cutting through infill of blocked arcade, looking north.

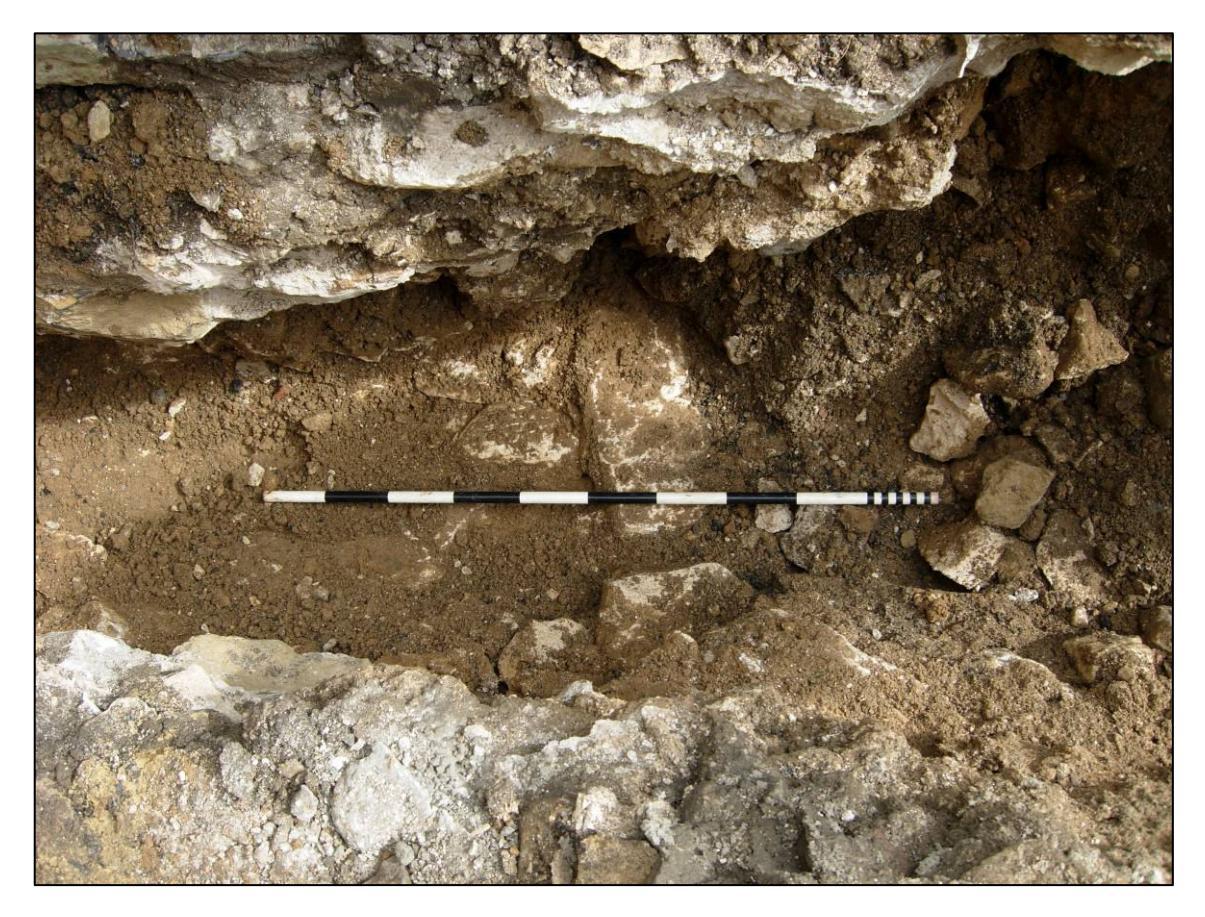
Plate 8: East-west aligned wall foundation [304], looking east.

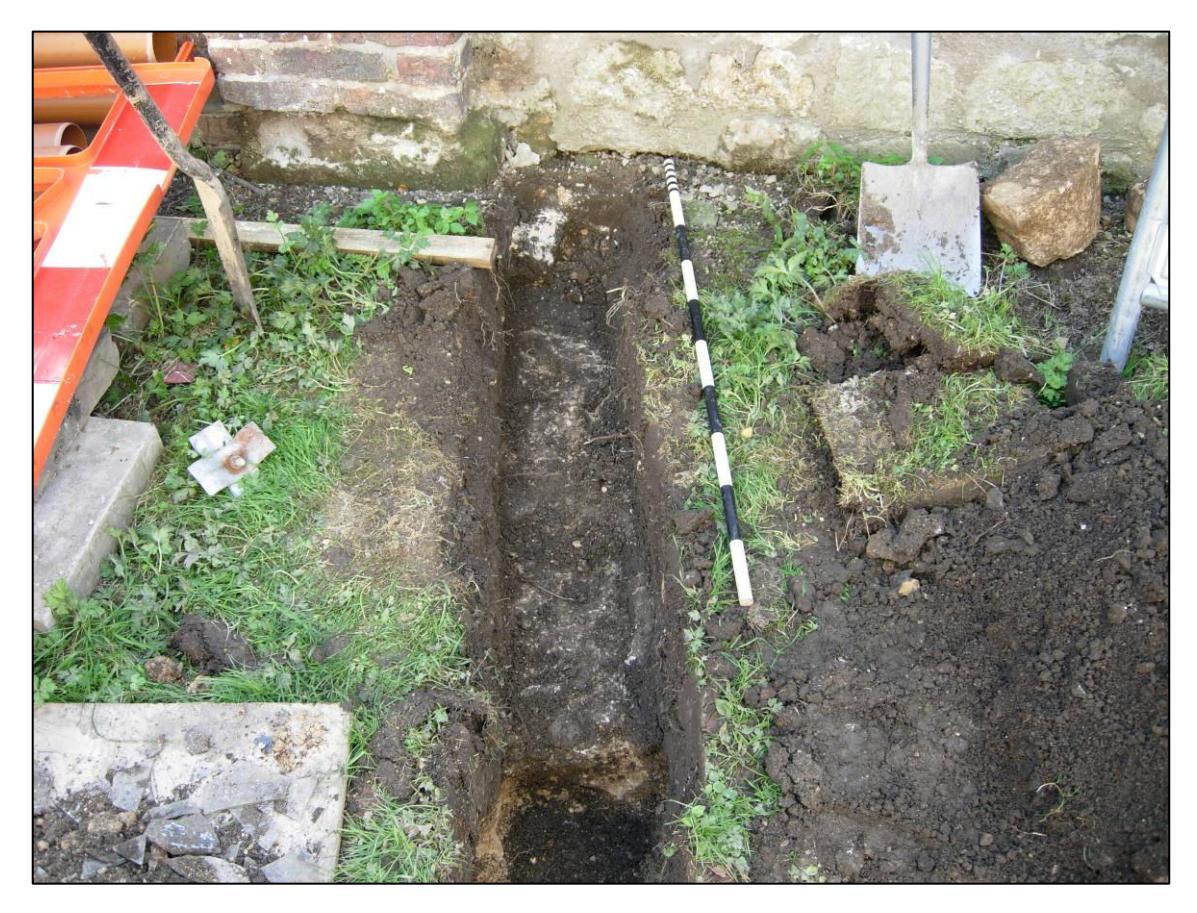
- 6.19 At the very southern end of Trench 3, there was evidence for some 0.07m thick stone slabs [308] which ran underneath the adjacent boundary wall of the churchyard; they extended north along the trench for around c.0.70m and the top was found at 22.30m OD, 0.20m below ground level (see plate 9). The limited

nature of the excavations here means that interpretation of these slabs is not possible, but it is possible that they are associated with now demolished priory buildings, or even potentially a part of the cloister - wall lines and surfaces at a similar depth OD were recently noted in archaeological investigations on the south side of the churchyard wall (MAP 2013).

Plate 9: Stone slabs [308] running under churchyard boundary, looking south.

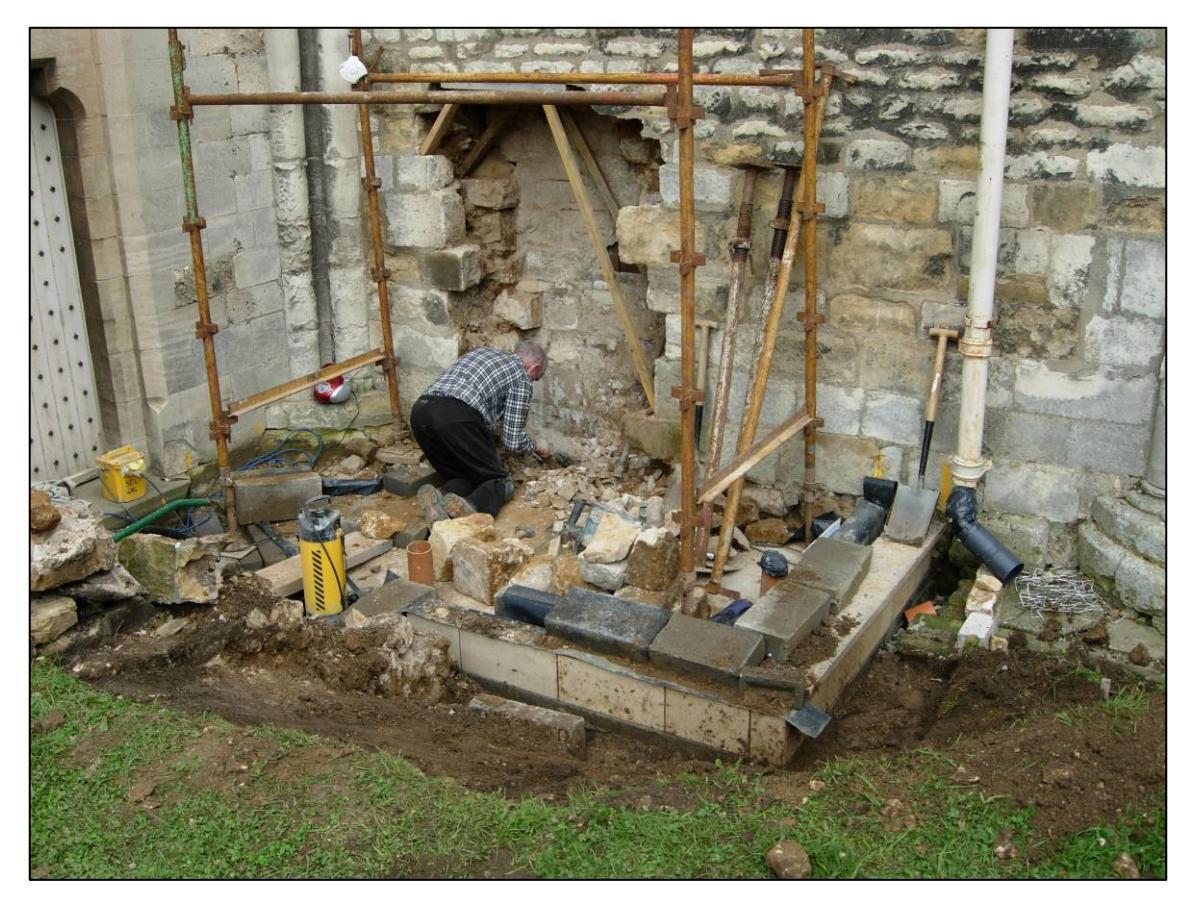
- 6.10 Following the initial laying of the foundations of the new toilet block, it was considered necessary to undertake further landscaping works to the sloping earthen bank which lay to the south and south-east of the new building footprint (see plate 10).

Plate 10: Construction work in progress, after additional landscaping, looking north-west.

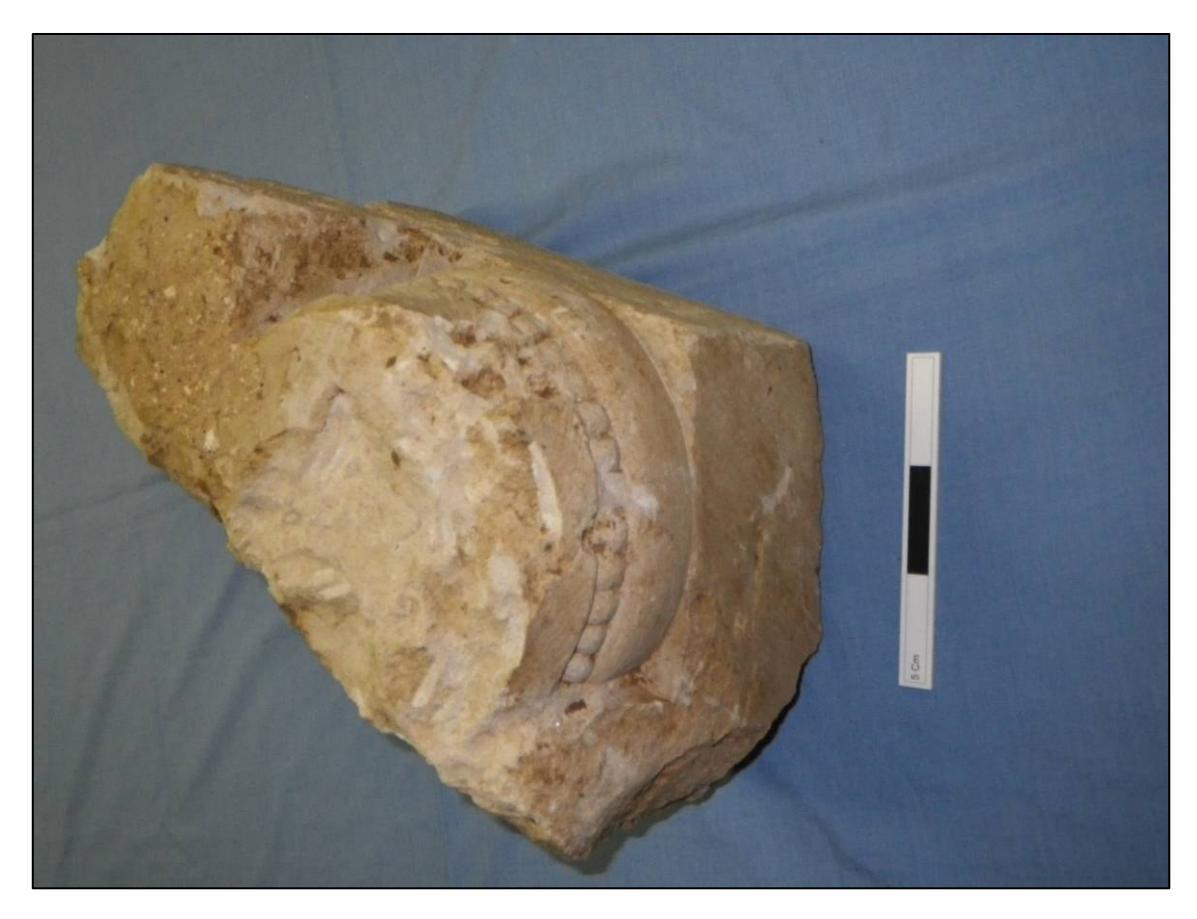
Plate 11: Carved limestone fragment, forming a 12th century nook-shaft base with a row of bead moulding, recovered from infill of blocked arcade.

With regard to date the nook shaft dates to the Romanesque period and would be consistent with the date of the Priory's foundation in 1150 until the advent of the Gothic style (Early English) in the late 12th century (Fleming et al. 1980, 107).
