BLAKETHWAITE DAMS, BLAKETHWAITE GILL, MELBECKS, NORTH YORKSHIRE (NGR NY 935 029)

CONDITION INSPECTION

Report no: Version: Date: Author: 2015/495.R01 Final June 2015 Ed Dennison & Shaun Richardson

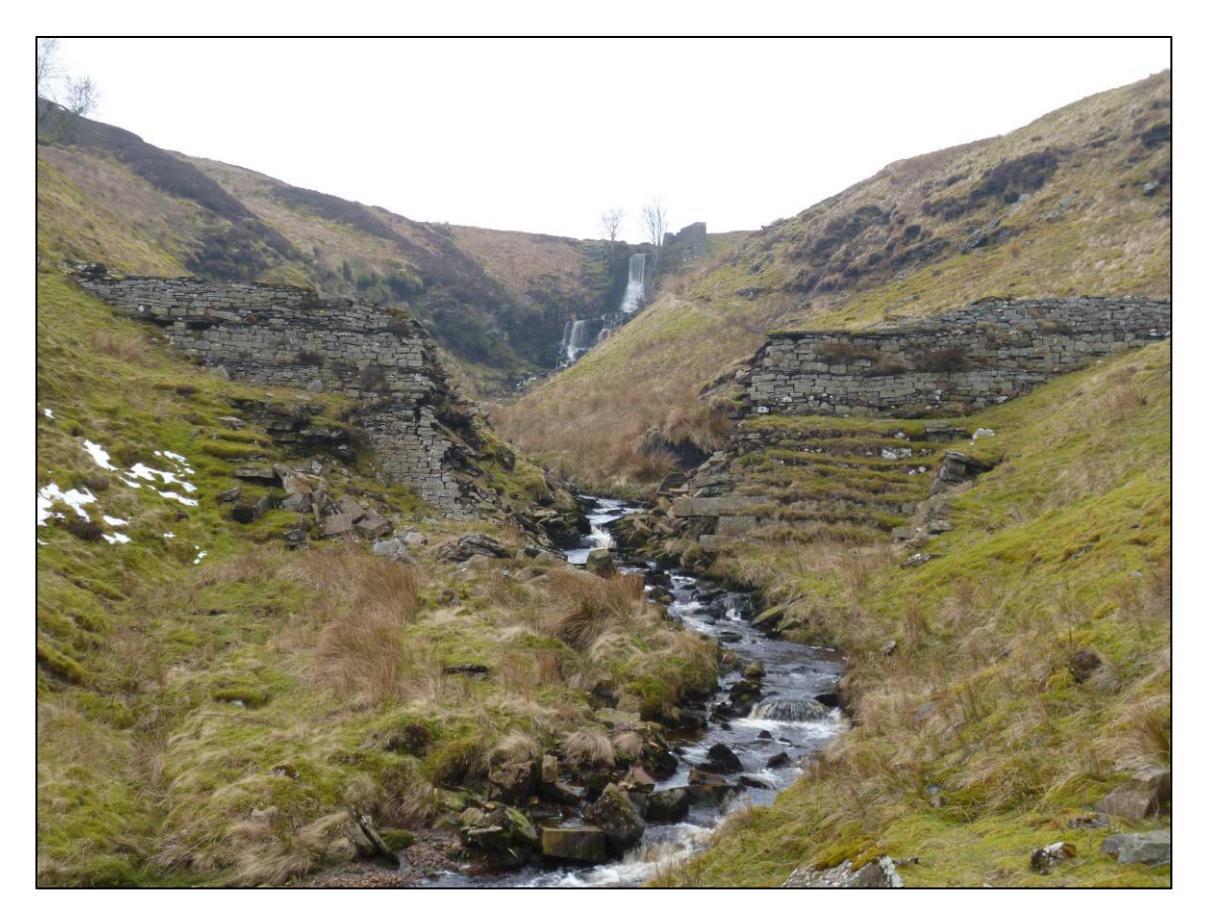
Plate 2: View to upper dam from lower dam, looking W (photo 1/200).

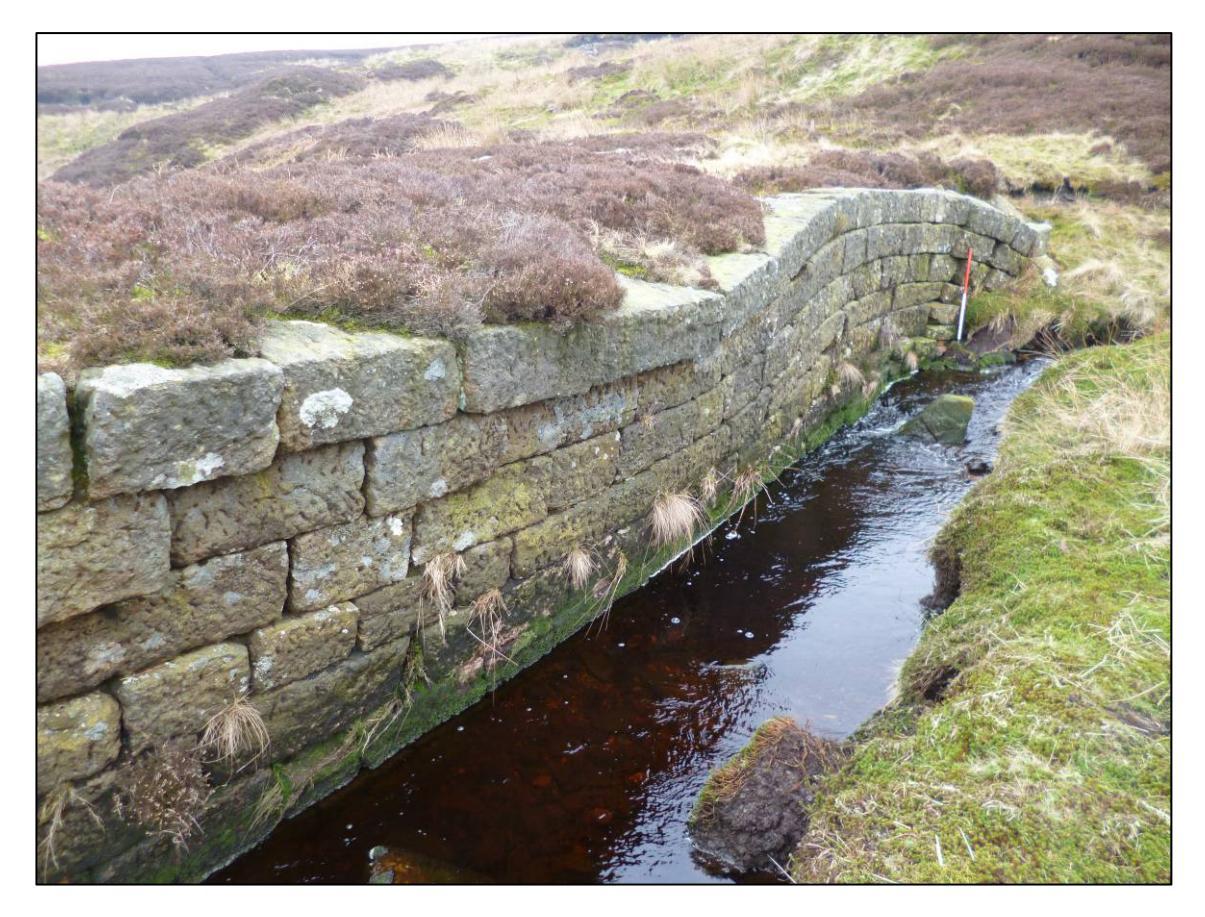
Plate 5: West wall of upper dam, south end of west face, looking SE (photo 1/108).

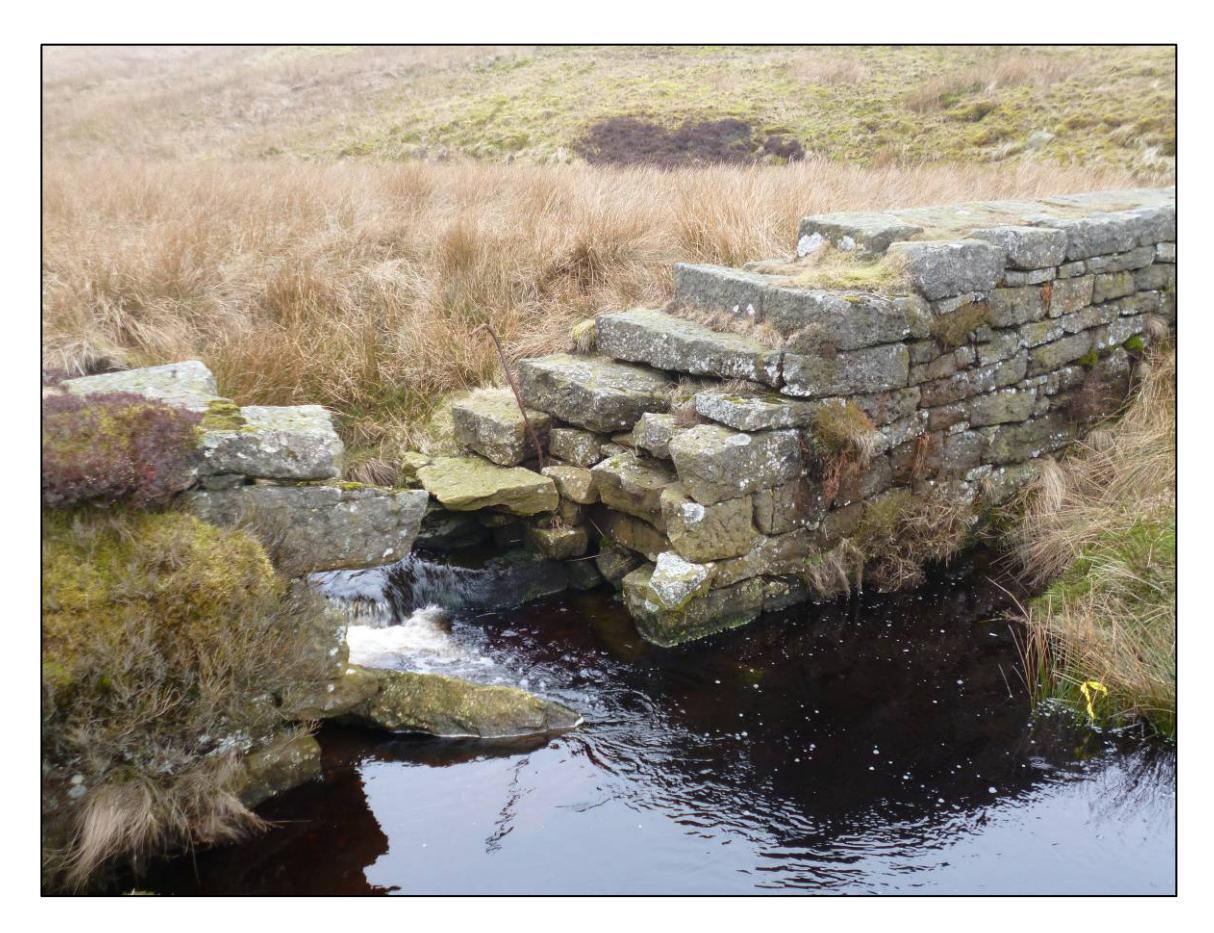
Plate 6: Upper dam, breached former sluice position in west wall, looking SE (photo 1/126).

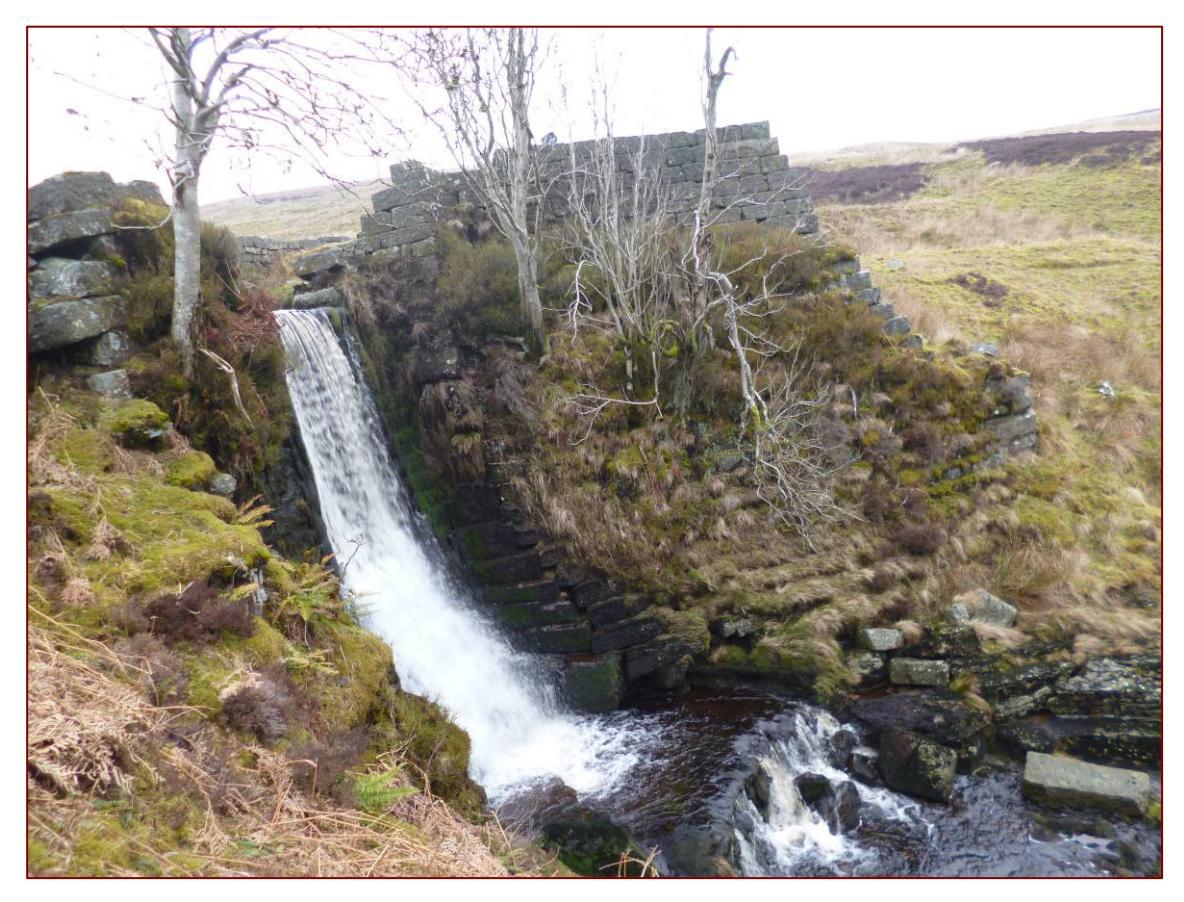
Plate 7: East wall of upper dam, showing breach in east face and buttress, looking N (photo 1/115).

4.6 It would be beneficial to undertake some limited low-level consolidation or rebuilding works to prevent further or continued collapse of several key areas. At the upper dam, this could, for example, include the south end and around the central breach in the west wall, and the around the breach in the east wall (see plate 8), while for the lower dam, it would include the ends of supporting buttress on the east wall either side of the breach (see plate 16). It would also be beneficial to channel the water through the breach of the lower dam, to prevent further undercutting and collapse of the dam core (see plates 11 and 13) - this need only involve the placement of large stones either side of the stumps of the rowan trees growing from the east wall of the upper dam (see plate 7).

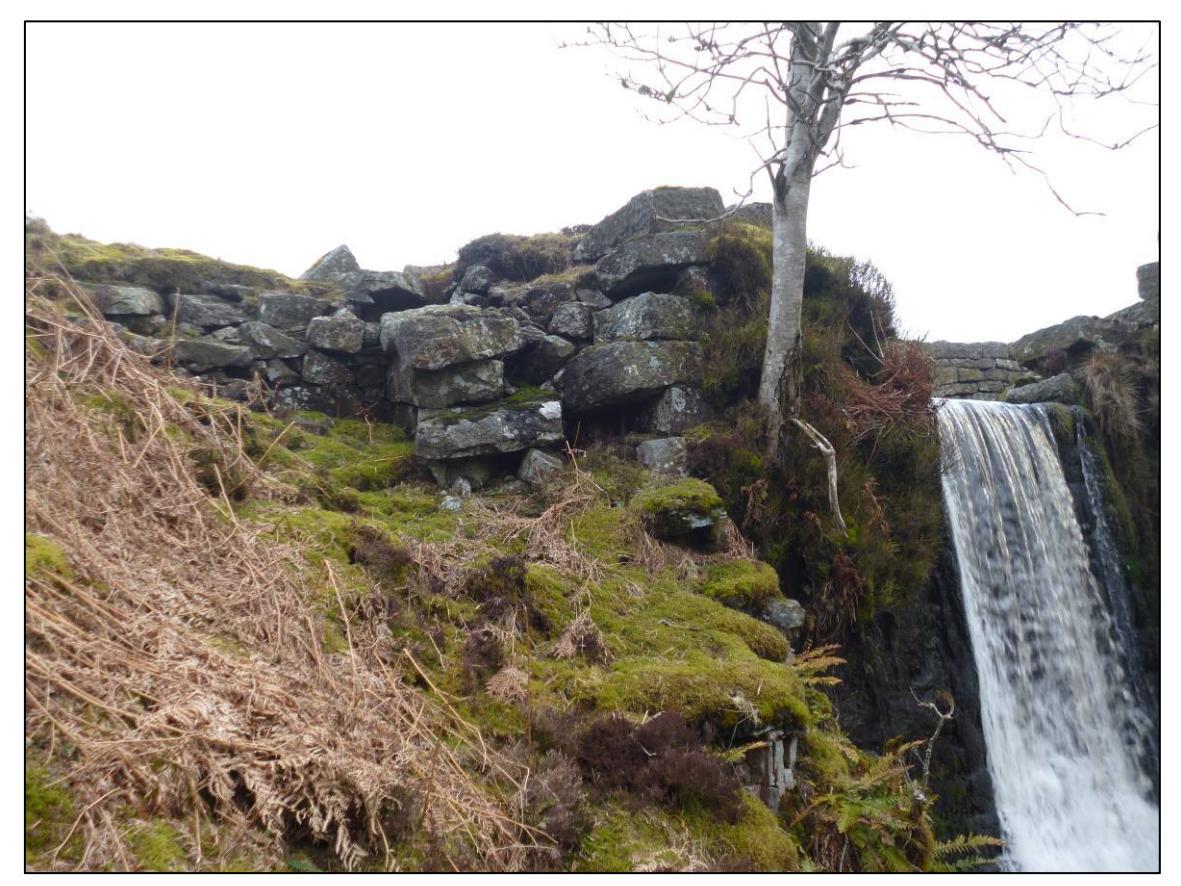
Plate 8: East wall of upper dam, showing potential area of collapse at south end of east face, looking NW (photo 1/117).

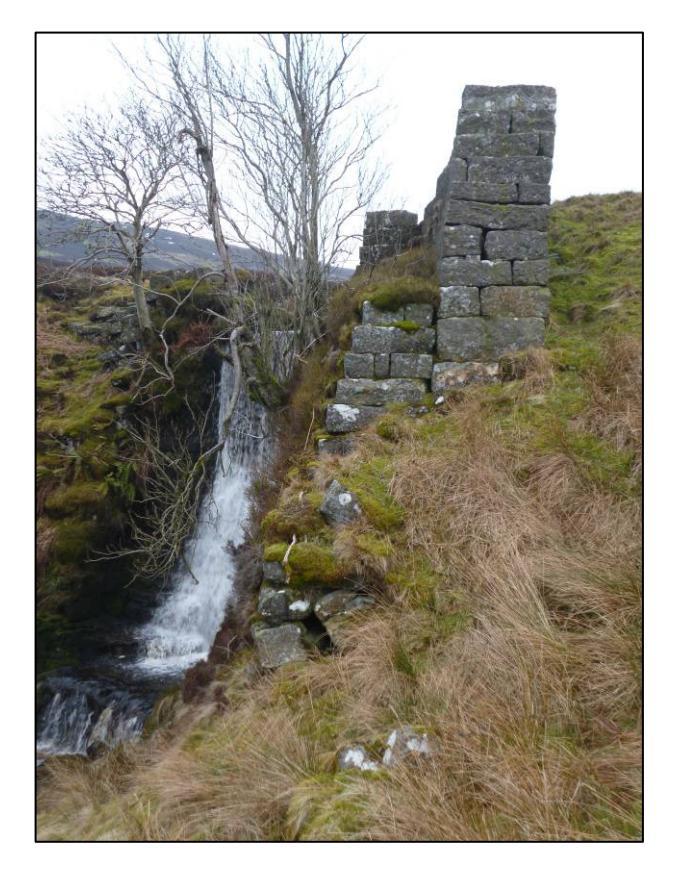
Plate 9: Revetment and buttress to upper dam, looking W (photo 1/144).

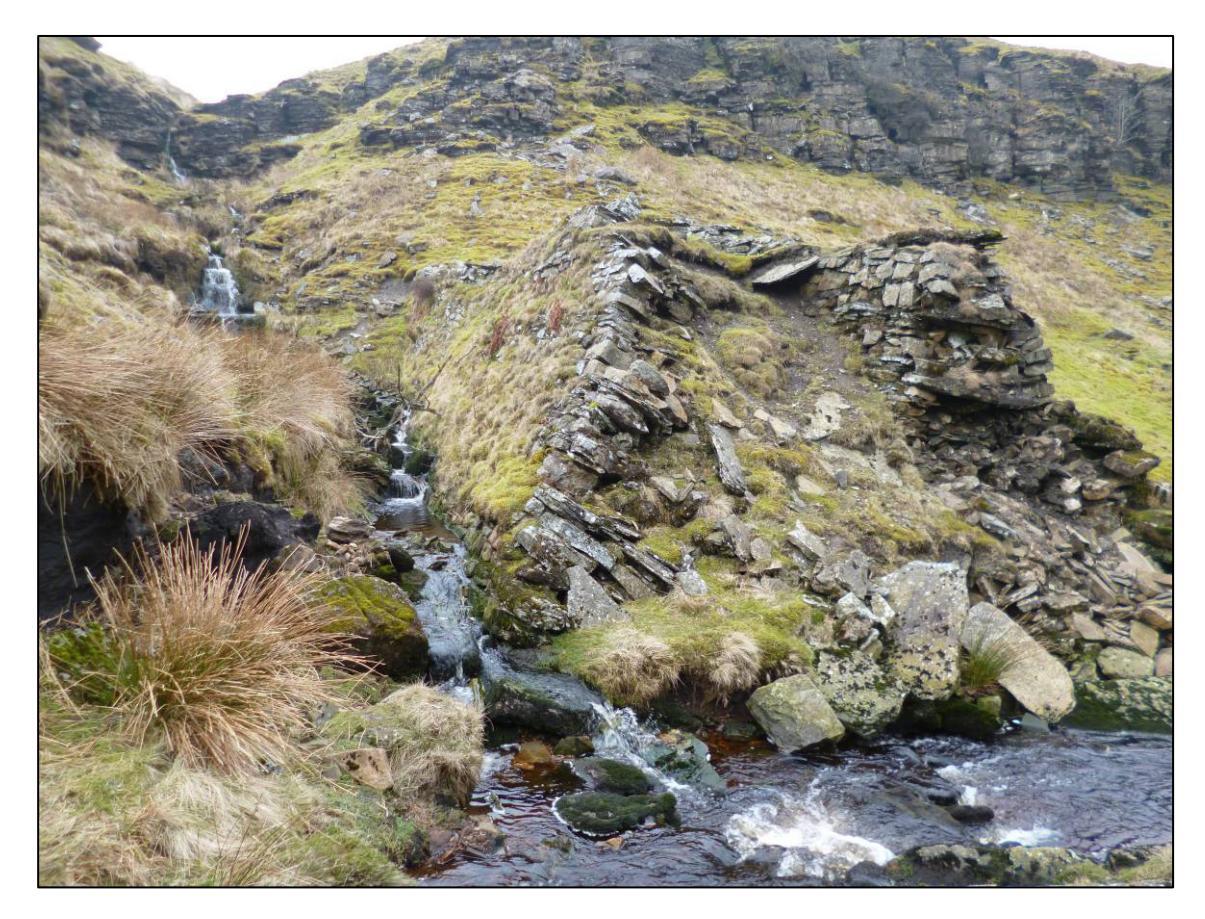
Plate 11: Breach through lower dam and view up Benty Gutter, looking N (photo 1/163).

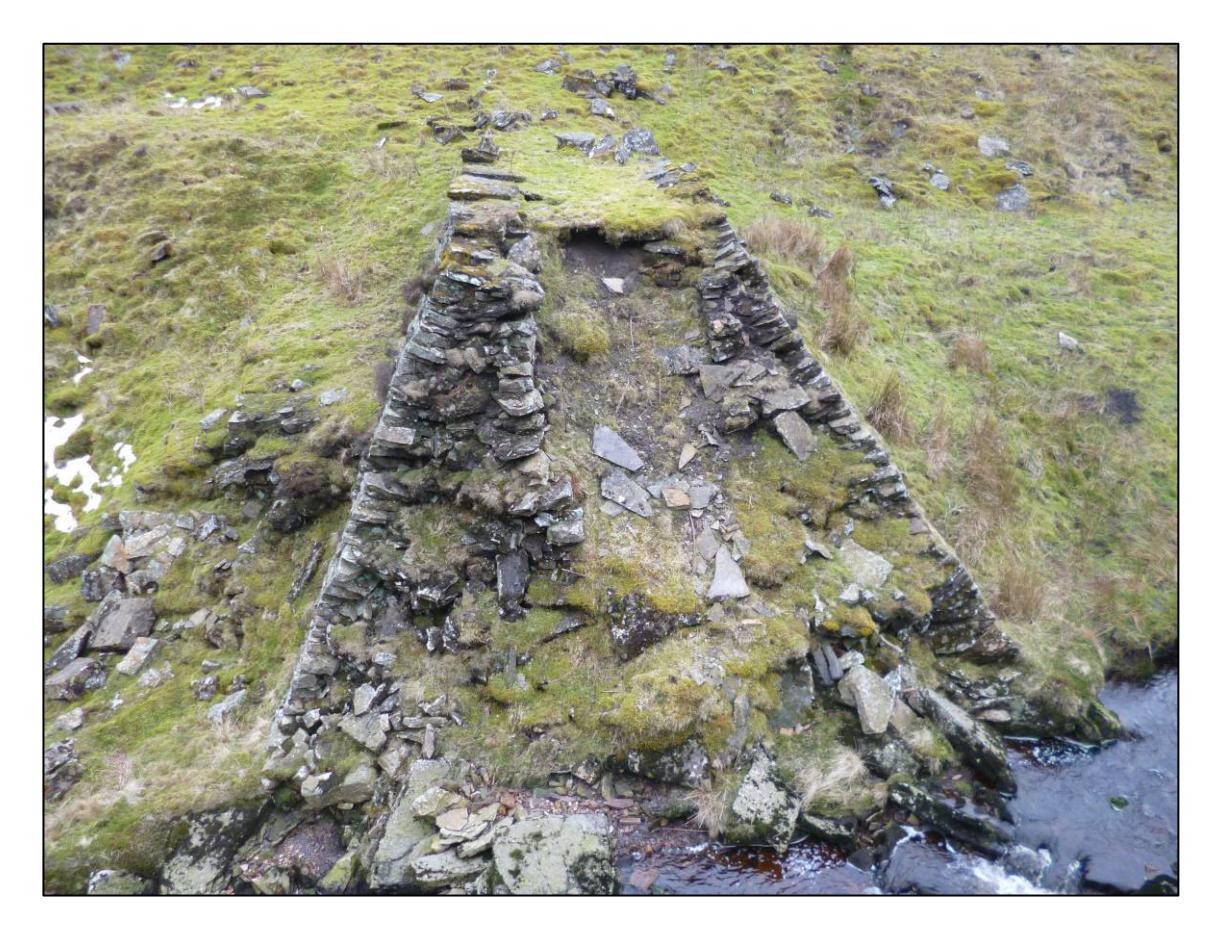
Plate 13: Breach through lower dam providing section through construction, looking S (photo 1/191).

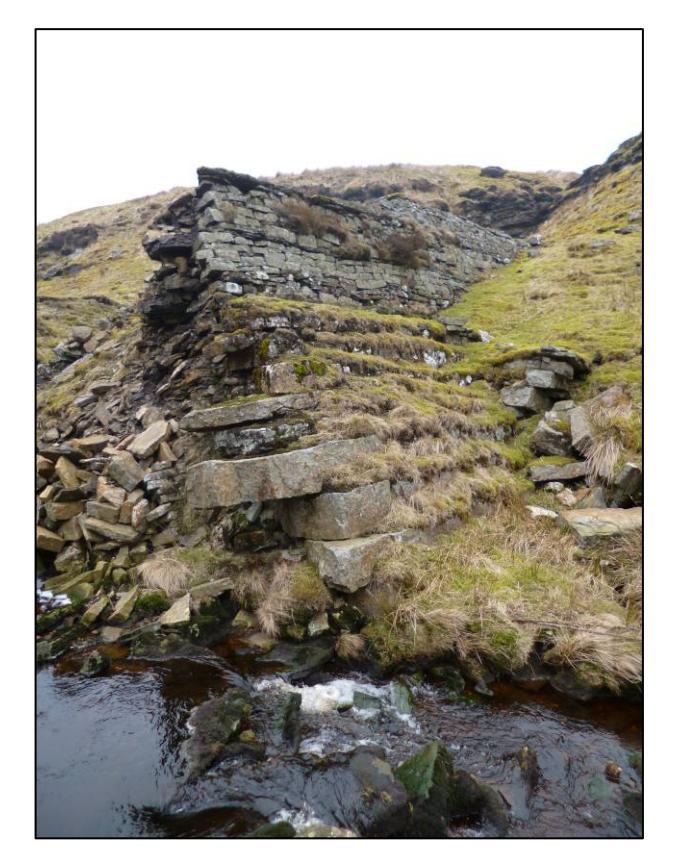
Plate 16: Eroding buttress on north side of east wall of lower dam, looking NW (photo 1/179).

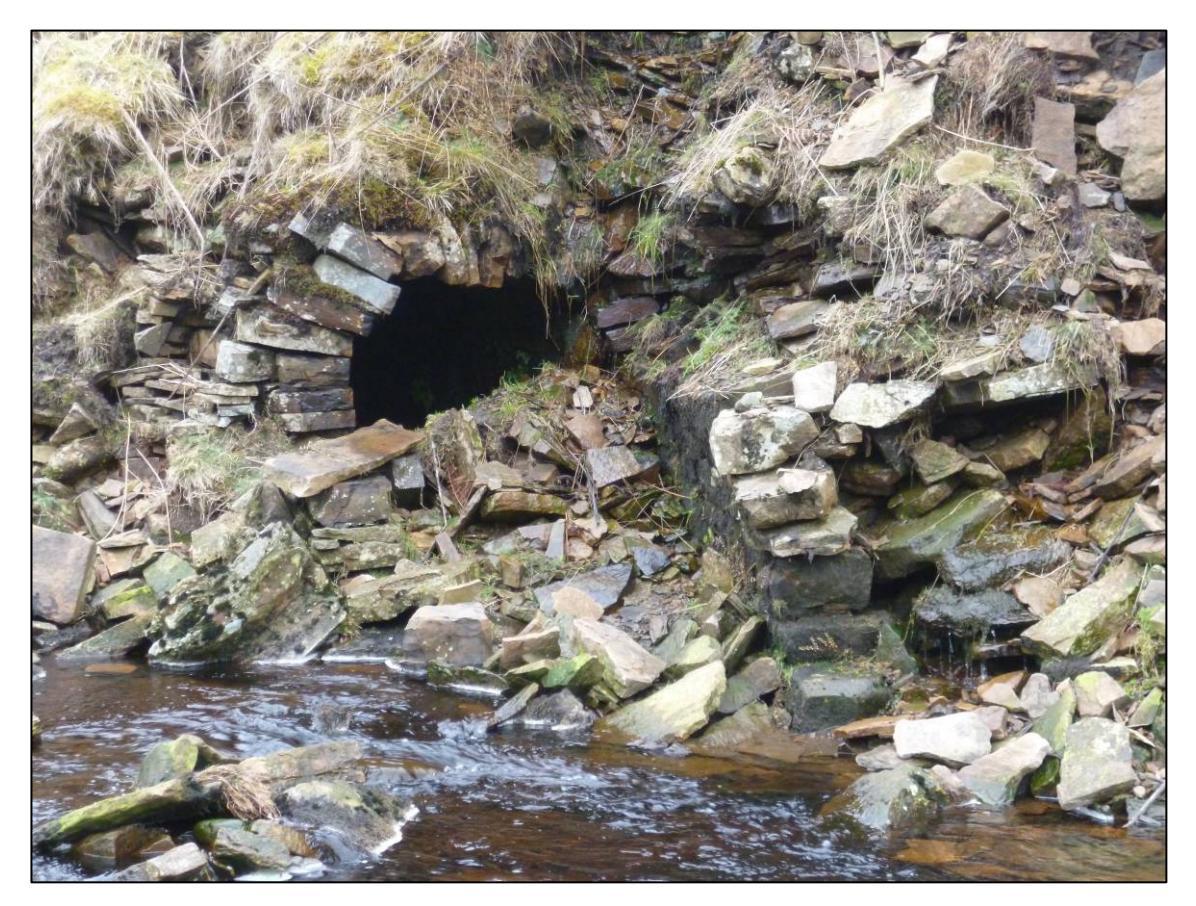
3.18 The truncated entrance of the level entrance survived in March 2015, now on the very edge of the beck [1/212, 1/218, 1/226-1/230] (see plate 18). It is unknown how much of the entrance has been lost, but it might be considerable as Close's 1837 drawing shows the reservoir dam lay beyond the entrance. The interior of the level is well preserved, with a broad semi-circular vault over [1/215] (see plate 19),

Plate 18: Eroded entrance to Low Level, looking N (photo 1/230).

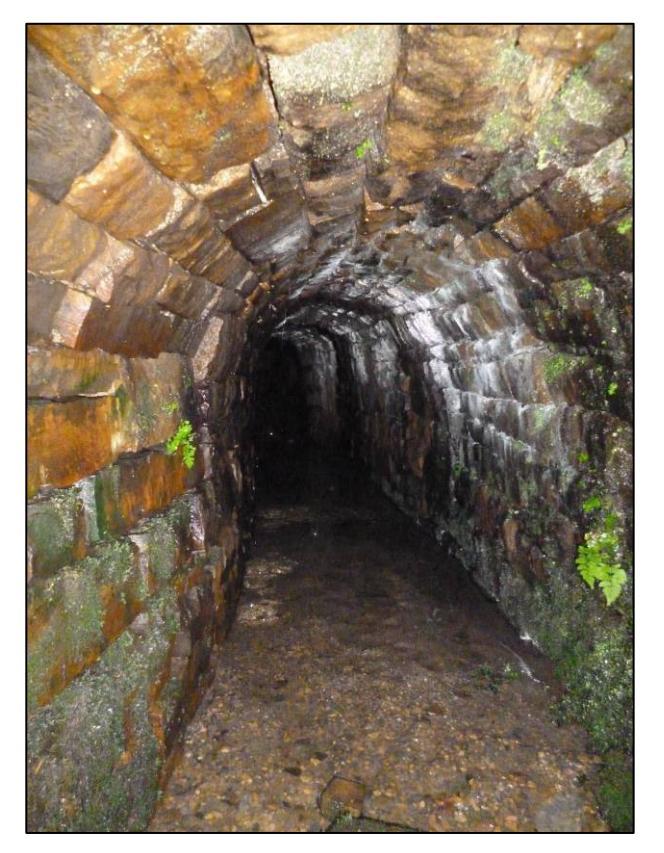
Plate 19: Interior of Low Level, looking N (photo 1/215).

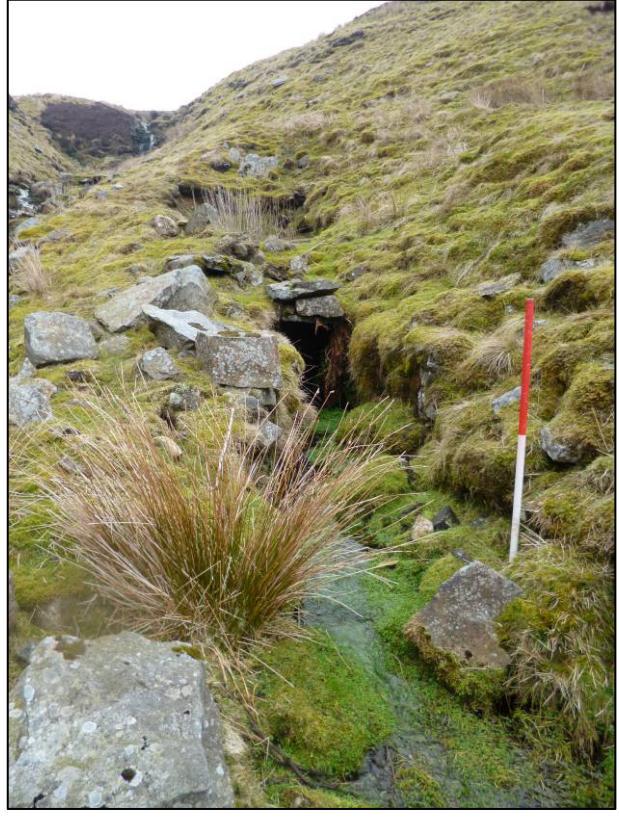
Plate 20: Possible entrance to Top Level, looking NE (photo 1/205).

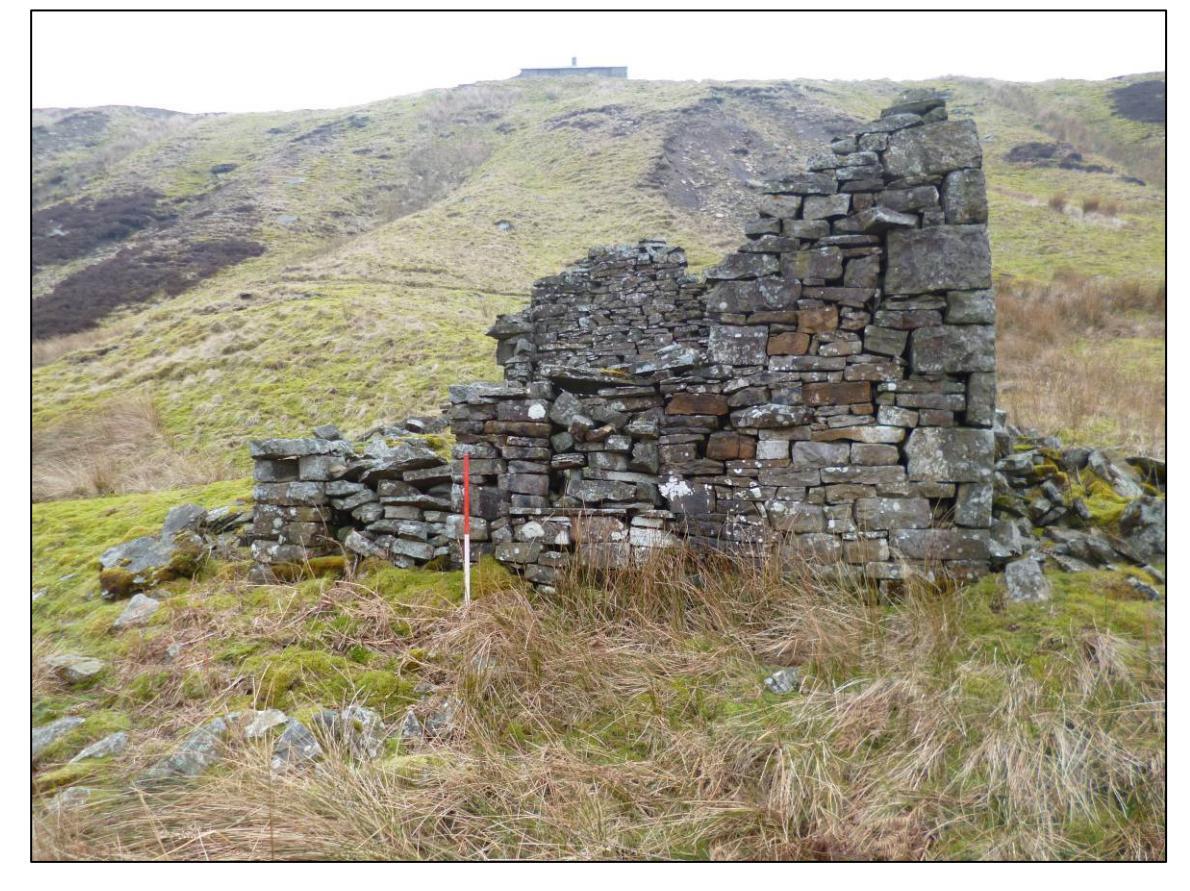
Plate 21: West elevation of 'High House' office building, looking E (photo 1/220).
