CHURCH OF ST MARY,
STRENSALL, YORK

ARCHAEOLOGICAL WATCHING BRIEF

Report no: 2004/227.R01
Version: Final
Date: October 2006
Author: Ed Dennison

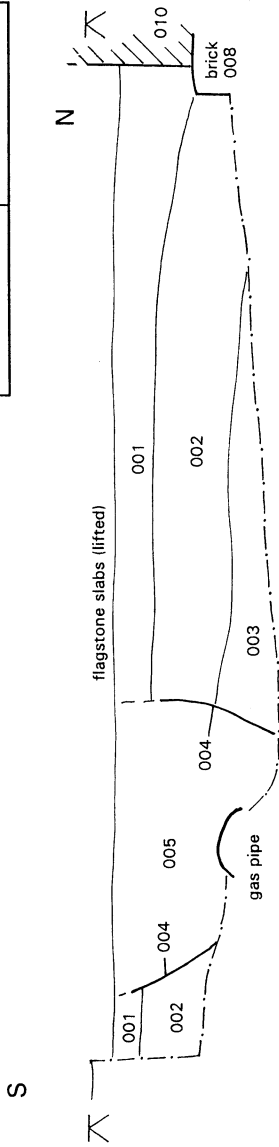
Section 1: west side of Trench 1

- 4.1 Trench 1, excavated immediately to the south of the porch, revealed a thin layer of brown loamy soil with gravel (001) less than 0.14m thick underneath the flagstones, and overlying a c.0.18m depth of fine sandstone rubble hardcore (002). This in turn overlay a fine, orange-brown sand (003) of unknown depth. All these three deposits had been cut by a recent trench (004) which had been excavated for a gas pipe which ran approximately north-south, and then east-west along the line of the southern kerb; the fill of the trench was a loose brown loam containing small stones, gravel and brick fragments (005). The excavation at the north end of the trench, adjacent to the south-west corner of the porch, revealed a brick plinth (008) under the main sandstone foundation (010); the bricks measured 78mm thick and 102mm wide but only one course was exposed.

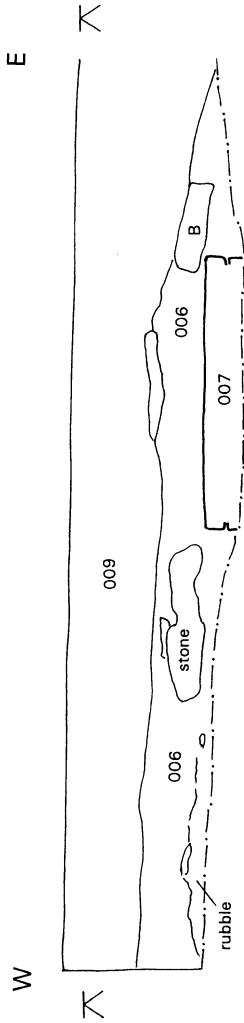
Section 2: north side of Trench 2

- 4.2 Trench 2 followed the south side of the flagstone path, and was excavated for a distance of c.12.0m in an eastwards direction. The deposits in this trench were dominated by the gas pipe trench and its fill (004/005), although further to the east a friable brown topsoil (009) was visible.

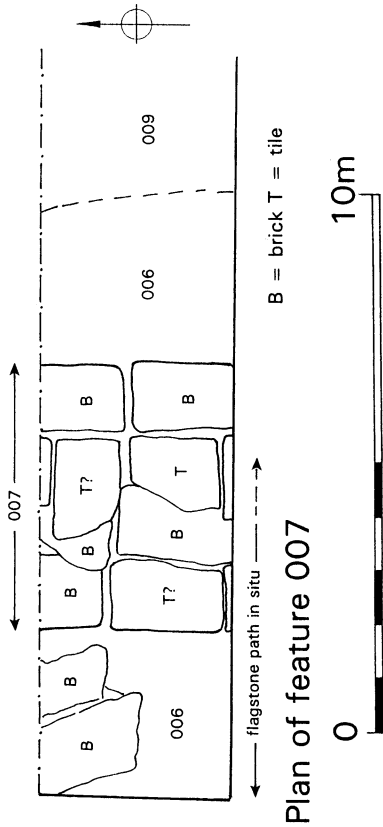
Plan of feature 007

- 4.3 Trench 3 was excavated eastwards from the south-east corner of the porch for a distance of c.8.0m. At a point c.1.0m from the west end of the trench, a north-south wall footing (007) was visible, 0.50m wide and 0.25m below the turf surface. The footings comprised at least two courses of re-used brick and floor tiles heavily bonded with a lime mortar, and they appeared to run north towards the wall of the nave; the full depth of the footings was not revealed in the shallow trench (see plate 2). Although OD levels were not taken, the footings appeared to be at approximately the same level as the brick plinth (008) beneath the porch. The footings were overlain by a disturbed deposit of dirty brown loam containing much brick, tile and sandstone rubble (006) with the turf and topsoil (009) averaging 0.27m thick above. There was no evidence of any continuation of the footings in the adjacent trench (Trench 2), although they may have been removed when the path was first laid.

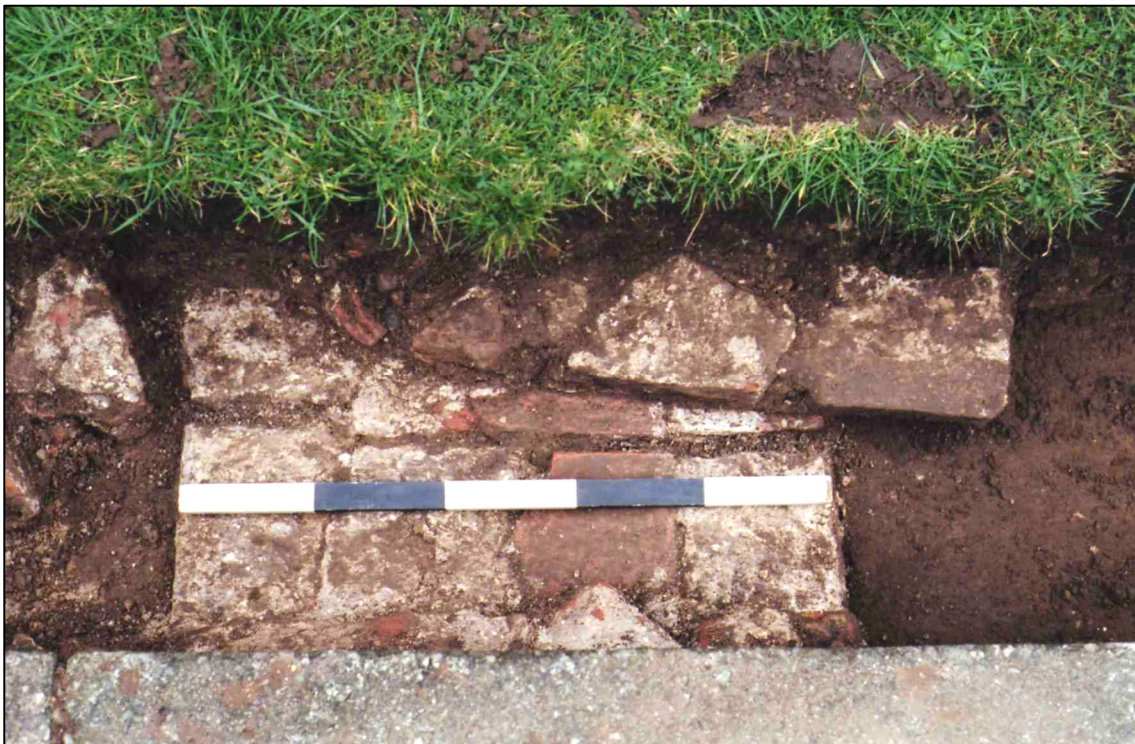
- 5.1 The narrow width of the excavated trenches made any positive interpretation of the exposed features difficult. However, it would seem that the portion of the north-south aligned brick wall footing (007) seen in Trench 3 represents part of the brick-built church which was erected c.1800 and then demolished when the present church was built in 1865-66. It is also likely that the brick plinth (008) underlying the sandstone wall of the west side of the porch is related to the same structure. The material overlying the north-south wall footing, a dirty brown loam containing brick, tile and sandstone rubble (006), is likely to represent a demolition deposit associated with this 19th century brick-built structure, while the sandstone rubble hardcore (002) seen at a higher level is probably related to the construction of the existing church.

Plate 2: Brick feature 007 in Trench 3 (east to right).
