***BILSMOOR DRAINAGE SCHEME,
COQUETDALE
NORTHUMBERLAND***

~ ARCHAEOLOGICAL RECORDING ~

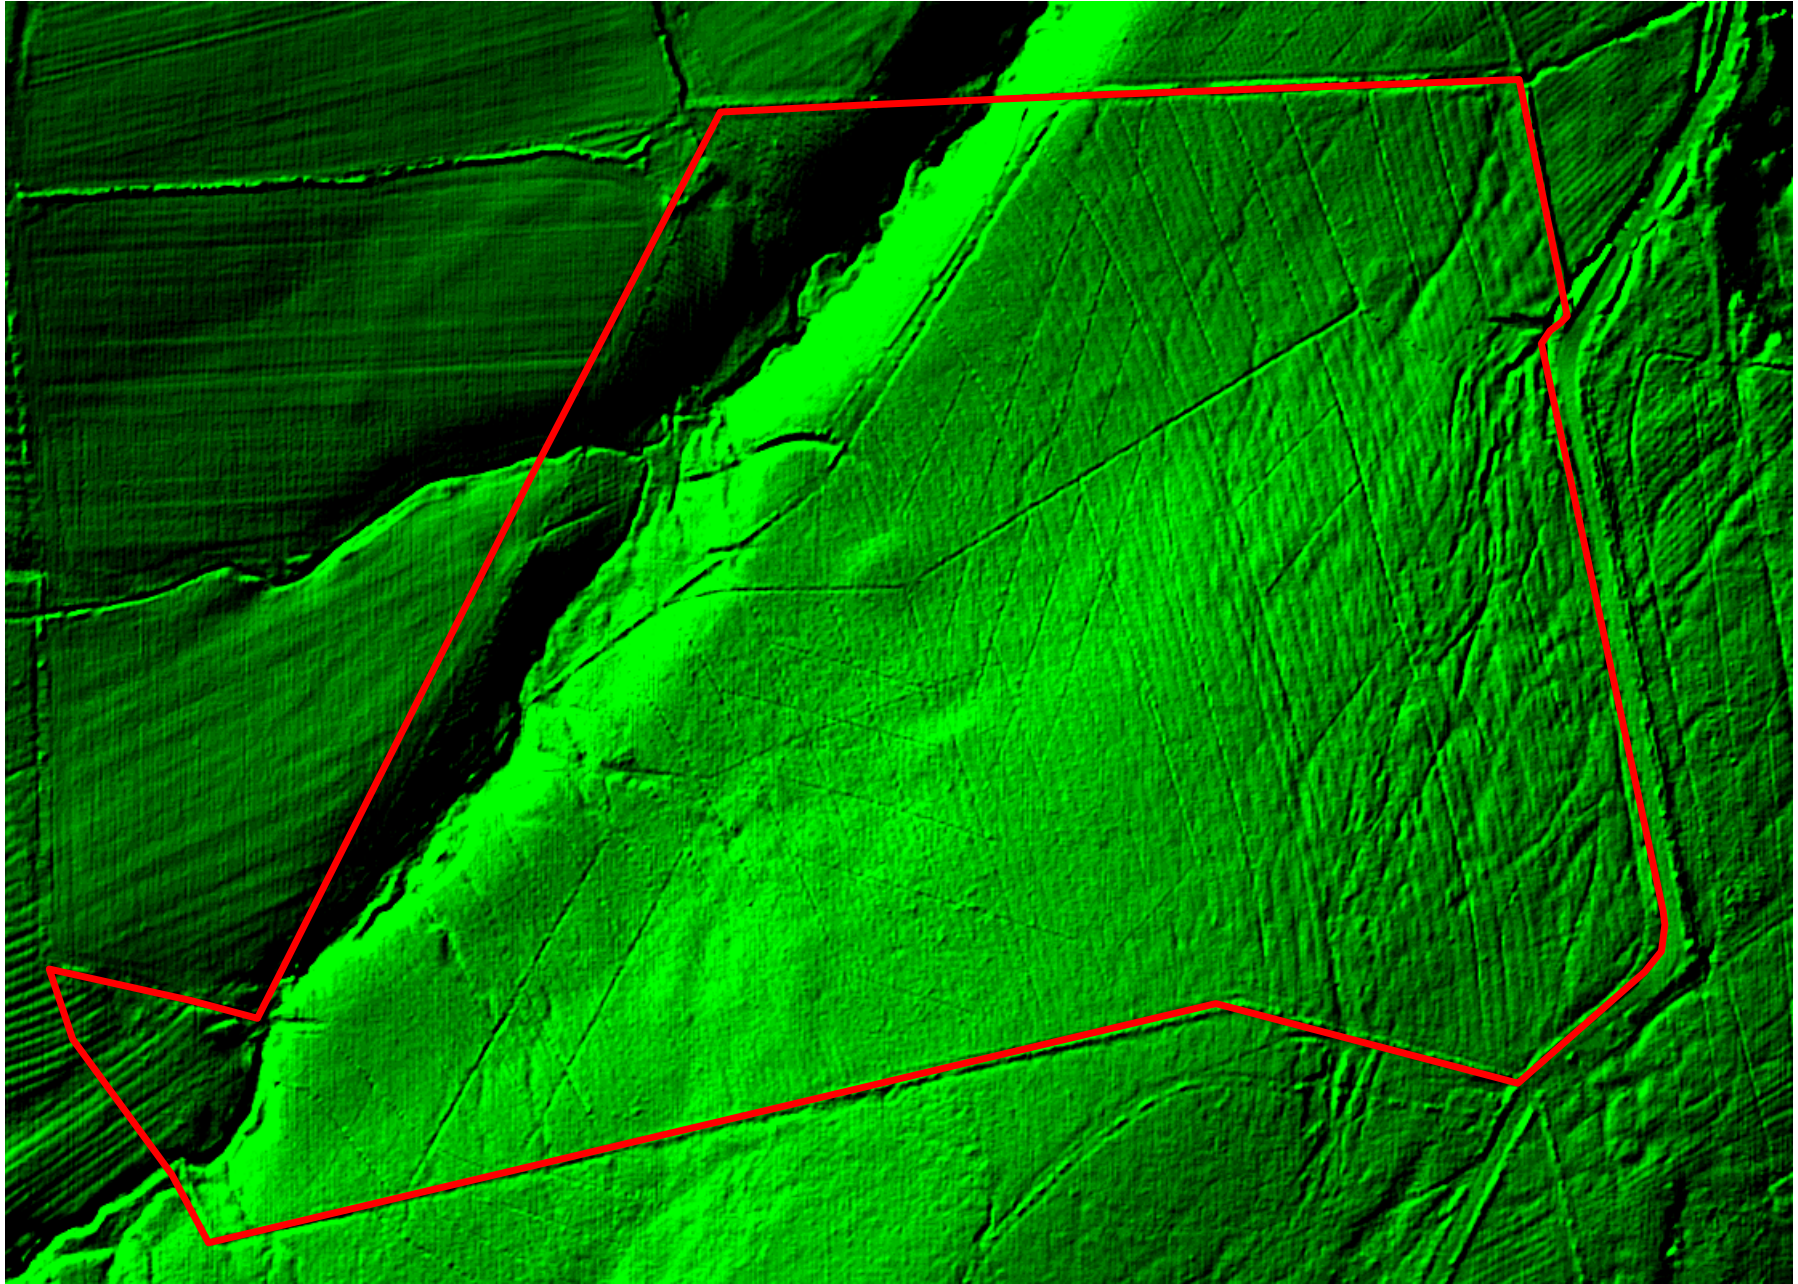
Illus. 07 - Coloured Lidar survey plan of the site (red outline).
