## ARCHAEOLOGICAL WATCHING BRIEF at the FORMER COUNCIL DEPOT, BIRCH ROAD, BARNARD CASTLE

A report to Browne, Smith and Baker

14th September 2006

In connection with planning consent no 6/2005/0384/DM

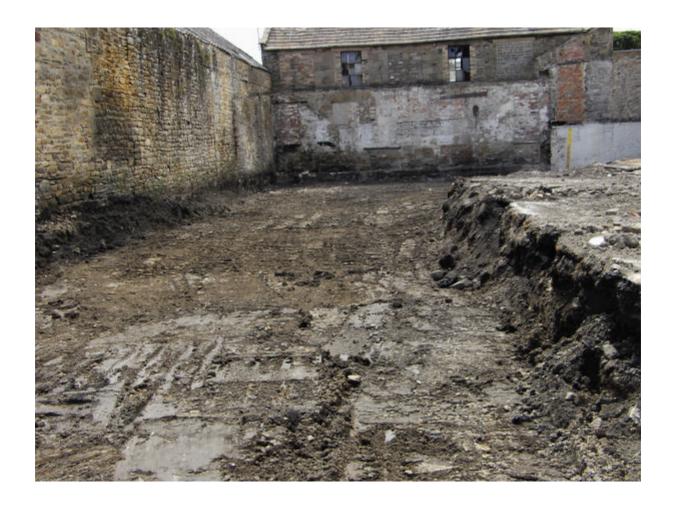
Fig. 2

- 7. A broad strip along the full length of the eastern side of the site was stripped to a depth below ambient surface of between 80 and 100 cms, to expose the surface of the natural sandy clay which in this area directly overlies Carboniferous sandstone (Fig. 2). In places, traces were left of the bottom of the black cultivated soil which seems to be ubiquitous in this part of the town, and which must have its origins in the cultivation of the rear parts of the Newgate burgage plots.

Excavation down eastern side of site, looking south

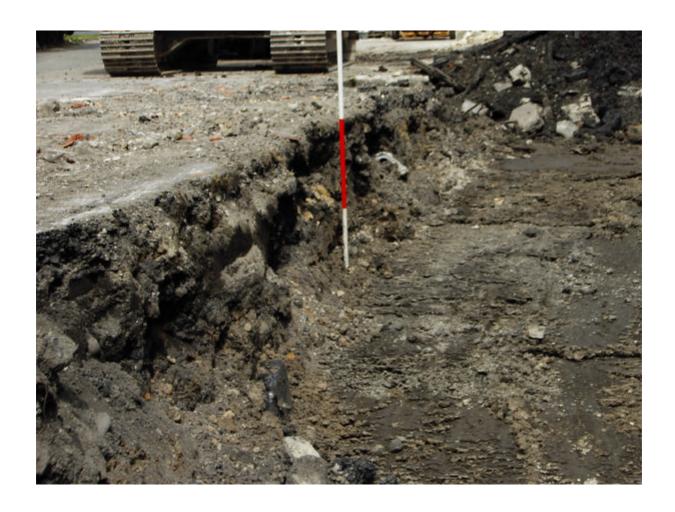
Fig. 3

- 8. The deposits removed along this eastern strip consisted entirely (apart from some tarmac and concrete hard-standings) of a dirty, loose black soil containing abundant stone and brick rubble, and pottery and other rubbish of the 19<sup>th</sup> and early 20<sup>th</sup> centuries (Fig. 3). This is probably best seen as a highly disturbed form of the cultivated soil discussed above, perhaps churned up during demolition activity immediately before the establishment of the Council depot.

Excavation down eastern side of site, showing rubble backfill in section

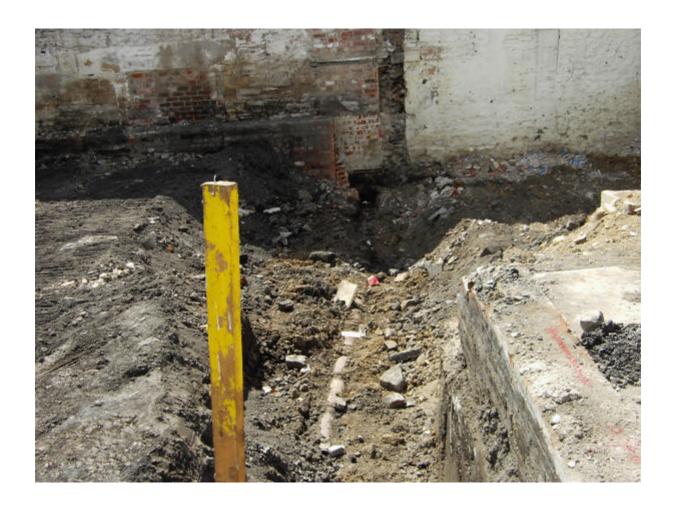
Fig. 4

- 9. On the western side of the site, extensive excavation was involved in exposing an existing main sewer (Fig. 4), running from the southern boundary of the site to a point 50 metres to the north. Again, upper deposits were highly disturbed, and contained much stone and brick rubble. Close to the south-west corner of the site were the floors of two buildings recently demolished, and including the base of a furnace or industrial hearth.

Sewer trench along western side of site

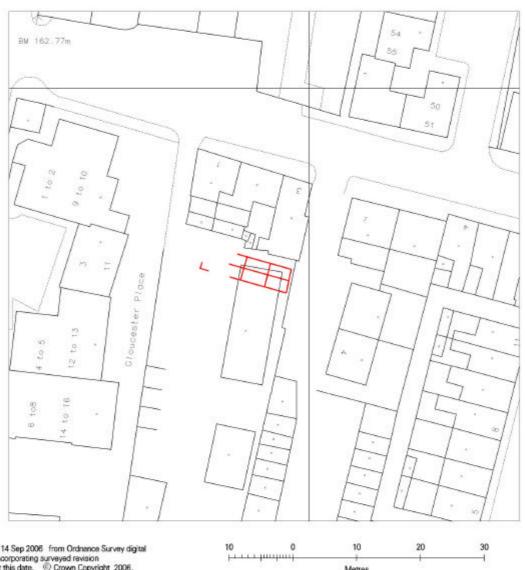
Fig. 5

**Location of tanpits**

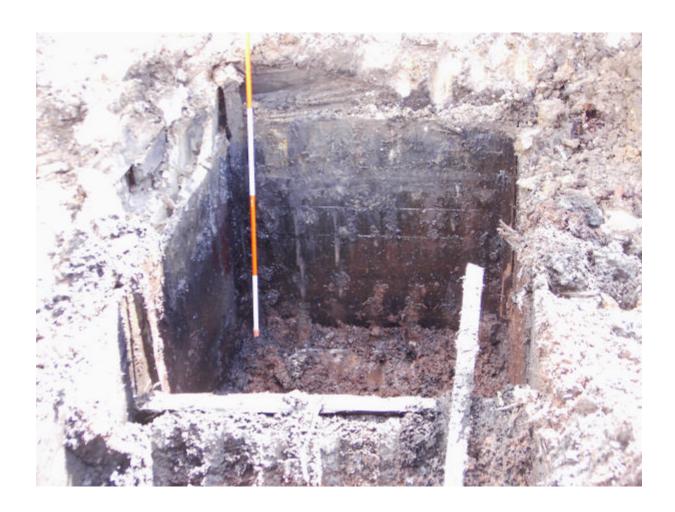
Fig. 6

- 11. The first tanpit to be exposed (Fig. 6) was the north-easternmost of those identified: it appeared that it represented the northern limit of the array, but since excavation ceased at this point the matter was not placed wholly beyond doubt. It lay directly against the eastern boundary wall of the site and, indeed, once the tanpits had been identified it became a matter of priority that they be filled with stone to ensure the safety of the wall from collapse.

- 12. The tanpits survived to a maximum depth of 1.5 metres (Fig. 6): it is most probable that this represents fairly well the full original depth, because ground levels seem to be much the same as in the early 19<sup>th</sup> century. In plan, the eastern pair were almost exactly 2 metres wide by 3 metres long (measurements varied slightly because of the bulging of timbers); the pair to the west were circa 3.4 metres long; and the length of the pair further again to the west could not be determined (there is a

The north-easternmost tanpit

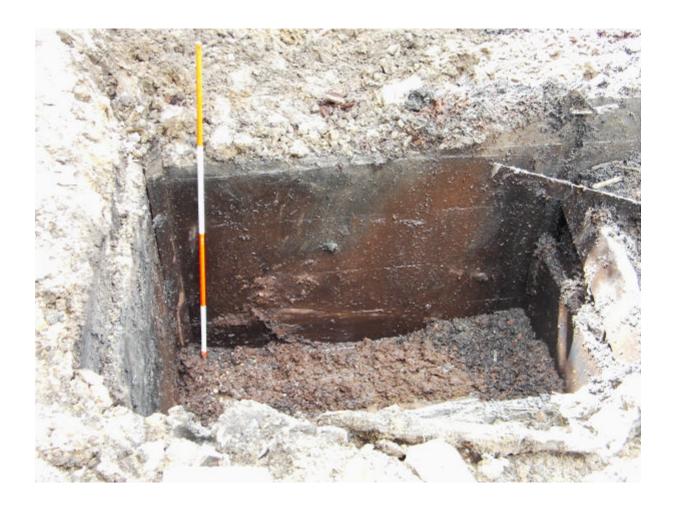
Fig. 7

- 13. The tanks were fully lined and floored with timber (Figs. 6 & 7): this proved, rather surprisingly, to be oak, and in a surprisingly good state of preservation. Why expensive oak rather than, say, deal should be chosen for such a mundane task as lining pits is not clear. It is possible that the natural qualities of oak enhanced the tanning process: equally, it might be that the timber was obtained from an existing supplier who delivered the constant supplies of oak bark which the traditional tanning process required.

- 14. The timbers were thick boards, 30 centimetres (or twelve inches) broad and 3.5 centimetres (an inch and a half) thick. They were arranged horizontally (Fig. 7) without joints or nails. However, the timbers of the sections aligned north-south which divided each pair of pits were bored through their thickness at the centre line of the pit, so that the boards could be threaded onto an iron rod (Fig. 8). This looks like some sort of sluice arrangement, by which the contents of one pit could be let into the next (perhaps merely for cleaning them out).

Construction of north-easternmost tanpit

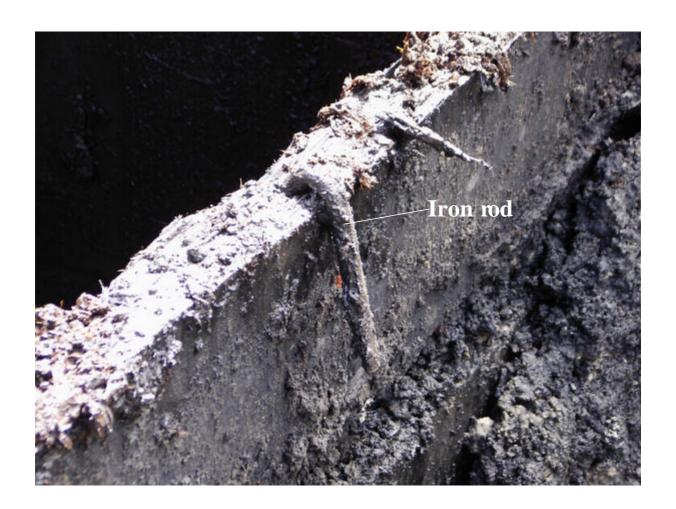
Fig. 8

Construction of tanpits, showing vertical iron rod

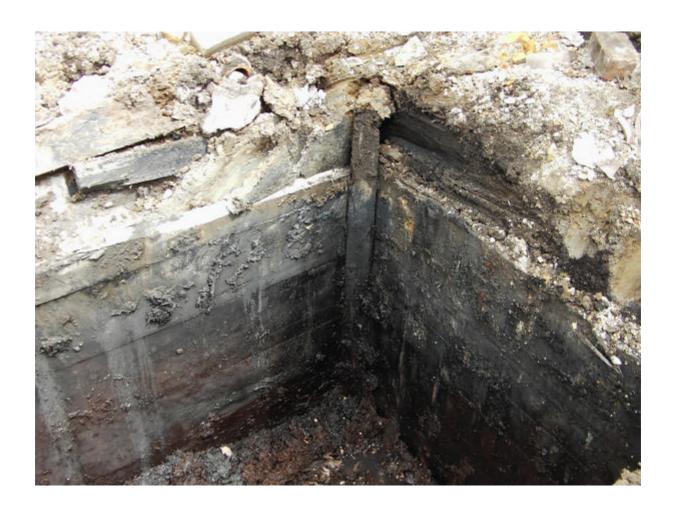
Fig. 9

- 15. Each corner of each piece was covered by a triangular piece of timber (Fig. 9).
- 16. The pits were filled with large quantities of sodden, shredded oak bark (Fig. 11), with a small quantity of rubble and clay on top. A large amount of the shredded bark was examined closely, and proved to contain no leather scraps at all: if whole hides were being tanned, this is unsurprising, since they would easily be removed entirely. A few pieces of hemp rope, and a sack made of hemp or jute were also found, though it was not practical to recover them.

Construction of tanpits, showing corner piece

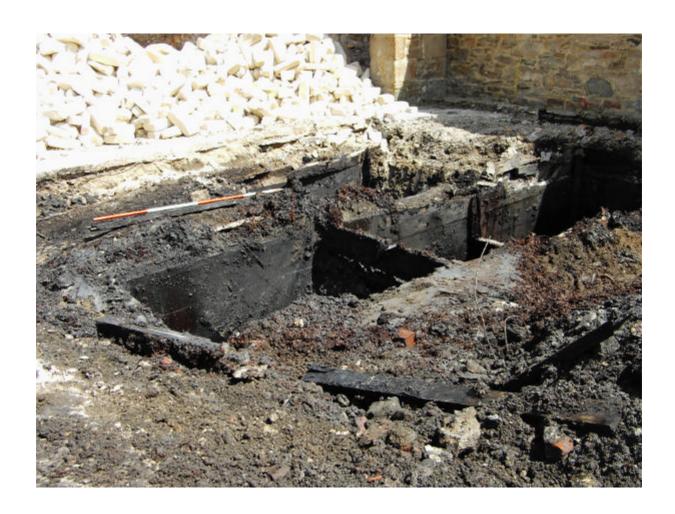
Fig. 10

View of tanpits.

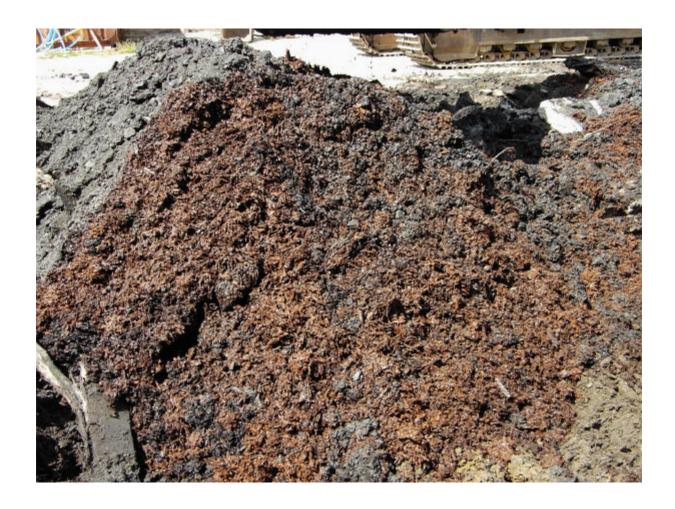
Fig. 11

Bark from tanpit.
