## UNIT 1, CASTLE PRECINCT, KNARESBOROUGH, NORTH YORKSHIRE: AN ARCHAEOLOGICAL WATCHING BRIEF

CS Archaeology June 2009 **On behalf of:** Martinhal LLP

**Project Number:** 54

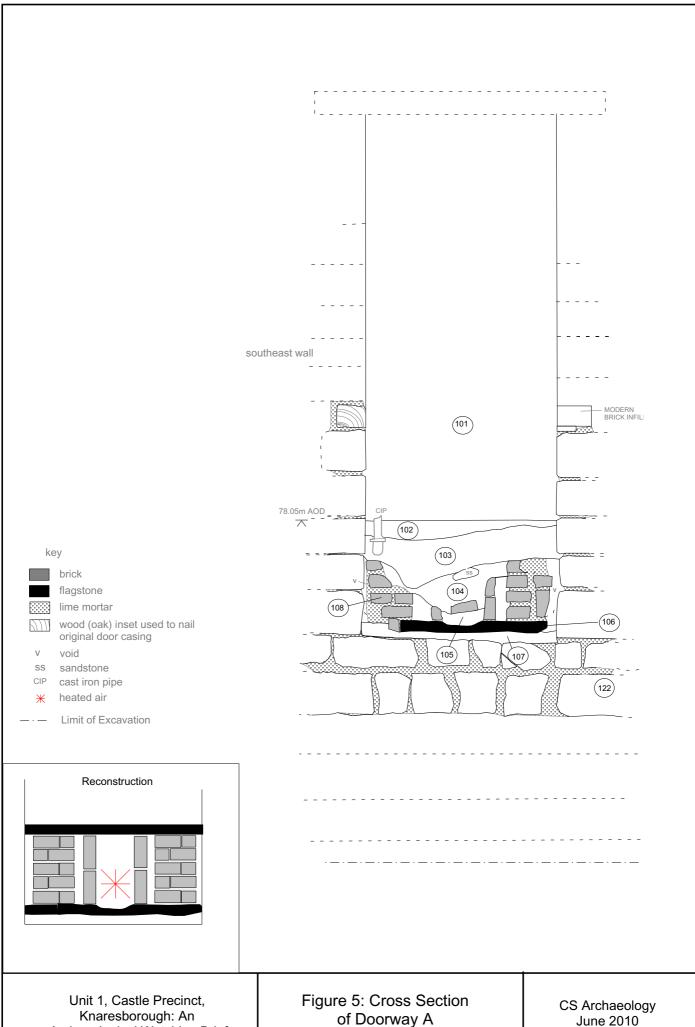
of Doorway A

Doorway A (**Plate 5,** 37) suggesting the duct and doorway were contemporary. Therefore an alternative function of this feature was required in order to meet the developing evidence for the watching brief. Doorways A and B are depicted in the Ordnance Survey plan of 1849 (Figure 3) and denote two external doorways into the main school room. Doorway A provided a suitable opportunity to record a cross section through the brick duct (Figure 5: Plates 6 and 7, 38 and 40). Doorway A represented an unusually high opening of 2.8m (width 1m). This tall design is unusual and can only be explained by allowing enough room for the brick duct [108] to be fitted below floor level. The brick duct [108] was constructed by an initial levelling bed of crushed limestone [107] onto which a 0.78m wide flagstone [106] was laid. On top of the flagstone, brick and lime mortared walls had been built either side of a central 0.5m wide aperture. This aperture was in turn reduced, by vertically set bricks, to create a narrower 0.21m wide central duct. This central duct had a corresponding linear hollow to the flagstone beneath and evidences that the structure was still largely in situ. The central duct was partially filled with dark brown sandy silt [105] reminiscent of chimney soot. The red bricks (0.225m x 0.066m x 0.113m) were poorly ground with characteristic lower linear scars were they were lifted when the clay was still wet and probably positioned within a kiln. A small percentage (c.2%) of these bricks were sub-standard, over-fired bricks (Plate **8,** 98) which actually proved resilient to the temperature fluctuations of the heating system.

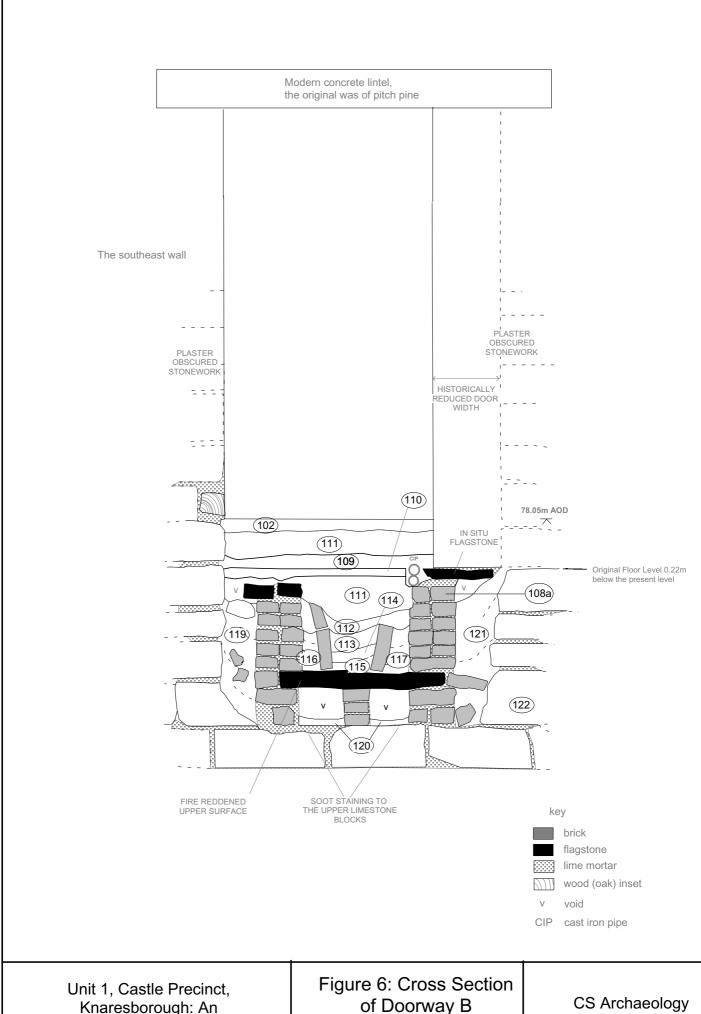
Knaresborough: An Archaeological Watching Brief of Doorway B

- 6.8 Along the southeast trenches, no further evidence of the brick ducts were encountered until trench 20b was opened up in front of Doorway B (Figure 6). Doorway B was plastered but had been reduced in width from 1.4m to 1.2m (Plate 9, 42). The original width was evidenced by the vertical building line to the plastered southeast wall [122]. Oak inserts were built into the walls to fix the original door casing, one of these was still in situ. The lower doorway featured a similar brick and flagstone structure to Doorway A. Differences between the ducts (between doorways A & B) were noted. These consisted of a slightly wider overall structure and two lower ducts in Doorway B, separated from the upper duct by a substantial horizontal flagstone (Plates 10 and 11, 32 and 31). The lower flagstone was 0.88m wide x 0.04m thick and was built into the brick structure and acted as a cover for the two lower ducts. The lower ducts measured 0.2m<sup>2</sup>. The two lower ducts appear to have been run at lower temperatures, as there was an absence of heat discolouration but the ducts were partially filled by a fine soot like deposit and there was also soot staining to the upper limestone blocks [122].

- 6.9 The upper duct was very similar to Doorway A. with vertically set bricks presumably originally bonded with lime mortar although the lime had been heavily eroded. These inner brick linings defined the central duct from the flanking voids which had been filled with fine deposits [116 and 117] which like doorway A was 0.2m wide. The upper duct had been subject to intense heat as evidenced by the

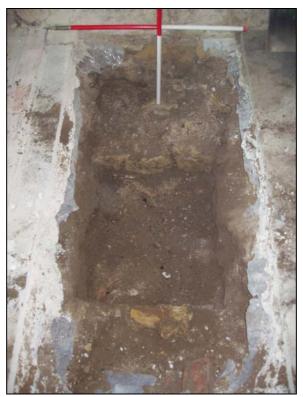
- 6.3 As the trenches were excavated a series of limestone walls [123], 0.5m wide, were revealed. In plan (Figure 7; Plate 1, 34) it was revealed that there were at least two consecutive walls at an interval of c.0.9m. These extended down to 1.2m below the present floor level, with the bottom of the trenches a further 0.6m (Plate 2, 2). All the excavated deposits, throughout the building were of a 19<sup>th</sup> century date, and included clay pipe stem fragments, stoneware and transfer decorated pottery and these can be characterised as levelling deposits for the 'new' school building.

**Plate 1**, 34: Trench 11b, general view with the pair of limestone walls [123] just becoming visible, from the northwest

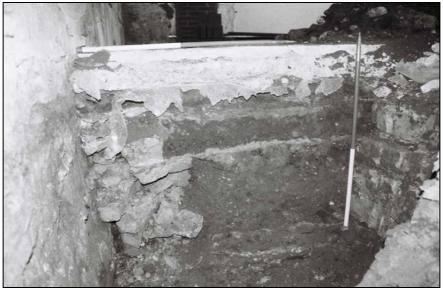
Plate 2, 2: Trench 4b, NW facing section, showing the levelling sequence, with a section through the outer (left) limestone wall [123], and the face of the inner (right) wall [123], from the northwest

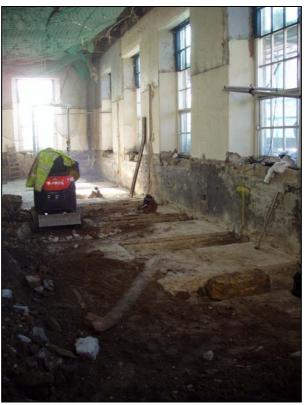
- 6.5 The northwest trenches (Plate 3, 3) were excavated first. These confirmed the nature and extent of the limestone support walls [123]. As each new trench was excavated, a pattern emerged of two walls running through the trenches. The first wall abutted the main building wall with a further inner wall set at a 2m interval. As work moved along the northeast wall the same pattern continued until in the centre trench, 3b a brick structure was encountered at its southwest end (Plate 4, 16) and in plan it featured a bend towards the southeast wall. Initially the brick duct [108] was thought to represent a relict section of drain which predated the school The brick duct [108] was also revealed in Trench 2b, bisecting its southwest end at 90°.

Plate 3, 3: general view of the excavated trenches along the northwest wall, from the northeast

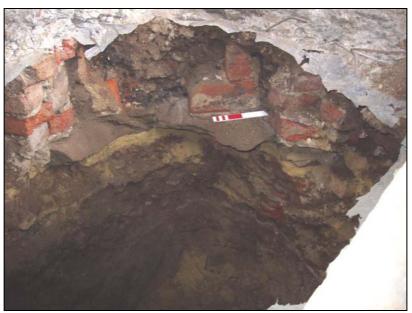
Plate 4, 16: trench 3b, the northern edge of a brick duct [108], from the north

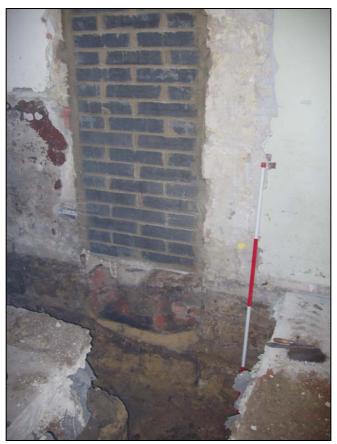
Plate 5, 37: trench 1b, Doorway A with the brick duct [108], from the northwest

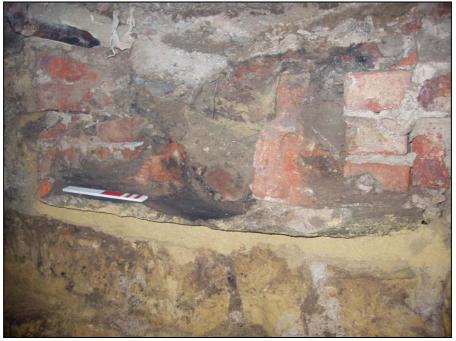
**Plate 6**, 38: trench 1b, Doorway A with a detailed (oblique) view (0.2m scale) of the brick duct [108] with partially collapsed baffle and soot stained moulded flagstone, from the northwest

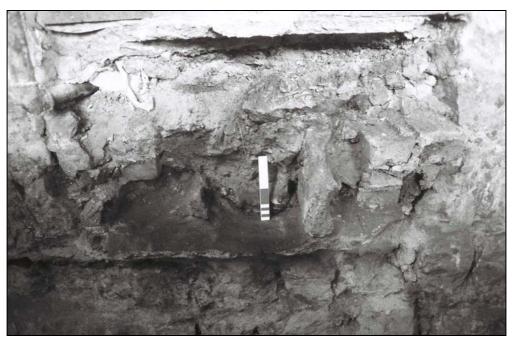
Plate 7, 40: trench 1b, Doorway A with a detailed (oblique) view (0.2m scale) of the brick duct [108] with partially collapsed baffle and soot stained moulded flagstone, from the northwest

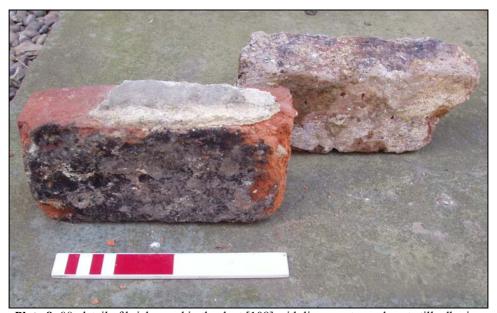
Plate 8, 98: detail of bricks used in the duct [108] with lime mortar and soot still adhering

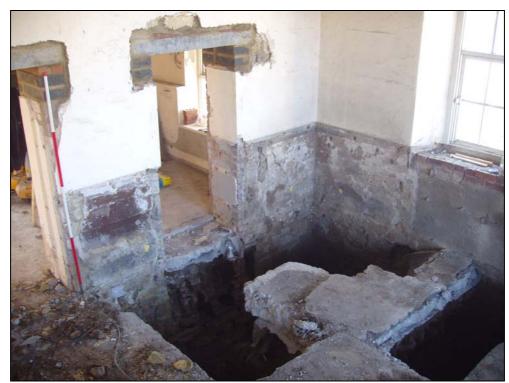
Plate 9, 42: general view of the southeast corner of the PDA with Doorway B, from the northwest

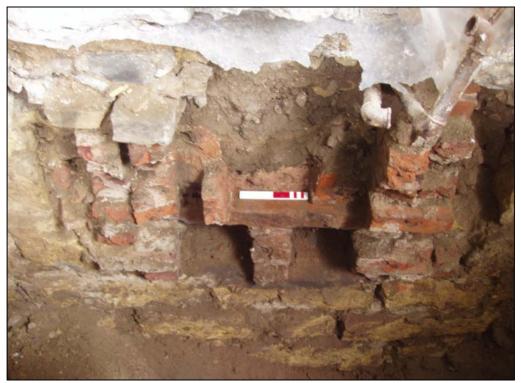
Plate 10, 32: trench 20b, detail of the brick duct [108a] below doorway B, from the northwest

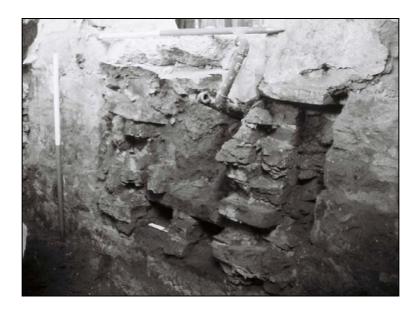
Plate 11, 31: trench 20b, oblique view of the brick duct [108a] below Doorway B, from the west
