SITE	English Martyrs Church, Dalton Terrace, York					
CLIENT NAME	Diocese of Middlesborough					
YAT PROJECT #	5962	YAT REPORT #	2017/71			
MUSEUM ACCESSION #	tbc	GRID REFERENCE	SE 59300 51140			
PLANNING REFERENCE #	13/03595/FUL	AAI OPS NOTICE #	N/A

Introduction

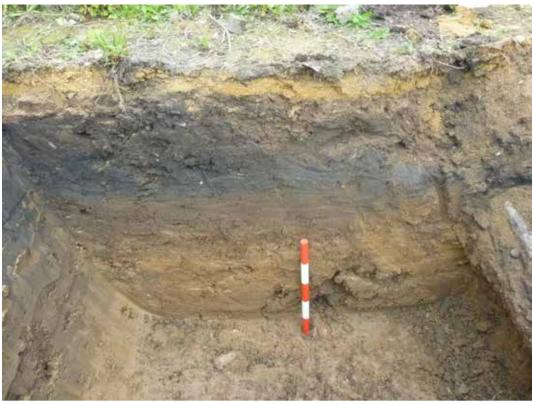
Plate 1: South-west facing section of trial trench 1

Trench 1 measured 1.9m in length, 1.2m in width and 1.1m in depth (Figure 2). Modern deposits including the current ground surface (C100), a makeup deposit (C101), a gas service trench (C107 and C108) and a succession of levelling deposits (C102 and C103) formed the upper 0.45m-0.55m of the trench section. These contexts overlay a 0.2m thick deposit of horticultural soil (C104) which appeared to be very similar in character to the horticultural deposit seen during the 2014 evaluation (Context 1003).

This horticultural soil overlay a heavily disturbed (possibly by root action) orangish brown clay (C105) which itself overlay an undisturbed firm orangish brown clay (C106). Both of these deposits are thought to be naturally occurring. The disturbed natural was encountered at a depth of 0.65m to 0.75m BGL (c.whilst the undisturbed natural deposits were encountered at a depth of 0.85m to 0.9m BGL.

No finds were recovered from trial trench 1.

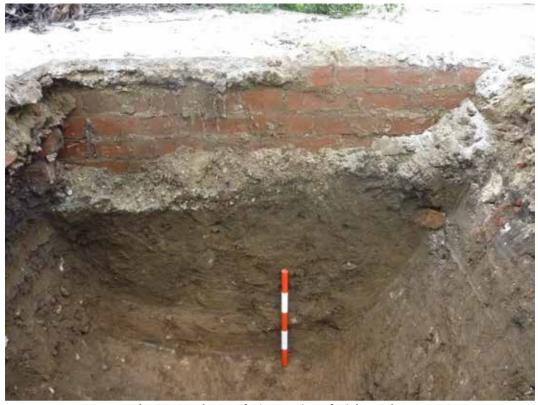
Plate 2: North-west facing section of trial trench 2

The concrete pad (C200) that formed part of the demolished church hall was 100mm thick. It overlay demolition rubble within most of the trench but the north eastern side was formed of a brick wall foundation (C201 and C200). The 20th century demolition deposits extended to a depth of 0.57m BGL. They overlay a 0.43m to 0.6m thick deposit of horticultural soil (C203) which appeared to be very similar in character to the horticultural deposit seen during the 2014 evaluation (Context 1003). A small quantity of animal bone, ceramic building material (including a piece of Roman Imbrex) and 12th century medieval gritty pottery was recovered from Context 203. This material was assessed to be of low research value and discarded.

This horticultural soil overlay a heavily disturbed (possibly by root action) orangish brown clay (C204) which itself overlay an undisturbed firm orangish brown clay (C205). Both of these deposits are thought to be naturally occurring. The disturbed natural was encountered at a depth of 1.00m to 1.05m BGL whilst the undisturbed natural deposits were encountered at a depth of 1.12m to 1.22m BGL.

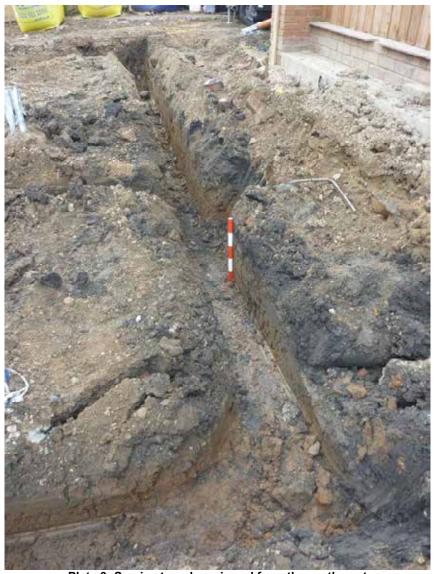
The service trenches were comprised of a main drainage channel running on a north-west to south-east alignment with four separate channels running off of it towards the south east or east (Figure 1, Plate 3).

Plate 3: Service trenches viewed from the north-east

The trenches were excavated to a depth of between 600mm and 800mm below ground level. The archaeological deposit sequence visible in their sections was identical to those identified in the trial trenches (a 20th century demolition material which overlay a horticultural soil which overlay the natural orangish brown clay). No context numbers were assigned to these deposits and no finds were recovered.

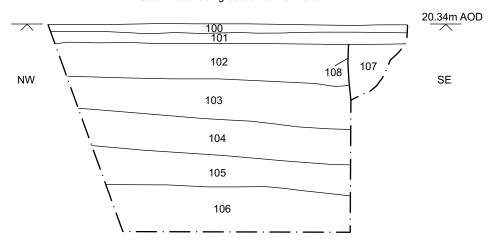
Fig. 2 Trench sections

South-west facing section of trial trench 1

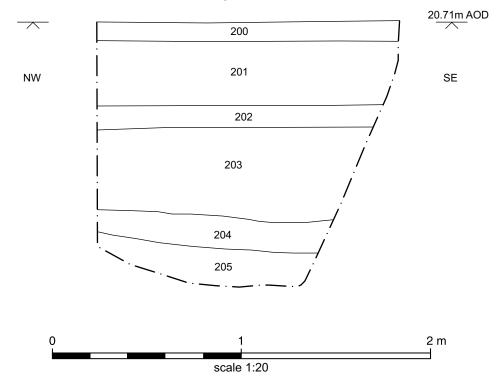
North-west facing section of trial trench 2
