YORK ARCHAEOLOGICAL TRUST

Historic Building Assessment The Magnet, Osbaldwick Lane, York

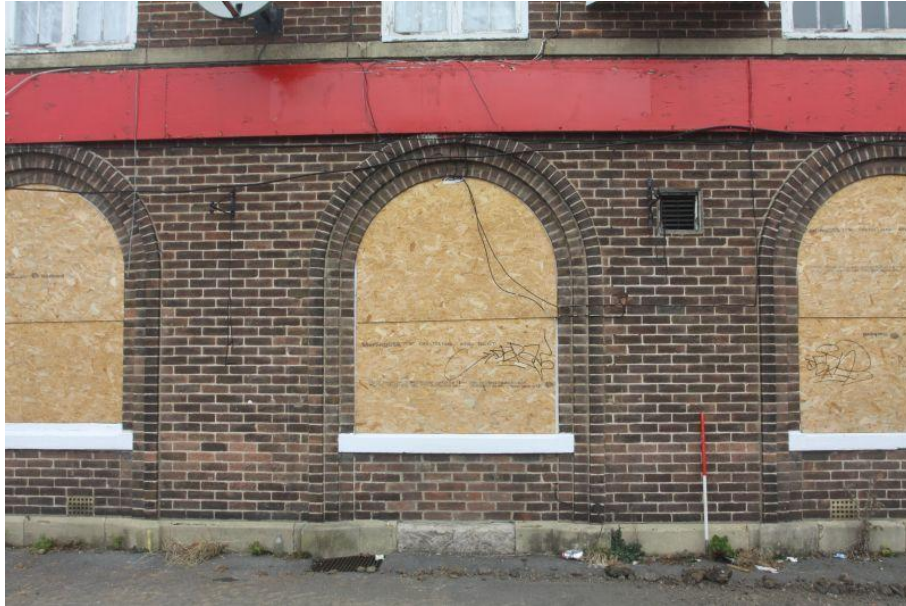
Plate 2 Recessed orders around the arched window, facing north-west

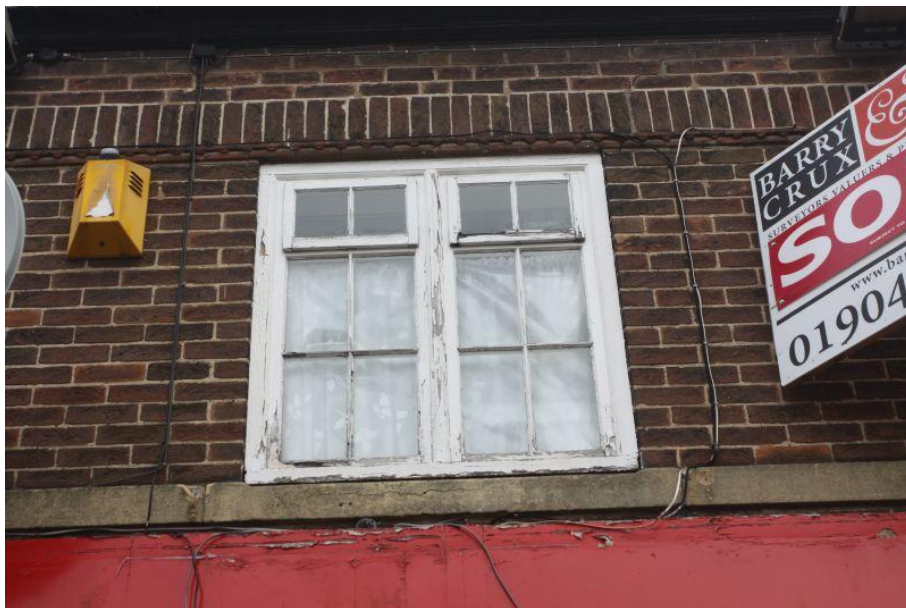
Plate 3 Window Design A, facing north-west

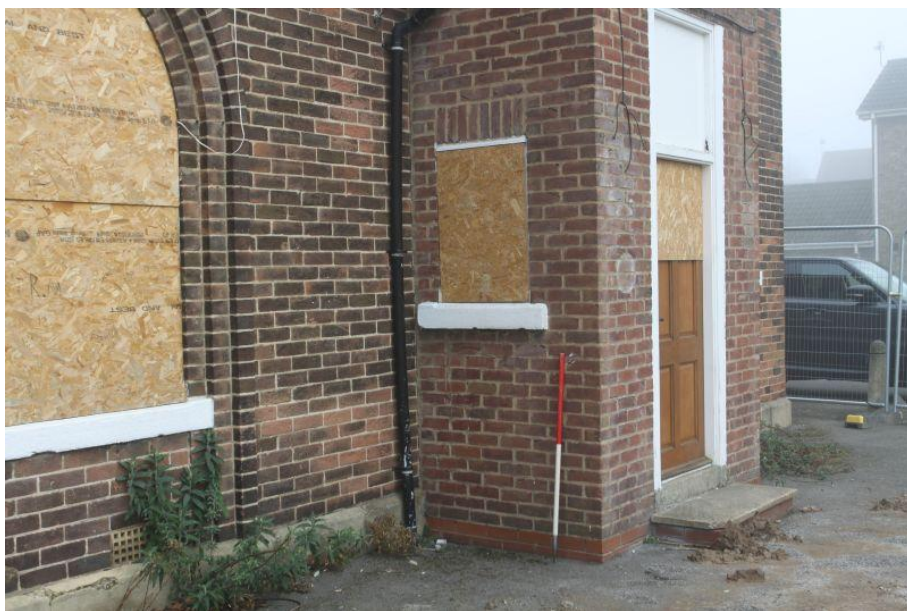
Plate 7 The porch, facing north-east

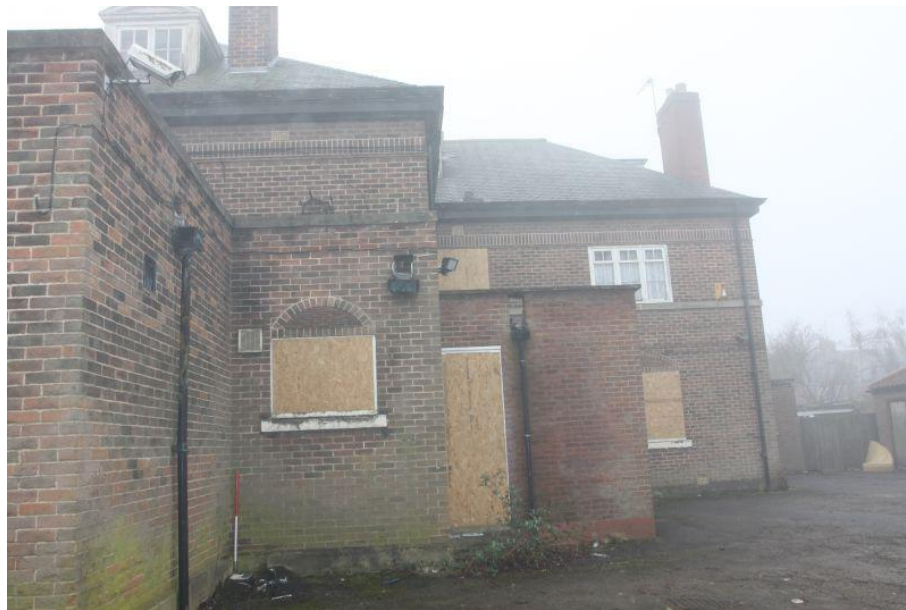
Plate 11 Part of the north-eastern elevation facing south-west

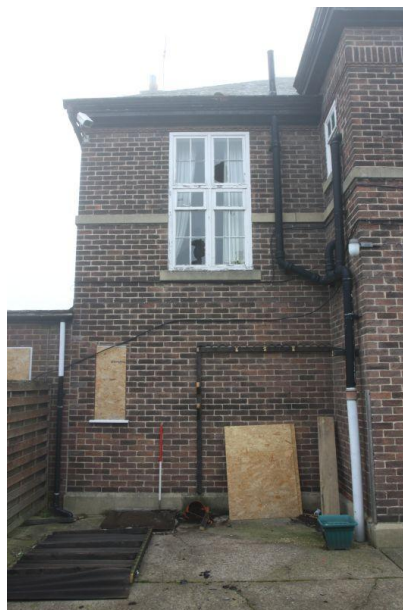
Plate 17 The northern portion of the south-western elevation, facing north-east

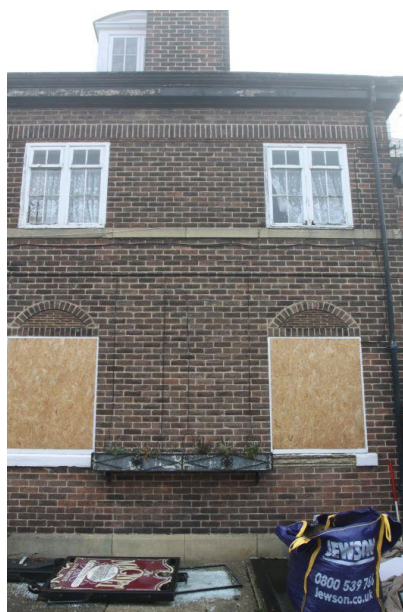
Plate 19 The central portion of the south-western elevation, facing north-east

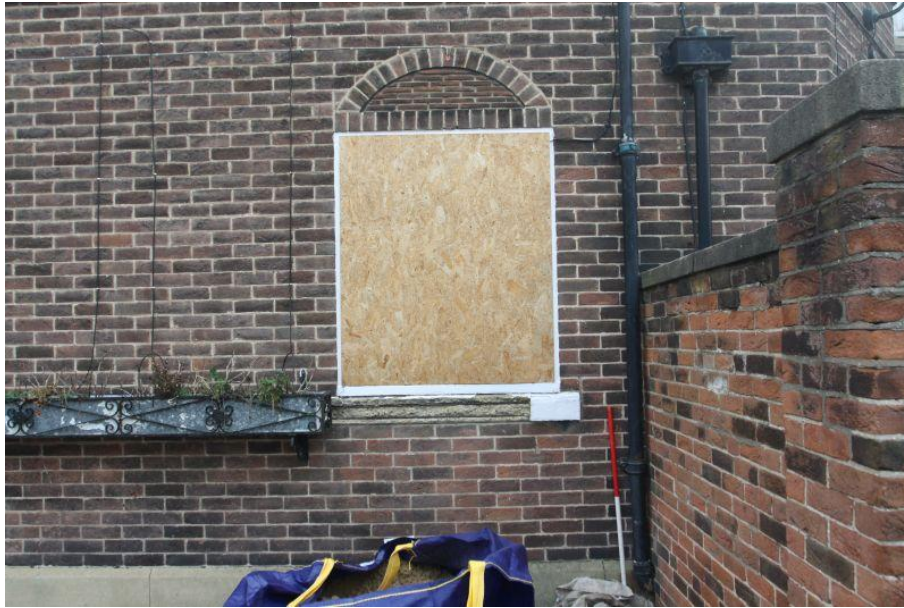
Plate 20 The decayed window sill on the south-western elevation, facing north-east

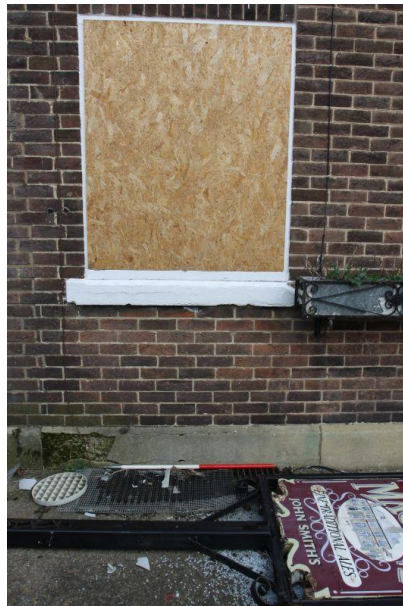
Plate 21 The light-well grille on the south-western side (beneath the scale), facing north-east

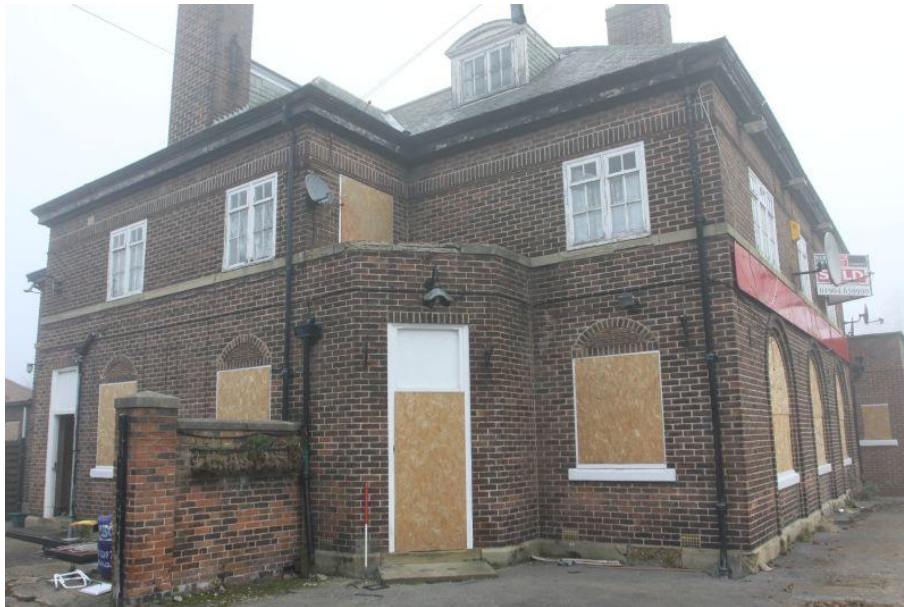
Plate 24 the south-western elevation, facing north

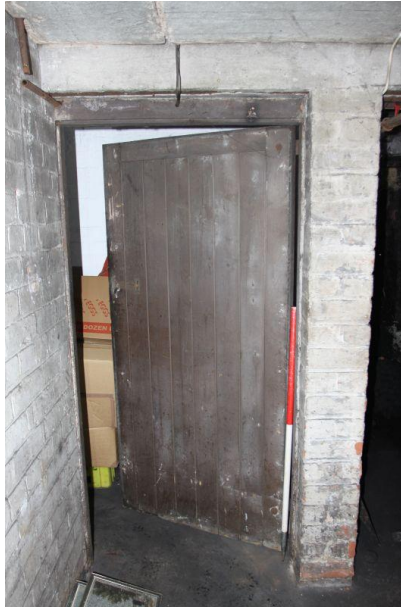
Plate 42 Room C3 entry door, facing south-west

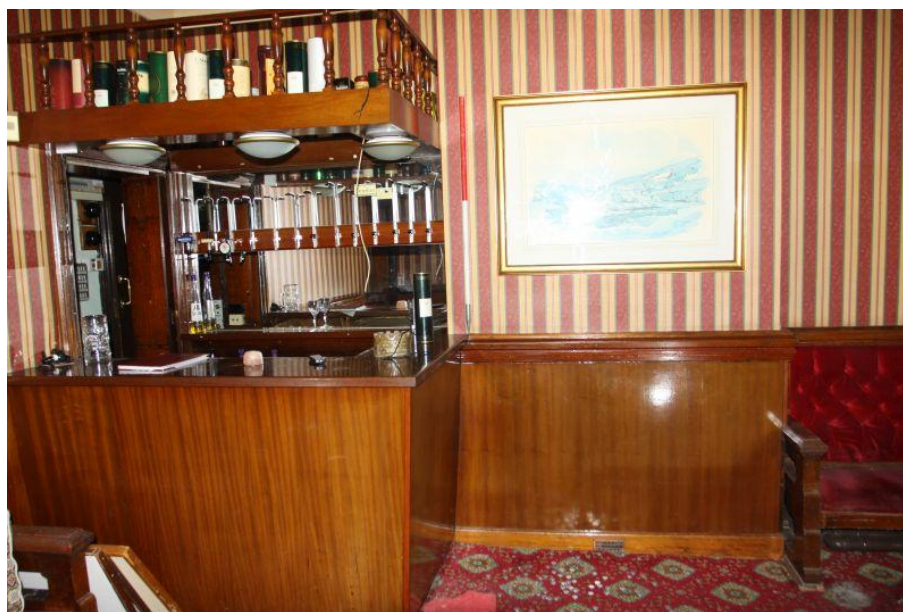
Plate 44 The north-eastern wall of Room A, facing north-east

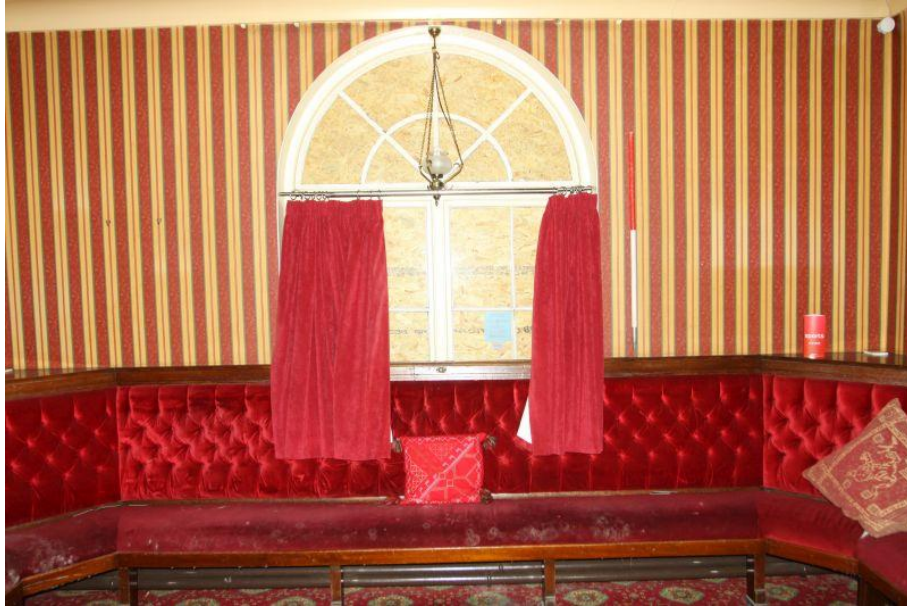
Plate 45 the south-eastern wall of Room A, facing south-east

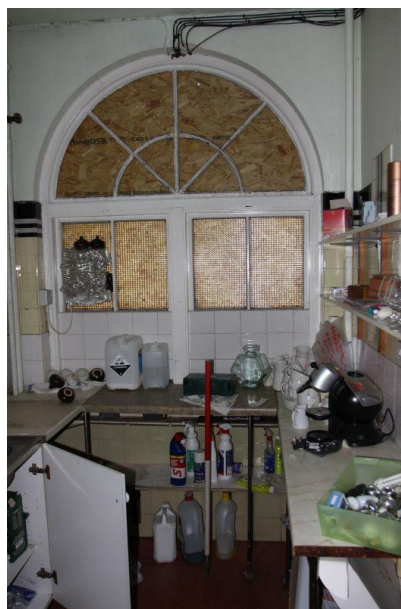
Plate 48 The bar kitchen, facing south-east

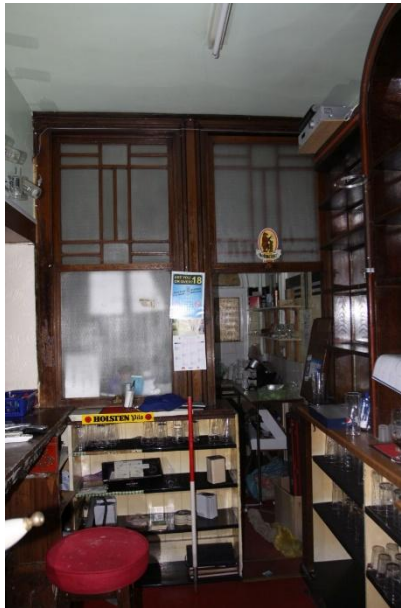
Plate 49 The screen between the bar and kitchen, facing south-east

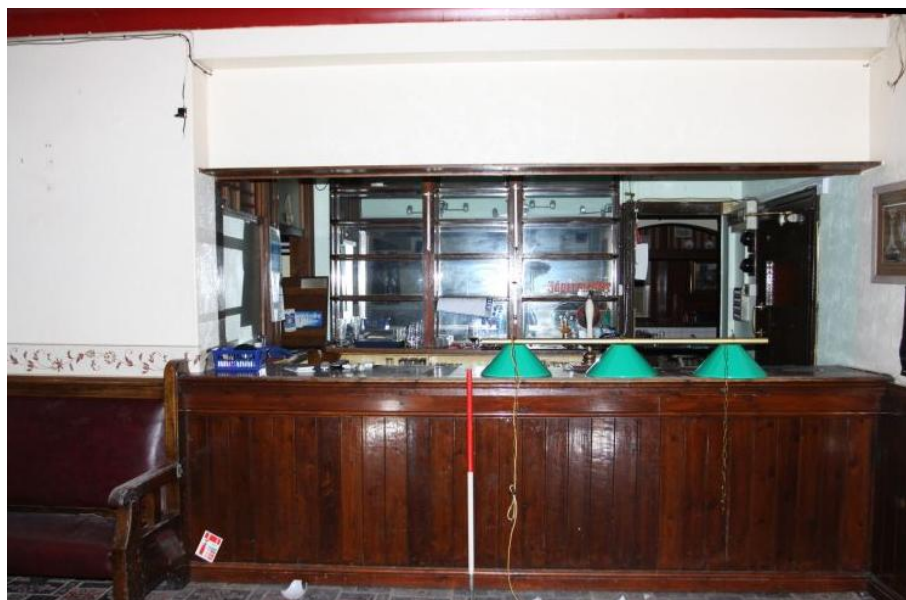
Plate 50 The bar counter Rooms B/C, facing south-west

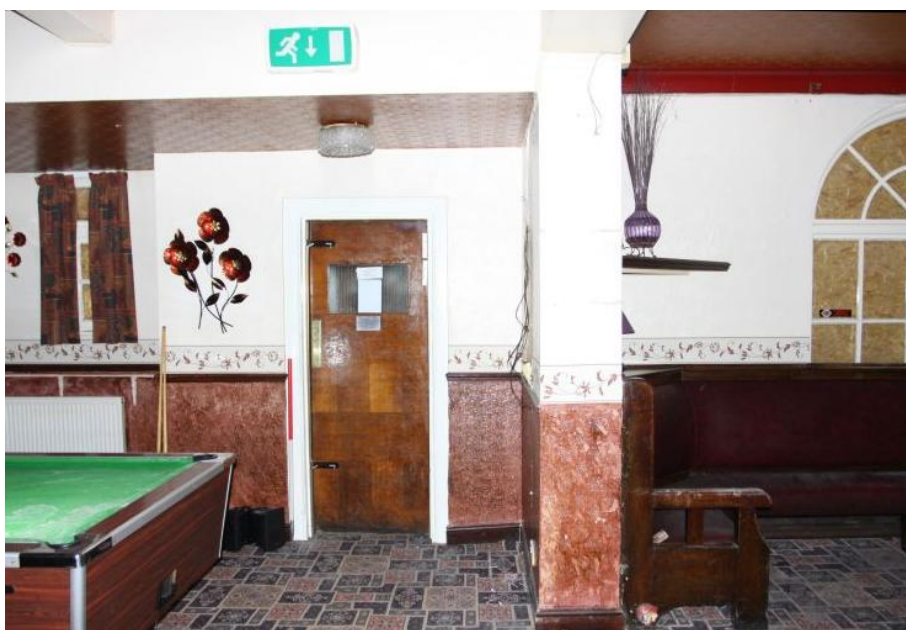
Plate 60 The doorway to the porch in Room C, facing south-east

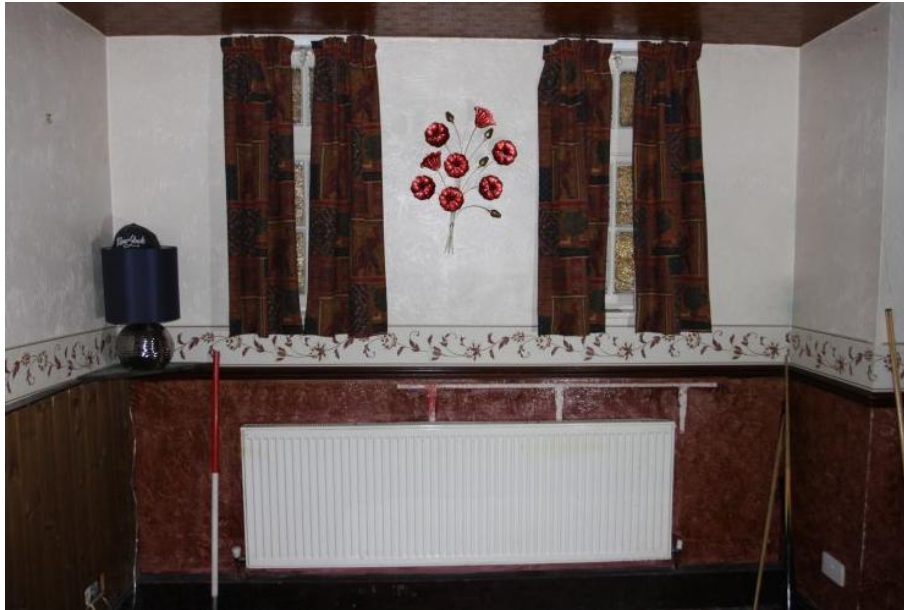
Plate 61 the Design C windows facing south-east

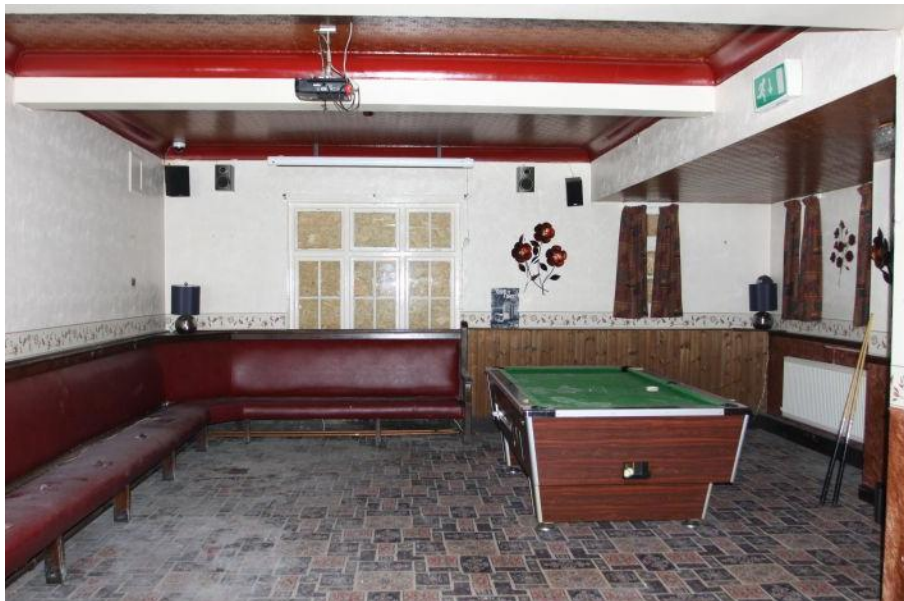
Plate 62 The north-eastern wall of Room C, facing north-east

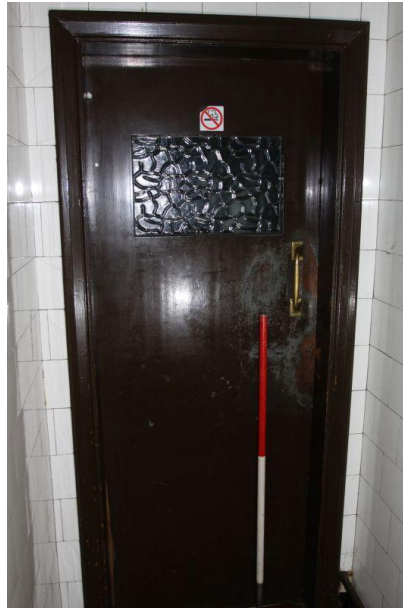
Plate 64 The door between the gents' toilet and Room J, facing south-west

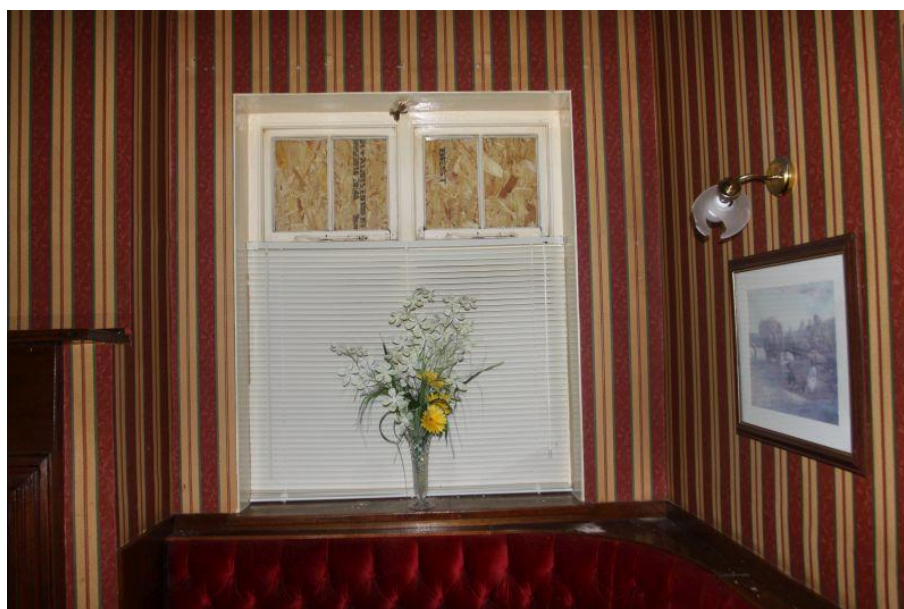
Plate 72 Window of Design E in Room G, facing north-west

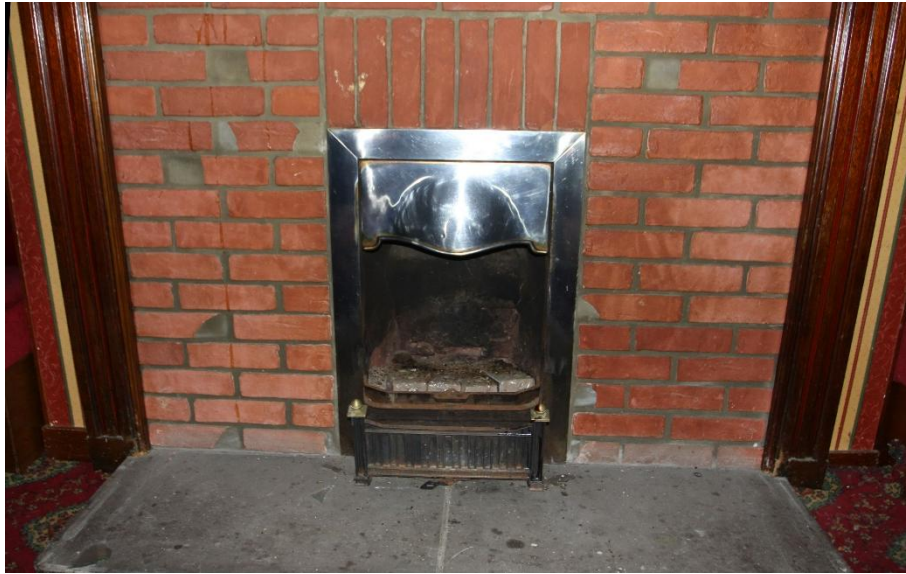
Plate 73 The Room G fireplace hood, facing north-west

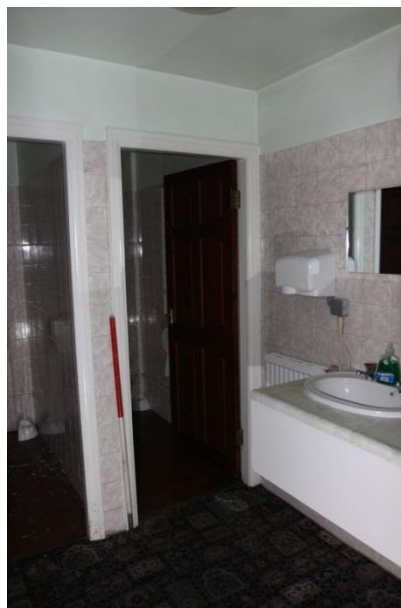
Plate 78 The ladies' toilet, facing north

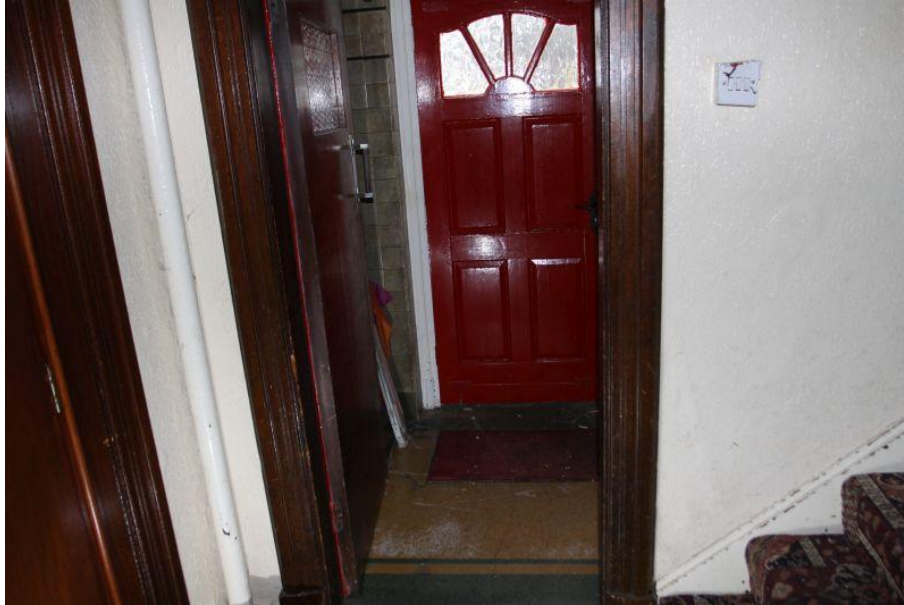
Plate 79 the porch of Room J facing south-west

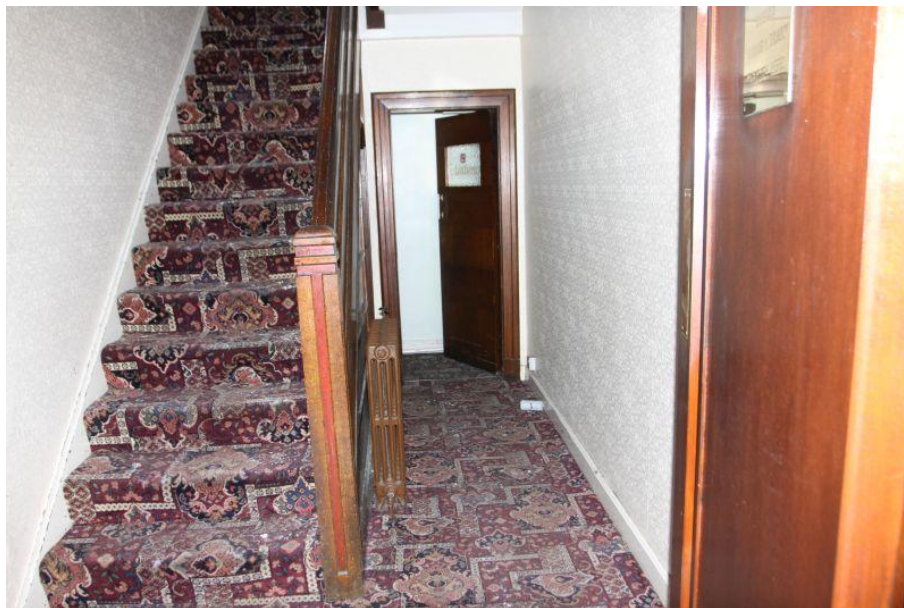
Plate 80 Room I, facing north-west

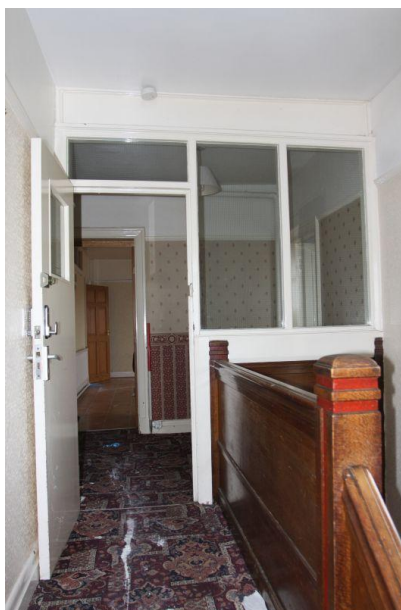
Plate 82 the partition wall at the top of the stairs, facing south-east

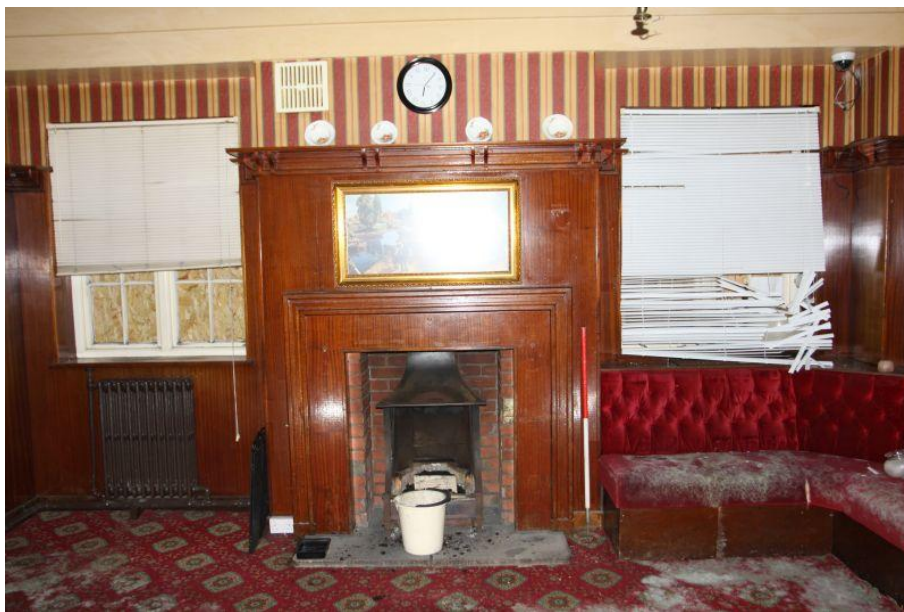
Plate 85 The south-western wall of Room J, facing south-west

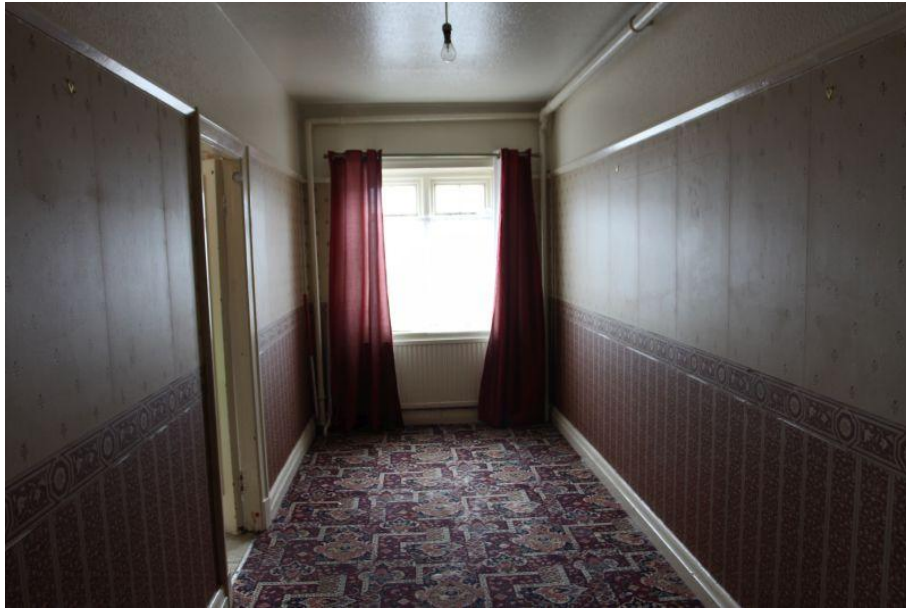
Plate 93 Room M south-eastern portion, facing south-east

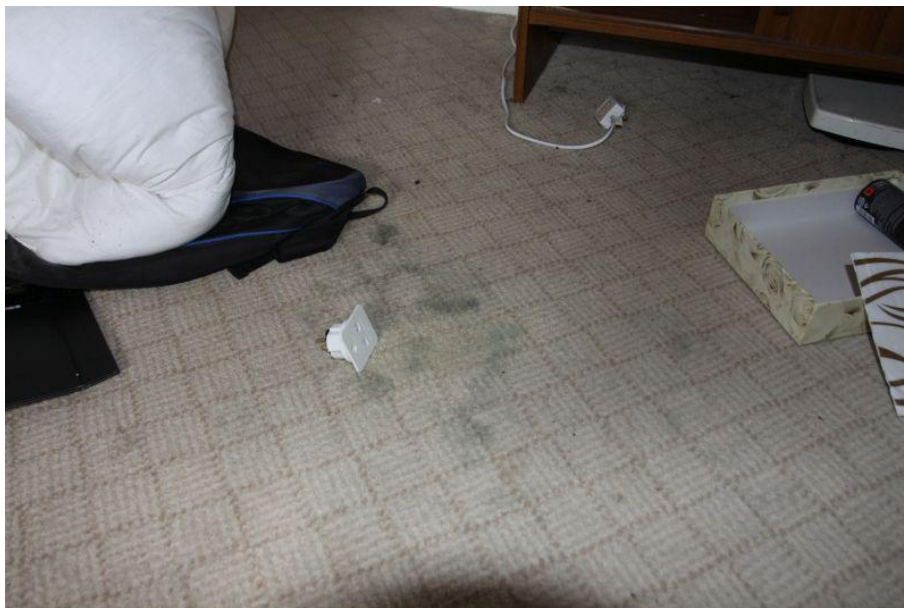
Plate 116 Room V the mouldy carpet

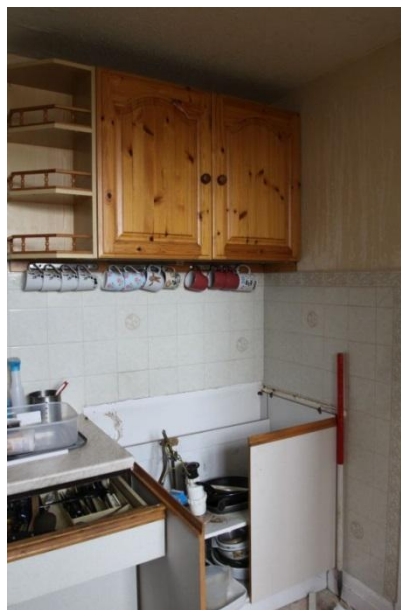
Plate 126 Room X the kitchen cupboards, facing north-west

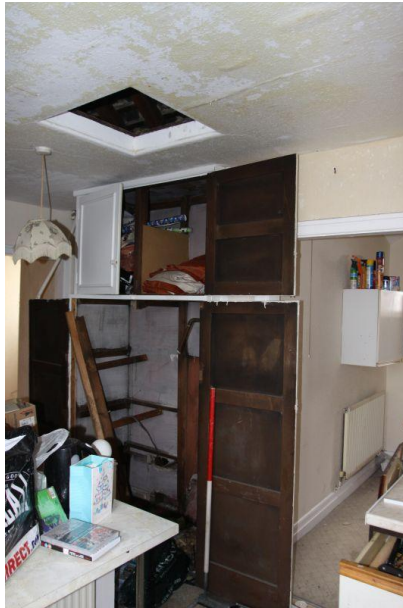
Plate 127 Room X the access hatch for the roof space, facing south-west

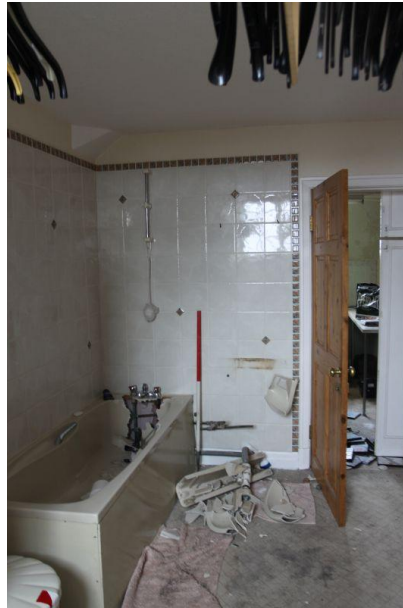
Plate 133 Room Z, facing north-east
