Archaeological Ground Survey of Sutton Park, Birmingham

Report 0957

December 2009

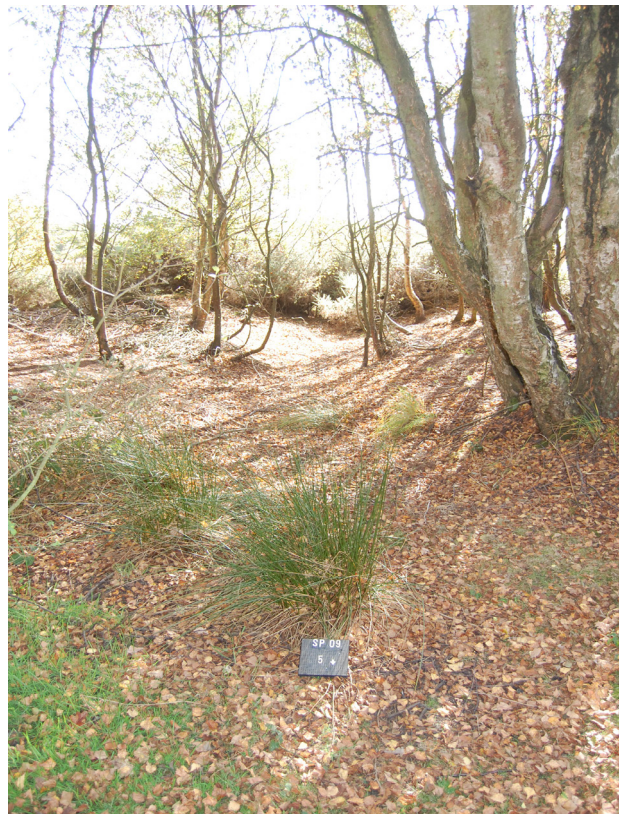
Fig. 5: Site 5

Notes: **Very prominent wide ditch, c.5m wide west bank, less prominent east bank, visible on both sides of path but less prominent to the south. The prominence of the feature suggests it was part of a former park boundary, running south off the 12th-century Park IV boundary and parallel to the 15th-century Park III boundary.**

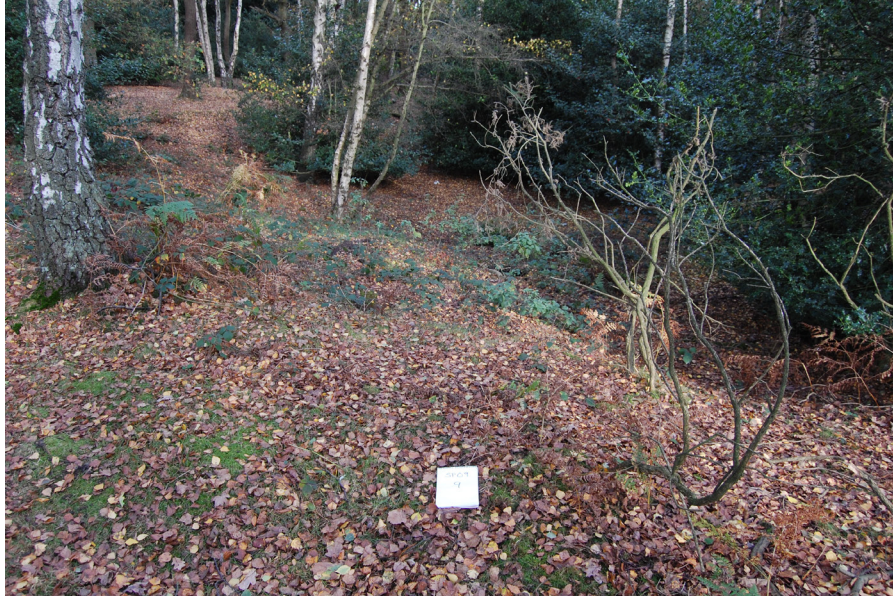
Fig. 6: Site 9

Notes: **This is a substantial pit, probably a quarry pit.** The land slopes down to the SE.

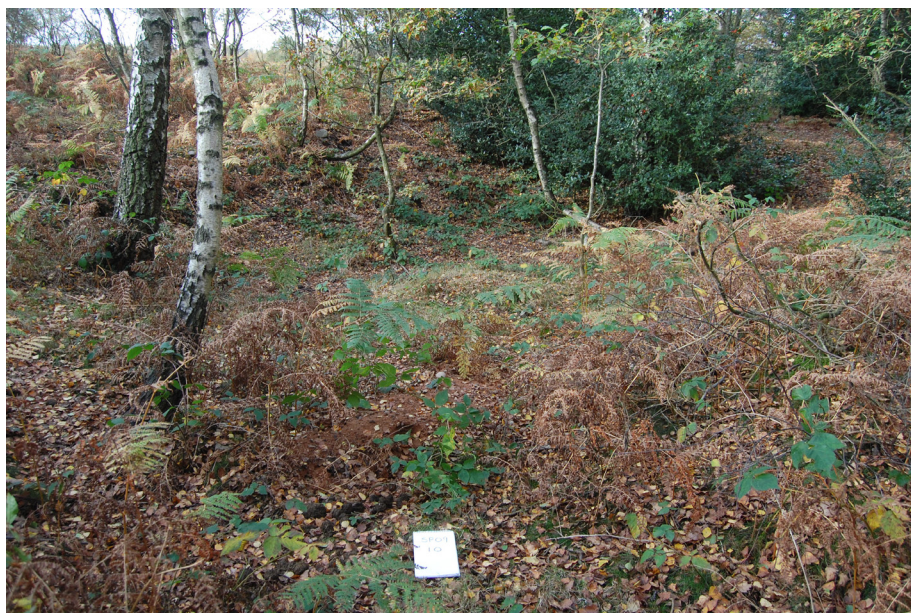
Fig. 7: Site 10

Notes: A number of bricks in this pit with lettering JUBILEE on their side – late 19th-/early 20th-century date? **Size of pit suggests it was probably a quarry pit.**

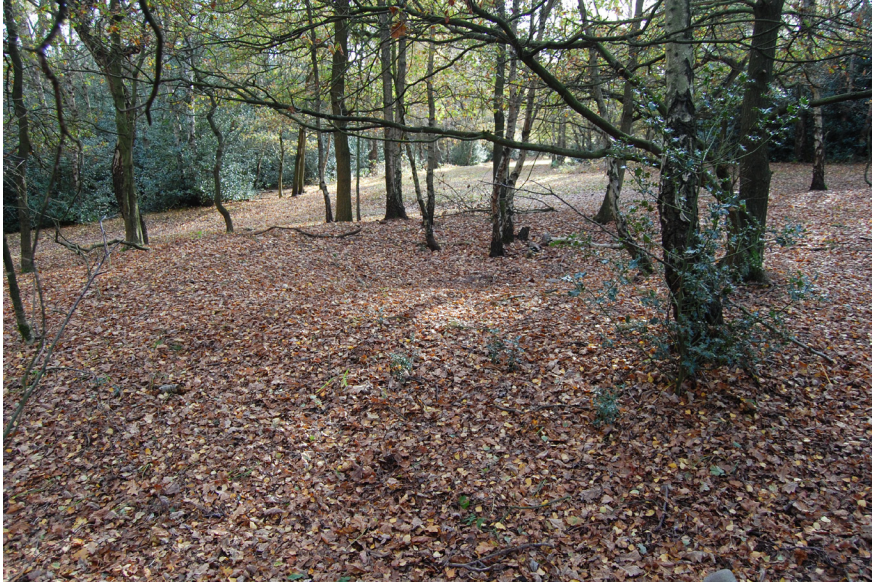
Fig. 8: Site 20

Notes: **Circular banked pit (?whitecoal pit or Q pit). Very good example.**

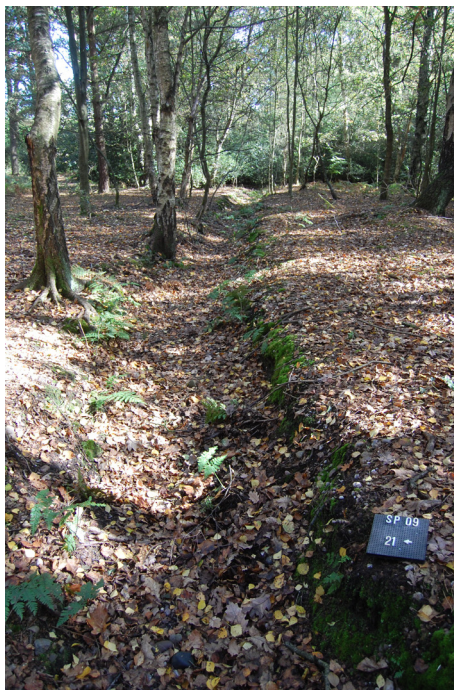
Fig. 9: Site 21

Notes: **Slightly curving ditch on slope - drainage?**

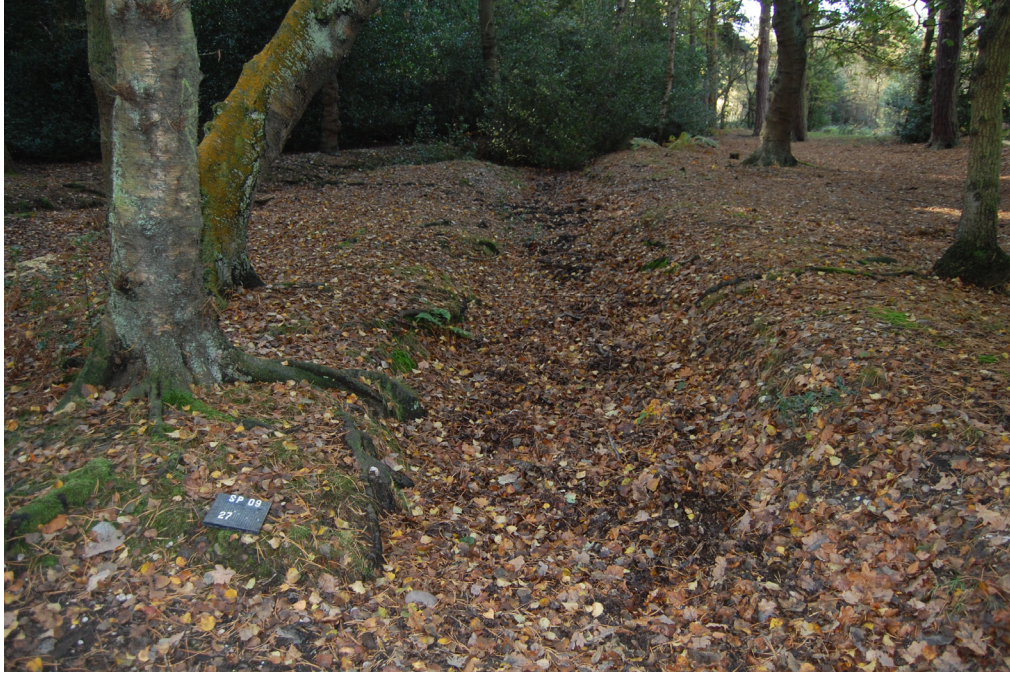
Fig. 10: Site 27 ditches

Notes: **A well-preserved series of banks and ditches. Some of the ditches converge as can be seen on Fig. 10 below. This area would benefit from a proper survey.**

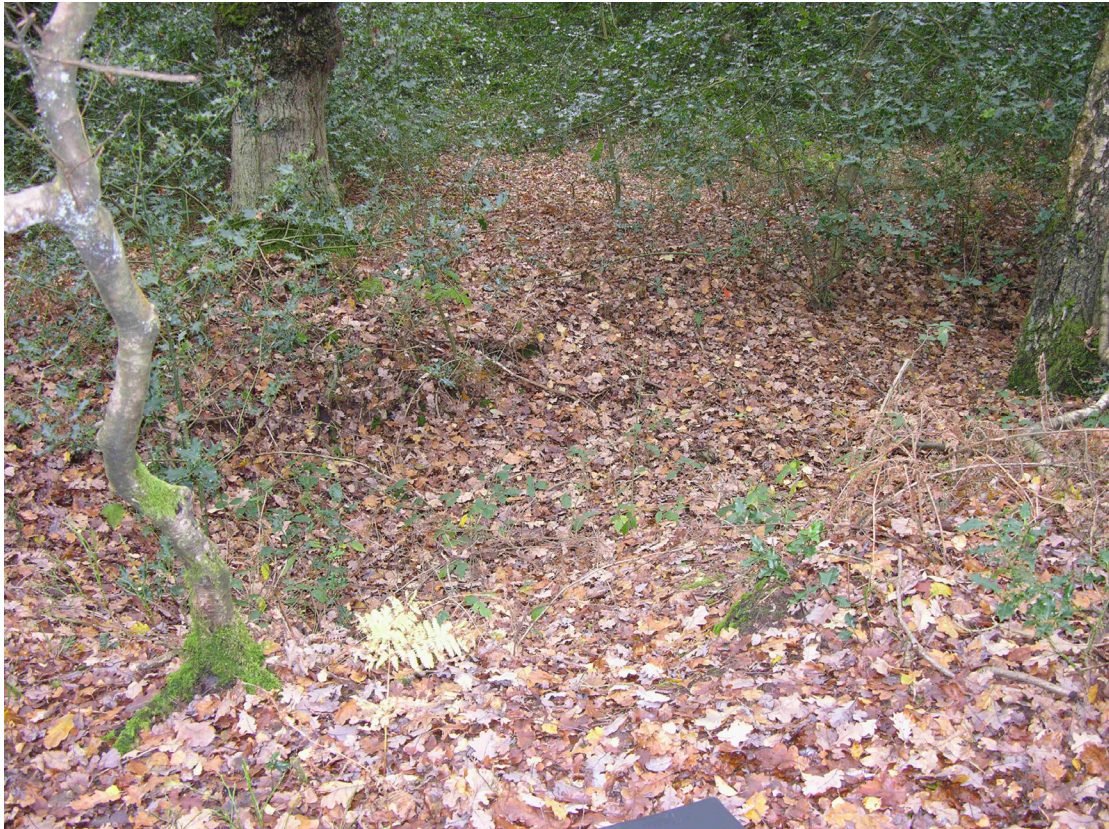
Fig. 12: Site 32

Notes: **Located deep in the woods in a relatively lightly vegetated area, surrounded by denser woodland.**

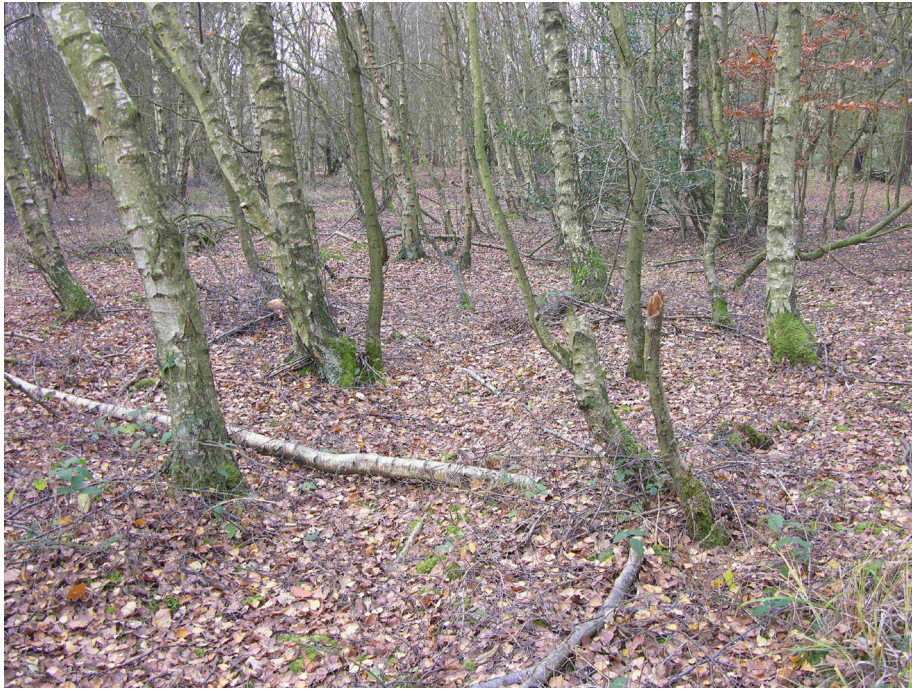
Fig. 13: Site 37

Notes: This is a fairly subtle ditch, c.1m wide and 0.20m deep. Trees generally run either side of it. The prominent bank surrounding Darnell Hurst is visible to the north of this and was also photographed (photo 161).

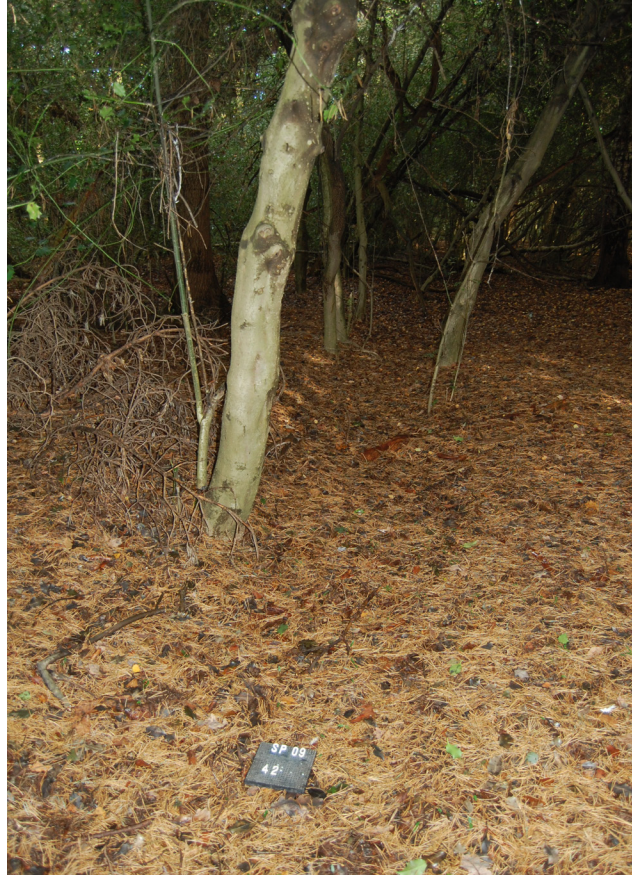
Fig. 14: Site 41

Notes: The ditch and bank are clearly visible most of the way up from the car park area. Continues further south than the area marked on lidar but set back from the current path and wood edge by 20m or so.

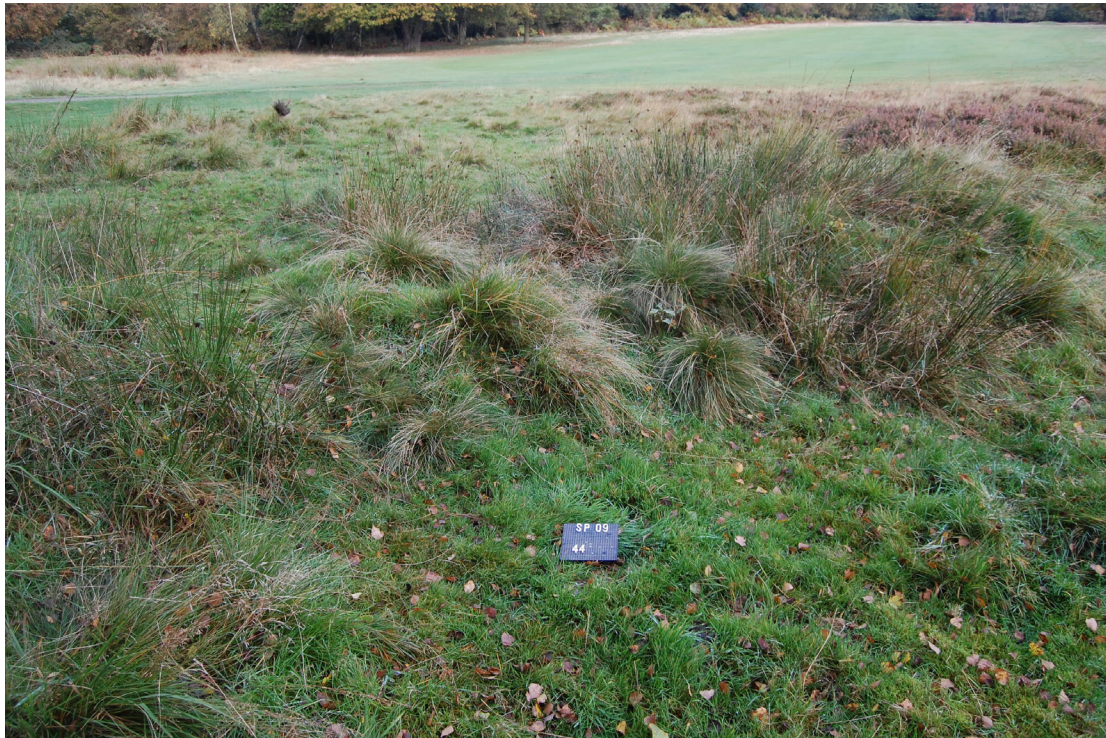
Fig. 15: Site 44

Notes: **Long mound, just north of drainage ditch.** This is an artificial feature and not golf-related, although it is within golf course area.

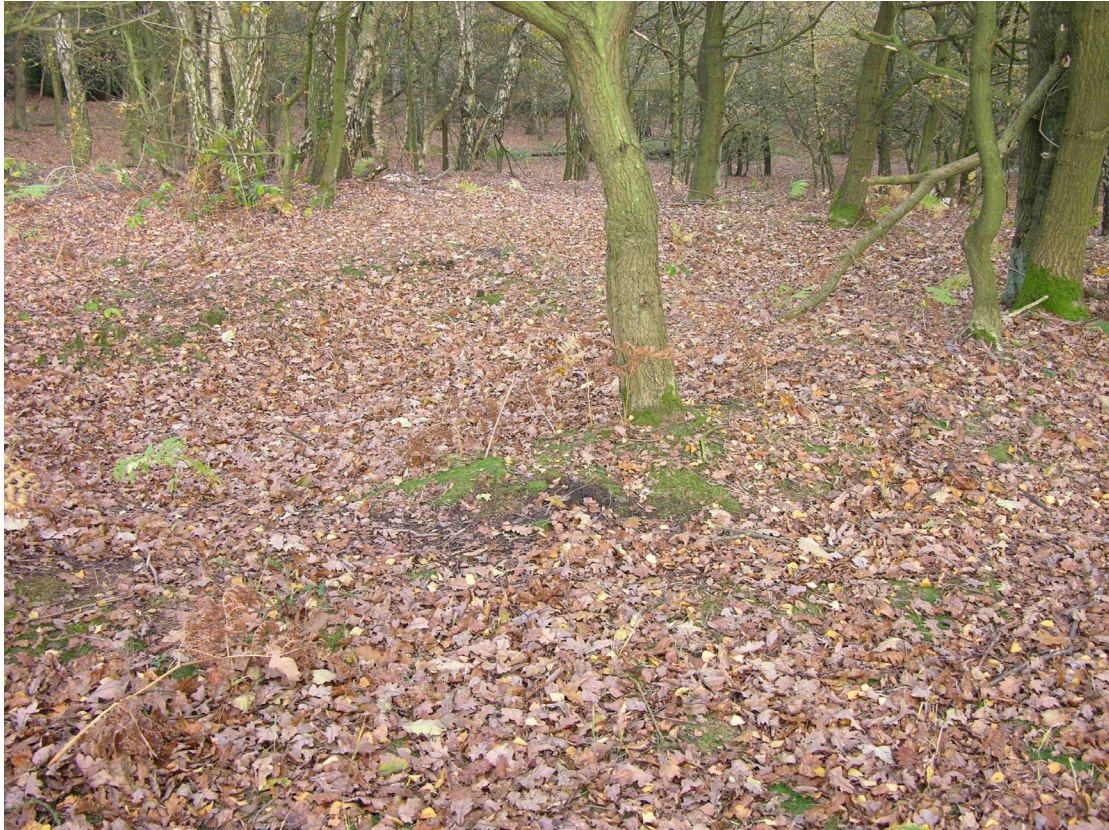
Fig. 16: Site 45

Notes: This double banked-pit may not be that identified on the lidar but it is in the right general area. They lie on a slight slope and are difficult to photograph. Possible double banked-pit (?whitecoal pit or Q-pit). Looking at the lidar retrospectively this may be the feature just to the south-west of that marked by MH. Nothing was visible on the ground in the area he circled. New Sites 2 has new site marked. On the photo below the upper pit lies to the left of the central tree, the other to the upper right.

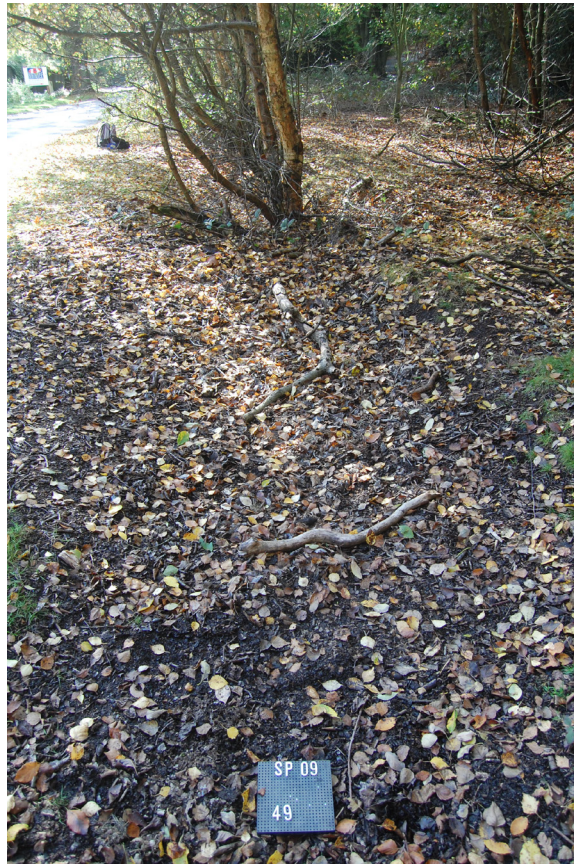
Fig. 17: Site 49

Notes: **The photo shows the northern part on a dry day where there is a bank and ditch. Looking at it further to the south (and after heavy rain) it is clearly part of a drainage watercourse - also marked on the MapInfo mapping.**

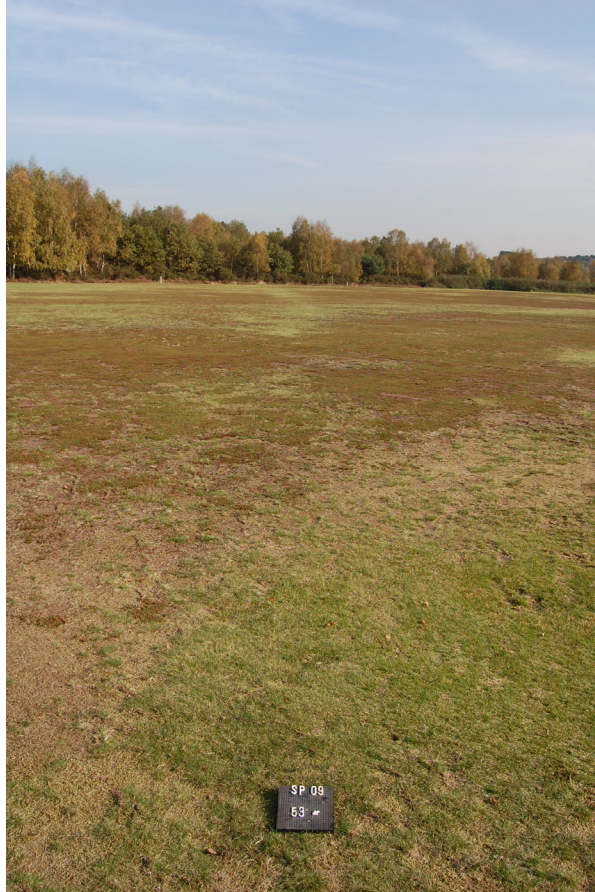
Fig. 18: Site 53

Notes: **This is a very low relief feature no more than a few centimetres deep, but can be seen both as a slight hollow and in change in vegetation across the area of open land.**

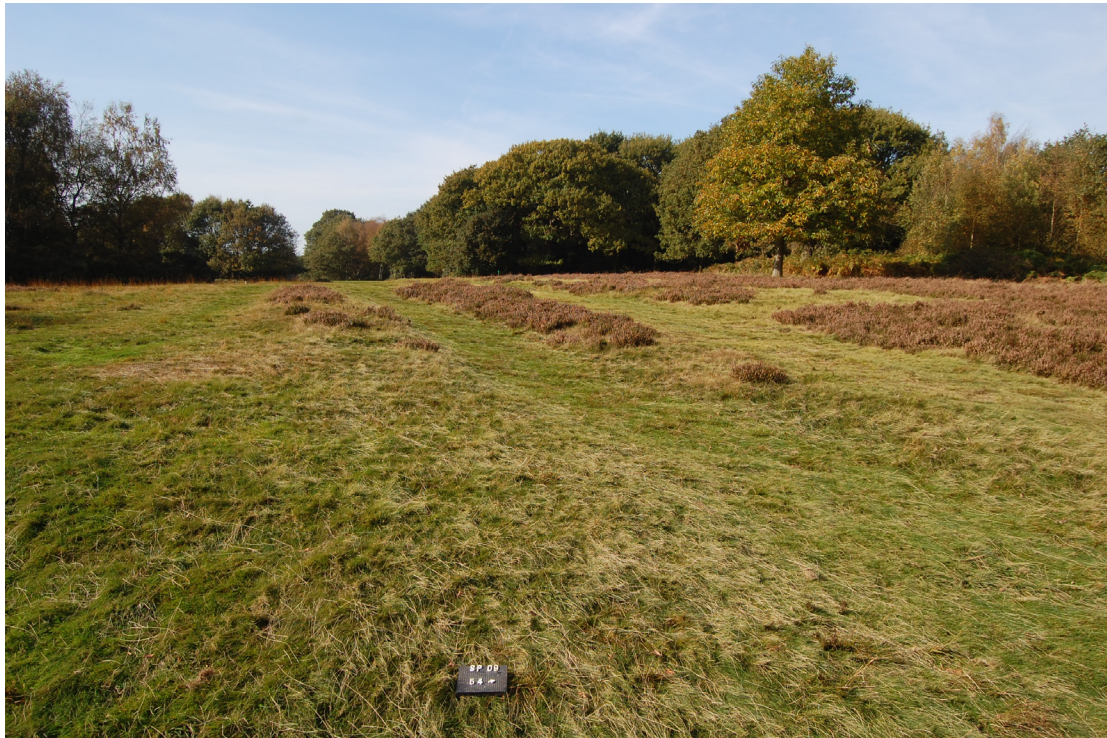
Fig. 19: Site 54

Notes: While these are prominent features, both on the lidar and in the landscape it is quite possible that they are the result of golf traffic over this rise of land; alternatively they may be relict ridge and furrow. There is now a golf path parallel to the south-west.

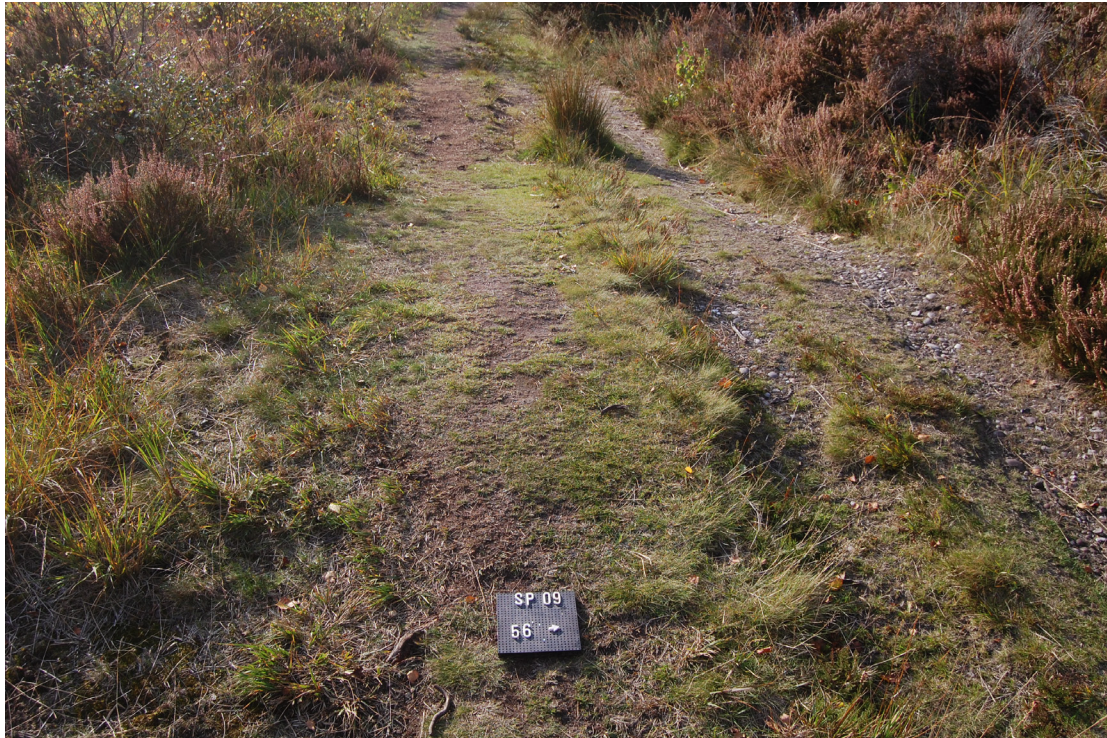
Fig. 20: Site 56

Notes: These two banks are highly visible where the path crosses but are subject to erosion here. The eastern bank is more prominent and this continues into field to south of path. Monument number 2498 in SMR - 'linear earthwork'.

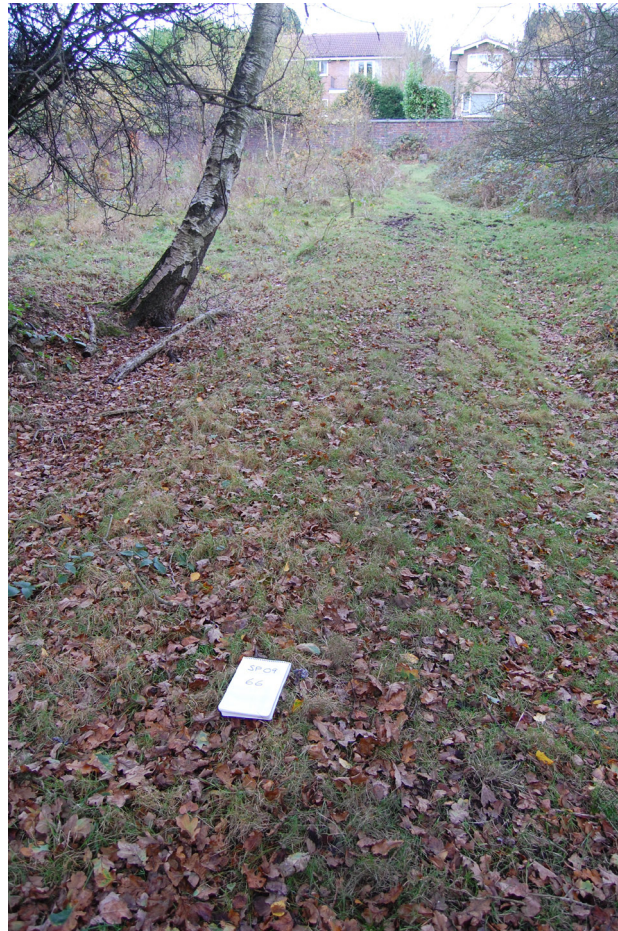
Fig. 21: Site 66

Notes: Runs upslope towards road. This bank has ditches either side and is a clear feature in the landscape. However it is mapped as a footpath so may be of recent date.

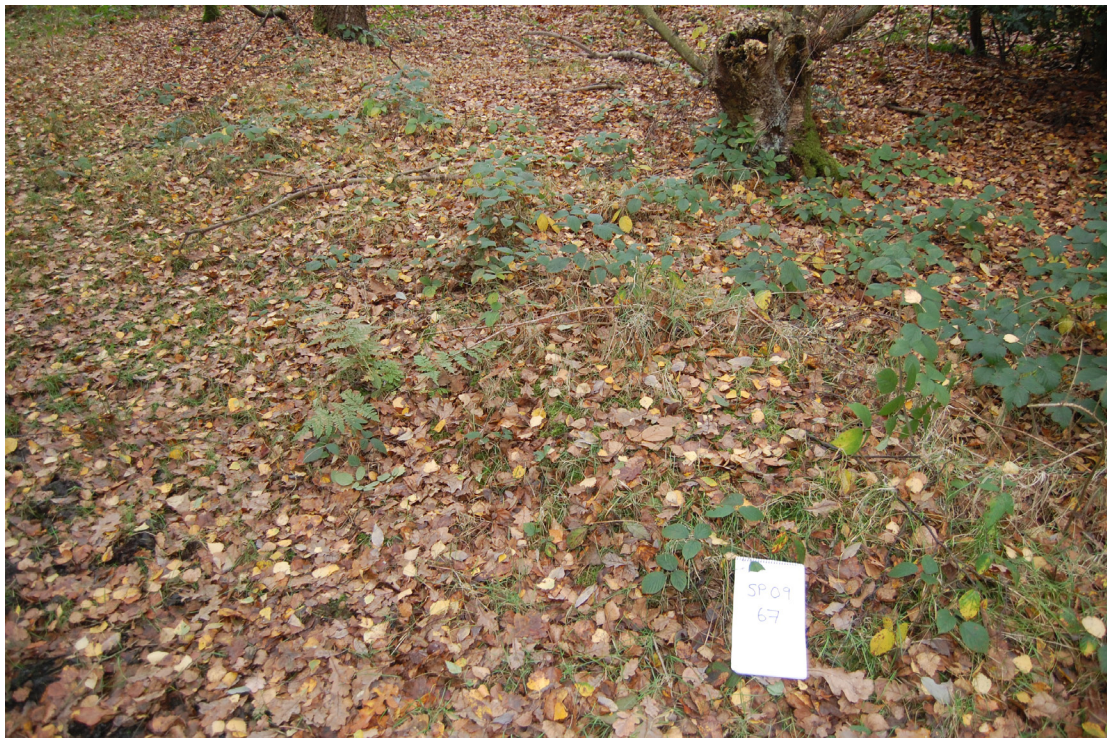
Fig. 22: Site 67

Notes: **This is a genuine bank and may even run another 50m south** (suggested by lidar – would need checking on ground).

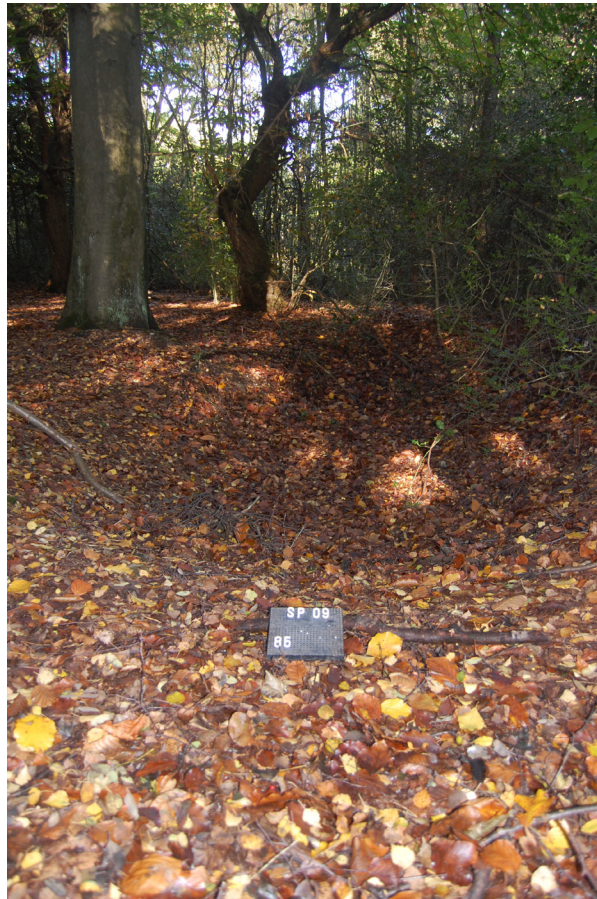
Fig. 23: Site 85

Notes: This oval pit lies in the wood just east of a pile of logs which are parallel with the track.

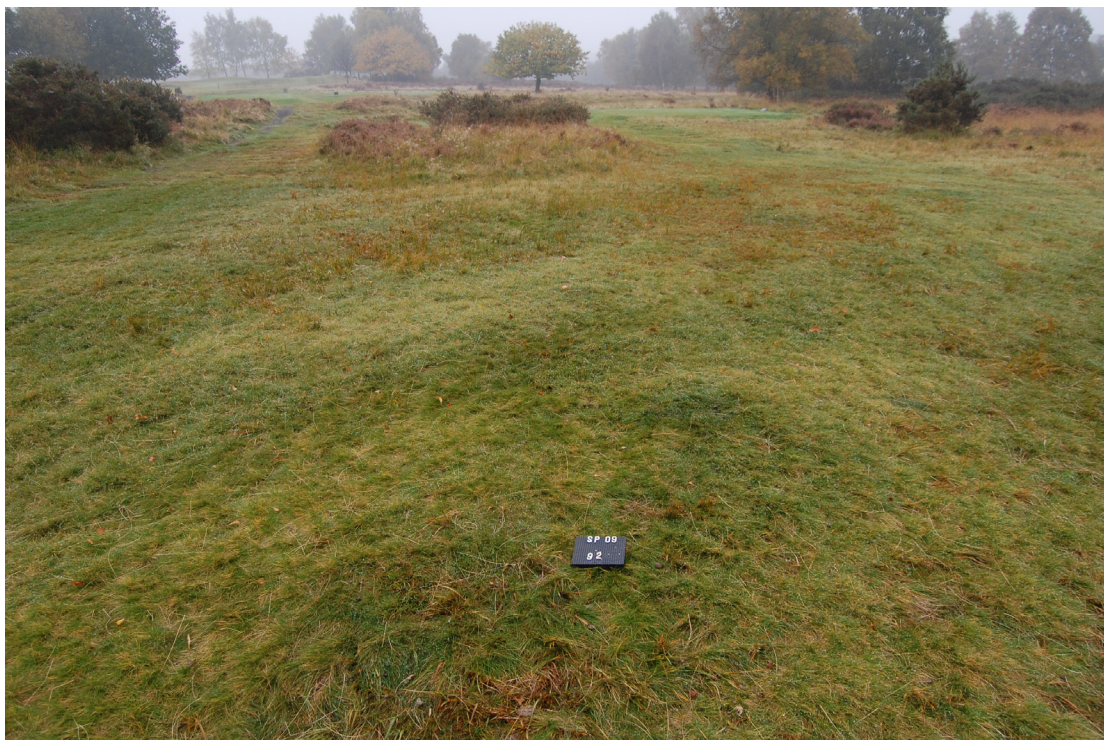
Fig. 24: Site 92

Notes: A small area clearly visible c.13m across in rough grass, probably more under heather.

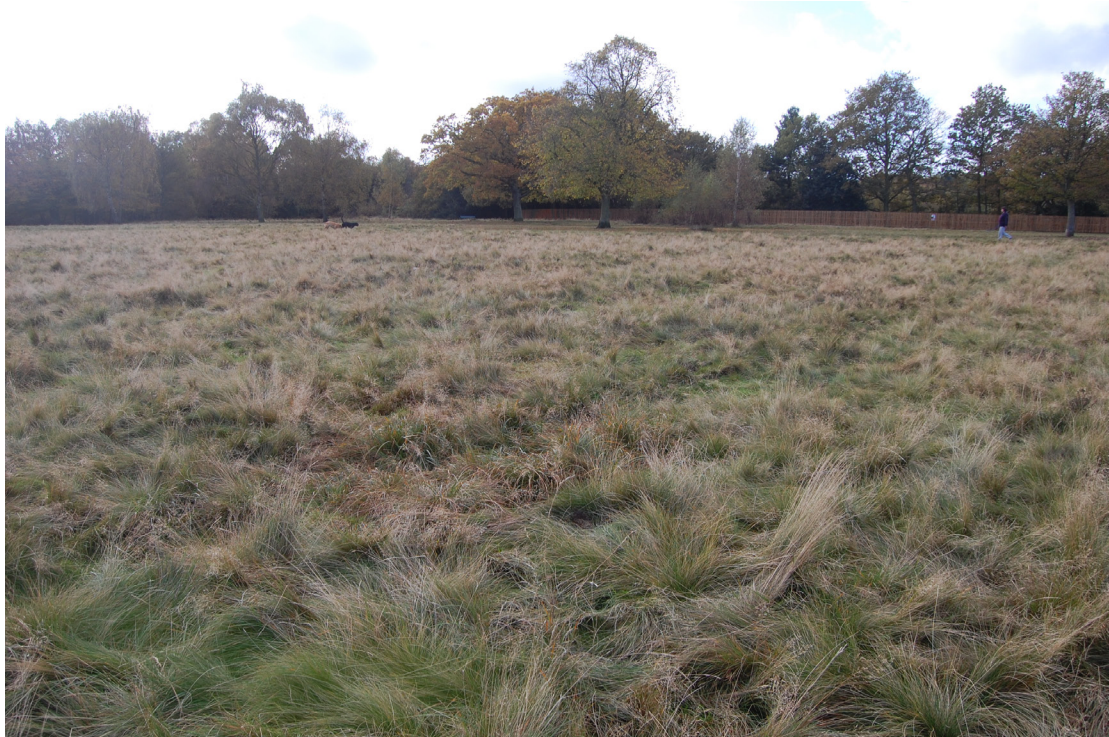
Fig. 25: Site 103

Notes: **Very slight 3m wide 'ridges' more visible as the 0.20m depressions between them.** These can be seen as differential vegetation growth on the ground. Become invisible in wet weather. I would suggest these continue further south, but not as far east as MH indicated. Good example of lidar picking up something that would not otherwise have been spotted.

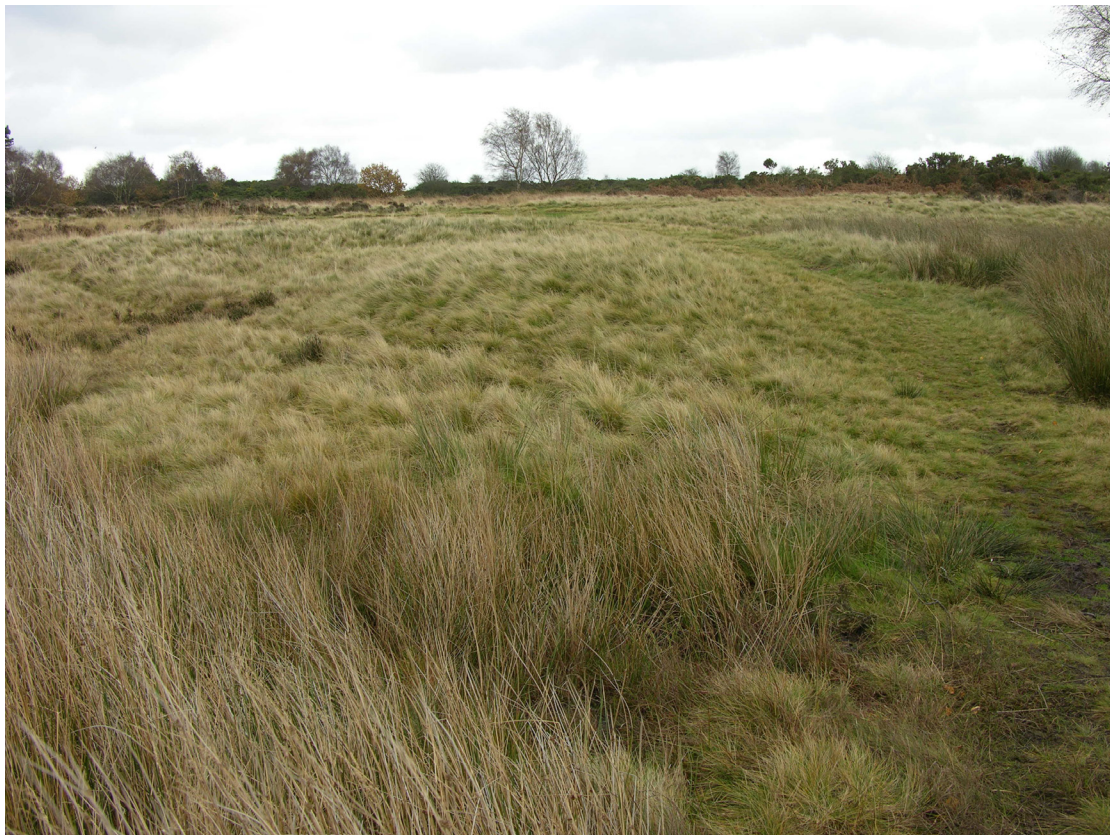
Fig. 26: Site 117

Notes: Two mounds seen were on west side of path – nothing visible on east of path as area obscured by gorse and bracken. This might be worth revisiting in winter. The roughly circular mound is quite a prominent feature. **Possible burnt mounds?** The paths in this area are confusing however – more exist than are mapped.

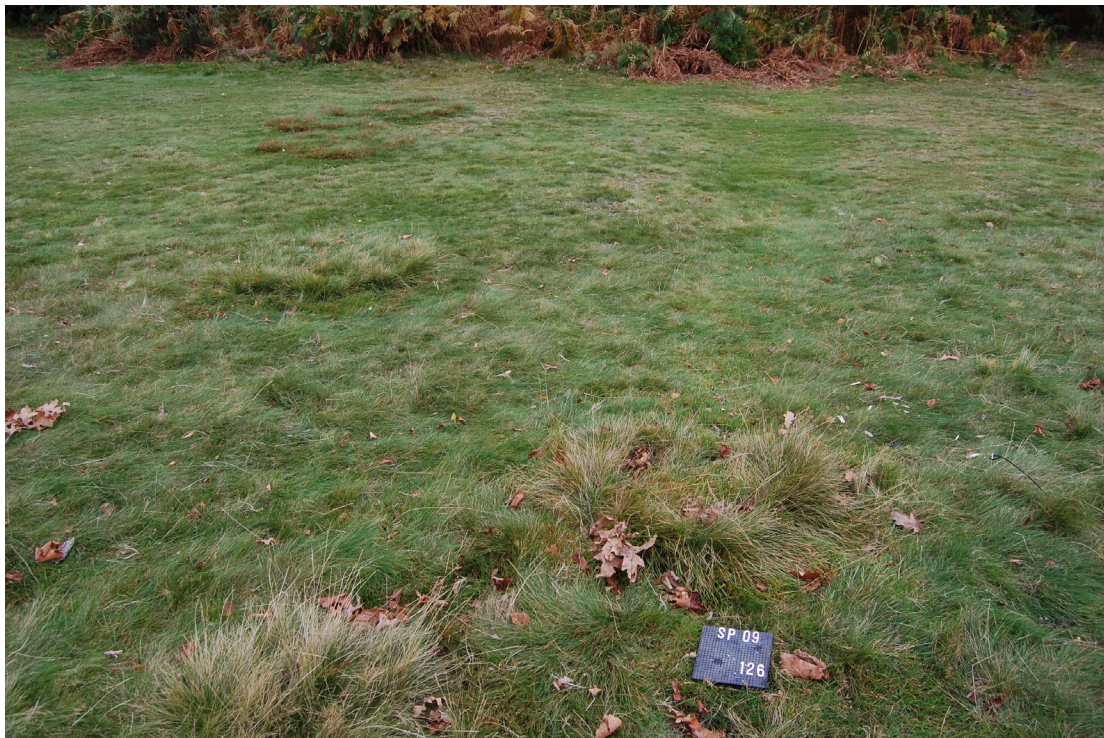
Fig. 27: Site 126

Notes: Ridges run W-E, north-west of visitor centre. Visible in less densely vegetated areas.

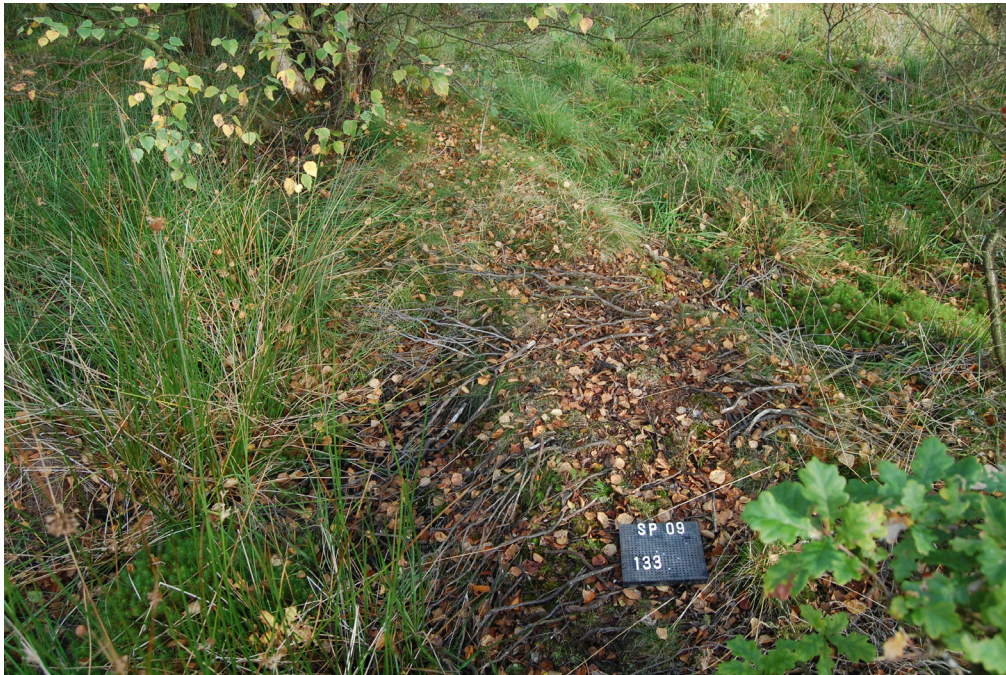
Fig. 128: Site 133

Notes: **Flat-topped bank. 500 foot distance marker for firing range.**

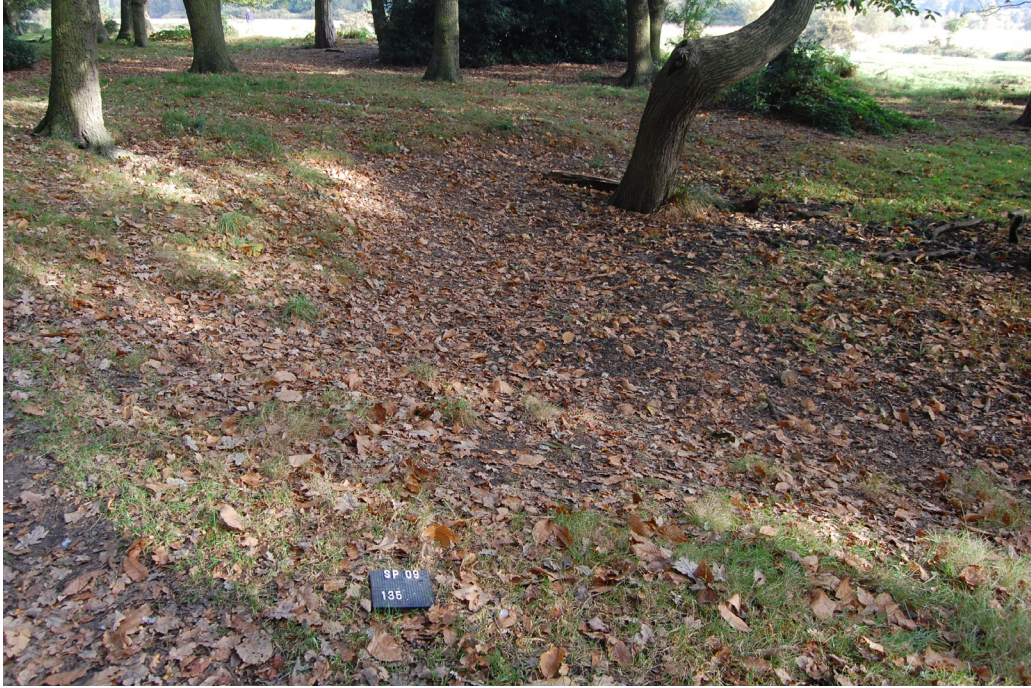
Fig. 29: Site 135

Notes: **Possible quarry pit.**

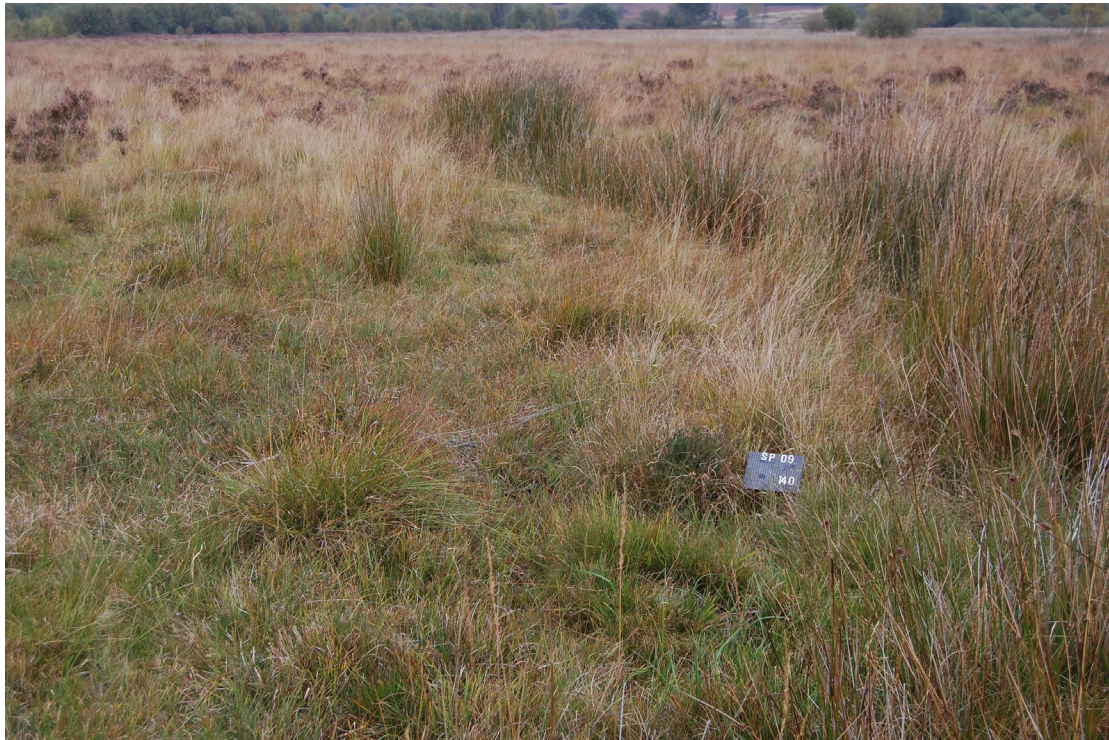
Fig. 30: Site 140

Notes: **A low but visible feature which could be seen in non-heather covered ground.**

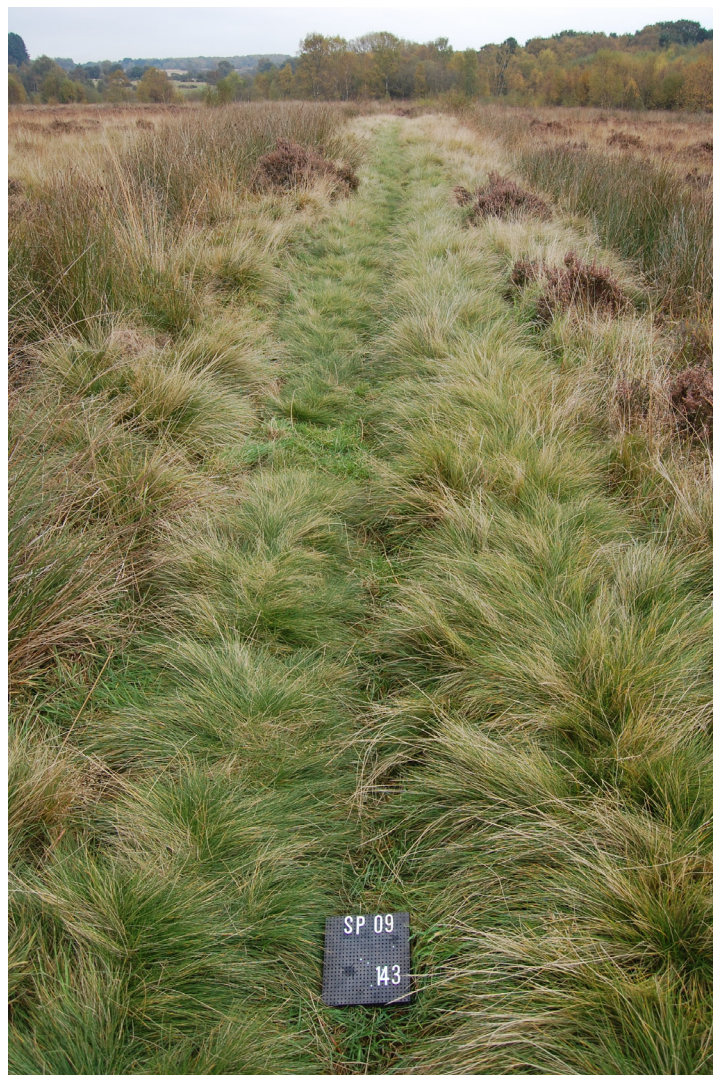
Fig. 31: Site 143

Notes: **The NE-SW stretch is highly visible as a wide bank, ditched on either side,** and where indicated by MHI on lidar as 75m long could actually be up to 150m long. The NW-SE stretch, which is c.40m long on lidar, was less clear.

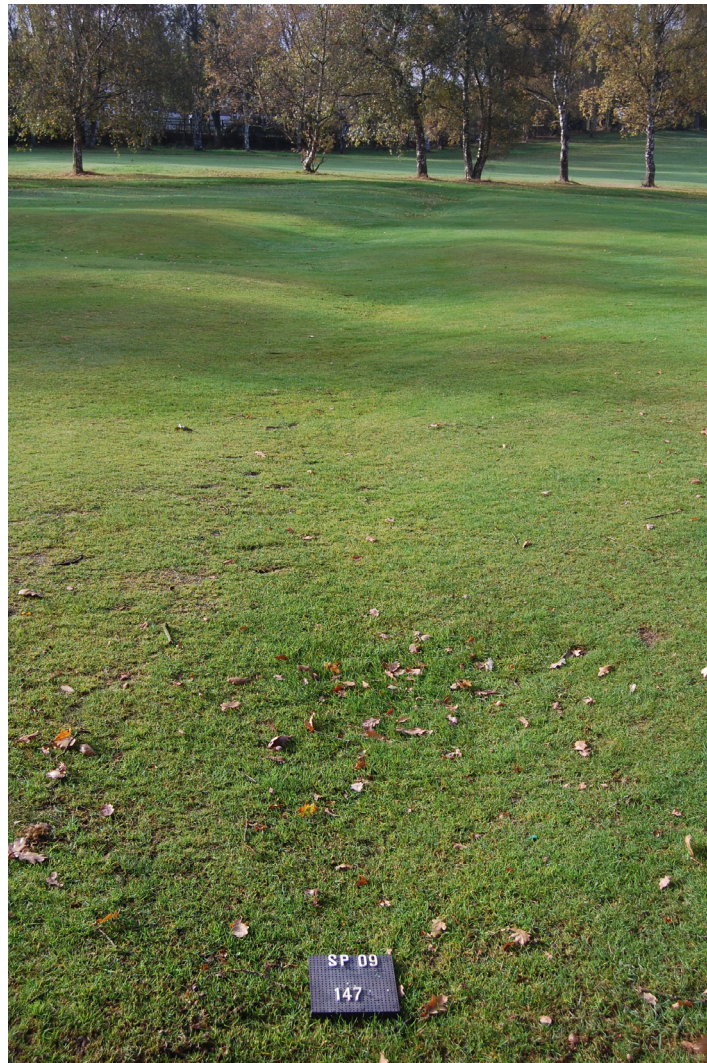
Fig. 32: Site 147

Notes: Curving ditch running from 146, across 148 and into ditch to north, Lies at west end of ridges 165. This is a more uneven feature than 146 and 148. **It represents part of a field boundary shown on the first edition map, along with southern stretch of 146.**

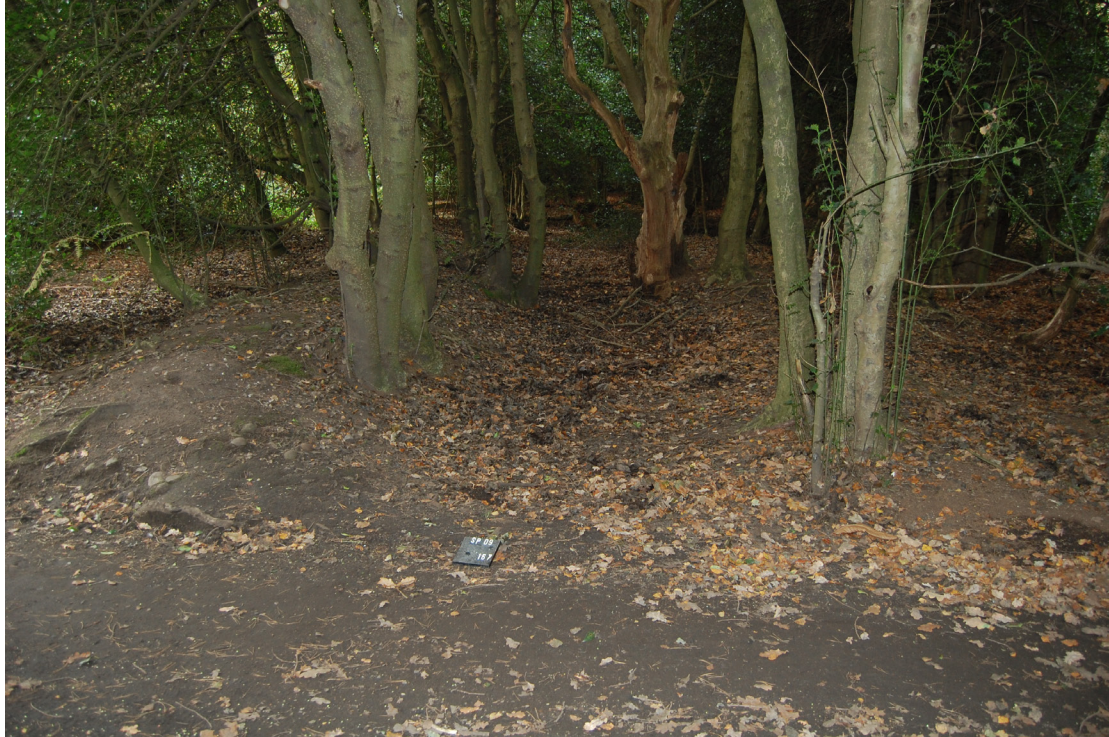
Fig. 33: Site 159

Notes: **Good example of park boundary. Totalling 9m across double bank and ditch.**

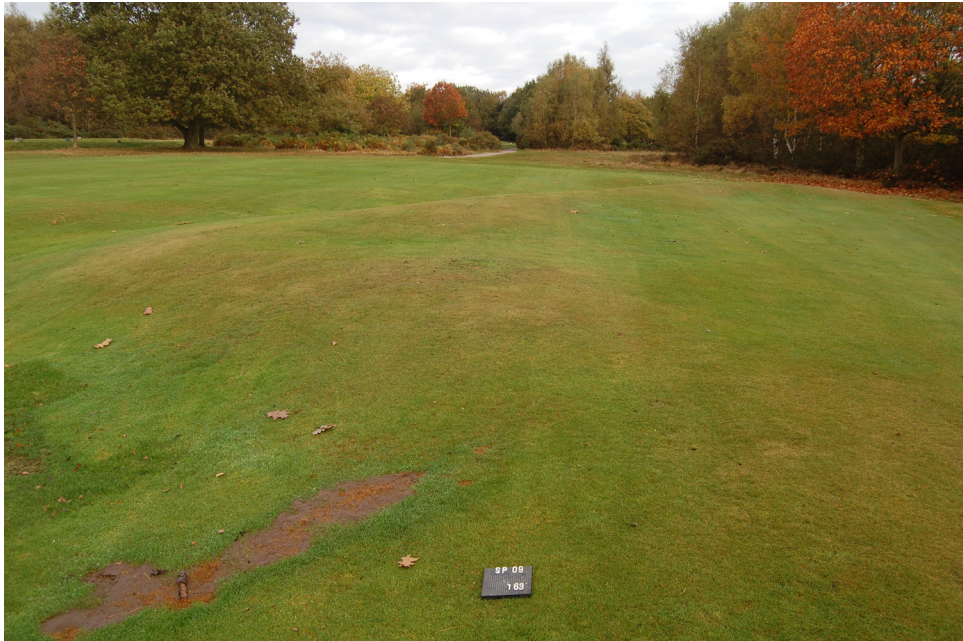
Fig. 34: Site 163

Notes: **This appears to be a golf course feature but the golf club say it is not so it may be a feature that had been incorporated into course. It is a smooth bank forming what could be one half of a square or rectangle with round corners. It is square on to Ryknild Street - could it be remains of a signal station? If so, nationally important - possible candidate for excavation.**

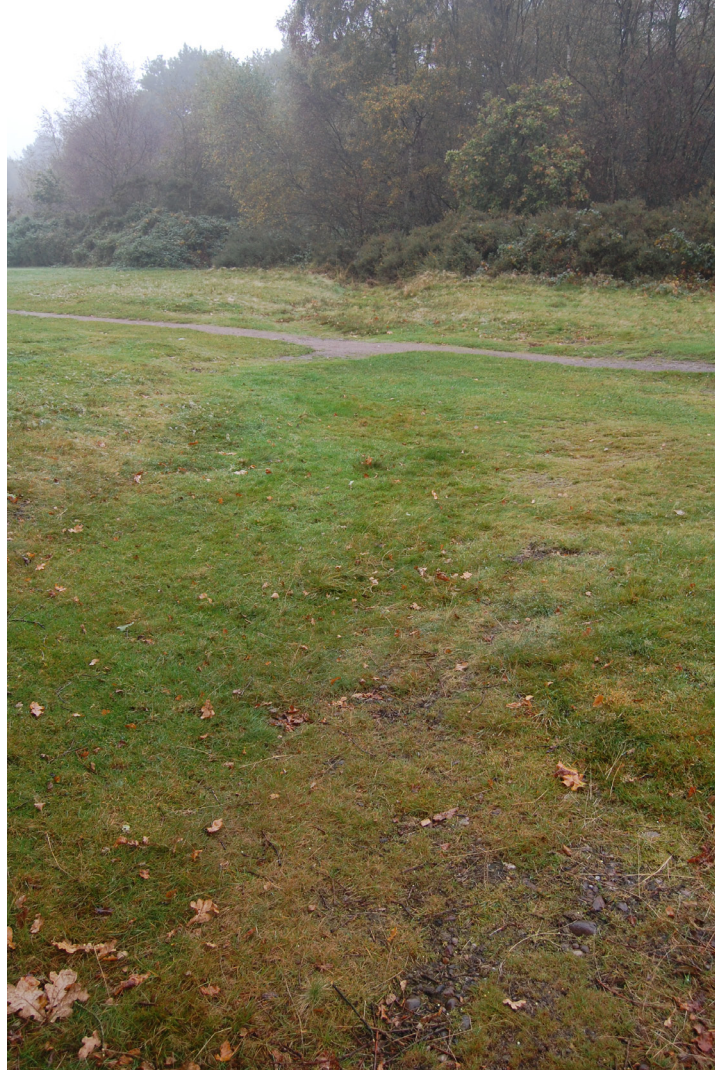
Fig. 35: Site 164

Notes: **Ditch running SW- NE across an area of the golf course.**

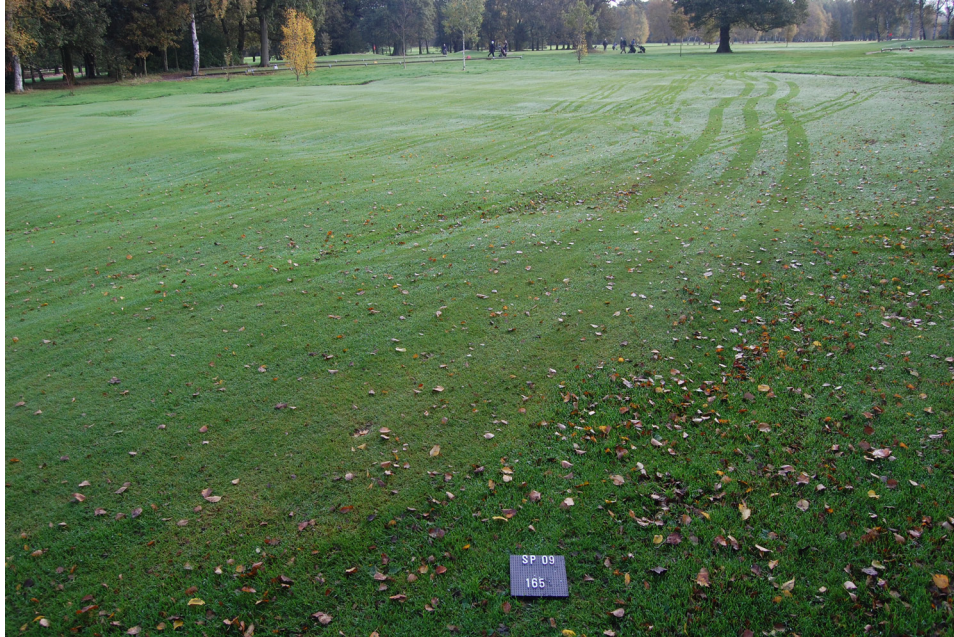
Fig. 36: Site 165

Notes: **These ridges show up very clearly on the ground.** The lidar suggests they run parallel (within?) field boundaries on first edition maps, they show up very well on aerial photo where the ridges in the north-east of the area can be seen to run at right angles to the rest, suggesting a former field boundary (Bing maps 2009).
