Archaeological Ground Survey of Sutton Park, Birmingham

Report 0957

December 2009

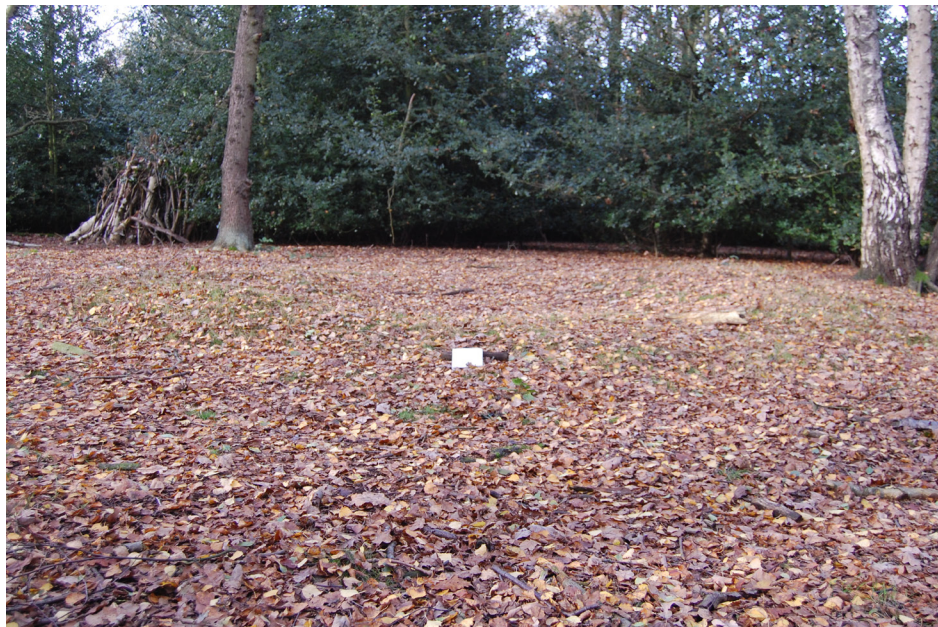
Fig. 37: Site 166

Notes: **Small banked pit north of feature 9. Possible white coal kiln/Q pit.**

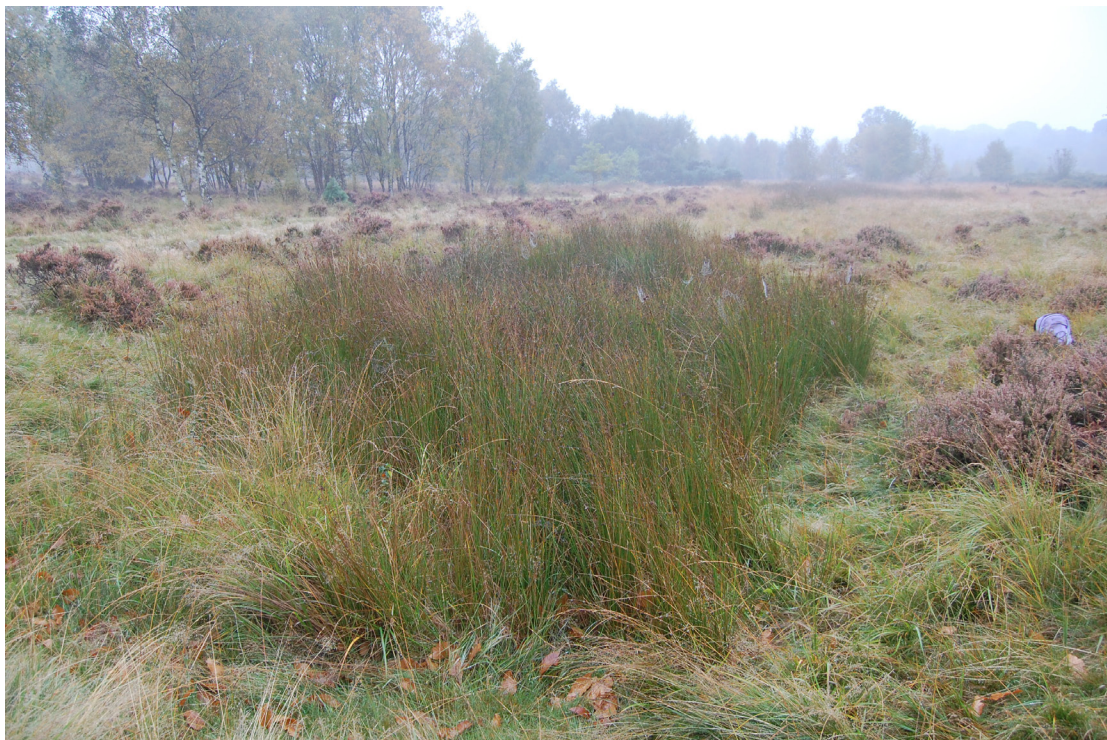
Fig. 38: Site 168

Notes: Long oval quarry pit.

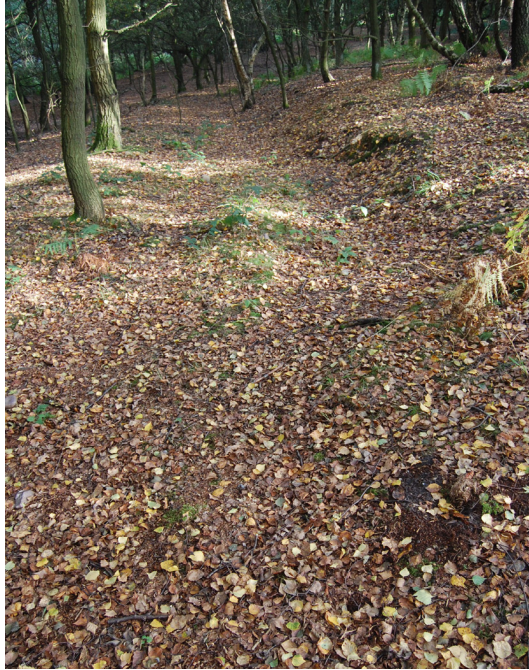
Fig. 39: Site 171

Notes: Hollow way going down hill from car park area towards stream/drain.

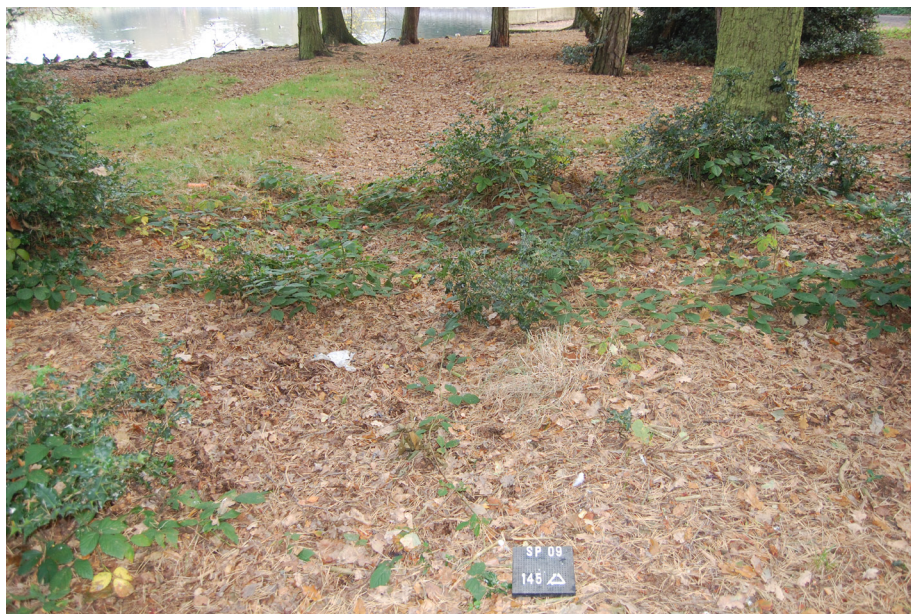
Fig. 40: Site 172

Notes: **Very well-defined series of ridges identified on the ground but can also be seen on lidar.** NB number on number board refers to adjacent site 145.
