JOHN MOORE HERITAGE SERVICES

**ARCHAEOLOGICAL WATCHING BRIEF**  
**DURING TRIAL PIT EXCAVATION**  
**AT**  
**ST MARY MAGDALENE CHURCH,**  
**WOODSTOCK, OXFORDSHIRE**

**FEBRUARY 2016**

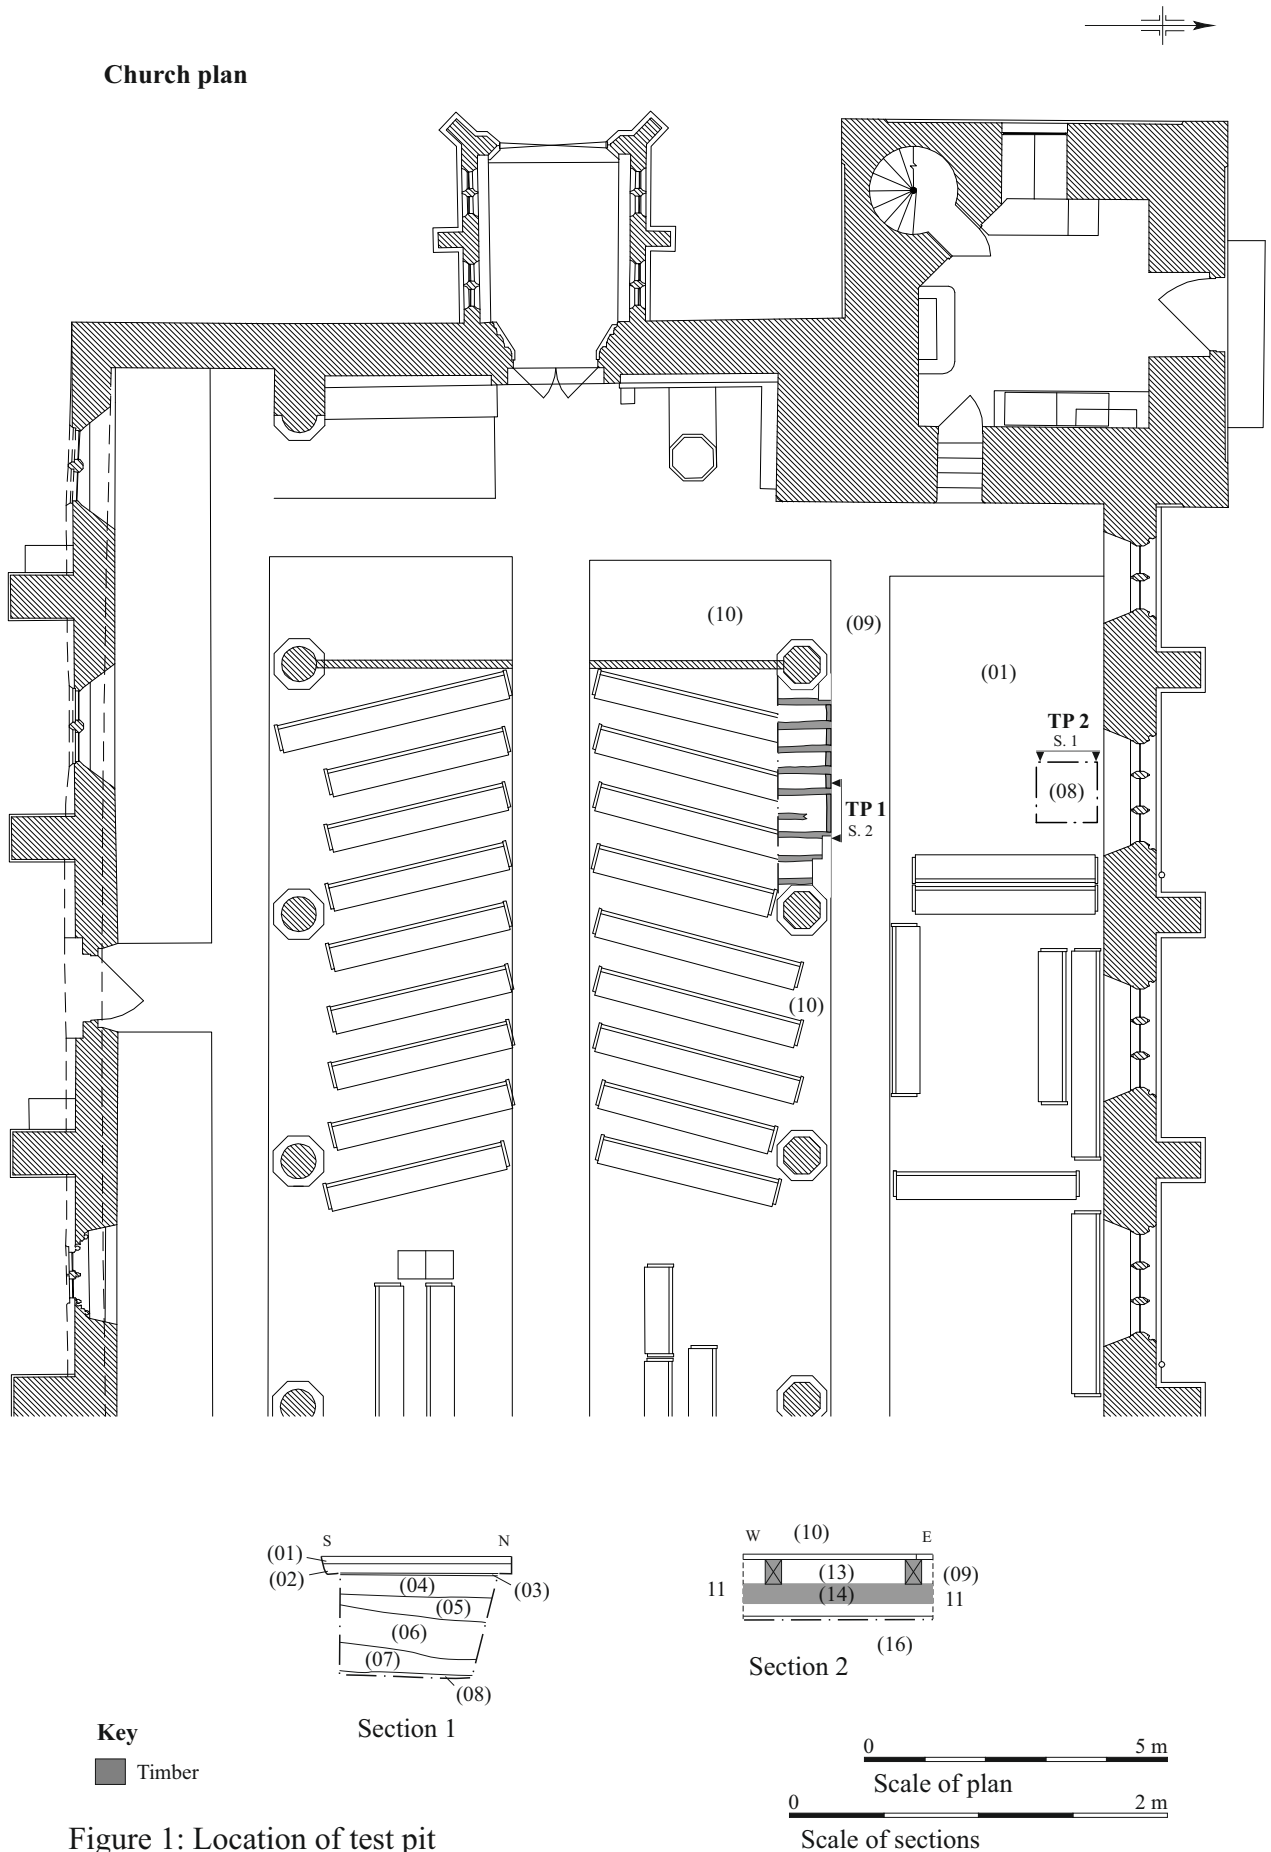
Figure 1: Location of test pit

The trial pit was situated in the north aisle, against the lateral wall. Aligned with this one, another test pit was to be centred between the first two northern pillars of the nave, right after the entrance. However this was not necessary, see below.

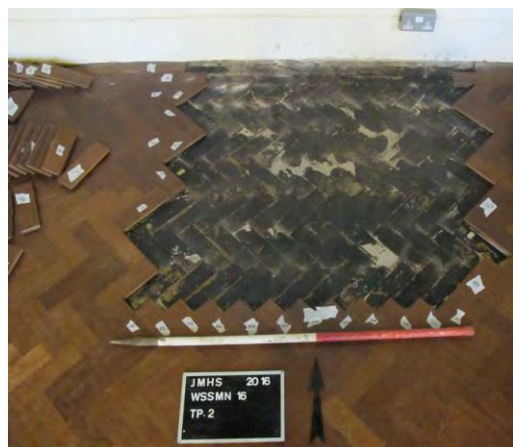
The first stage of this excavation consisted of individually marking the wooden floor tiles (**Plate 1**), so that they could be repositioned at the exact same place after completion of the job. As hard surface were encountered below, contractors had to use heavy duty drill to pierce through top layers. Subsequent deposits were removed using mattock, bar and shovel.

Plate 1: Wood tiles marked and removed Plate 2: Section 1

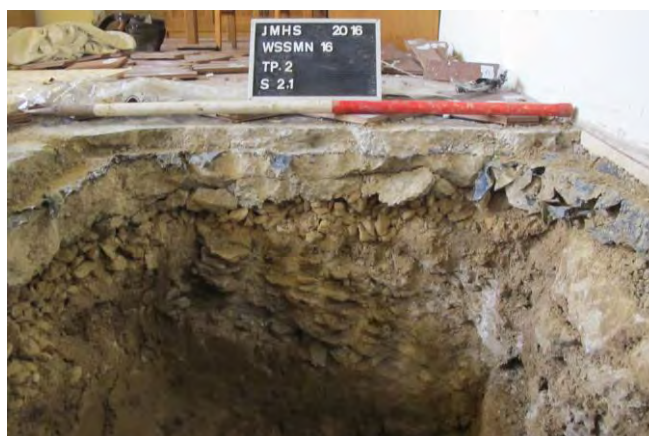
As the north aisle was erected by A.W. Blomfield only in 1878, with no surprise, the first test pit (TP2) proved to be archaeologically negative. The intended air duct was not encountered and certainly lies further west. The floor (1) of this aisle consisted of wood tiles (76 x 220mm, 20mm thick), glued to the underlying concrete (2) by a thin bitumen binder. That concrete, 50mm thick, overlaid another 120mm thick concrete layer (4). In between lies another 2mm deposit of bitumen (3). Beneath, a levelling layer (5) was encountered made of yellowish/light brown unsorted sub-angular limestones (10-150mm) with yellowish brown sand. Below that a hard layer of grey limestone was found, whose thickness reached up to 300mm. We were uncertain whether it was the top of the geological deposit, an outcrop of marble Forest Formation, or part of the north wall foundation as it becomes thinner towards the south. Underneath was a mid-brown clay deposit (7), containing no inclusions and presumably undisturbed that might be part of the geology. Up to 220mm thick, it overlays another limestone layer (8), which was not excavated. This trial pit was 650mm deep, enough to ascertain the composition of the church ground.

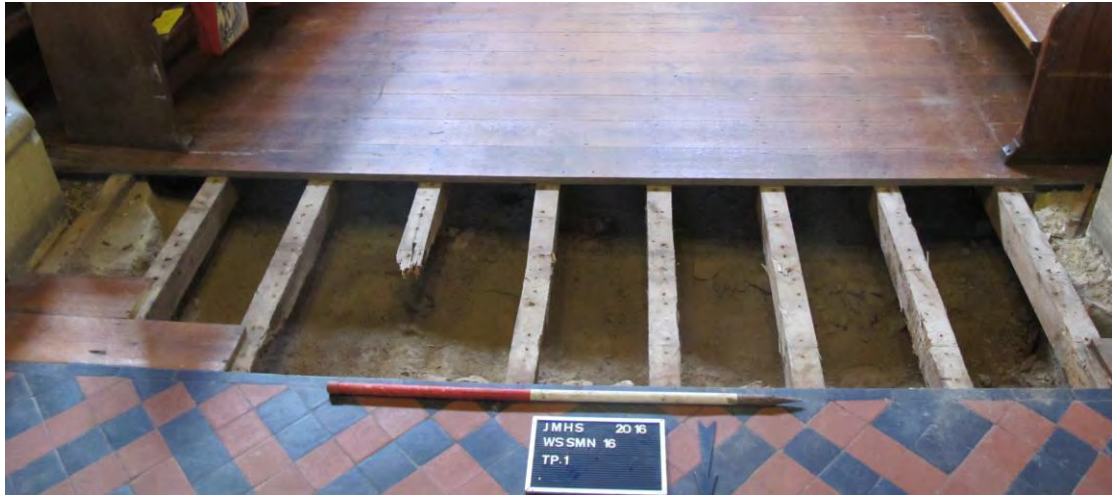
The second trial hole (**Plate 3**), between two pillars of the nave, originally planned as a one square meter hole, was finally more widely opened so that the contractors and architects had a better idea of the state of the joists supporting the actual floating floor. As a gap between the floor and the ground underneath was observed and was declared sufficient for the needs of the further renovation of the floor, no excavation was necessary there.

The other trial hole (TP1), approximately 3.15 x 0.88m, revealed the substructure of the actual church floor. The floating floor (9), made of wooden laths (30mm thick for 180mm wide) rest on an array of north-south equidistant joists (11), measuring 80 x 100mm in section. This timber frame then lies on an east-west timber beam (14), measuring 110 x 180mm in section, visible underneath the junction of the walkway tiles and the wooden floating floor, between the pillars. Below the timber beam is masonry made of possibly cemented ashlar stones (15). Below is a yellowish powdery mortar (16). This is probably a base for a tiled/paved floor that existed before the Victorian reordering of the church. The mortar surface is 330mm below the top of the existing floor.

Plate 3: General view of trial hole 1
