**Former Queen's Hospital Buildings, Bath Row  
Edgbaston, Birmingham**

**Historic Building Assessment**

**September 2007**

Chris Hewitson  
(Birmingham Archaeology)

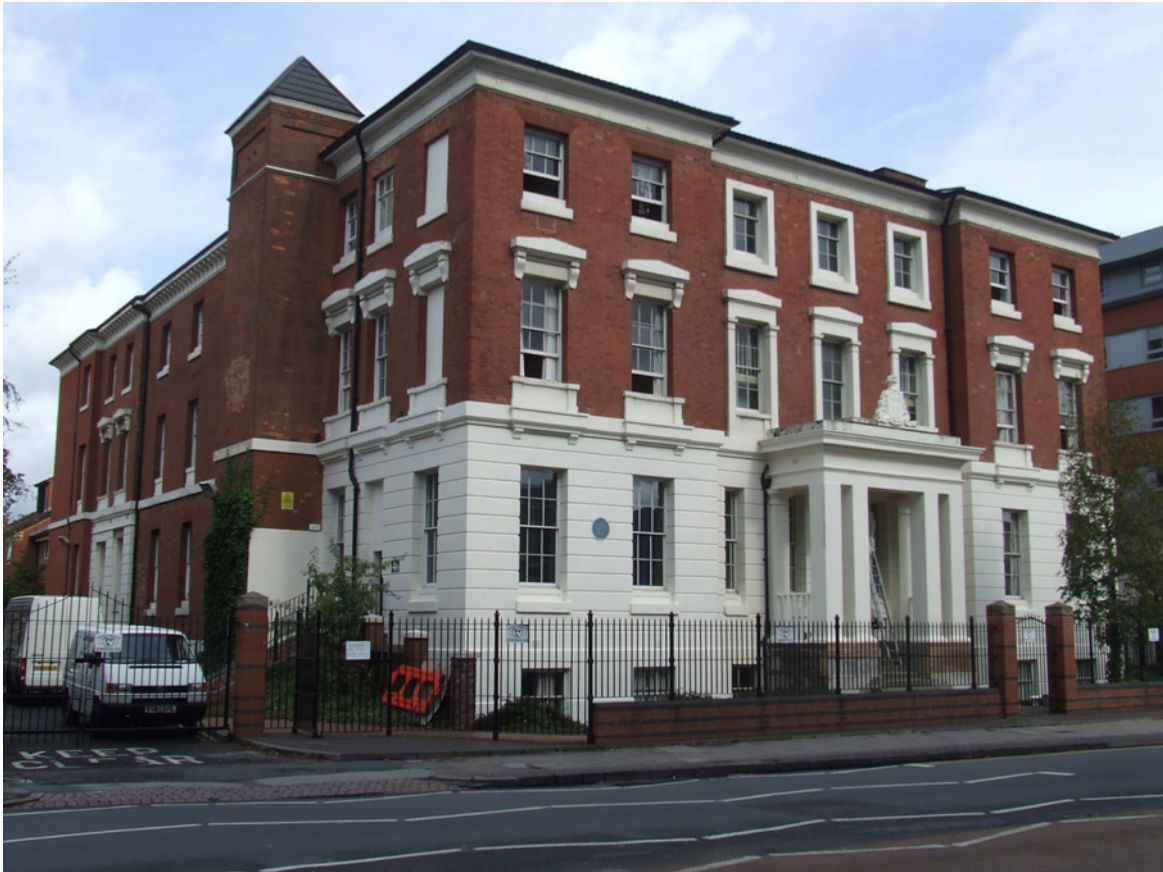
- 6.1.2 In the centre of the ground floor was a large, stuccoed, tripartite square-pier portico with a flight of steps leading up through the centre bay (Plate 1). It had a deep, plain entablature with projecting cornice and blocking course surmounted by the coat of arms of the Rev. Dr. Warneford.

**Plate 1:** Block K, street (south) elevation.

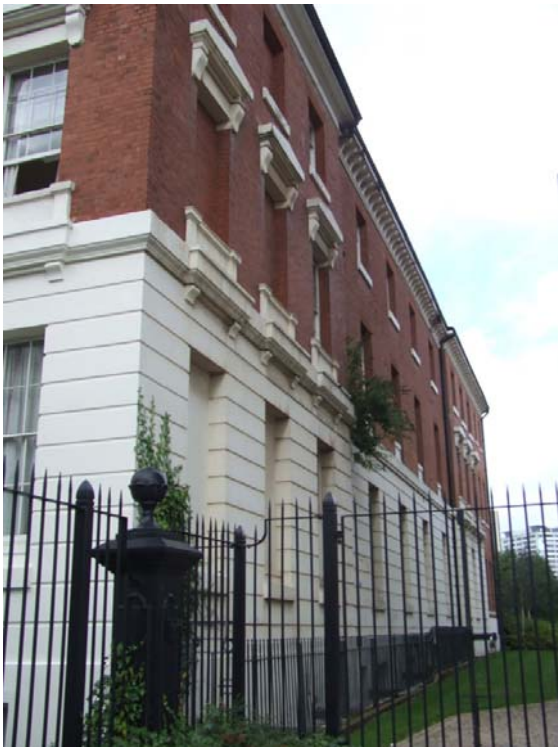
- 6.1.4 The visible western and eastern façades maintained the composition and form of the principal façade; the windows on the eastern façade however were blind (Plate 2). The rear (northern) façade was plain and had larger windows in a less uniform fenestration pattern (Plate 3).

**Plate 2:** Block K, east elevation, oblique view.

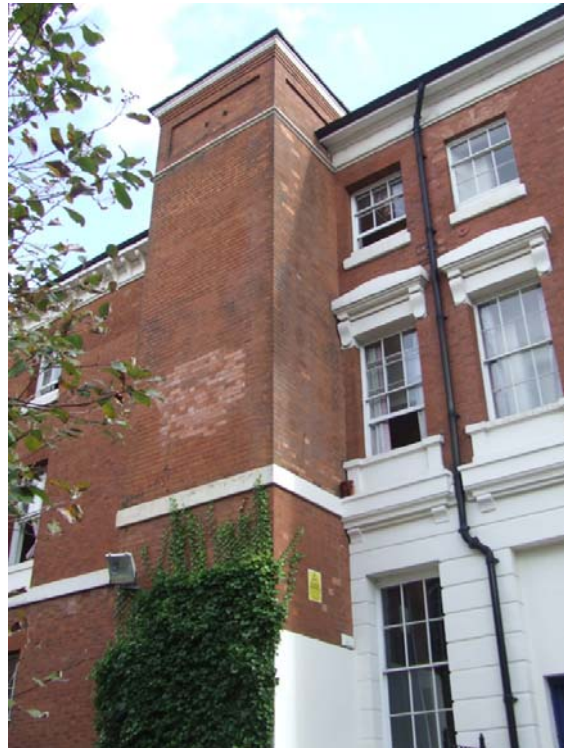
- 6.1.6 The western wing was stylistically identical to the eastern wing. The northern two bays were part of a later (20<sup>th</sup> century) addition. A square tower with hipped roof had been appended to the western façade (Plate 5). The eastern façade within the courtyard was embellished by the addition of a two storey, three bay applied stucco surround with blind central light on the first floor (Plate 3). It served no clear function and may have been purely decorative.

**Plate 5:** Block K, west elevation; secondary turret,.

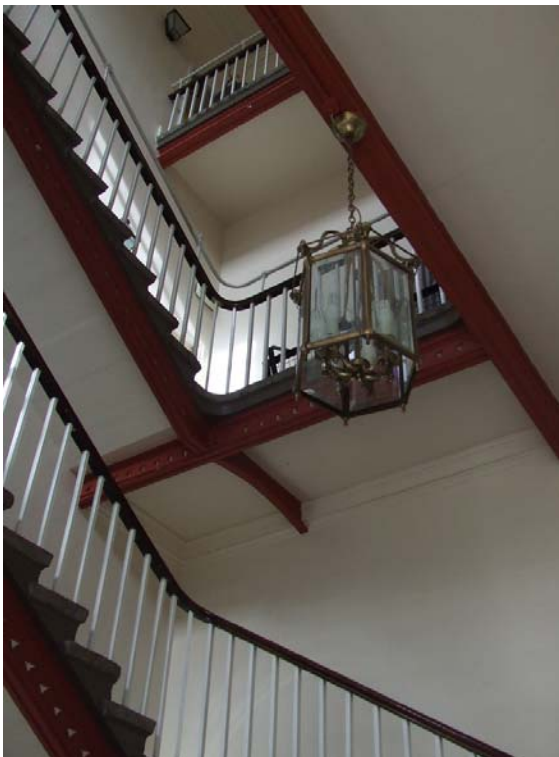
- 6.1.7 The interior of the main block was dominated by a twin, open stairwell leading from the main entrance hall to a balconied first floor landing (Plate 6). The stairwell lead from a central main stairwell before performing a three-quarter turn and continuing to the third floor in an elegant fashion. The stairwell was centrally dissected to form eastern and western flights above ground floor level, to serve the two sides of the building. The steps were of concrete on a cast-iron frame with moulded wooden banisters and iron balusters. The hallway floor was of set concrete, decorated with mosaic detailing set around areas of terrazzo flooring. Set around the hallway were a series of dedicatory marble inscriptions.

**Plate 6:** Block K, principal stair.

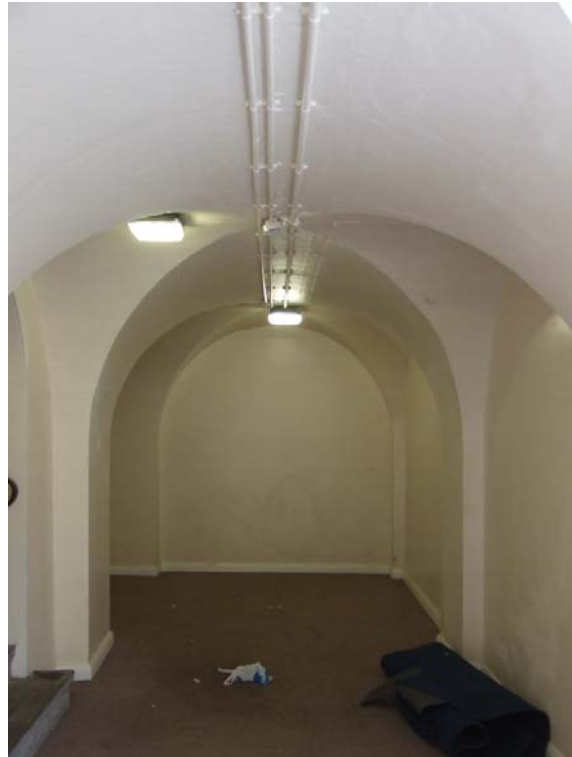
- 6.1.8 In the principal block the rooms had been sub-divided and none of the original plan survived. Those to the rear of the building had been sub-divided to create two kitchen and dining rooms for communal use. None of the original fabric was discernible, although the basic footprint of the area probably related to the earlier layout. To the west and east the units were sub-divided to create a series of small en-suite bedroom/bathrooms. On the ground floor, the western end of the main block contained the warden's flat and accommodation. The remainder of the plan was uniform throughout the floor levels. The only variation in plan occurred at basement level, where access was via a quarter-turn stairwell to a barrel vaulted open space directly below the stairwell (Plate 7).

**Plate 7:** Block K, vaulted basement.

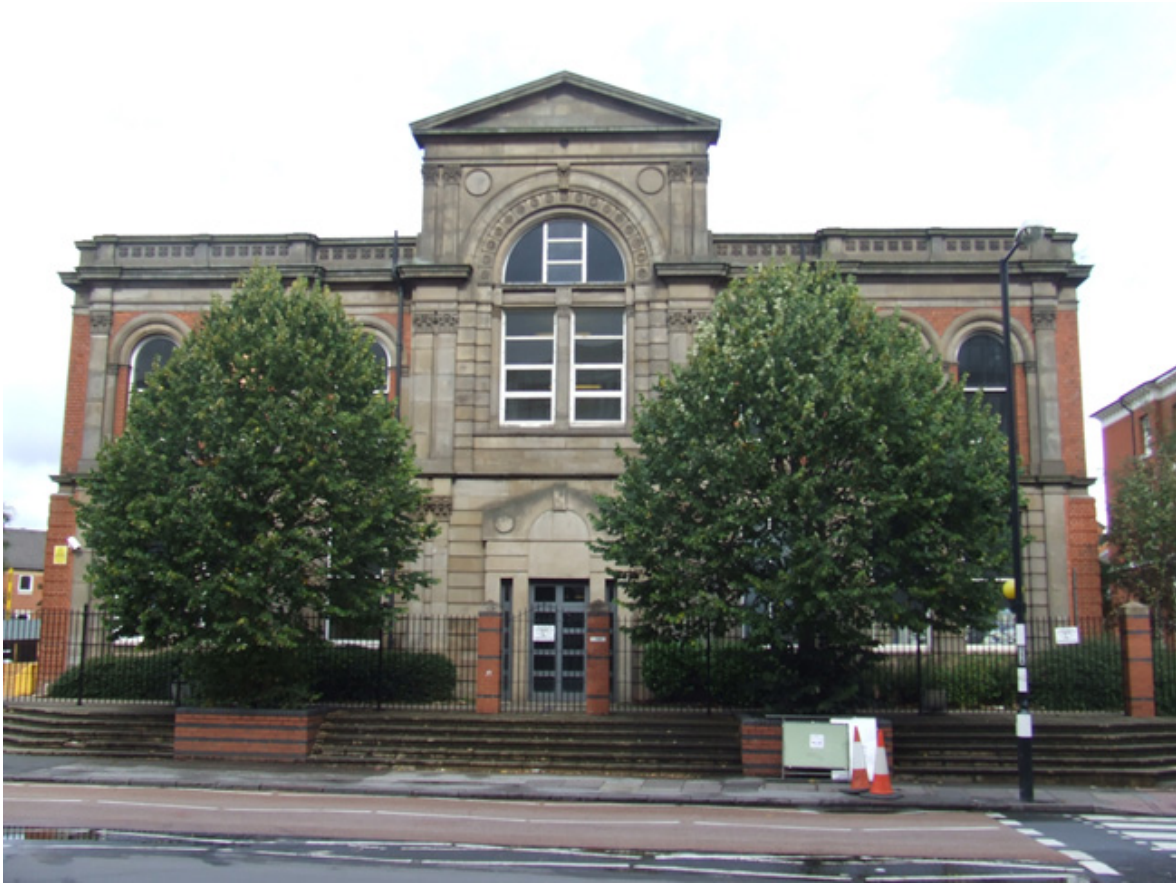
- 6.2.2. The principal façade comprised a broad central entrance bay, flanked by a pair of three-bay wings, slightly recessed to either side of the central entrance bay (Plate 8). The wings were of banded ashlar with plain, flat-arched windows to ground level and round-arched, pilastered windows to first floor (Plate 9). The central bay was embellished with superimposed orders of paired, ashlar-dressed, brick Corinthian pilasters, with single pilasters to the flanking wings. An ashlar entablature with panelled parapet surmounted the elevation, broken in the centre by a pilastered attic storey with pediment, enclosing a tall 2-light window, surmounted by a Diocletian window with decorated voussoirs (Plates 8 and 10). The ground floor of the central bay had been altered by the introduction of a cement-rendered, modernised entrance mimicking the classical surround

**Plate 8:** Block J, street (south) elevation.

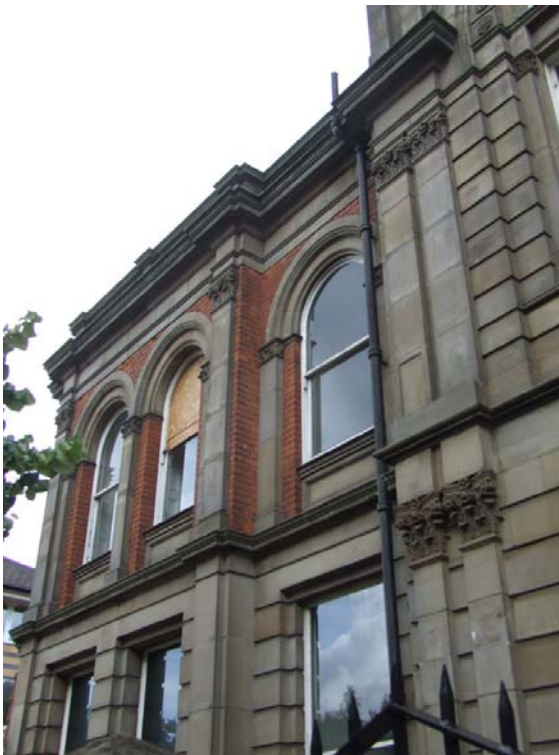
**Plate 9:** Block J, flanking bay fenestration.

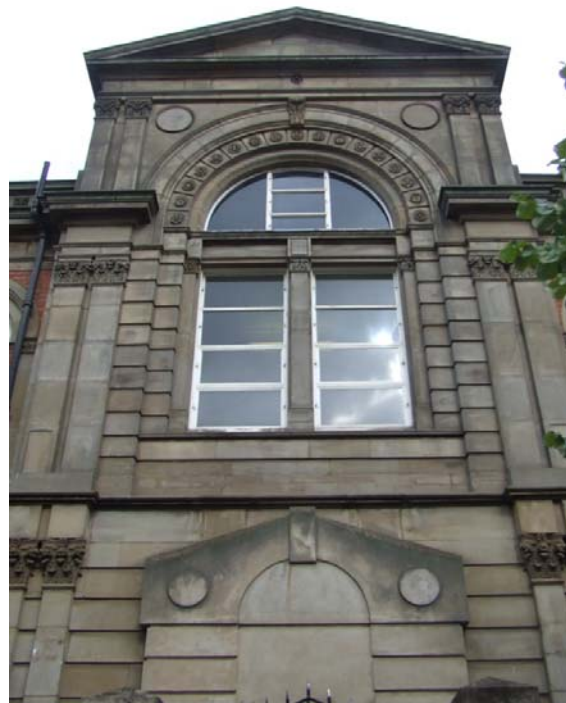
**Plate 10:** Block J, street elevation; central bay.

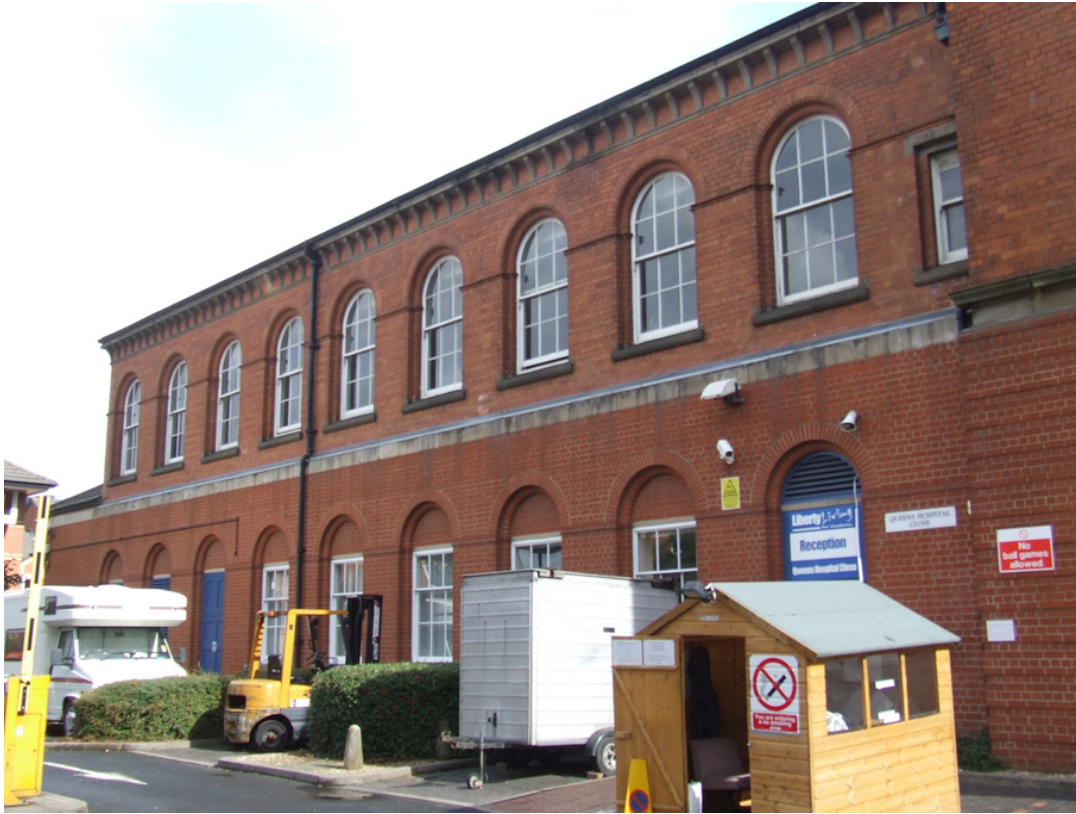
- 6.2.3. The western (Plate 11) and eastern elevations were plain in comparison. The southern end of the elevations maintained the ashlar cill-band and paneled parapet of the front façade, with a single, centrally placed window at each level (round arched and blind at first floor level). North of this, the wings were slightly recessed and displayed uniform fenestration of nine bays of semi-circular arched, 12-pane sashes to ground and first floors. The eaves cornice displayed dentilation, in common with the wings of Block K.

- 6.2.5. Restoration or alteration had occurred to the entire façade on both wings on the ground floor during the course of the 20<sup>th</sup> century (Plate 11), and this continued around to the rear of the building as two hipped-roof extensions, presumed to house electricity-sub-stations (Plate 12). The introduction of an entire new façade to the ground floor resulted from the demolition of the series of low-scale buildings surrounding the block, visible on historic maps. This is presumed to have occurred in the early 1990s when the buildings were converted to student accommodation.

**Plate 11:** Block J, west elevation.

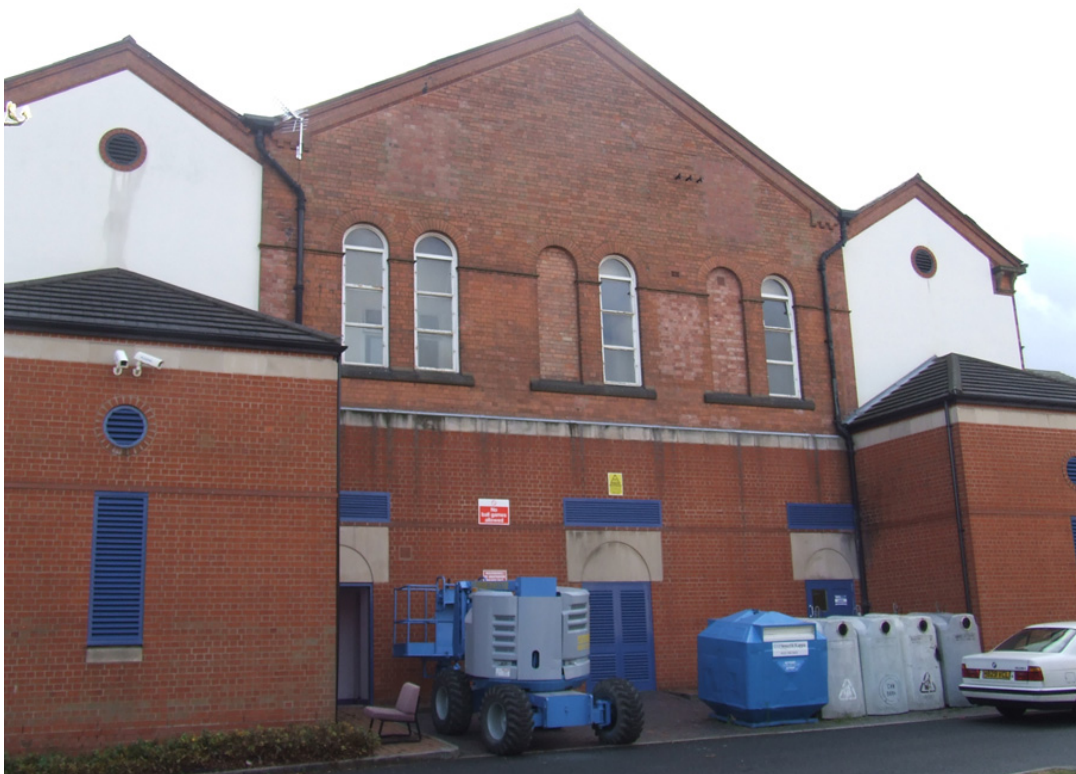
- 6.2.4. The rear façade was plain, with the east and west wings gabled either side of the gabled central block (Plate 12). The surviving fenestration was visible on the first floor as three sets of paired, semi-circular arched windows. The roof was pitched, clad in grey slate with window-lights set within the central block.

**Plate 12:** Block J, rear (north) elevation.

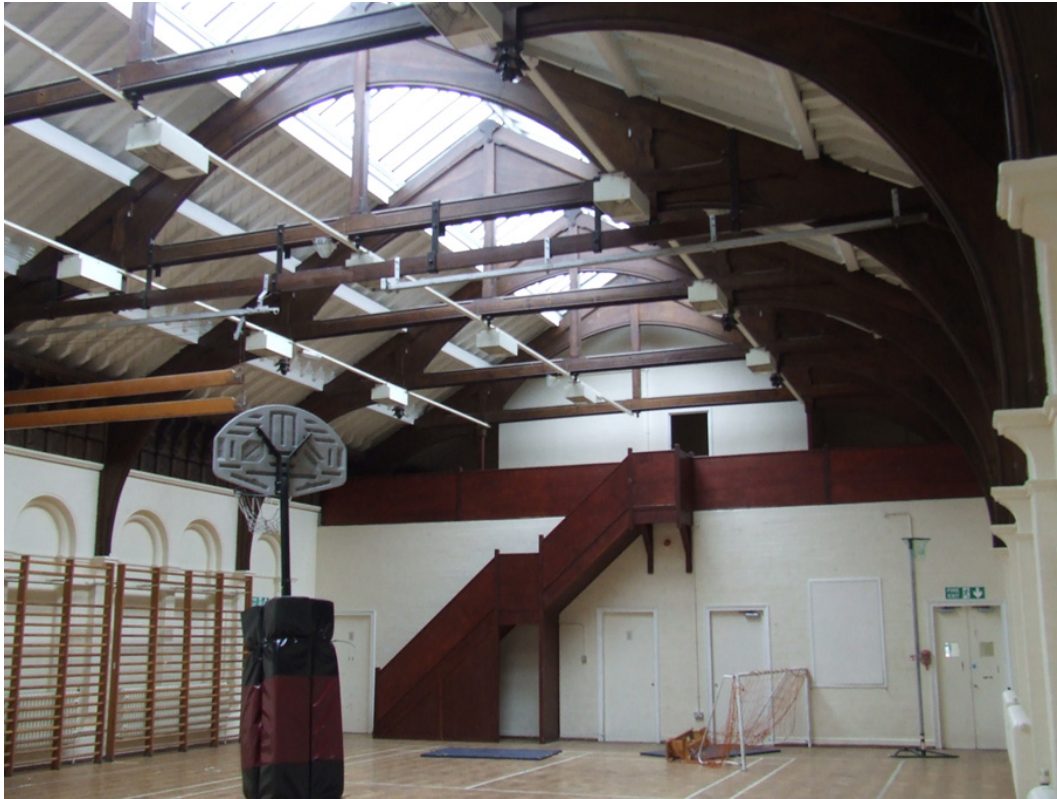
- 6.2.9 The roof was supported on a series of seven fine decorated hammer-beam trusses (Plate 13) with floral pendants hanging from below the hammer-beams (Plate 14). Between the trusses, a series of wood panels formed a frieze around the upper part of the east and west walls, above which was a parapet supported on decorated consoles. The panels were decorated with a series of inscribed floral designs, reminiscent and influenced by the Arts and Crafts movement of the later 19<sup>th</sup> century (Plate 15).

**Plate 13:** Block J, first floor, central room.

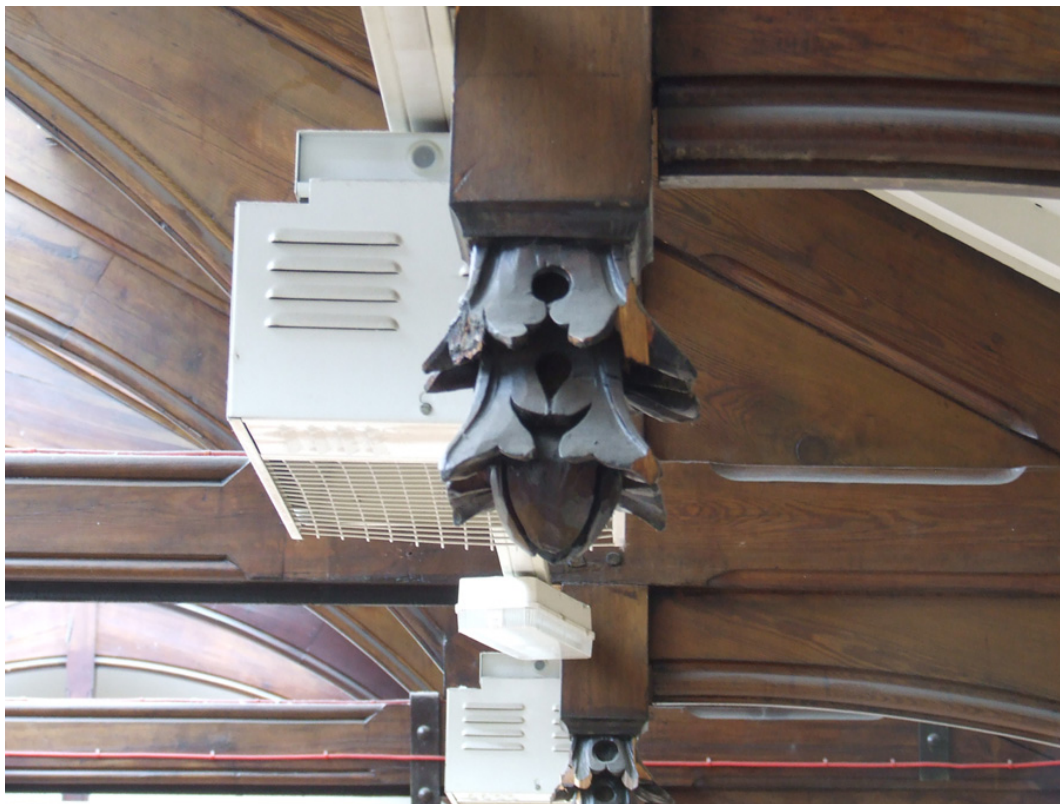
**Plate 14:** Block J, first floor, detail of carved hammer-beam pendant.

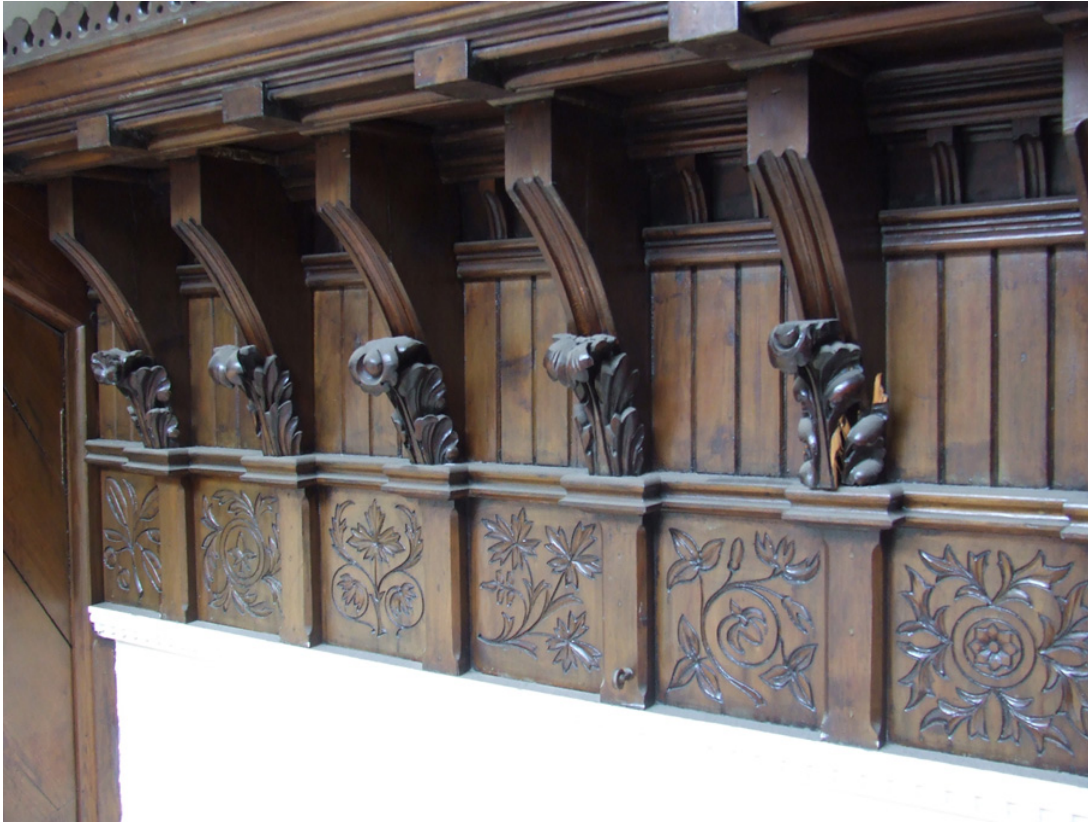
**Plate 15:** Block J, first floor, central room: detail of carved frieze.

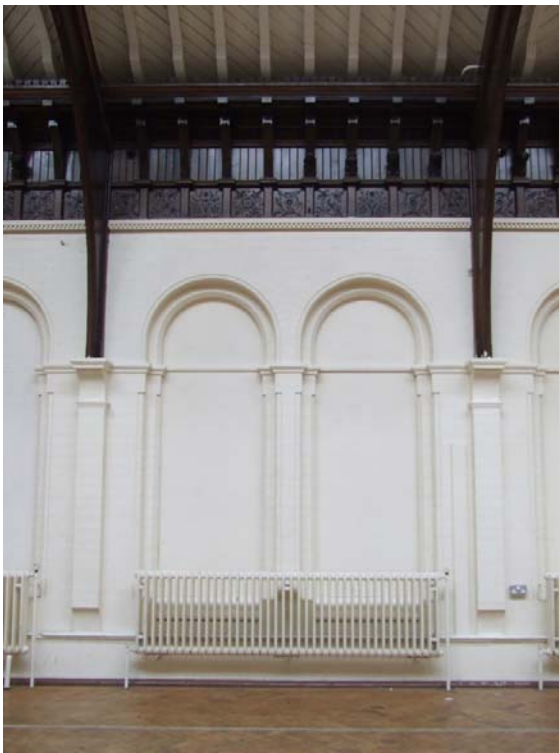
**Plate 16:** Block J, first floor, central room, blocked arcading with frieze over.
