# **Castle an Dinas, St Columb Major, Cornwall**

## **Management and interpretation works**

<b>Client</b>	<b>EH, CHT, HLF</b>
<b>Report Number</b>	<b>2011R010</b>
<b>Date</b>	<b>January 2011</b>
<b>Status</b>	<b>Final</b>
<b>Report author(s)</b>	<b>Ann Preston-Jones, Jane Stanley</b>
<b>Checked by</b>	<b>Peter Rose</b>
<b>Approved by</b>

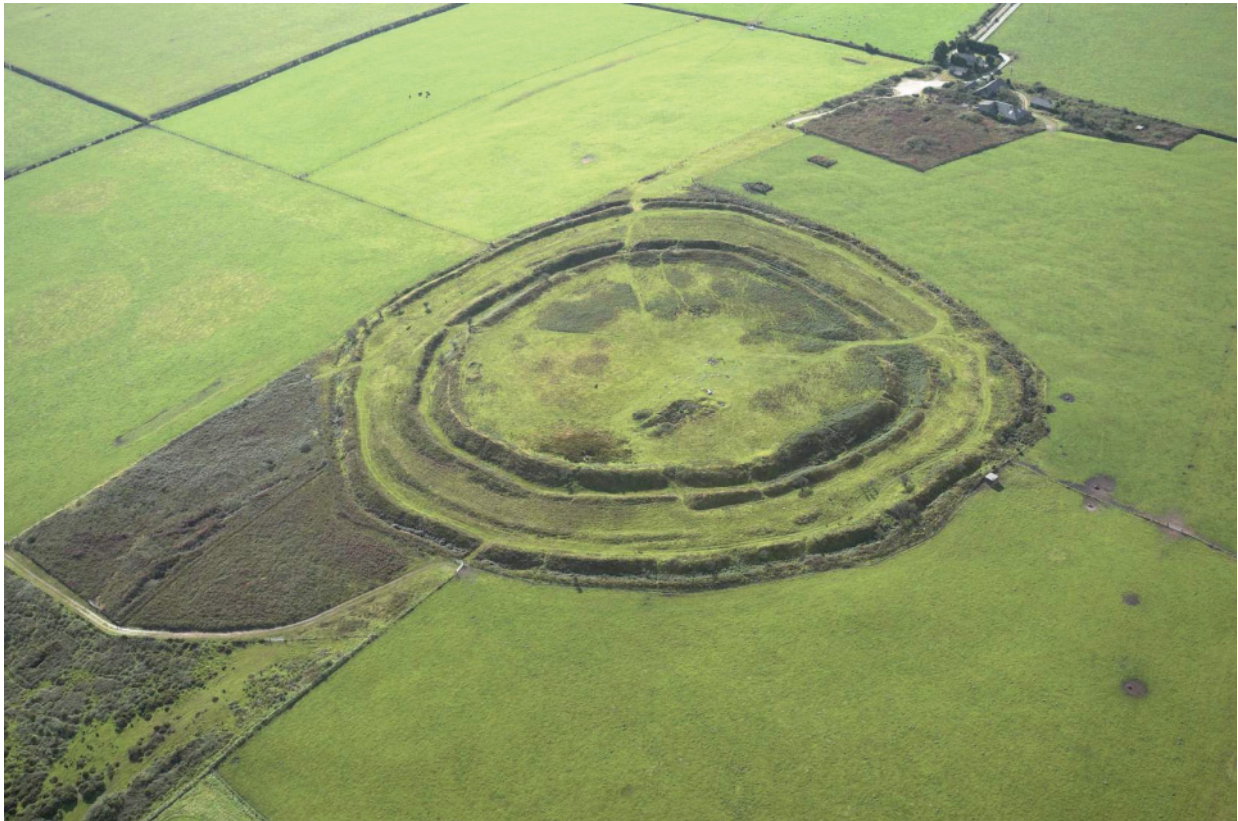
Fig 4 Air photo of Castle an Dinas (HES AP F80-006, September 2007)

The Cornwall Heritage Trust was keen to address this and one or two other localised problems. These were as follows (Fig 4):

Material from the tank was re-used on site as the core for the reconstructed section of rampart on the south (for location, see Fig 4).

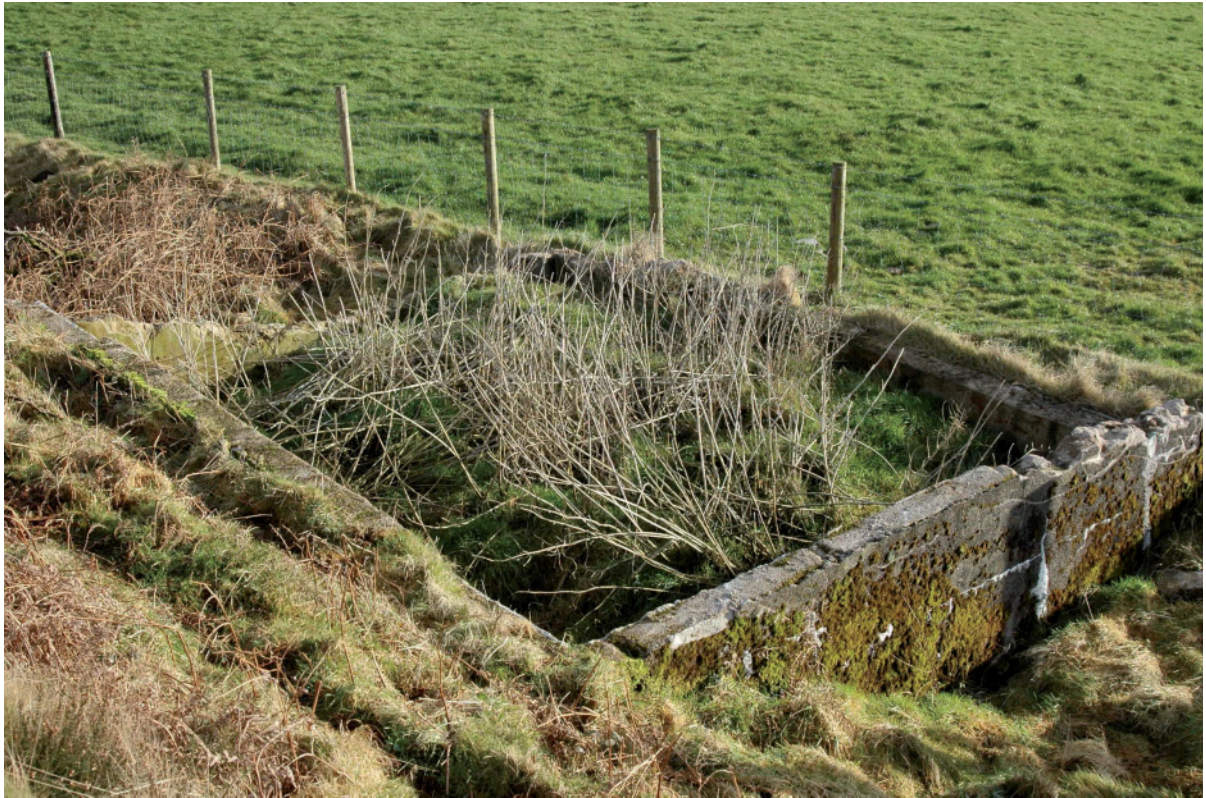
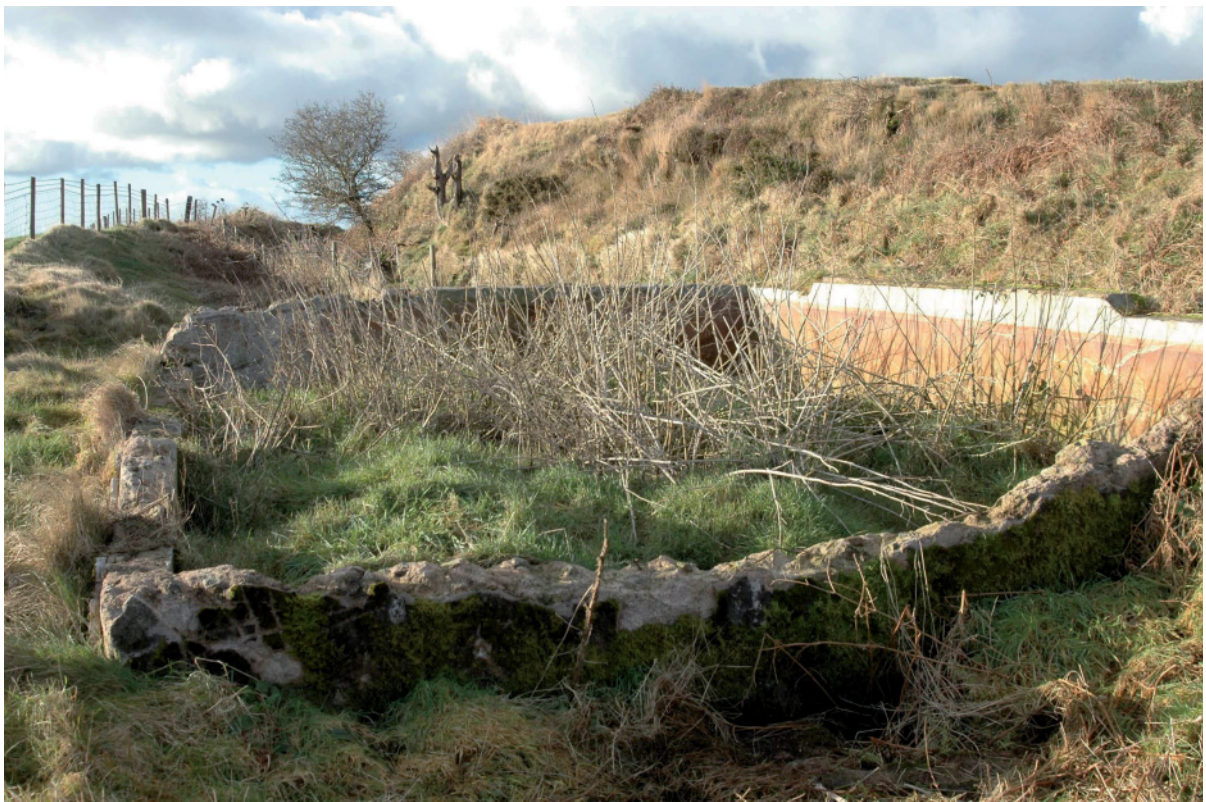
*Fig 6 The concrete tank before demolition*

- The remains of a redundant 20<sup>th</sup> century concrete tank on the outer rampart on the east represented a scar affecting the integrity of the Iron Age hillfort. This tank, which measured approximately 5 metres by 3.5 was also a potential safety hazard since at one point there was a drop of 2 metres to the interior and the broken tops of the walls had sections of metal reinforcing sticking out of them in places (Fig 6).

- Demolish the old concrete water tank, built into the ramparts on the eastern side of the monument.

The concrete water tank located in the outer ditch reflects agricultural improvement of the surrounding downs in the twentieth century. It therefore has significance in the history of the site, but is clearly not its most important attribute. The decision was therefore taken not to remove it entirely, but to leave the base in the ground and cover it over. This would have the further benefit of reducing the risk to the Iron Age ramparts that might have been posed by fully excavating out the tank.

Demolition of the tank was undertaken by John Hart on 8<sup>th</sup> February 2009; an archaeological watching brief was carried out by Dick Cole.

To minimise damage to the ground, the work was done using a tracked mini-digger (Fig 8). A tractor with trailer conveyed the demolition material to the point where it was to be used in restoring the rampart.

The tank was not completely removed: only the parts that protrude above the ground were demolished; then the resulting platform was levelled, covered with soil, and left to re-vegetate naturally. No re-seeding or re-turfing was considered necessary since the location is relatively inconspicuous.

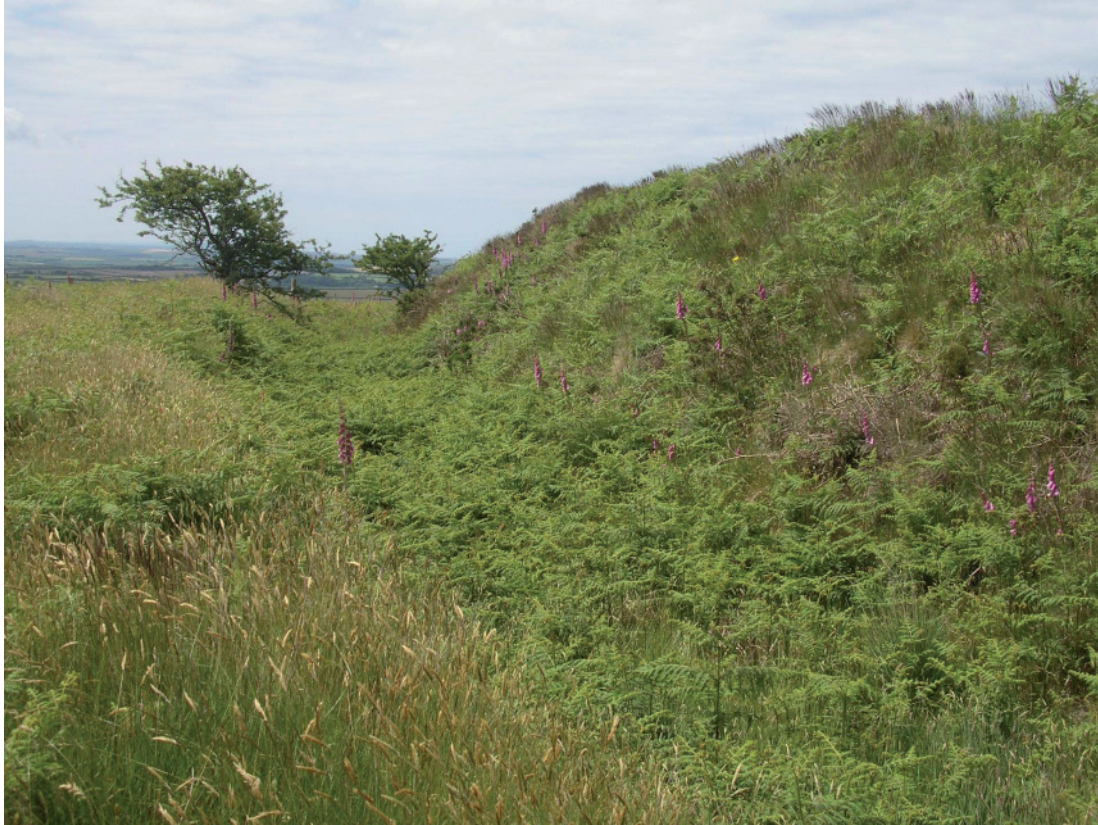
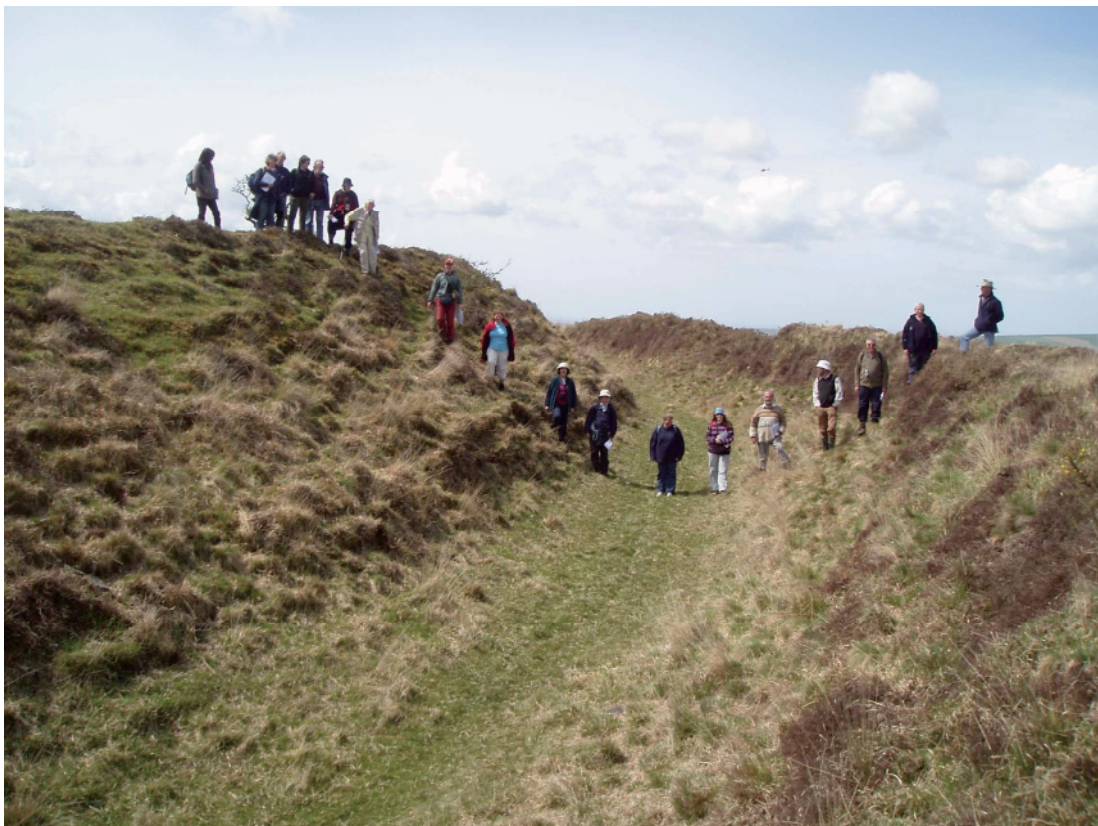
*Fig 7 Two contrasting views of the ramparts at Castle an Dinas. Above: the bracken and grass-filled ditch is far less accessible than that in the picture below, with well-managed vegetation (Photo 2: Graeme Kirkham)*

- After two years without grazing, the vegetation was in need of cutting to open up the earthworks and prevent the spread of invasive species, prior to a re-introduction of grazing (Fig 7).

Prior to scrub clearance taking place, the site was cloaked in thick grasses (Molinia-dominated), with European gorse up to a metre high general throughout the areas of Molinia. There was also some heather, a few trees and much bracken (Fig 7). Access was restricted to a few narrow paths.

The scrub clearance was carried out by Anthony Hart on three days in late January/early February 2009, using a tractor-mounted flail. As much of the site as could be reached with the flail was cut: this included all flat areas, and the banks and ditches where accessible for the tractor.

The work was highly effective: leaving the site clearly visible and fully accessible.

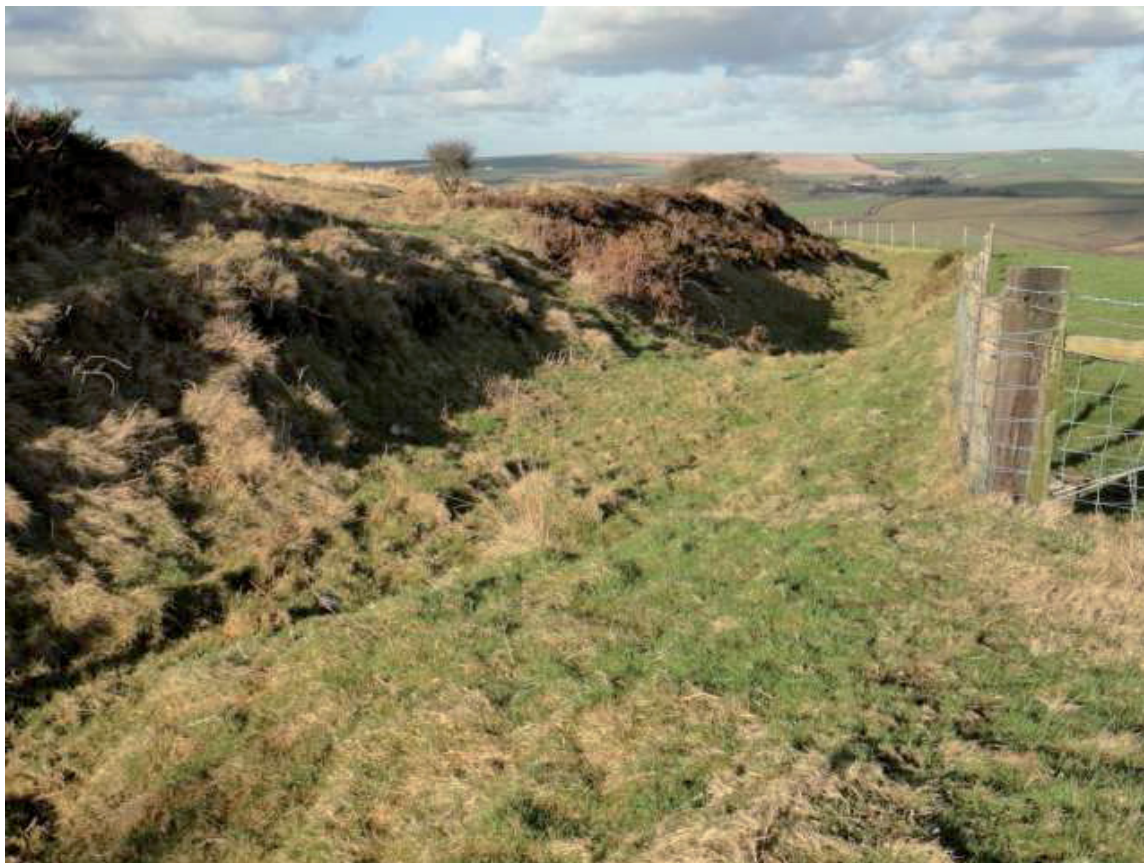
*Fig 9 The site of the tank in January 2011, nearly two years later*

Two years later, the site now appears as a rectangular grass-covered platform where the former presence of the tank would hardly be suspected. Only the level platform in the ditch gives a clue to its existence (Fig 9).

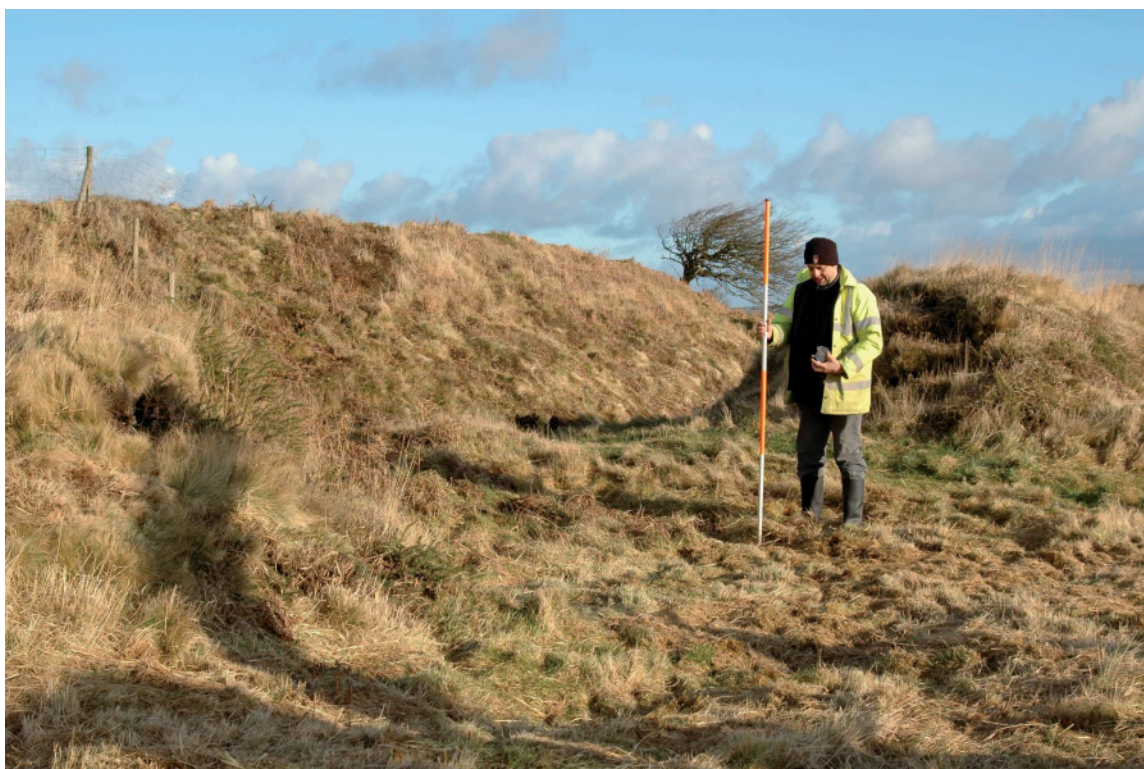
*Fig 10 The gap in the rampart on the south, before it was filled to prevent access through the gap*

- The original entrance to the hillfort is on the south-west. However visitors to the site approach from the south-south-east along the line of the track created to link Castle an Dinas mine with its processing works. Due to a 5 metre-wide break in the second rampart caused by the levelling of a section for the aerial ropeway (Fig 5); visitors have tended to follow the straight line up and over the inner rampart to the centre of the fort. This desire line, clearly seen on the air photo, Fig 3 was causing erosion at this point where both visitors and grazing stock climbed over the inner rampart to gain access to the interior of the fort.

Here, the rampart had been cut through in the twentieth century to create a level stance for one of the pylons supporting the aerial ropeway which straddled the site when the Castle an Dinas wolfram mine was in operation. However, the existence of the gap here was proving detrimental to the monument, for it encouraged visitors to the site to head through the gap and straight over the inner rampart to reach the interior of the fort, thereby leading to significant erosion to the inner rampart at this point. After numerous attempts to prevent access this way by signing and fencing and repairs to the inner rampart, it was finally decided that the best way to prevent access would be to fill the gap in.

- Use rubble from the tank to help rebuild a modern gap in the middle rampart on the south-south-east, and encourage the alternative use of the original entrance to the site on the south-west.
- Undertake scrub clearance to improve the presentation of and access to the hillfort.
- Update the interpretation of this significant site.

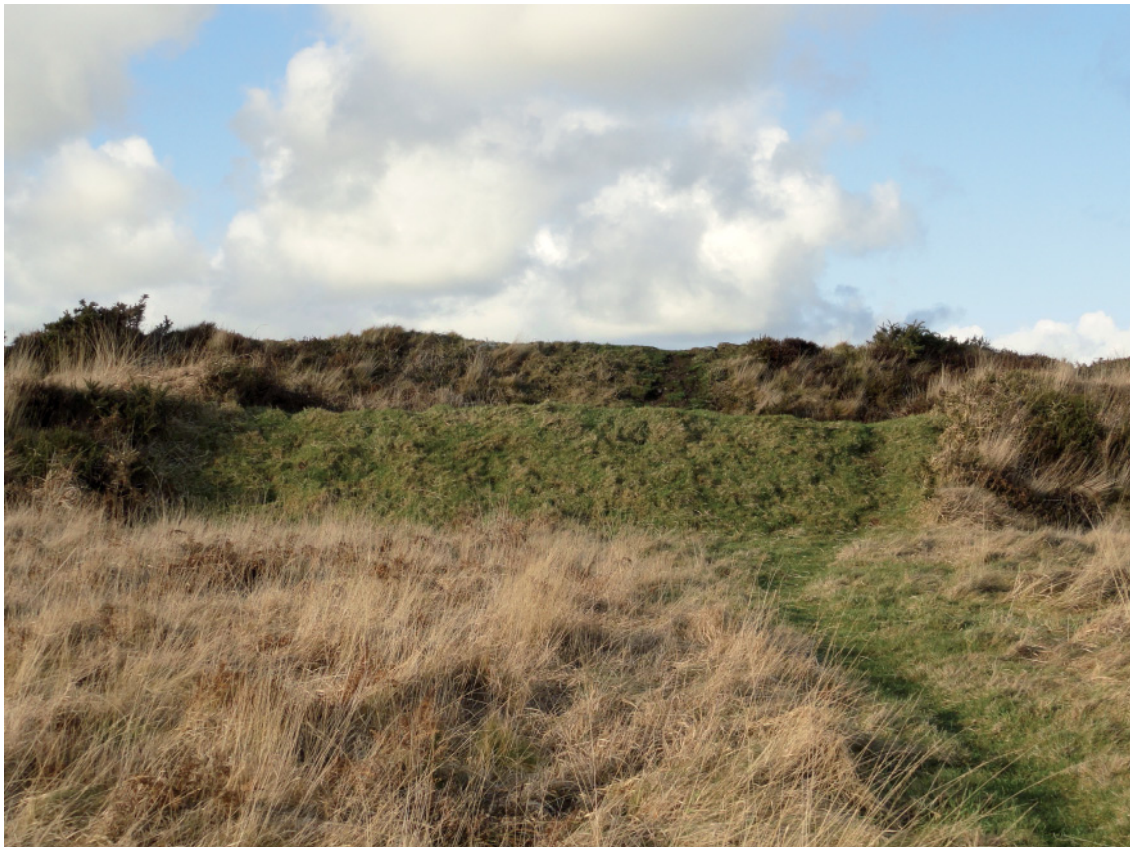
*Fig 12 The restored section of rampart two years later, in January 2011*

Two years later, the repair looks excellent and seems to be working in terms of preventing access to the top of the hill at this point. Helped also by a small sign, visitors are clearly now using the original entrance to the site. Both inner and outer faces of the reconstructed bank are fully grassed over and although this section of the bank stands out because it is very much greener than the rampart to either side, with time it will undoubtedly develop a rougher vegetation cover which blends in seamlessly. There is a slight pathway up the inner rampart beyond, but this appears to be a sheep track, rather than a footpath worn by visitors.

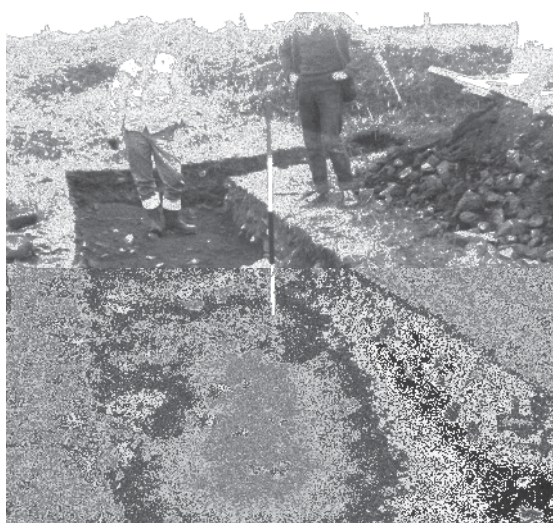
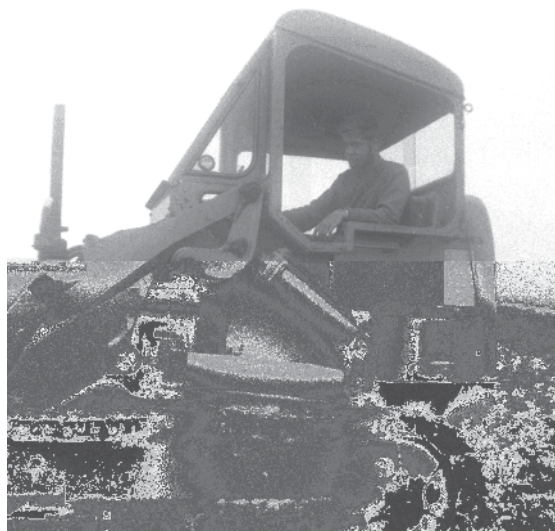
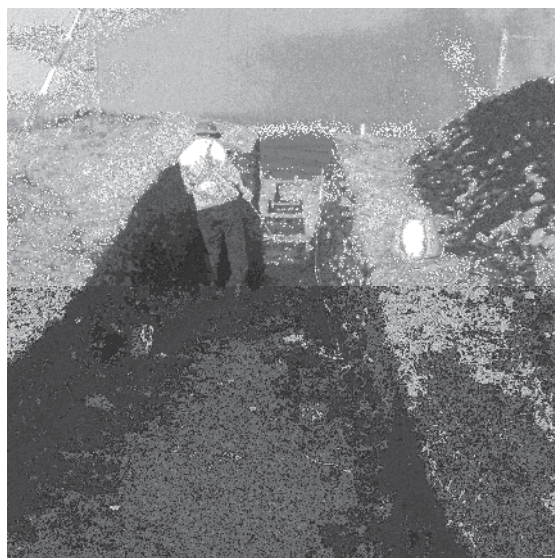
*Fig 13 To help with the reconstruction painting of the 1960s excavation Joan Taylor, who dug on the site at the time, kindly supplied a number of images, of which this is a selection*

Excavations were carried out at Castle an Dinas in the 1960s, under the direction of Bernard Wailes of the University of Pennsylvania. He examined the ramparts and parts of the interior, in three seasons of work. The finds, which included sherds of Iron Age pottery and rounded pebbles, possibly sling stones, were few, suggesting that the occupation here had been only short-term. Photos and information helping with this illustration were kindly supplied by Joan Taylor, FSA, who helped on site in the 1960s (Fig 13).

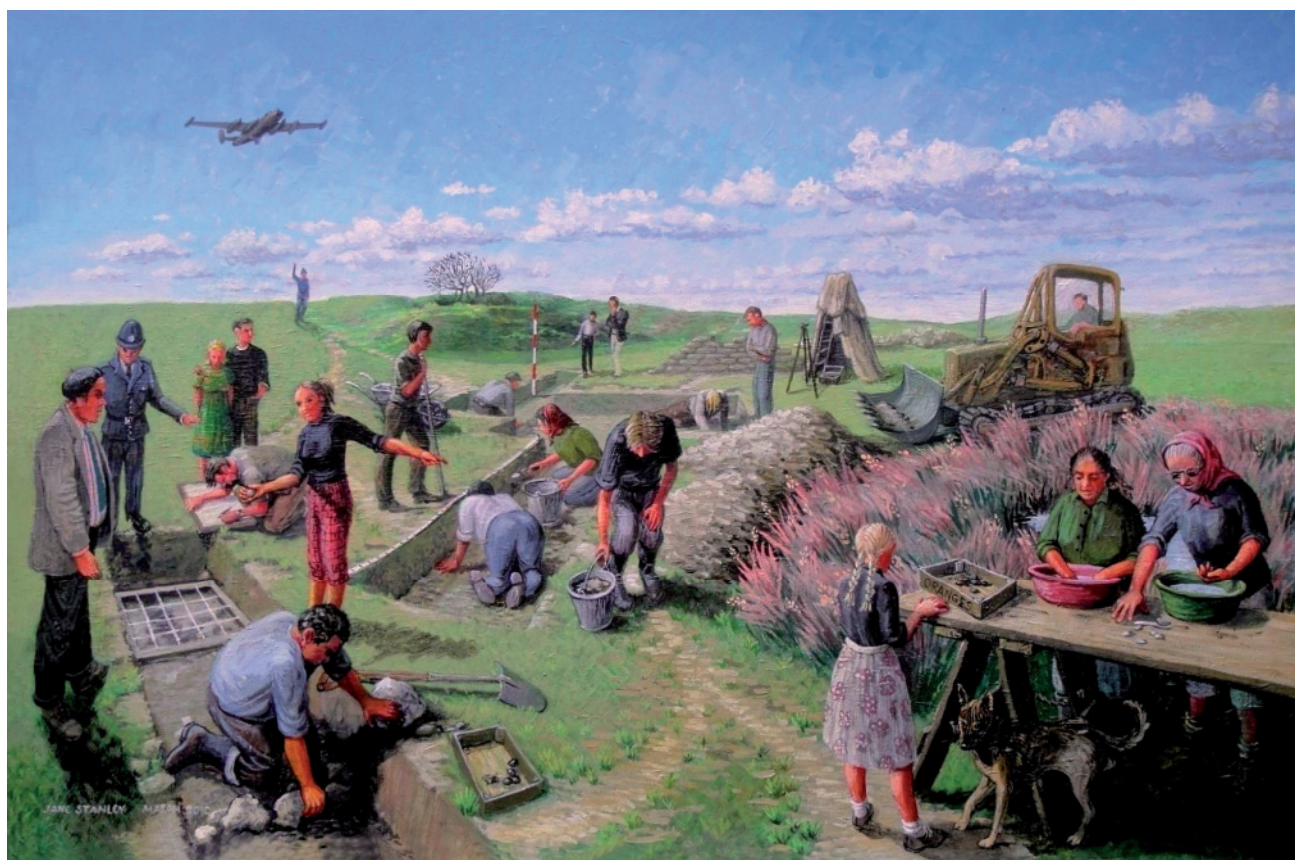
Fig 17 Excavation at Castle an Dinas under the direction of Bernard Wailes in the 1960s
