Roche Holy Well, Cornwall

Consolidation work and archaeological recording

August 2007

Report No: 2007R056

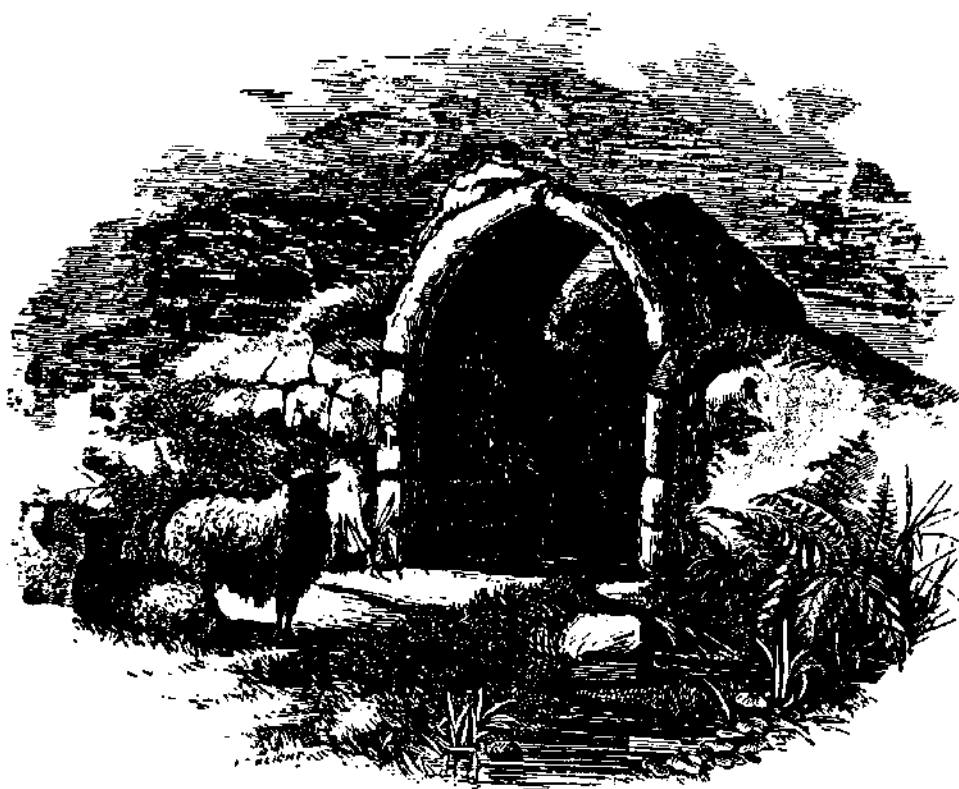
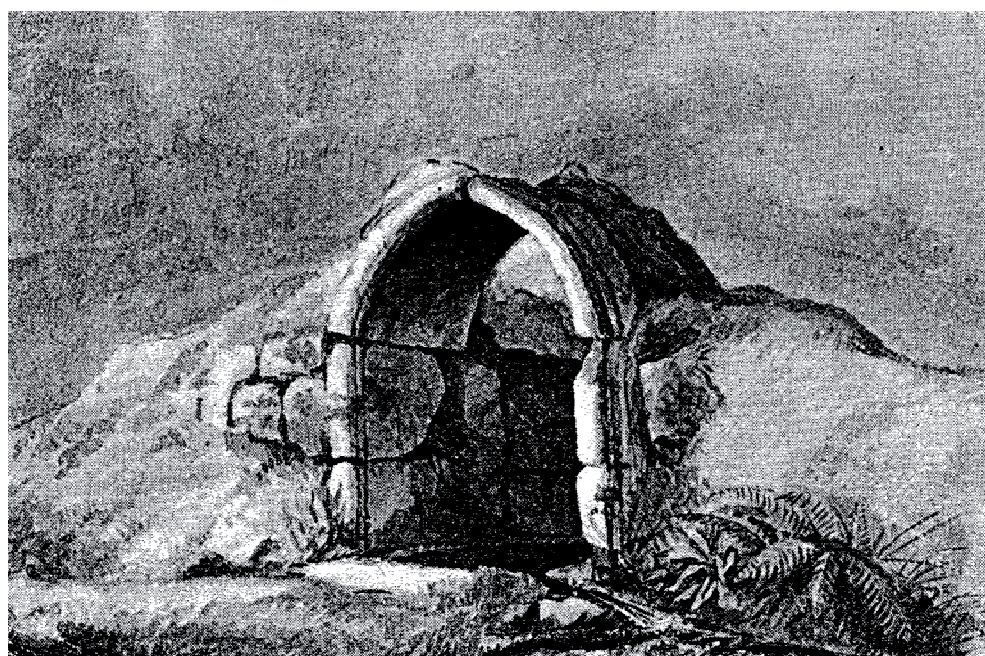
An illustration by M and L Quiller-Couch from 1894 shows that in the late 19th century the well house stood three courses of stone high, with the roof area open to the sky (Fig. 6). In the accompanying text in their publication, they also make reference to the chapel.

Figs. 5 and 6 Roche Holy Well drawn by Blight in 1858 and Quiller-Couch in 1894.

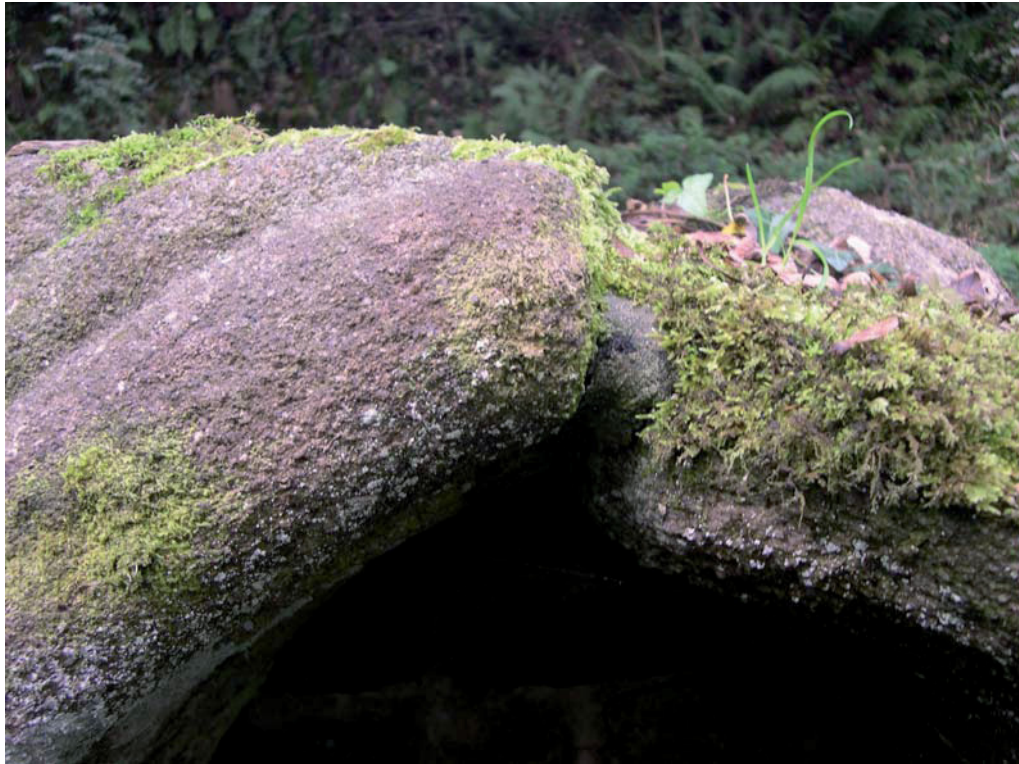
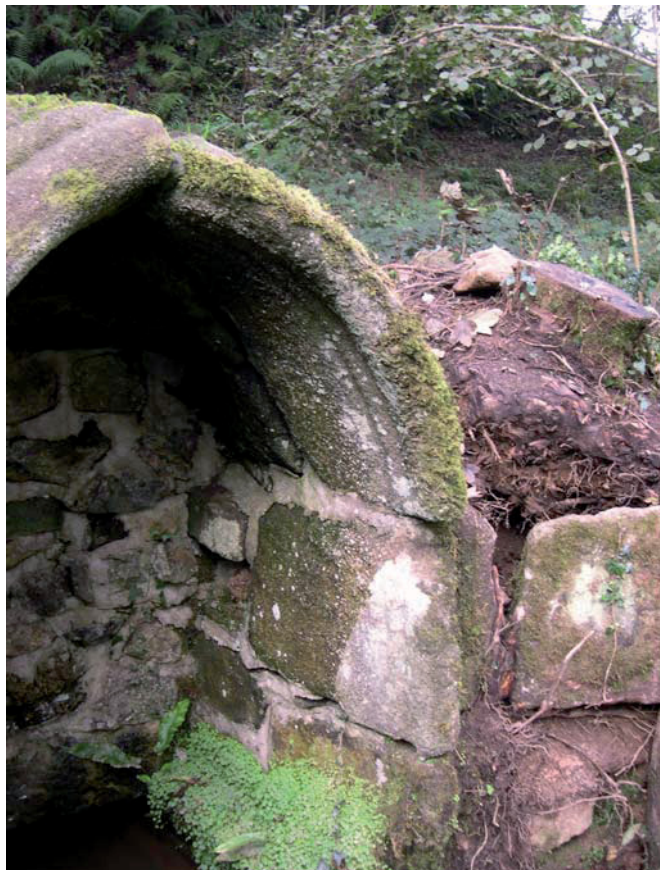
“The stones forming the arch have moved and there is concern about the overall stability of the arch ... the arch is formed of a single stone on the left side and two stones on the right. In addition to vertical movement of the stones, the left hand stone has also rotated in plan. There now appears to be minimal contact between the stones at the apex of the arch ... further movement of the arch is possible which is likely to result in the arch stones falling to the ground.

Figs. 9 and 10 The stones forming the arch showing how they have shifted and one of the arch-stones standing on a decorated jamb-stone.

“The stability of the arch could be improved by packing mortar into the joints but the improvement would be minimal and is unlikely to significantly improve the long-term stability.....In my view it would be better to take down the stones and rebuild them in their correct position. Any future movement could be controlled by introducing stainless steel dowels (12mm diameter) connecting the base of the arch stones to the supporting stones. The joints should also be mortared to ensure full contact between the connecting surfaces of the stones.

At this point, Darrock and Brown carried out the consolidation of the well house structure in line with the methodology proposed by Keith Weston (Figs. 12 and 13). The cement pointing that had been added to the monument in past years was removed, the arch was stabilised with stainless steel dowels inserted between the arch-stones to the supporting stones and lime mortar packed into joints to further improve the long-term stability of the structure. The cement pointing in the rear wall of the well was also removed and redone with a lime mortar. Fragments of concrete block in this walling, which had clearly been reconfigured in the recent past, was removed and replaced with other local stone. Further stone was used to pack in around the well top, prior to the addition of soil.

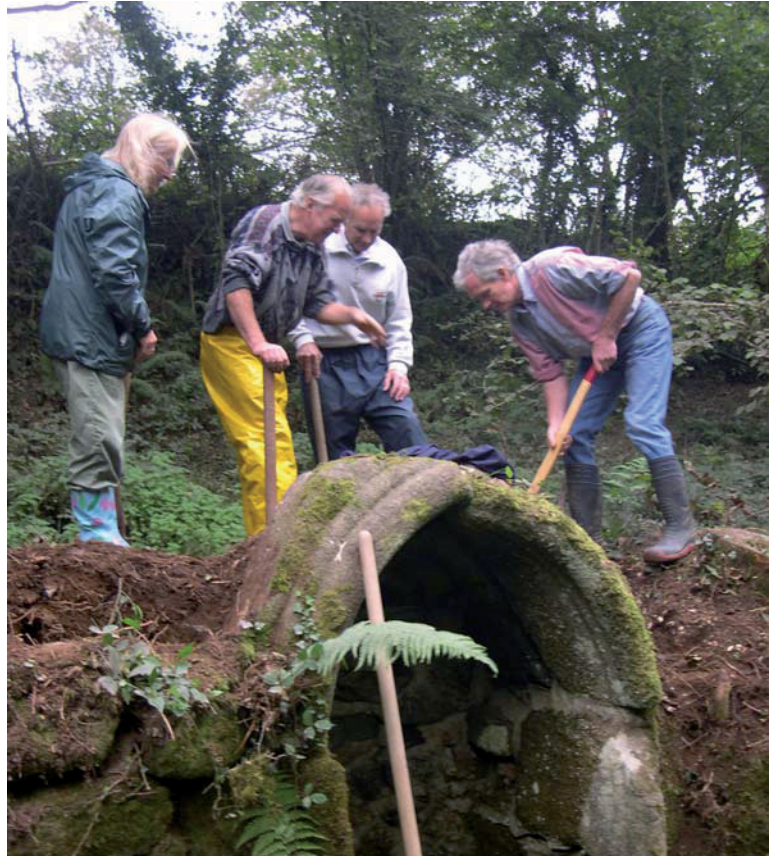
The volunteers from the St Austell Old Cornwall Society visited the site on three separate occasions (Fig. 11). On the first two visits, they removed the sycamore tree that was growing out of the Holy Well structure and also a number of limbs from trees in the general area of the valley in order to improve the visibility of the monument. On their third visit, in the presence of an archaeologist, they excavated out the bank immediately to the rear of the front walls flanking the well and around the well itself, in order to make it easier for the masons to carry out the conservation work. To the south, it proved easy work to remove a large number of roots and allow the wall to be pushed back and consolidated. However, to the north, the roots of the removed sycamore tree were quite extensive and difficult to remove, though the volunteers removed as much as they could.

Figs. 11 and 12 Volunteers from St Austell Old Cornwall Society preparing the site for the conservation work and staff from Darrock and Brown repointing of the front walling.

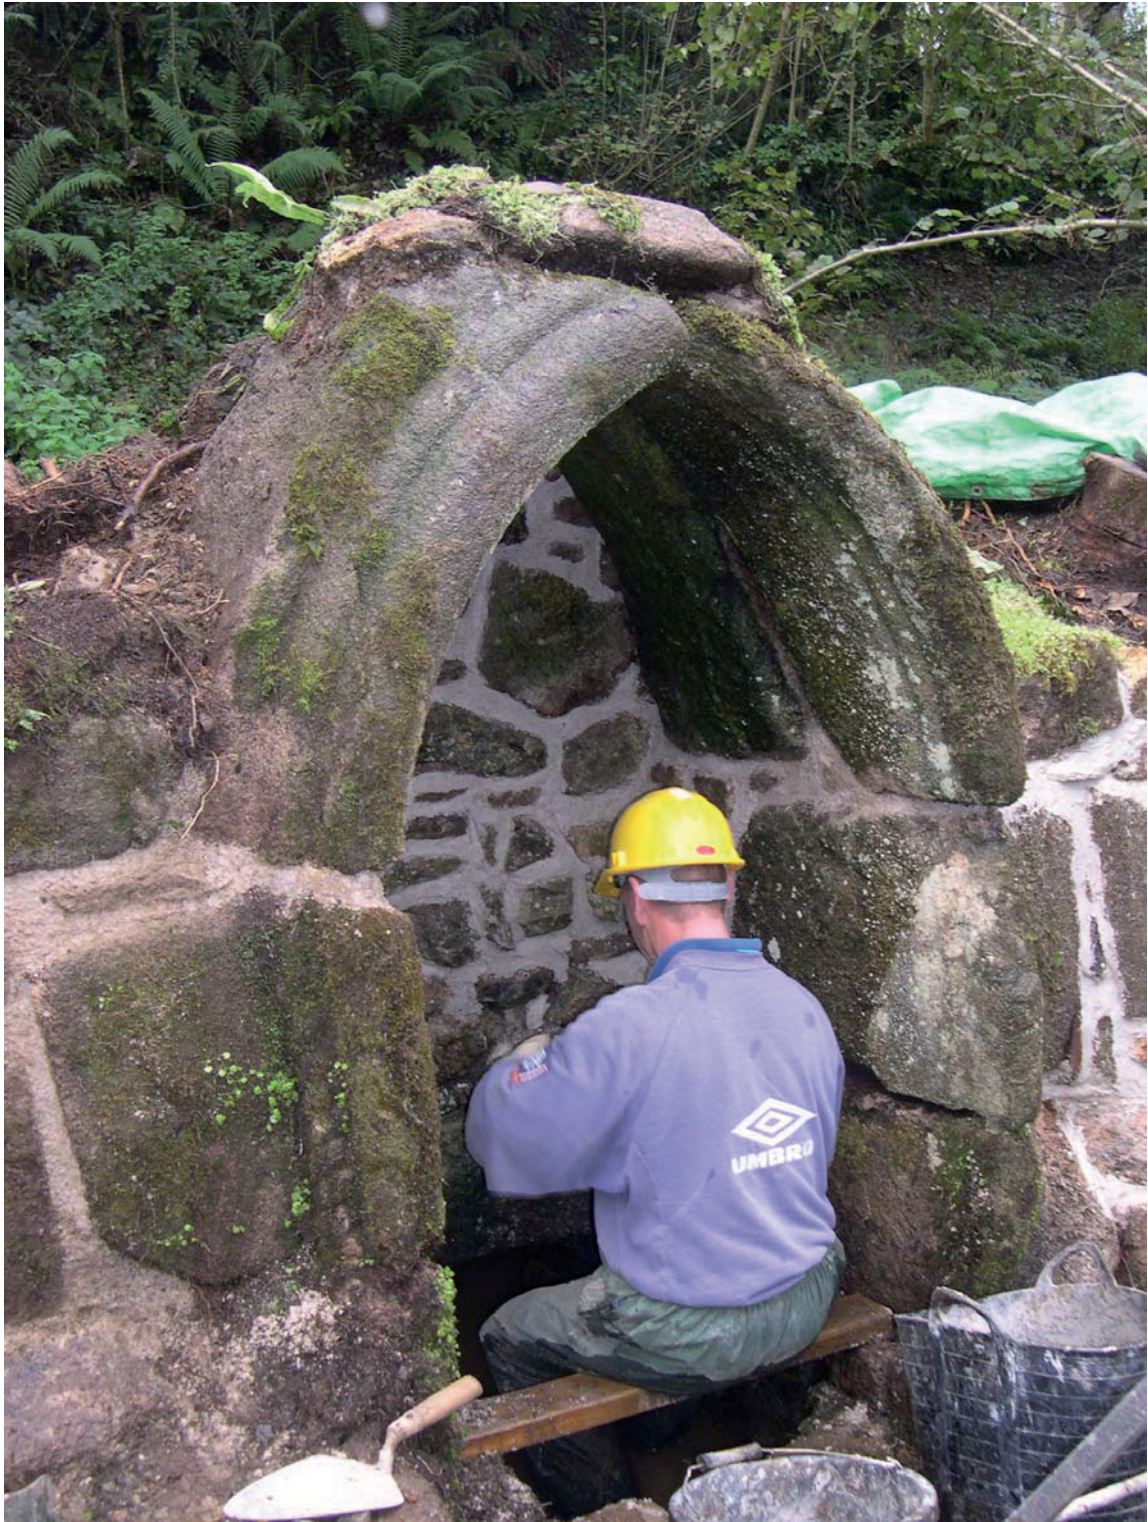
Figs. 13

The repointing of the interior of the Holy Well.

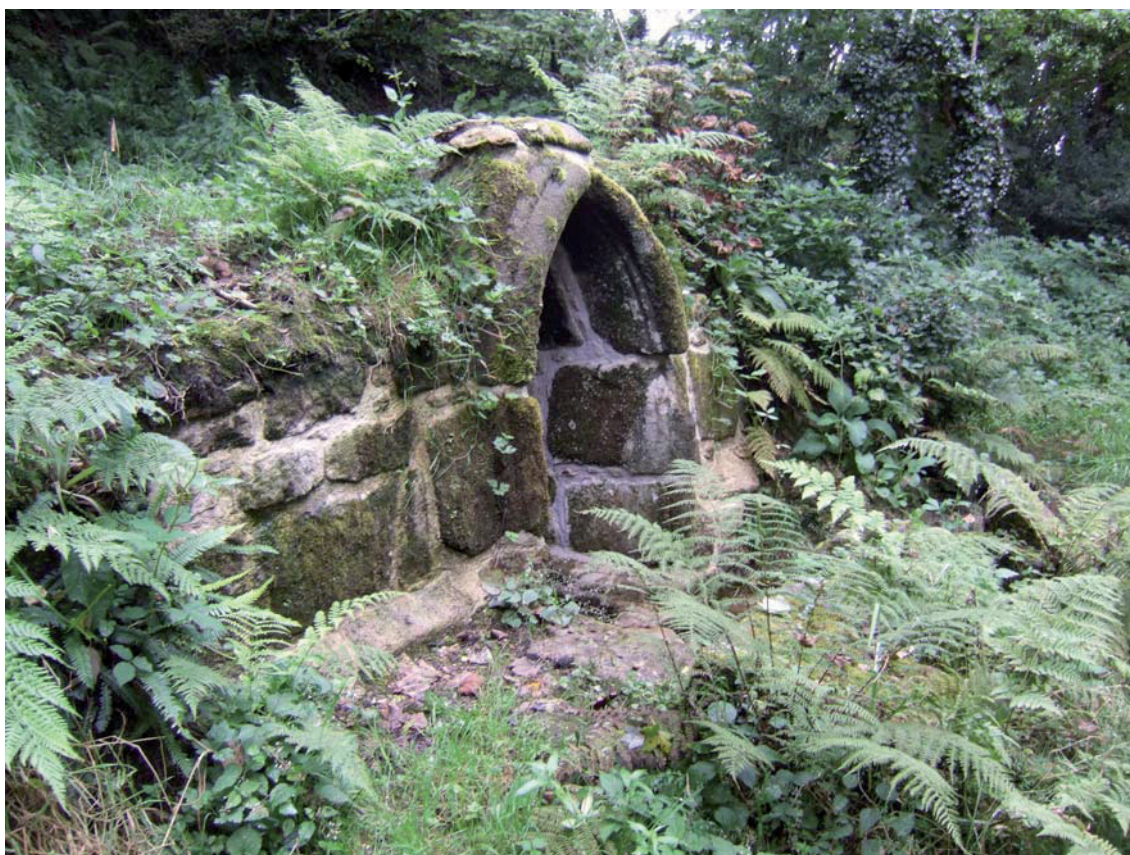
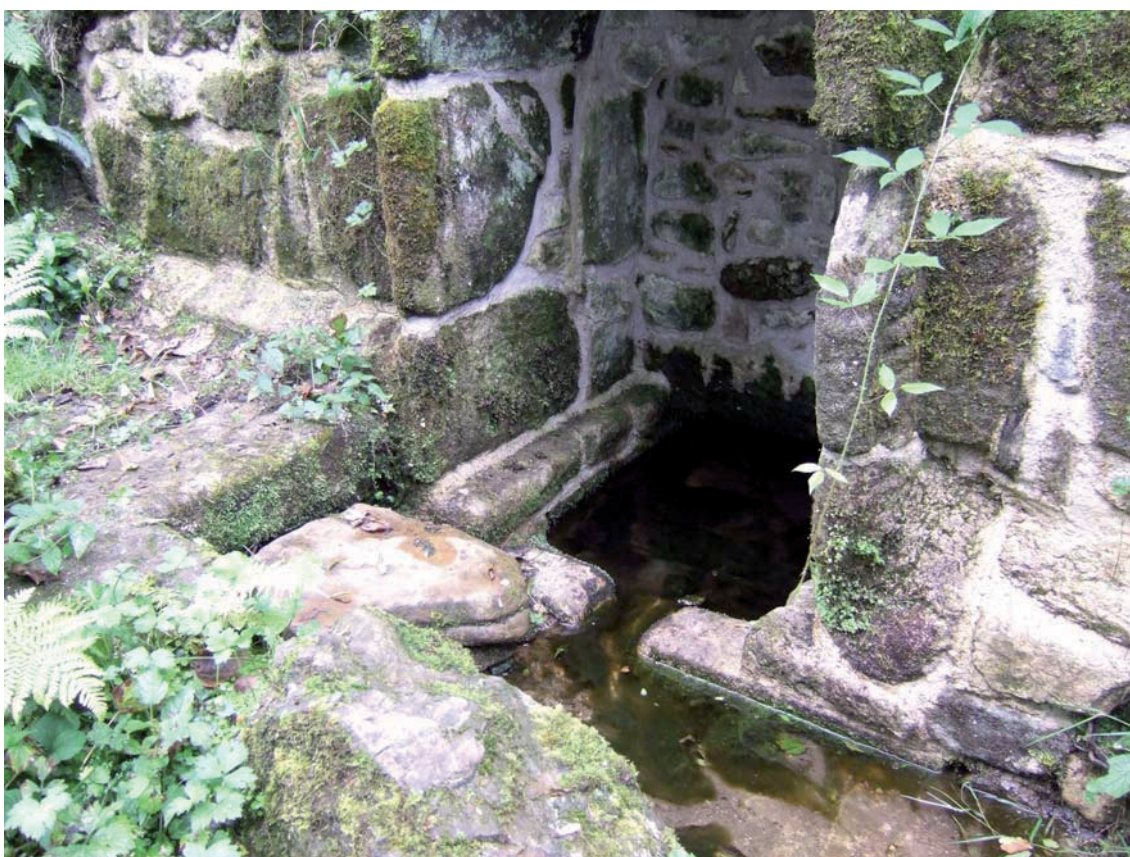
Roche Holy Well was visited again in August 2007 (Figs. 14 and 15) and it was noted that the vegetation around the well had grown back remarkably well and the character of the monument and its immediate environs was largely that as prior to the conservation works taking place. To the north of the arched opening, there is considerable fresh growth of sycamore.

Figs. 14 and 15 Roche Holy Well pictured in August 2007.

It is recommended that a proactive management regime is established and this should be arranged through the English Heritage Field Monument Warden in association with the tenants at Holywell Farm and could involve volunteers from bodies such as the St Austell Old Cornwall Society.

Management work should include:

- Control of sycamore regrowth through annual cutting or spraying with herbicide.
- Clearance of silt from pathways once a year.
- Control of brambles by cutting and spraying on the mound at least twice a year in order to encourage a vegetation cover of grass and fern.
