TREGARGUS VALLEY, ST STEPHEN

Repair work to two bridges

Report No: 2004R006

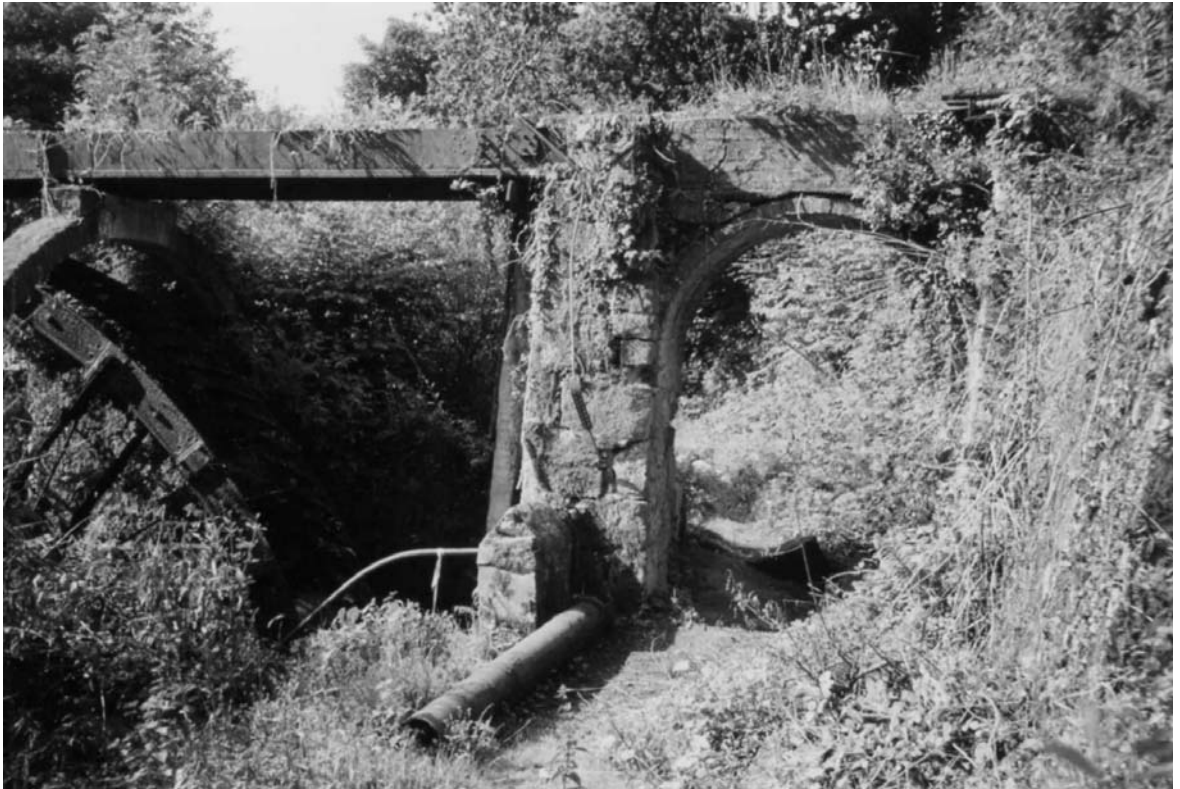
The bridge is largely of granite construction, with the arch and parapets built out of red brick (see Figs. 4, 6 and 7). The south-facing arch was in a very poor condition, with much of the stonework of the main column having collapsed. Part of the brick parapet above the column was missing while a small number of bricks had fallen away from the brick arch (see Figs. 6 and 7).

Fig. 4 Bridge to rear of Big Wheel Mill prior to repair work (from north).

The contractor removed those sections of stonework from the bridge which were unstable, marking each individual stone. The various roots and areas of unstable fill were then removed and the individual stones replaced in their original positions using a lime mortar.

The south-facing column which had suffered most damage was rebuilt. This included the missing section of walling directly beneath the red brick arch, as well as the top of the column where part of the parapet was also missing. This parapet was reconstructed using red brick brought onto site and a small section of missing arch was also replaced.

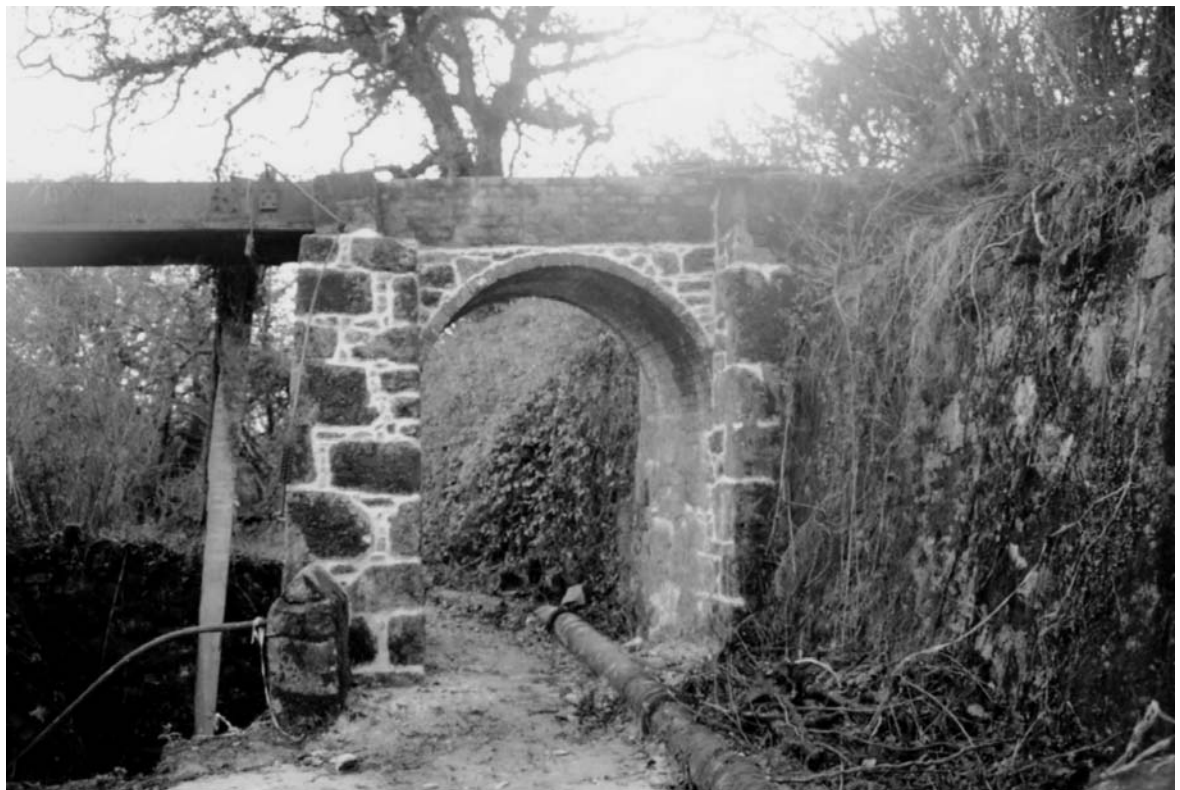
Fig. 5 Bridge to rear of Big Wheel Mill following repair work (from north).

The north-facing parapet was in a better condition but a small part of it had to be reconstructed. Both parapets appeared very unstable. Concrete was laid inside the parapets in order to stabilise the structure.

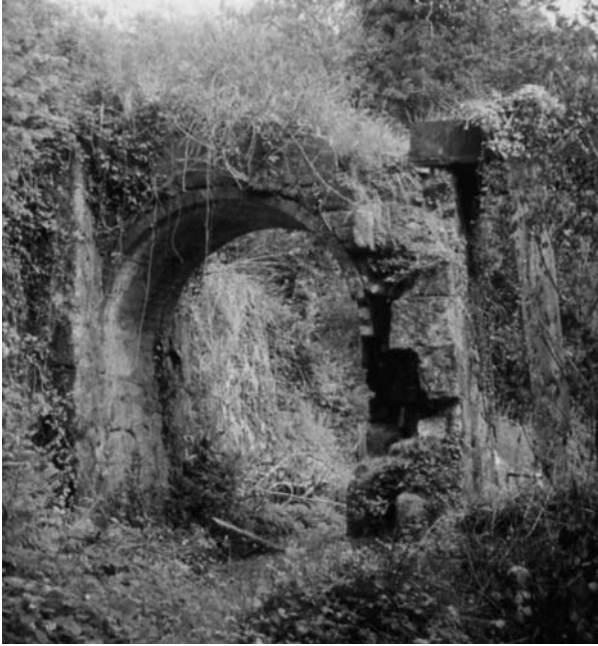
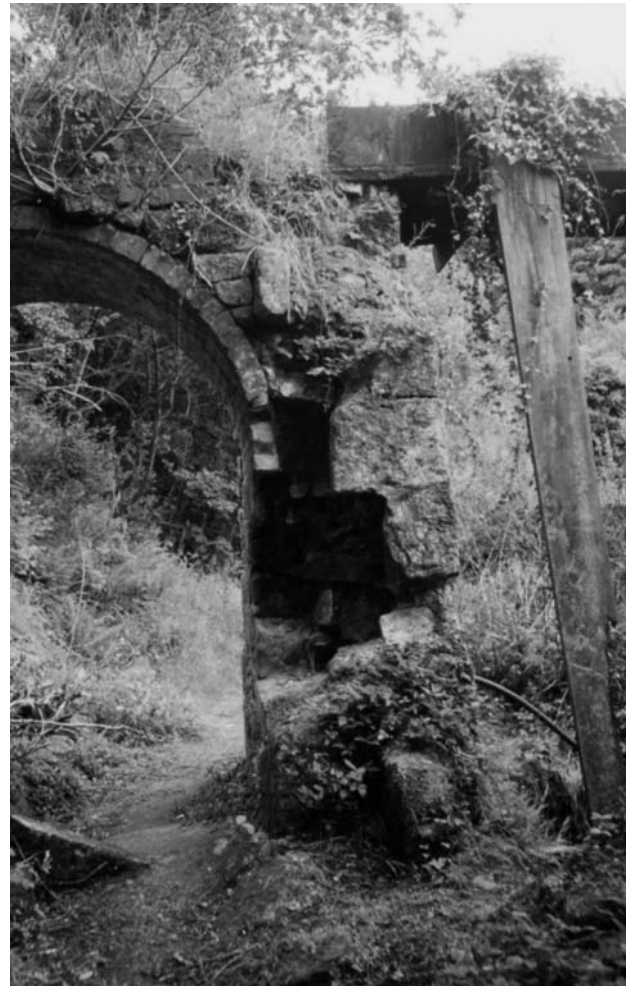
Fig. 6 – Bridge to rear of Big Wheel Mill prior to repair work (from south). Fig. 7 – Close-up of damaged column. Fig. 8 – Bridge to rear of Big Wheel Mill following repair work (from south).

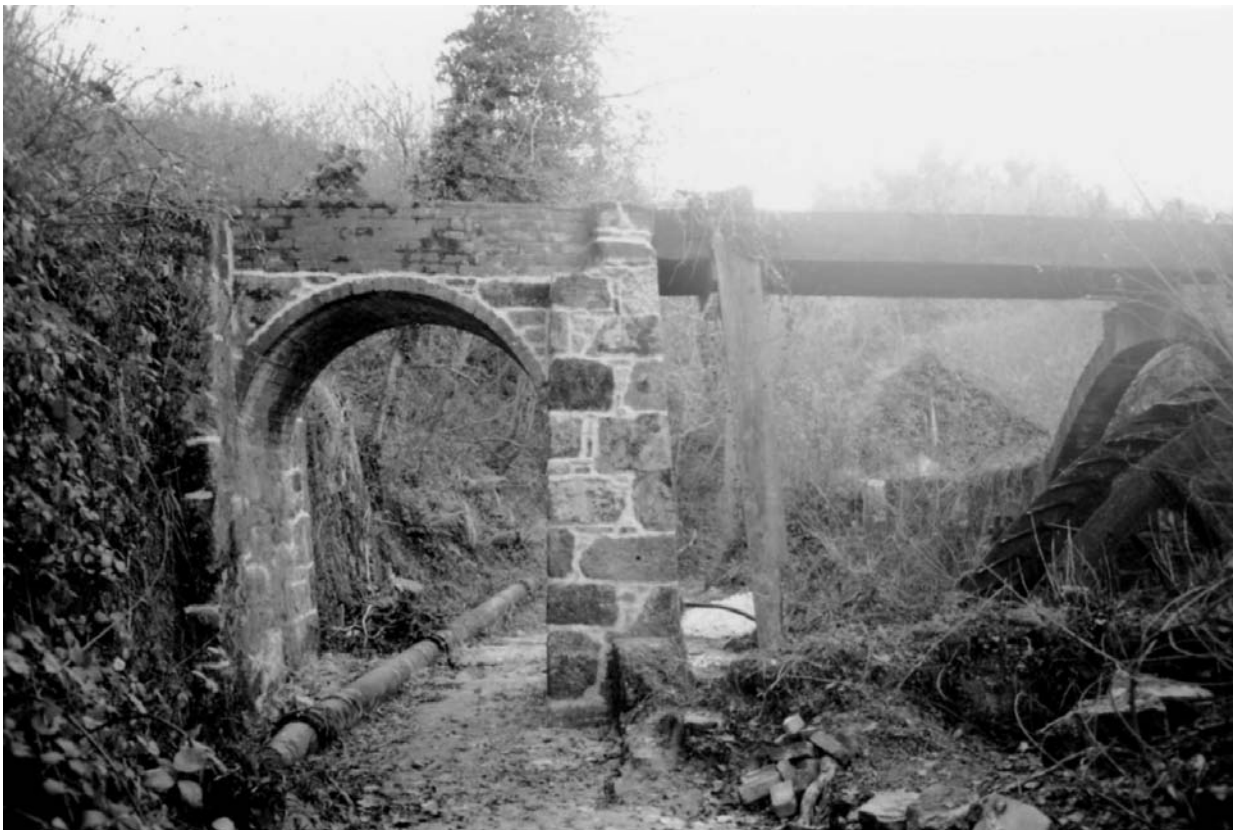
A bridge to the west of Big Wheel Mill was first recorded at this location on the 1880 OS map. It carried a tramway over a lower trackway or access road, between the Big Wheel Mill complex and the Trevear Stone Mill complex. Constructed of granite masonry with a very fine arch, its western face had collapsed leaving the remainder of the structure open to further deterioration (see Fig. 9).

As well as the collapsed arch, the stone-faced abutment to the west of the arch had collapsed while tree roots had also caused considerable damage to similar walling on the eastern side of the bridge.

Fig. 9 (top) – Bridge under tramway prior to repair work (from west).

This bridge was repaired during July 2003. The contractor cleared away collapsed stonework from the bridge and the associated abutments. Overhanging vegetation and the roots of tree which had caused considerable damage were then removed.

The bridge and associated walling were then rebuilt in a style similar to that of the original construction, using adjoining sections as a guide. The arch itself was reconstructed over a wooden frame.

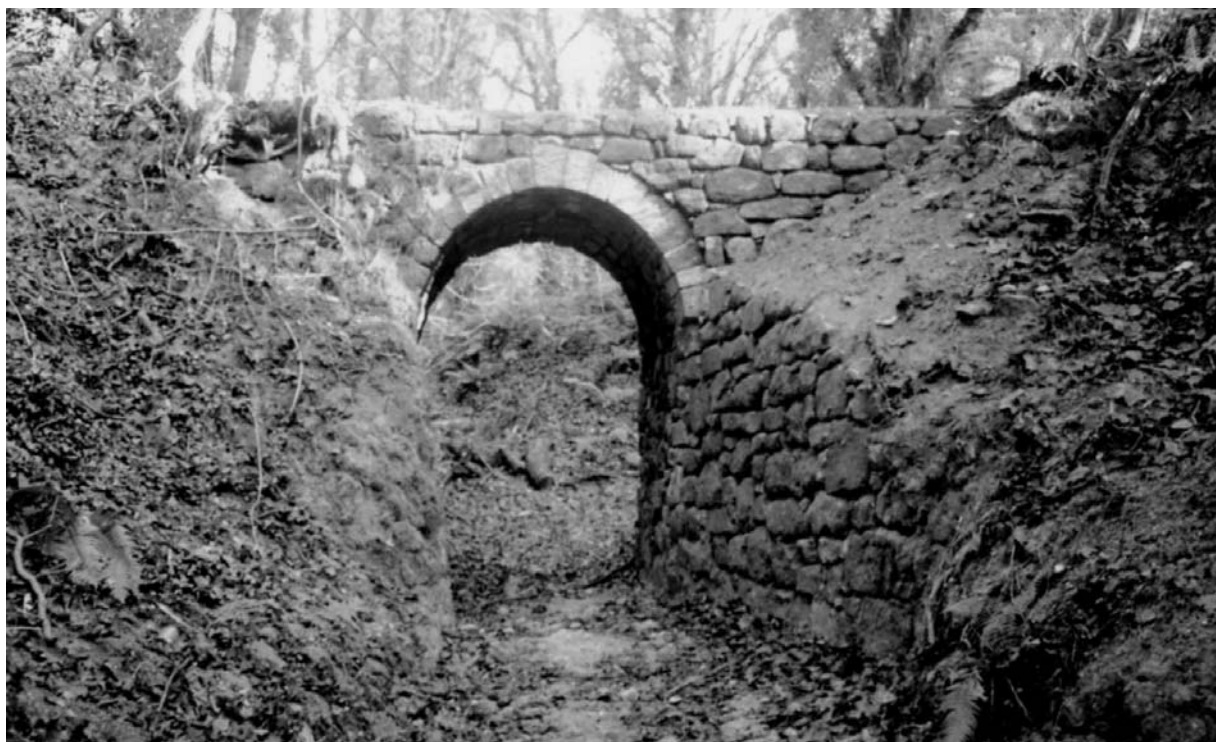
Fig 10 (bottom) – Bridge under tramway following repair work (from west).

The abutment to the west was largely rebuilt. Some mortar was used in the rebuilding and for filling in behind the stonework, but no mortar was showing giving the impression of a drystone wall, retaining the character of other walling in the area. The walling to the east was also rebuilt in a similar fashion, as was the edging to the tramway.

Mr Piper primarily used the stone lying loose in the general area to undertake the repair, though a small number of voussoirs had to be specially prepared off-site in order to reconstruct the face of the arch (see Fig. 10).
