Castle an Dinas, Ludgvan, Cornwall

Conservation work to Rogers Tower and ruined 19th century farmhouse

Report No: 2004R010

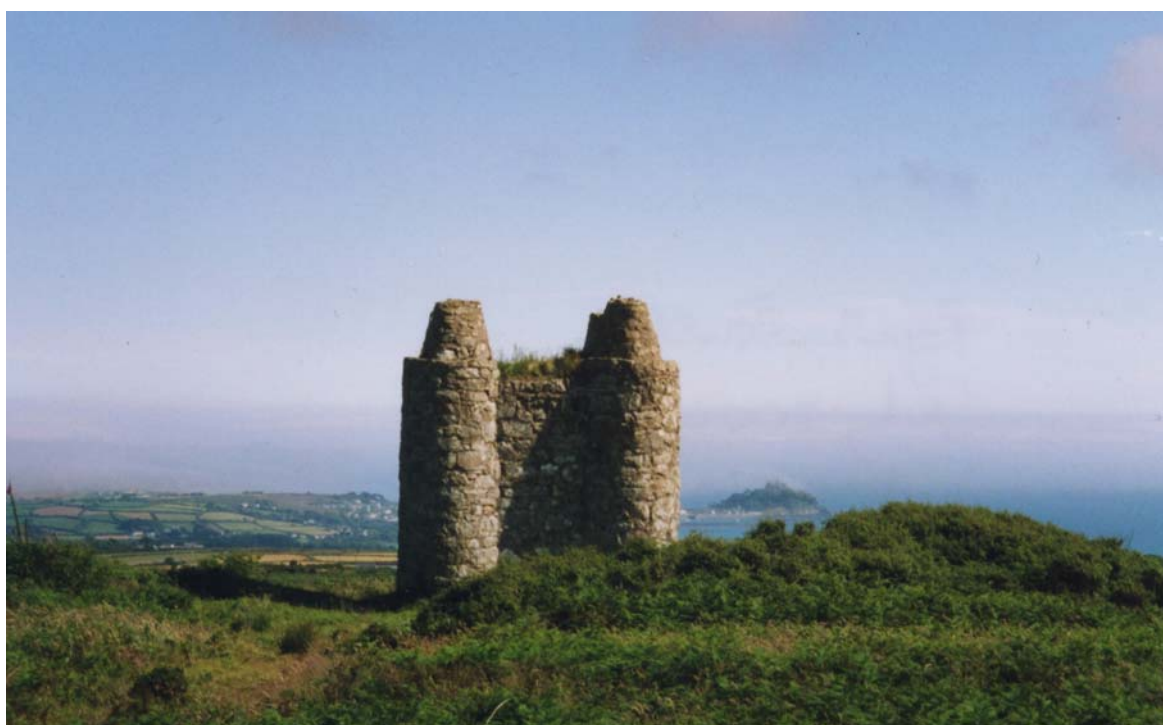
Fig 2 Rogers Tower – view from the north, with St Michael's Mount in the background

Castle an Dinas is a substantial prehistoric hillfort, standing in enclosed heathland on a prominent rounded hill above the B 3311 road from Penzance to St Ives (Fig 1). Associated with the hillfort are two stone buildings: one, a late 18th century folly known as Rogers' Tower (Fig 2) and the other a small 19th century farmhouse (Fig 3). A short distance east of the fort, and named after it, is Castle an Dinas Quarry, owned by Castle Granite. Together, the quarry, tower, and farmhouse form conspicuous landmarks in this part of Cornwall.

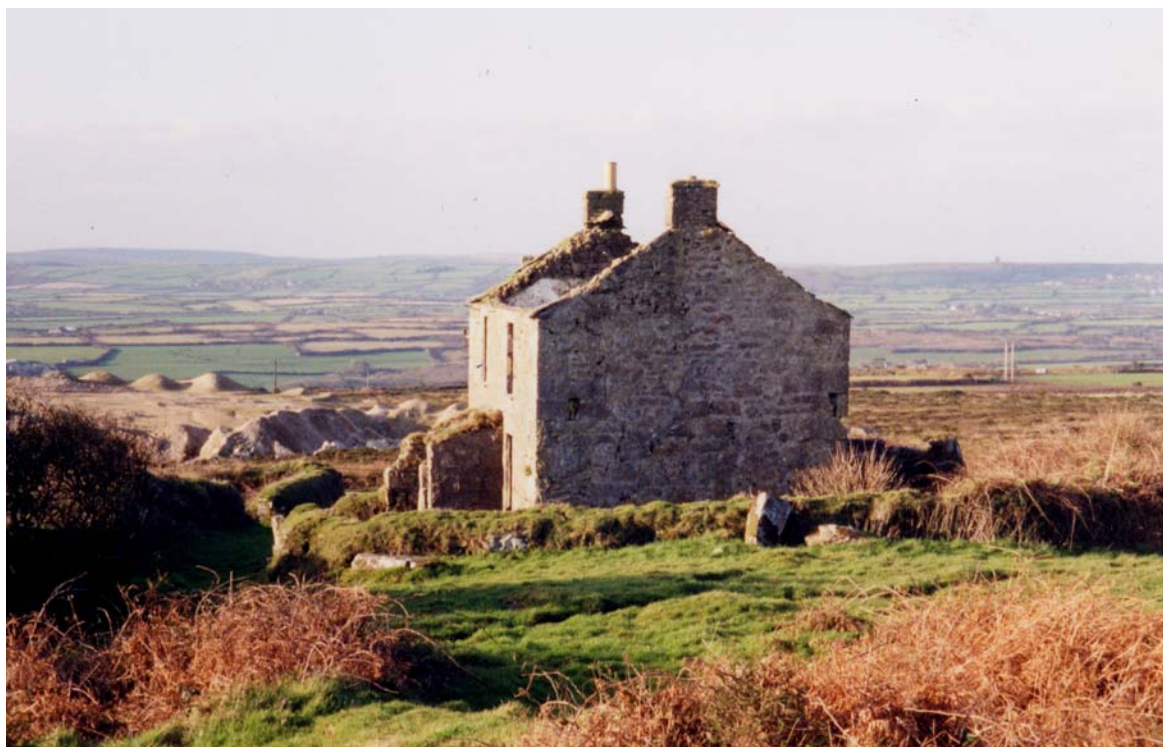
Fig 3 The 19th century farmhouse

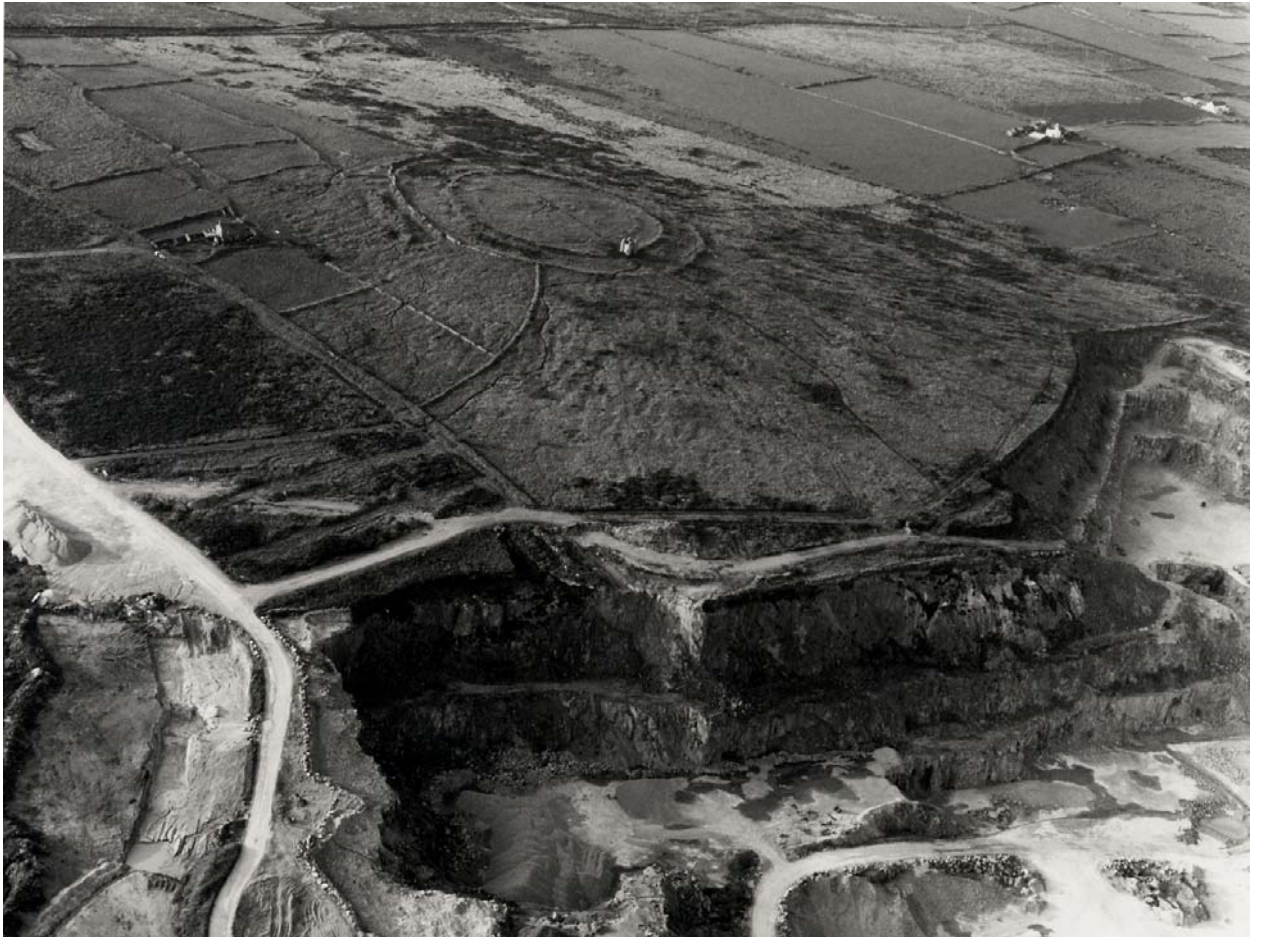
*Fig 4 Air photo of Castle an Dinas and the quarry, taken in 1993.
CAU air photo, F40/177/SW 485 350*

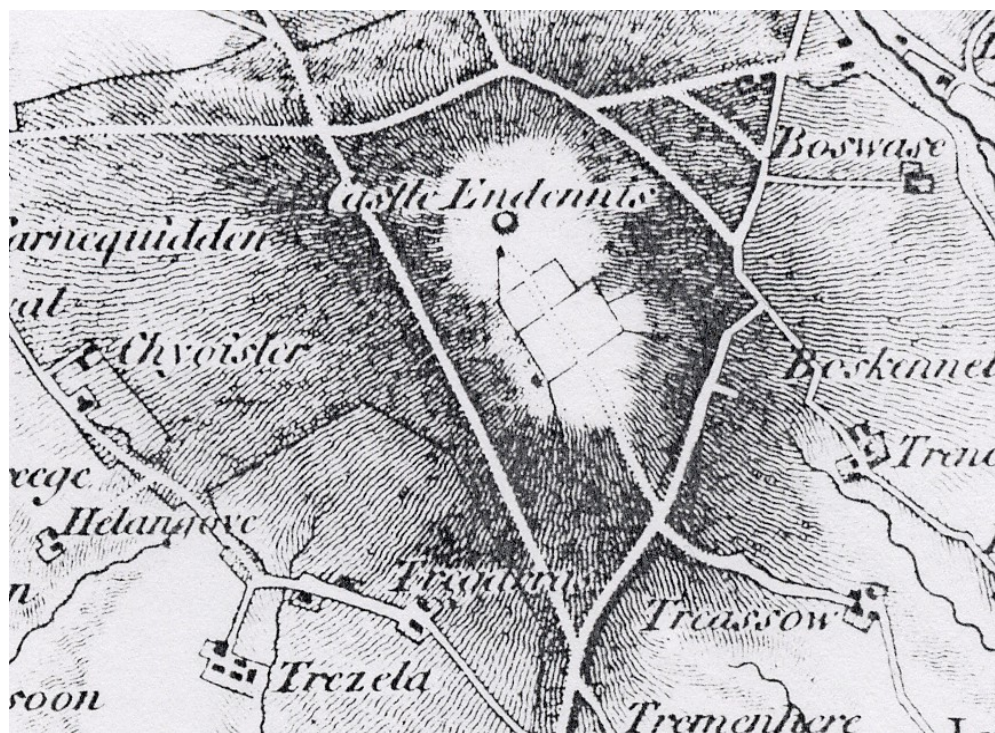
Fig 6 The first edition OS one- inch map, 1813

The land broken in by James Hosking is probably identical with enclosures depicted on the OS first edition map of 1813 to the south of Castle an Dinas (Fig 6). The land here was still rented by the Hoskings in 1838 (the Tithe Award) and on this land, in a small plot beside the track that goes up to Castle an Dinas, is the burial place of James Hosking (Hosking 1970). Although this is not the farm which is the subject of this report, the

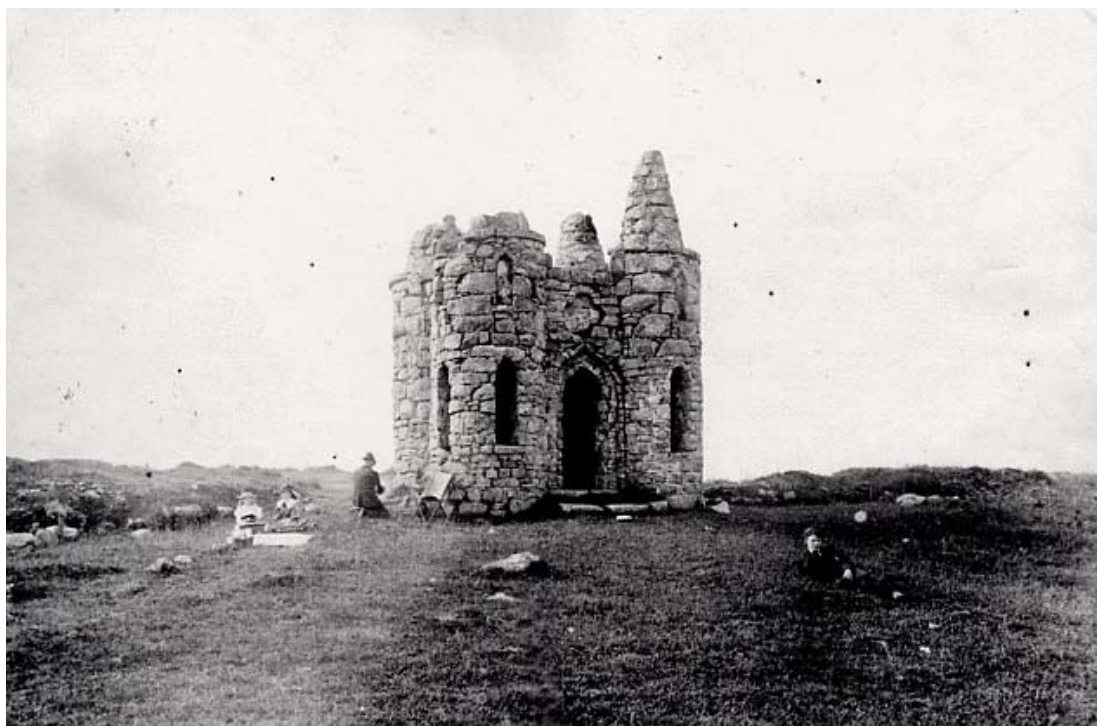
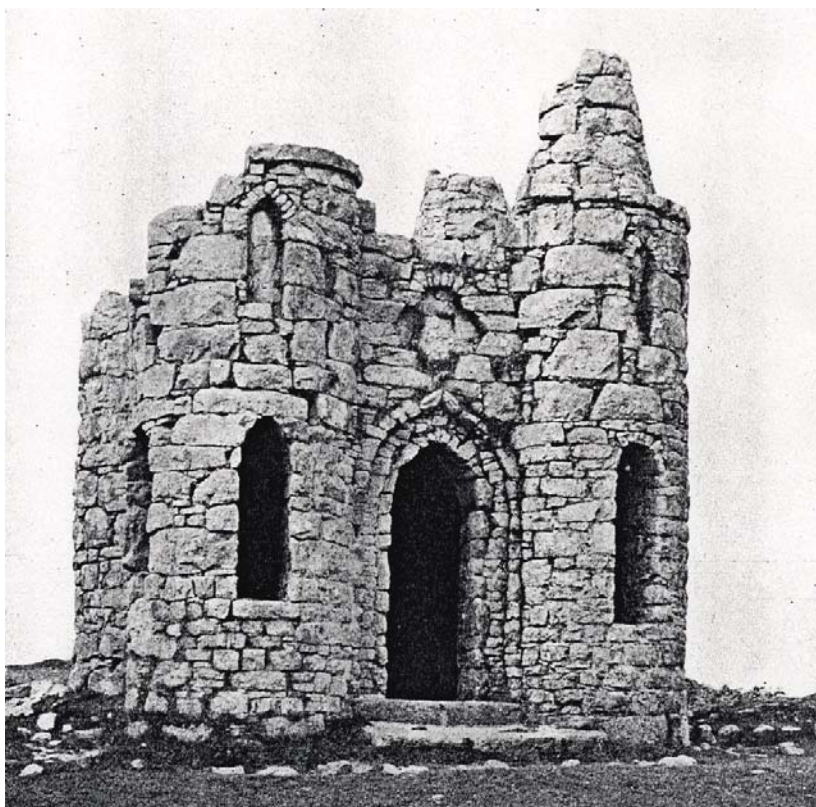
tower. The damage at this time was said to have been so extensive that the turrets had to be put back – although it is clear from the early photos described above (Figs 11 and 12; also Holmes 1993, 39) that they were already in a degraded state in the early 20th century. This repair work, carried out in hard Portland Cement, took place in 1960. The date is incised in the cement both inside and outside the building, along with the initials GS, HT, RM (Fig 13), which must be the names of the builders who were involved. This work affected all parts of the building apart from the domed ceiling, which was perhaps left because of the difficulty of re-pointing the very small stones, above head-height. The fact that when undertaking the conservation work described in this report, the stonework of three of the turrets was found to be entirely bedded in cement, confirms 1960 as the date for their restoration. In the absence of any evidence to the contrary, they were rebuilt at the time with a flat-topped and rather stumpy profile, so that the tower nowadays resembles a child's sand-castle. As noted above, however, they were originally taller, more pointed, and considerably more elegant.

Fig 11 Rogers Tower c 1900. From the photographic collection at the Royal Institution of Cornwall, Royal Cornwall Museum.

Fig 12 Rogers tower in about 1910. Photo from J Harris Stone, Englands Riviera, opposite page 326

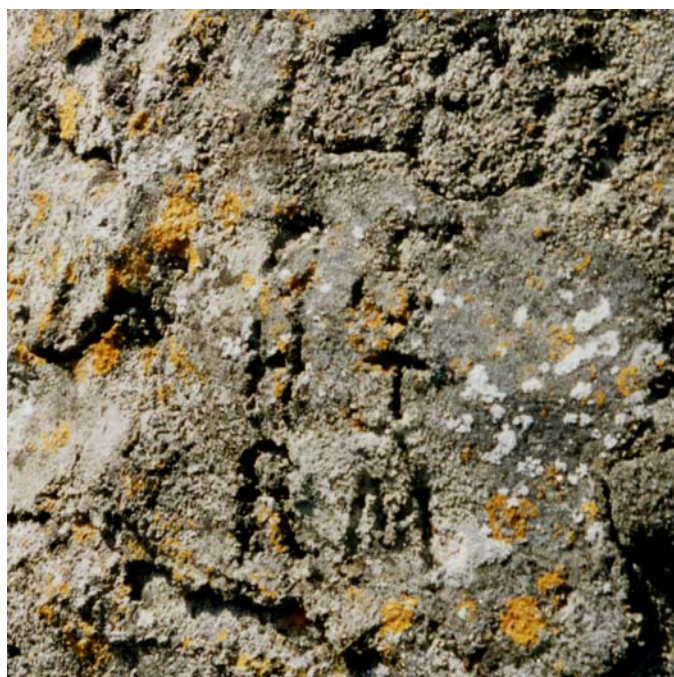
Fig 13 Initials of the builders who restored Rogers Tower in 1960

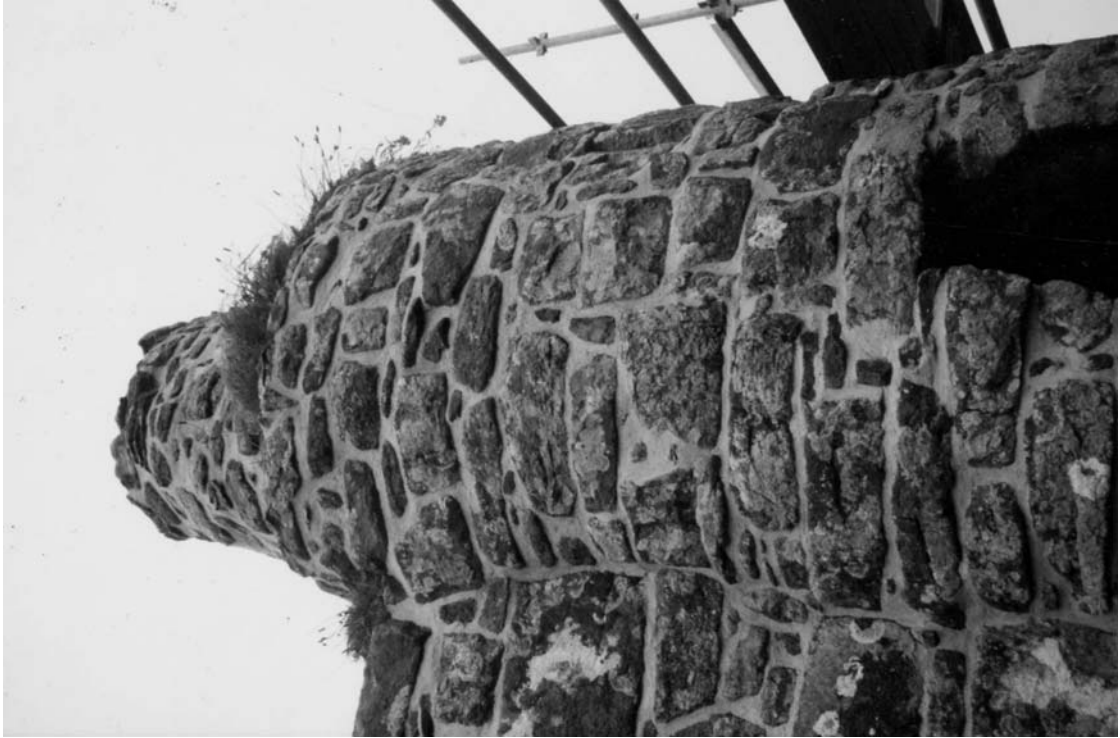
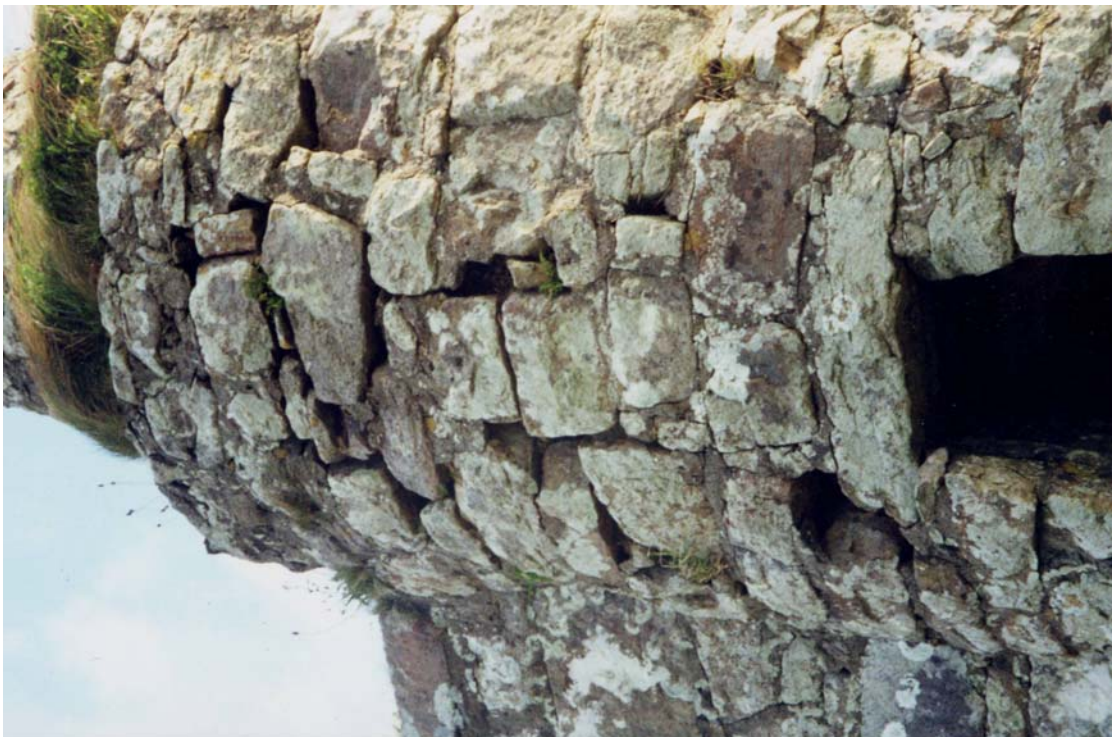
Fig 14 Rogers Tower, SW bastion before conservation work (left) and after conservation work (right)

All of the failed cement pointing was removed, the joints raked and washed out, and repointed according to the methods and with the mortar recommended by Stephen Tucker of SMT Associates. This consisted of one part St Astier Naturally Hydraulic Lime (NHL 3.5) to two and a half parts sand, the latter being a mix in equal parts of Clevedon Farm (a limestone) New Milton coarse and Doble sand - the latter being the only Cornish sand used. The reason for including the limestone was to increase the porosity of the mortar: an important factor in this very exposed location. The Doble and New Milton are both very clean sands, which balance each other to produce a well-graded mix, the Doble being very fine and the New Milton quite coarse. The resultant pointing is a very light creamy – white, which considerably lifts and lightens the overall appearance of the building.

In areas where the cement was too solid or too deep to remove – notably in the turrets which had been rebuilt in 1960, and in the top third of the back (north-west) wall, the top inch or so was removed only, and the lime placed on top of the cement, in order to create a uniform appearance.

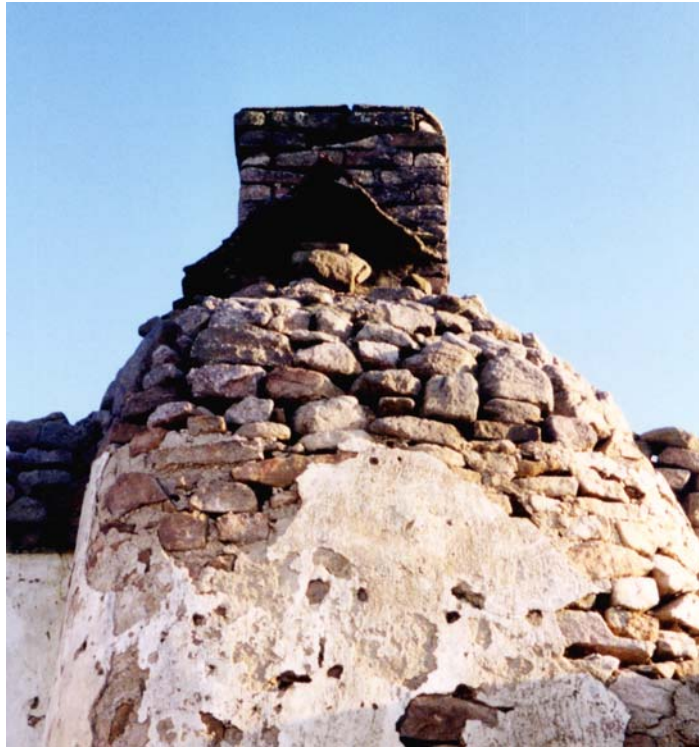
- The wall tops were all exposed, allowing rainwater penetration. In places, the tops of the walls had developed a good cover of grass, but in large parts, notably on the north-east gable, the stone was loose and unstable.
- The two chimney stacks were severely eroded, particularly near the top, where the wall had never been plastered (Fig 15).
- All window openings on the front elevation originally had granite lintels on the outside, but softwood inside. The wooden lintels were damaged in the fire, those downstairs being completely lost, those upstairs being badly burnt but still extant. Where the downstairs lintels were lost, the masonry above had collapsed. A further wooden lintel above a blocked doorway in the rear elevation had similarly caused localised collapse of the masonry above it.

Fig 15 Eroded chimney breast, before conservation work

The deeply eroded chimney breasts were repointed in the same lime mortar as that used for the wall tops, to consolidate the loose stone; and finally, some repointing of the walls was undertaken, the majority in the upper part of the most exposed, south-west facing wall.

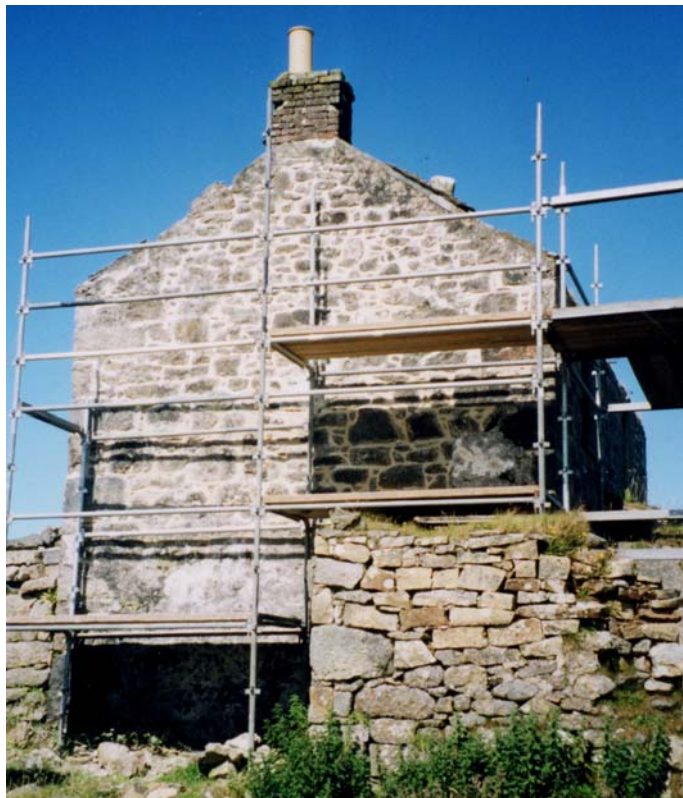
Fig 16 Work in progress on the farmhouse

Work to the farmhouse was limited to that considered essential for stabilising the stonework, halting erosion, and prolonging the life of the building. The most important element of this was the capping of the walls and gables, to prevent water from penetrating the stonework. To provide a stronger mortar for this exposed position, the lime used in the mortar was NHL 5 in a 1 : 2.5 mix with the same sands as those used for Roger's Tower. After capping with mortar, a thick layer of local turf was laid on top of the walls, to provide an additional layer of protection.

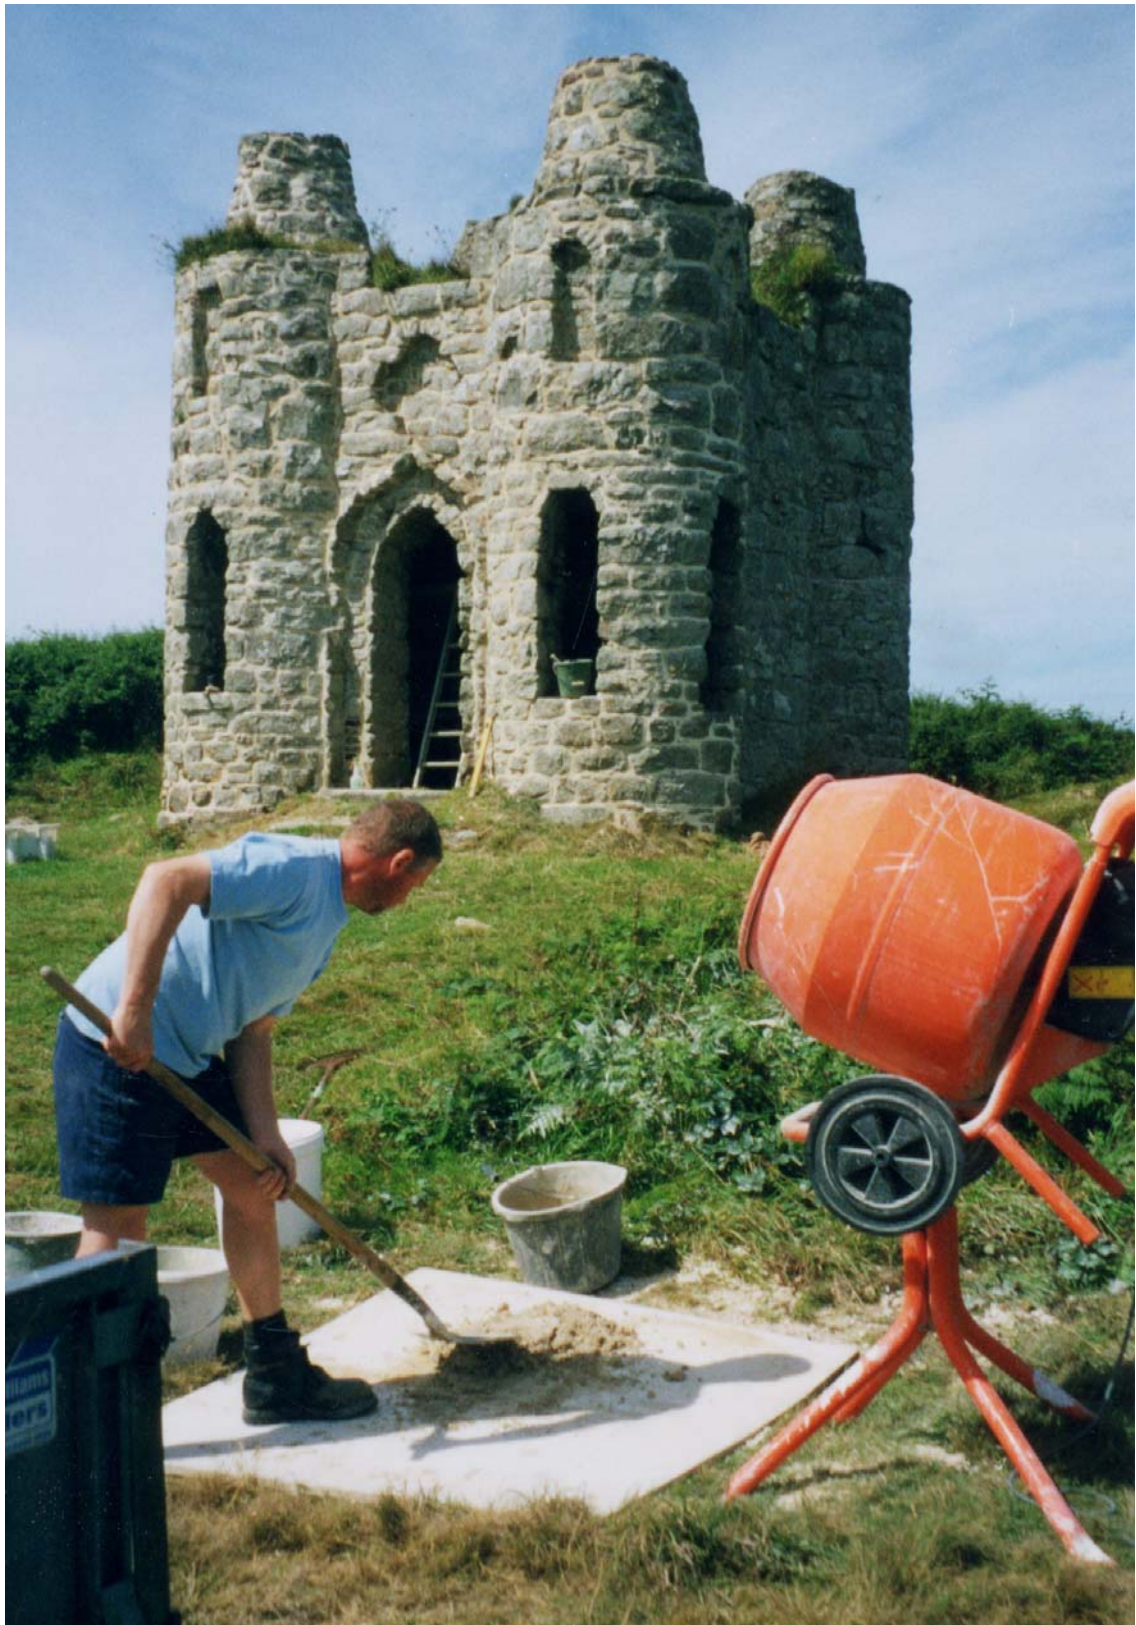
Fig 17 Work in progress at Rogers Tower.

In the first season of work, two external faces of the tower, two bastions and two turrets were repointed, as well as the domed ceiling inside. The elevations chosen for repointing first were the south-west, because this is exposed to the worst weather, and the south-east, because this is the side from which the folly is generally approached, and the side which is most conspicuous from the nearby B3311 road (which sadly, is as close as most people get).

In the second season, the two north-facing elevations and the two northern turrets were tackled.

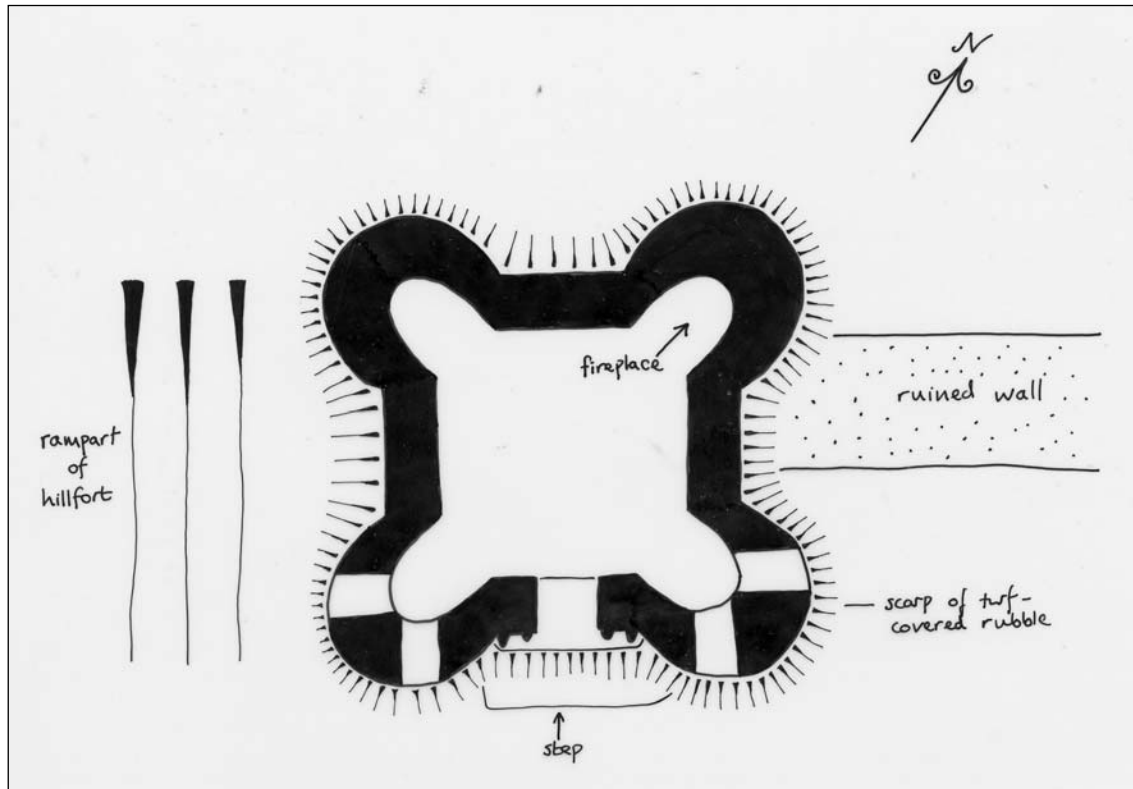
The squat tower, built of roughly coursed granite with an earth and rubble core, is square, with circular angle bastions. Overall, it measures just over 5 metres from south-west to north-east, and from north-west to south-east. The main, front, elevation faces south-east. Occupying almost the full width of the front elevation, between the bastions, is a doorway with pointed arch (the outer of ogee form), framed by two projecting courses of smaller stone, with above it, a quatrefoil formed of recessed masonry. The two bastions in the front (south-east face) of the building each contain two narrow, pointed windows at ground level, with two similar but 'blind' windows formed of recessed masonry above. Comparison of the early photos (Figs 10, 11 and 12) with the present building shows that some of these windows, notably the lower window to the right of the doorway and the upper 'blind' window to the left, have been rebuilt with a single lintel-like stone replacing the original pointed top of the arch. Likewise, the reconstruction of the turrets does not reflect their original character. Fig 10 shows clearly that the turrets on Rogers Tower were originally more pointed and cone-shaped, like smaller versions of the sugar loaves at Werrington Park (Daw 2002).

Taking measurements for the sketch plan that is reproduced in fig 18 proved instructive and informative. After grappling for a while with unwieldy metric measurements, the tape measure was flipped over and neat round figures emerged. For example, the tower's

straight walls all measure 5 ft long and are 2 ft thick. The bastions are 6 ft in diameter, the doorway is 2 ft 6 in wide and the windows, though more variable, are on average 1 ft 6 in wide! The implication of this precision and symmetry is that the tower was carefully designed and laid out, according to Imperial standards, and was not just thrown up to a vague idea.

Fig 18 Sketch plan of Rogers Tower.
